Re: 2025 Inspection Summary – Treated Sub-Grade Berm
Portland International Airport
ECSI #2118

This letter, prepared on behalf of the Port of Portland (Port), documents the inspection and reporting associated with the Treated Sub-Grade Berm (Berm) constructed at the Portland International Airport (PDX). Berm management for the period covered by this report (2025) has been in accordance with the Treated Sub-Grade Berm Management Report, dated May 28, 1998.

Treated Sub-Grade Berm
Portland International Airport, Port of Portland
Portland, Oregon

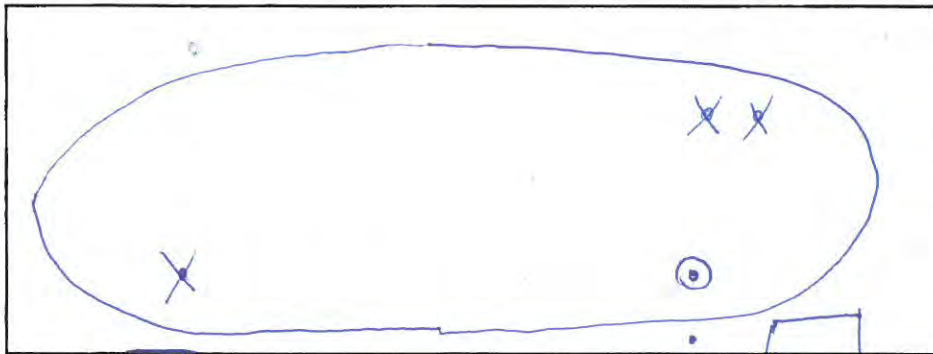
⊙ = previously reported erosion
 X = animal burrows w/ holes ~ 1 ft deep could be deeper

| 1) | <input checked="" type="checkbox"/> | <input type="checkbox"/> | Are erosion scars > 3" deep visible? = ⊙ |

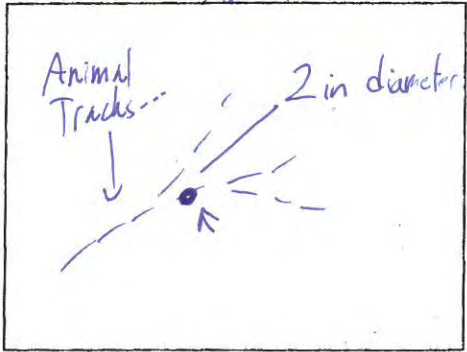
General Animal Burrow

Animal Burrow/Erosion Scar
Found on top of Berm approx.
6 inches Deep See Photo

Hole is not a straight
line down approx 2 ft
deep per hole. They could go
lower. Apex is unable to confirm;
will monitor

Carmen Owens contacted on findings

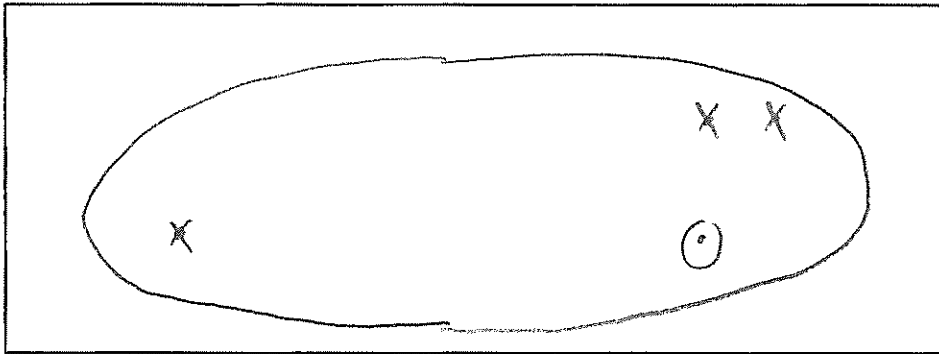
key N4
 ⊙ = previously reported erosion (< 3" deep)
 X = animal burrows
