Operation and Maintenance Report
January 2014 to December 2014

McCormick and Baxter Superfund Site

Portland, Oregon

July 6, 2015
15670-10/Task 4

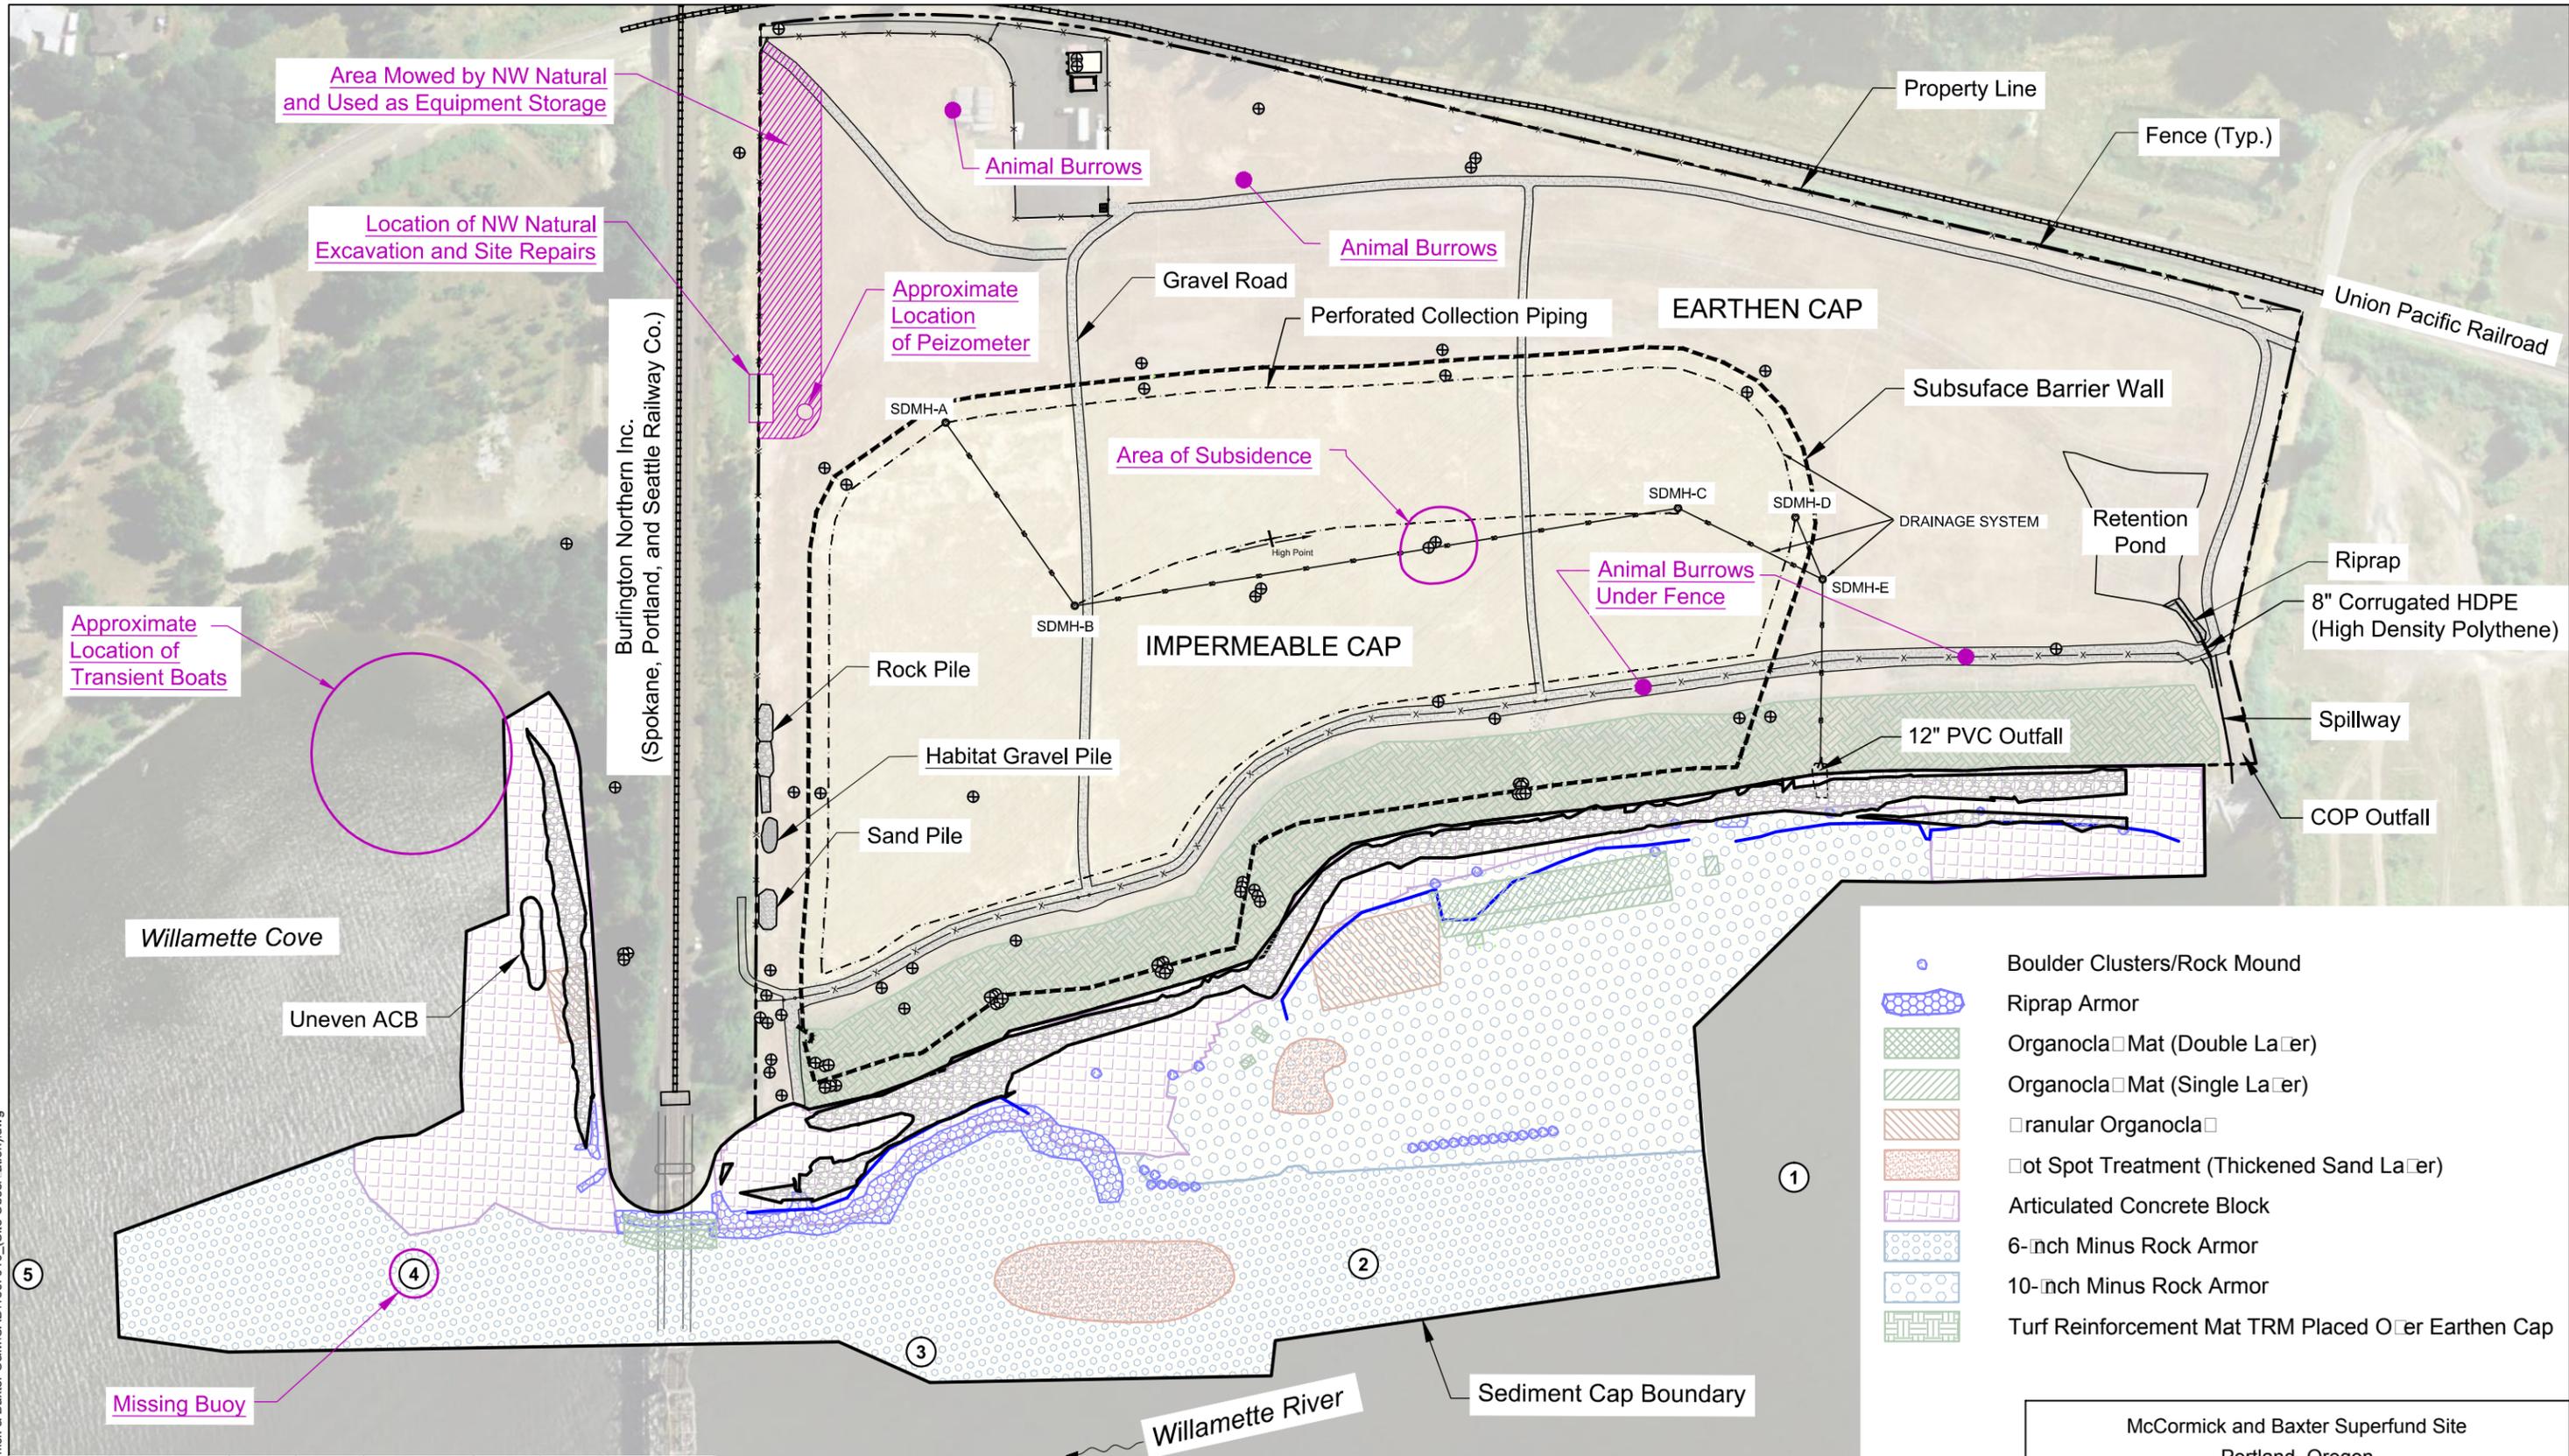
Soil cap observations were conducted according to the Final O&M Plan. Site inspections were conducted on January 29, April 16, July 28, and October 14, 2014, by the DEQ and HC/GSI. Observations of interest from the routine inspections are summarized on Figure 2-1 and described below.

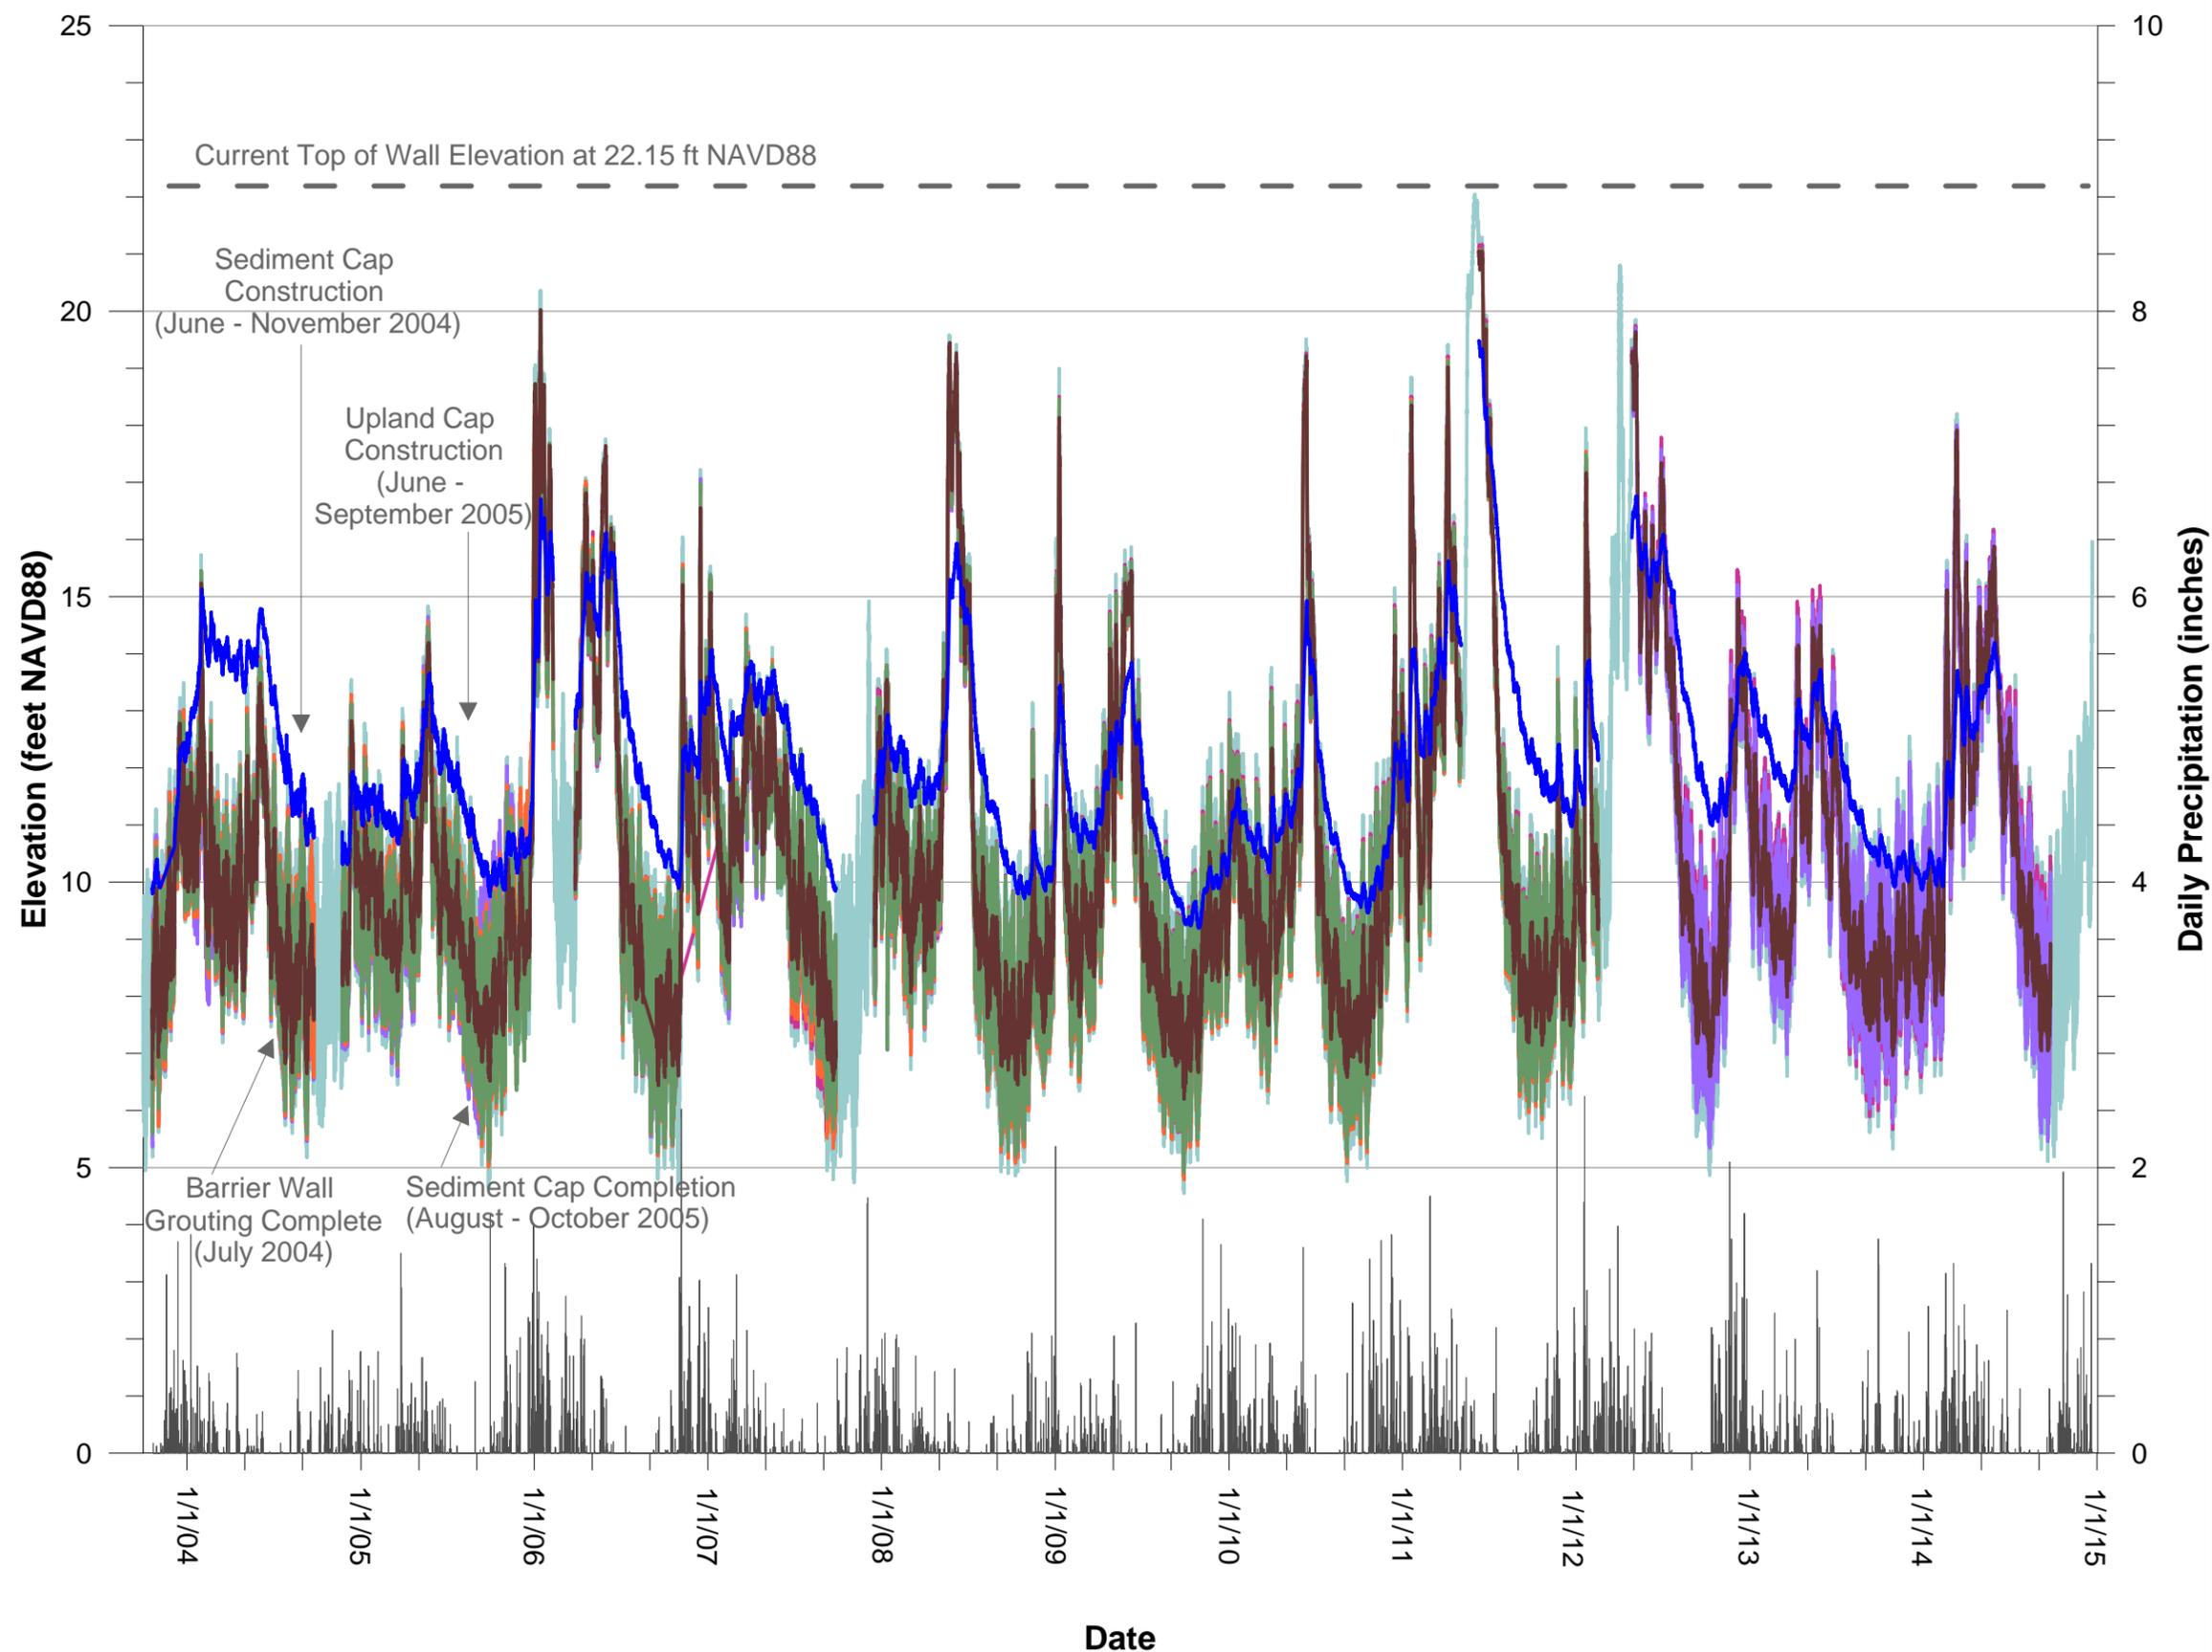
**Figure 4-8:
Post-Barrier Wall Groundwater Elevations
in Monitoring Wells MW-36 and MW-37**

Vertical gradients inside and outside the barrier wall along the Willamette River were observed in monitoring well clusters MW-36/MW-37 and MW-44/MW-45 (Table 4-3). The hydrographs for these wells (Figures 4-8 through 4-11) indicate that the deep groundwater zone is in direct hydraulic connection with the river. The deep zone both inside and outside of the barrier wall closely mimics the river stage, both in elevation and timing, with a small vertical gradient that varies upward and downward with the tidal changes. The exterior shallow wells, also in hydraulic connection with the river, show about a quarter cycle delay from river fluctuations and have dampened amplitude in comparison with the deeper wells.

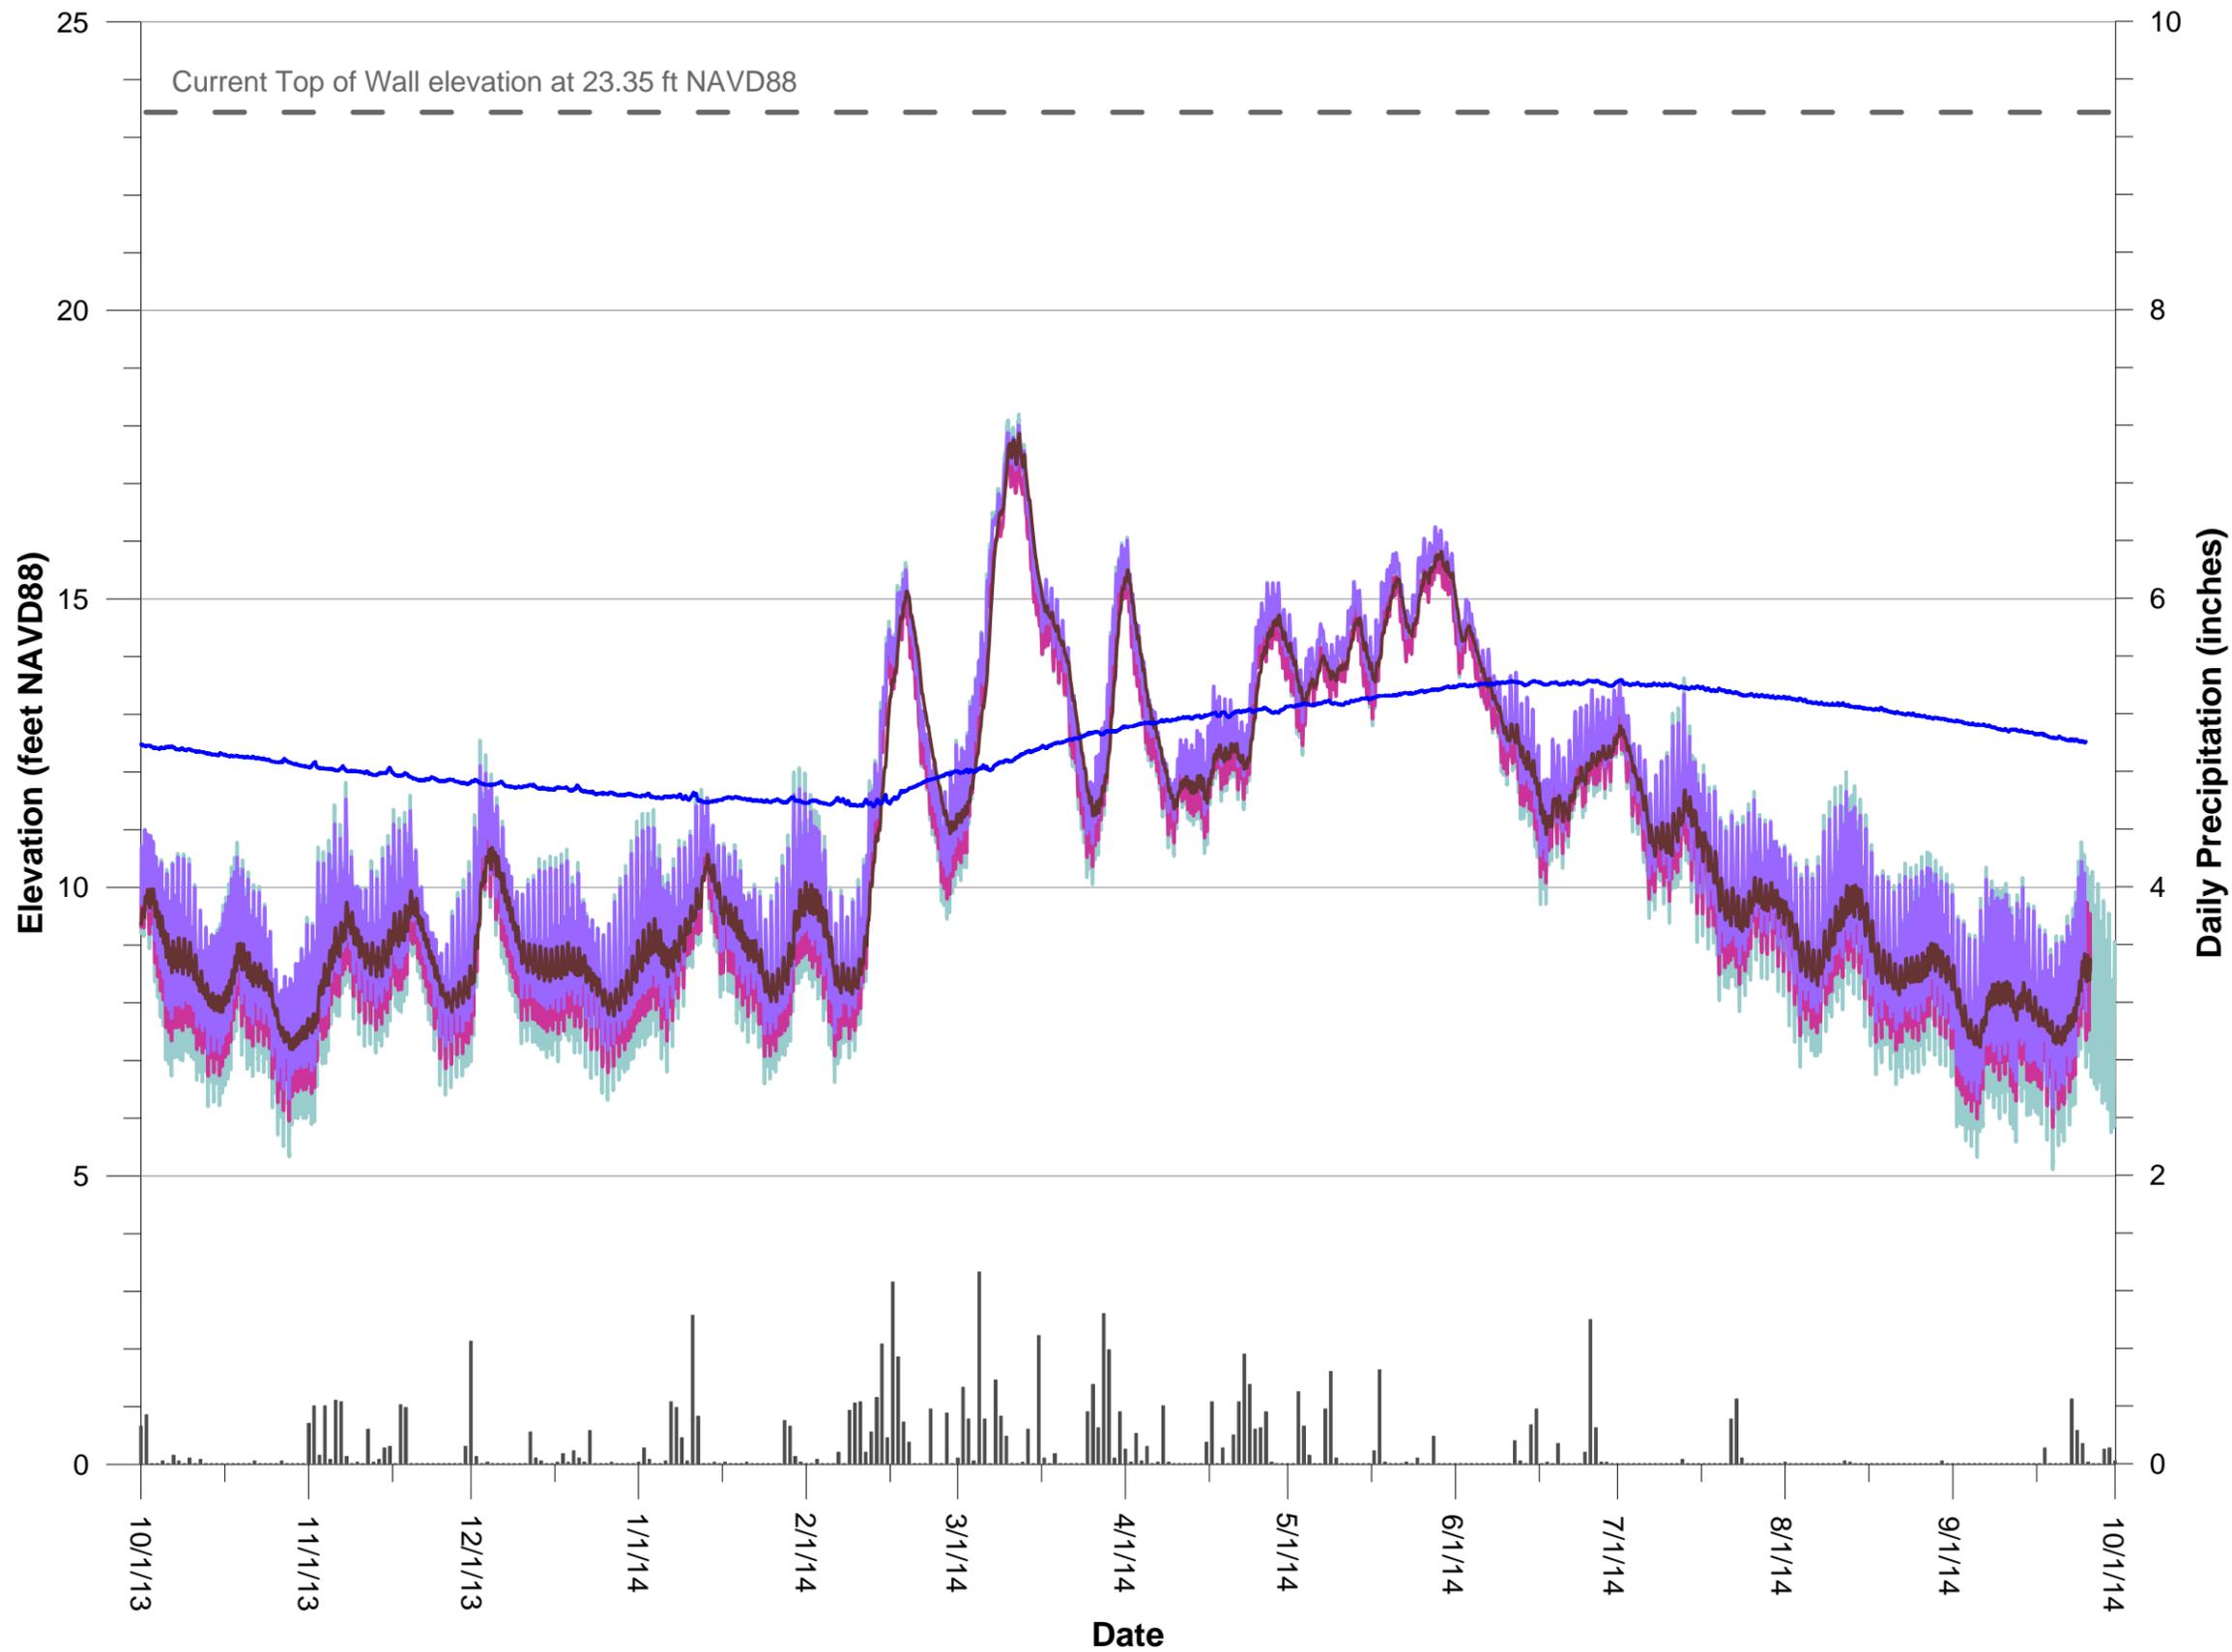
**Figure 4-11:
2014 Groundwater Elevations
in Monitoring Wells MW-44 and MW-45
McCormick and Baxter Superfund Site
Portland, OR**

The muted or nonexistent response of interior shallow wells compared with the intermediate and deep zone wells suggests a clear hydraulic disconnect between the shallow aquifer within the barrier wall and the deeper water-bearing zones. The location where the response is greatest, but still significantly muted, is in well MW-36s (Figures 4-6 through 4-9), where a hydraulic connection exists at the base of the barrier wall. While a muted response of well MW-36s to changes in daily river stage elevation is still observed, water levels in the shallow interior wells MW-44s and EW-1s are virtually non-responsive to the changes in the Willamette River stage (Figures 4-10 and 4-11 for MW-44s, and Figures 4-6 and 4-7 for EW-1s). This reflects the presence of a confining silt layer between the shallow and intermediate zones near wells MW-44 and EW-1s.

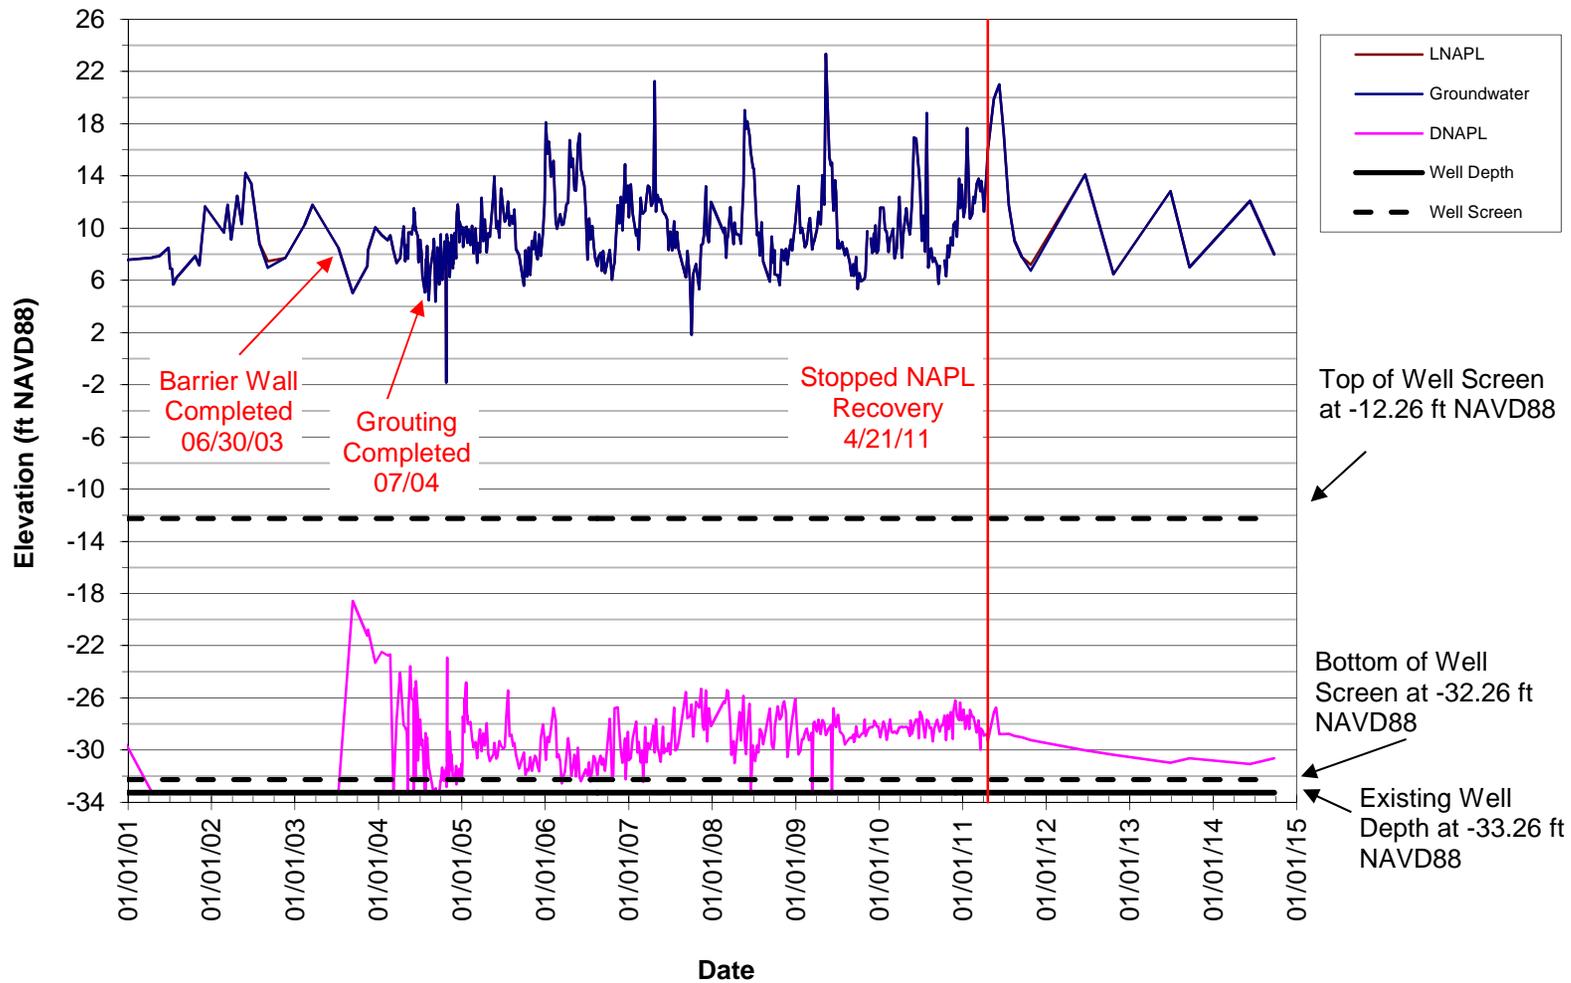
Note: DNAPL recovery was attempted in July 2007 but the extracted liquid appeared to be water with speck sized globules of DNAPL (with a creosote odor), rather than a distinct layer, suggesting that the DNAPL thicknesses measured may not accurately reflect the amount of DNAPL in the well.

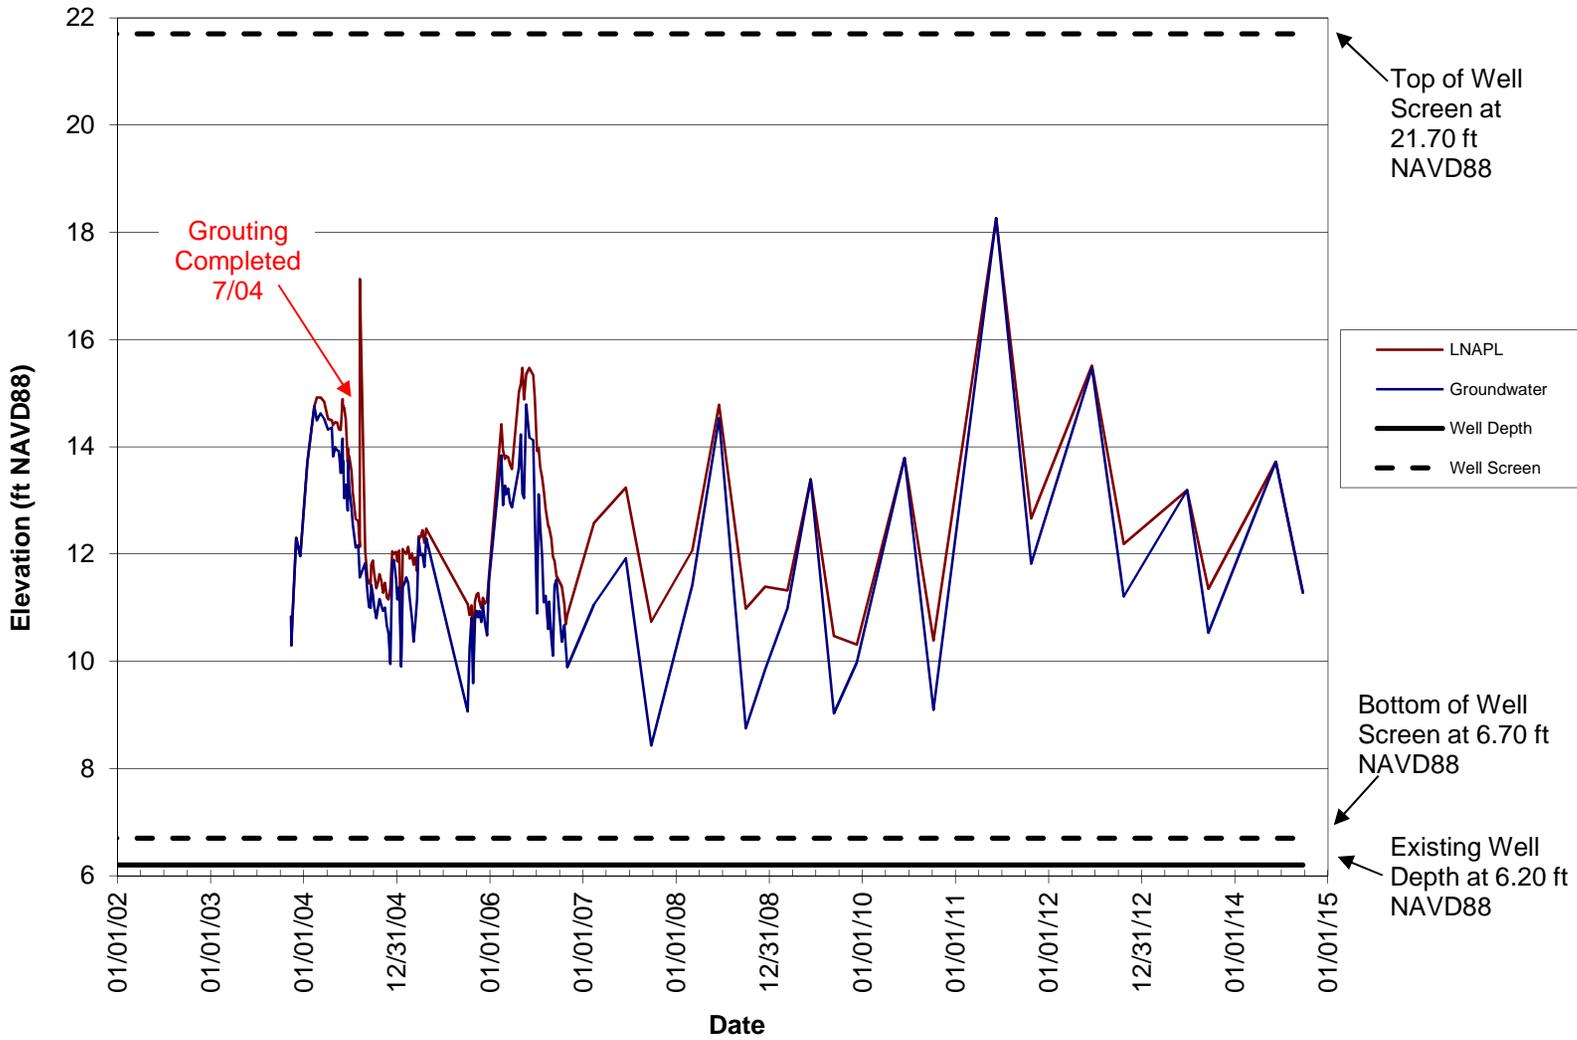
McCormick and Baxter Superfund Site Portland, Oregon	
	2009 to 2014 NAPL Thickness Plot for Well EW-1s	
4-21	Figure 7/15

In June 2008, subsidence of the soil cap was observed near groundwater monitoring wells EW-1s and MW-23d. An upland site survey confirmed that the ground surface had subsided approximately 1 foot between the time that the soil cap was installed in 2005 and 2008 in a limited area around the wells. A Subsidence in Upland Cap Memorandum (HC/GSI 2008) and an Additional Subsidence Monitoring Memorandum (HC/GSI 2009) present the results of the survey and additional investigation to determine the cause of the subsidence.

Based on elevated groundwater temperatures in well EW-1s (40 °C) and the large amount of buried woody debris in the area, it is suspected that aerobic degradation of woody debris was occurring and causing the ground surface subsidence. Decreasing groundwater levels within the sediment cap also may have contributed by opening a larger unsaturated zone that allows compaction. In 2009, the shallow well EW-1s, was sealed to reduce the amount of oxygen reaching the unsaturated zone. Since the well was sealed, the subsidence has slowed and in the past few years has become insignificant. The groundwater temperature dropped to approximately 23-25°C and has remained stable for the past 4 years (see Figure 4-6). This temperature is still higher than groundwater from surrounding wells (approximately 15°C) indicating that some heat is still being produced in the subsurface near well EW-1s; this may be caused by anaerobic degradation, which generates less heat than aerobic degradation.

Note: Ground subsidence has been observed in the vicinity of EW-1s and the well casing has sunk over time. The screened interval and total well depth have been referenced to the most recent ground survey from September 2009. Given that the elevations are changing with time, the elevations shown are approximate.

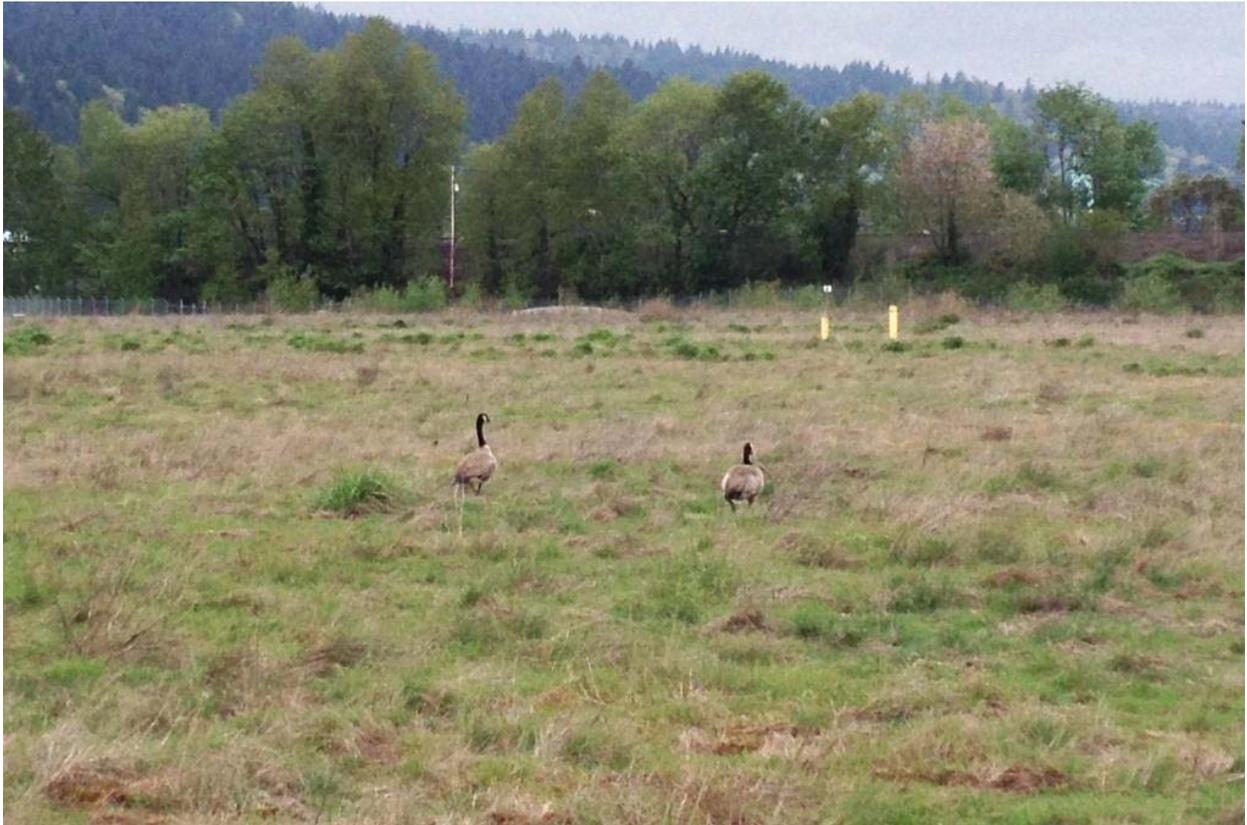
Photograph 3 – Canada geese observed on the upland portion of the Site. Photograph taken facing west.

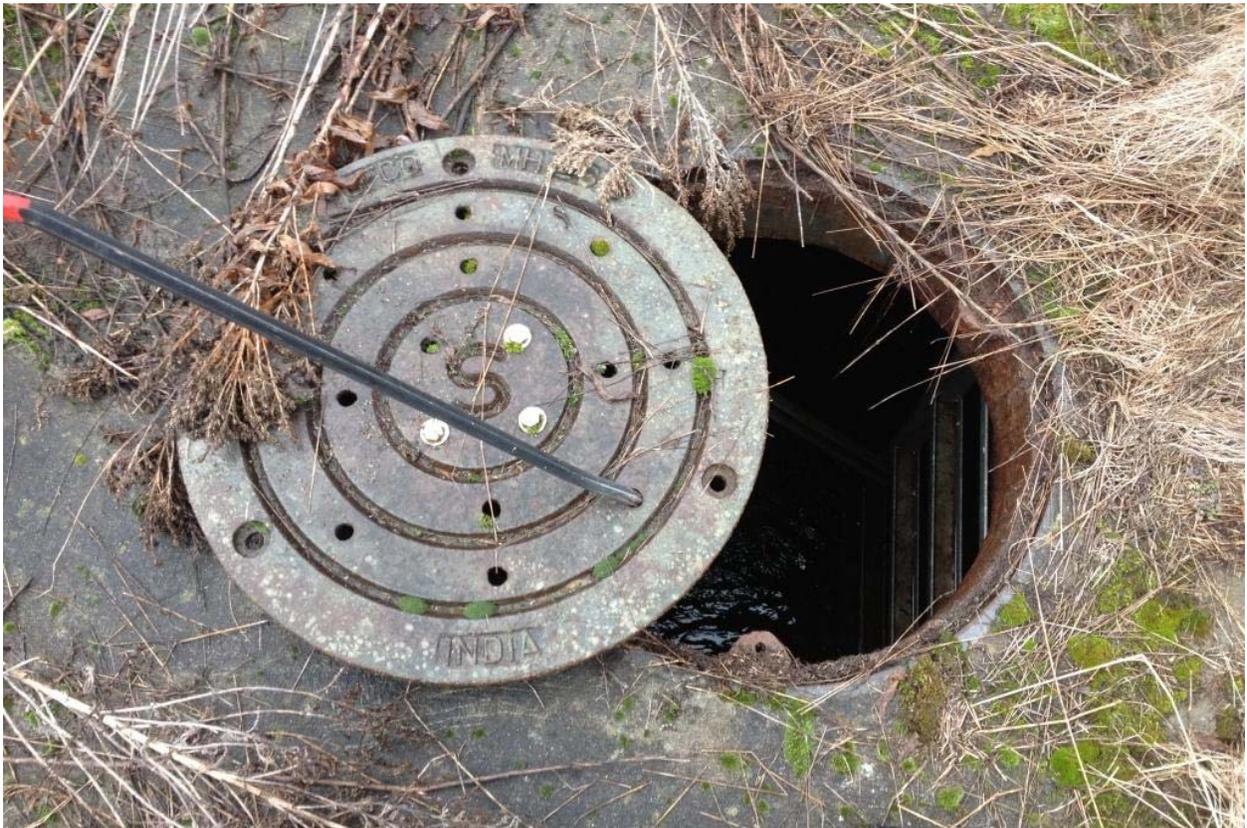
Photograph 4 – Subsurface drainage manhole (SDMH-B).

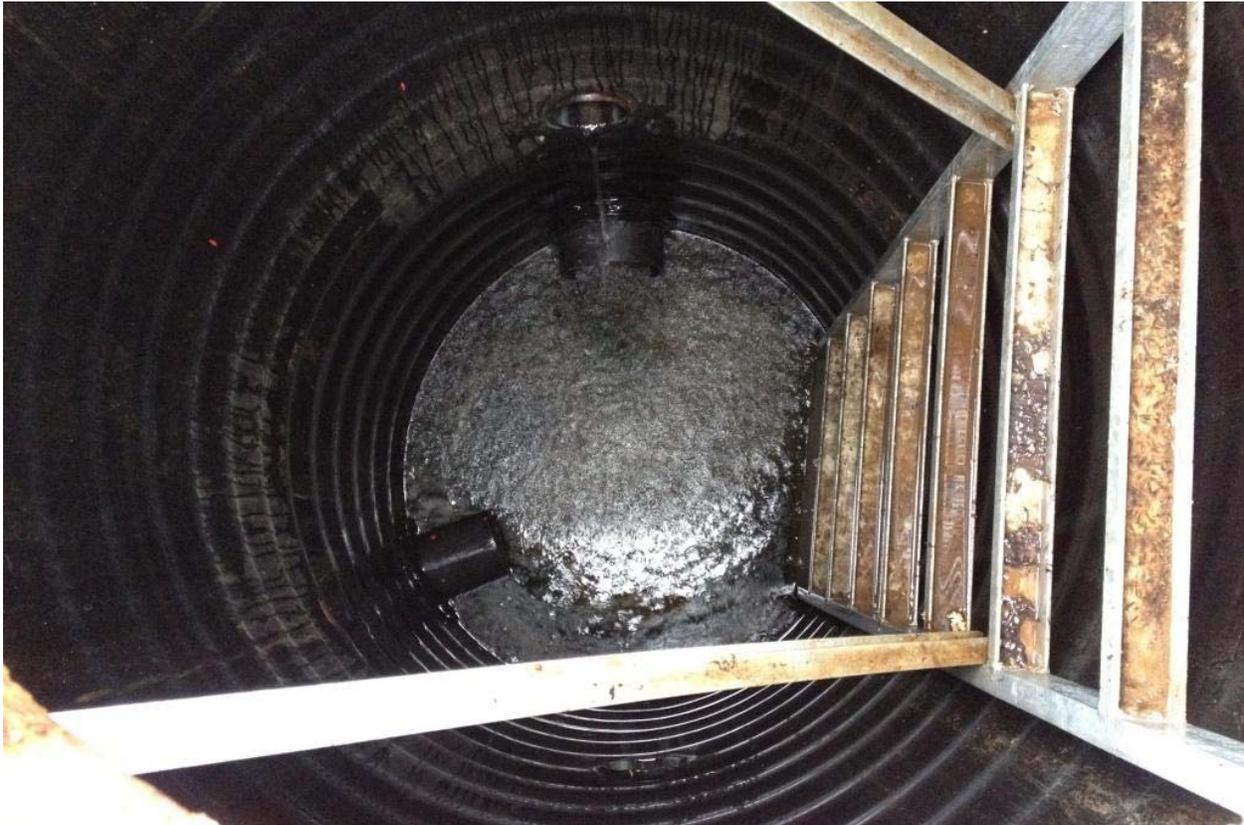
Photograph 5 – Subsurface drainage flow observations in SDMH-B within the impermeable cap.

Manholes B and C associated with the stormwater conveyance system were observed to have water flowing in from all observed inlets to each vault with no sediment accumulation observed.

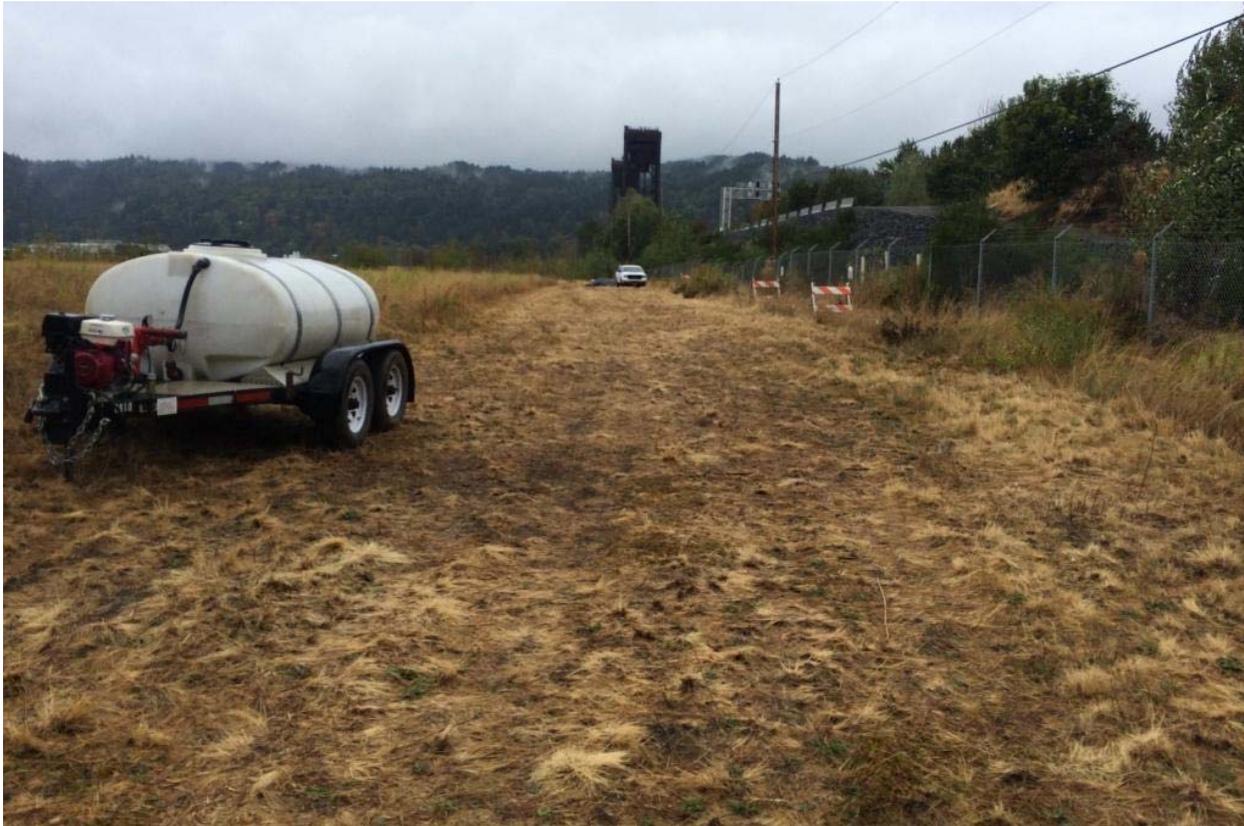
Photograph 6 – Area mowed by NW Natural in preparation of gas line decommissioning. Photograph taken facing southwest.

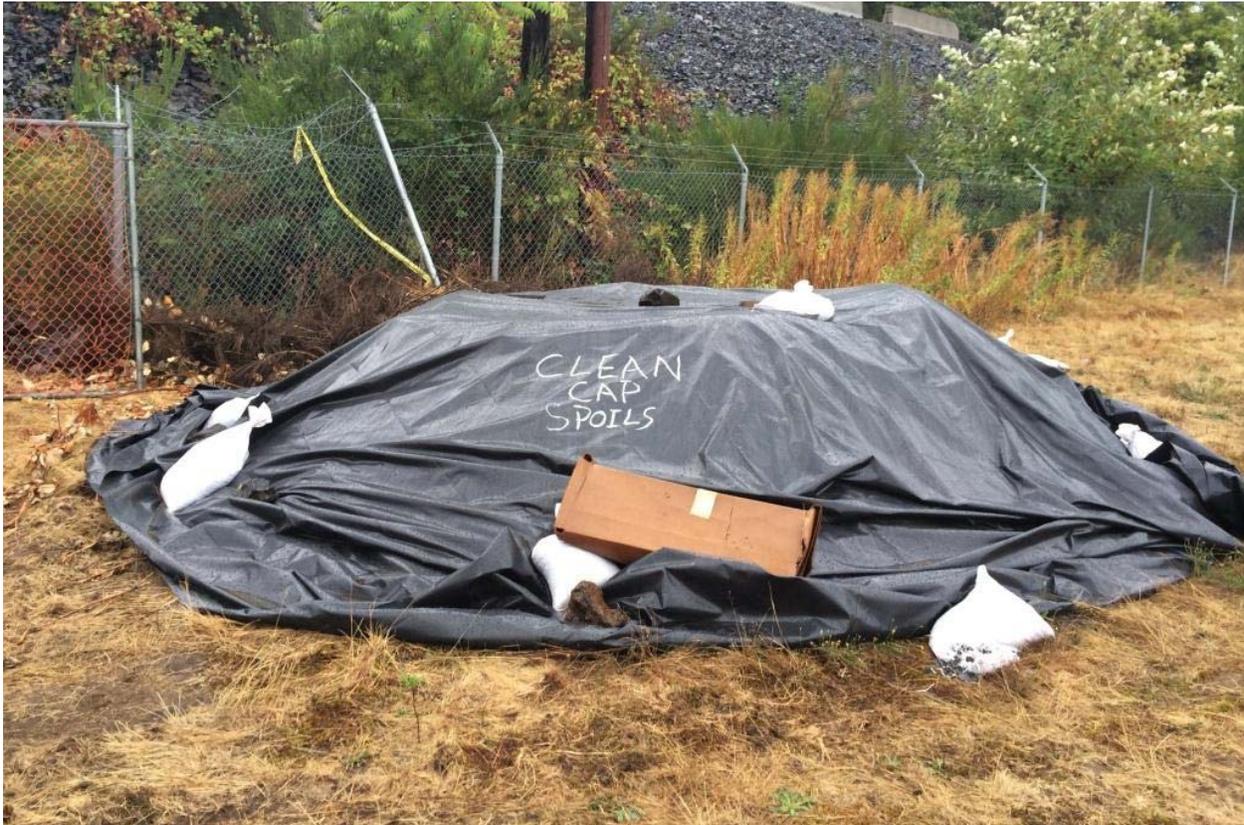
Photograph 7 – Clean earthen cap soil excavated during gas line decommissioning. Soil is placed on, and covered with plastic. Photograph taken facing north.

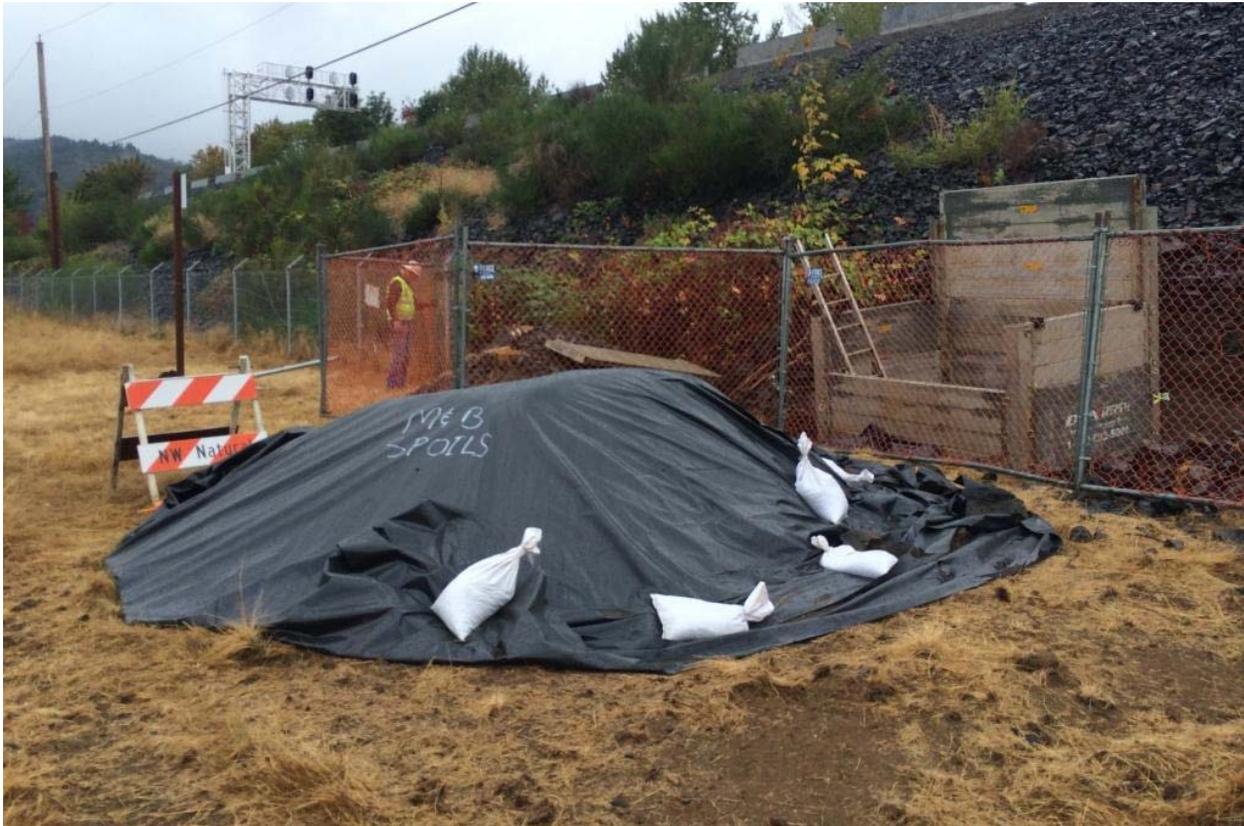
Photograph 8 – Contaminated soil excavated during gas line decommissioning. Temporary construction fence can be seen behind the soil pile. Photograph taken facing northwest.

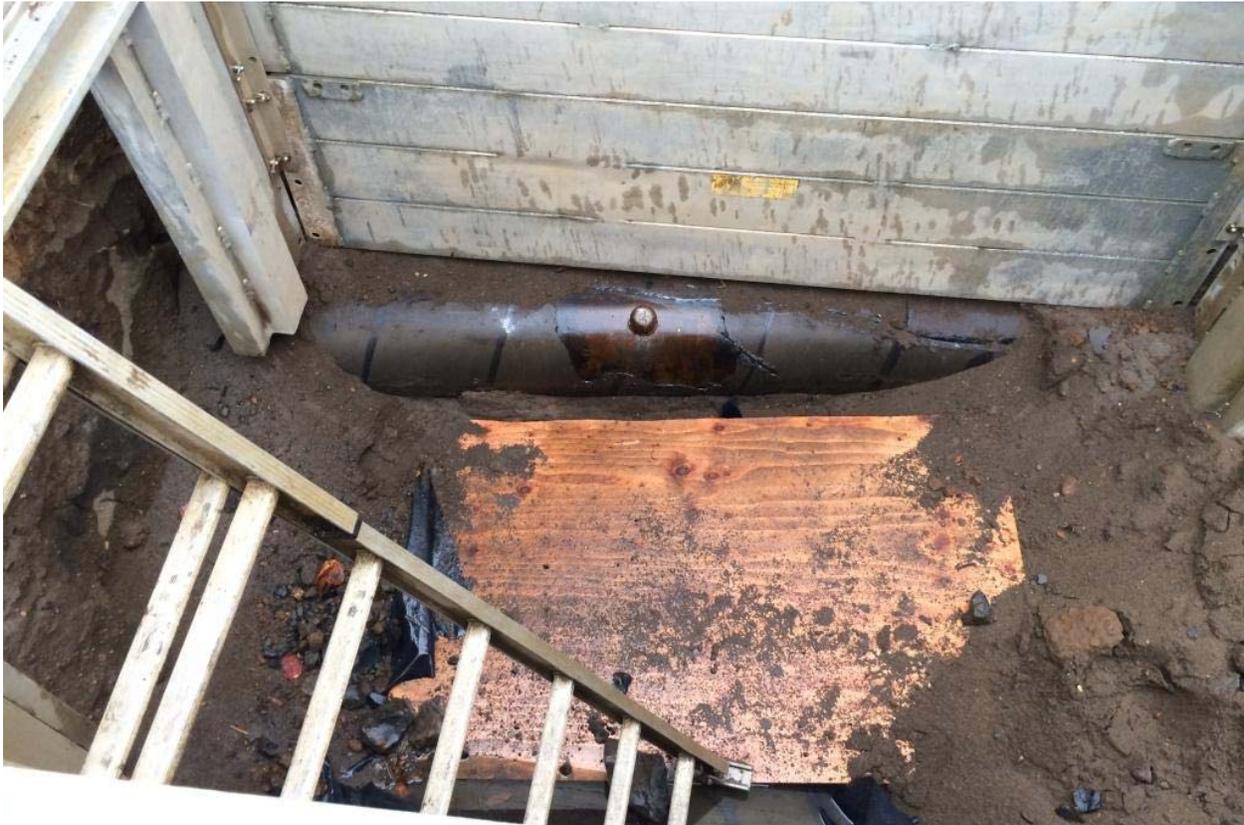
Photograph 9 – NW Natural gas line exposed during decommissioning.
