Operation and Maintenance Report
January 2014 to December 2014

McCormick and Baxter Superfund Site

Portland, Oregon

July 6, 2015
15670-10/Task 4

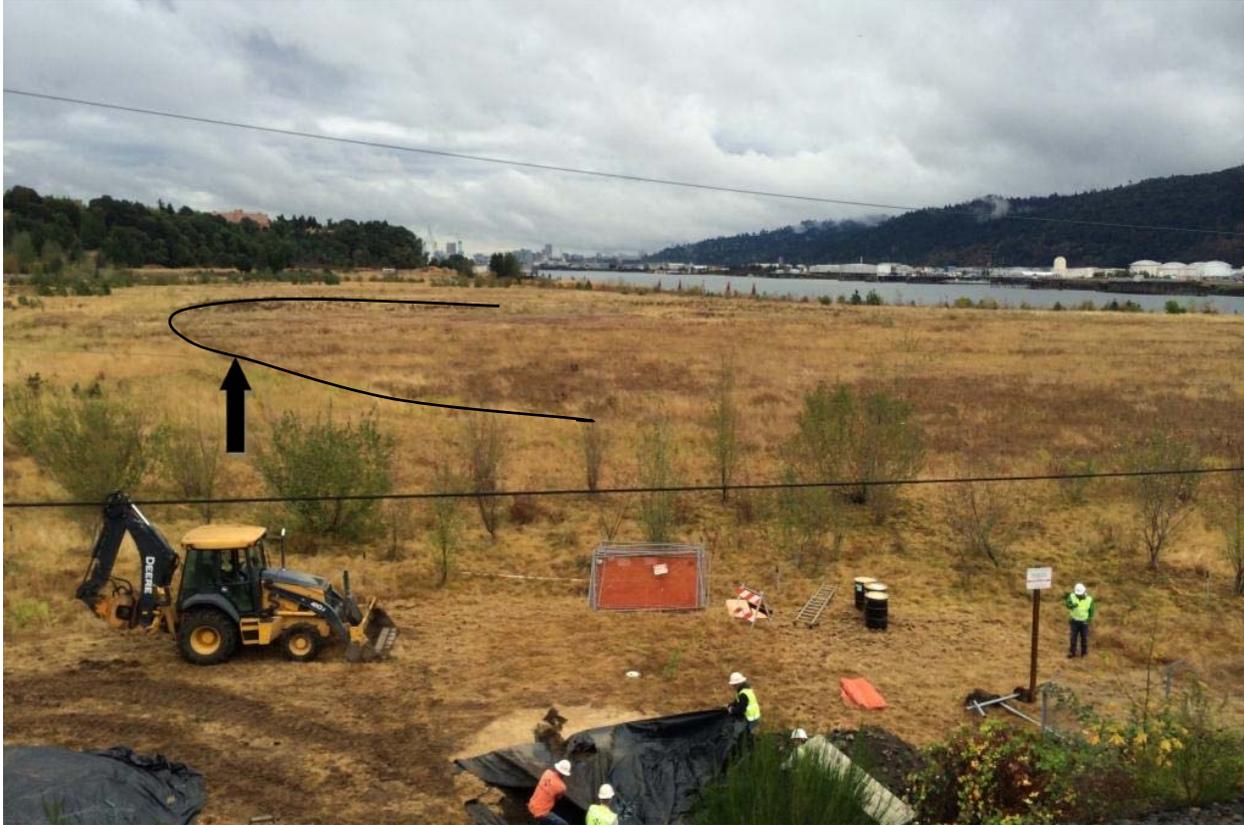
Photograph 10 – Overview of the site during gas line decommissioning. The boundary between the earthen and impermeable caps can be seen in the background. Photograph taken facing south.

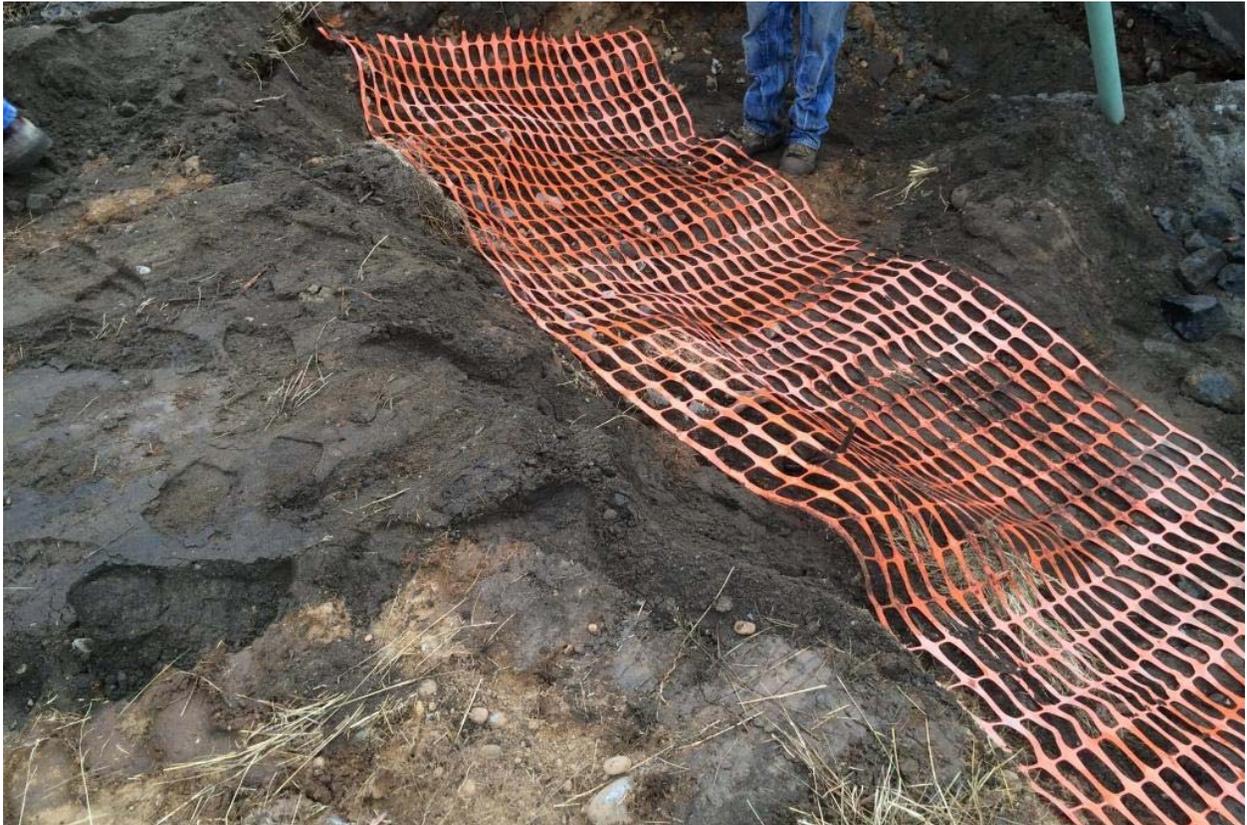
Photograph 11 – Construction fence used as demarcation barrier to delineate the contaminated soil from the clean earthen cap material.

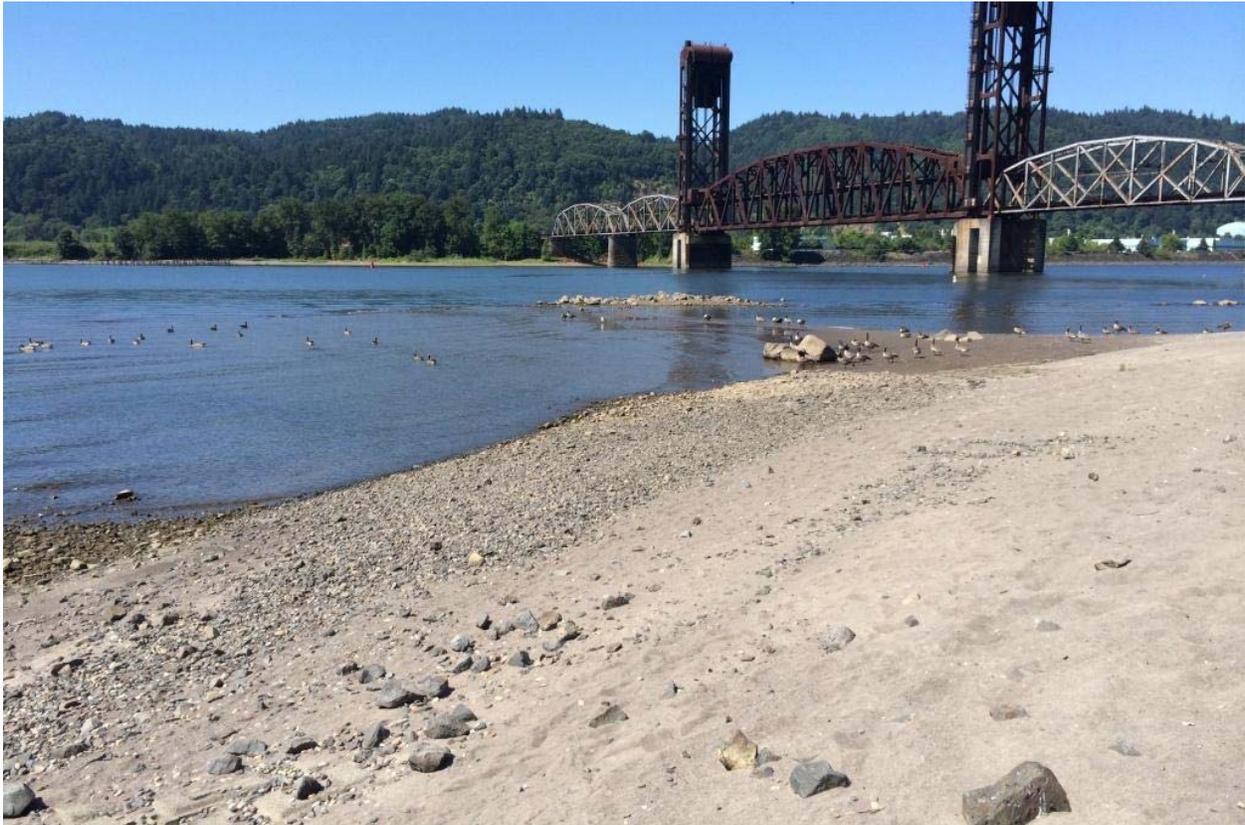
Photograph 13 – Canada geese observed on the Riparian Area and over Sediment Cap. Photograph taken facing west.

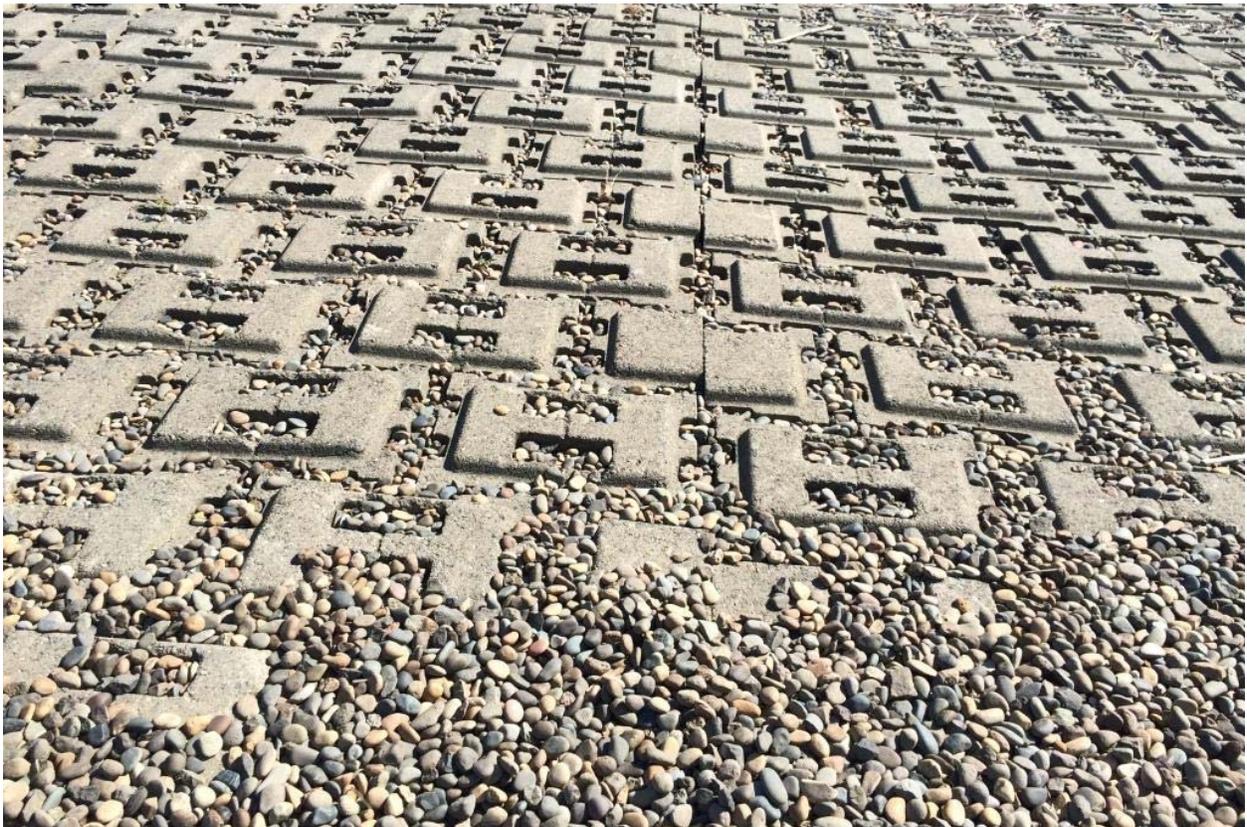
Photograph 15 – Typical habitat gravel within ACB armoring.

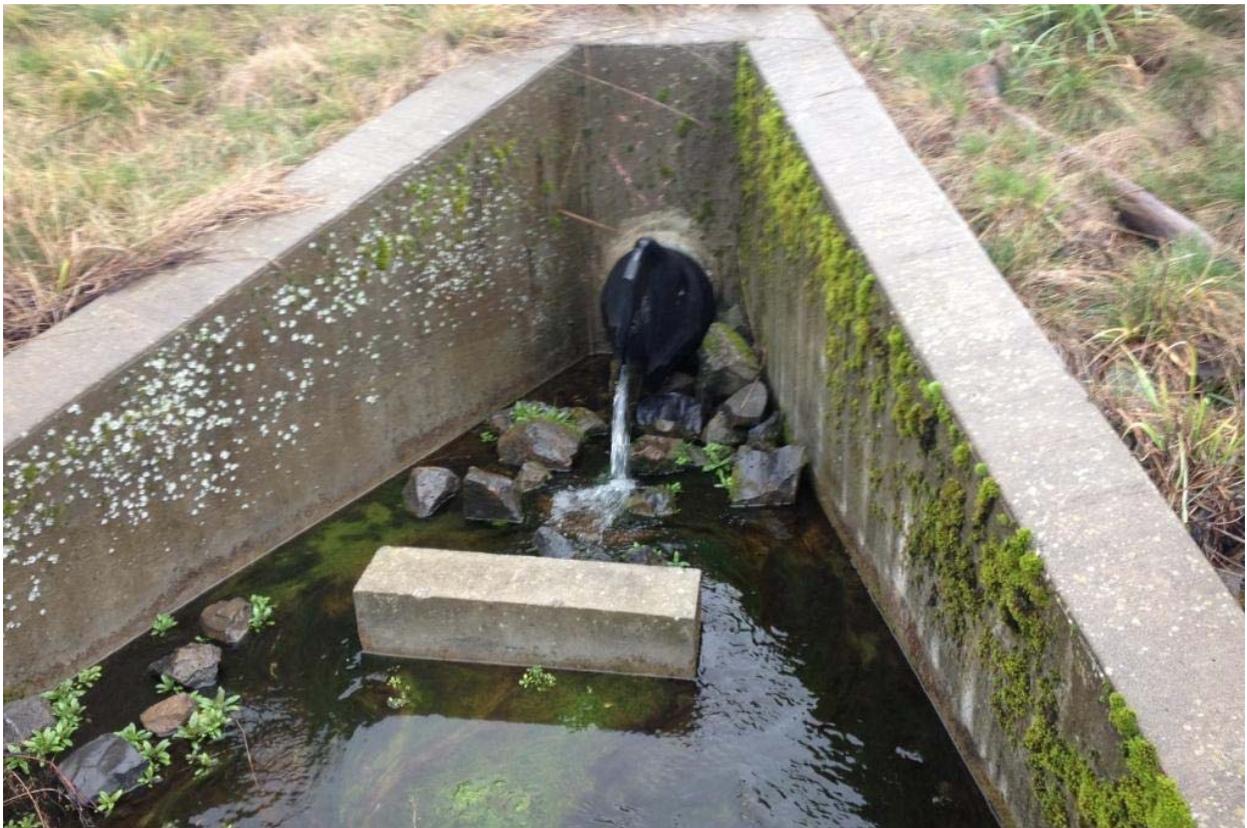
Photograph 18 – Stormwater drainage outfall.

Discharge from the outfall was moderate (approximately 20 gpm). The outfall was in good condition and free of weeds.

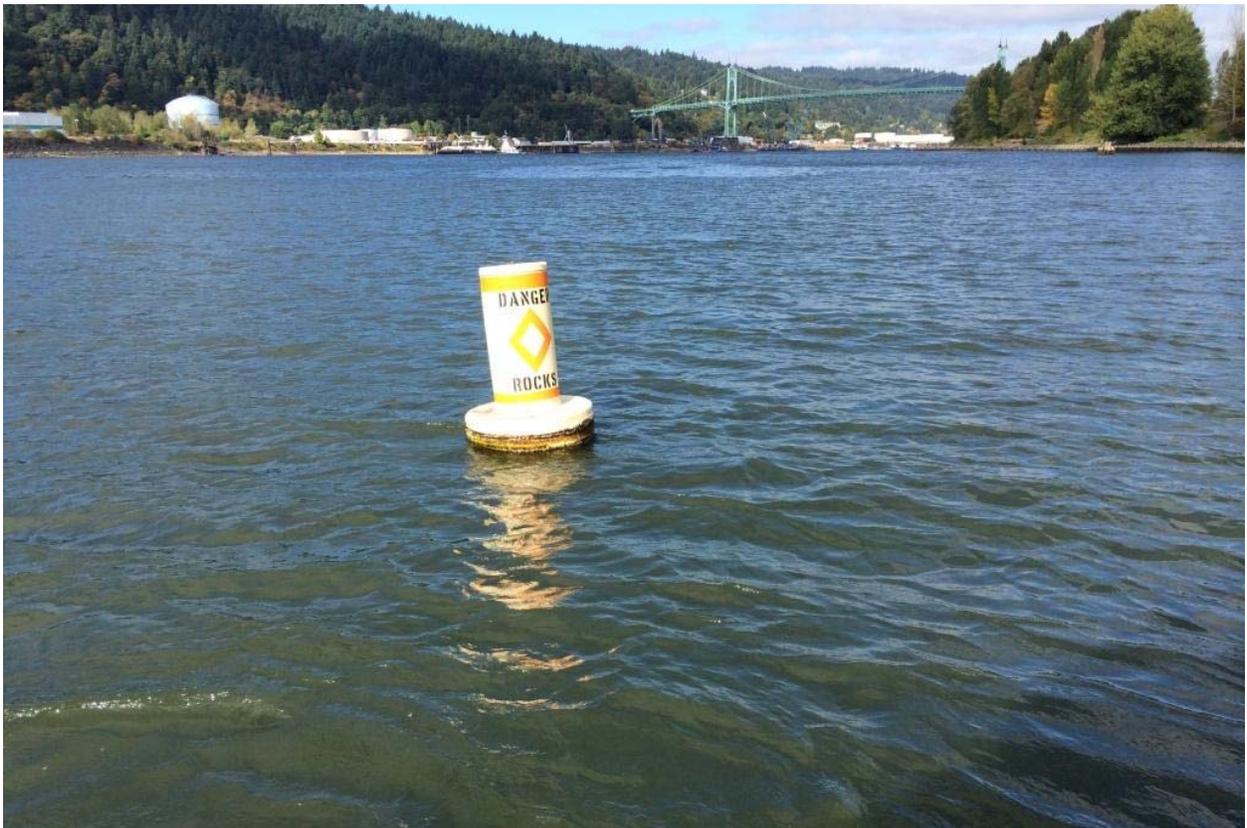
Photograph 24 – Buoy #5 remains in-place, used as a reference to assist divers in locating Buoy #4. Photograph taken facing west.

The Willamette River at the time of inspection (between 9:30 and 11:30 AM) was between 5.4 and 4.8 feet NAVD88. Low tide was at approximately 11:45 AM with a tide of approximately 4.8 feet NAVD88. The southernmost buoy along Willamette Cove, (Buoy #4 from the Site Observation Summary figure attached), could not be seen. No indications that the buoy was still present could be observed.

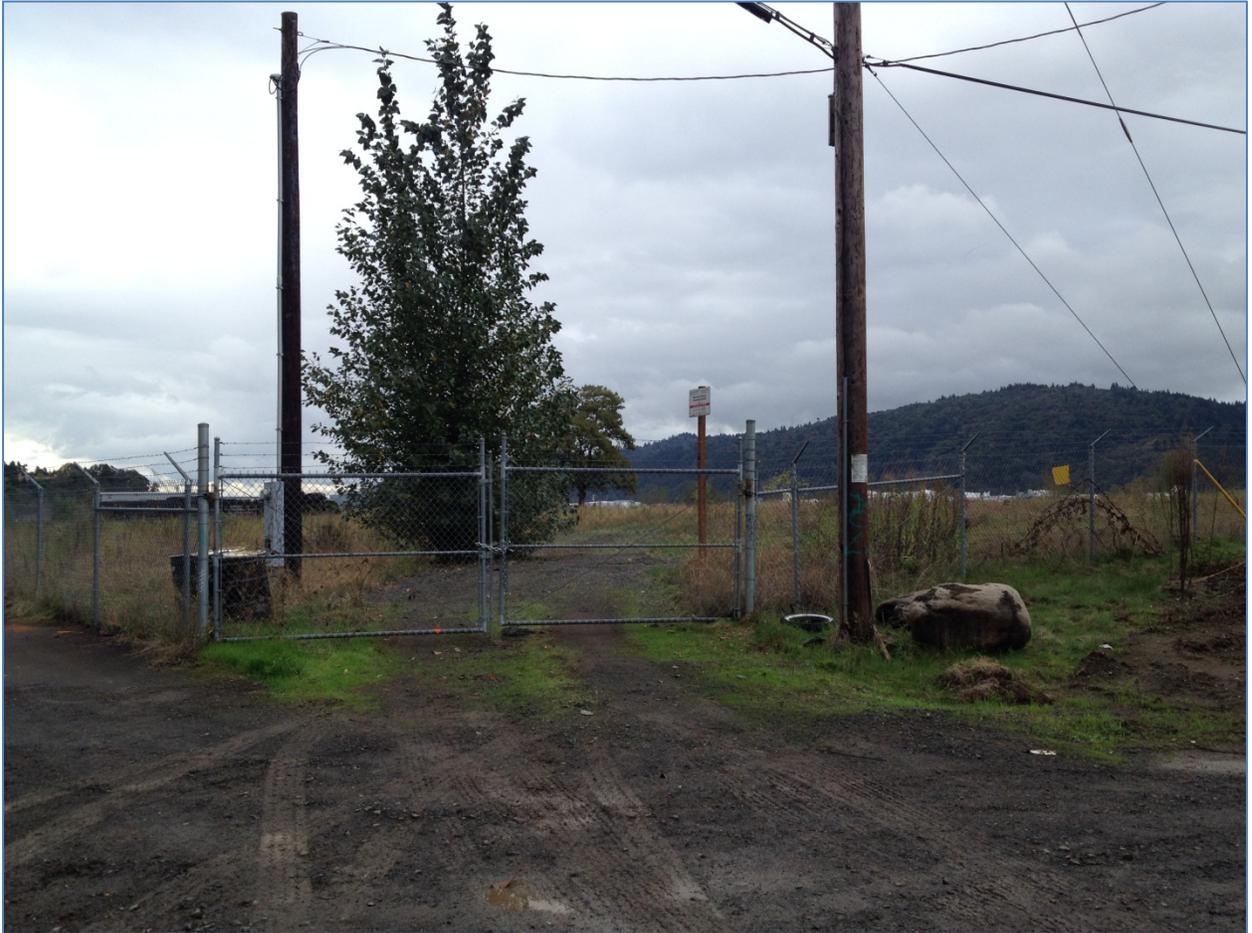
Photo 1: Looking south, near proposed excavation #1, at McCormick & Baxter Northern Gate. Soil waste drums (on left) from piezometer abandonment have since been hauled off.

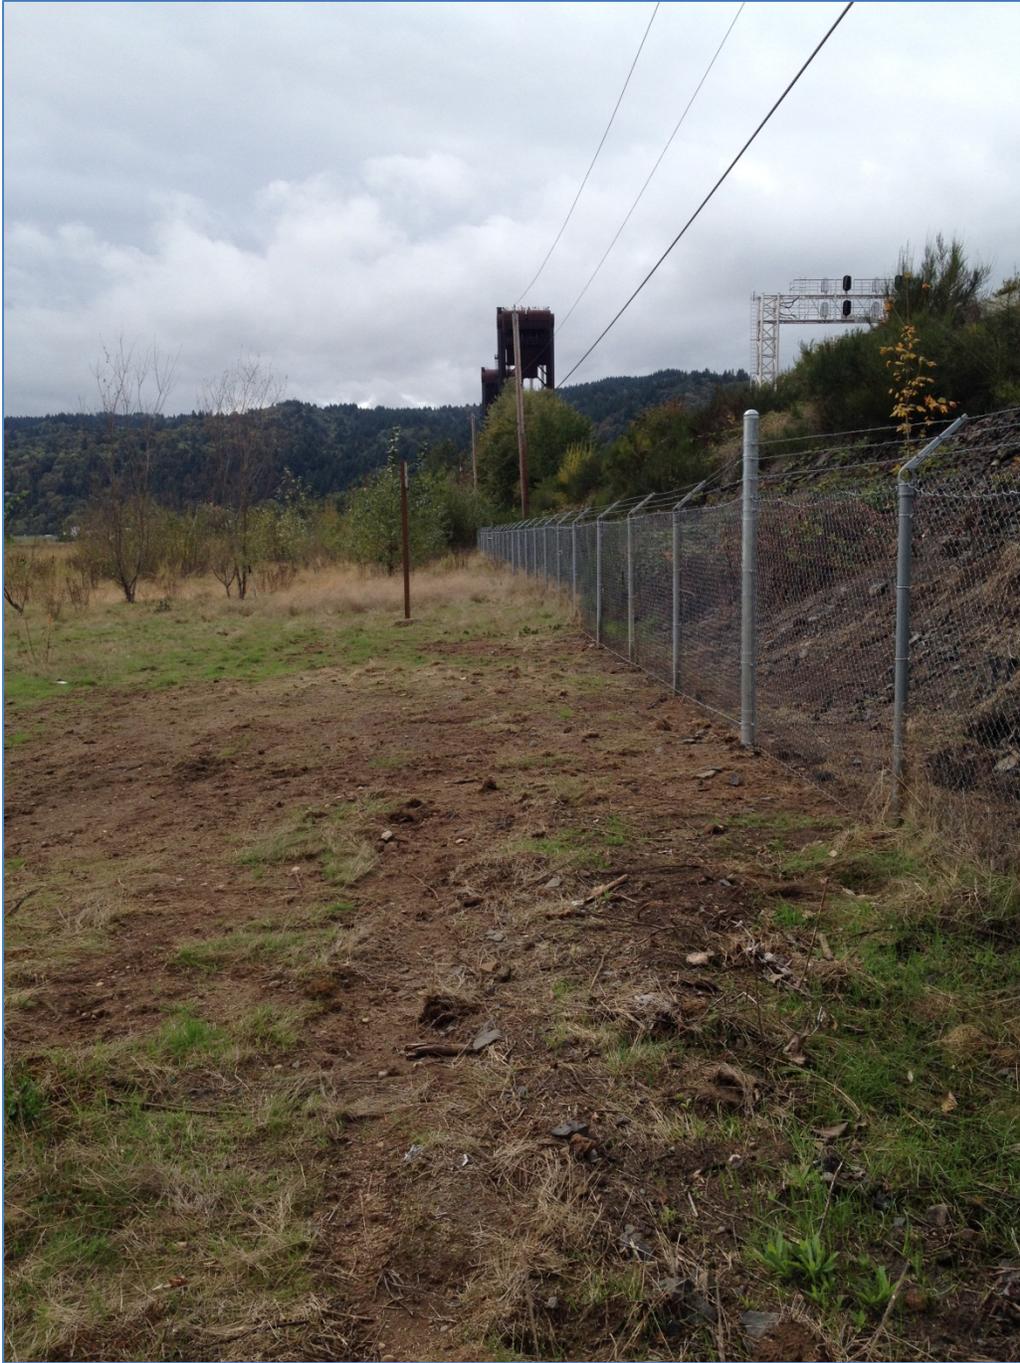
At the time of construction completion NW Natural restored construction area to its pre-construction grading and re-vegetated the area with native grass seed mix. The 30 feet of removed fencing was re-installed with new fencing to match pre-existing conditions. The two piezometers installed on May 15, 2014 during the environmental investigation were later decommissioned on October 31, 2014. The Investigation-Derived Wastes (IDW) generated from the drilling activities were drummed up and sent to a RCRA subtitle C hazardous waste disposal facility based on the listed waste codes associated with the McCormick & Baxter Superfund Site.

Photo 2: Looking south, near excavation #2. Notice fence and site conditions have been restored to pre-construction conditions.

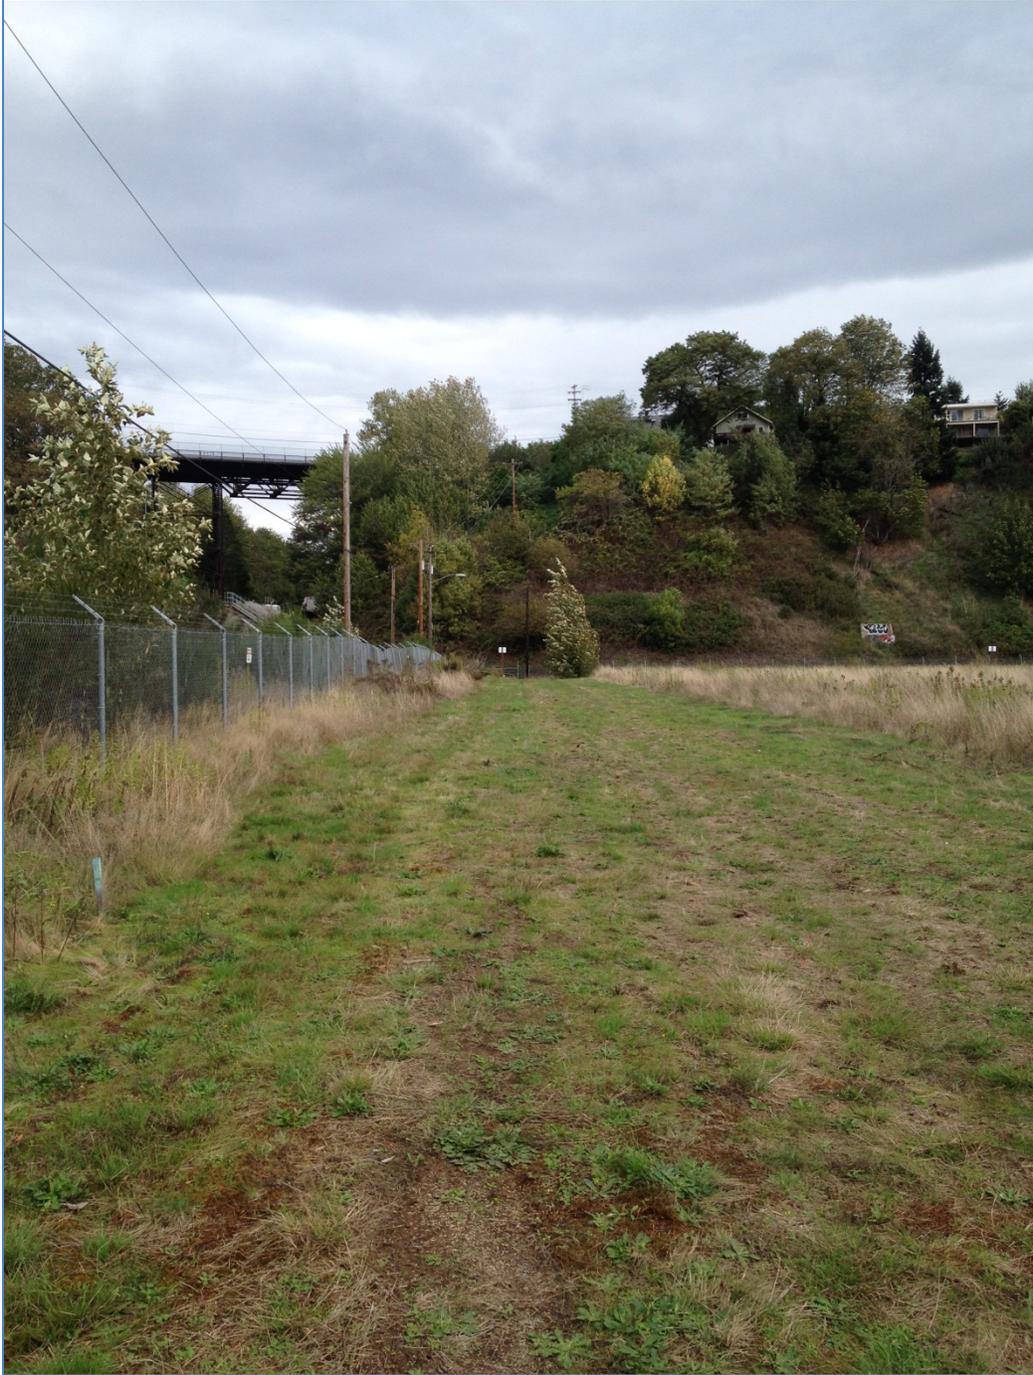
Photo 3: Photo, near excavation #2, of mowed grass area where haul road existed during construction.

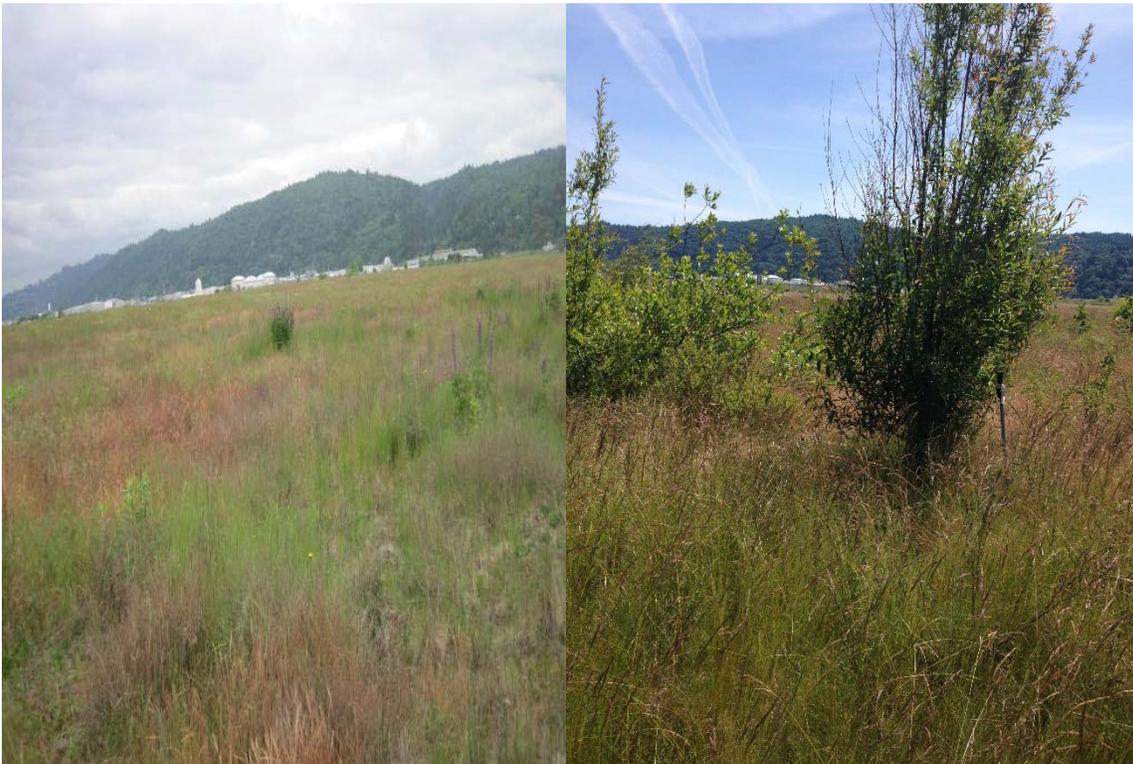
Photograph 2 – Earthen cap and drainage swale in the foreground with the impermeable cap in the background. Taken looking south from Photograph Location 1 comparing baseline and current conditions. (Left - June 2011, Right – June 2014)

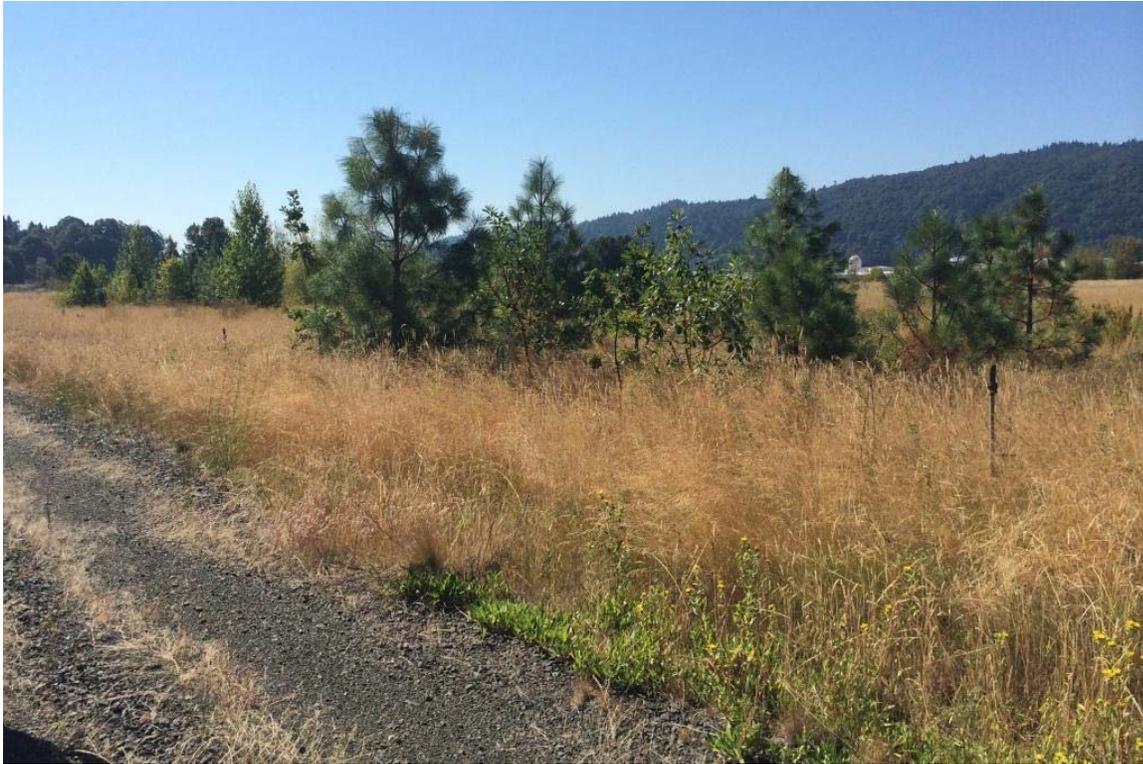
Earthen Cap Component. Tree and shrub plantings on the earthen cap were healthy and growing well (Photographs 2, 3, 4, and 6, Appendix C). Ponderosa pine, Oregon grape, elderberry, and serviceberry were performing the best. Nootka rose dominated the northwest portion of the earthen cap and were previously stressed, but have recovered well. Trees and shrubs ranged in height from approximately 6 to 15 feet. Herbaceous species provided full coverage of the ground. No indications of stress were observed. Localized areas of moss were observed in the herbaceous layer. Small quantities of knapweed and thistle were present, primarily within the southern portion near the fence line.

Photograph 3 - Tree and shrub plantings on the earthen cap continue to spread. Taken looking southeast from Photograph Location 2. (June 2014)

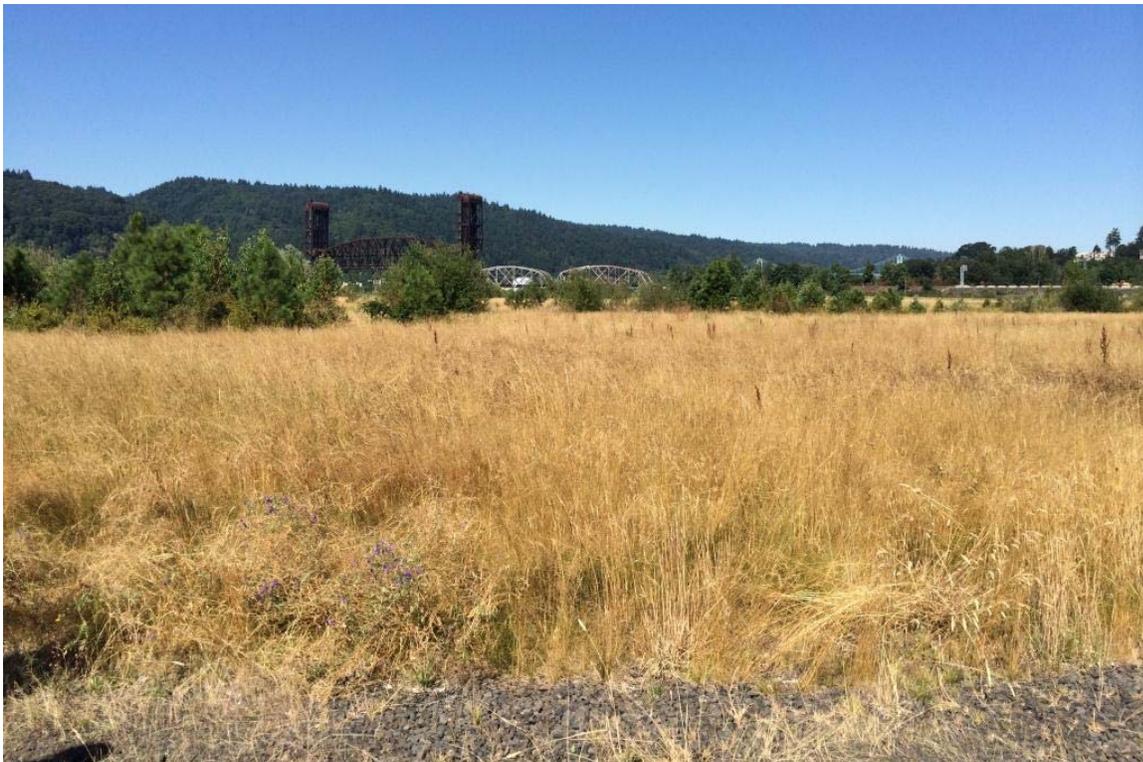
Photograph 4 – Eastern edge of the earthen cap with perimeter road in foreground. Taken looking west from Photograph Location 3. (June 2014)

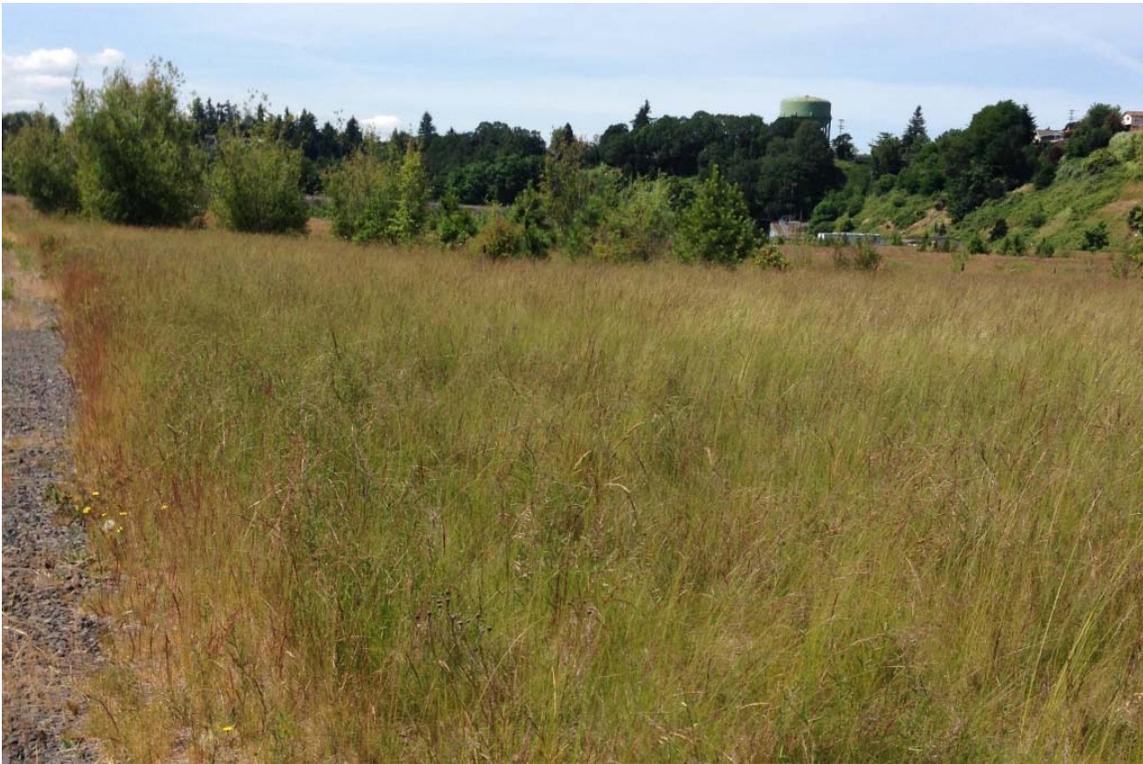
Photograph 6 – Tree plantings on the earthen cap. Taken looking northwest from Photograph Location 5. (June 2014).

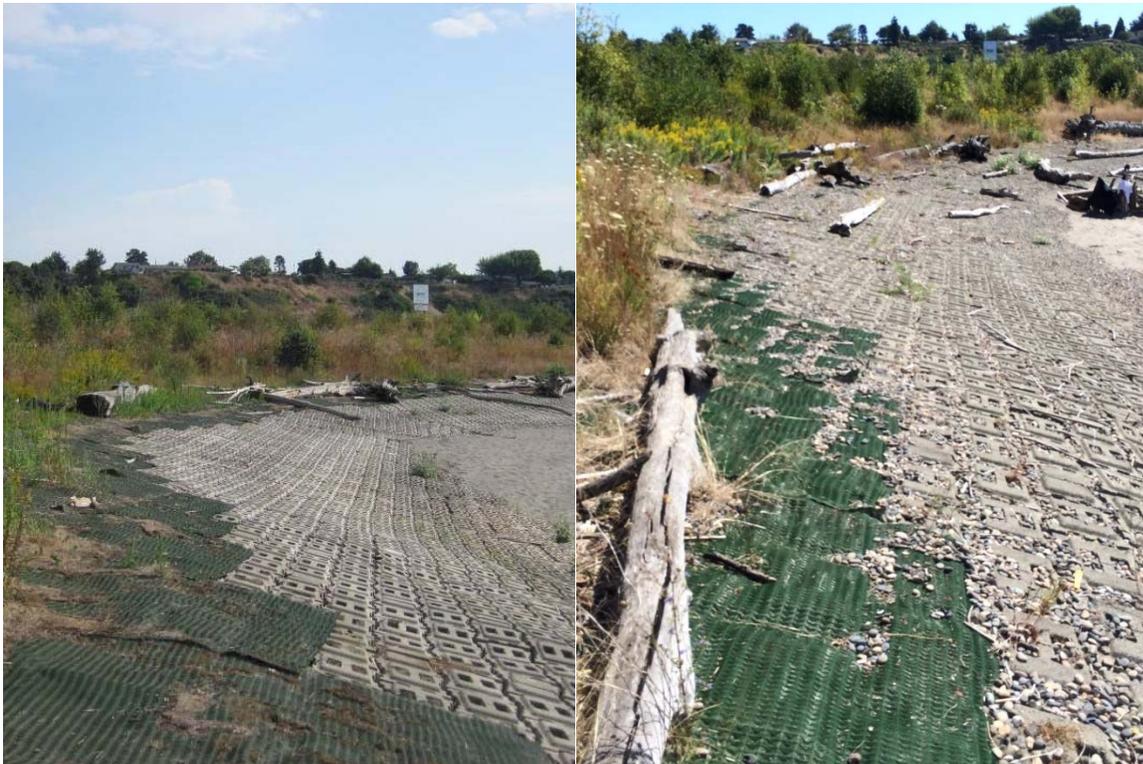
At the time of the 2014 inspections, water levels in the Willamette River were low, and the mid- to upper-beach face was exposed (Photograph 8, Appendix C). The species originally planted in the lower component continued to perform well during the summer months despite the dry conditions. A notable amount of thistle (*Cirsium spp.*) and non-native pea (*Vicia sp.*) were observed throughout the lower component, but were stressed or dead. Small quantities of Saint John's wort (*Hypericum sp.*), knapweed, and butterfly bush were present and did not appear to be colonizing other locations in the area.

Photograph 8 – Vegetation growth and wood debris within the lower riparian component. Taken looking southeast from Photograph Location 7 comparing baseline and current conditions. (Left - September 2011, Right – June 2014)

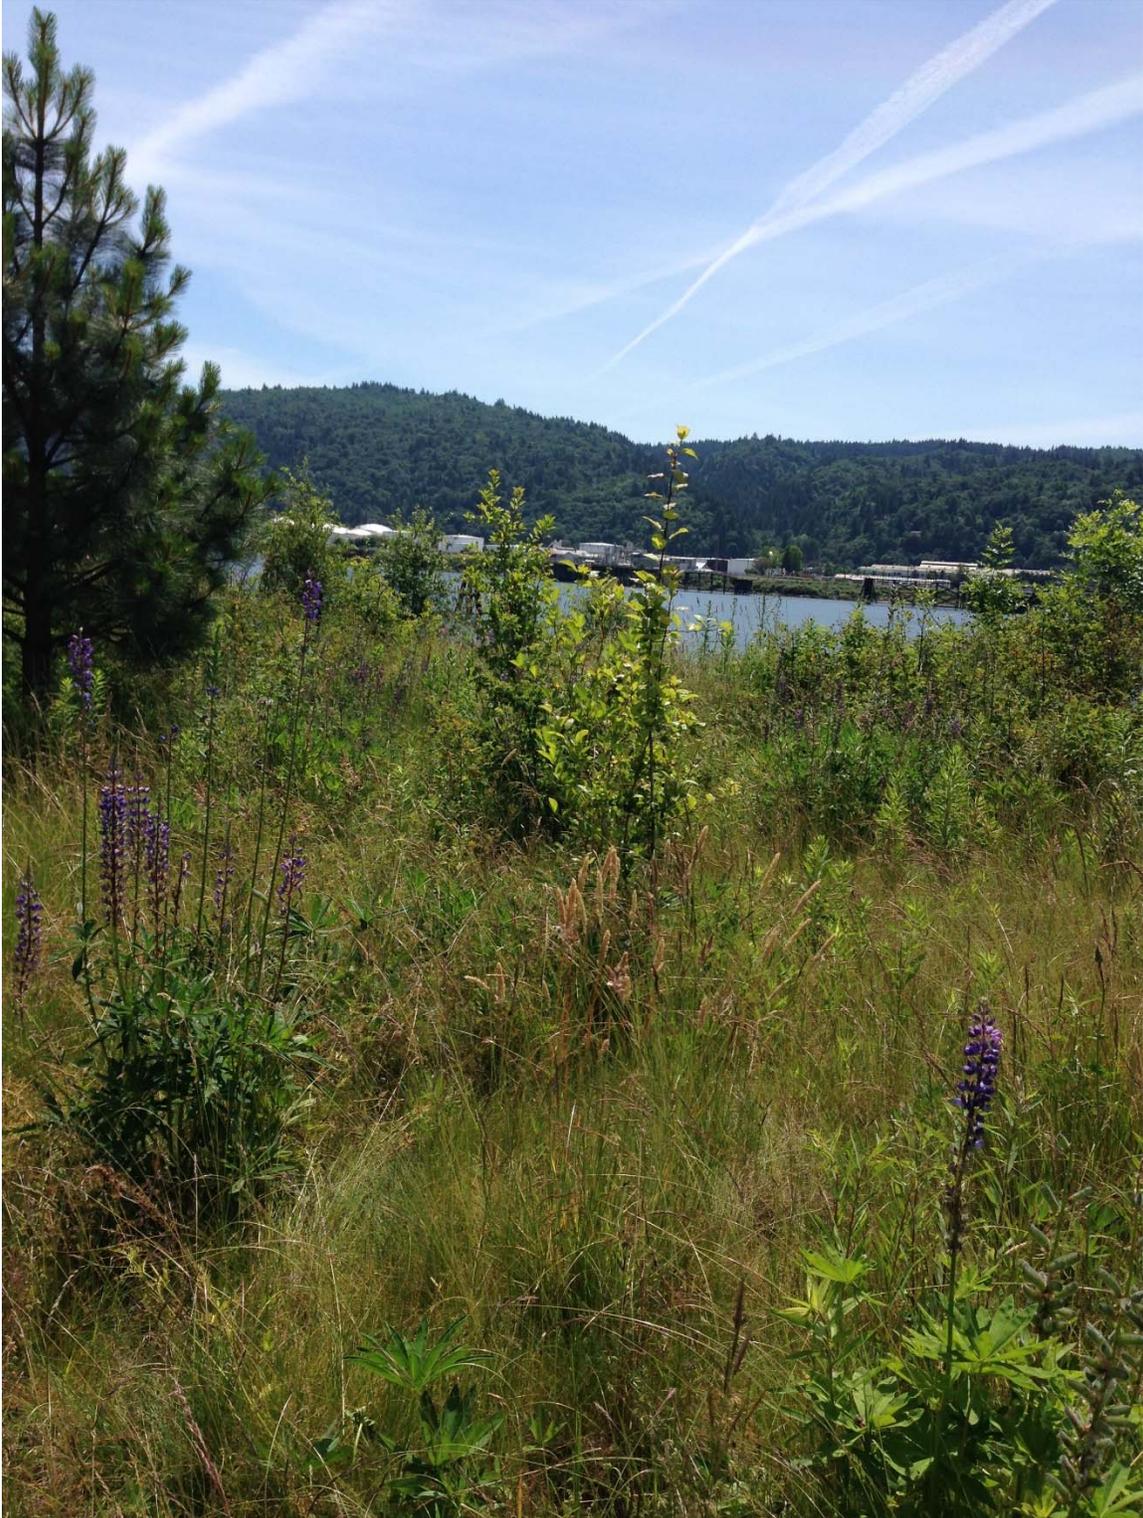
Photograph 9 – Upper riparian component with native trees and shrubs performing well. Taken looking southwest from Photograph Location 8. (June 2014)

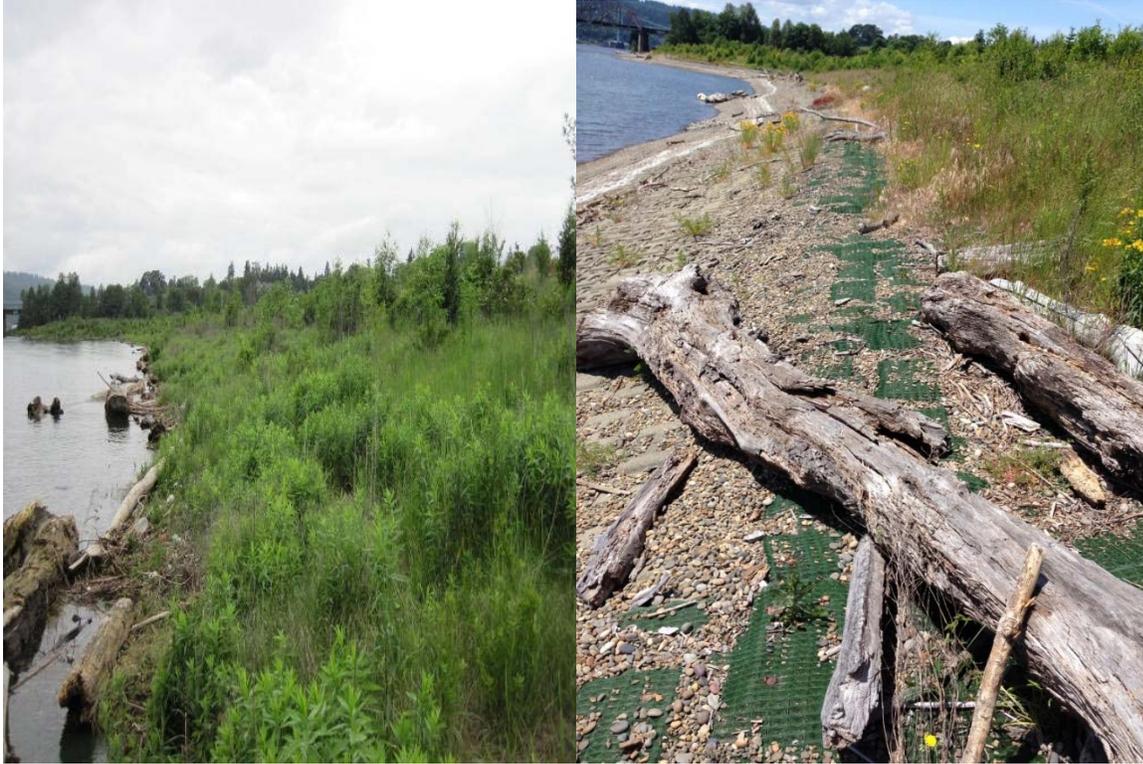
Photograph 10 – Lower riparian component with large wood debris along the edge. Taken looking northwest from Photograph Location 9 comparing baseline and current conditions. (Left - June 2011, Right – June 2014)
