Site: The Fields Neighborhood Park

Inspection Date: 10/21/2025

2025 Cap Inspection

The Fields Park - 2025 Annual Cap Inspection Photo Log

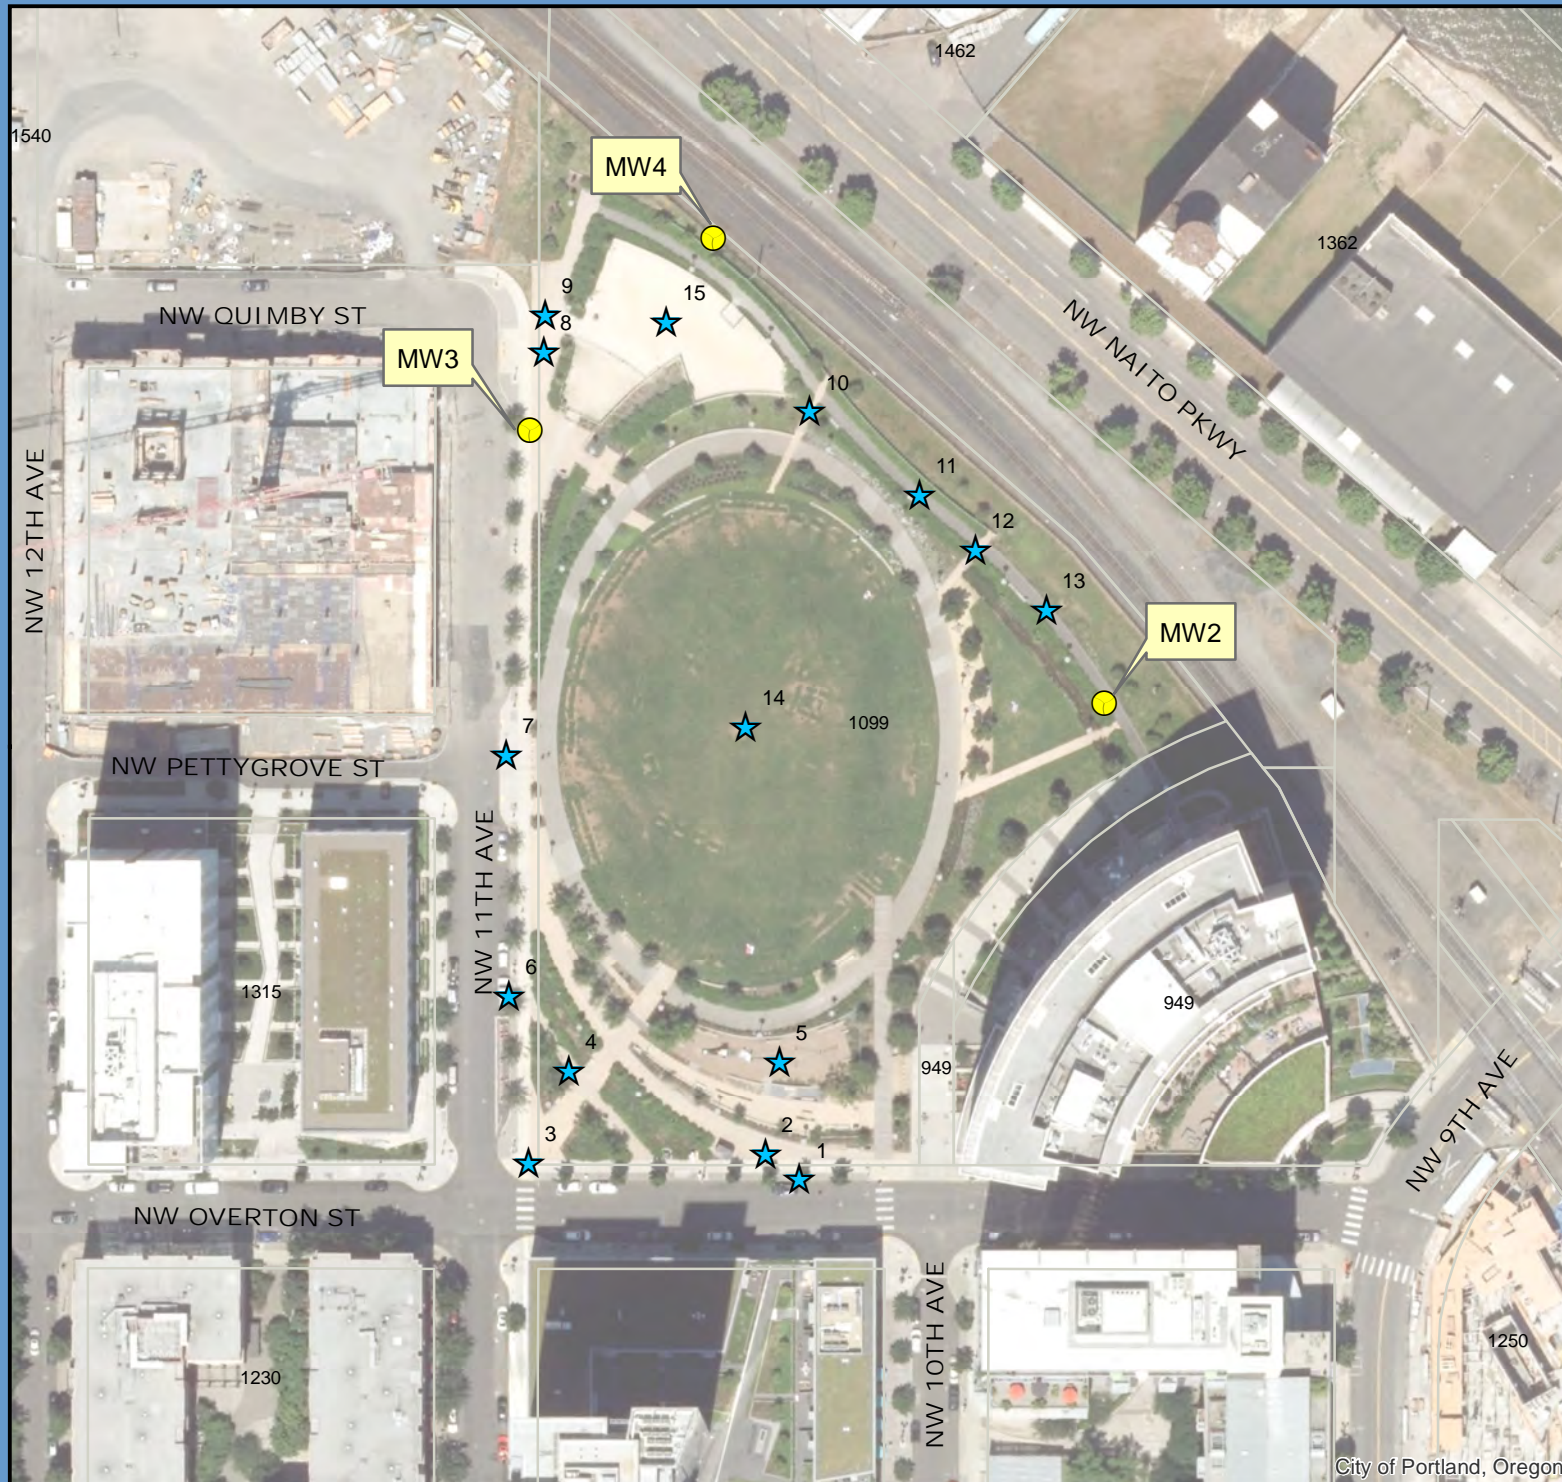
Fields Park Annual Cap Inspection Photo Points

Hardscaped areas are generally in good condition with localized minor to moderate concrete damage due to heavy equipment from PacificCorp’s site activities. The cap is not compromised in the hardscape areas of the park. See attached Figure 1 and Photo Log.
