## SOURCE CONTROL EVALUATION

### **Peninsula Iron Works Facility BUILDING 2**

6618 N. Alta Avenue  
Portland, Oregon

Project No. 351-12023-04

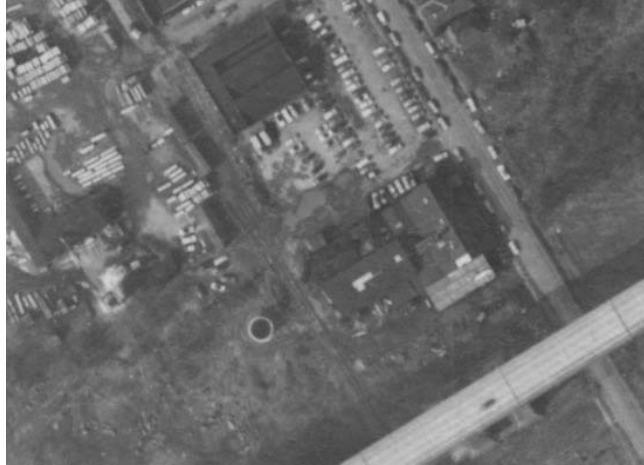
1956 Aerial photograph showing residual flood waters surrounding the south and north sided of the subject site (University of Oregon, Knight Library).

On January 19, 2012 the City of Portland sent an Industrial Source Control Memo to Peninsula Iron Works regarding ponding of water around the southwest portion of the site. This document clearly documents ponding of storm water between the subject site and the railroad easement/ballast located west of the subject site. It should be noted that ponding of storm water in this area of the site has occurred during heavy rain events since development of the property, as can be inferred in the 1956 aerial photograph, and based on conversation with Peninsula Iron Works owners<sup>8,12</sup>.
