## TECHNICAL MEMORANDUM

### JH Baxter Removal Action – 2023 Offsite Removal Action Scope

**Date:** October 10, 2023

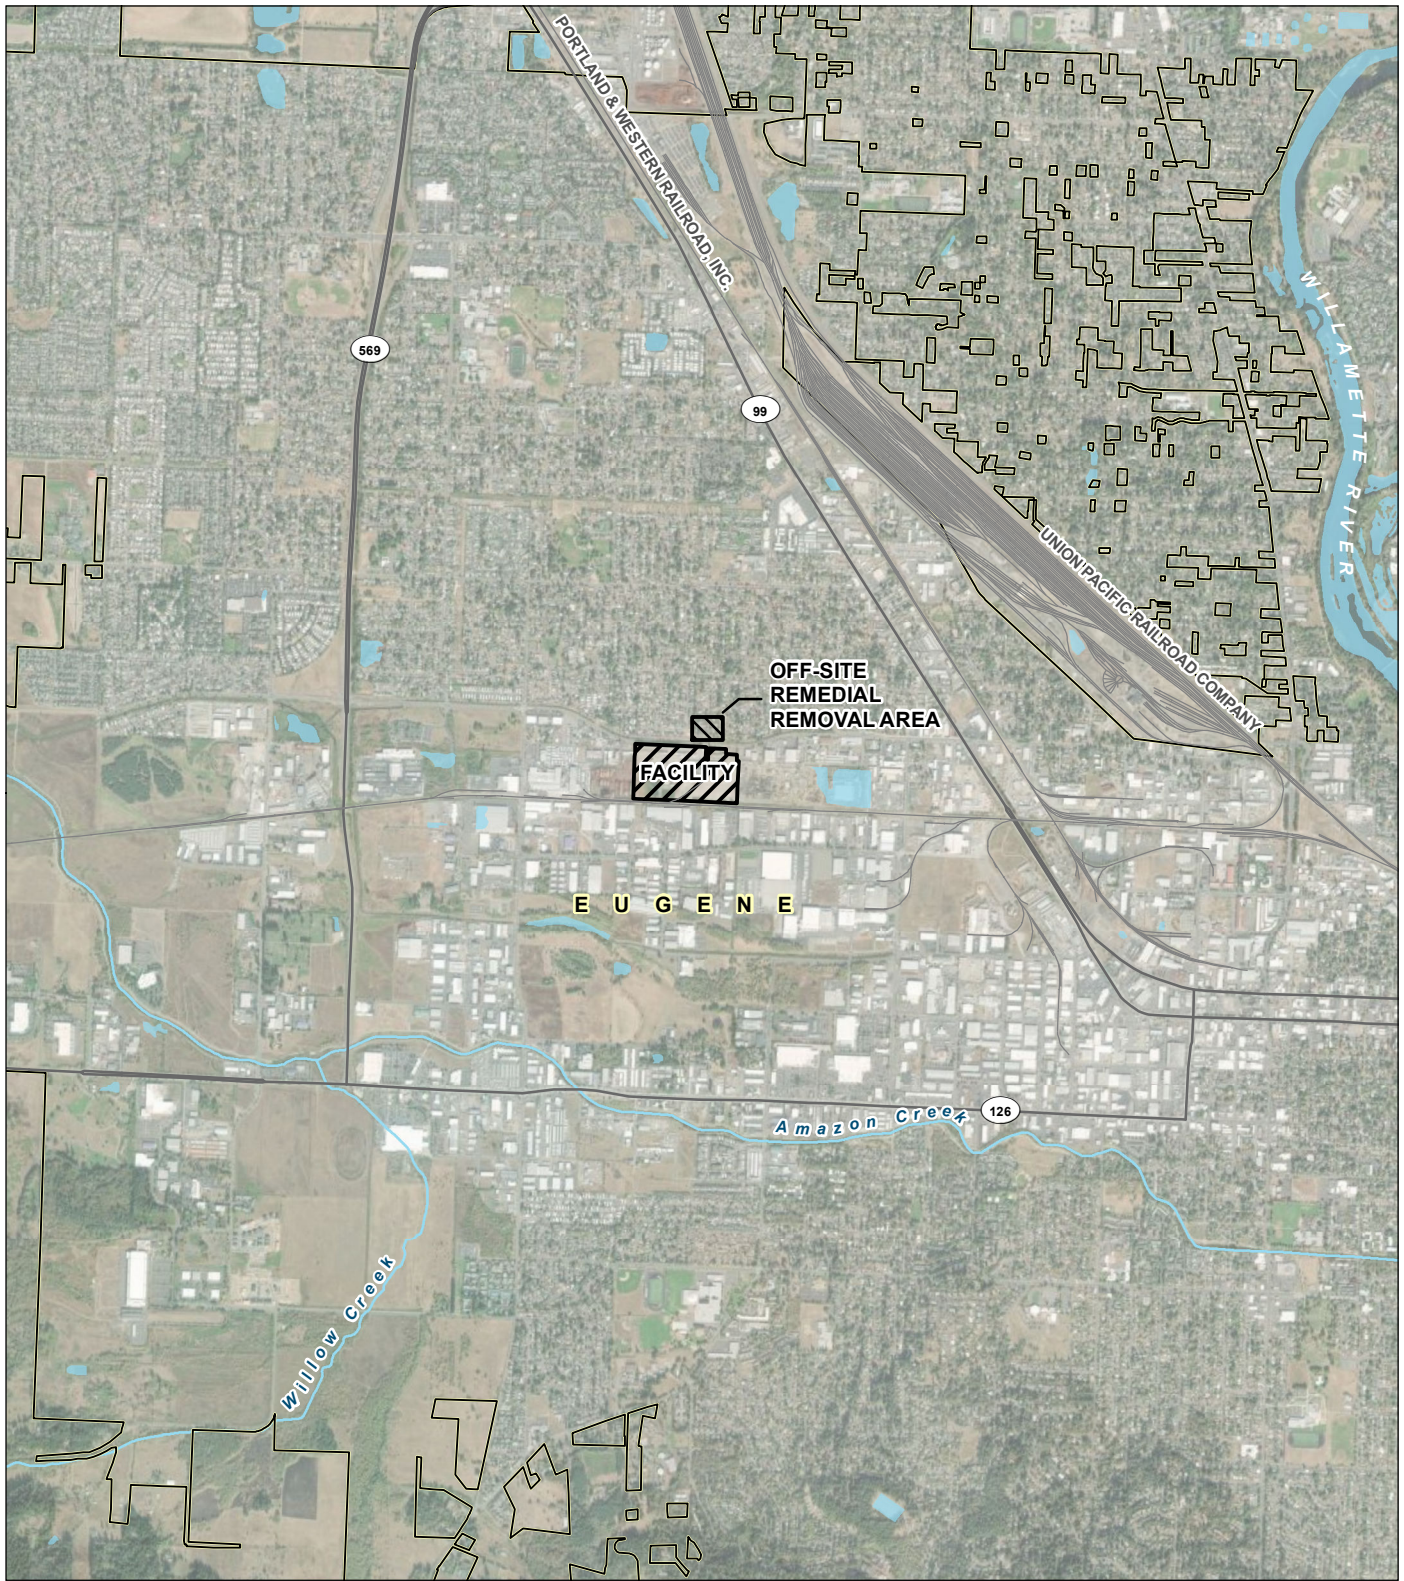
**FIGURE 1**  
**Vicinity Map**  
 Offsite Remedial Action

This memorandum (memo) describes the property-specific scopes for surface soil removal action (RA) at seven residential properties north of the former JH Baxter & Co. (Baxter) facility in Eugene, Oregon (Figure 1). The seven properties are presented on Figure 2. The scope of the RA has been determined following offsite sampling activities conducted to characterize polychlorinated dibenzo-p-dioxin and polychlorinated dibenzofuran (PCDD/F) concentrations in surface soils.

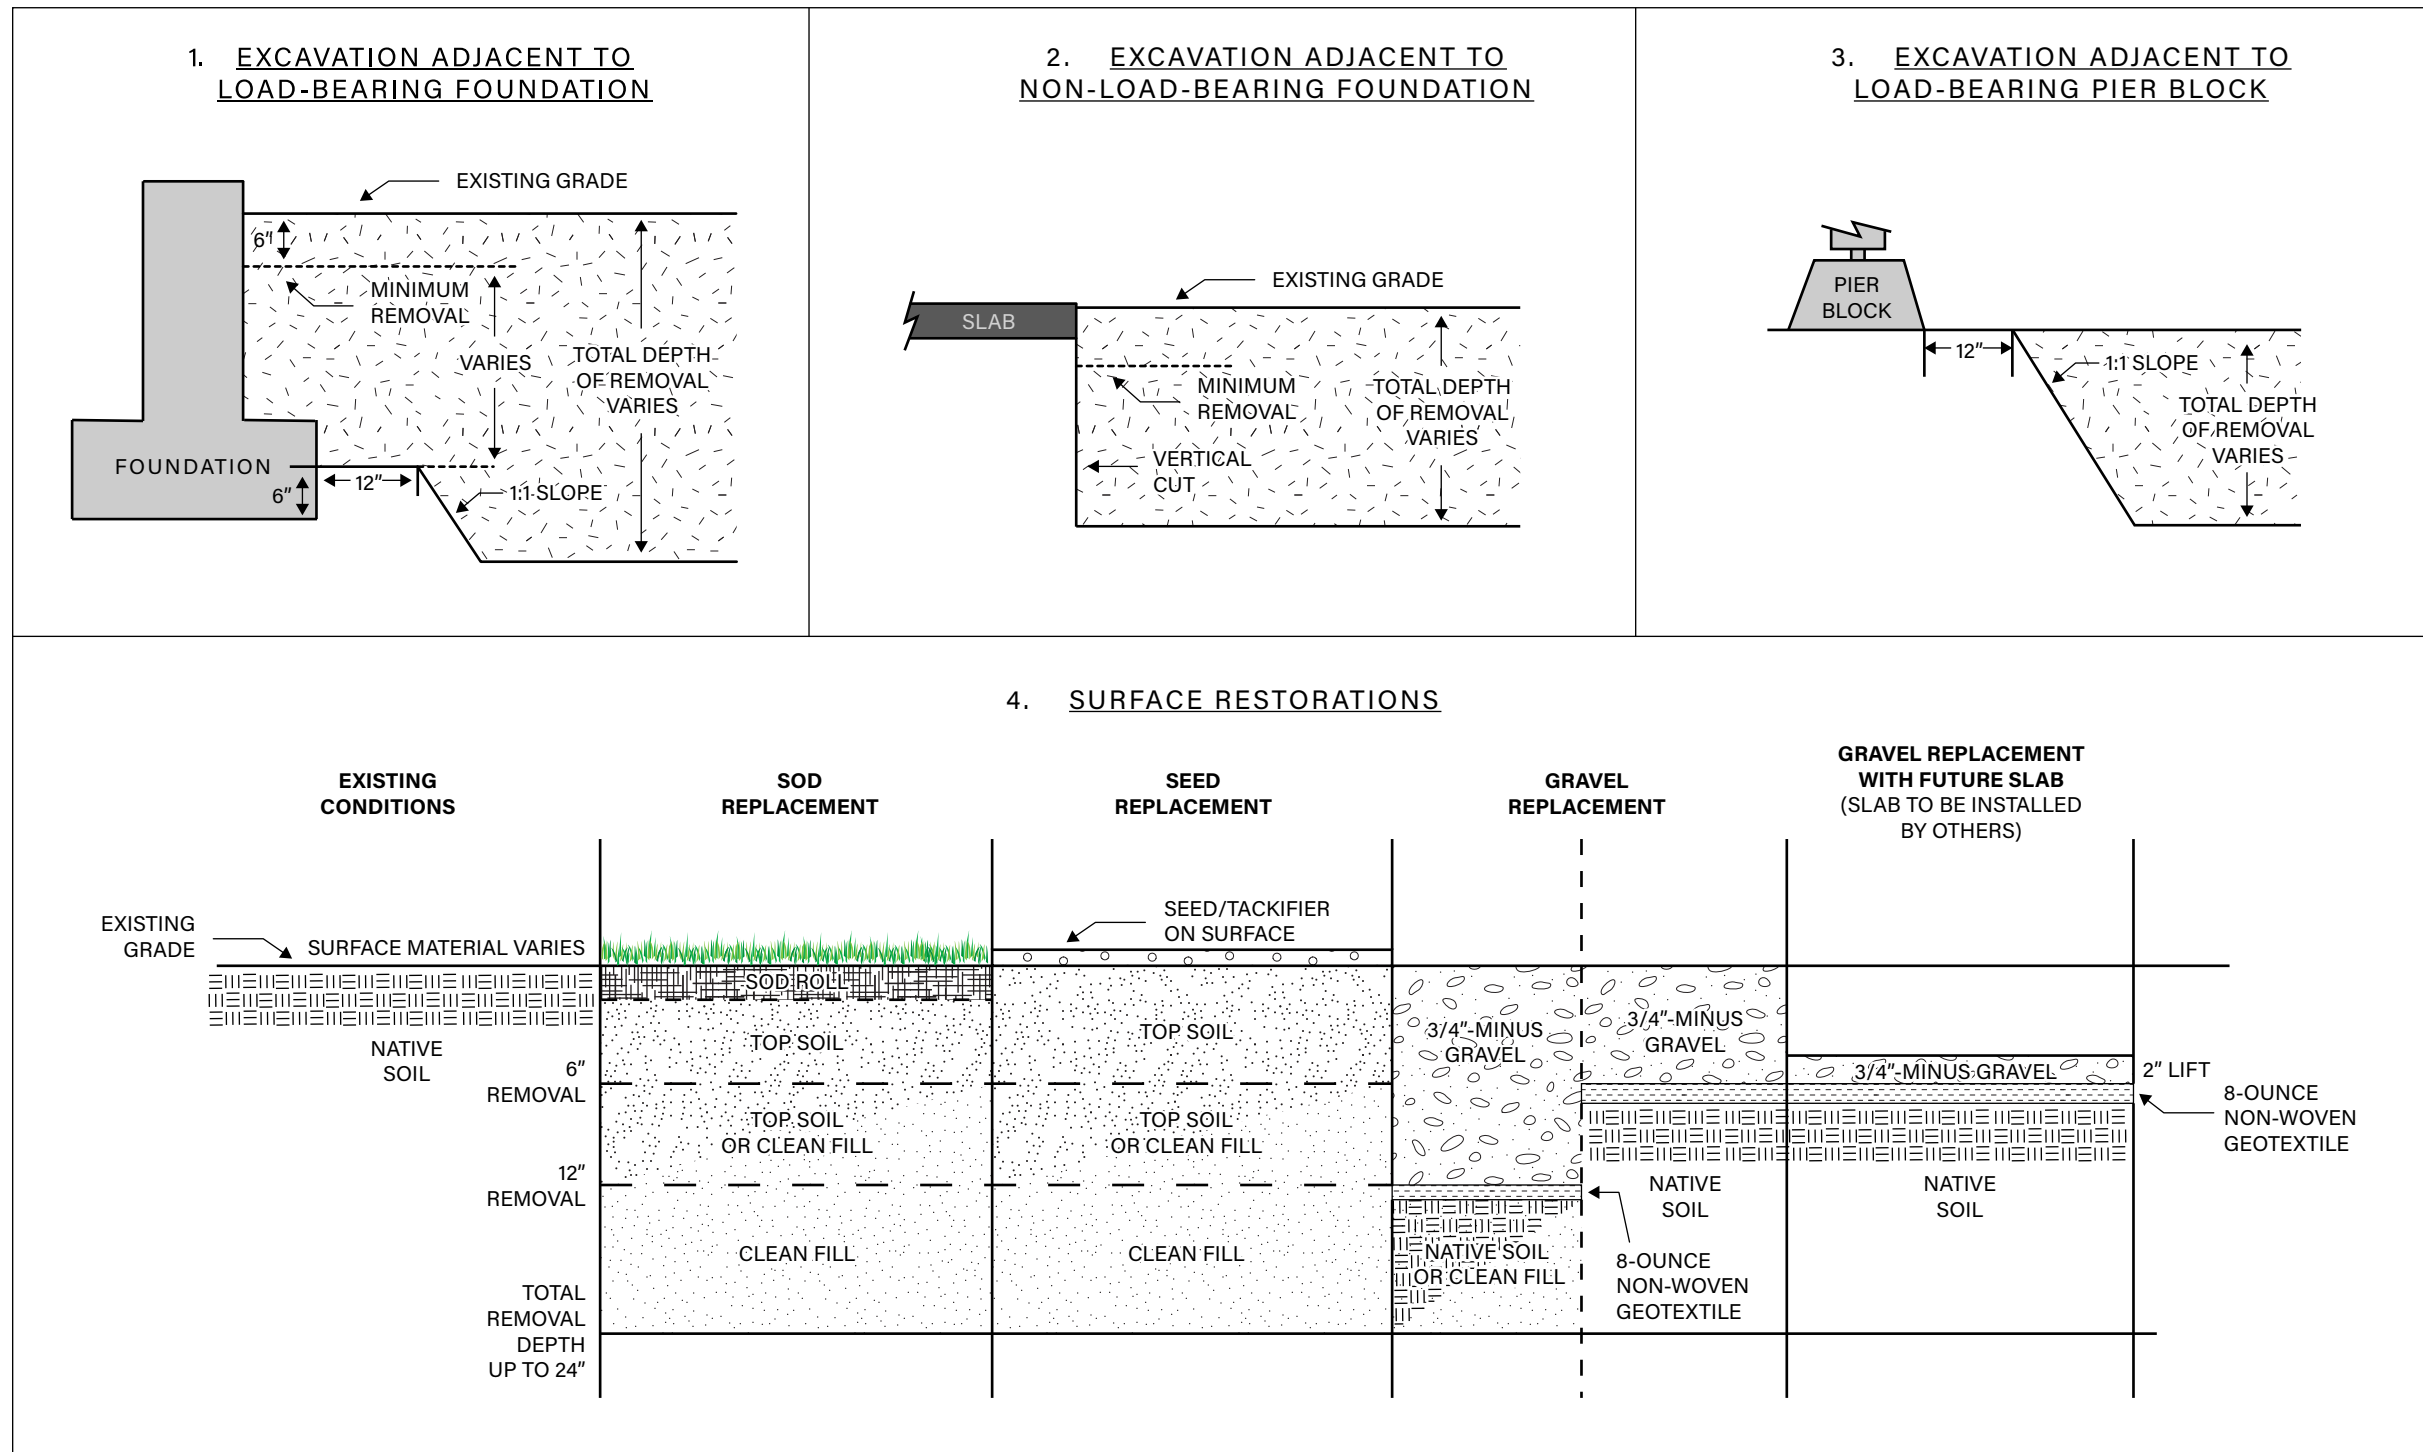
**FIGURE 3**

**Excavation Details**

- Excavations adjacent to structural foundations will be excavated to a minimum of 6-inches bgs at the foundation. The depth of the foundation will be determined by the earthwork subcontractor. Soil removal along the foundation will continue to approximately 6-inches above the bottom of the foundation footing, or the bottom extent of the RA, whichever is shallower. Once 6-inches above the base of the foundation, and if necessary, the excavation will be stepped out 1 foot before sloping or benching the excavation at a 1 foot horizontal to 1 foot vertical (1:1) slope to the total depth of excavation (Figure 3).
