Intertidal Sediment Remedy Operations, Maintenance, and Monitoring Plan

Former Petroleum Terminal #0022 and Manufactured Gas Plant
256 Marine Drive
Astoria, Oregon
(DEQ ECSI Number 1646)

PacifiCorp and Union Oil Company of California
September 2019; Revised June 2020

DALTON, OLMSTED, & FUGLEVAND
1236 Finn Hill Road
Poulsbo, Washington 98370

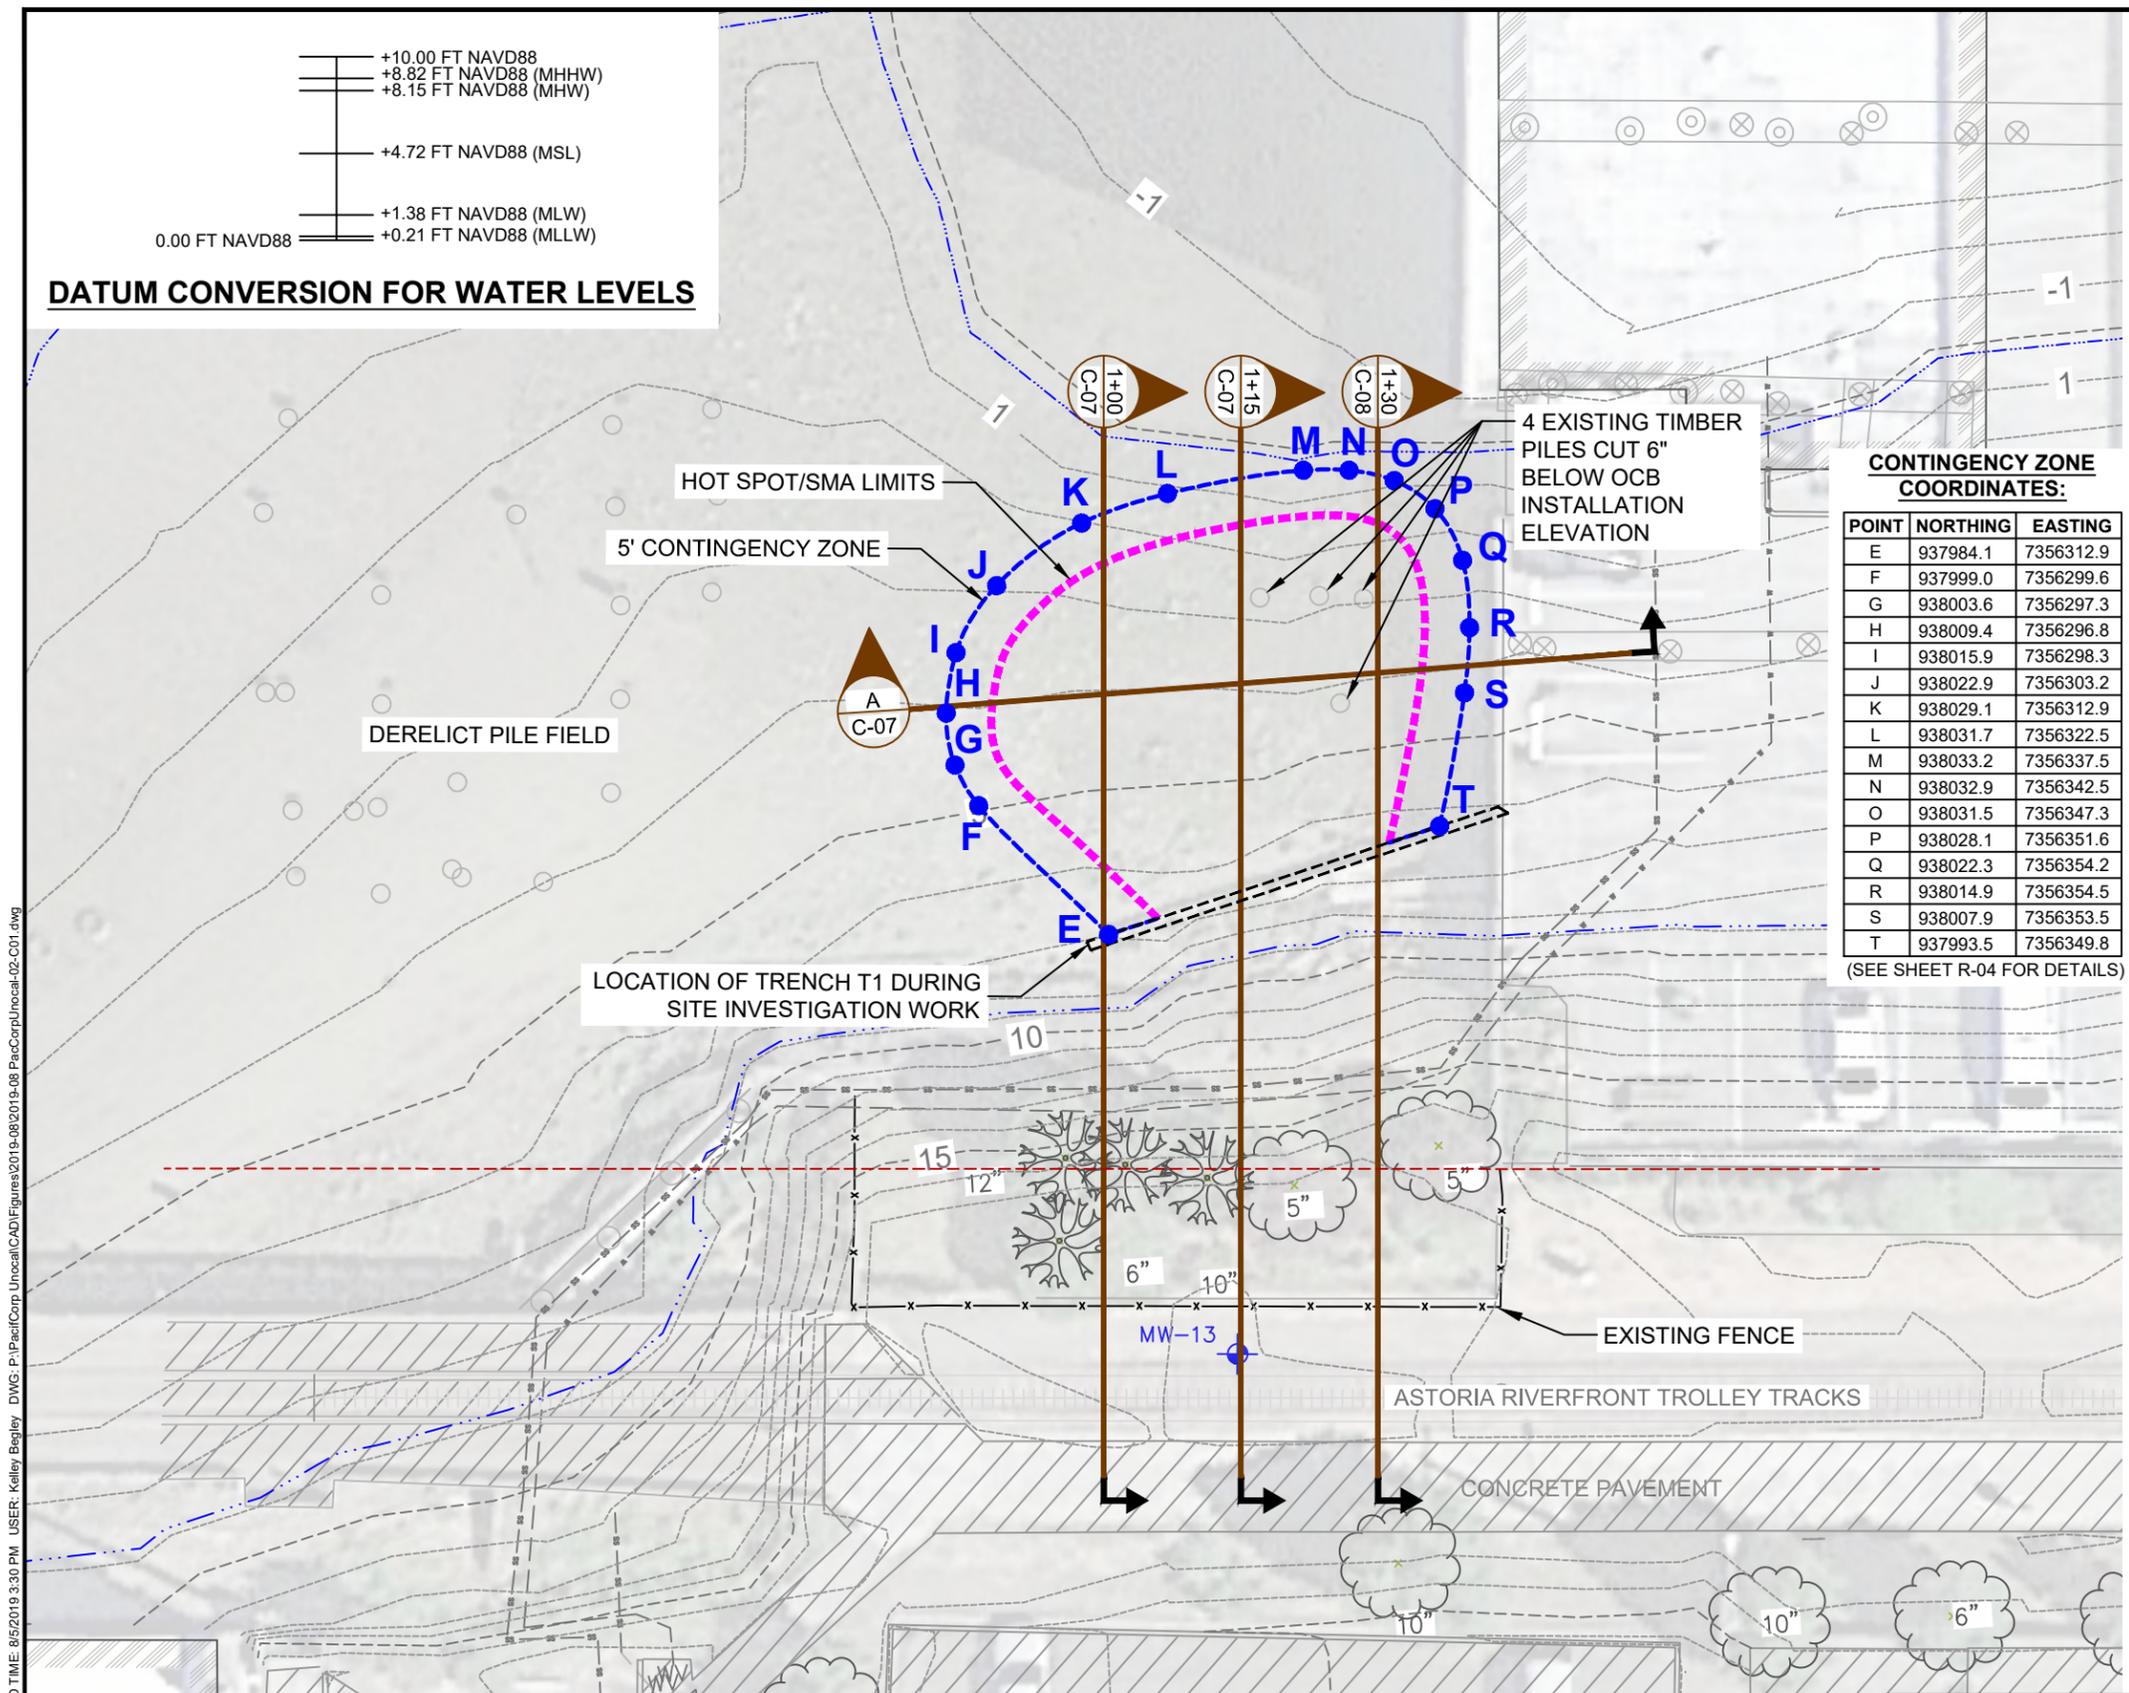
POINT	NORTHING	EASTING
E	937984.1	7356312.9
F	937999.0	7356299.6
G	938003.6	7356297.3
H	938009.4	7356296.8
I	938015.9	7356298.3
J	938022.9	7356303.2
K	938029.1	7356312.9
L	938031.7	7356322.5
M	938033.2	7356337.5
N	938032.9	7356342.5
O	938031.5	7356347.3
P	938028.1	7356351.6
Q	938022.3	7356354.2
R	938014.9	7356354.5
S	938007.9	7356353.5
T	937993.5	7356349.8

(SEE SHEET R-04 FOR DETAILS)

The purpose of visual inspections is to monitor the engineering controls and their effectiveness in their intended purpose of meeting the sediment RAOs. The intertidal sediment cap will be monitored to verify effective containment of underlying contamination. The monitoring program is intended to detect and evaluate any potential changes in cap integrity over time. The intertidal sediment cap was constructed consistent with the project design and specifications. A Plan view of the design is shown on Figure 2. Typical design sections are shown in Figures 3 & 4.

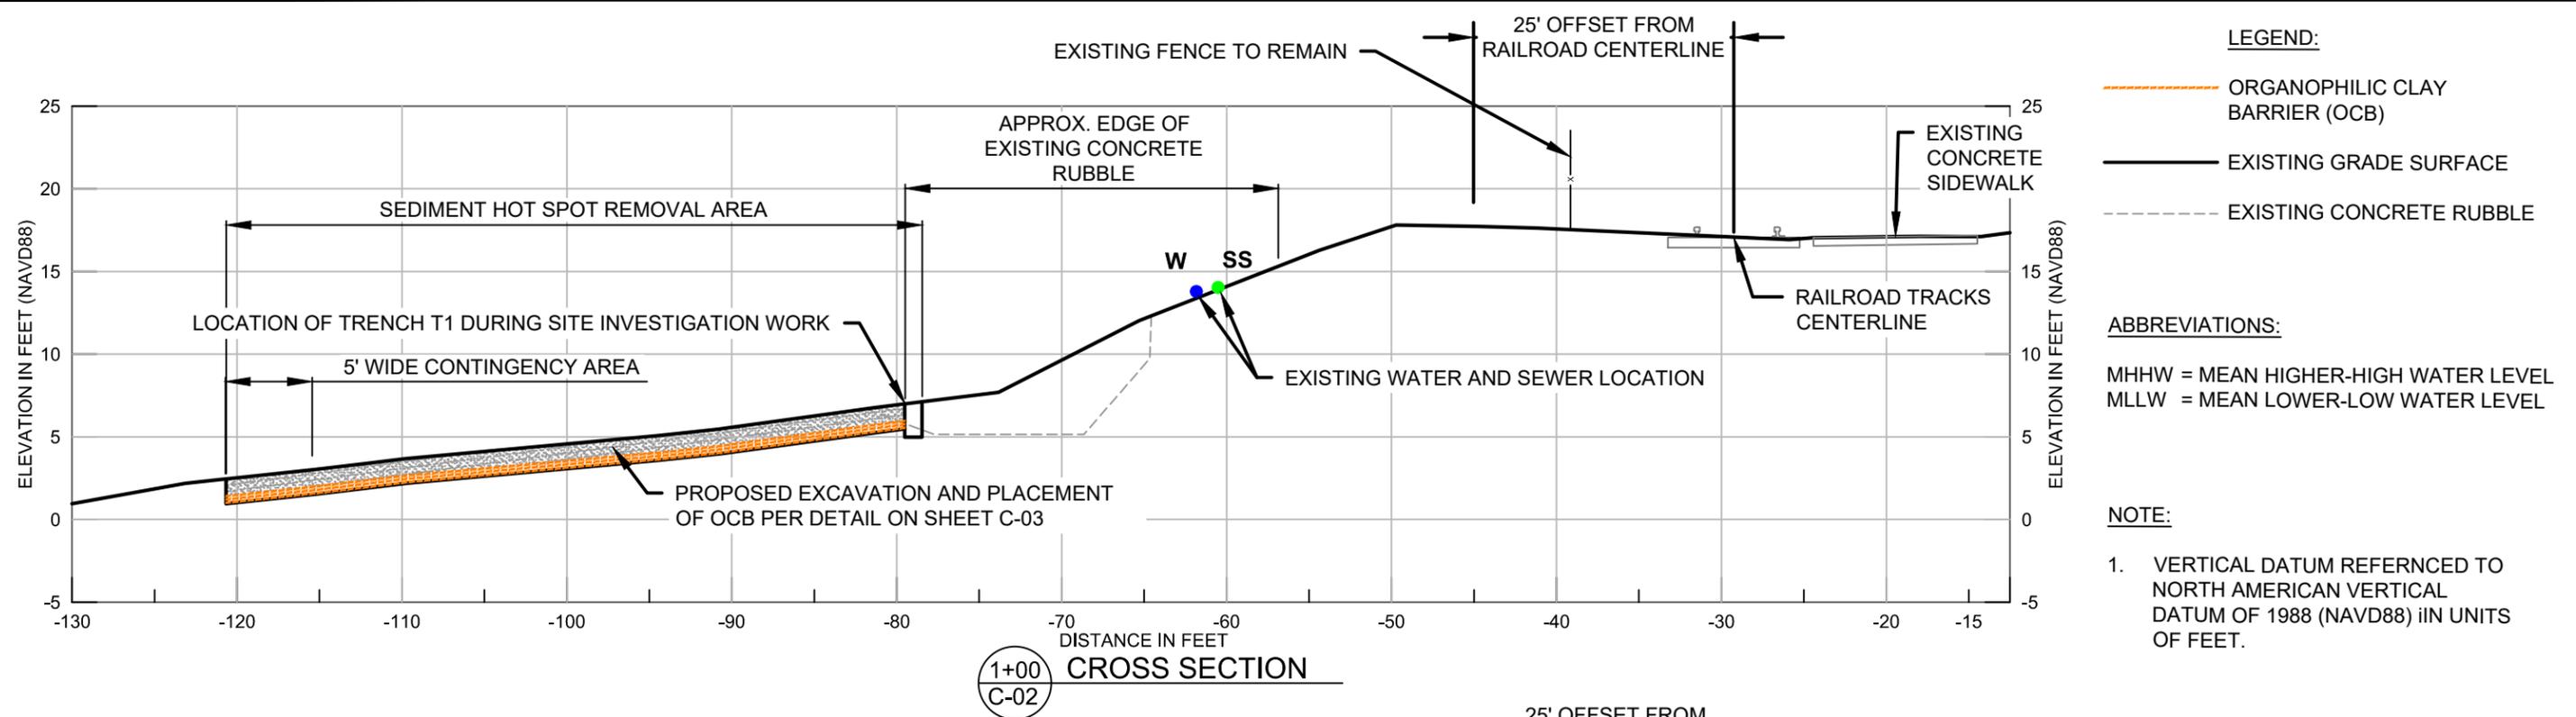
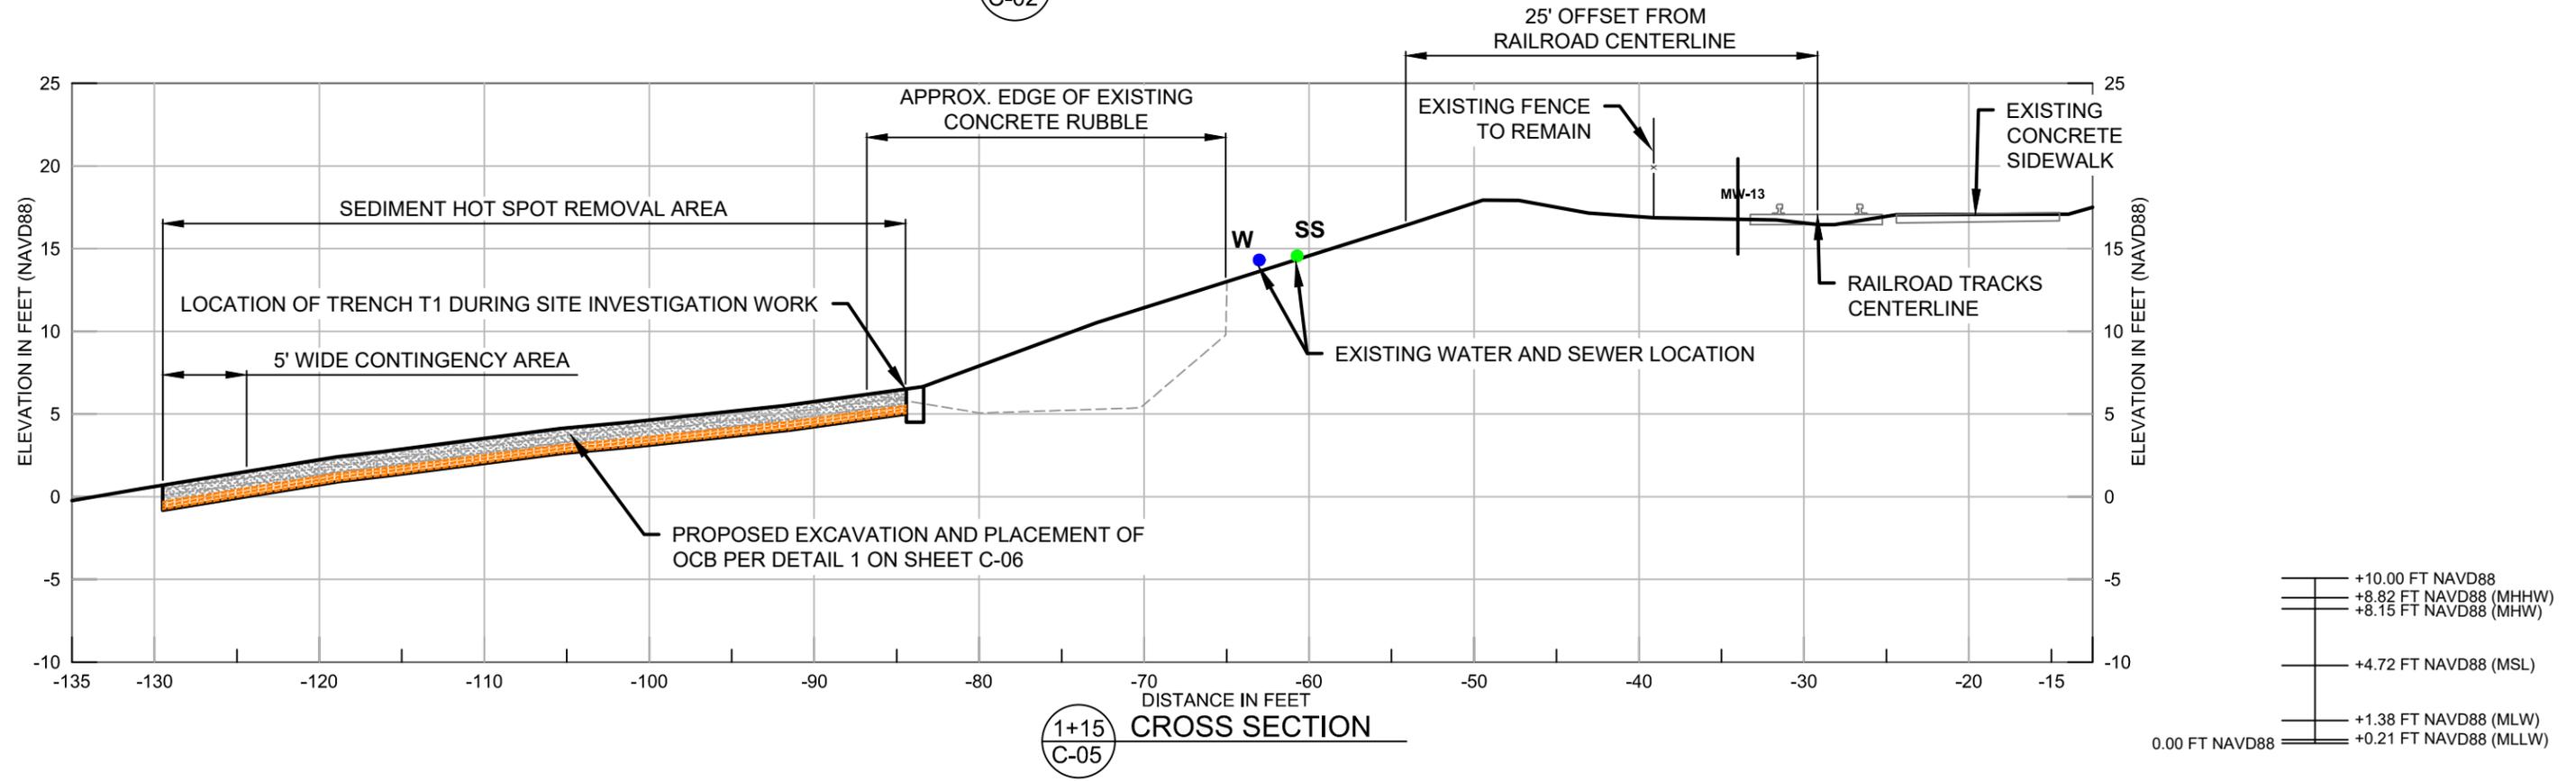
PACIFICORP / UNOCAL SITE ASTORIA, OREGON	
IN-WATER (INTERTIDAL) OCB REMEDY	
IN-WATER REMEDY PLAN CROSS SECTIONS	FIGURE 3 August 5, 2019

- ORGANOPHILIC CLAY BARRIER (OCB)
- EXISTING GRADE SURFACE
- EXISTING CONCRETE RUBBLE

1. VERTICAL DATUM REFERENCED TO NORTH AMERICAN VERTICAL DATUM OF 1988 (NAVD88) IN UNITS OF FEET.

+10.00 FT NAVD88
+8.82 FT NAVD88 (MHHW)
+8.15 FT NAVD88 (MHW)
+4.72 FT NAVD88 (MSL)
+1.38 FT NAVD88 (MLW)
+0.21 FT NAVD88 (MLLW)
0.00 FT NAVD88

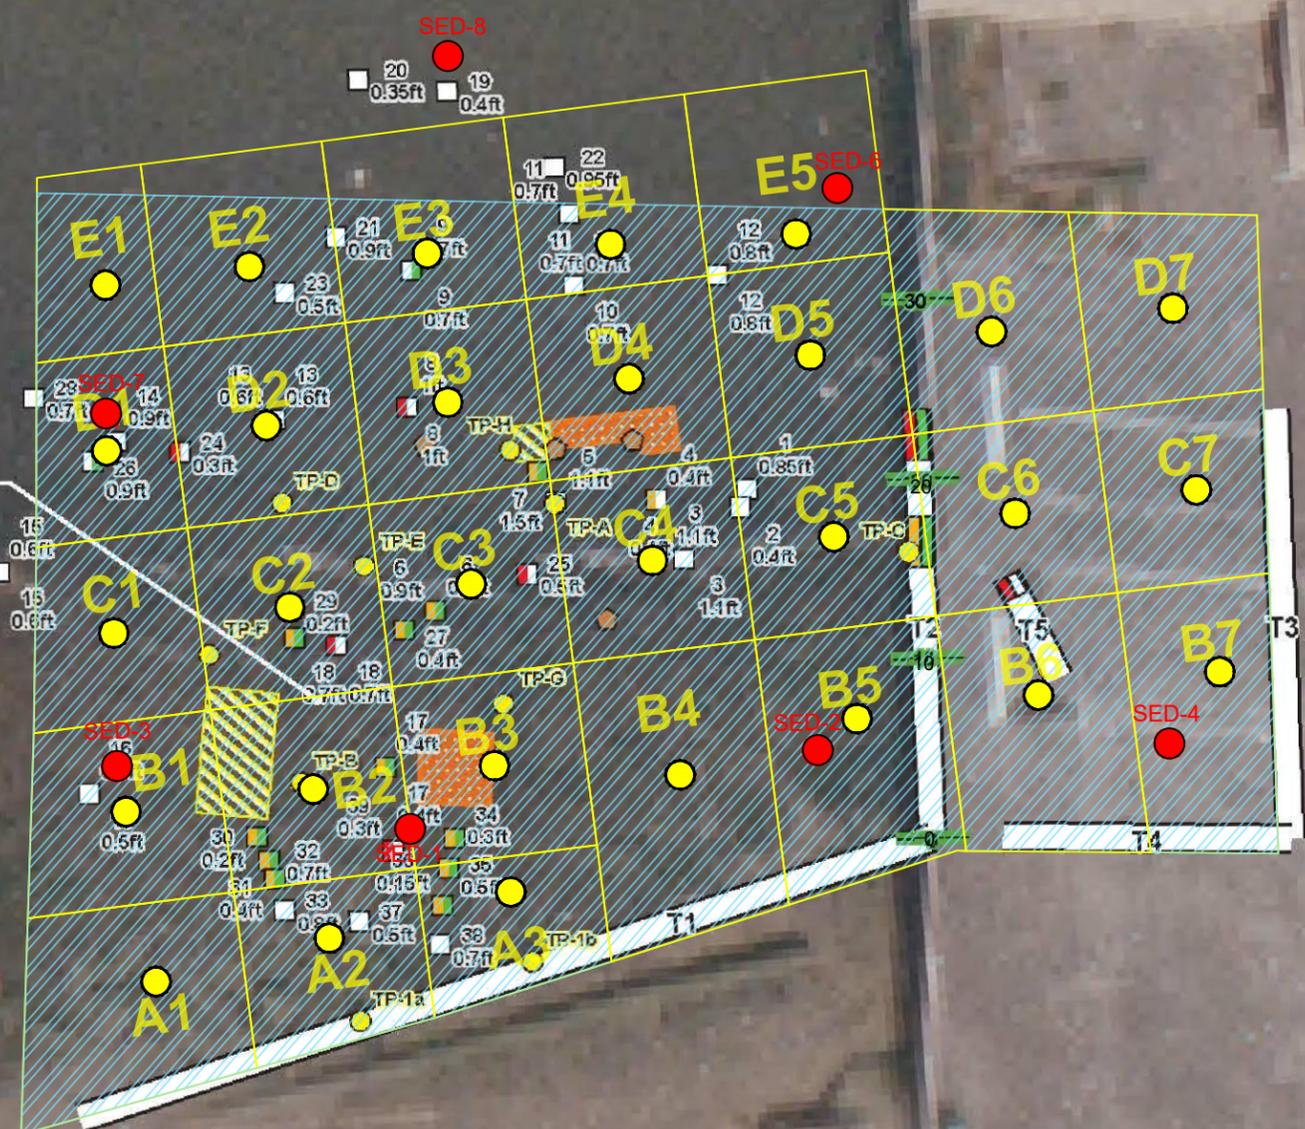
Hydrocarbon-Impacted Sediment Area

- E6 Proposed Sampling Grid
10'x10' Cell
- Proposed Sheen Sample
(Observation) Location

- SED-4 ● Sediment Sample
- Test Pit
- T5 Trench
- No Observed Impact
- LNAPL
- Sheen
- Impacted Sediment
- LNAPL and Impacted Sediment
- Sheen and Impacted Sediment
- Trench Stationing, 10 Feet
- Organoclay Contained in Geotextile Fabric
- Reactive Core Mat
- Conceptual Sediment Management Area
Extent as shown in FS

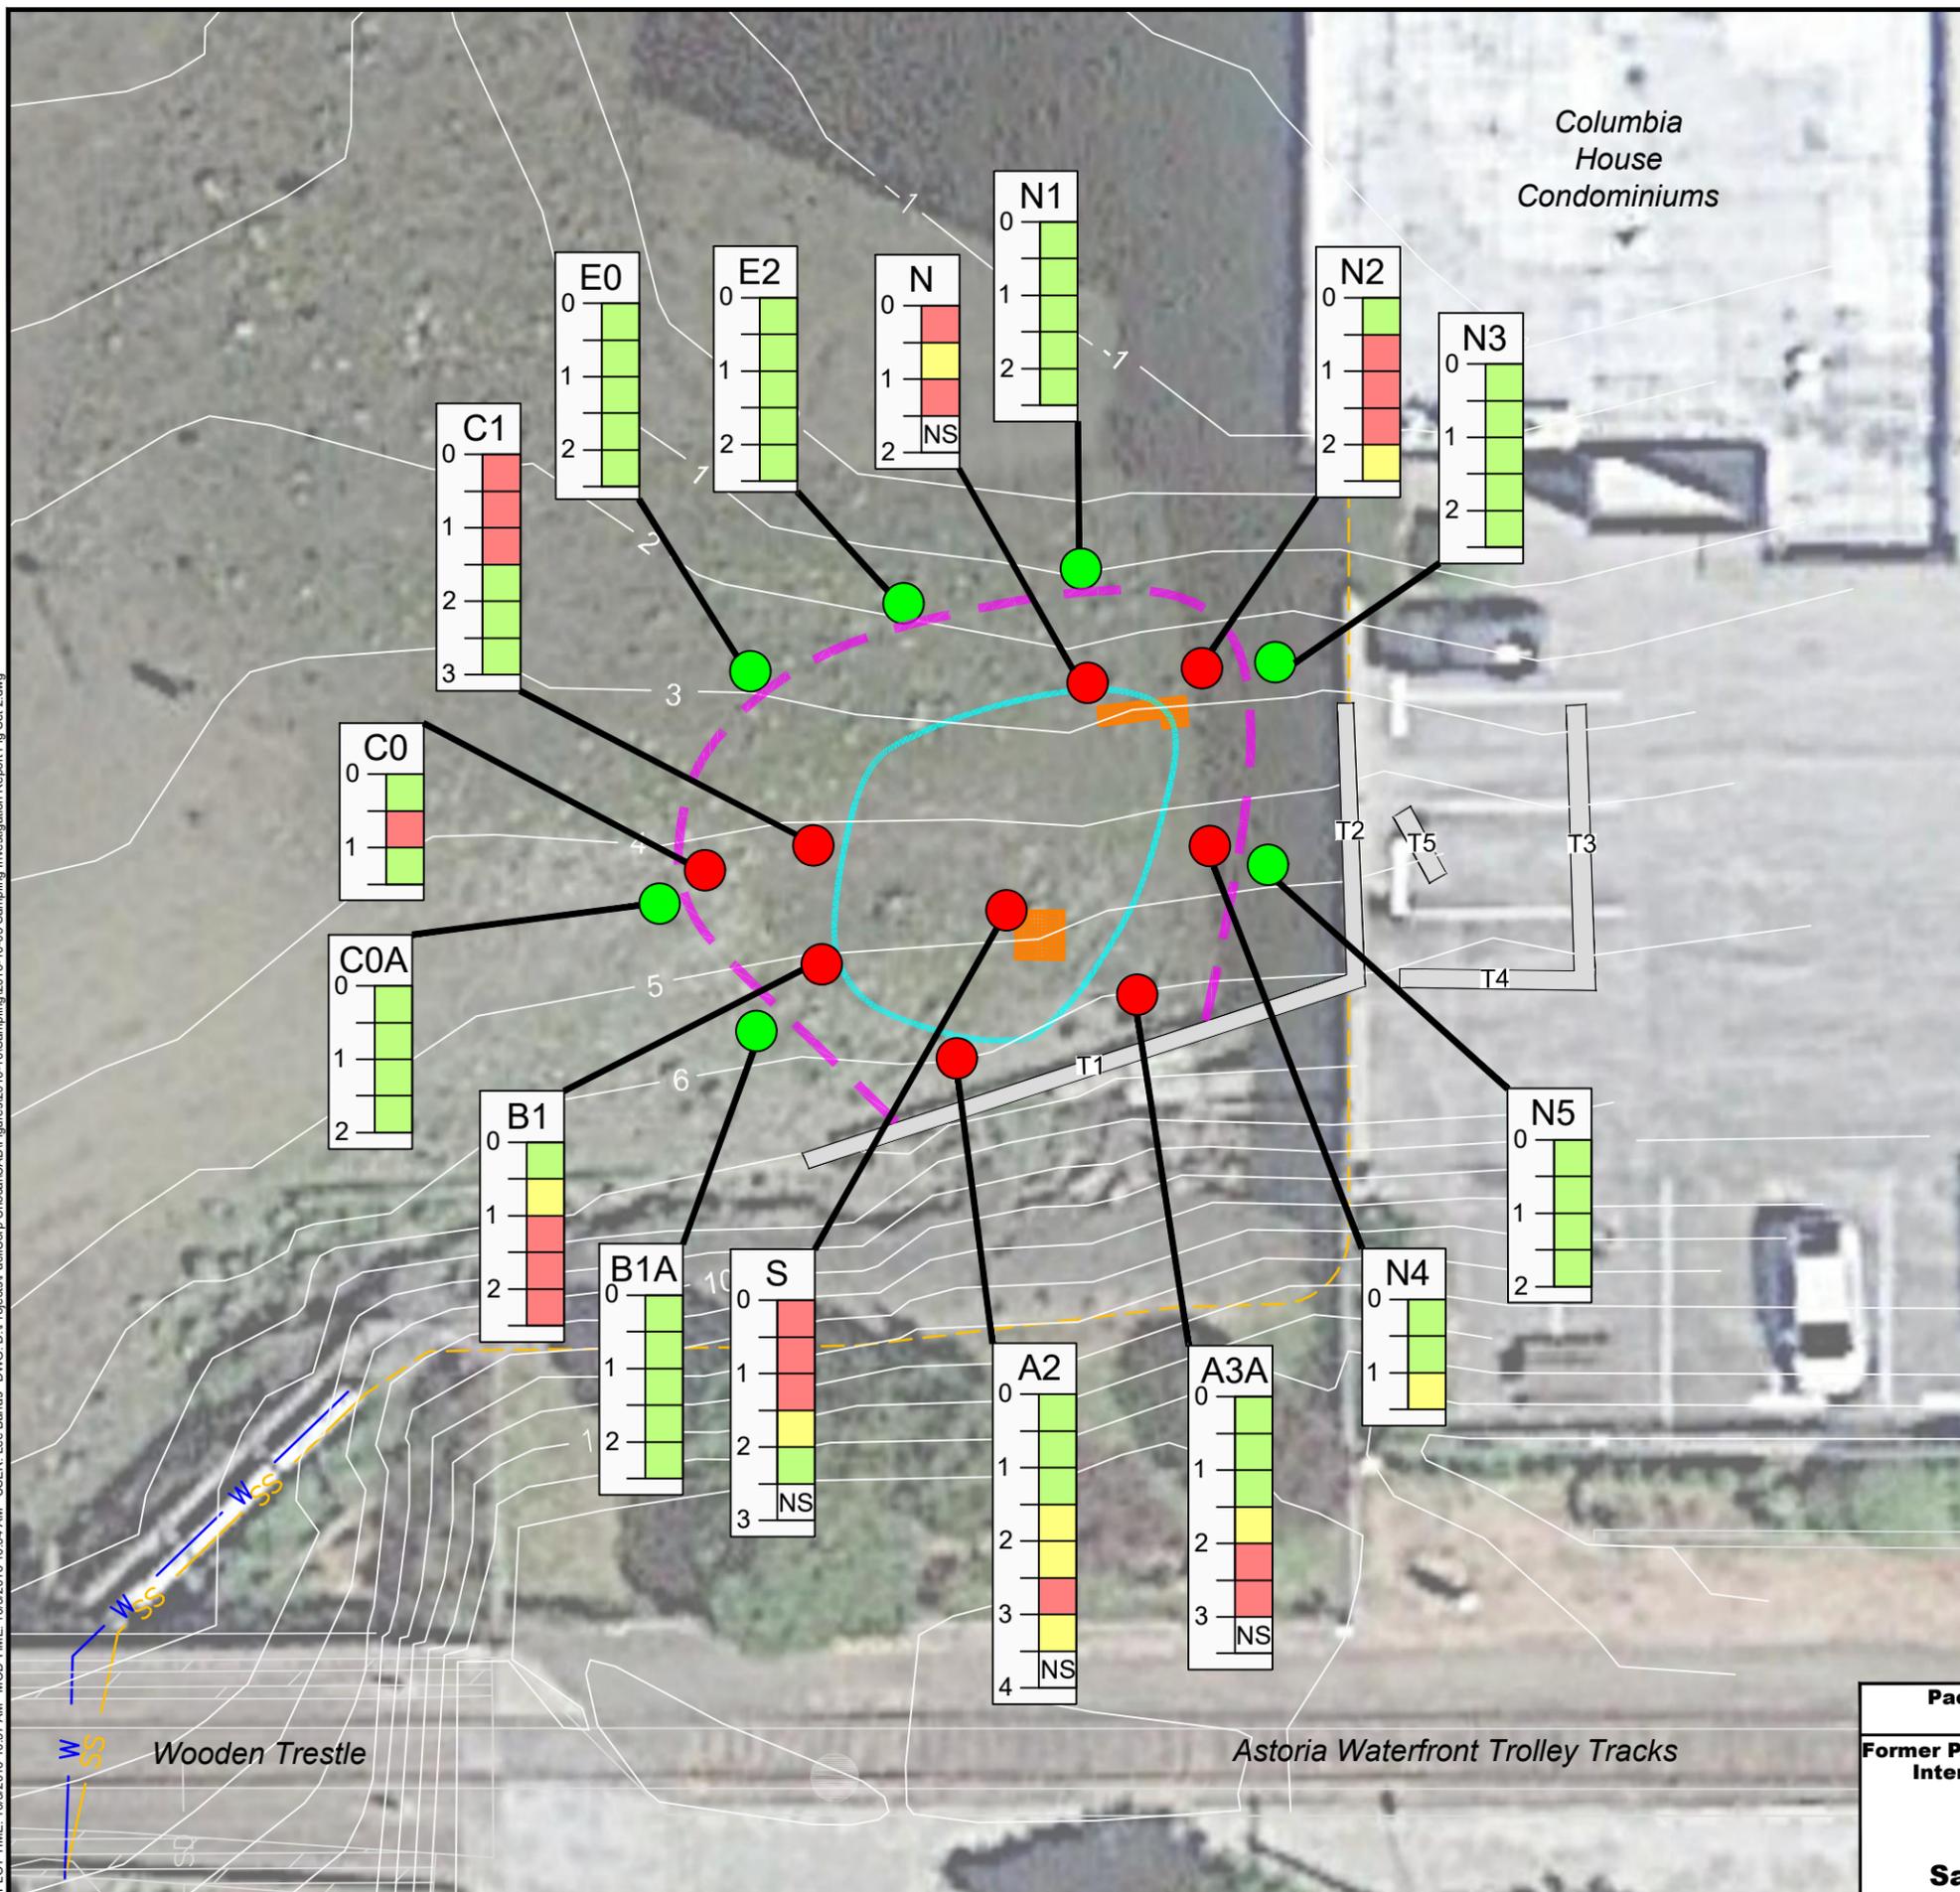
DOF DALTON
 OLMSTED
 FUGLEVAND
Figure 5
 October 5, 2016

- Subsurface - Hydrocarbon Sheen or LNAPL Detected
- Subsurface - No Hydrocarbon Sheen or LNAPL Detected
*(LNAPL = Light Non Aqueous Phase Liquid)

Petroleum hydrocarbons, polycyclic aromatic hydrocarbons, and some metals were detected in sediment samples and groundwater discharge samples in the intertidal zone of the Columbia River north of the Site (see Tables 4-28, 4-29, 4-39, and 4-40, and Tables 7-2 through 7-9 of the 2008 Off-Site Remedial Investigation and Risk Assessment [MFA, 2008] and Figure 7-1 of the 2009 Feasibility Study [MFA, 2009]. The extent of a 3,000-square-foot (SF) Sediment Management Area (SMA) was based on limited sediment bioassay results for surface sediment samples and visual observations of a hydrocarbon sheen/light non-aqueous phase liquid (LNAPL) in surface and subsurface sediment. The extent of the LNAPL, about 600 square feet, was defined as a Hot Spot. The extent of the SMA, including the Hot Spot, was refined based on additional surface and subsurface explorations in 2016 (see Investigation Report (DOF 2016) Figures 5 & 6 in Appendix C).

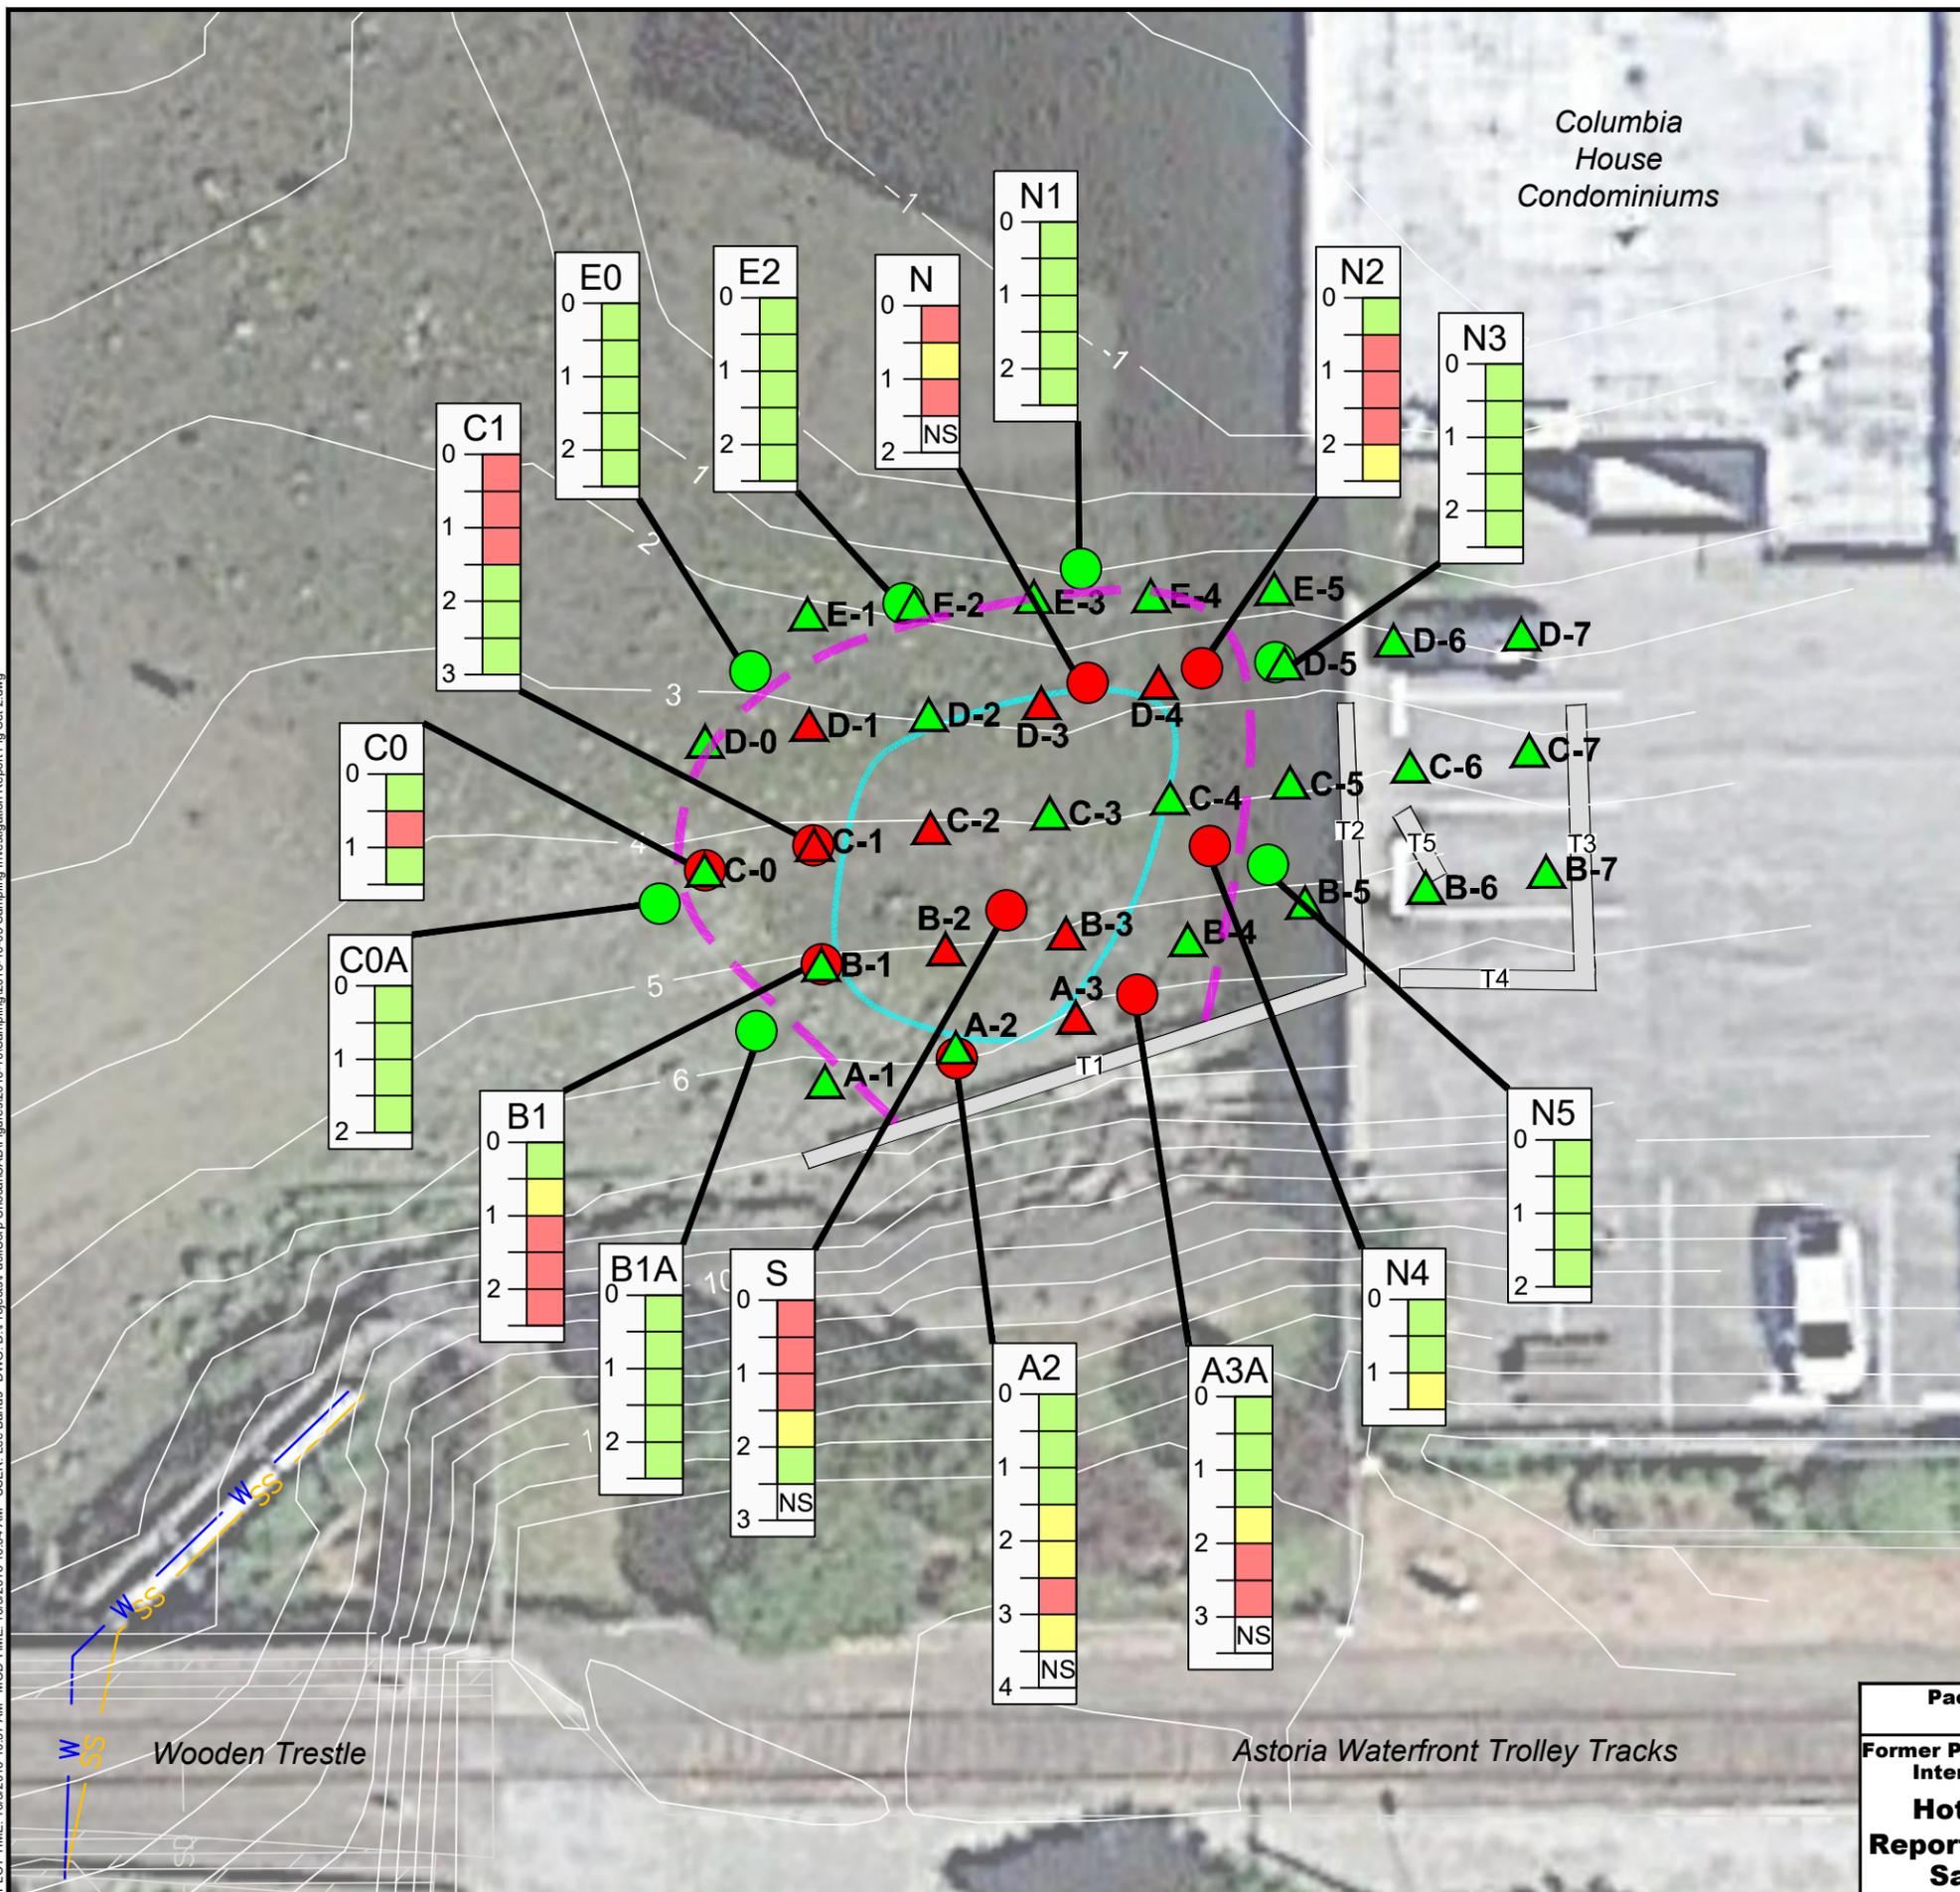
- ▲ Surface - Hydrocarbon Sheen or LNAPL Detected
 - ▲ Surface - No Hydrocarbon Sheen or LNAPL Detected
 - Subsurface - Hydrocarbon Sheen or LNAPL Detected
 - Subsurface - No Hydrocarbon Sheen or LNAPL Detected
- *(LNAPL = Light Non Aqueous Phase Liquid)
