SUB-SLAB VENTILATION (SSV) SYSTEM OPERATIONS AND MAINTENANCE PLAN

Former Union Cleaners II Property

1220 S Main Street
Lebanon, Oregon 97355

Project No. 724-10001-05E

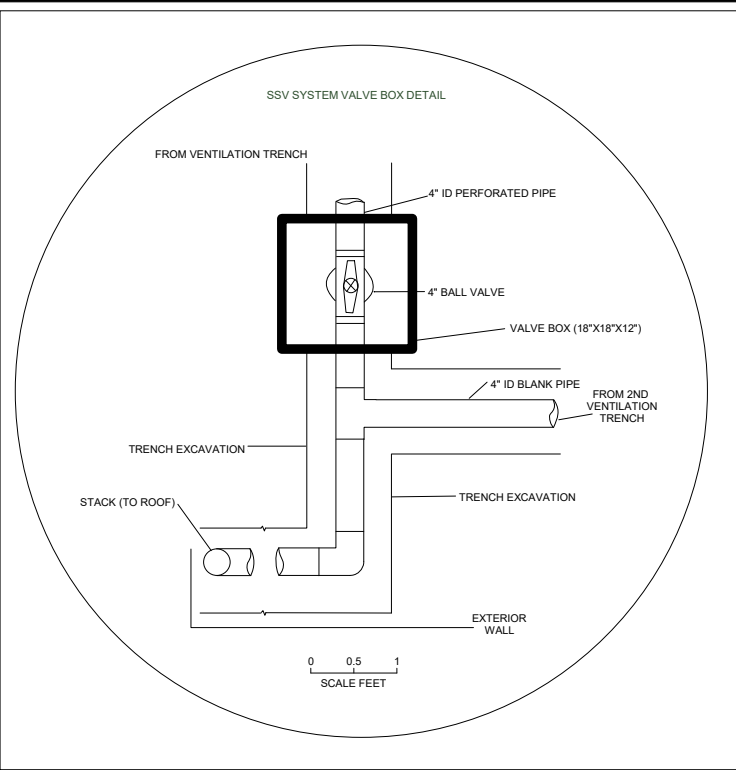
SSD SYSTEM VALVE BOX DETAIL

VENT RISER (STACK)

- A 4-inch ID PVC vertical vent riser running to the roof near the southwest corner of the former dry cleaner space. The vent riser is connected to the collector pipe in the trench with a 90° elbow, a short nipple, and a Fernco fitting.
- A wind-driven turbine fan attached to the vent riser to pull a vacuum through the system.
- A U-tube manometer to monitor system operations installed on the vertical riser vent pipe following manufacturer recommendations. *Note: this is a remnant of the active SSD system and is not needed for the passive SSV system.*

- **Observe Valve Boxes.** From the interior of the building, open and inspect the west leg and east leg valve boxes. At each valve box, confirm that the valve is open and allows airflow from the perforated vent leg to the collector line and to the vent riser. Confirm that the valves are operational and undamaged and in the open position. Replace any valve that is broken or stuck in the closed position.

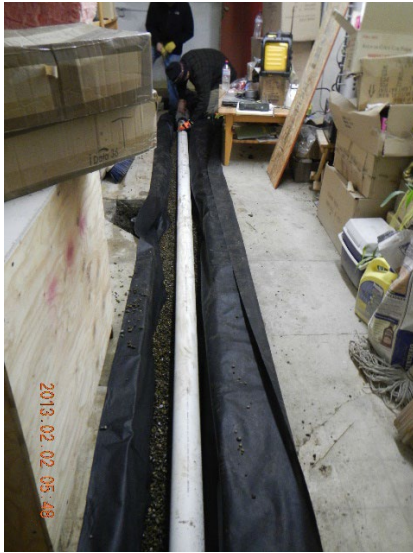
West SSV leg during installation – perforated 4-inch PVC bedded on gravel in a fabric-lined trench – view south.

- An east-west-trending 4-inch ID PVC collector pipe connecting two north-south-trending vent legs in filter fabric-lined SSV trenches. The 20-foot-long westside SSV leg and 30-foot-long eastside SSV leg each consist of 4-inch ID perforated PVC pipe on gravel bedding with a gravel covering that were all wrapped in filter fabric and covered with polyethylene sheeting prior to pouring concrete in the trench cuts. A 4-inch ID PVC ball valve is positioned in a flush-to-floor vault at each leg. The vent legs were each sloped so that condensate, if present, would pool and drain into the perforated sections.

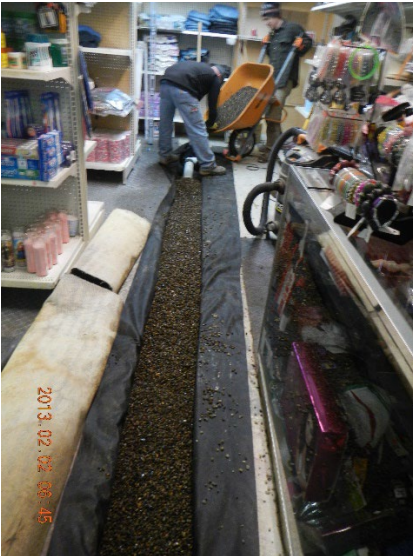
East SSV leg during installation – covered with gravel in a fabric-lined trench – view south.

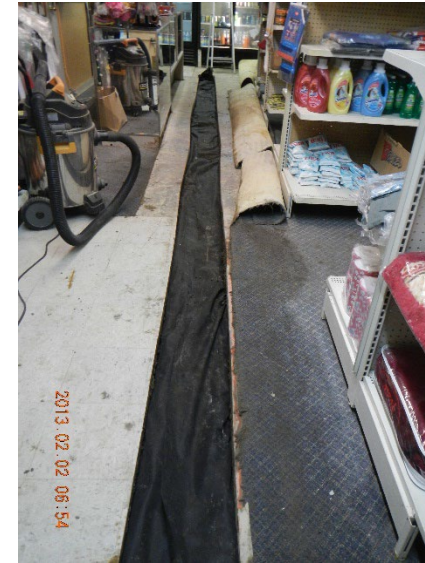
East SSV leg during installation – wrapped in fabric – view north.

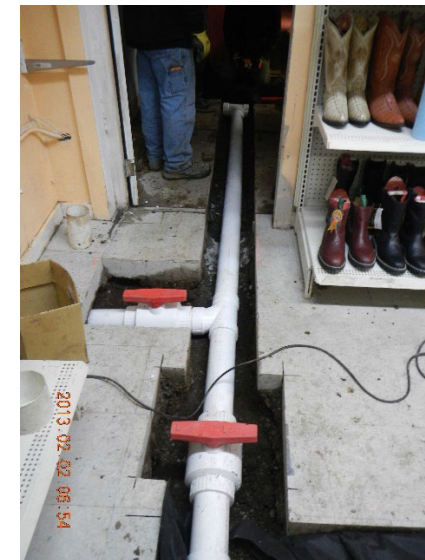
Collector line during installation. 1st valve (foreground) controls the east leg, 2nd valve (left of center) unused – view west.

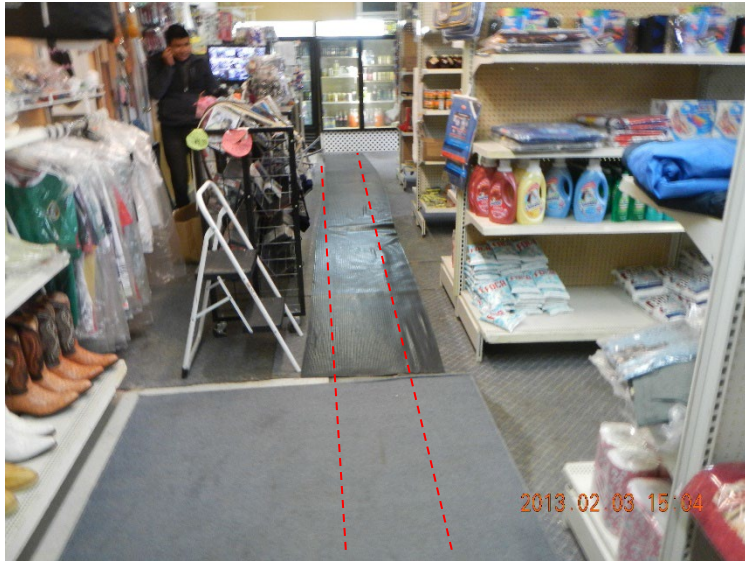
East leg after concrete pour – view north. Previous tenant.

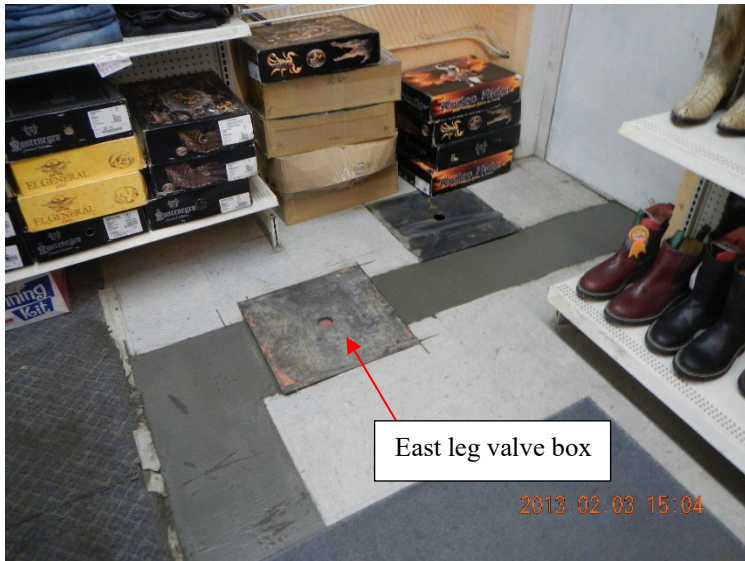
East leg valve box

Collector line and valve boxes after pouring concrete – view southwest.

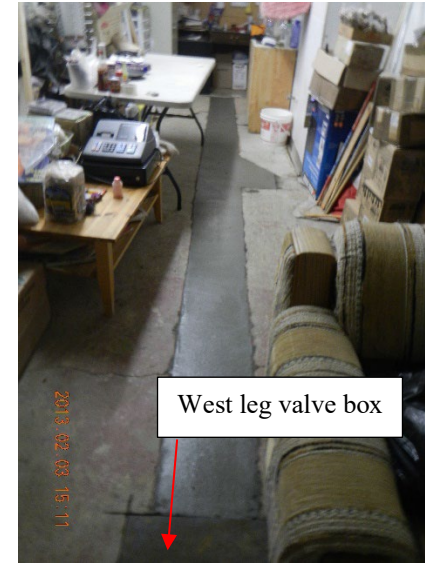
West leg valve box

West leg after pouring concrete – view south.

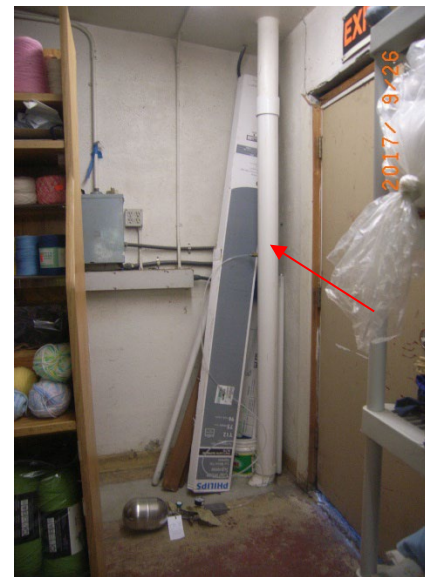
Interior view of SSV riser at southwest corner of suite 1220.

- **Observe the SSV riser.** From exterior roof-level, confirm that the riser opening is unobstructed, i.e., not clogged with debris such as bird or wasp nesting material. Clear out all obstructing debris. Also confirm that the riser is not bent or broken. Repair or replace the riser if damaged. From the interior of the building, confirm that the riser pipe is not damaged or broken. Repair or replace the riser if damaged.

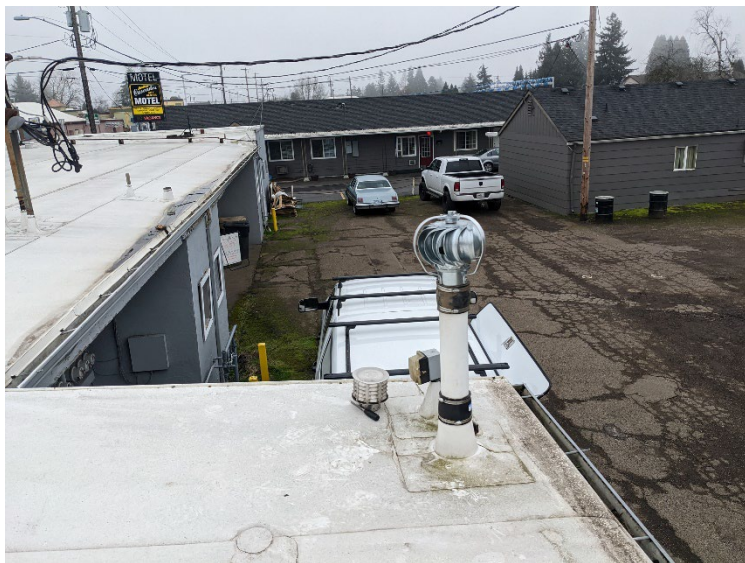
Wind-driven turbine on top of SSV riser above roof level – view facing south.

- **Observed the Wind-Driven Turbine.** From the exterior roof-level, confirm that the wind-driven turbine is undamaged and free-spinning. Replace turbine if damaged. If turbine is binding, trouble-shoot and correct the cause, i.e., lubricate and free obstruction. Replace the wind-driven turbine if attempts to free it are unsuccessful.
