**CAP MAINTENANCE PLAN**

River Terrace Town Center  
SW Roy Rogers Road  
Tigard, Oregon

For  
Oregon Department of Environmental Quality  
On behalf of TNHC Oregon LLC  
May 31, 2024

Project: NewHome-5-05

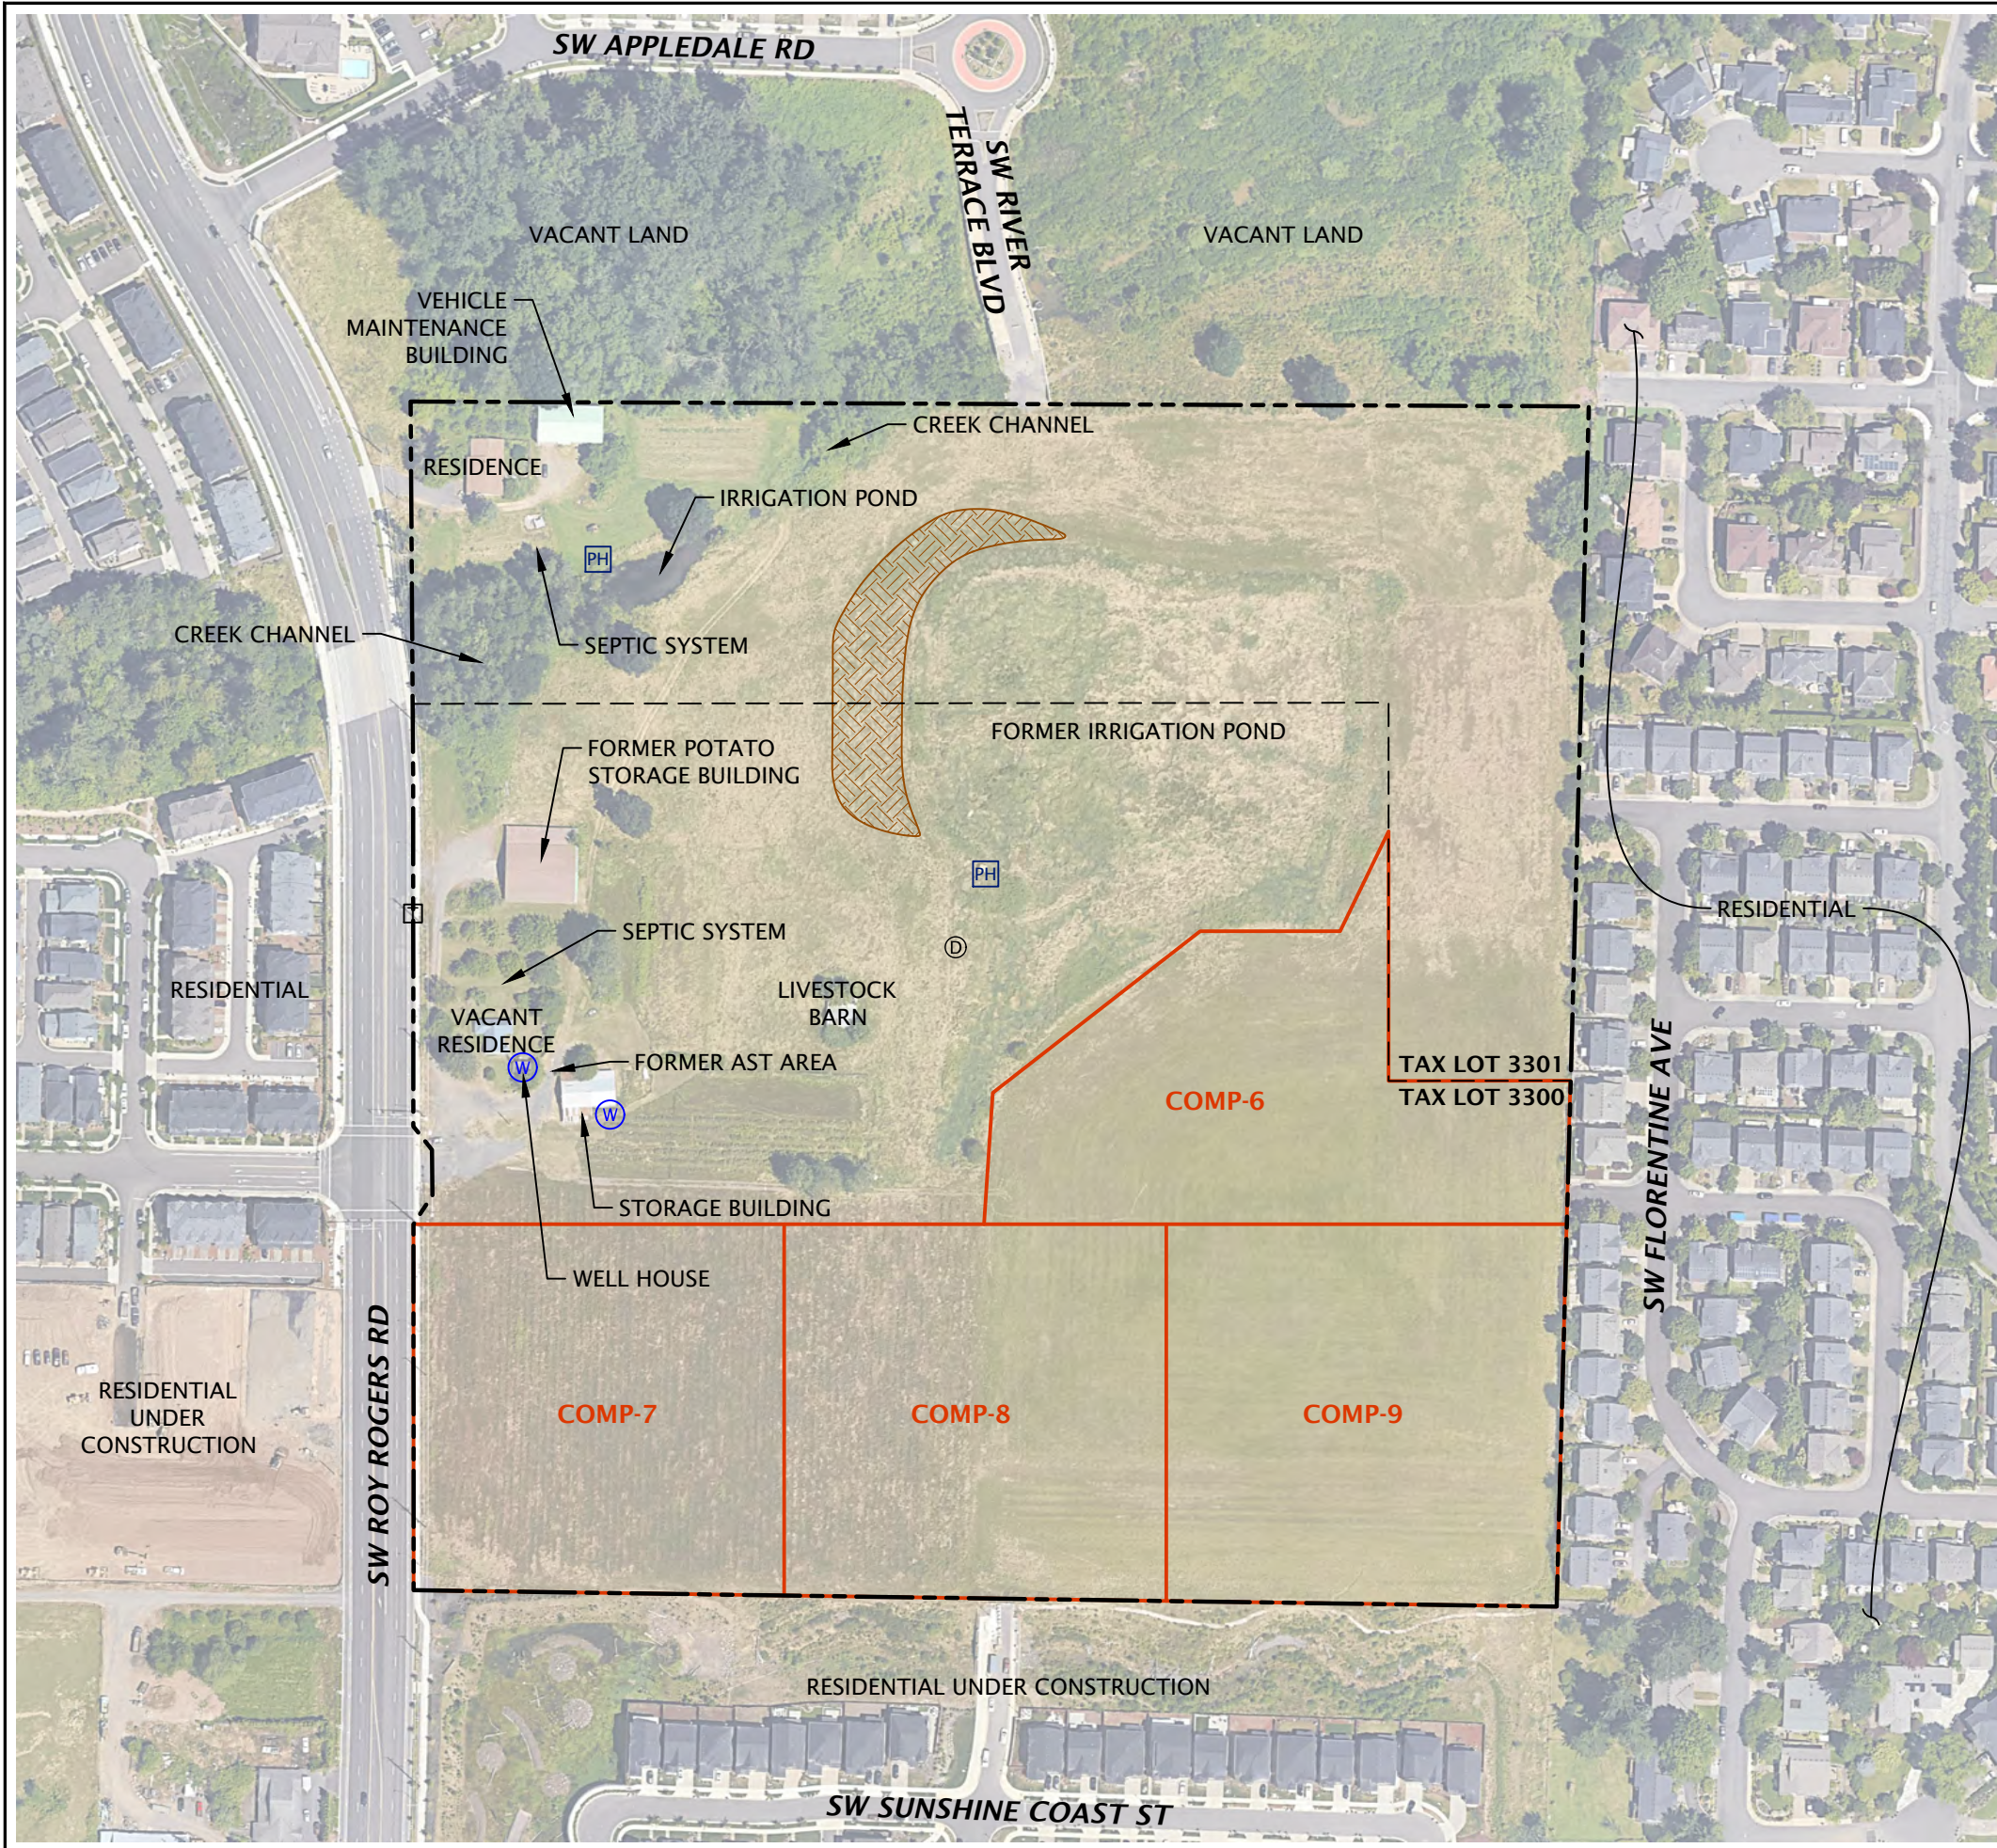
PRE-CONSTRUCTION SITE PLAN RIVER TERRACE TOWN CENTER TIGARD, OR	FIGURE 2
	NEWHOME-5-05 MAY 2024

SITE PLAN BASED ON AERIAL PHOTOGRAPH DATED JULY 10, 2022, OBTAINED FROM GOOGLE EARTH PRO.

The subject property is shown relative to surrounding physical features on Figure 1. The layout of the subject property prior to redevelopment is shown on Figure 2. The subject property layout and general locations of the disposal cells are shown on Figure 3. Acronyms and abbreviations used herein are defined above, immediately following the Table of Contents.

The subject property encompasses 38.69 acres east of SW Roy Rogers Road in Tigard, Oregon. The subject property was formerly developed for agricultural use with associated rural residences and outbuildings (Figure 2). An unnamed tributary of the Tualatin River transects the northwest portion of the subject property.

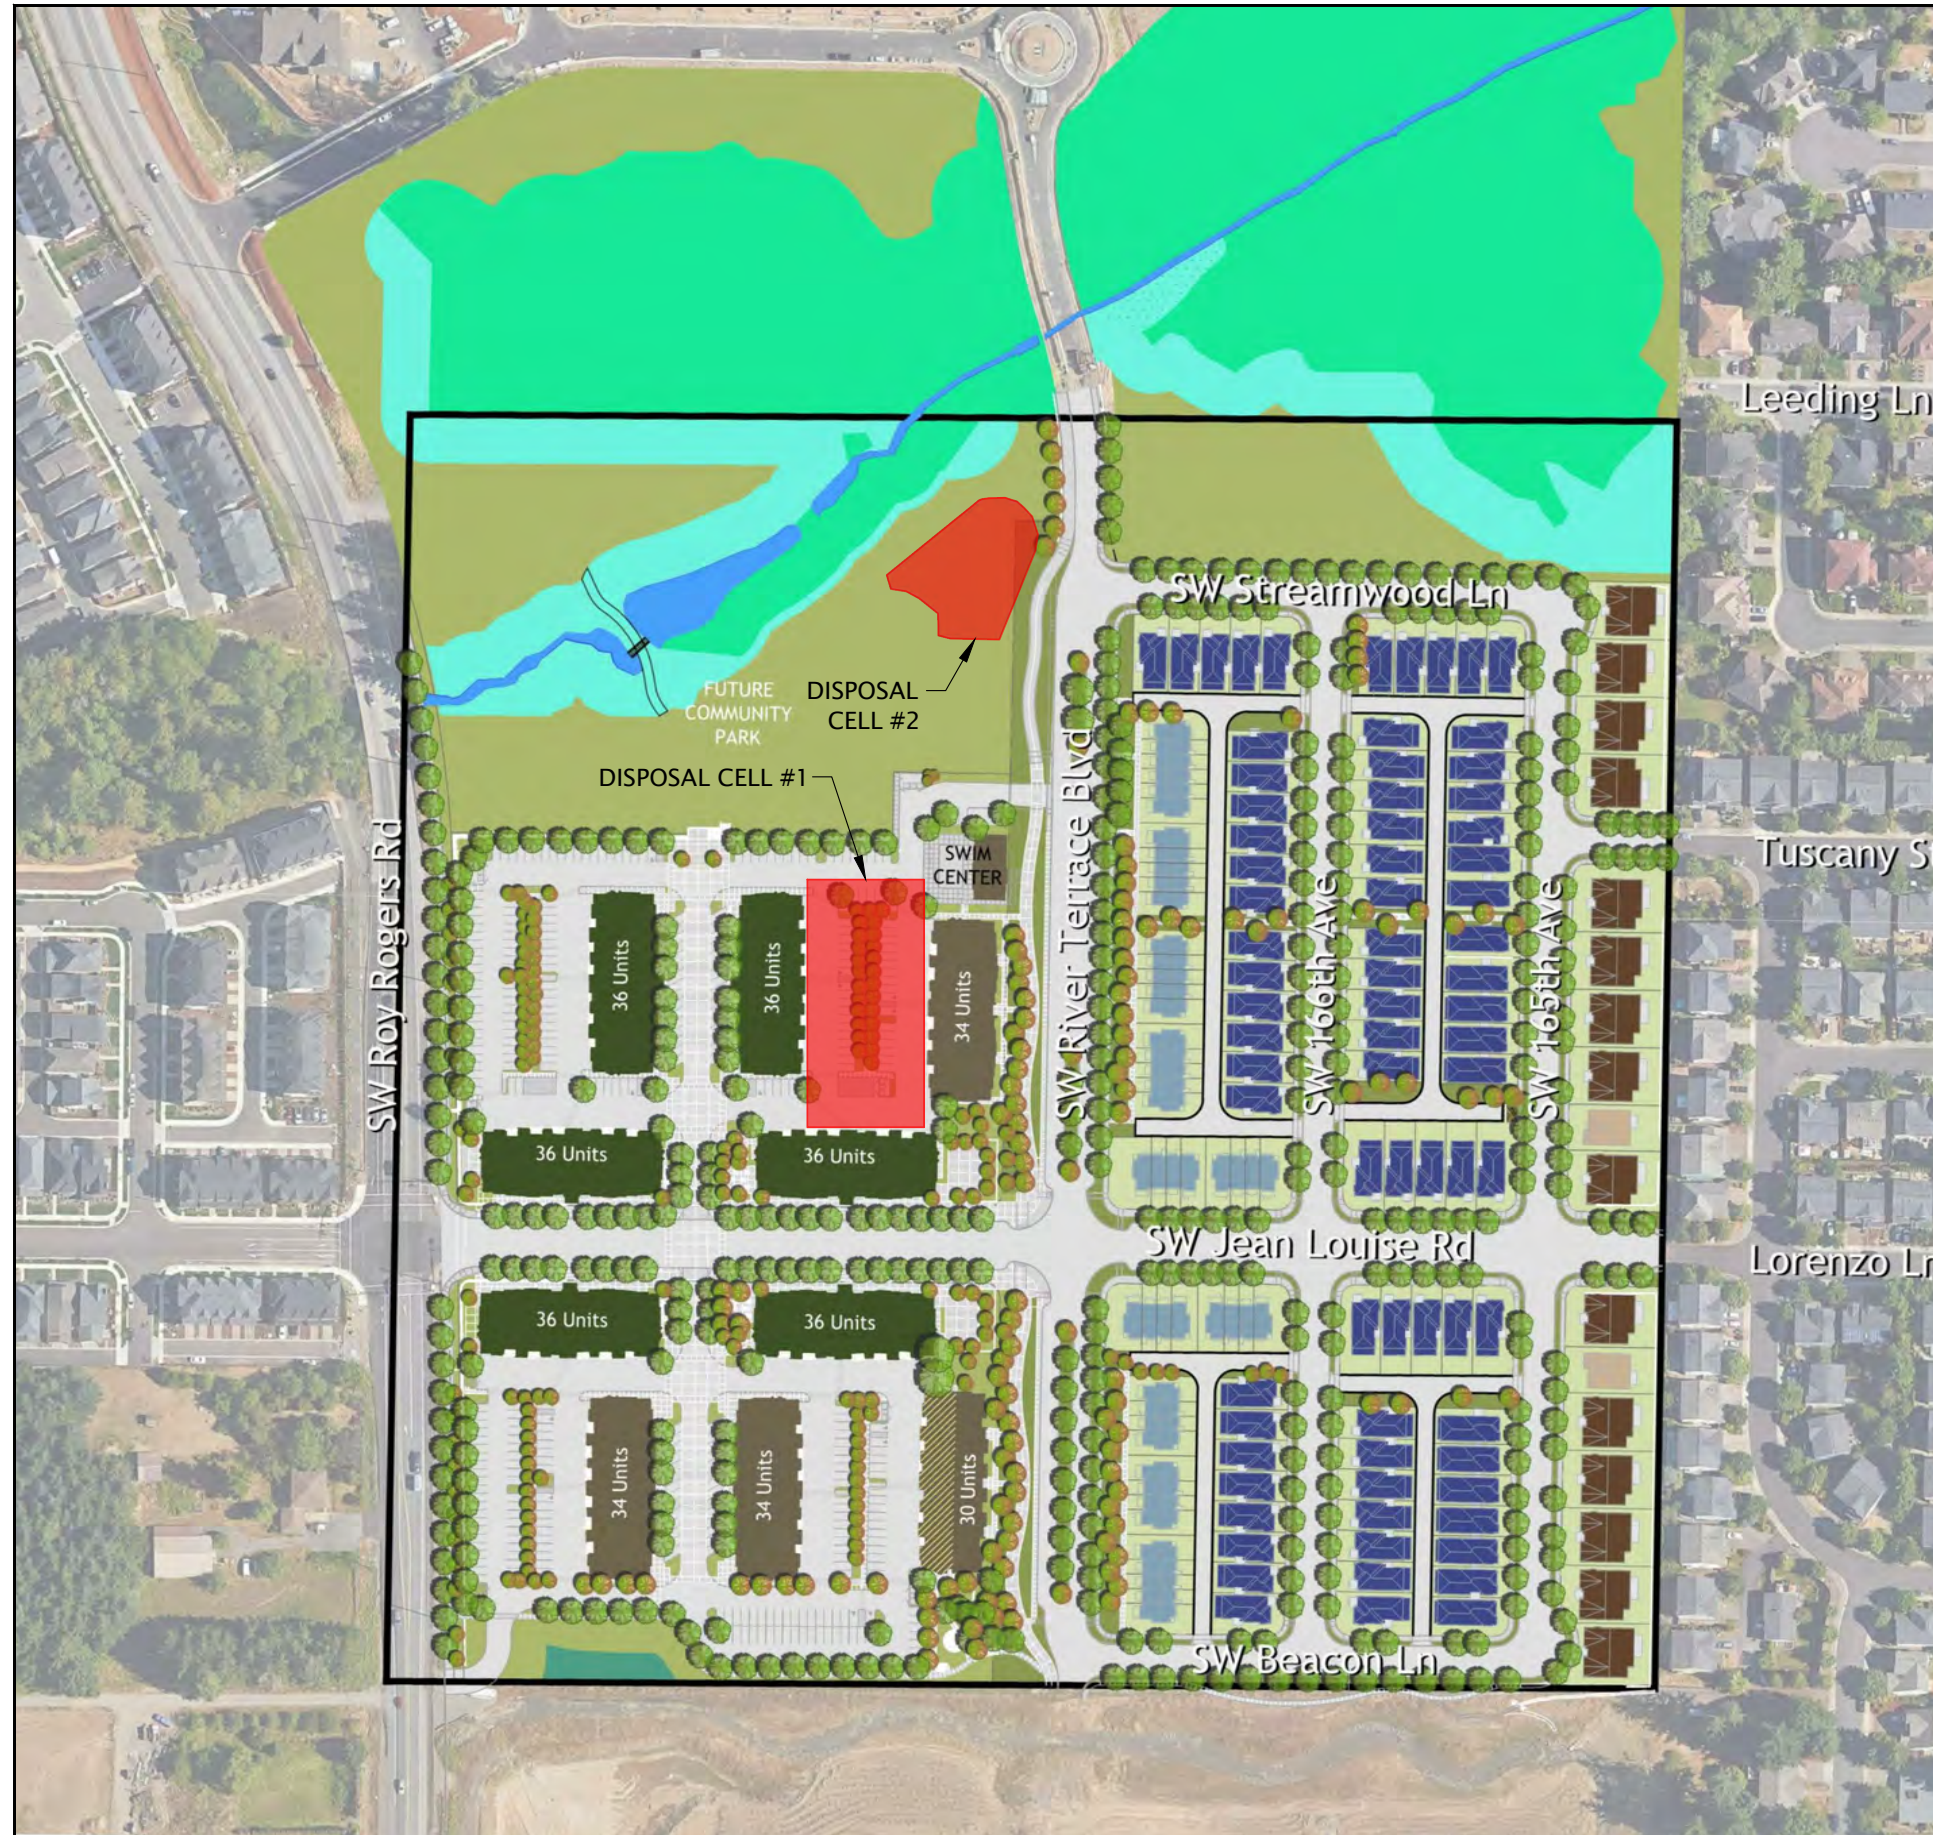
SITE PLAN BASED ON IMAGE OF SHEET 5.3 CONCEPT SITE MAP DATED DECEMBER 30, 2021, PREPARED BY PACIFIC COMMUNITY DESIGN
