# Department of Environmental Quality

## Memorandum

**Subject:** Dari Mart and Auto Repair, LUST 20-23-0538; Staff Memorandum in support of

a Conditional No Further Action determination

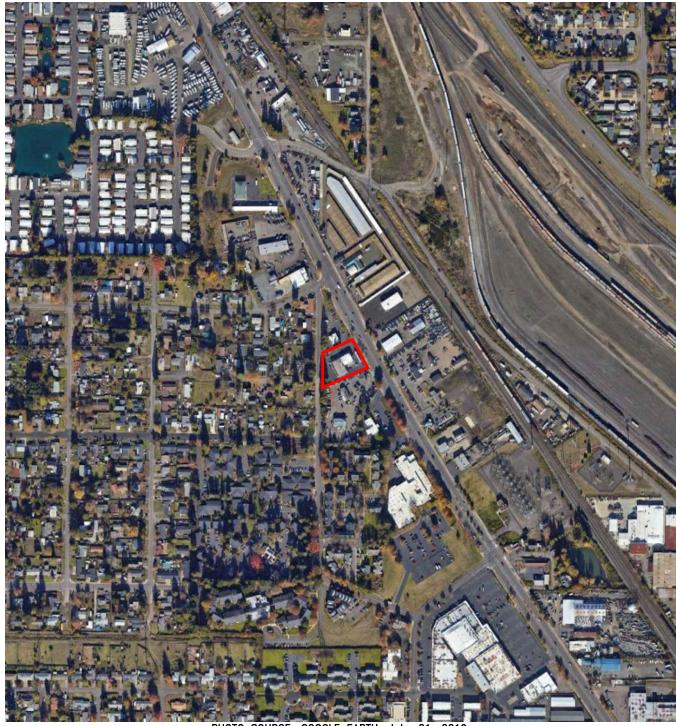
PHOTO SOURCE: GOOGLE EARTH, July, 21, 2019.

SUBJECT PROPERTY

SITE AERIAL COMMERCIAL PROPERTY 1510 HIGHWAY 99 N., EUGENE, OREGON

- Address: 1510 Highway 99 North, Eugene, Oregon (Figure 2)
- Latitude 44.07° North, longitude 123.166° West
- Tax Map170422114, Tax Lot 3308, Township 17 South, Range 4 West, Section 22
