SOIL CAP MANAGEMENT PLAN

***M. Carter Commons Development
3675 N Interstate Avenue
(formerly 3715-3717 N Interstate)
Portland, Oregon 97217***

ECSI Site # 6702

May 2025

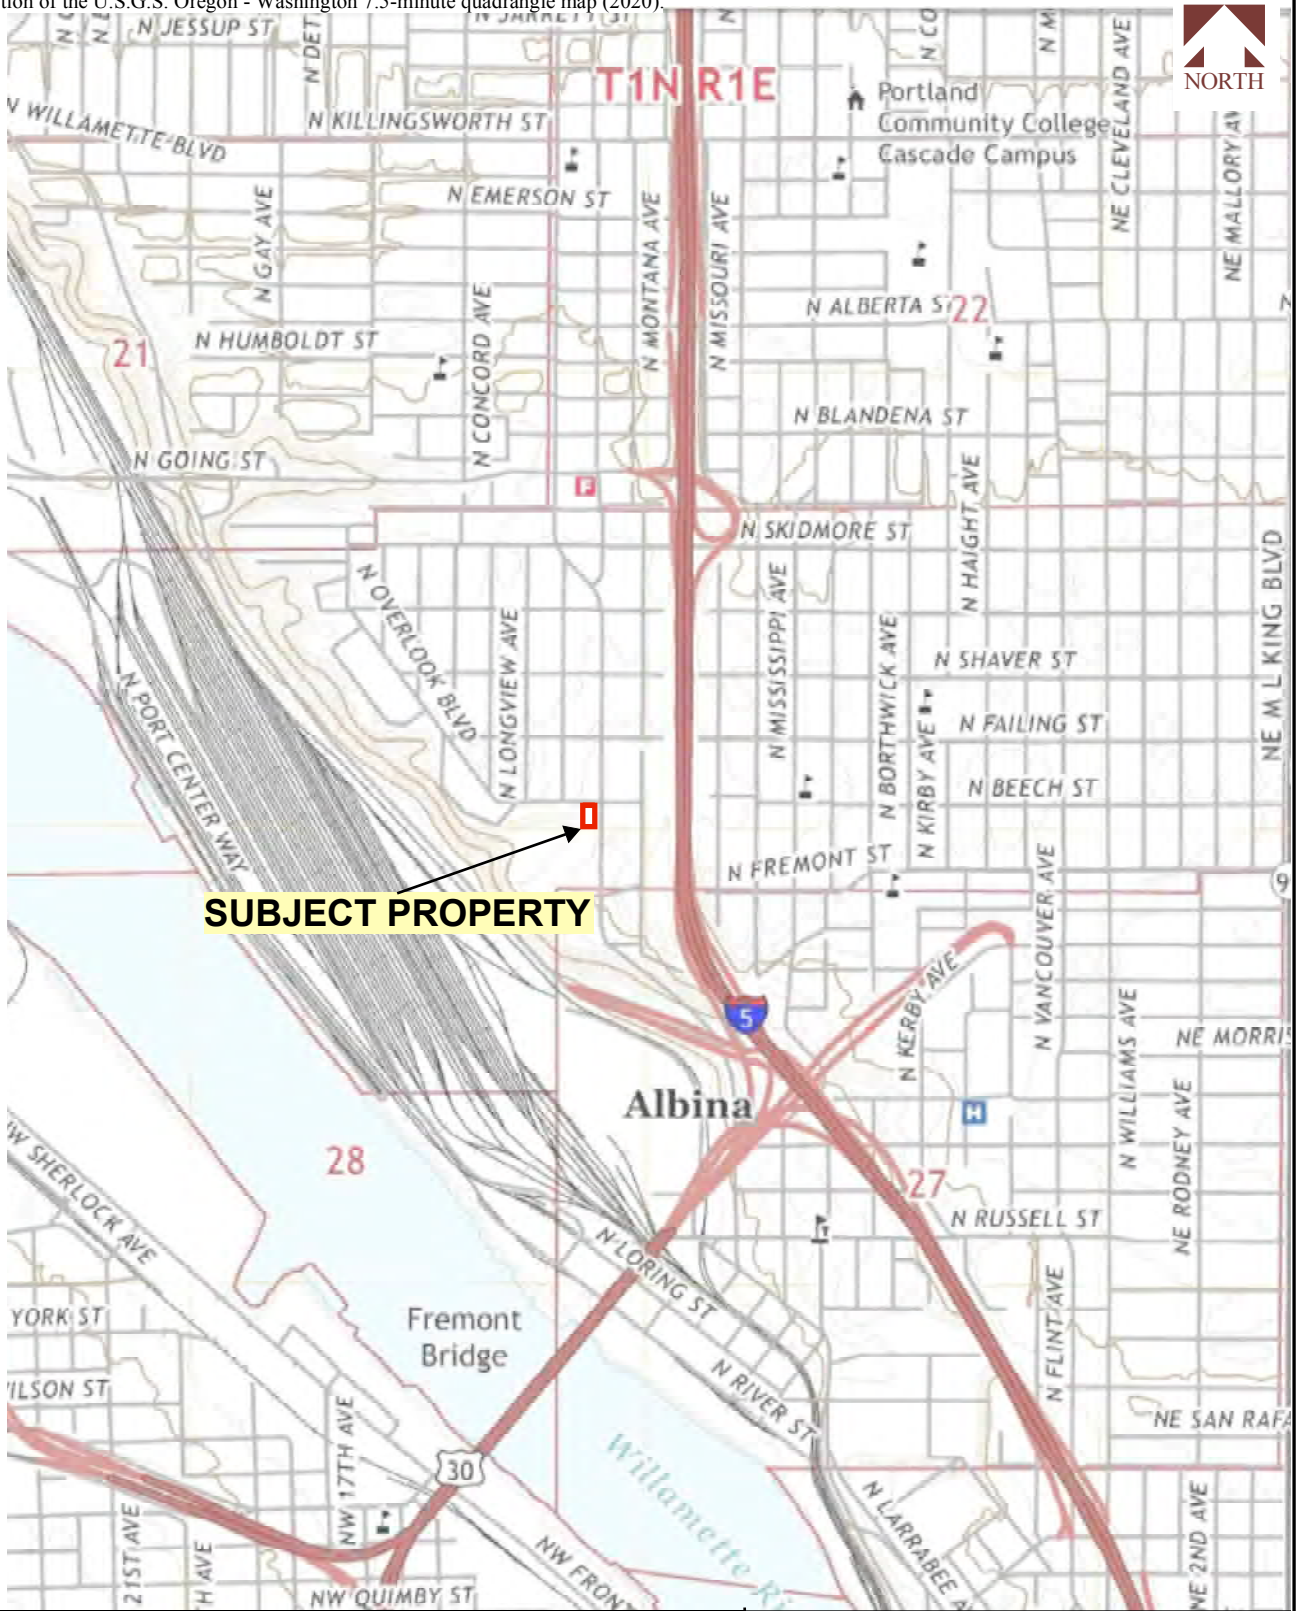
Figure 1. Topographic Map Showing the Location of the Property.

Note: Portion of the U.S.G.S. Oregon - Washington 7.5-minute quadrangle map (2020).

Subject Property Boundary

This Soil Cap Management Plan (SCMP) has been prepared to manage the cap within landscaped areas above the former landfill on the M. Carter Commons property. The M. Carter Commons property is located at 3675 N Interstate Ave, in Portland, Oregon (Figures 1 & 2). The landfill materials have been found to contain lead, mercury and selenium above the Oregon Department of Environmental Quality (DEQ) Clean Fill Criteria. This SCMP describes the long-term monitoring and maintenance requirements for the protective cap.

The property is located at 3675 N Interstate Ave, Portland, Multnomah County, Oregon (Township 1 North, Range 1 East, Section 22, tax lot number 1N1E22CC-13500) (Figures 1 and 2). The property is a multi-story residential use building (the M. Carter Commons building). The development has 62 affordable senior housing units, a community room, a property management office, laundry facilities, and a protected courtyard. Garbage and recycling container enclosure and emergency generator are on the southern portion of the property.

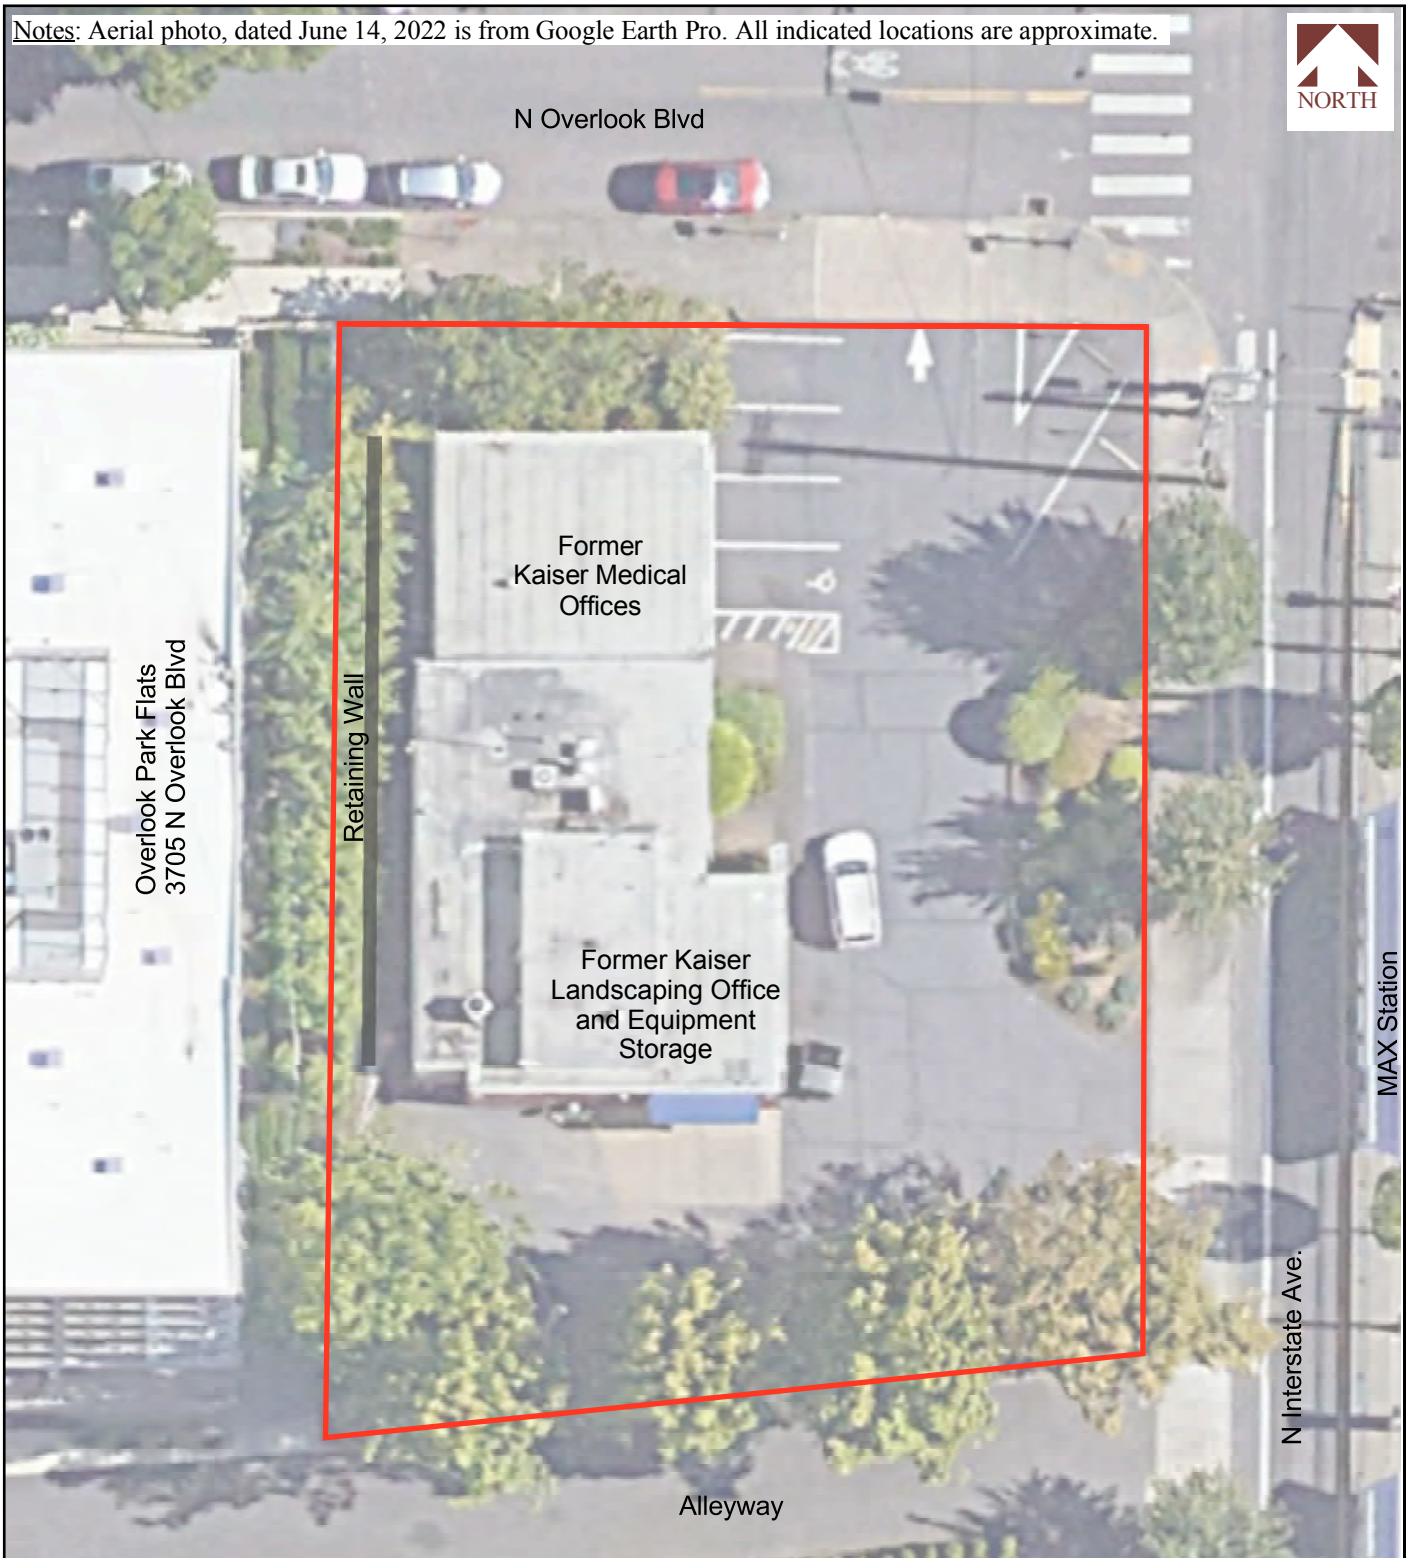
Figure 2. Property Map. The locations of features on the Property are shown.

Notes: Aerial photo, dated June 14, 2022 is from Google Earth Pro. All indicated locations are approximate.

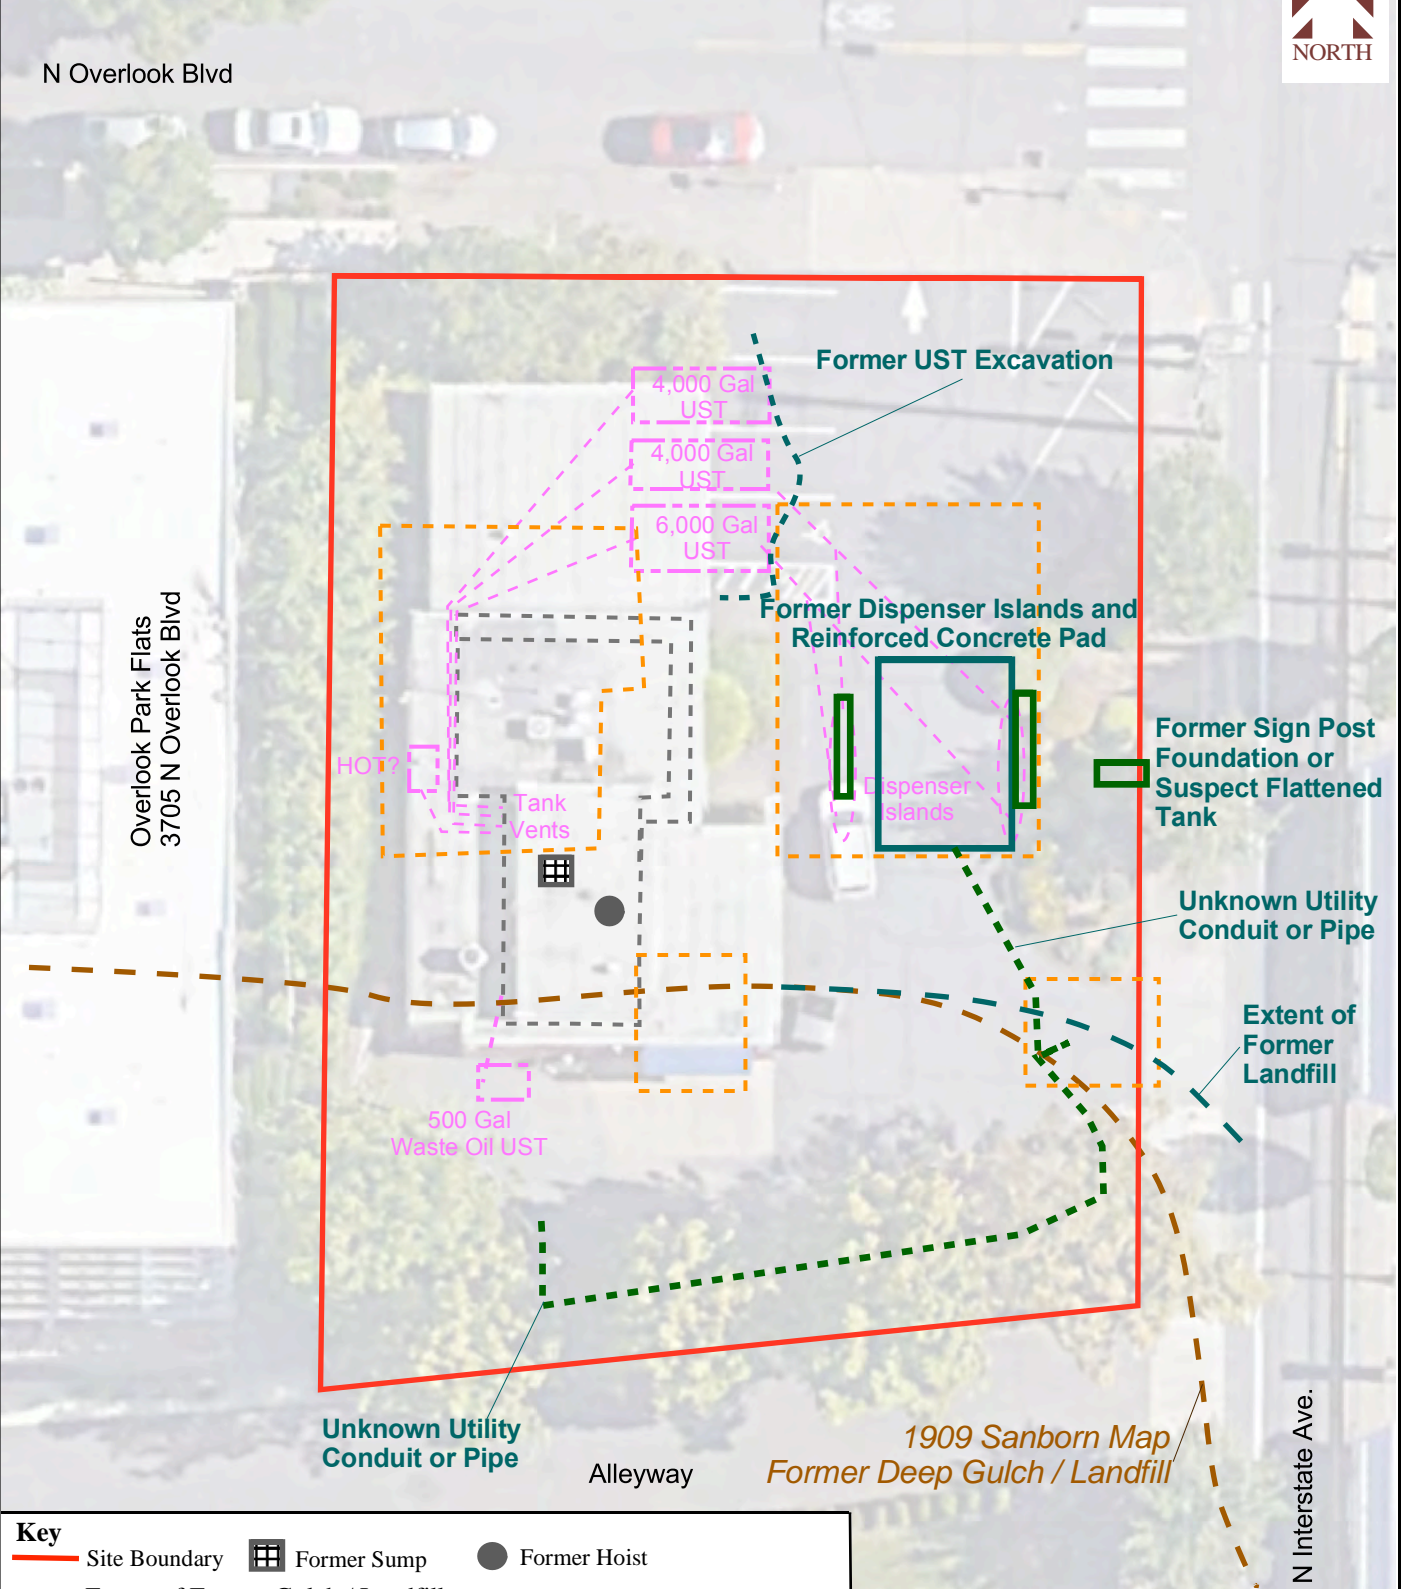
Figure 3. Geophysical Survey Findings With Items of Environmental Concern on the Property.

Key	
	Site Boundary
	Former Sump
	Former Hoist
	Extent of Former Gulch / Landfill
	Former Underground Storage Tank (UST)
	Former Gas Station Building Footprint (1960-1970s)
	Former Residences and Garages (1924-1960)
	Geophysical Survey Findings and Notes (in Green)

*1909 Sanborn Map
Former Deep Gulch / Landfill*

The extent of the former landfill relative to the M. Carter Commons development is shown in Figure 3.

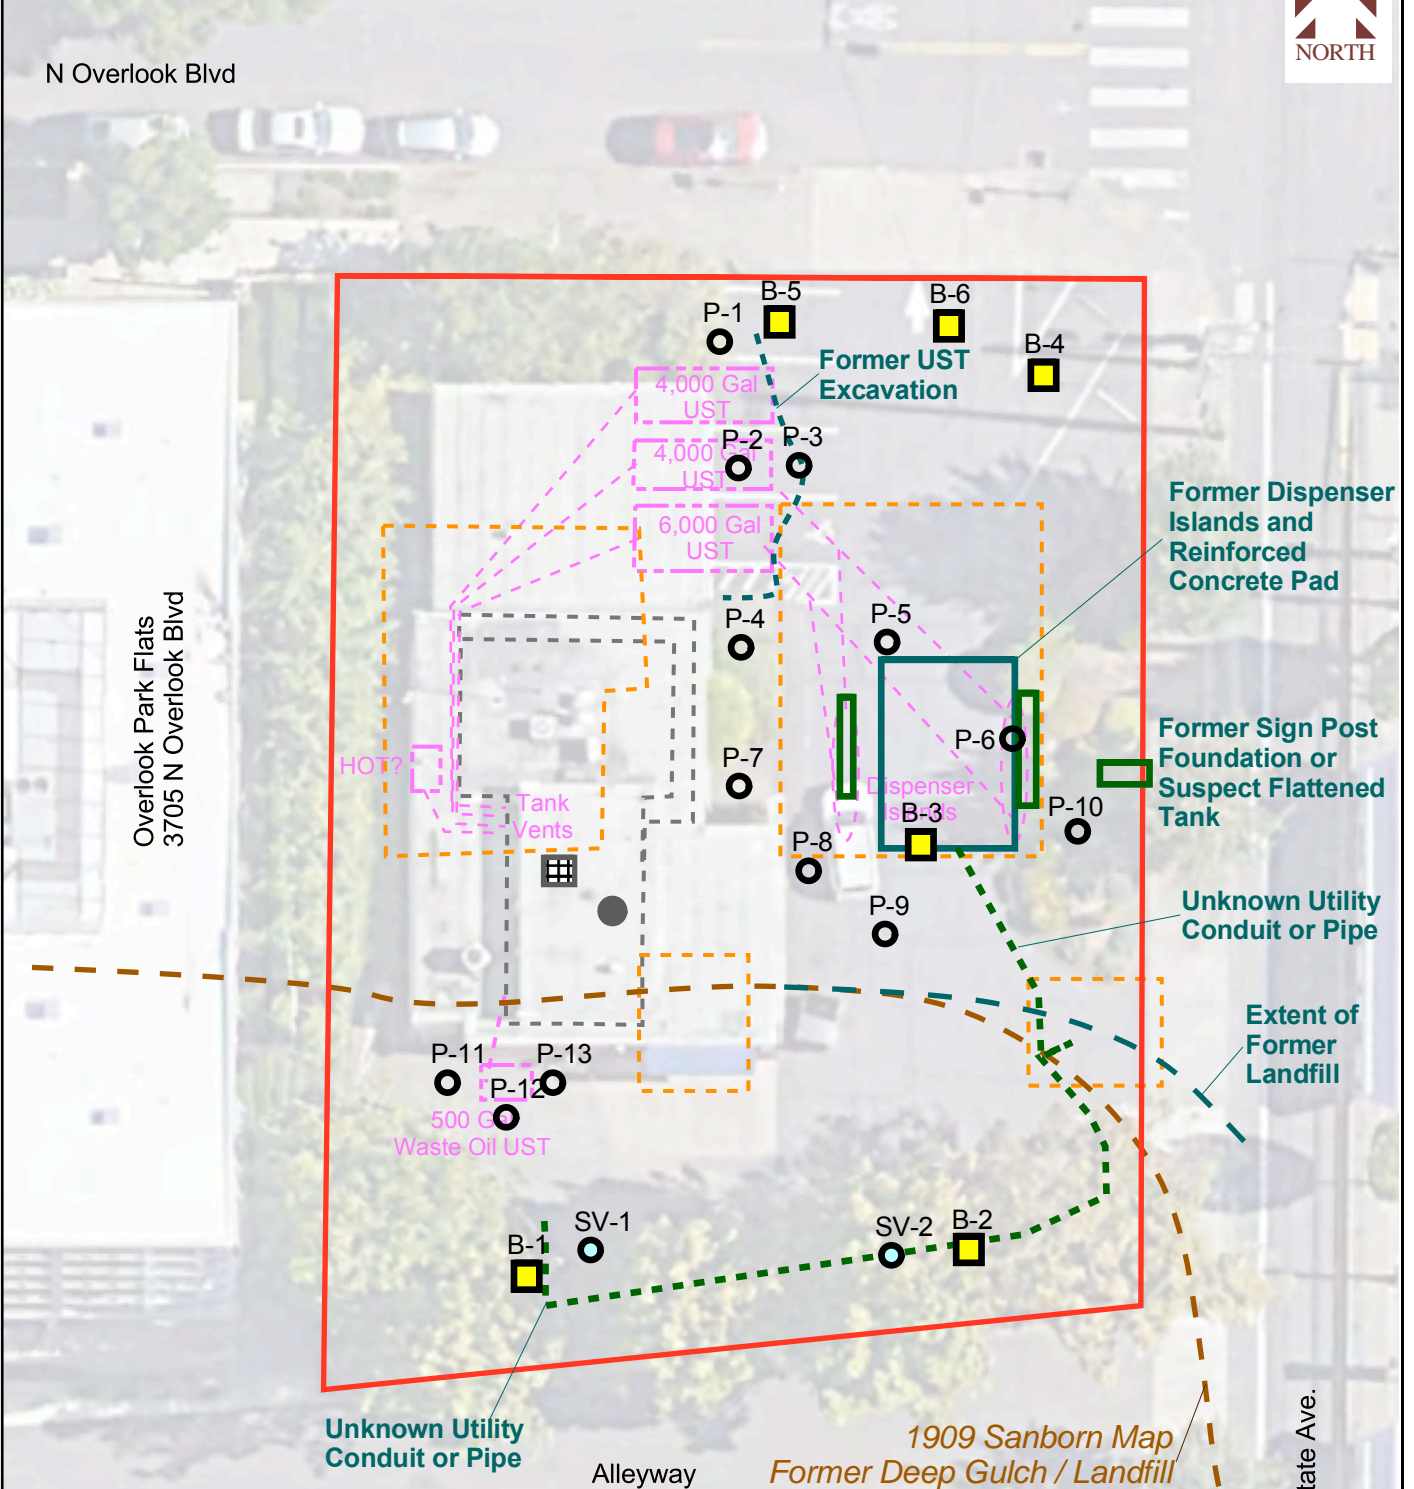
Key	
	Subject Property Boundary
	Extent of Former Gulch / Landfill
	Former Underground Storage Tank (UST)
	Former Gas Station Building Footprint (1960-1970s)
	Former Residences and Garages (1924-1960)
	Geophysical Survey Findings and Notes (in Green)
	Former Sump
	Former Hoist
	SV-1 Phase II ESA Soil Vapor Boring
	P-13 Phase II ESA Soil Boring
	B-2 Geotechnical Boring

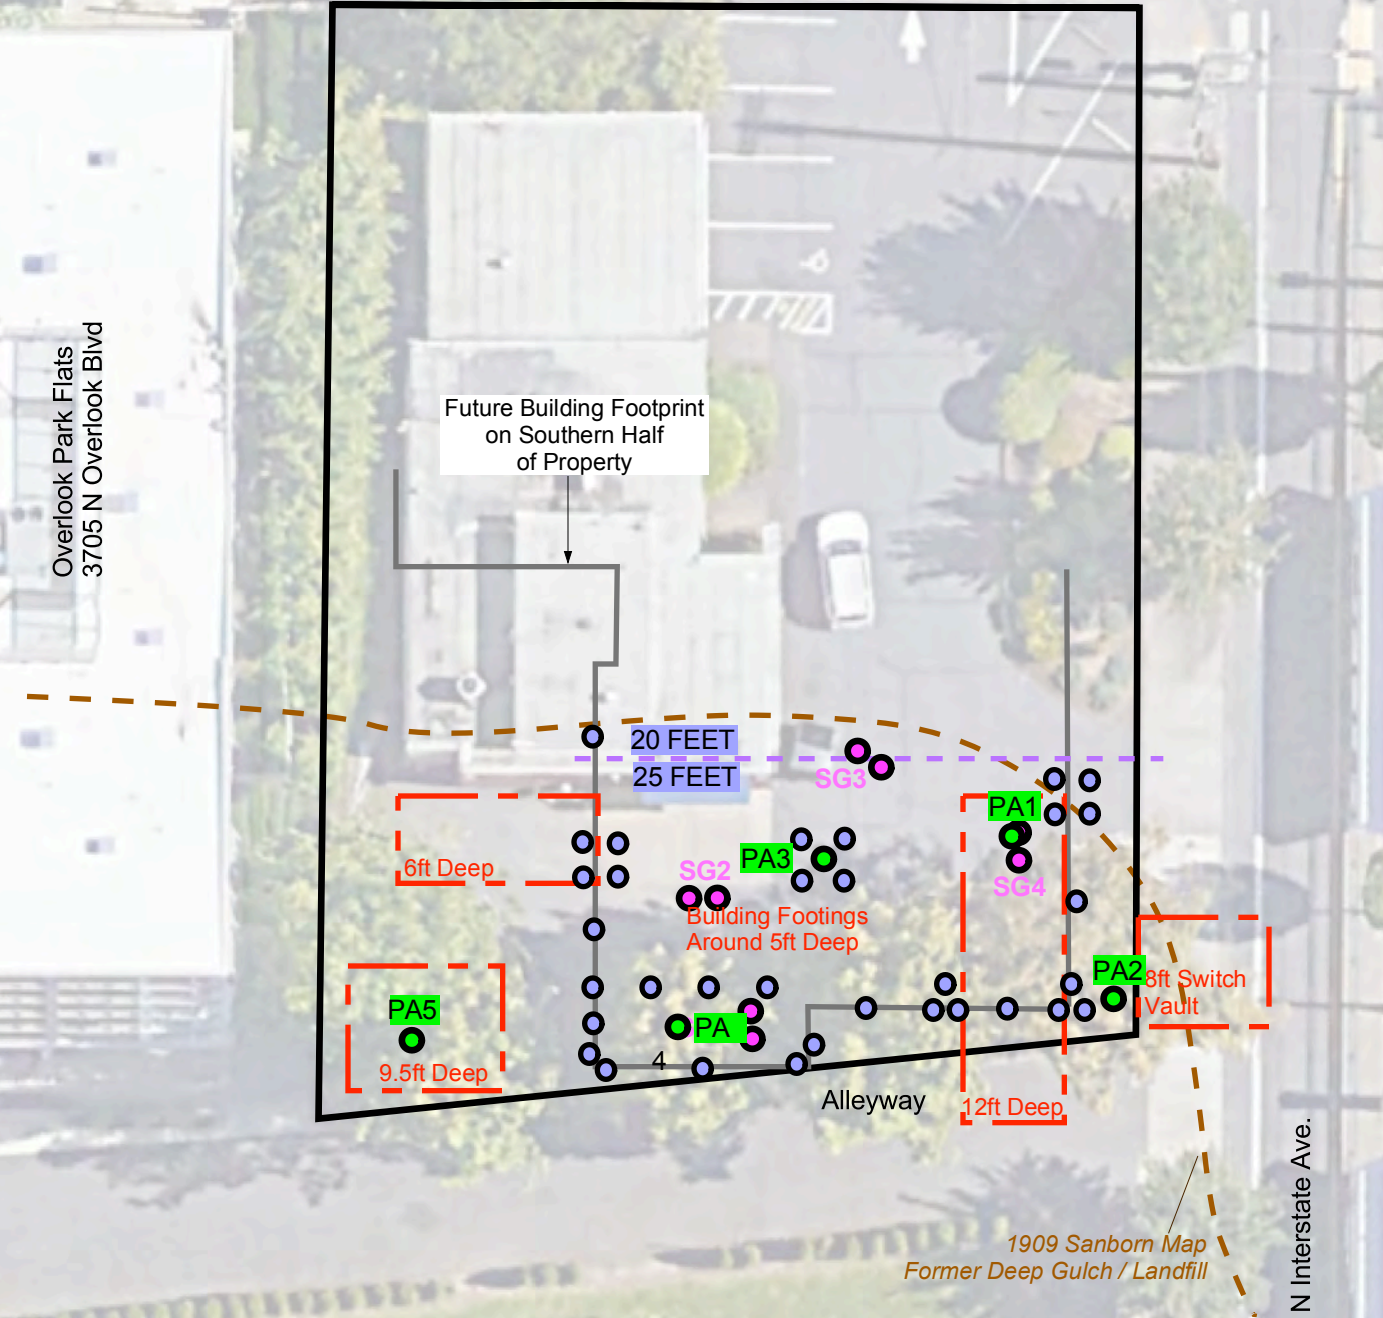
Summary of Excavation Depths Below Current Grade

- Deepest Building Foundation: 5 feet to 6 feet
- Plaza Landscape Areas: 3 feet to 4.5 feet
- Electrical Utility Corridors and Vaults: 6 feet to 12 feet
- Geopier Depths: 20 feet or 25 feet

Key	
	Property Boundary
	Future Electrical Vault or Conduit Excavation and Depth
	Future Geopier Location and Line Demarcating Geopier Depth (20 feet or 25 feet)
	Extent of Former Gulch / Landfill
	SG-1 PPA Soil Gas Sample Location
	PA5 Phase II ESA Boring Location

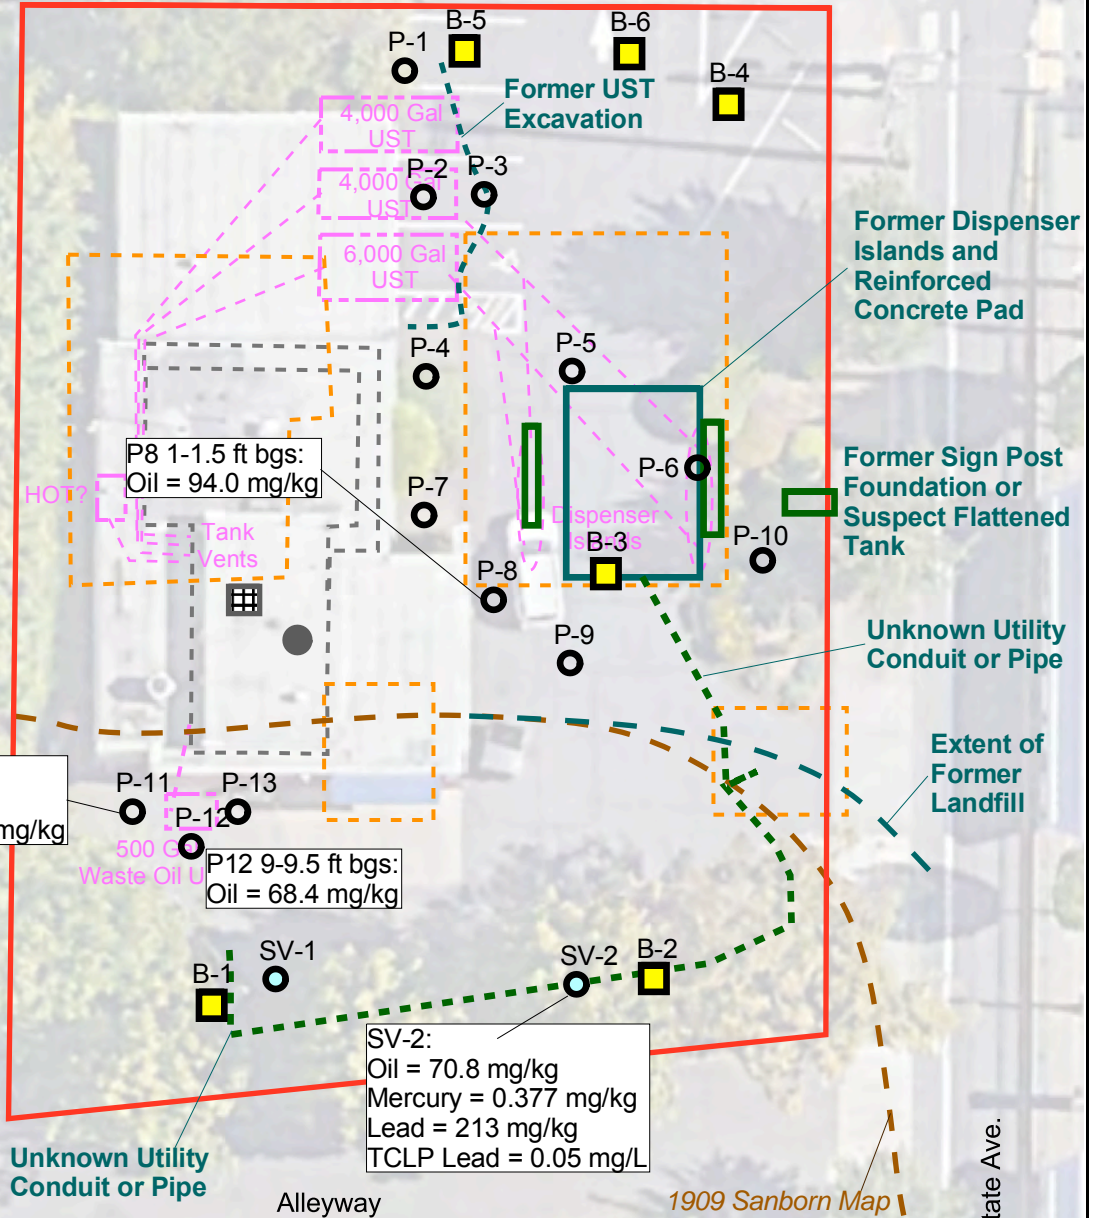
Key	
	Subject Property Boundary
	Extent of Former Gulch / Landfill
	Former Underground Storage Tank (UST)
	Former Gas Station Building Footprint (1960-1970s)
	Former Residences and Garages (1924-1960)
	Geophysical Survey Findings and Notes (in Green)
	Former Sump
	Former Hoist
	B-2 Geotechnical Boring
	SV-1 Phase II ESA Soil Vapor Boring
	P13 Phase II ESA Soil Boring

1909 Sanborn Map
Former Deep Gulch / Landfill

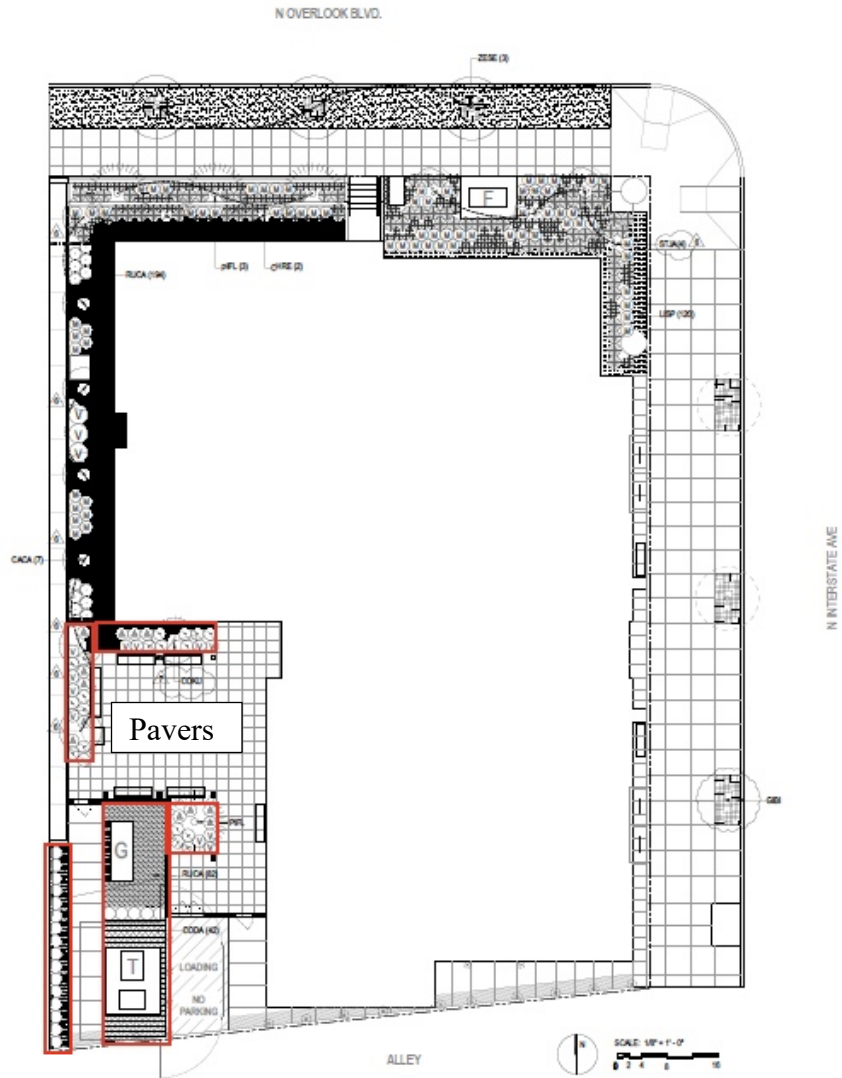
Map (Site Plan from Salazar Architect Landscape Planting Plan):

T = Transformer
G = Garbage area
