Memorandum

*Subject: Final Soil Cap Monitoring and Maintenance Plan –
Amendment No. 2,
Northwest Pipe and Casing, Superfund Site, Clackamas, Oregon*

Document Control No.: 3323-071-03447

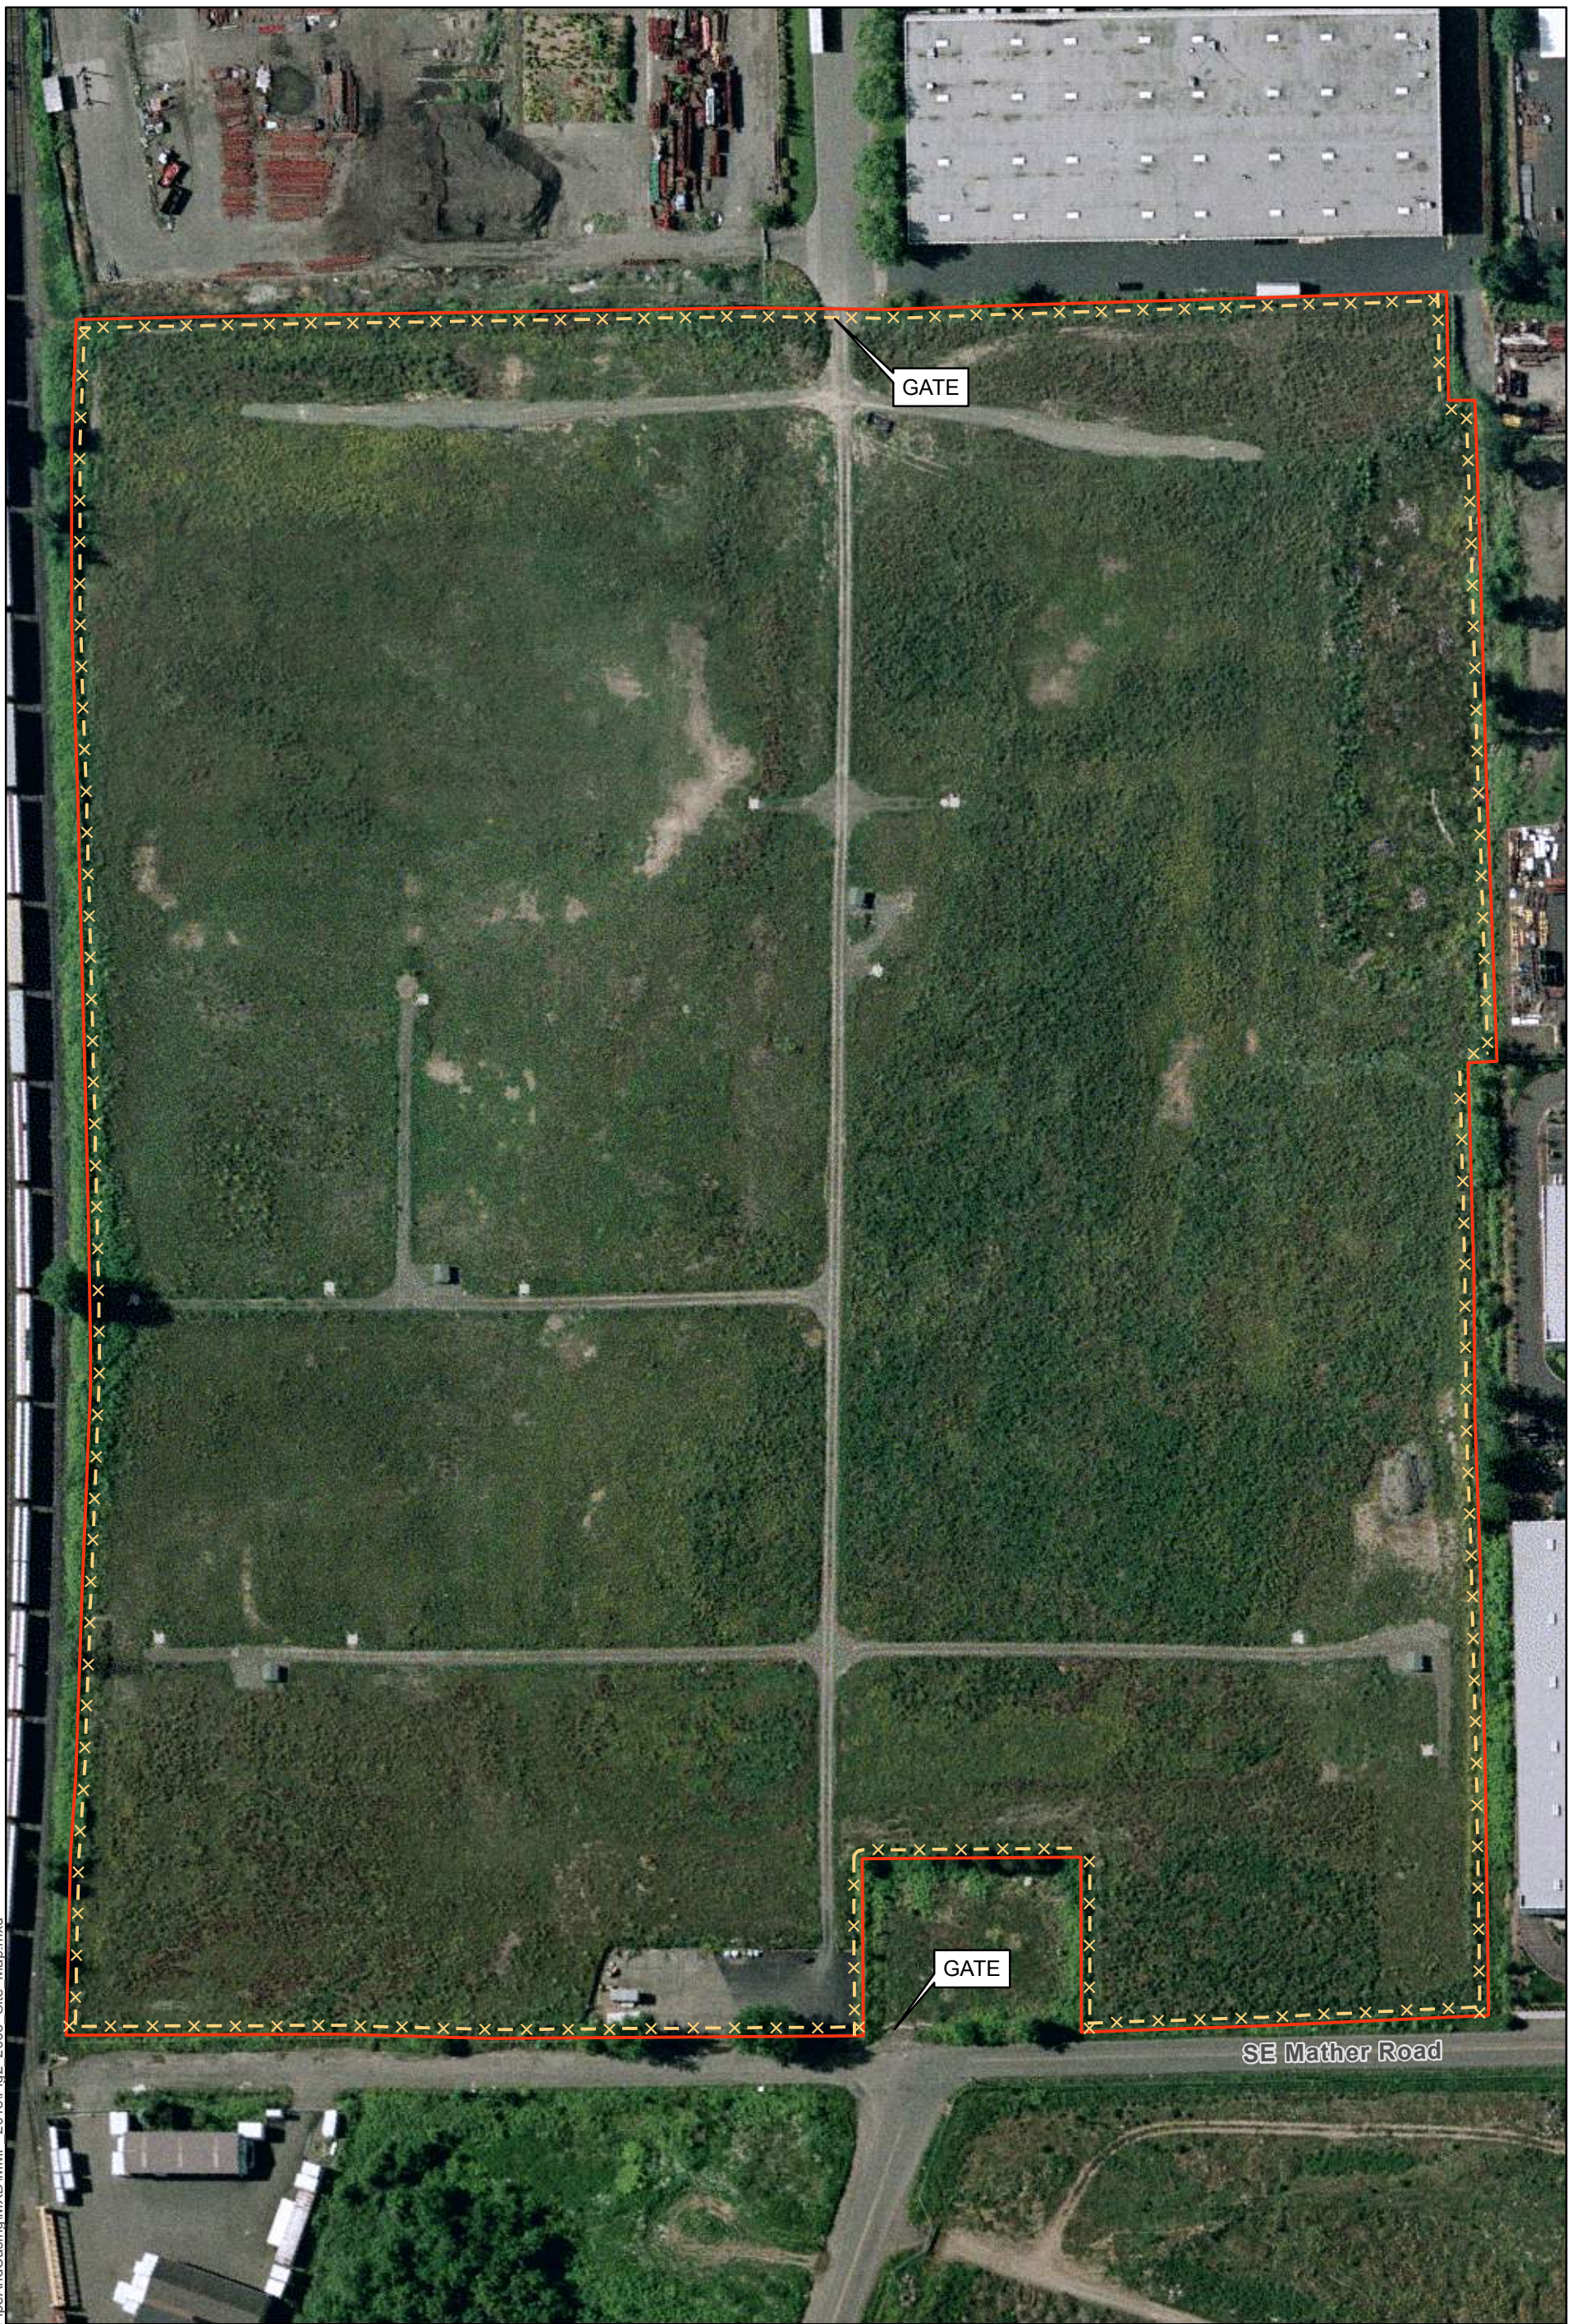
- 2004 Extent of Soil Cap
- - - Existing Fence

Revisions to the Monitoring and Maintenance Plan
Northwest Pipe and Casing Superfund Site
Clackamas, Oregon
