Department of Environmental Quality

Memorandum

Subject: Airways Aircraft Refinishing, ECSI # 1120; Staff Memorandum in support of a

No Further Action determination

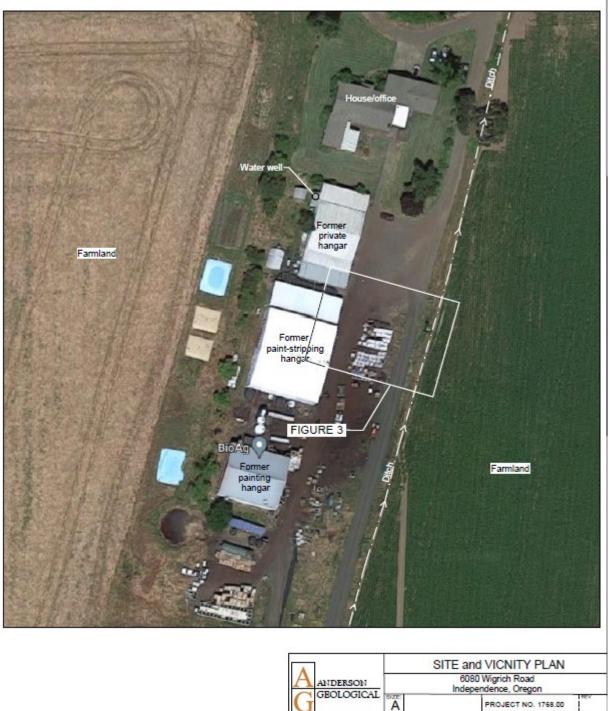
Figure 2. Site and Vicinity Plan Map (retrieved from AGI, May 2023).

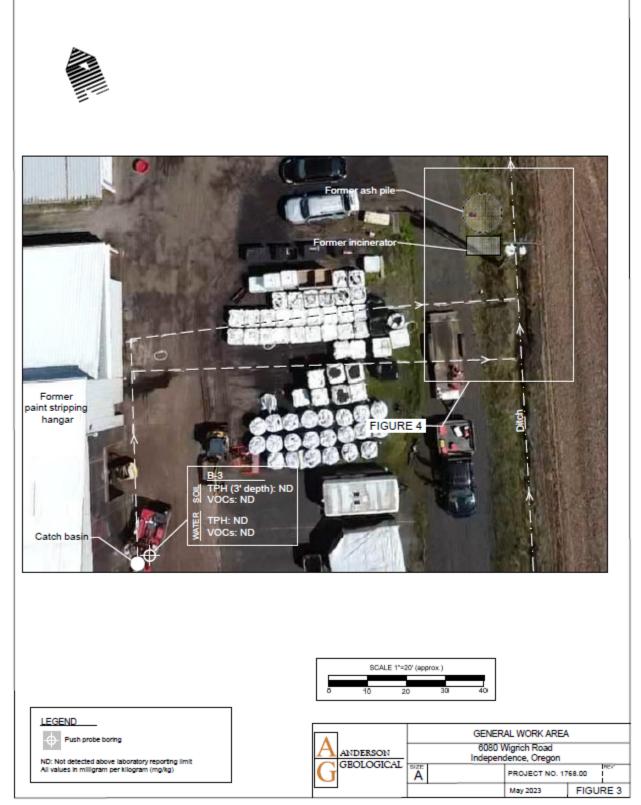
Figure 3. General Work Area Map (retrieved from AGI, May 2023).

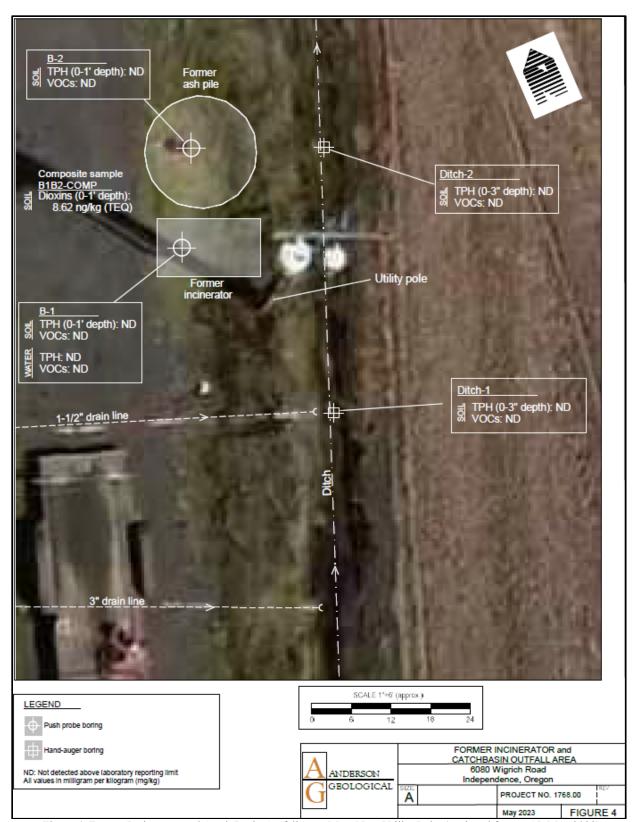
Figure 4. Former Incinerator and Catch Basin Outfall Area Map, Note Utility Pole (retrieved from AGI, May 2023).

All the soil containing dioxins above residential RBCs for the dermal, ingestion and inhalation pathway have been removed from the impacted area except for approximately two cubic yards of soil left around the utility pole (Figure 4). The impacted soil could not be removed due to safety concerns threatening the physical integrity of the pole and attached power lines.

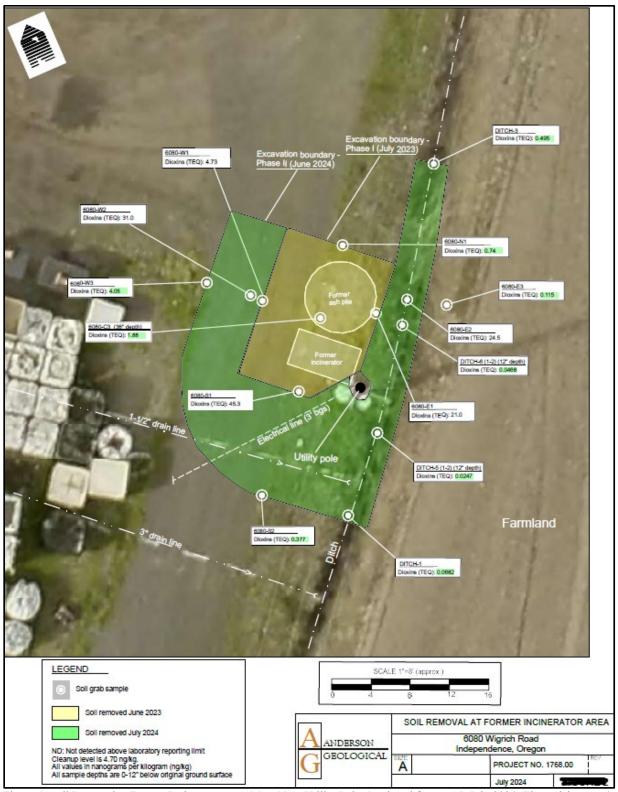
Figure 5. Soil Removal at Former Incinerator Area Map, Note Utility Pole (retrieved from AGI, July 2024- Figure 2 in report).
