State of Oregon  
Department of Environmental Quality

Memorandum

**Subject:** Union Pacific Railroad Klamath Falls Yard, ECSI #0297; Staff Memorandum in support of a Conditional No Further Action determination

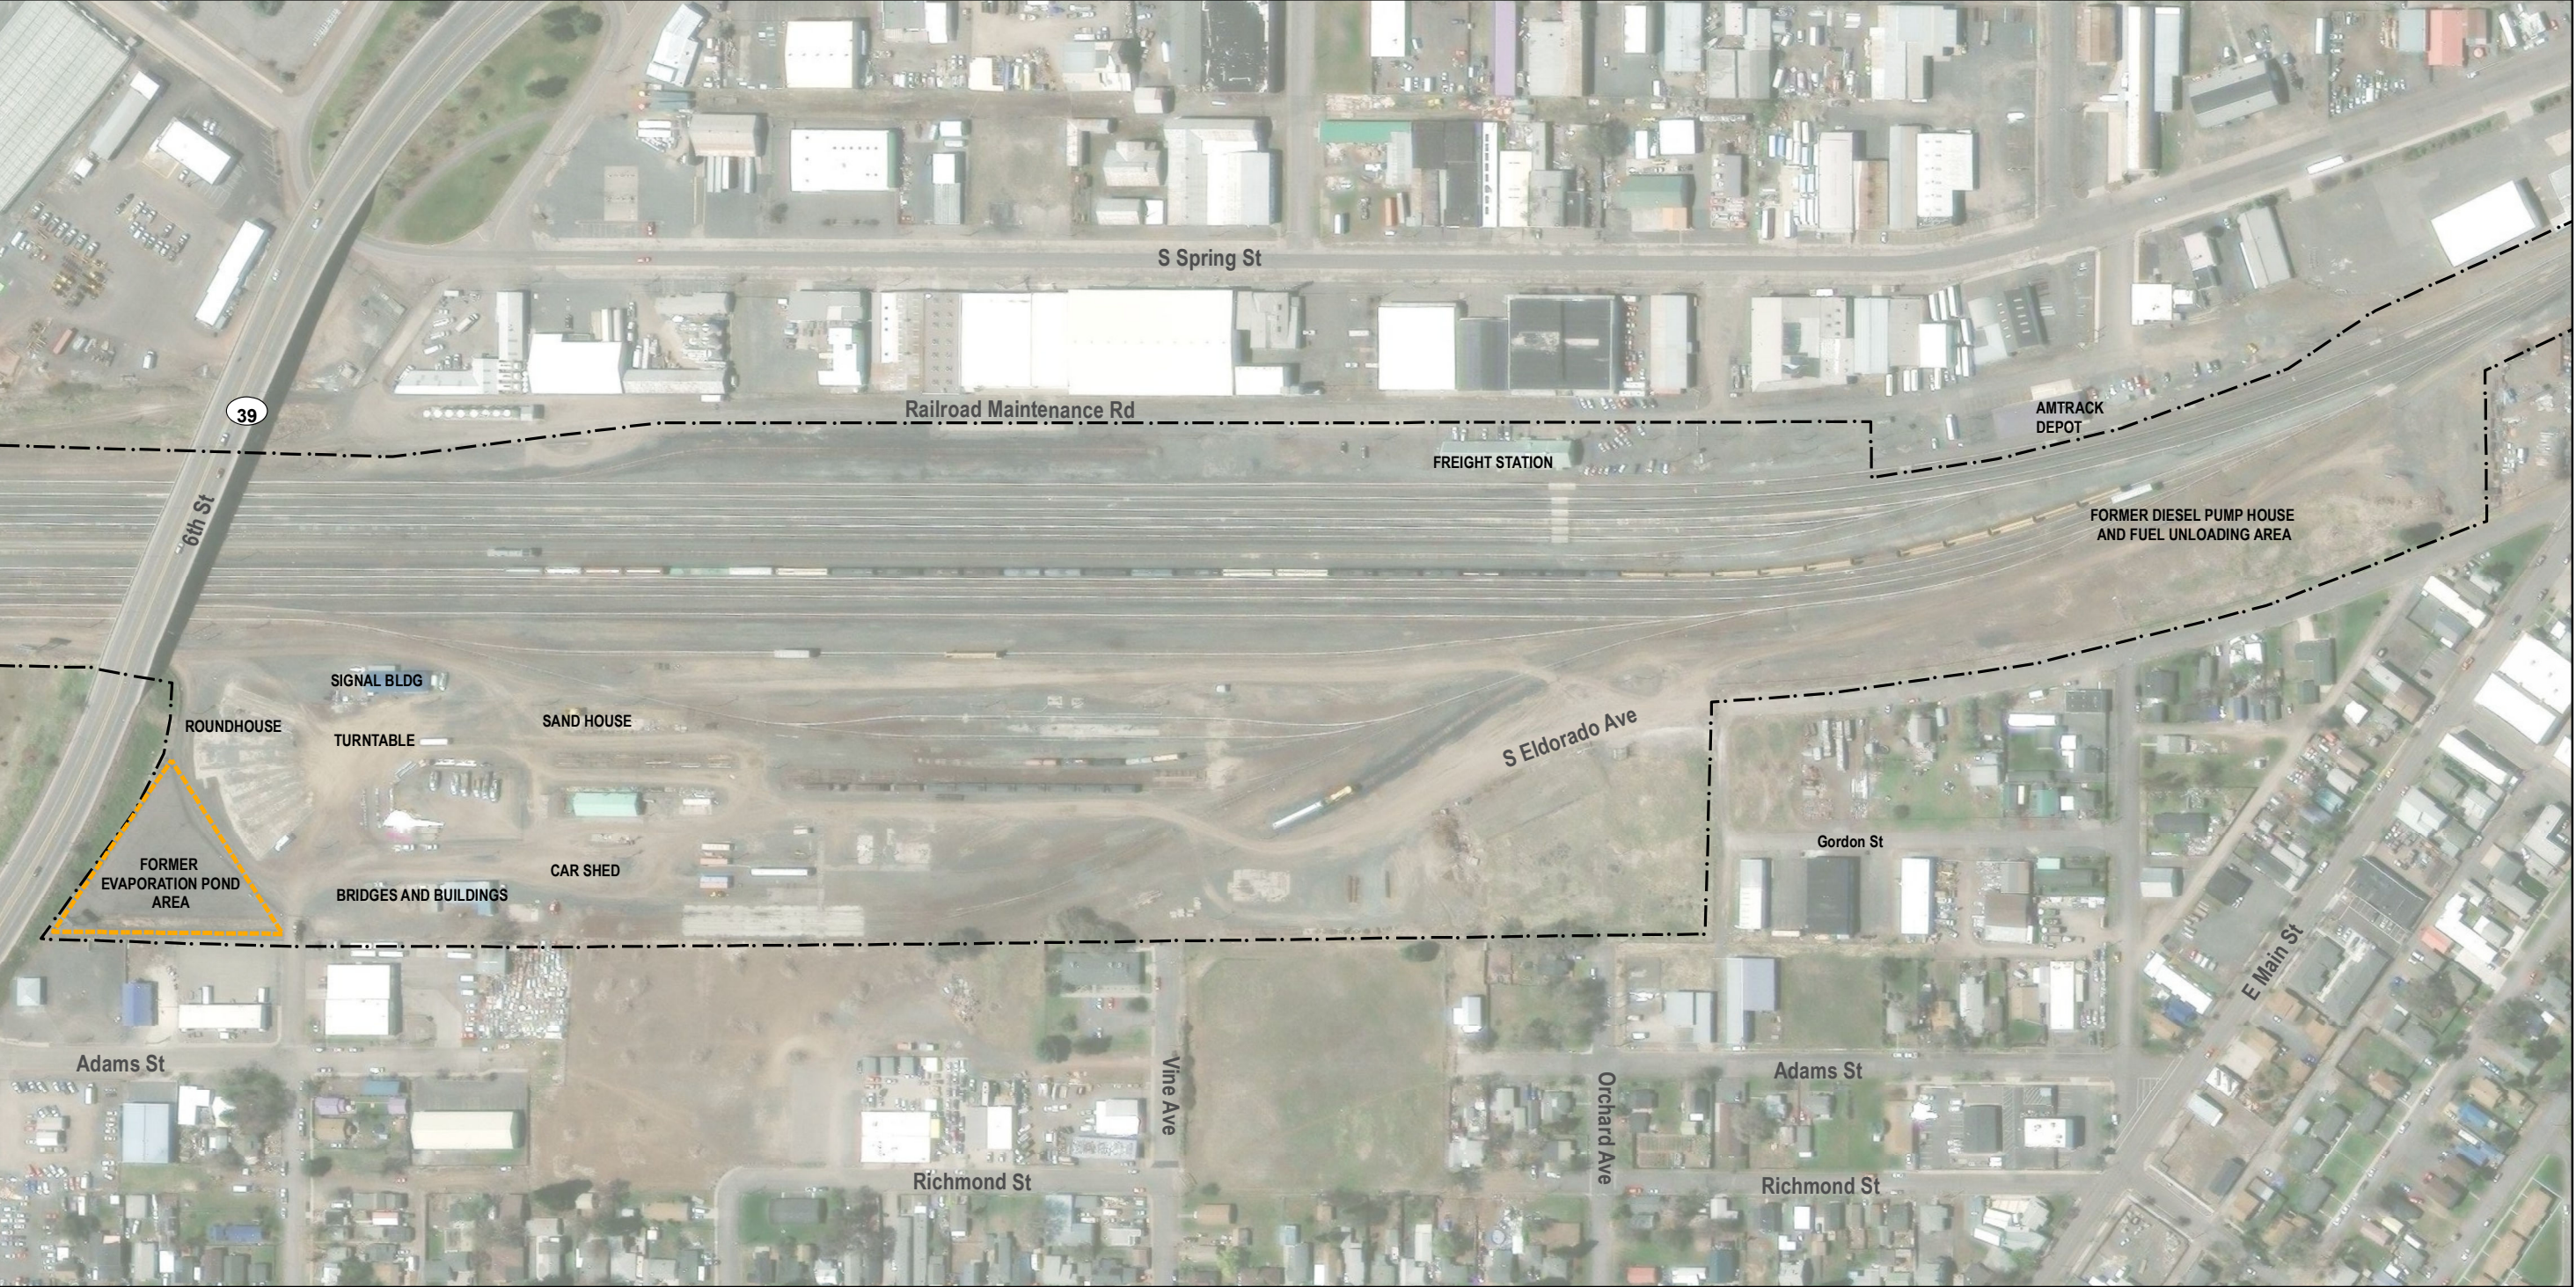
**FIGURE 2**  
**Current Site Configuration**  
*Union Pacific Railroad Company*  
*Klamath Falls Yard, Klamath Falls, Oregon*

turntable and sand house, and a 1.1-acre asphalt cap over the former evaporation pond area [Figure 2]. There are some limited residences located adjacent to the northeastern property boundary, at approximately Orchard Avenue and to the north, with the nearest residence within the Locality-of-Facility (LOF) as defined in the 2006 Record of Decision (ROD) [Figure 3]. Geographically, the facility is located within City of Klamath Falls urban area limits, approximately 1,500 feet northeast of Lake Ewauna and the Klamath River.

The eastern side of the asphalt cap over the former evaporation pond area [Figure 3] contains a grassy bioswale depression which was designed to contain stormwater runoff from the cap and allow it to infiltrate into the subsurface. The bioswale was sized sufficiently to hold water from a 100-year storm event or a combined 10-year storm event with 1 foot of snowmelt.
