Offsite Removal Action Construction Completion Report

Former JH Baxter & Co. Facility
Eugene, Oregon
ECSI No. 55

January 20, 2025

Prepared by:
GSI Water Solutions, Inc.
650 NE Holladay Street, Suite 900, Portland, OR 97232

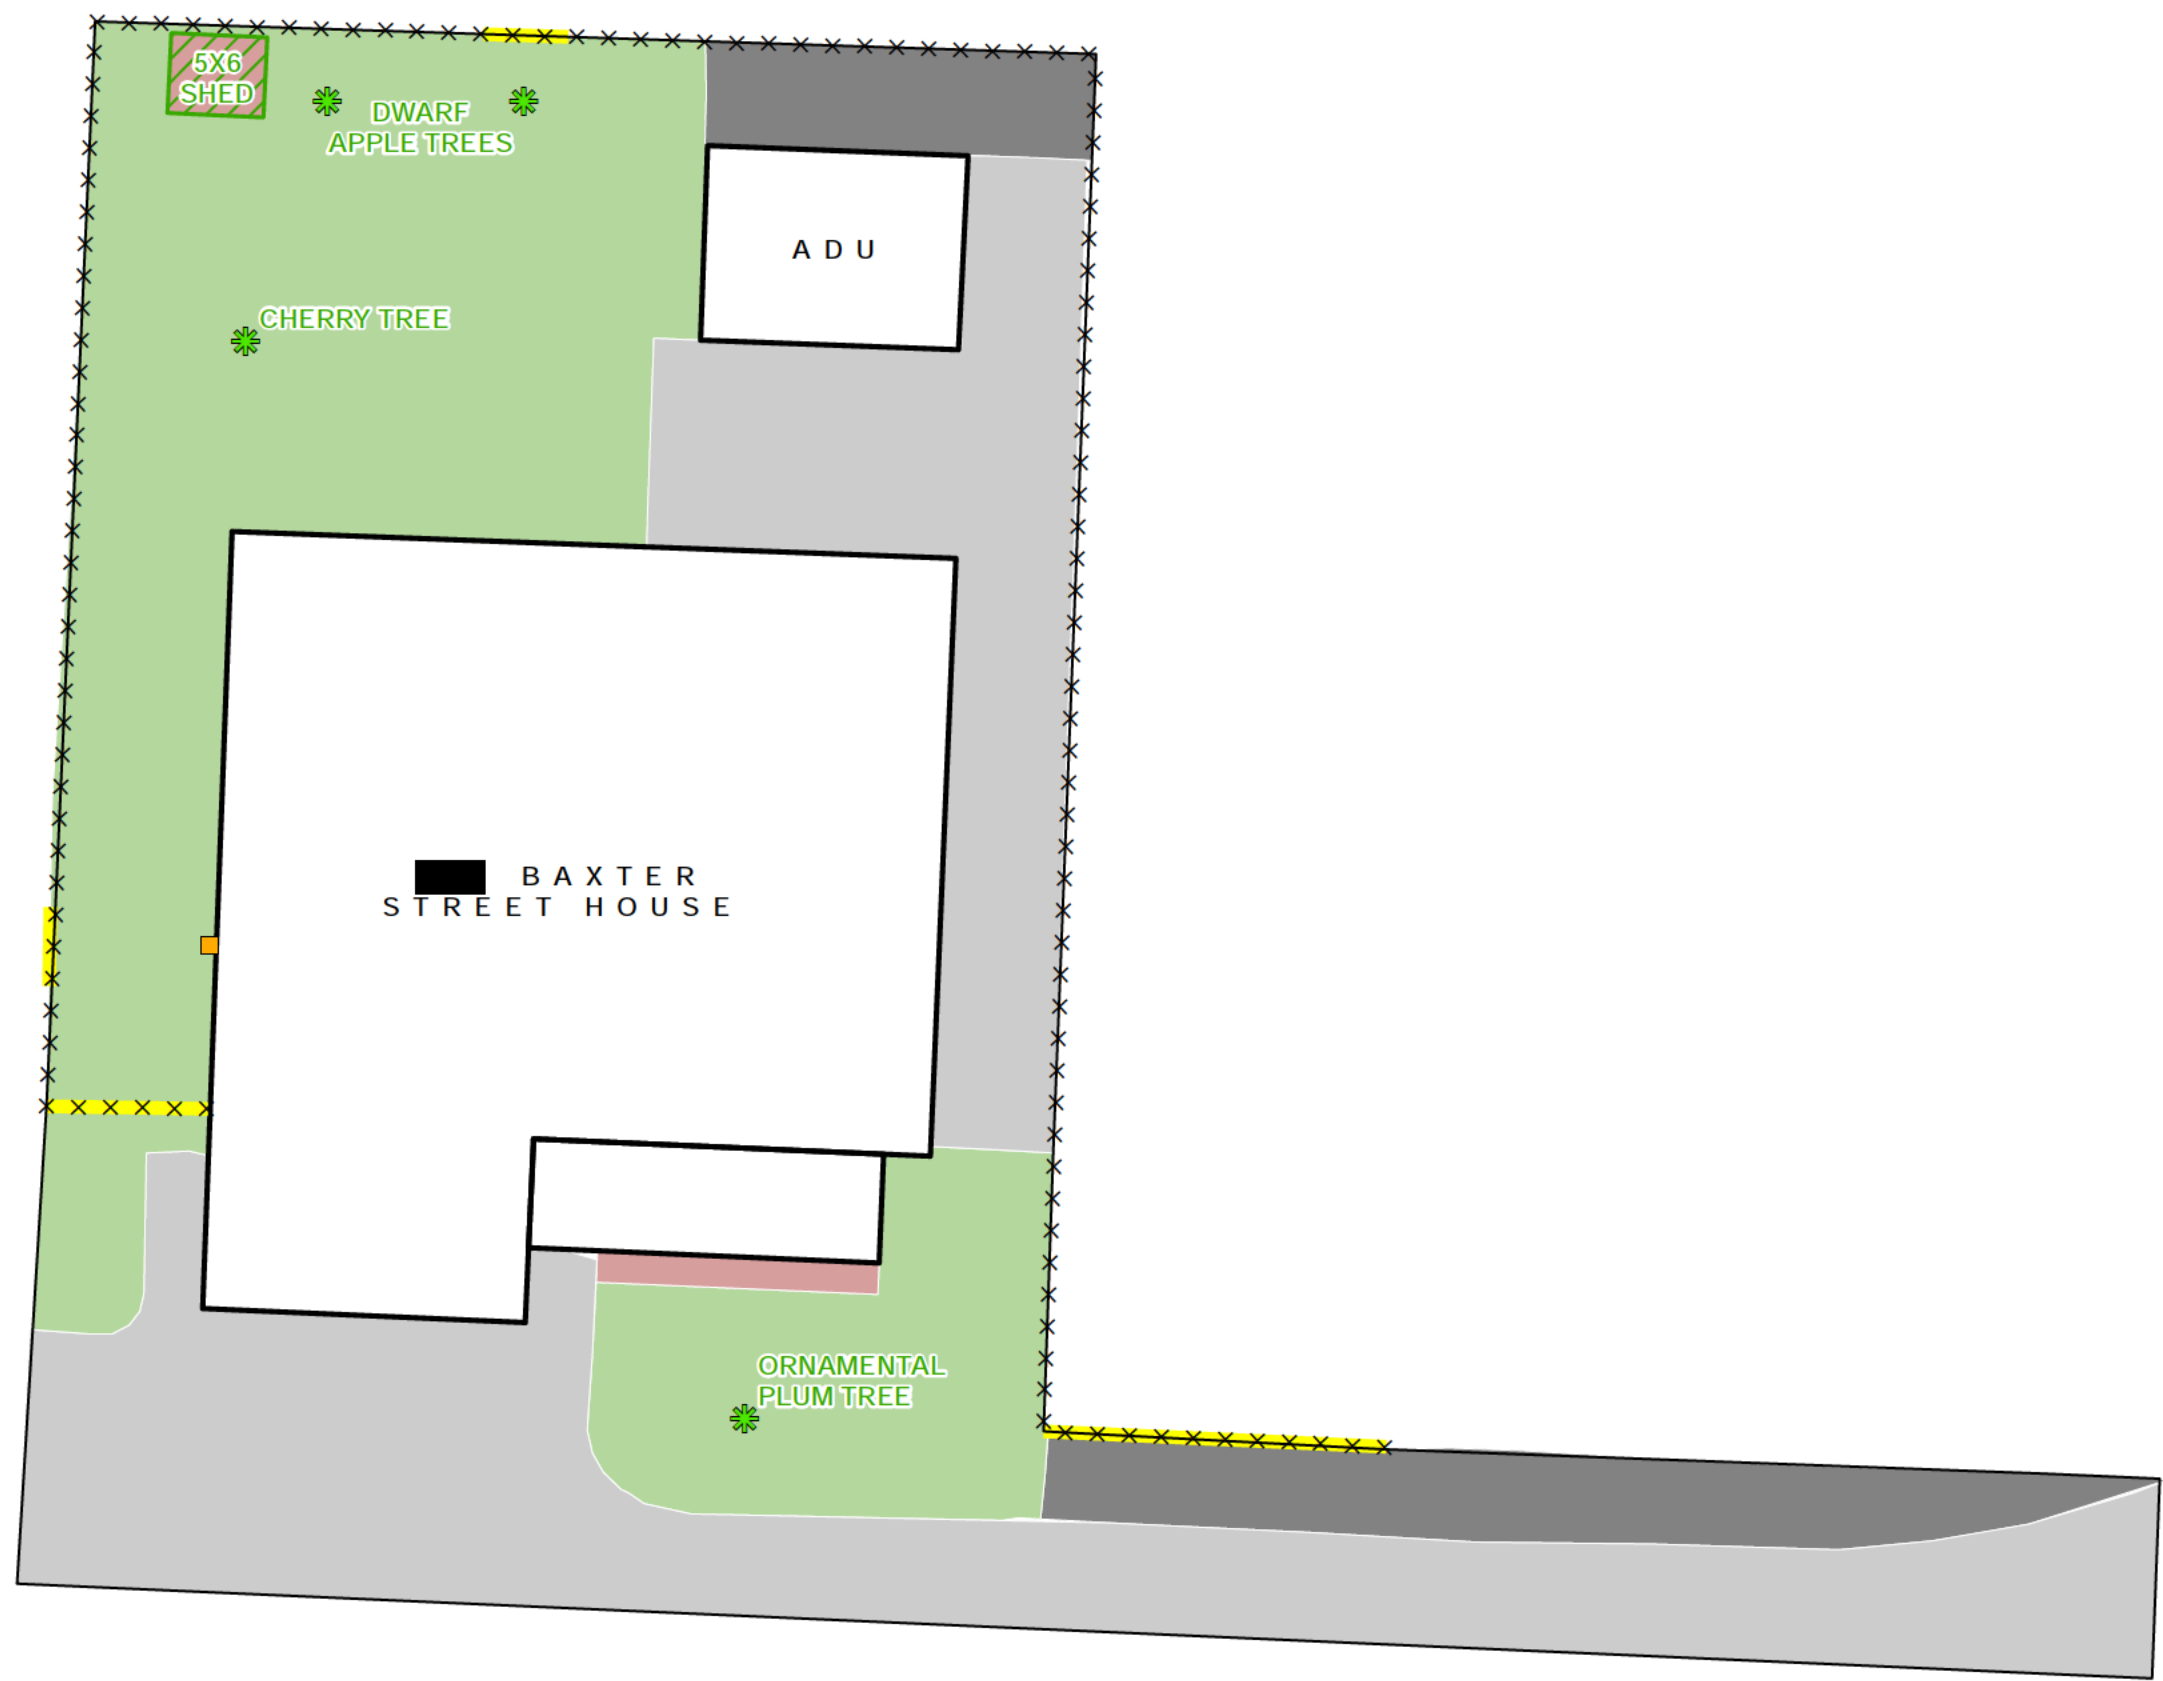
FIGURE 6a
DU-10: Baxter
Pre-Construction and RA Plan
Offsite Removal Action
Construction Completion Report

- Property of Interest
- Fence
- Protected Tree and Root Structure
- Critical Root Zone
- Concrete and/or Asphalt Hardscaped Surface
- Surface Soil Removal Depth
 - 6-inch
 - 12-inch
 - 18-inch
- Utilities
 - Power/Utility Pole
 - Natural Gas Meter
 - Water Meter
 - Roof Drain (discharging underground)
- Surveyed Utility Line
 - Natural Gas
 - Sewer
 - Water
- Inferred Utility Line
 - Sewer
 - Water
 - Septic Tank

DU-10. At DU-10 (Figure 6a), a wooden frame garden shed was demolished prior to excavation activities and was not replaced. A gazebo in the backyard was temporarily stored off the property during the RA and returned to its original location. Garden stones and pavers were removed from the front yard and stacked on the driveway for future use by the residents.

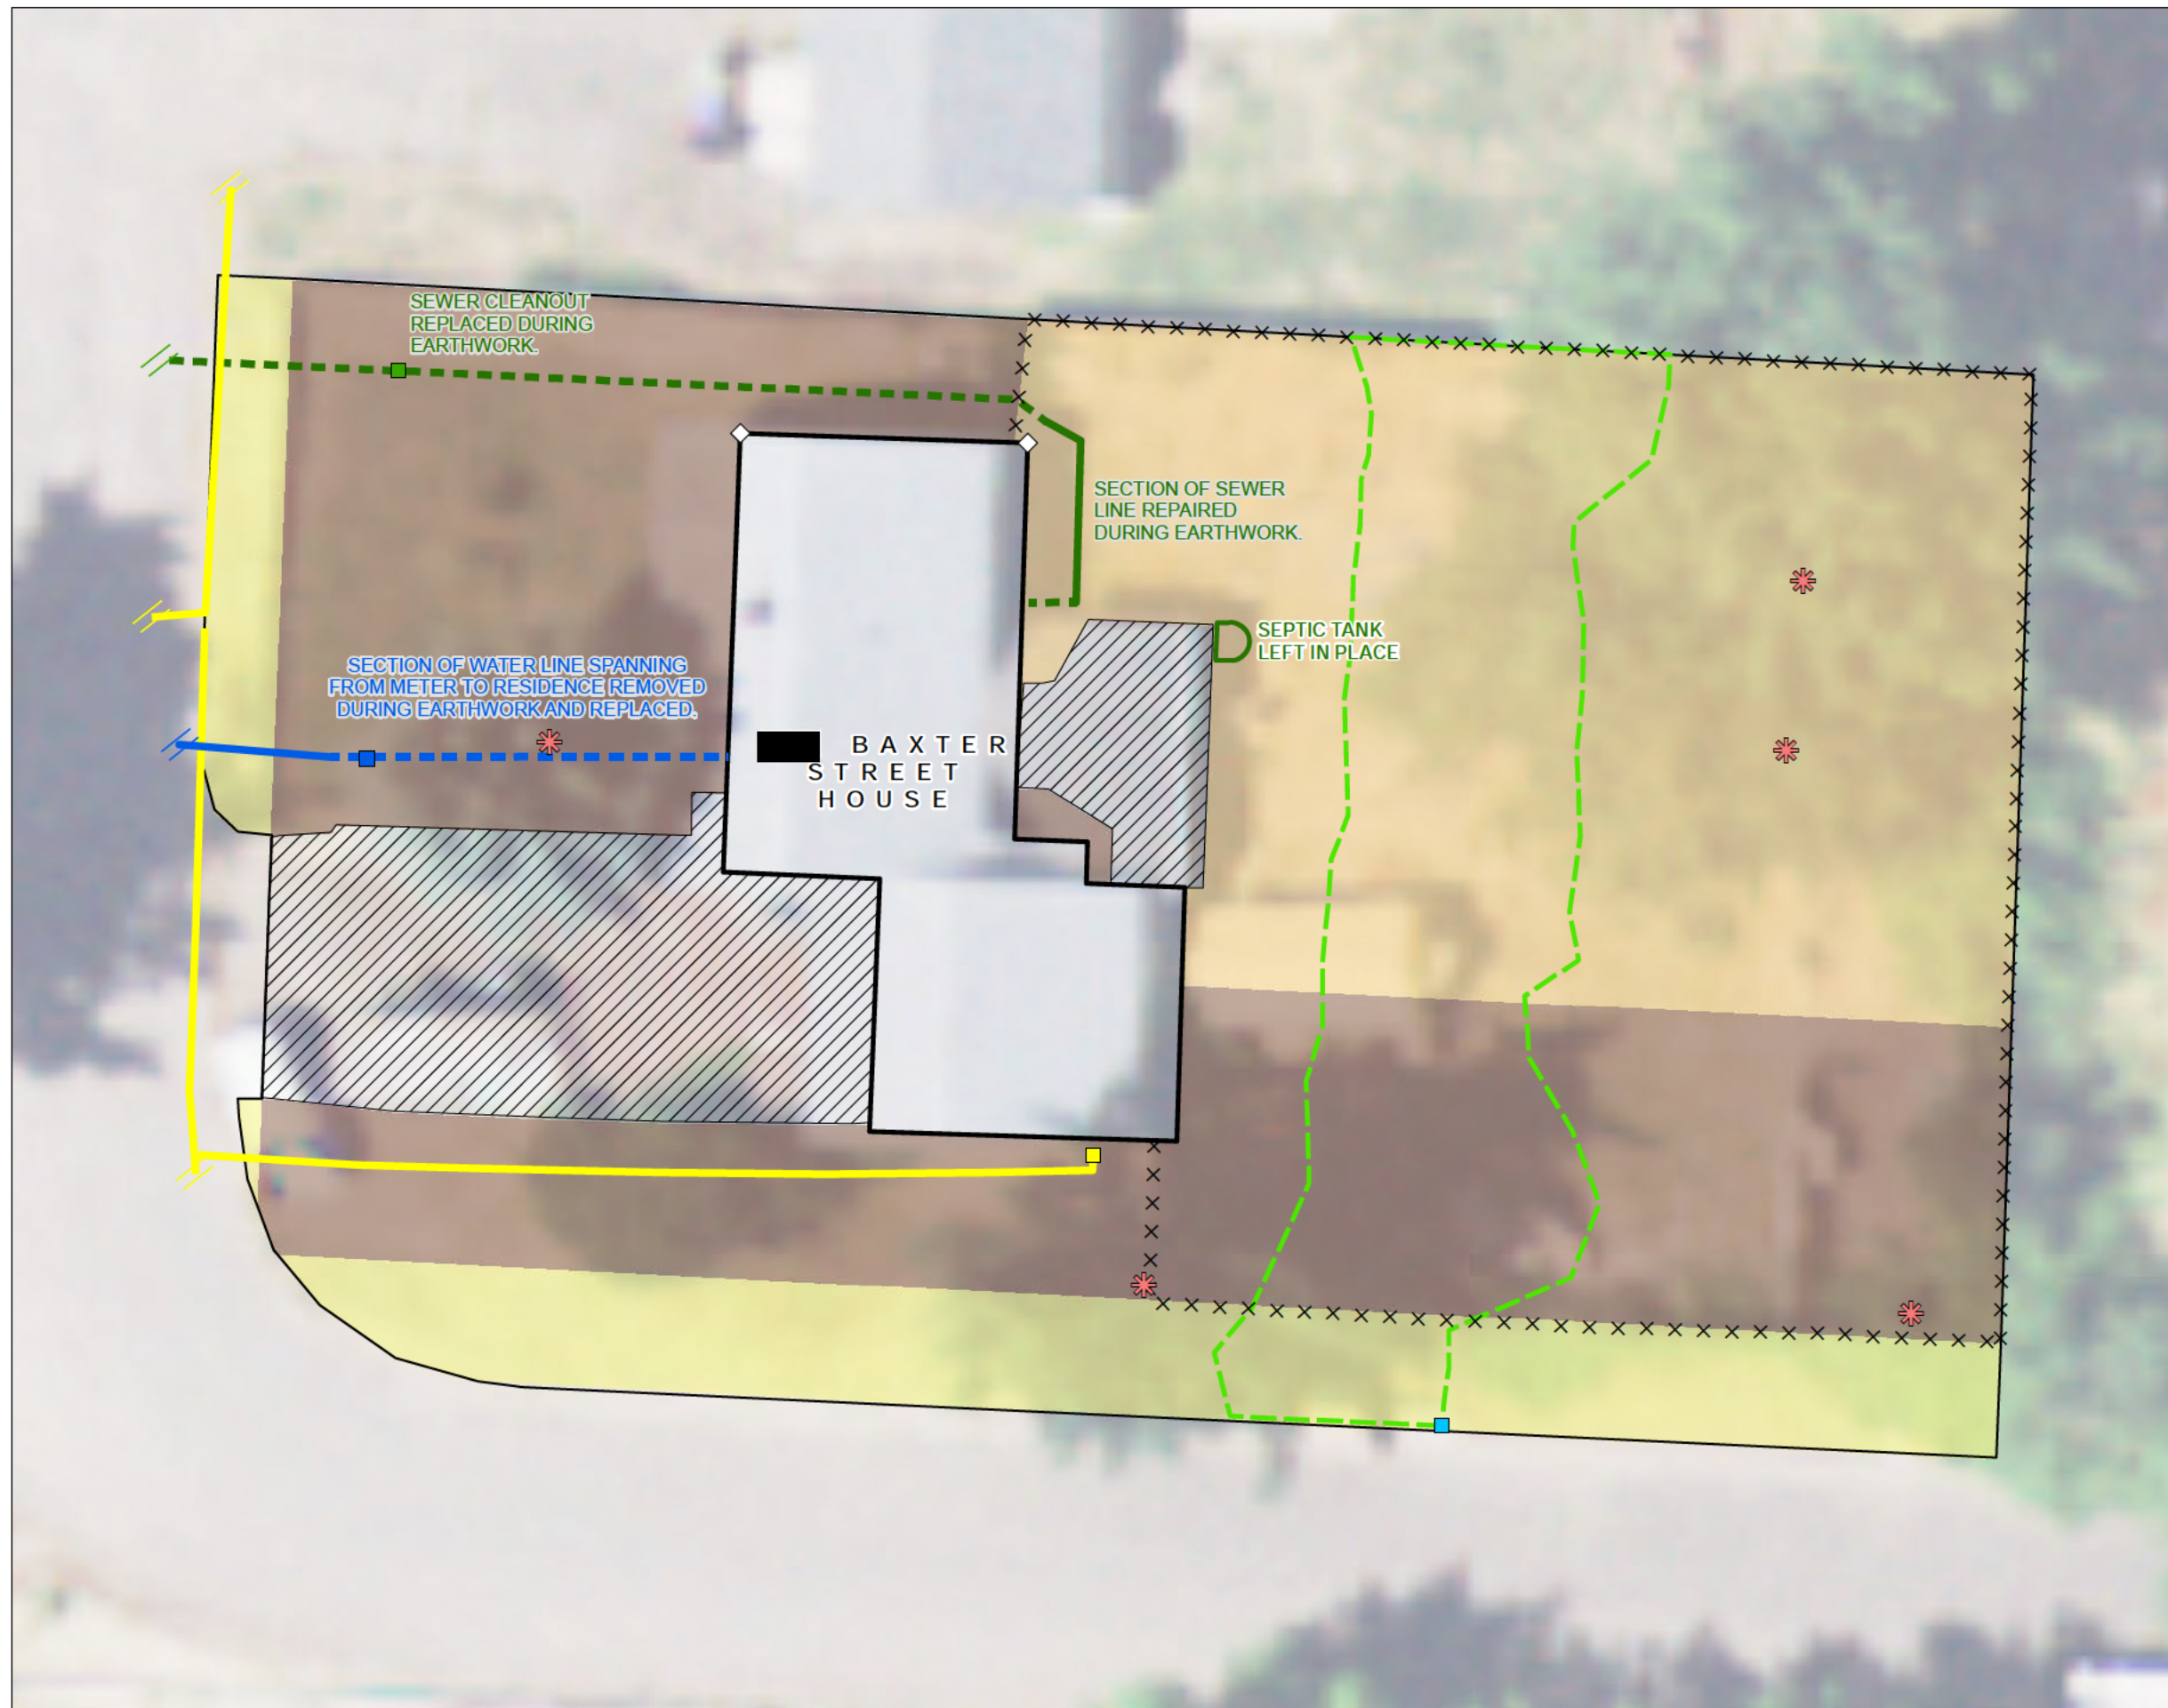
FIGURE 7b
DU-11: Baxter
Restoration Plan
Offsite Removal Action
Construction Completion Report

- LEGEND**
- Property of Interest
 - x x Fence
 - Repaired and/or Replaced Fence Section
 - ✱ Tree or Shrub Planted During RA
 - Finished Surface**
 - Bare Soil
 - Gravel Surface
 - Concrete/Asphalt
 - Sod

Imported soil materials were supplied from pre-approved sources (see Section 5.4) and included the following: clean fill (loam) from LFP, topsoil from Rexus, 0.75-inch minus gravel was supplied by Delta Sand and Gravel, and wood chips from LFP. GSI field staff were onsite to document imported material types, material origins, and methods of installation for each DU. Copies of the import material weigh tickets were provided by 3 Kings to DEQ and GSI, and are presented in Appendix D. Backfill details are shown in Figures 5b, 6b, 7b, 8b, and 9b.

Restoration activities also included restoring or replacing structures that had been removed for the RA to provide access to the DU. Relevant aspects of site restoration performed during Phase II of the RA are described in the following sections. Property-specific restoration details for each surface type are discussed below. Surface restoration details are shown in Figures 5b, 6b, 7b, 8b, and 9b.

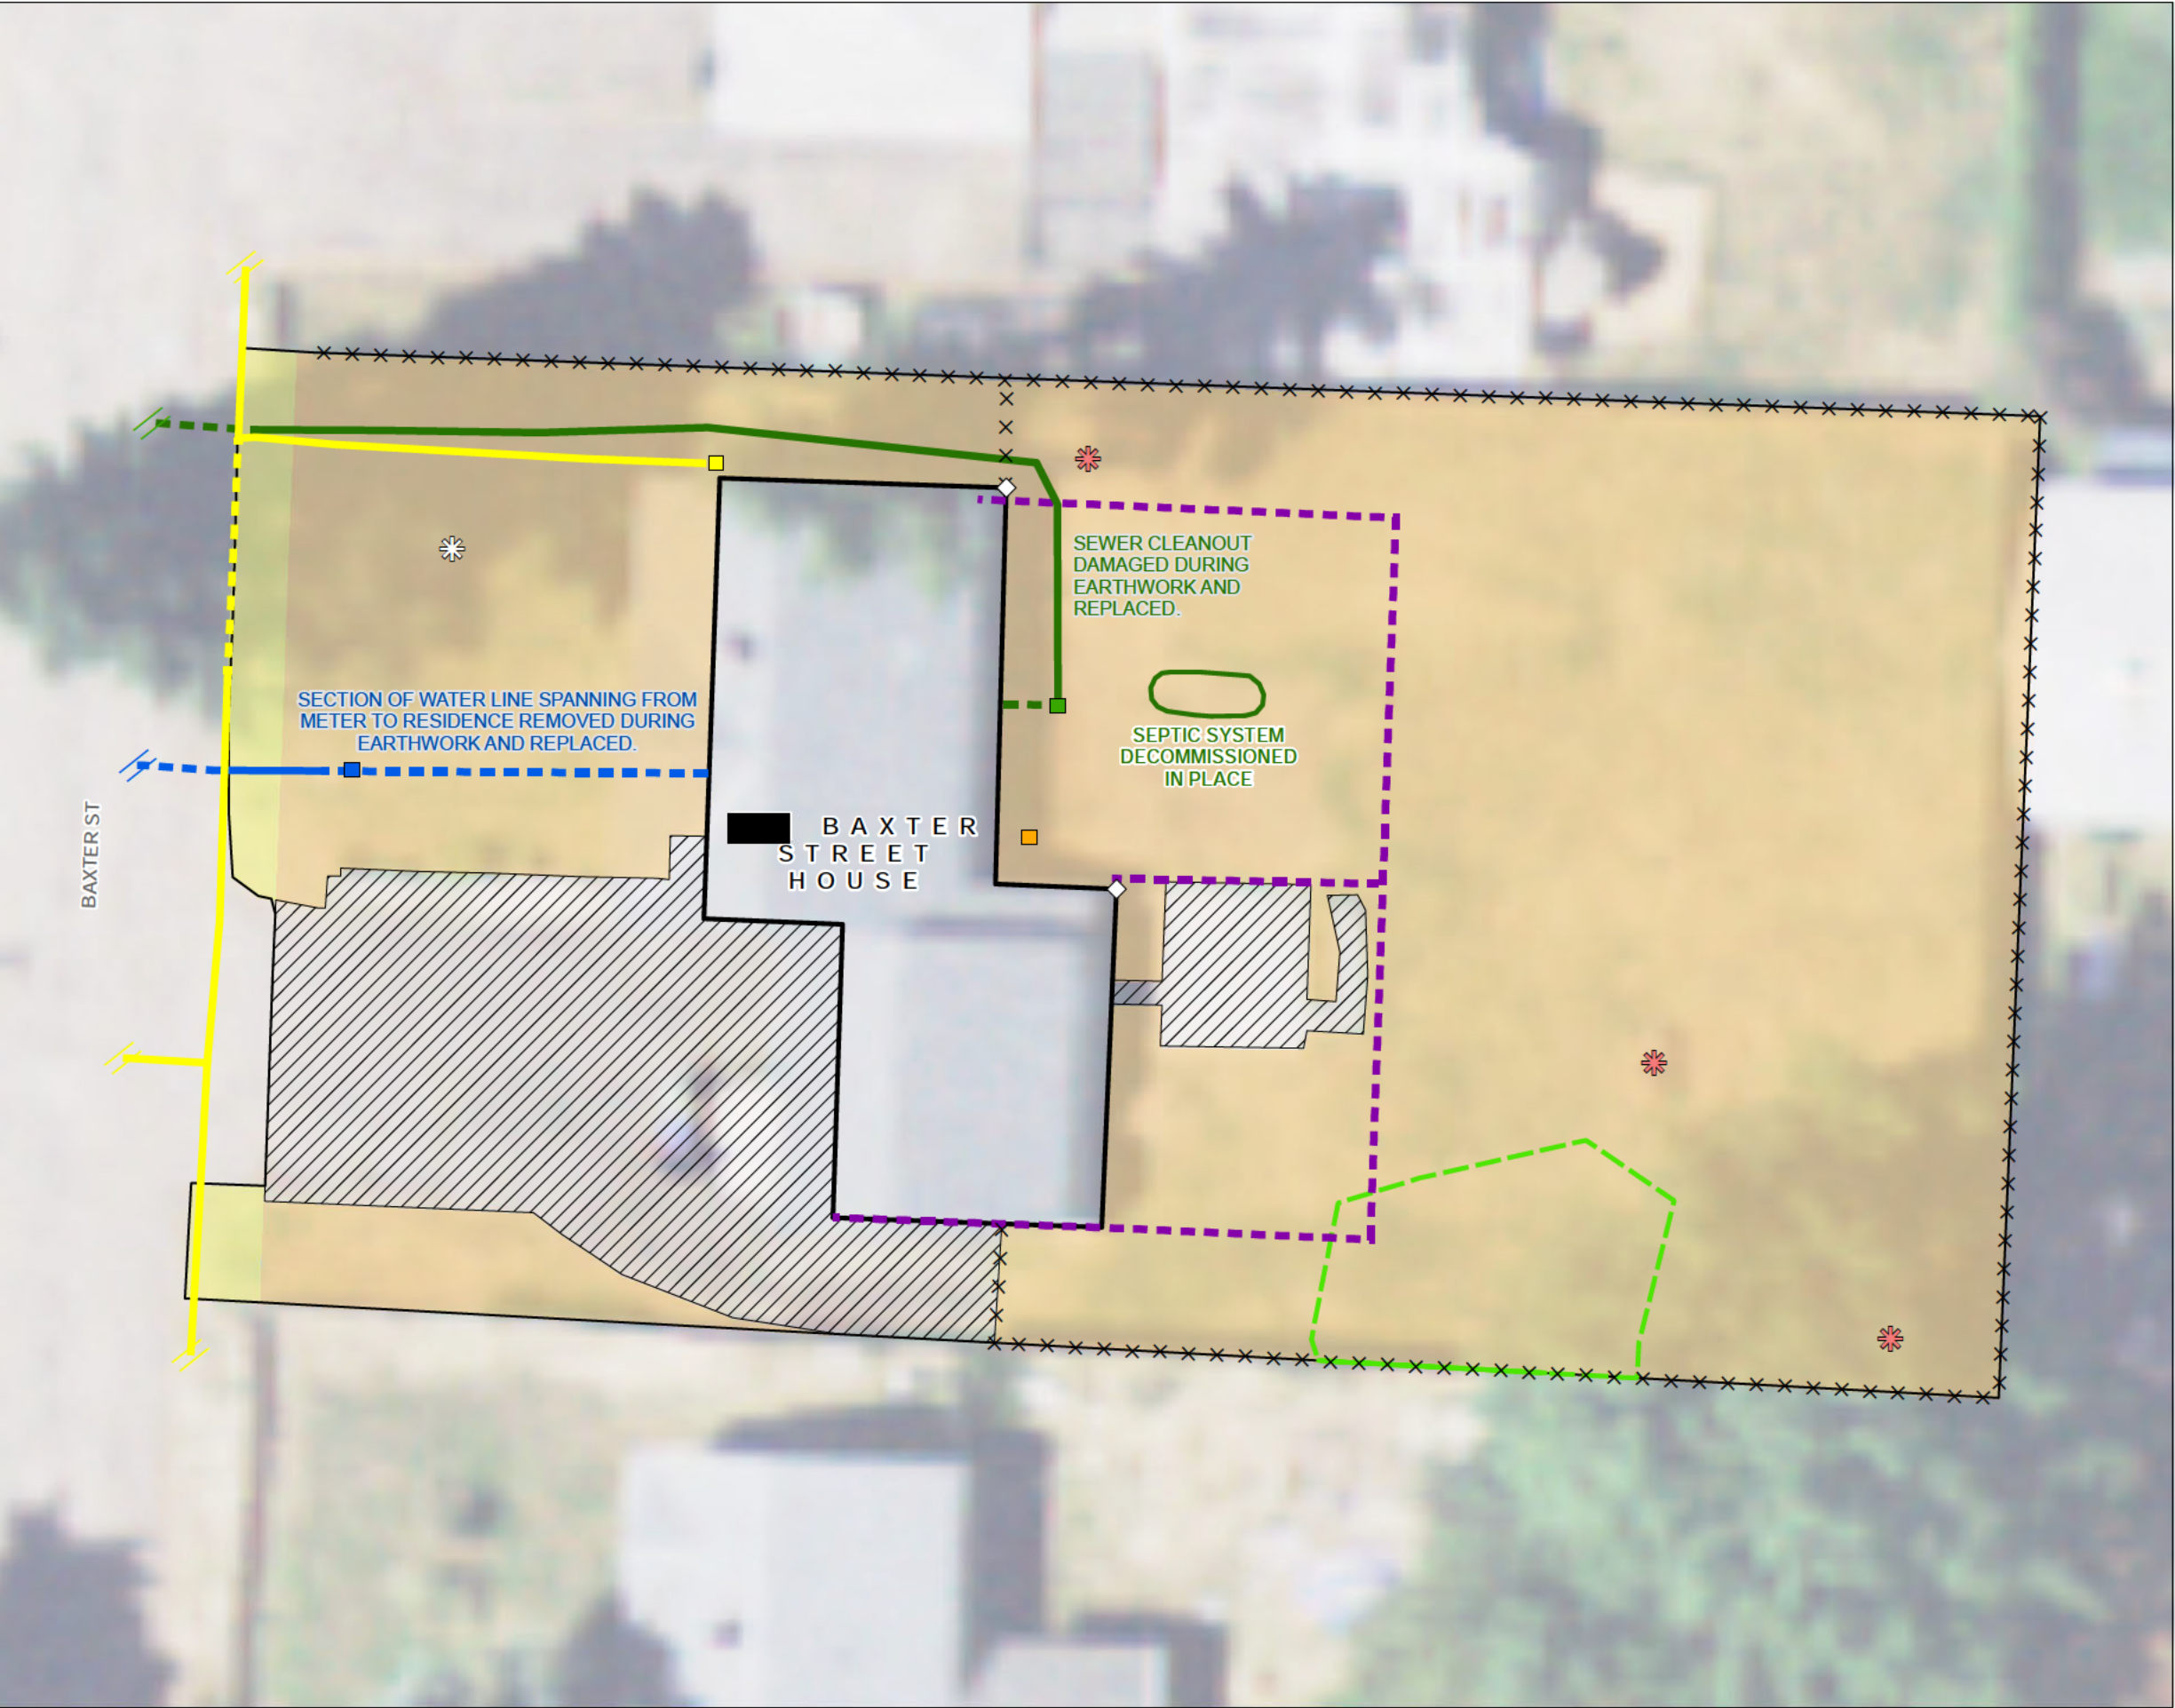
FIGURE 8a
DU-15: [REDACTED] Baxter
Pre-Construction and RA Plan
Offsite Removal Action
Construction Completion Report

□ Property of Interest
x x Fence
✱ Tree Stump (>12" diameter) Removed
✱ Protected Tree and Root Structure
▨ Concrete and/or Asphalt Hardscaped Surface
□ Temporary Construction Entrance

DU-15. At DU-15 (Figure 8a), a gazebo constructed on concrete pier footings and a wooden doghouse in the backyard were temporarily moved to other locations during excavation activities and later returned to their original location.
