DEQ SITE ASSESSMENT PROGRAM - STRATEGY RECOMMENDATION

Site Name: Bingo Truck Stop (ARCO AM-PM Brooks, Pilot Travel Center #386)

Site Address: 4220 Brooklake Rd NE, Brooks Oregon 97303

Date: December 16, 2015

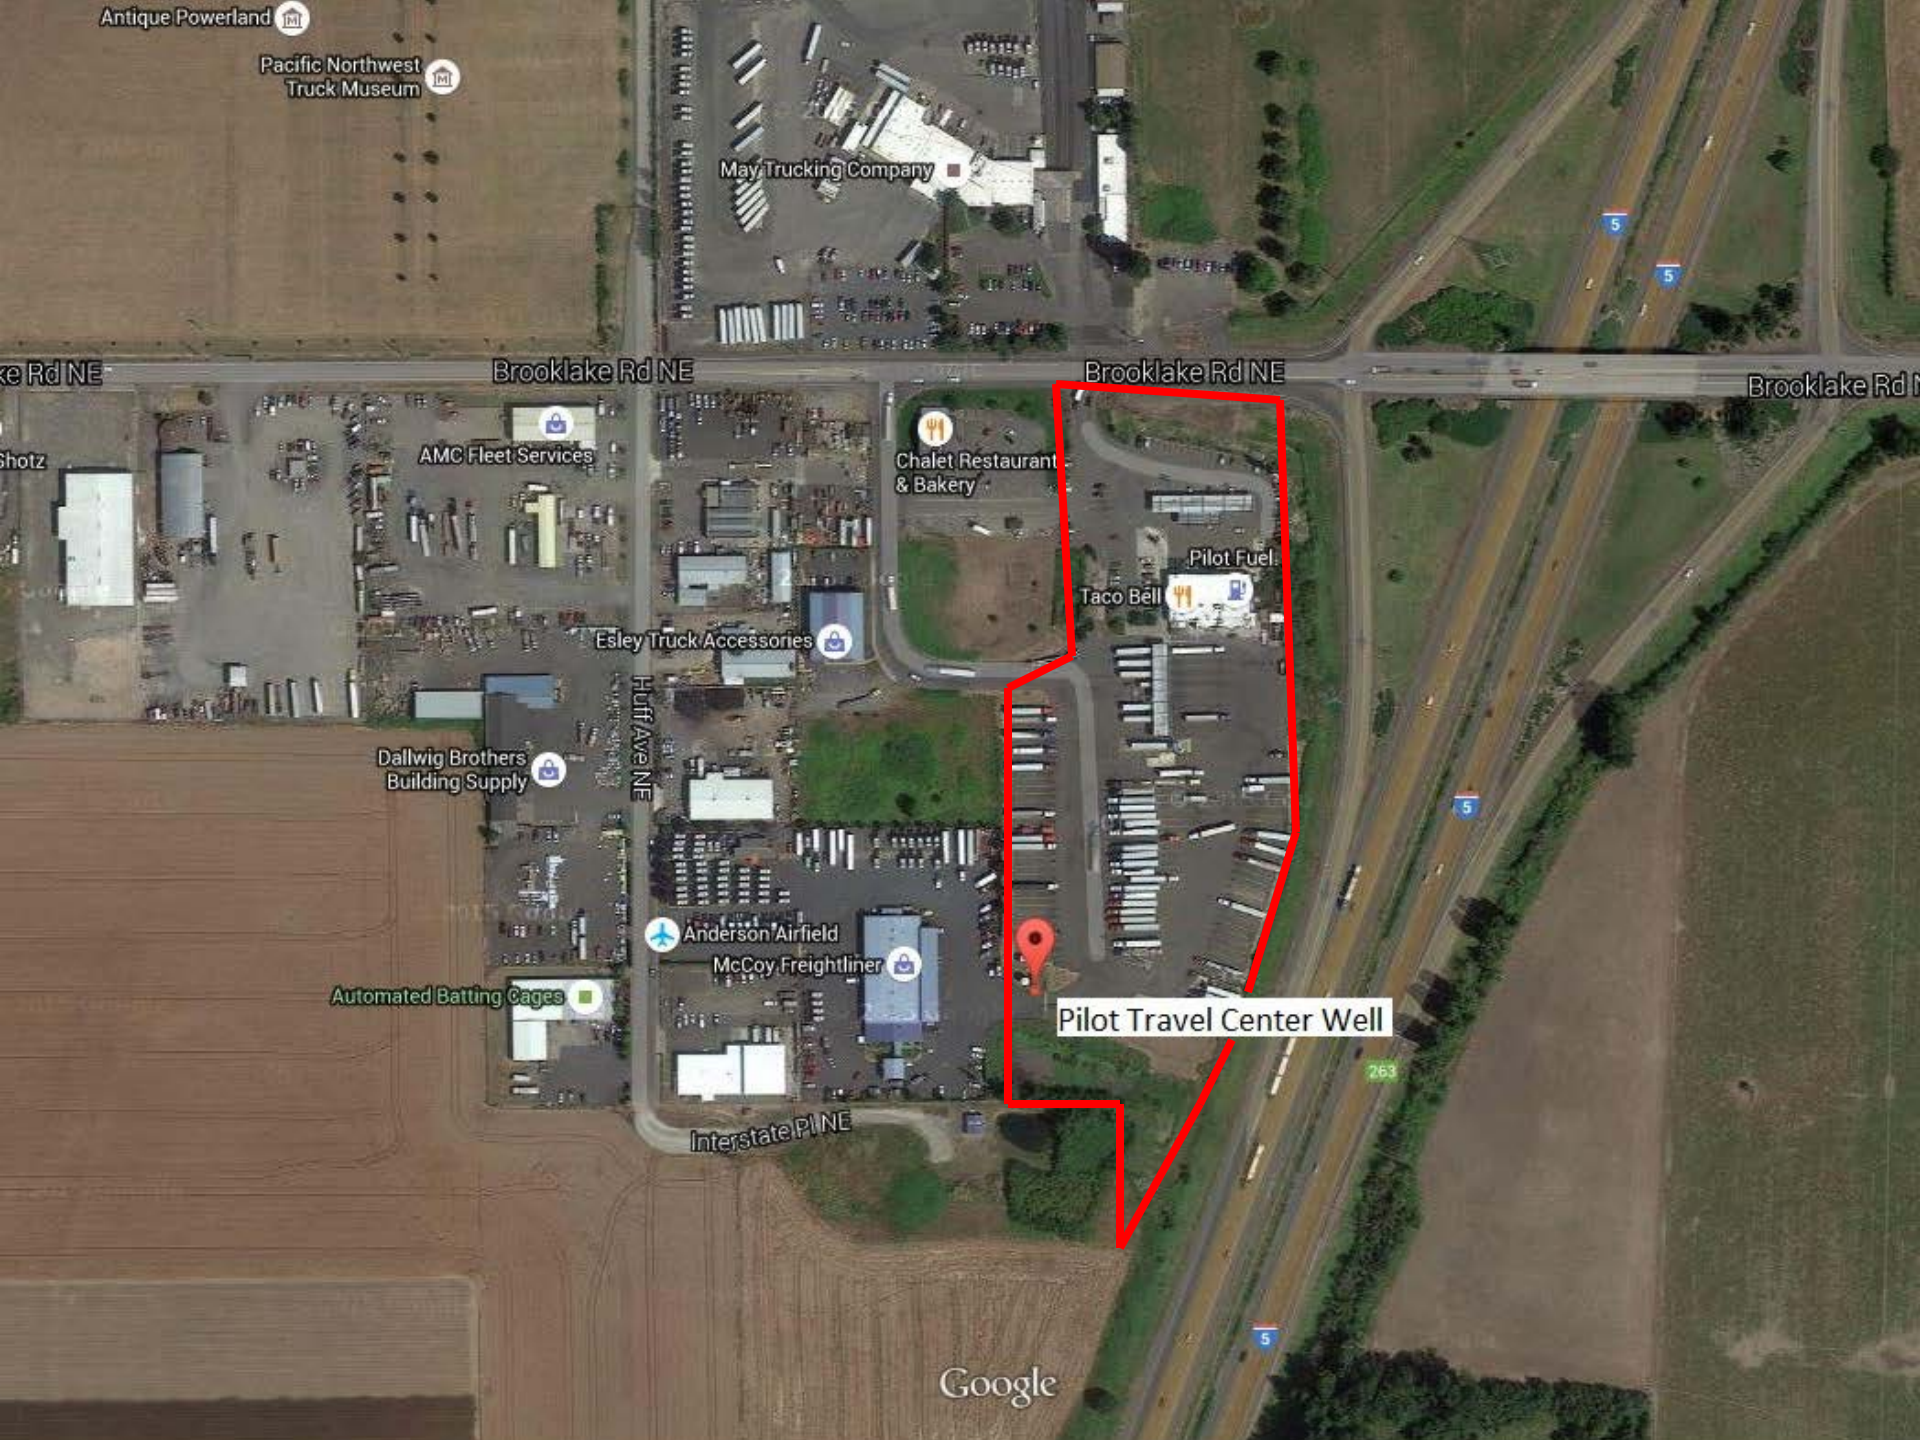
- Figure 1; Site Figure
- Figure 2, Site Diagram showing site and adjacent properties
- Figure 3; Drinking water source area from OHA

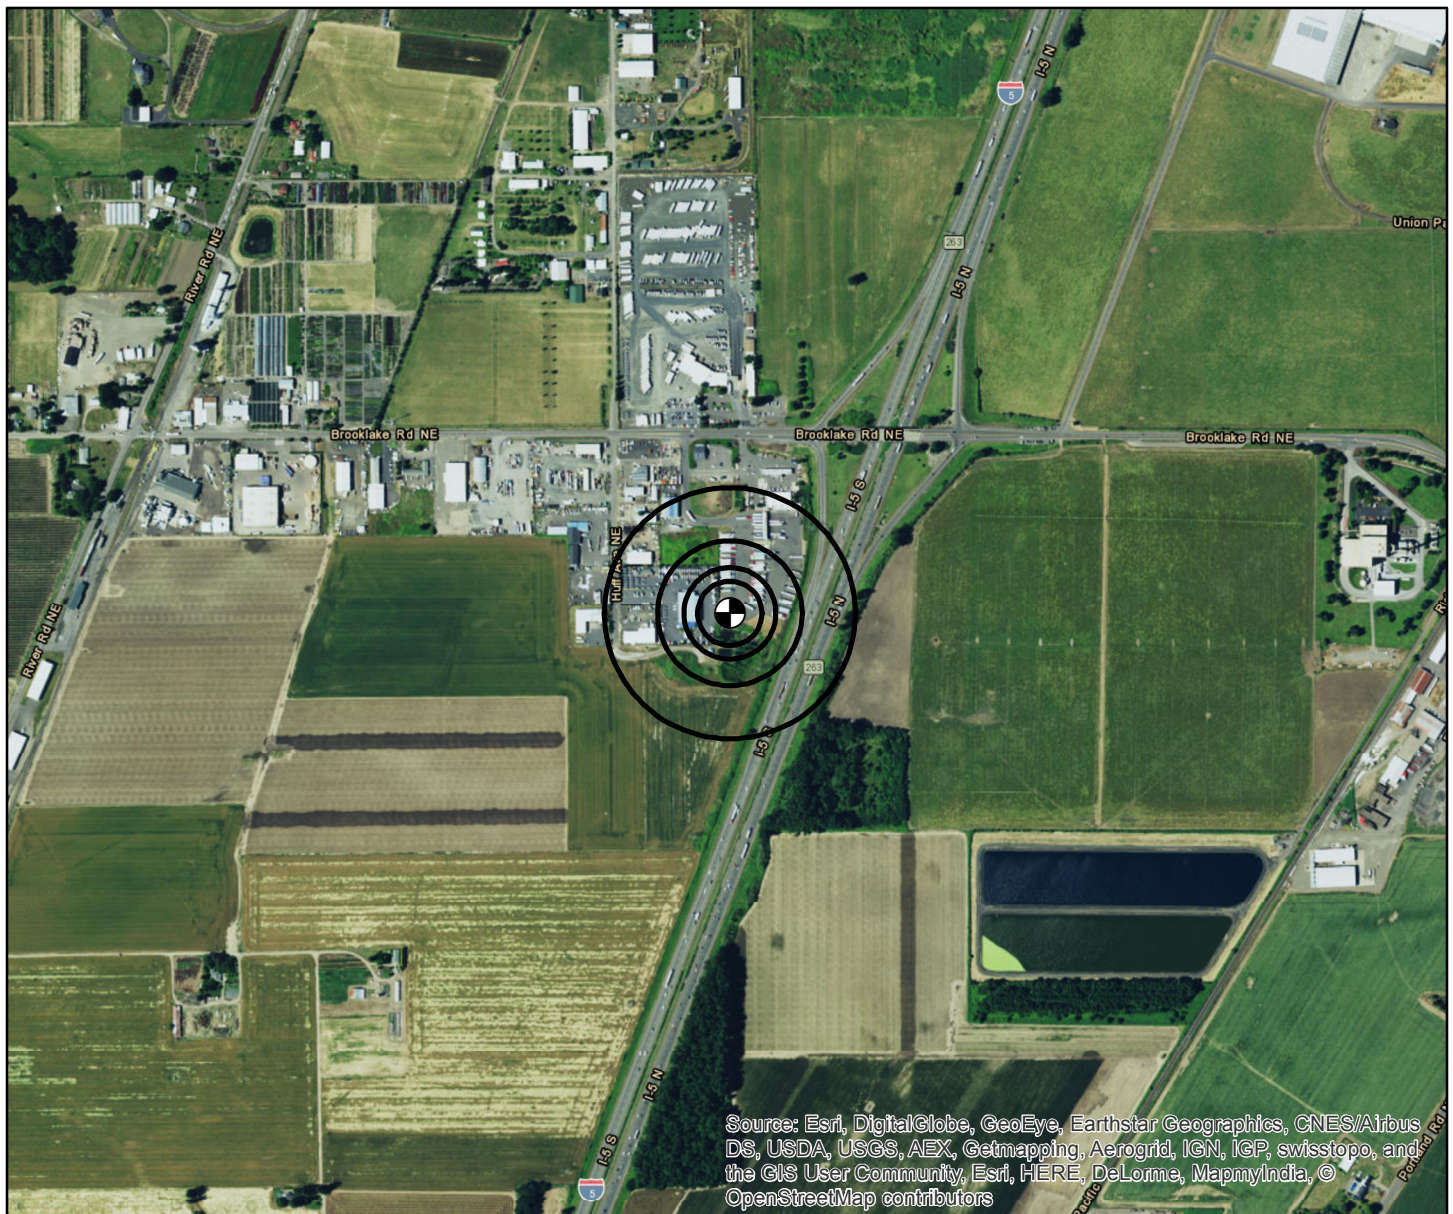
Figure 1. Pilot Travel Center #386 Drinking Water Source Area

0 500 1,000 2,000 3,000 4,000 Feet

Scale 1: 12,000

Because of the contamination and subsequent installation of the soil vapor extraction system, the domestic well used at that time was decommissioned. A new domestic well was installed in 1996 on the southern part of the facility. This well was sampled for volatile organic compounds (VOCs) at the time of installation. No VOCs were noted above detection limits at that time. In July 2003, 1,2-dichloroethane (EDC) was detected in this drinking water well. The well was not sampled from 2003 until recently because it was classified as a State-Regulated water system and was not required to sample for VOCs. The system was reclassified as a "Non-transient Non-Community" system in September 2014 and required to sample for VOCs.
