Re: Fourth Quarter 2025 Post-Closure Inspection Report – Gould Superfund Site

On behalf of the Gould PRP Group, BSI America Professional Services Inc. (BSI) is submitting the Fourth Quarter 2025 Post-Closure Inspection Report (Report) for the Gould Superfund Site (Site) to the United States Environmental Protection Agency (EPA). The inspection was conducted on November 17, 2025.

The fourth quarter 2025 Site inspection was performed in accordance with the Revised Operation and Maintenance Plan for the Gould Superfund Site, dated January 19, 2011 (AMEC 2011). Report attachments include a site location map (Attachment A), post-closure inspection form (Attachment B), and leak-detection sump analytical results summary table (Attachment C).

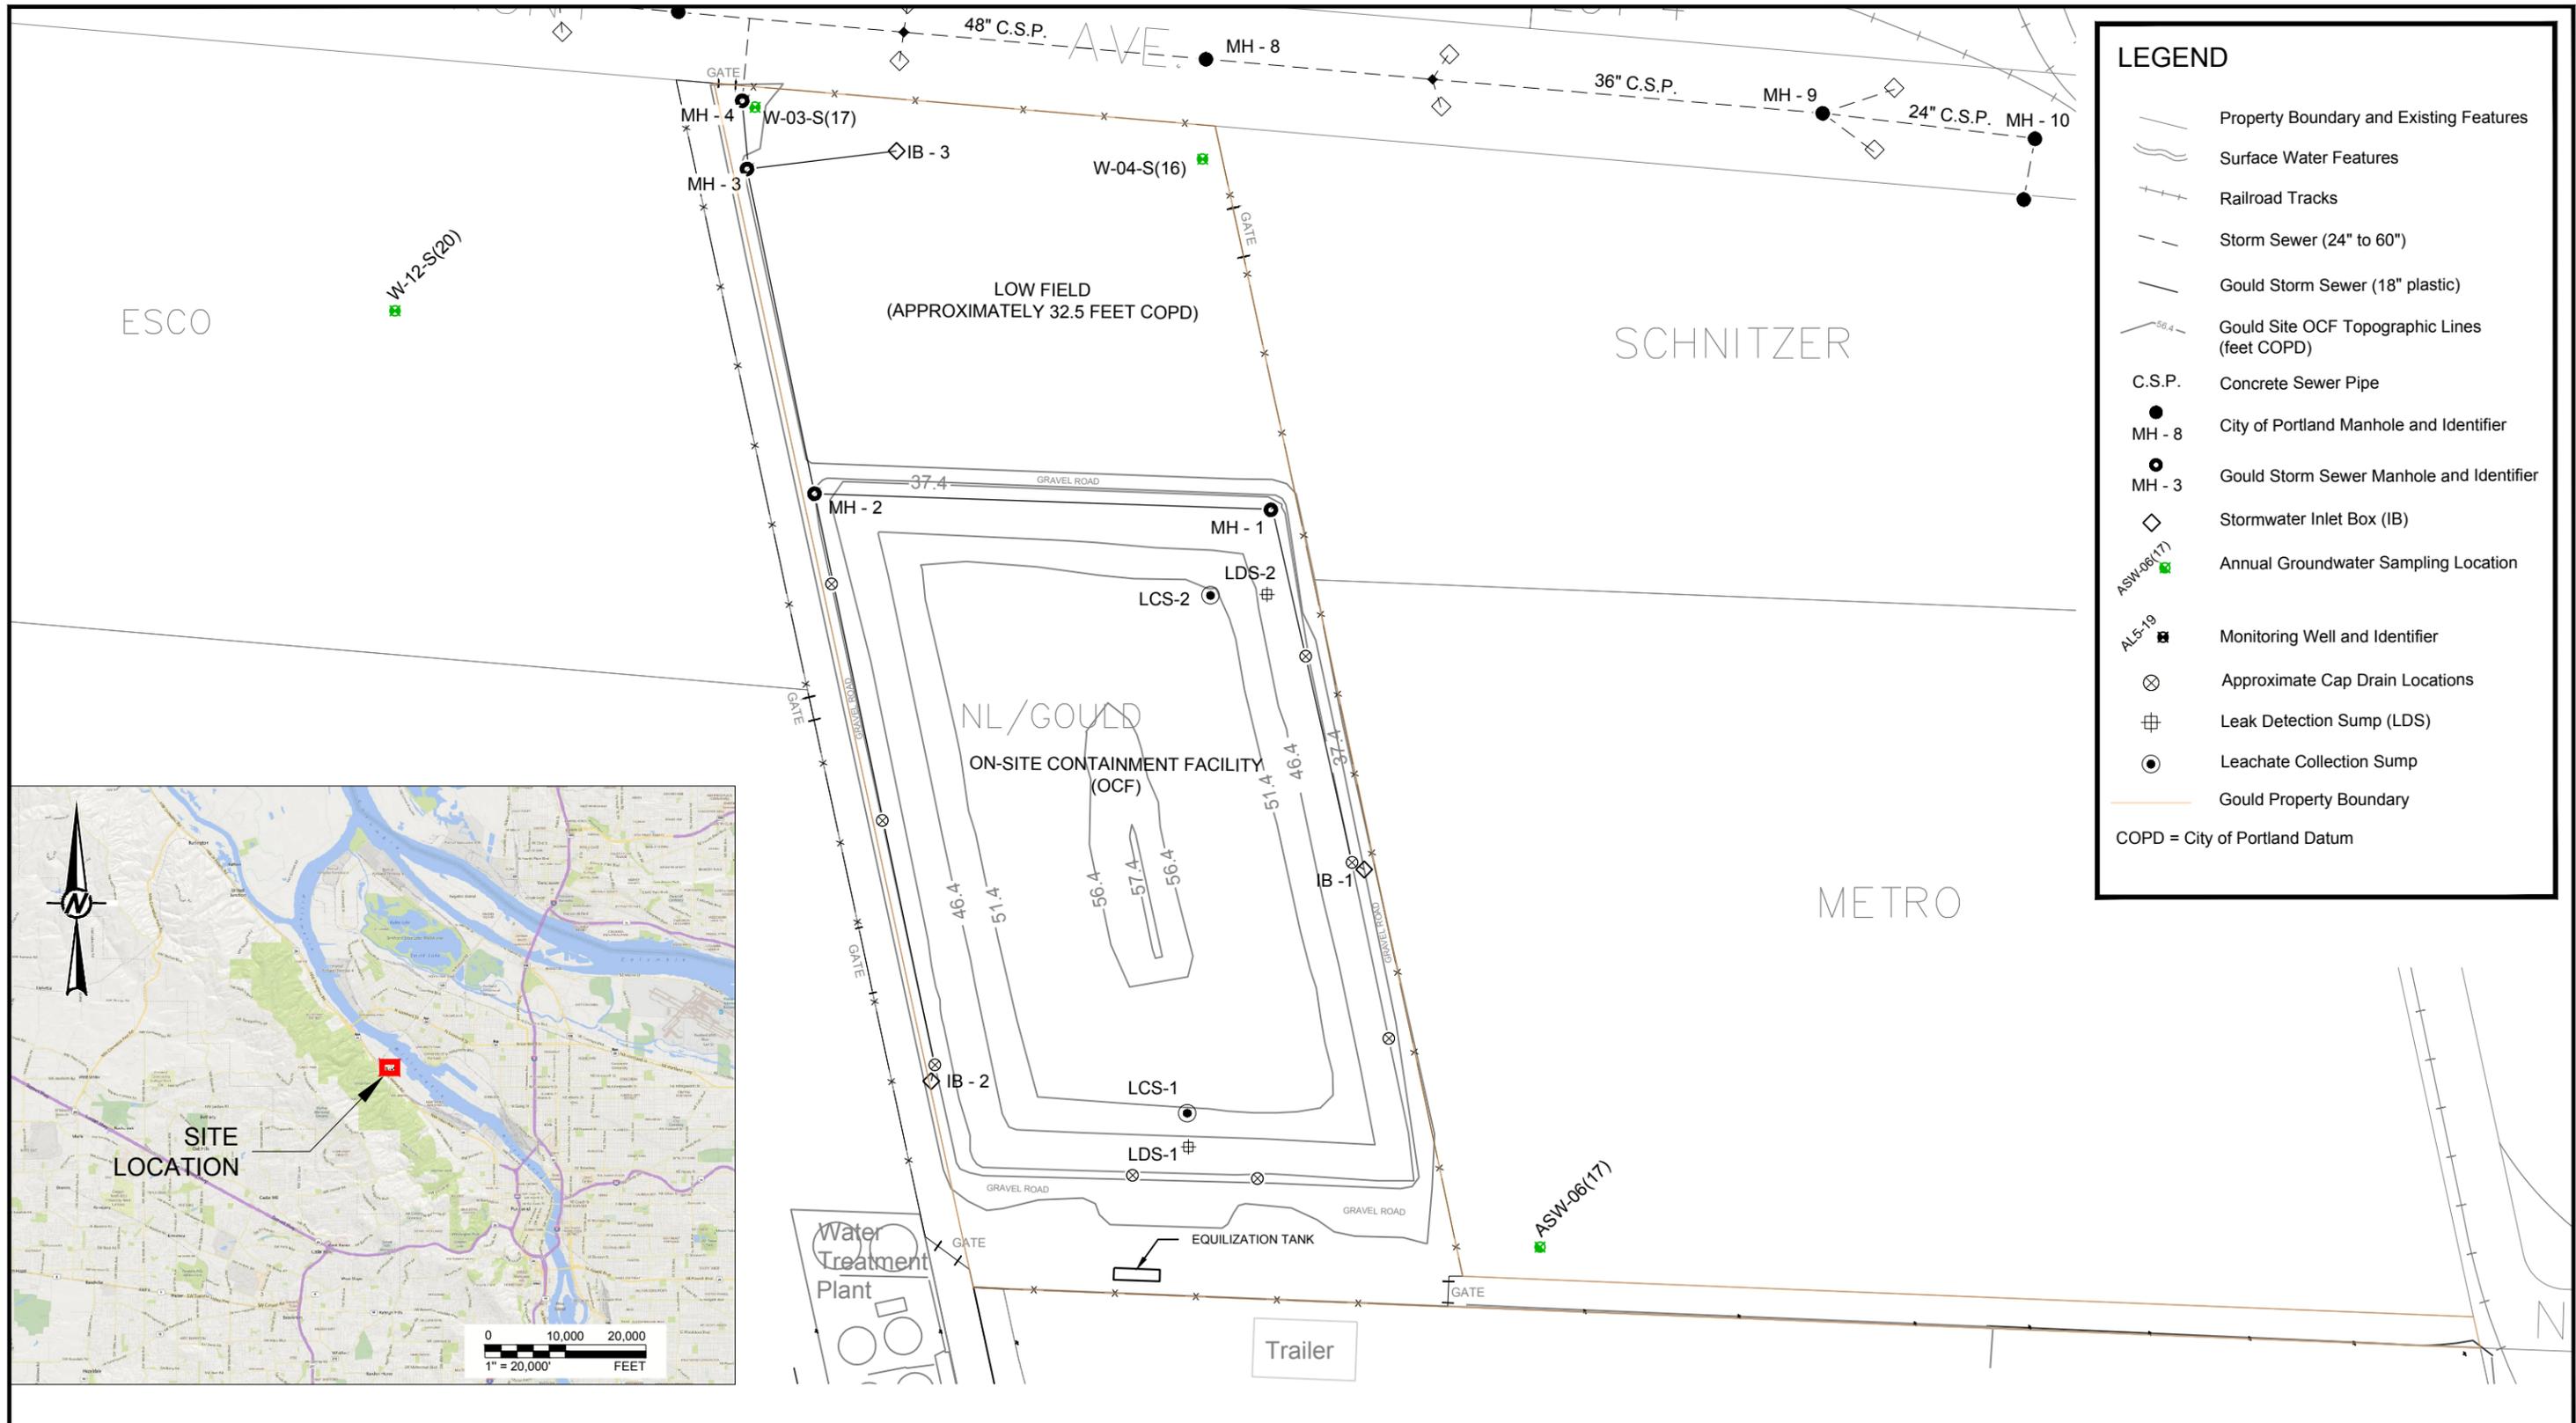
Site Location Map

- Property Boundary and Existing Features
- Surface Water Features
- Railroad Tracks
- Storm Sewer (24" to 60")
- Gould Storm Sewer (18" plastic)
- Gould Site OCF Topographic Lines (feet COPD)
- C.S.P.** Concrete Sewer Pipe
- City of Portland Manhole and Identifier
- Gould Storm Sewer Manhole and Identifier
- Stormwater Inlet Box (IB)
- Annual Groundwater Sampling Location
- Monitoring Well and Identifier
- Approximate Cap Drain Locations
- Leak Detection Sump (LDS)
- Leachate Collection Sump
- Gould Property Boundary

COPD = City of Portland Datum

General sewer information and location from www.portlandmaps.com, August 2003.

Information related to the location and elevation of the Gould Site storm sewer system was taken from the **Final As-Built Grading Plan Figure**, dated February 27, 2001; prepared by David Evans and Associates, Inc.
