**AGENDA**  
**CITY OF BROOKINGS**  
**PARKS AND RECREATION COMMISSION MEETING**  
**Council Chamber - 898 Elk Drive**  
**November 17, 2016 - 7:00 pm**

Background/Discussion: The overall condition of Kidtown is poor based on a field inspection and subsequent condition assessment report (see attached) performed by Leather and Associates, the original architect for Kidtown. To repair the structure as recommended by Leathers requires a surgical process that is very time consuming. Staff recommends the continued repairs and replacement of portions of the play structure as needed over the course of the next few years.

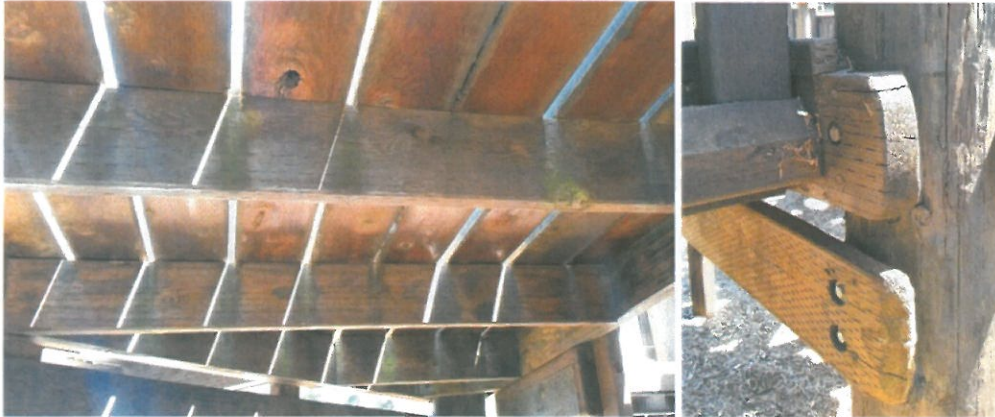
The framing is in medium condition. Has some splintering but not structural.

Replace Framing as needed

Stain with solid body stain.

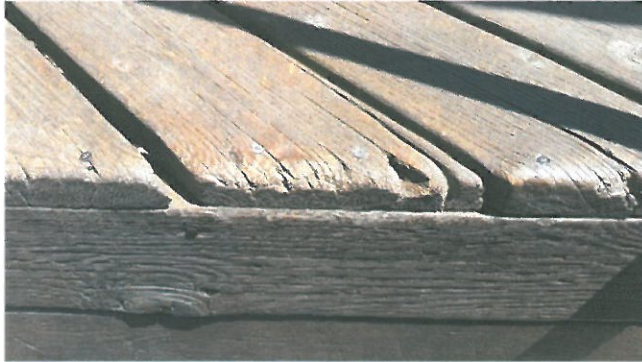
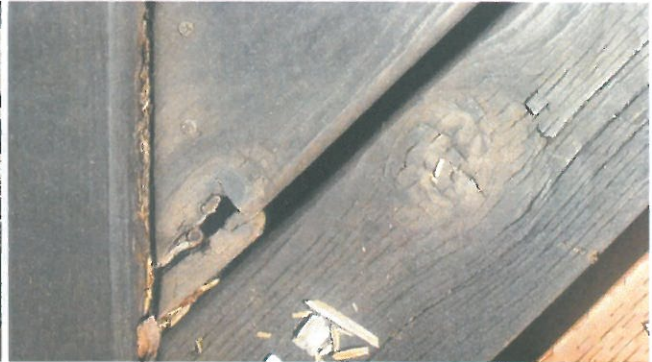
The decking is in poor condition and has severe splintering

Replace with recycled plastic to reduce the amount of pressure treated lumber on the structure

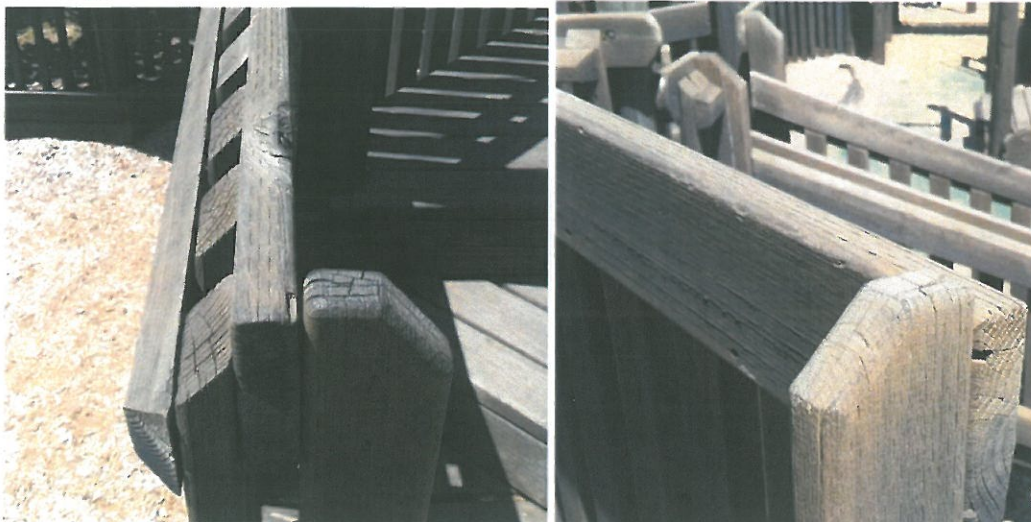
The handrails are in poor condition and have severe splintering

Replace with recycled plastic to reduce the amount of pressure treated lumber on the structure

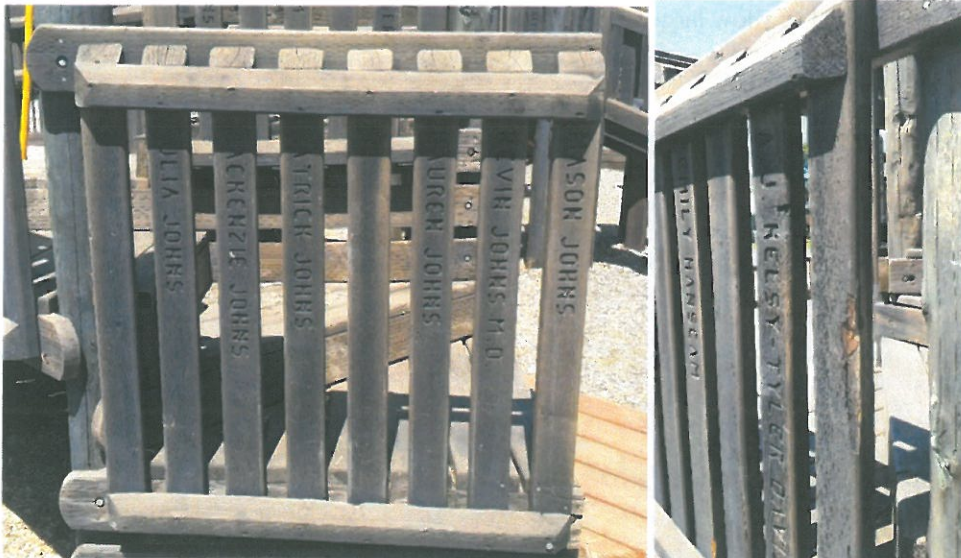
The balusters are in medium condition (minor splintering & wear).  
The balusters have names routed into them

Replace with recycled plastic and pipe balusters

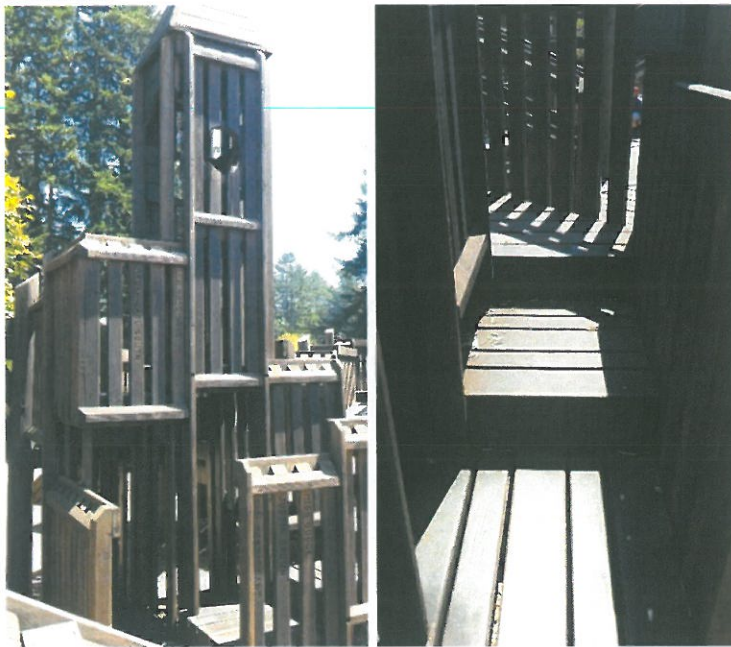
The maze cubes are in medium condition (minor splintering & wear).  
The maze cubes do not meet the current ADA requirements

Replace the decking with recycled plastic

Option 2 – redesign some of the playground to allow larger maze cubes and increase accessibility to that portion of the playground

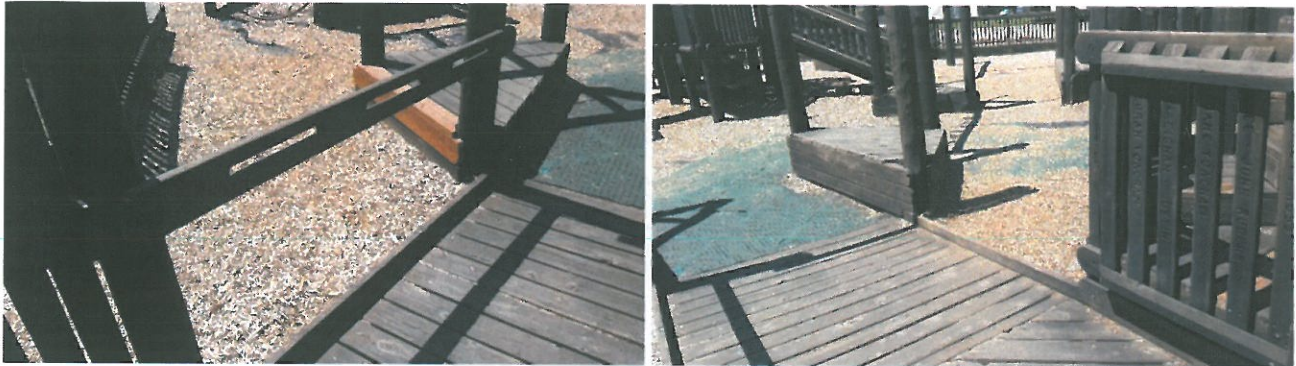
Some Ramp rails are missing

Replace ramp rails with recycled plastic ADA ramp rails

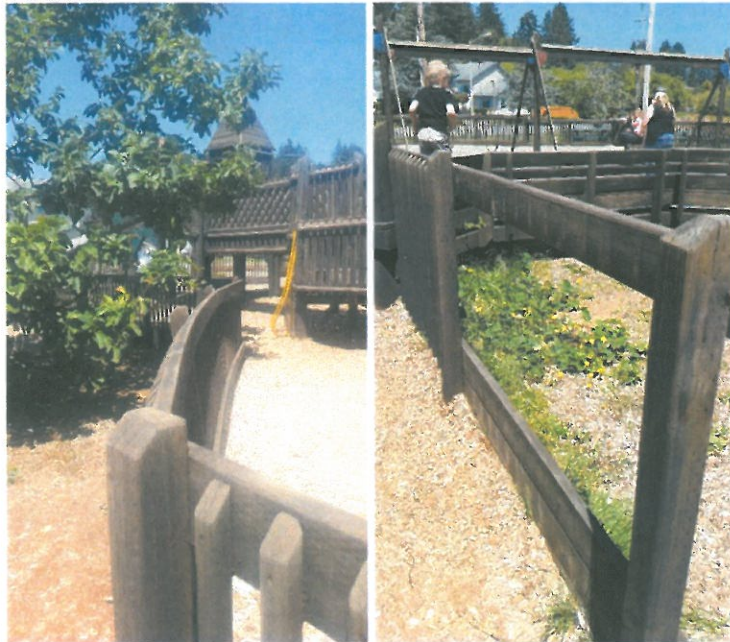
The fence is in medium condition (minor splintering, missing pickets and wear).

Replace with new all plastic fence.

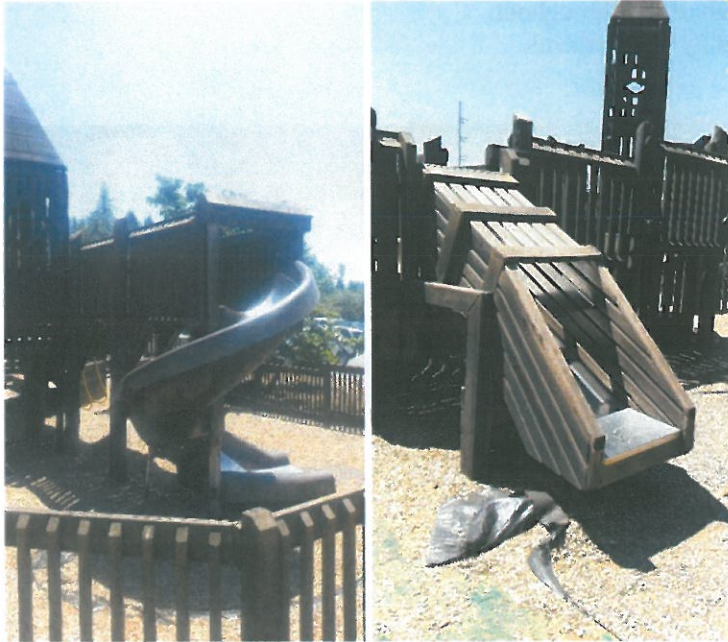
The slides are worn and missing some parts

Replace with new lower maintenance manufactured slides

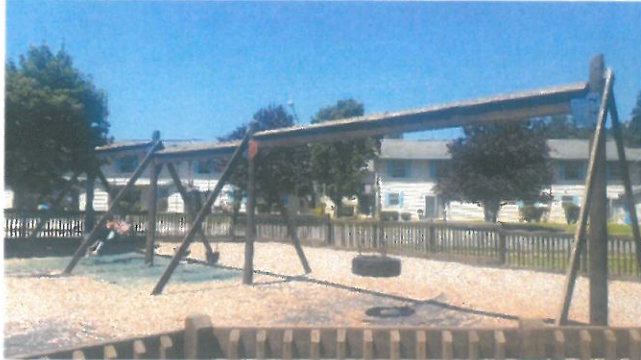
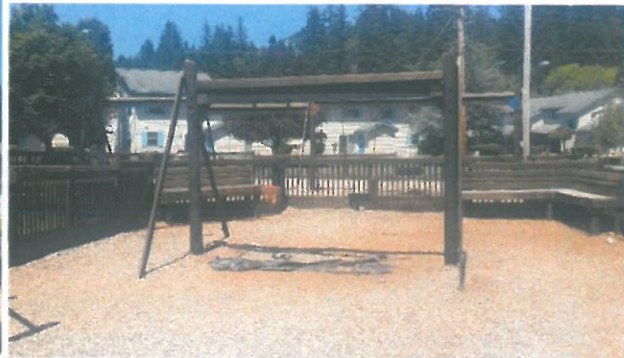
**Equipment type/name:** Swings – Tot & 5-12-year-old areas

The swing hardware is worn and corroded.

Replace with lower maintenance manufactured swings

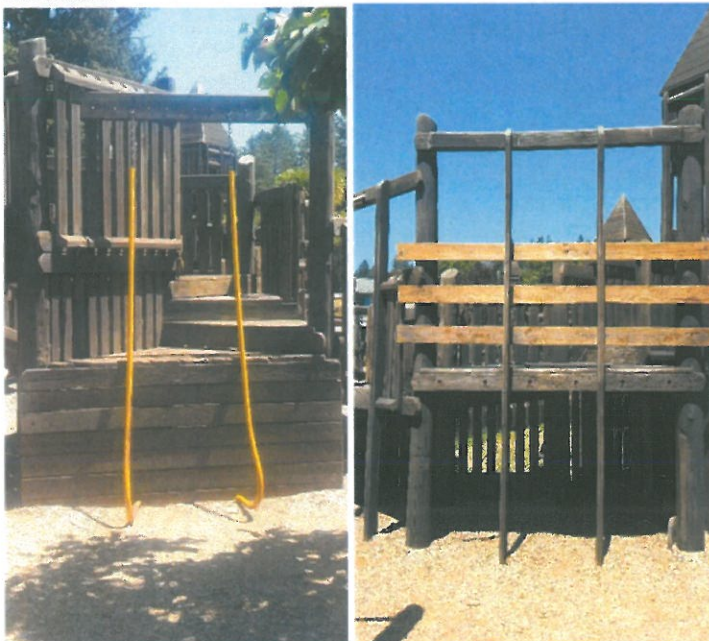
Most of the Chain and Hose equipment is stretched out, worn or missing

Replace with low maintenance cables and new custom designed, age appropriate equipment

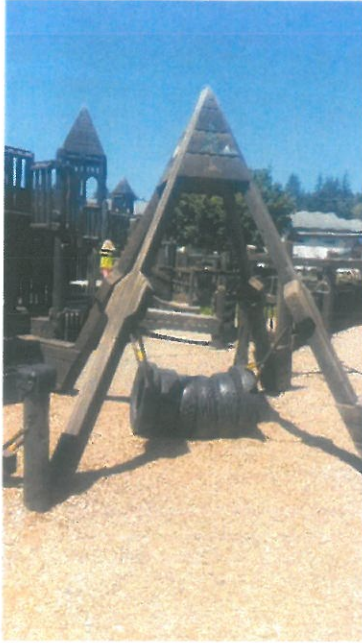
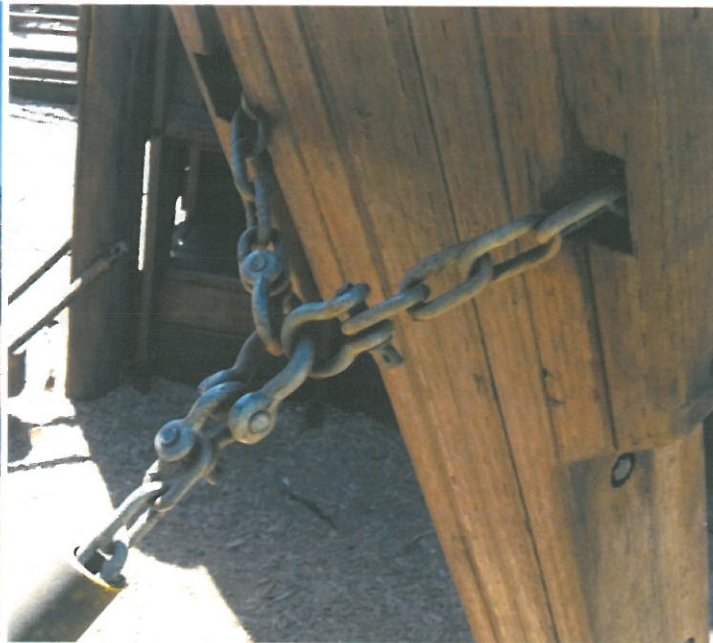
The "tire horse" is worn and has had many repairs

Replace with new age appropriate custom designed equipment to increase accessibility

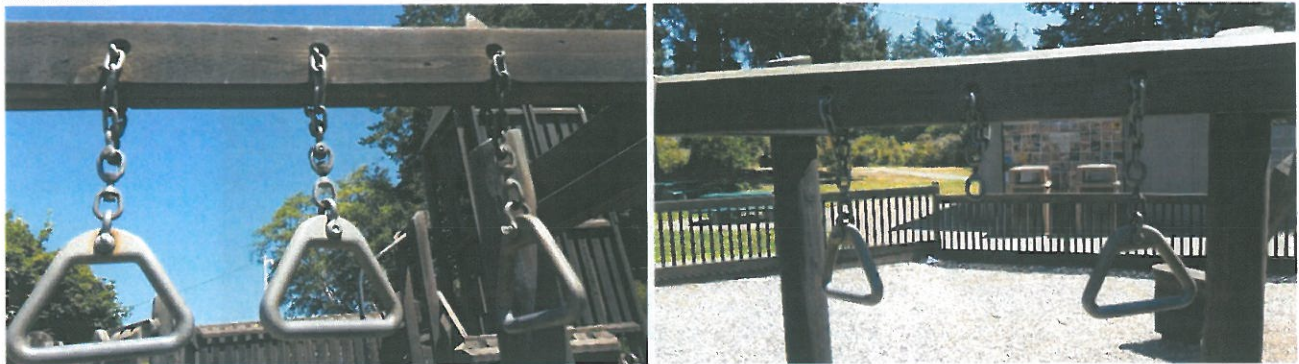
Some parts are missing.

Wood is showing its age and is very worn.

Replace with new low maintenance overhead equipment

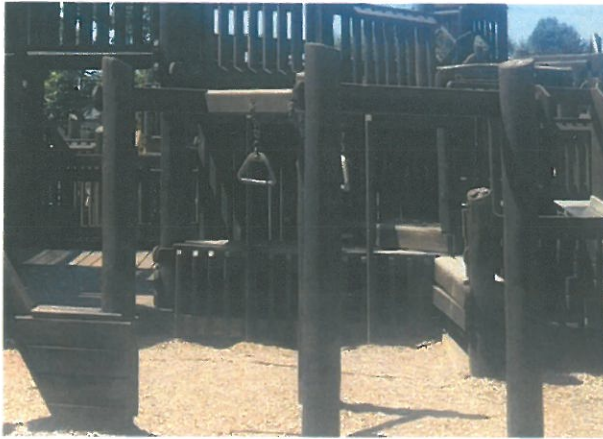
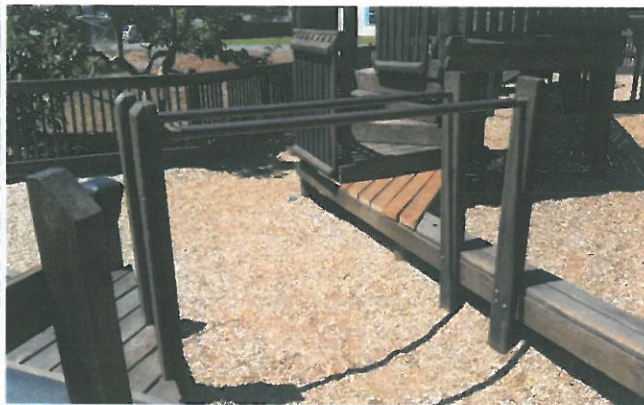
Wood is showing its age and is very worn.

Replace with new low maintenance accessible ladder & rings

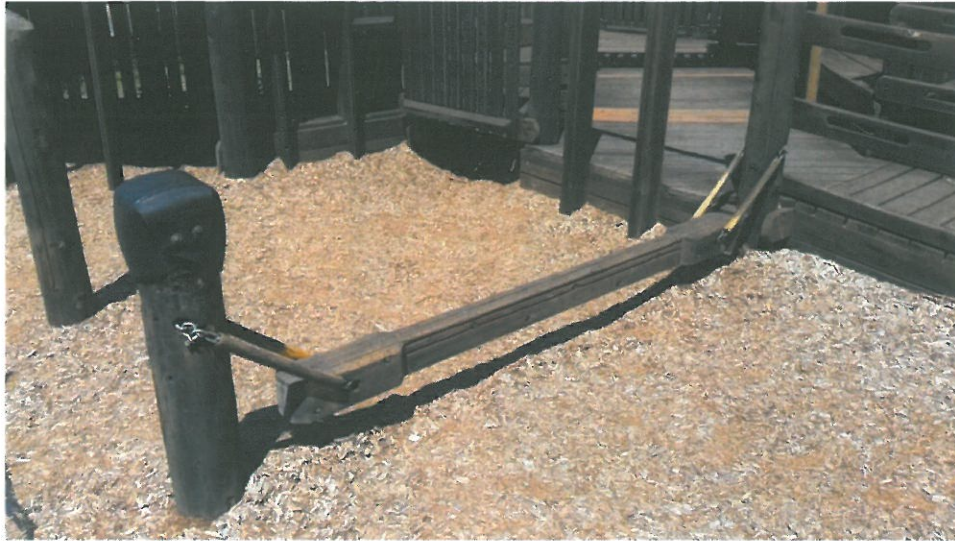
This piece of equipment is worn

Rebuild using structural plastic materials, possibly add springs for some movement to the piece.

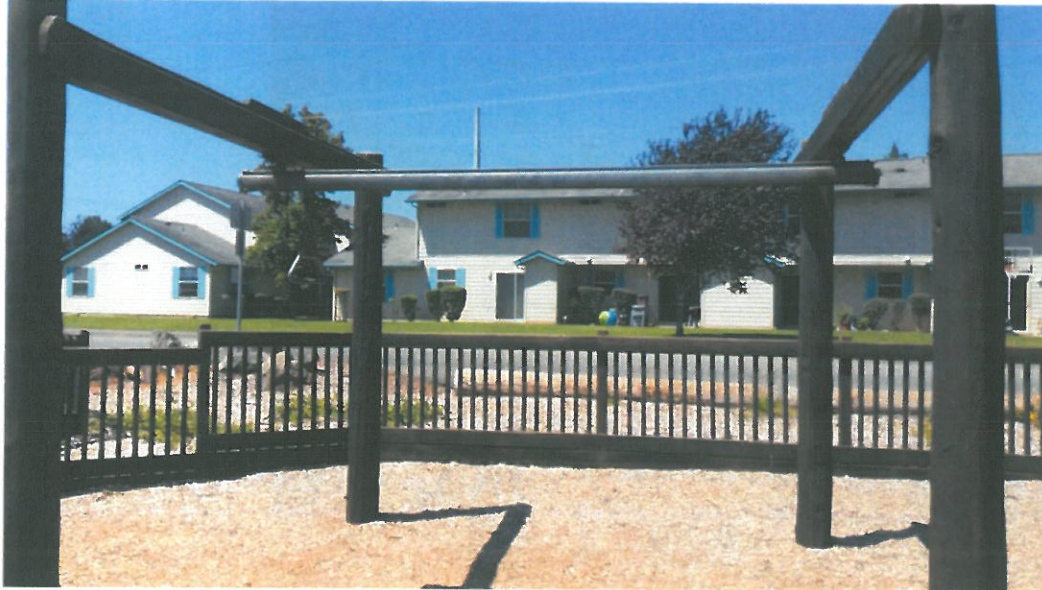
This equipment is worn, and no longer recommended

Redesign this area with new equipment that is more accessible

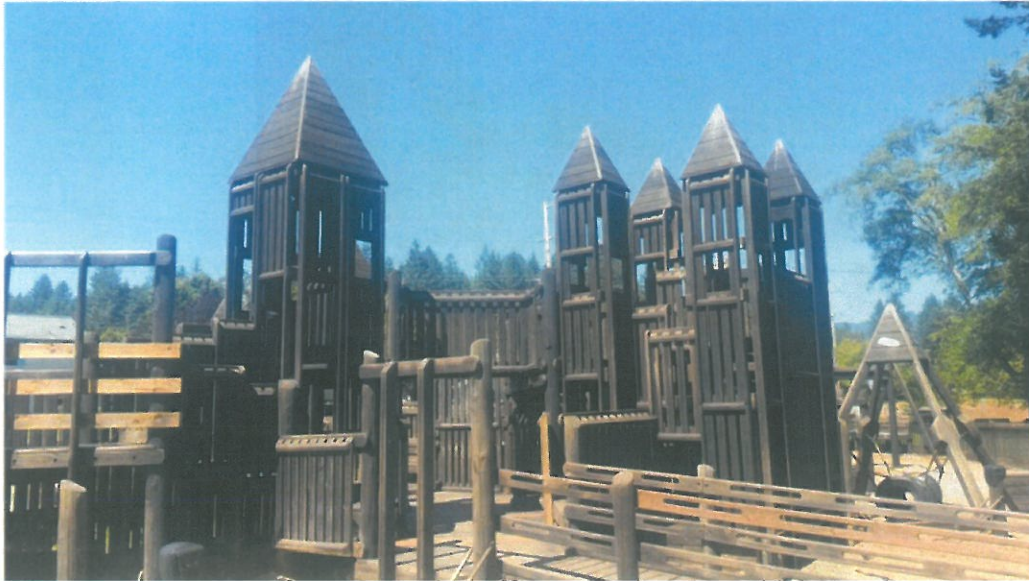
The pressure treated lumber is worn

Replace with structural plastic and composite cones as needed

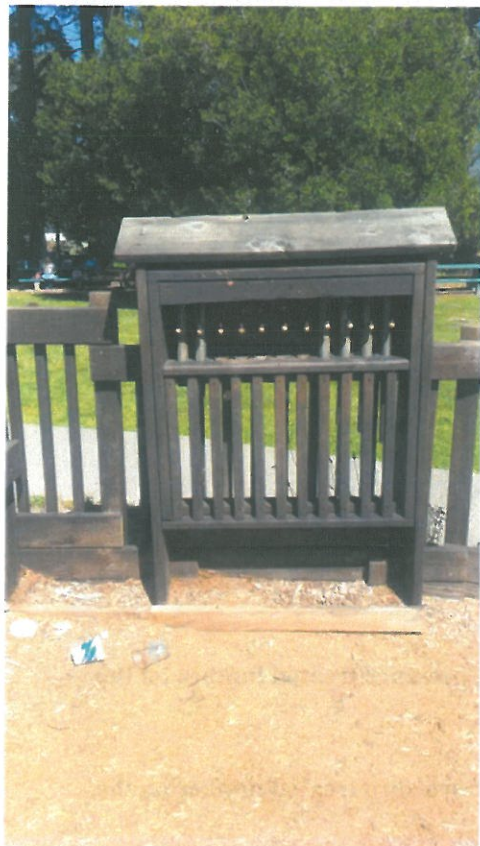
Pipes are missing

Rebuild using structural plastic

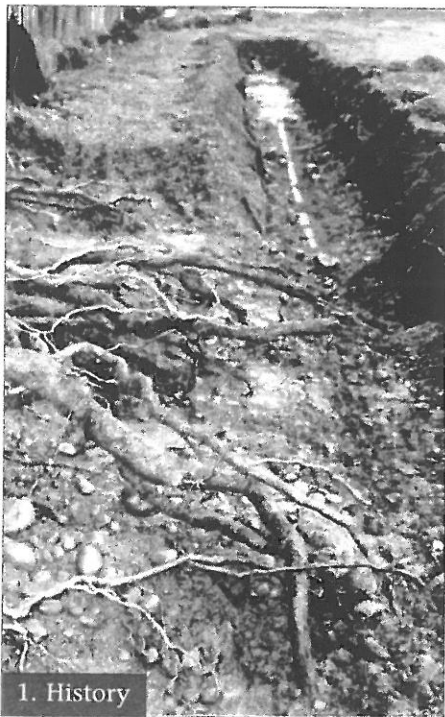
1. History

1. History. Past tree care and circumstances can affect the health of your trees. Construction, trenches, and tree topping can all have adverse effects on your tree. If roots have been cut or disturbed, the tree may become unstable.

(Bottom Left) Trenching in the critical root zone can cut anchoring roots and increase blow down risk.

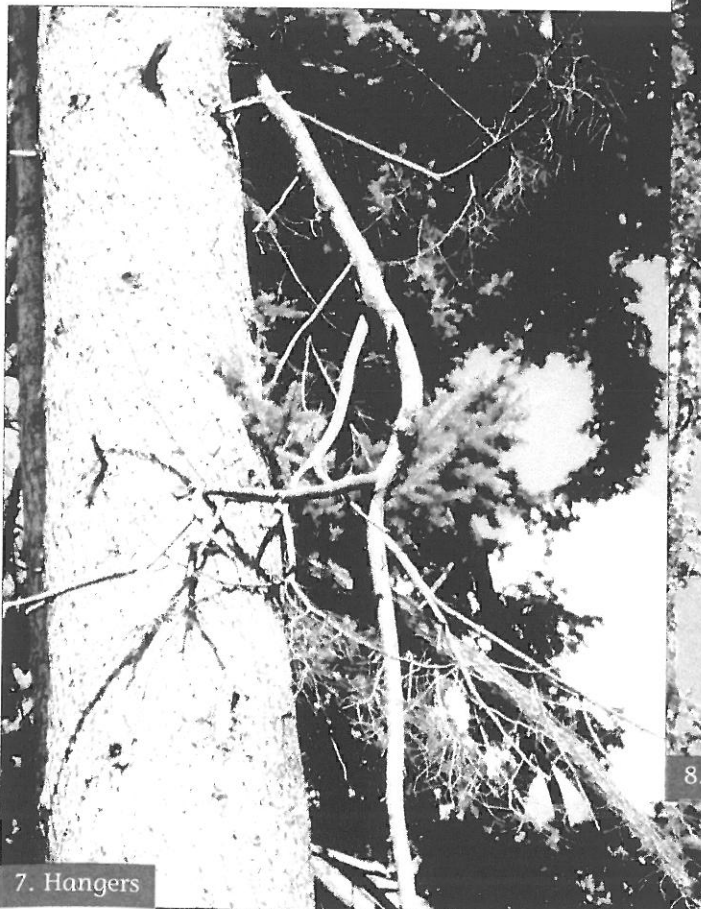
8. Deadwood

**8. Deadwood.** Deadwood, or dead branches, are a normal part of a tree's growth pattern but will eventually fall. Branches over two inches in diameter can cause serious damage when they fall. Removal of all deadwood may not be critical, but deadwood should not be ignored.

(Center) Deadwood in this tree should be removed before failure occurs.

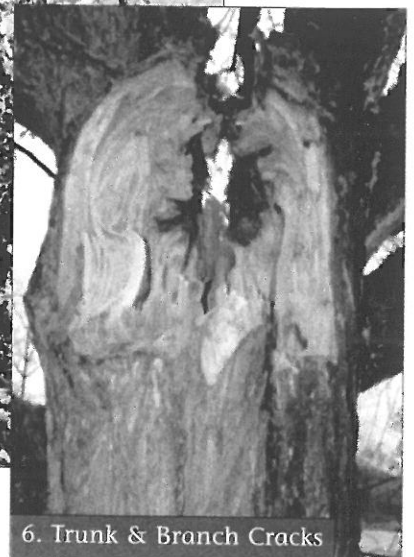
6. Trunk & Branch Cracks

**6. Trunk & Branch Cracks.** Inspect the trunk and large branches for cracks. Deep, large cracks indicate structural weakness in the tree and need careful evaluation.

(Bottom Right) Trunk cracks are not always obvious as in this tree. Be sure to inspect both the trunk and large branches
