TL-F-6

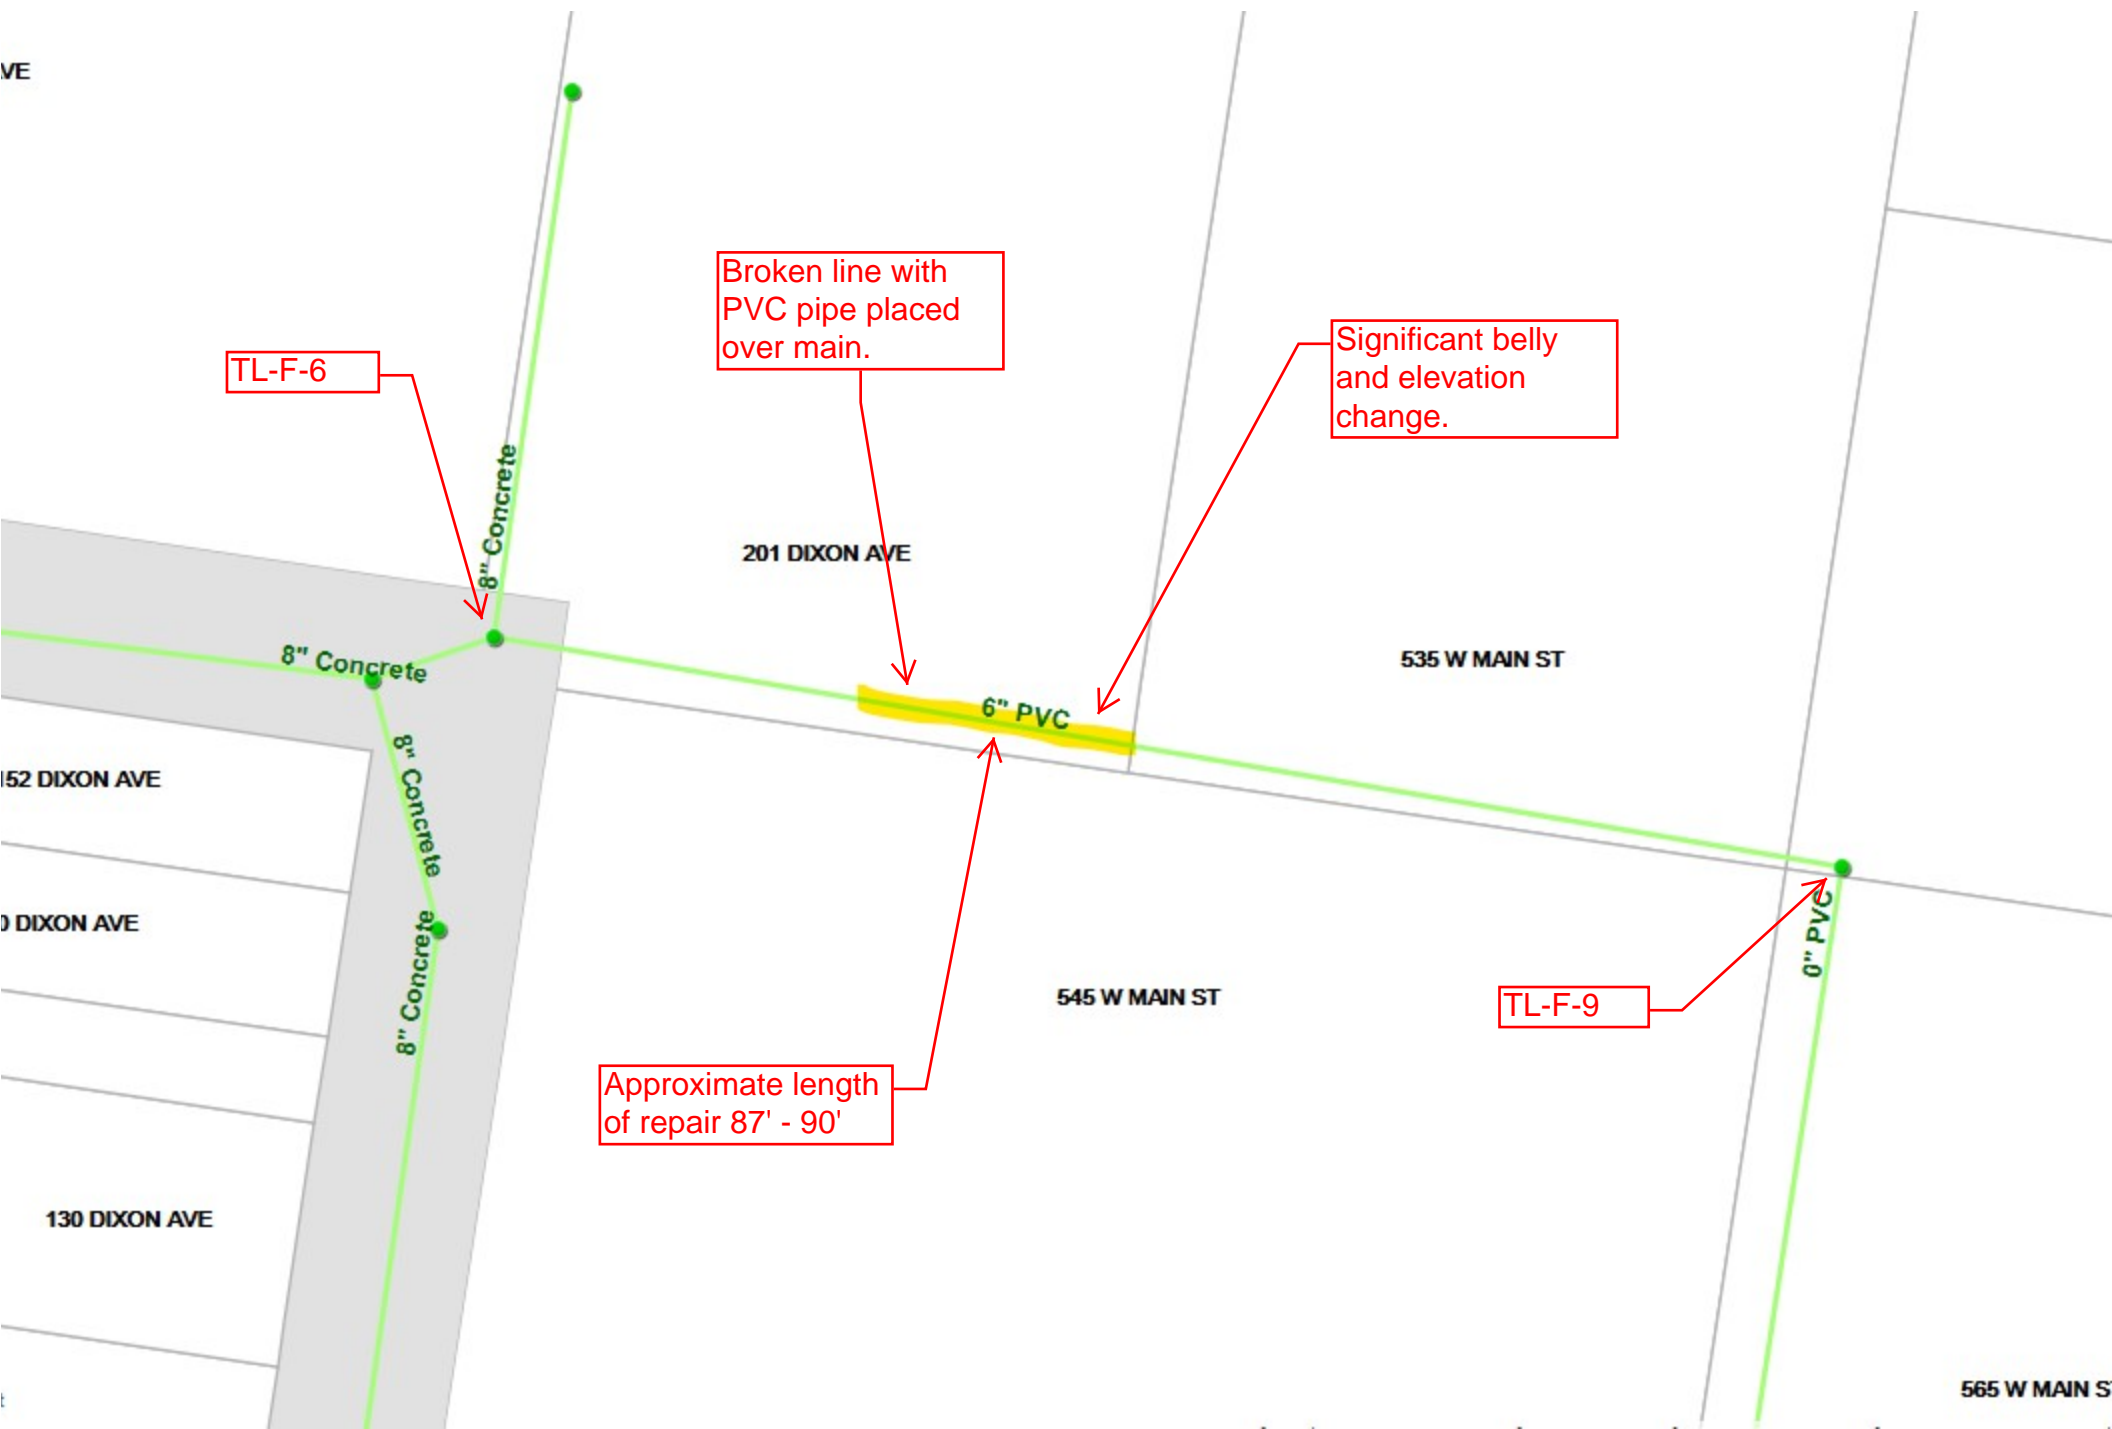
Broken line with  
PVC pipe placed  
over main.

Significant belly  
and elevation  
change.

Approximate length  
of repair 87' - 90'
