RISK EVALUATION REPORT

Galvanizers Company
2406 NW 30th Avenue
Portland, Oregon
DEQ ECSI No. 1196

For
Galvanizers Company and the Oregon Department of Environmental Quality
November 22, 2023

Project: Galvanizer-1-02-03

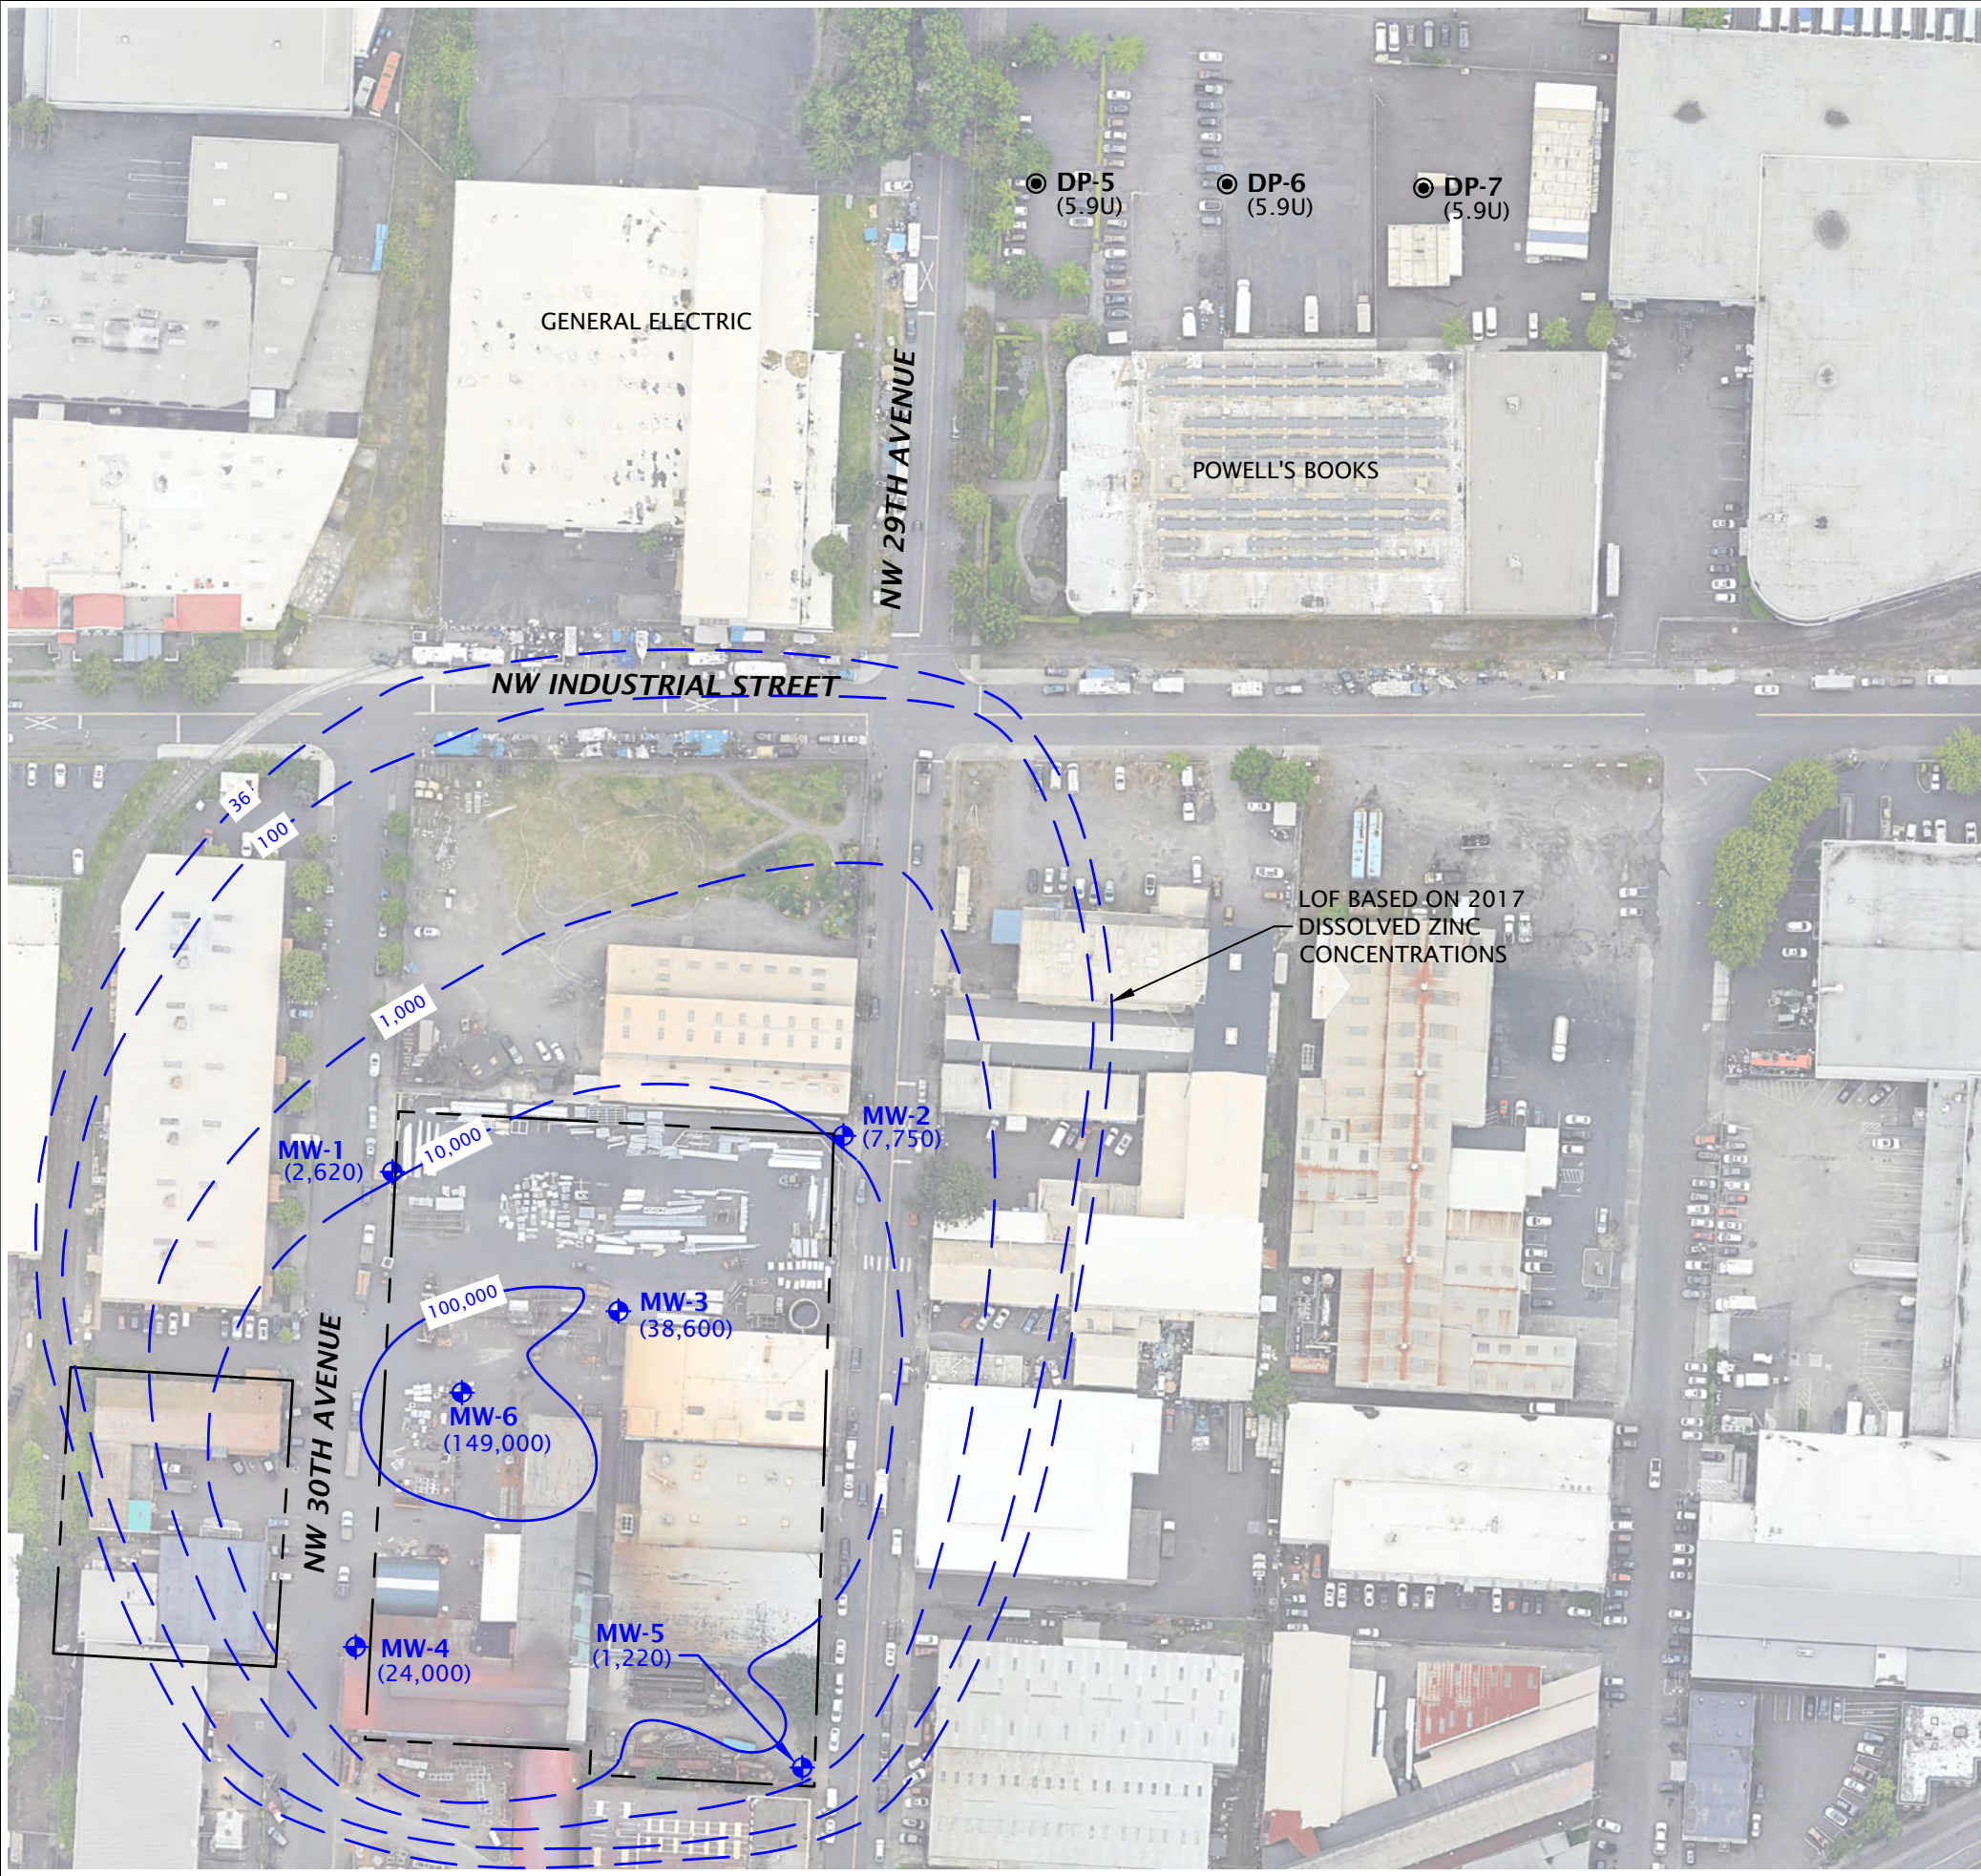
1. ANALYTICAL RESULTS SHOWN ARE FOR GROUNDWATER SAMPLES COLLECTED ON SEPTEMBER 25 AND 26, 2017.
2. CONTOUR INTERVAL: LOGARITHMIC

The distribution and transport of zinc in groundwater and soil are dependent on the species of zinc present and the characteristics of the environment. The solubility of zinc is a function of pH. Lower pH values tend to increase the solubility of zinc allowing for greater concentrations of zinc in groundwater. As pH increases closer to neutral (7.0), zinc tends to sorb to soil particles. Groundwater data indicate that on-site groundwater exhibits pH between 3.84 and 6.77. With more acidic conditions on site, elevated zinc concentrations in groundwater are observed. However, zinc concentrations in groundwater significantly decrease as natural buffering conditions neutralize the groundwater, decreasing the solubility of zinc and groundwater. This was demonstrated through fate and transport modeling (GeoDesign, 2017) and off site, downgradient groundwater sampling (GeoDesign, 2018).
