# Draft Stormwater System Decommissioning Work Plan

Tax Lots 500 and 600, North Central Avenue  
and Rossanley Drive, Medford, Oregon

ECSI Site Identification Number 537

Project No. M1419.14.007

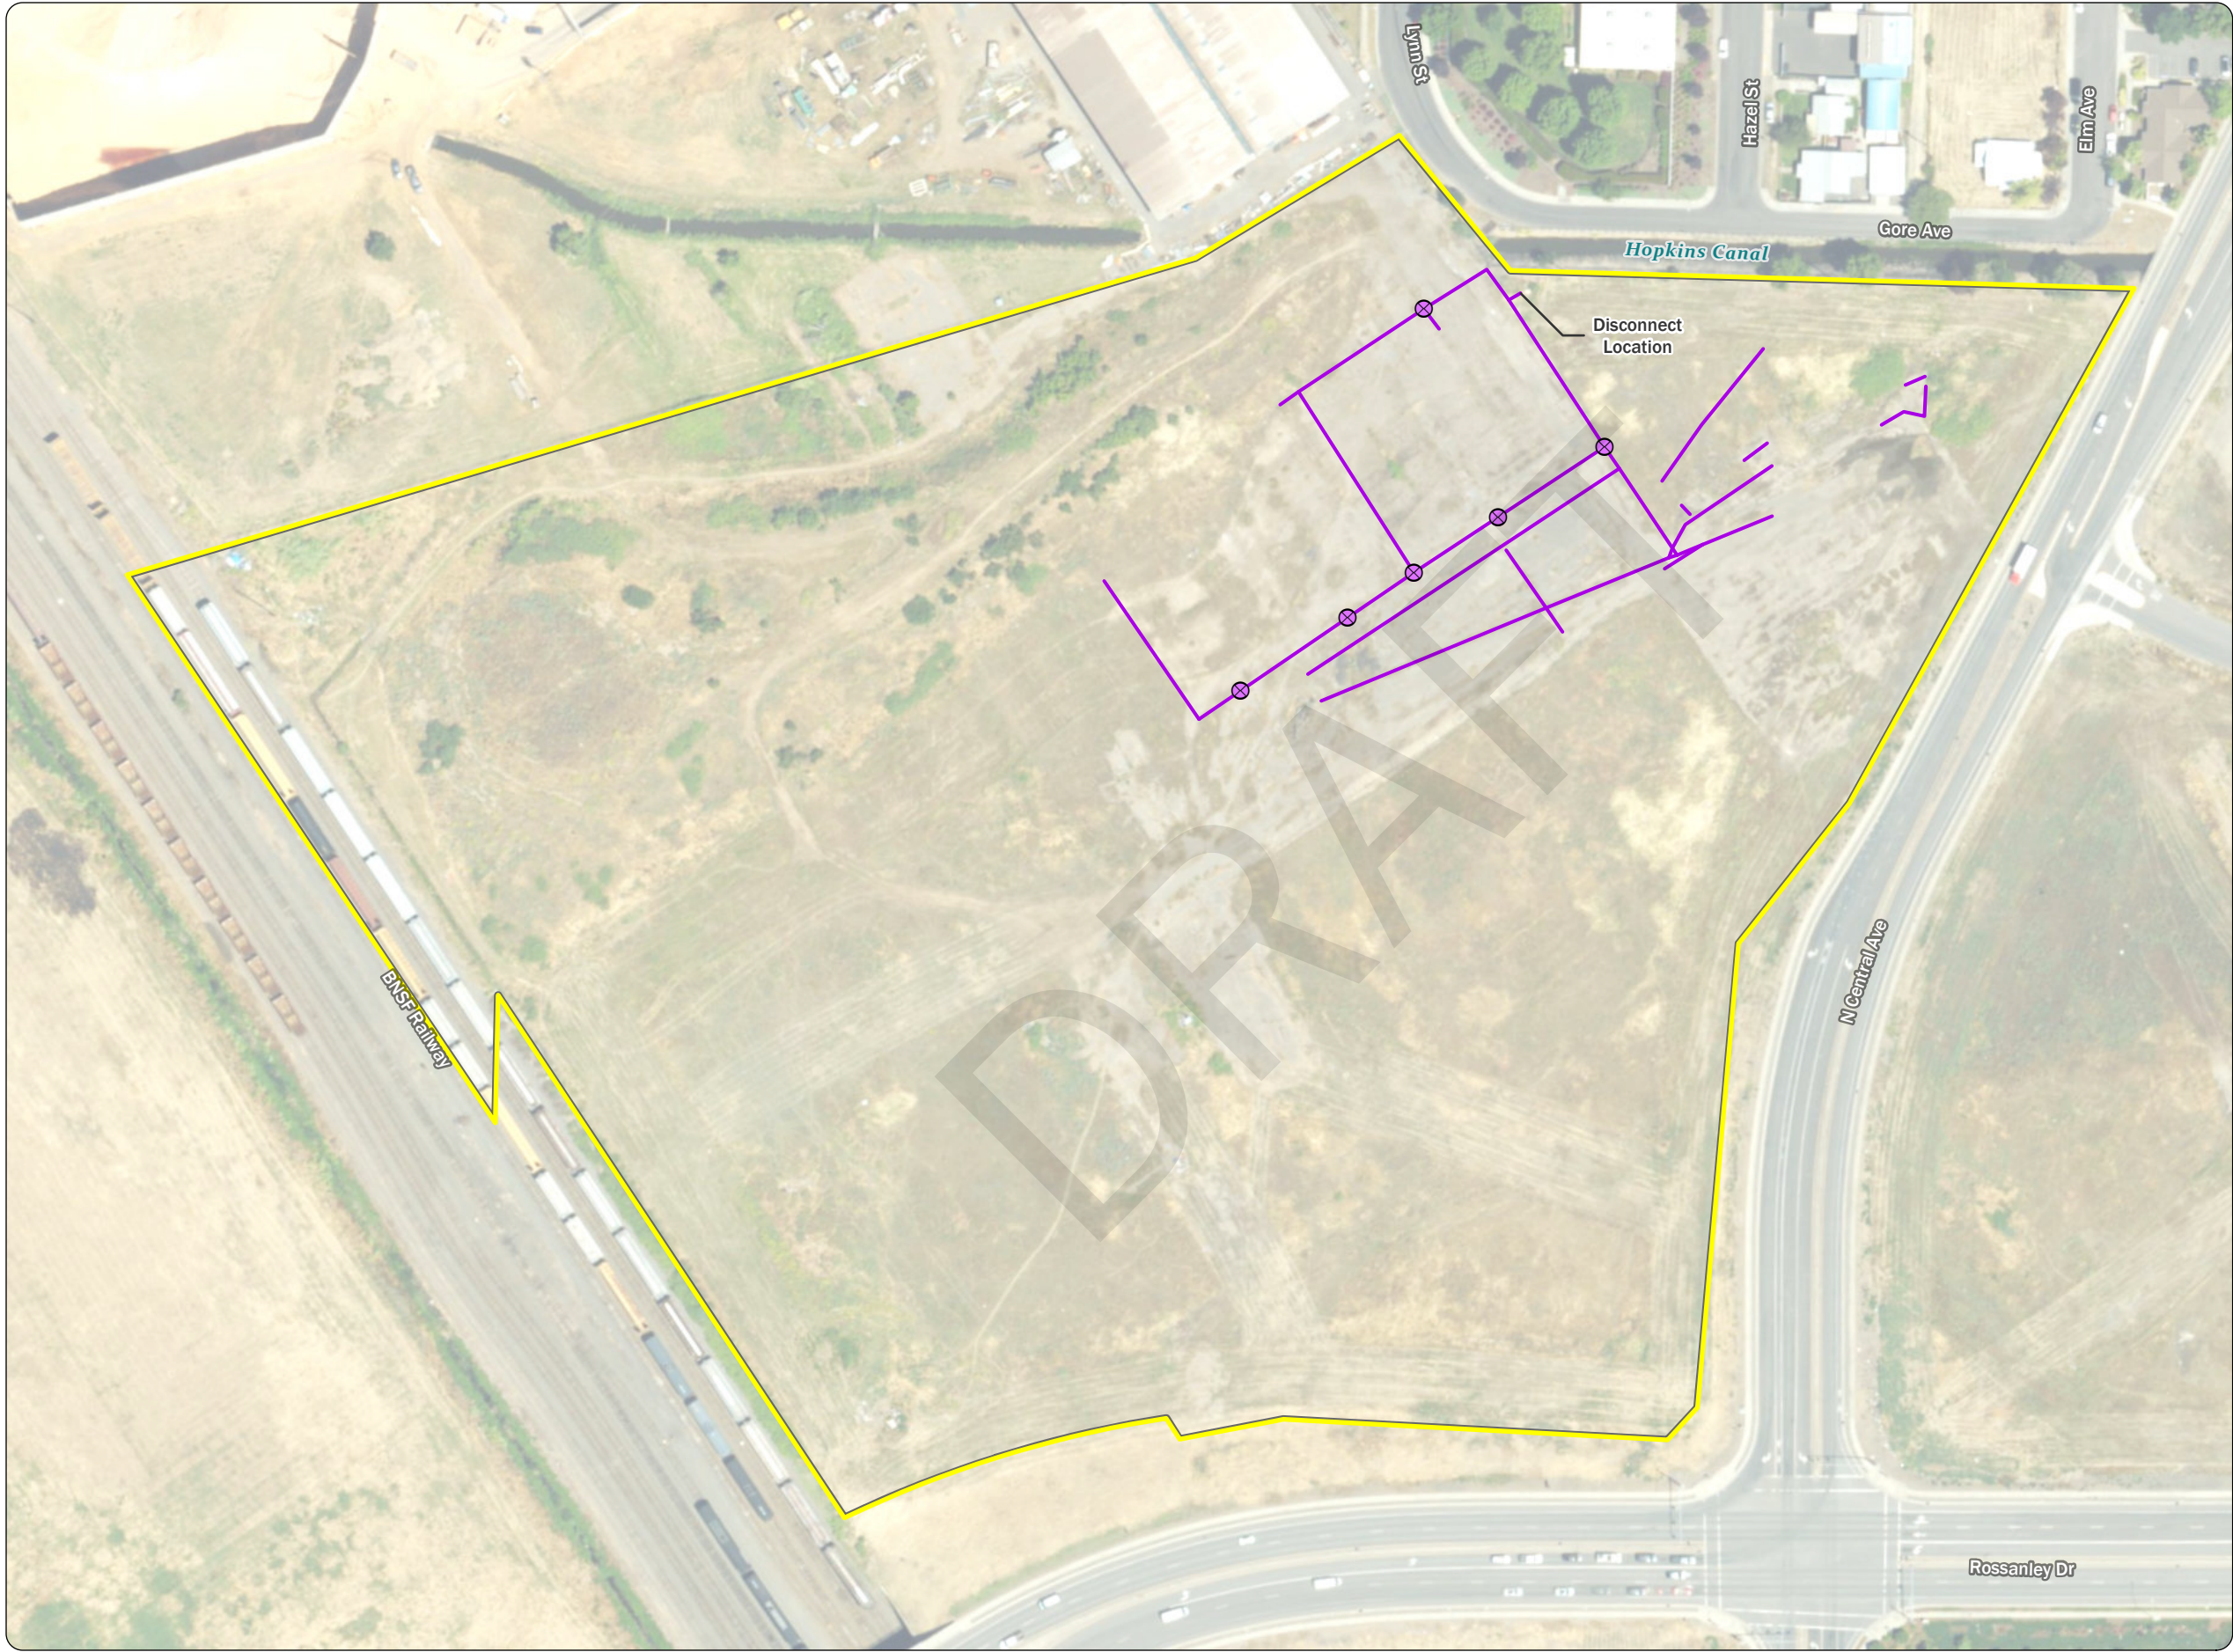
**Figure 2-1**  
**Potential Stormwater**  
**System Extent**

**Note**  
All utility feature locations are approximate. Utility features have been identified using a magnetometer and may not reflect stormwater system piping. Stormwater pipes and manholes or catch basins not depicted on this figure may be present on the property.

In May of 2022, MFA subcontracted a camera scope to evaluate the extent and condition of the stormwater system on the Property. The location of the discharge point for the remaining stormwater system is tentatively confirmed and appears to have been discharged to the Hopkins Canal on the northern end of the Property. Portions of the stormwater system that were observed during the camera scope survey were intact (offsets notwithstanding); however, it was infeasible to survey the entire system due to blockages at assumed catch basin connection points, likely caused by site grading of surface soils during previous activities on the Property. Portions of the stormwater system not accessible for survey may have been removed, disconnected, or damaged during demolition. A magnetometer survey of select portions of the Property was also conducted.

The extent of the system surveyed is depicted on Figure 2-1 and may not represent all remaining portions of the system.

An initial step to physical decommissioning activities shall be to advance an excavation at the furthest identifiable downgradient point of the stormwater system, and the stormwater pipe will be decommissioned with non-shrink grout at that location per the procedure described below; thereby preventing any off-site mobilization of stormwater or sediment (see “Disconnect Location” on Figure 2-1).
