Interim Remedial Action Measures Work Plan

Permapost Products, Inc., Hillsboro, Oregon,
ECSI #148

Project No. M8012.01.001

Maul Foster & Alongi, Inc.

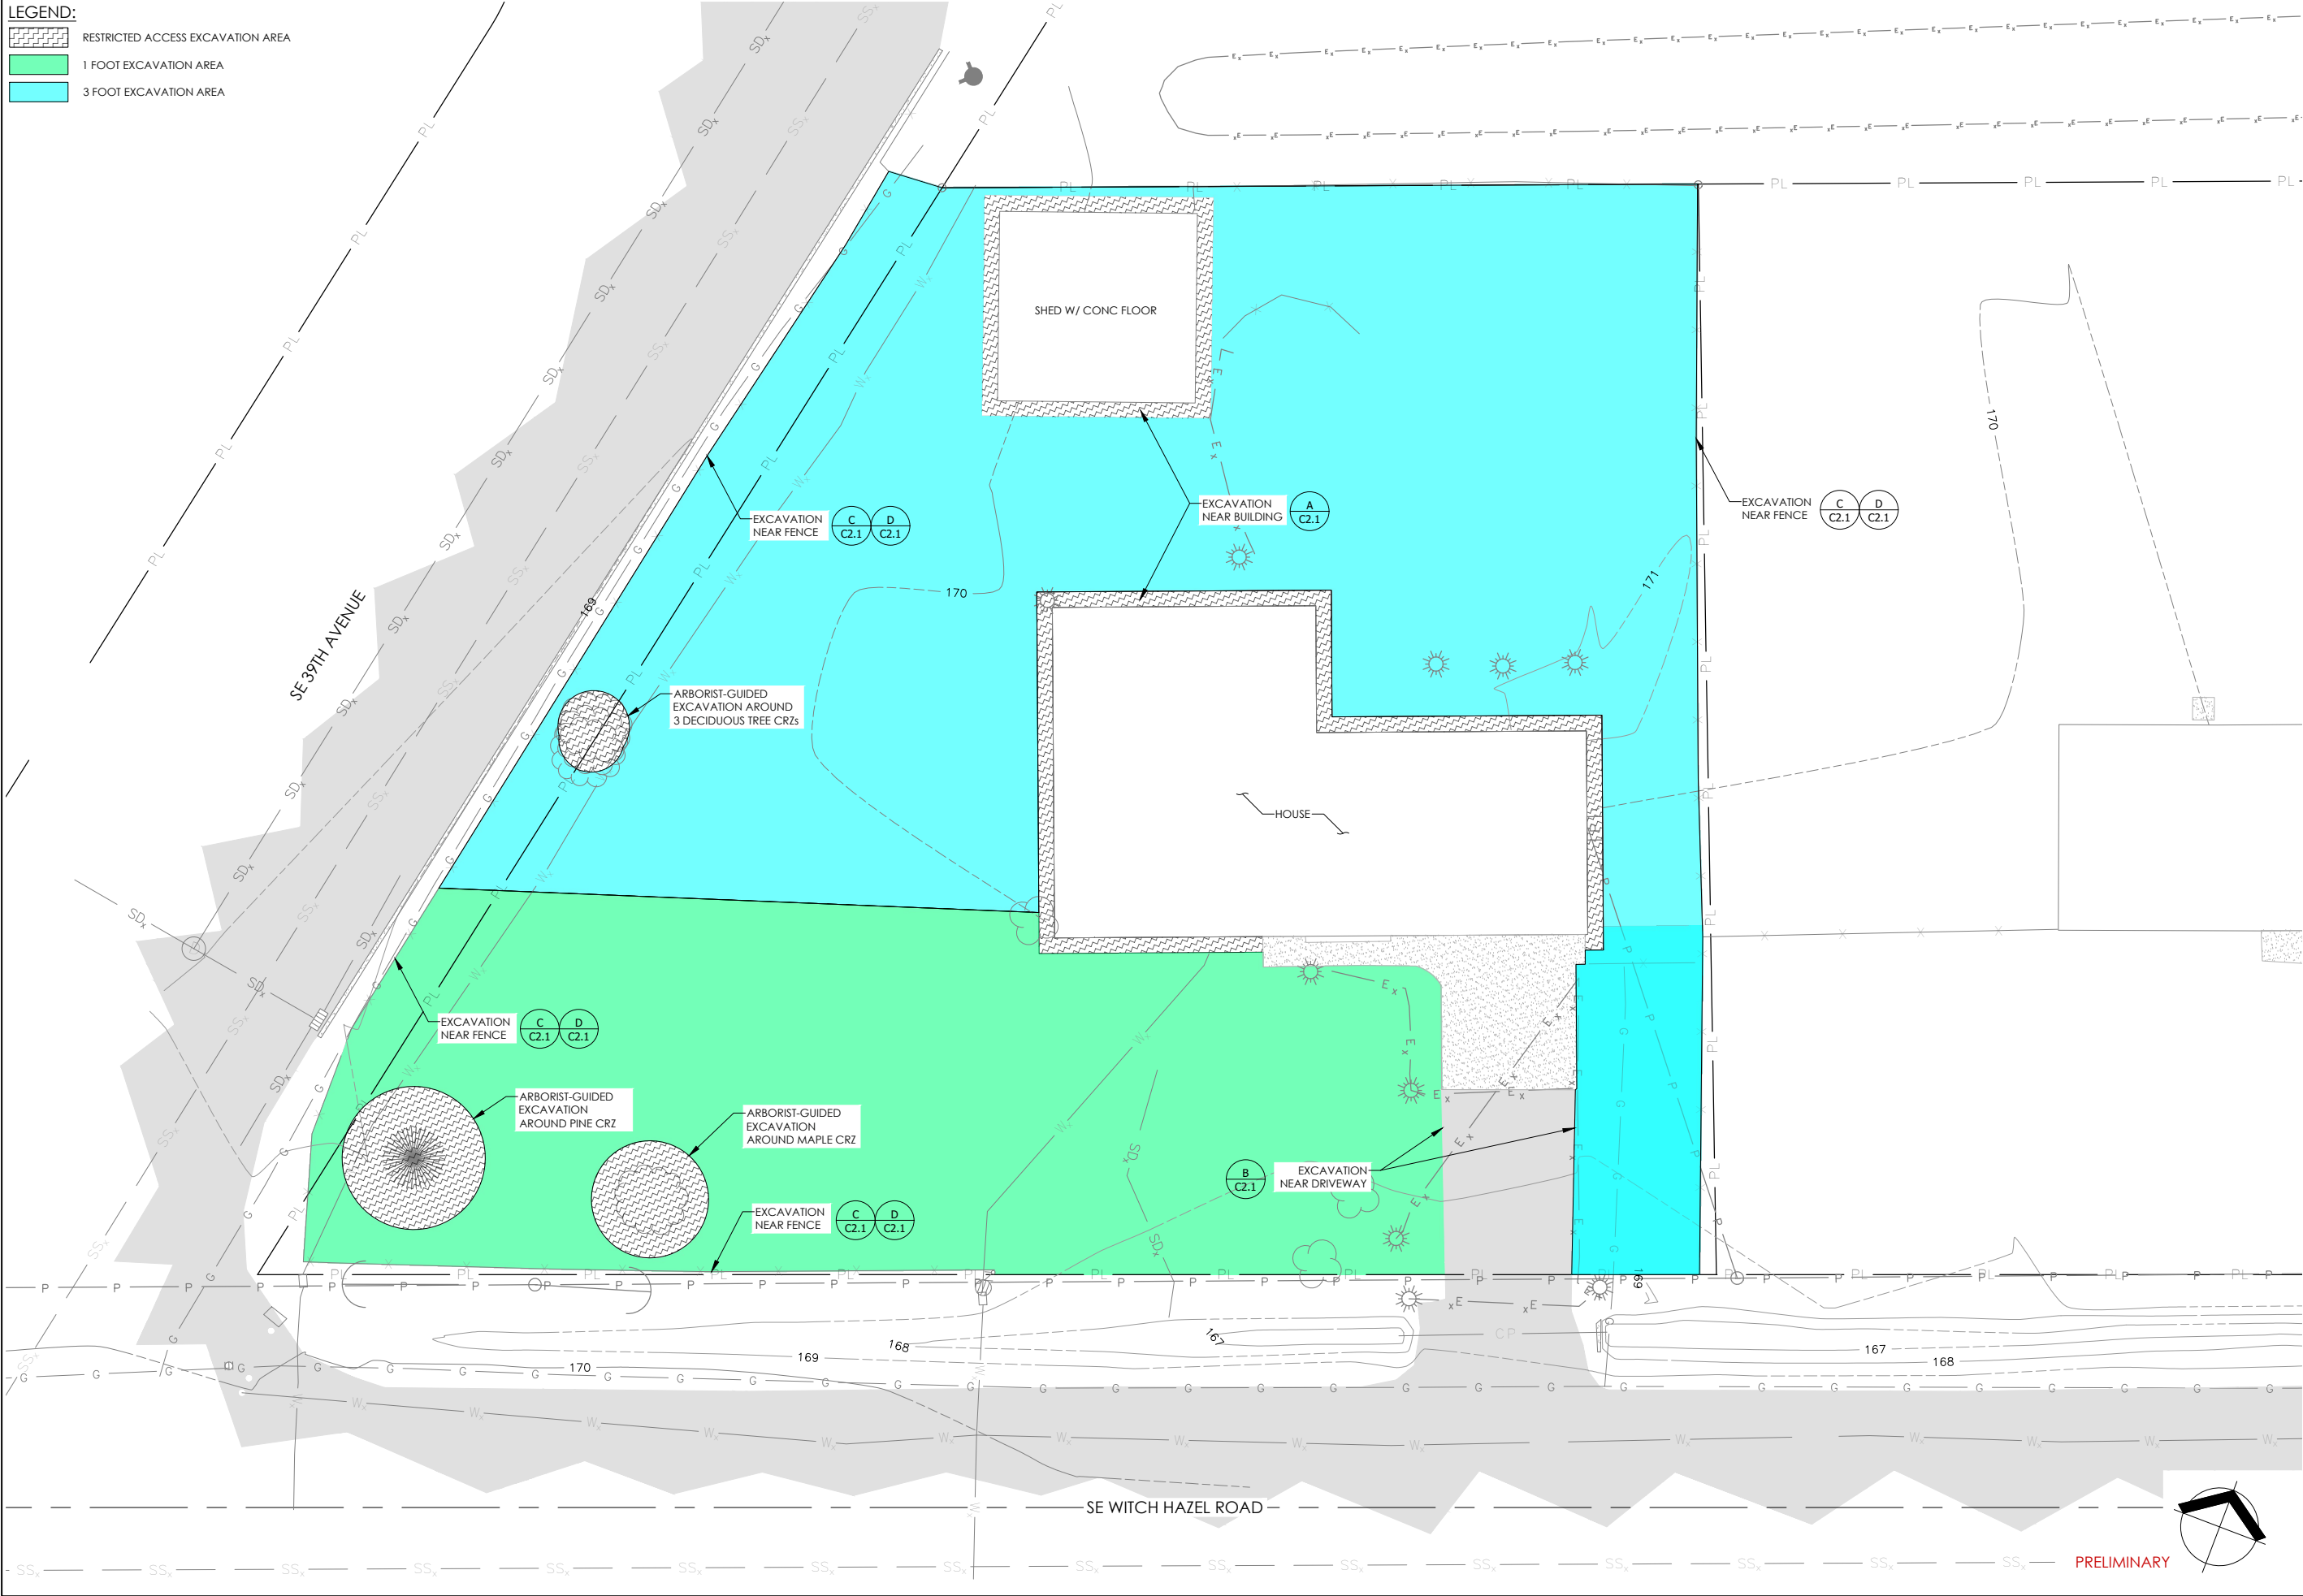
REMEDATION PLAN
SHEET
C2.0

3 FOOT EXCAVATION AREA
