# **STORMWATER SOURCE CONTROL EVALUATION REPORT – FINAL UPDATE**

## **Terminal 4 Slip 3**

#### **Port of Portland**

#### **Geosyntec Consultants, Inc.**

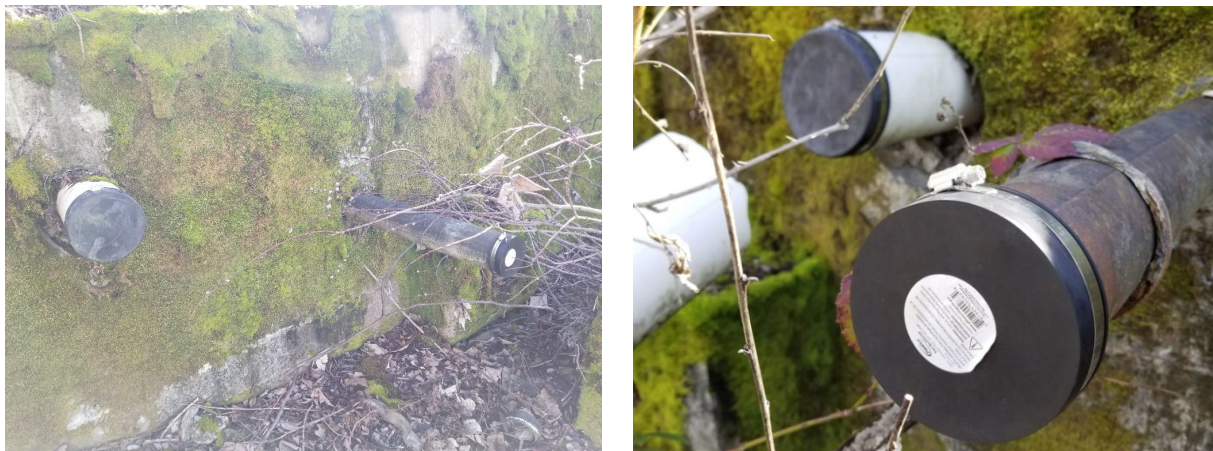
**Figure 7. Basin D Stormwater SCMs (left: capped outfall STSOUT262 and STSOUT001057; right: capped outfall STSOUT263)**

As described in the 2021 SER, all five minor outfalls from Basin D to Slip 3 were cut at the slip bulkhead wall and capped on January 20, 2021 (Figure 7; Geosyntec, 2021). These five outfalls and associated infrastructure are expected to be fully removed in conjunction with future redevelopment. No notable ponding has been observed in the area since the outfalls were capped.

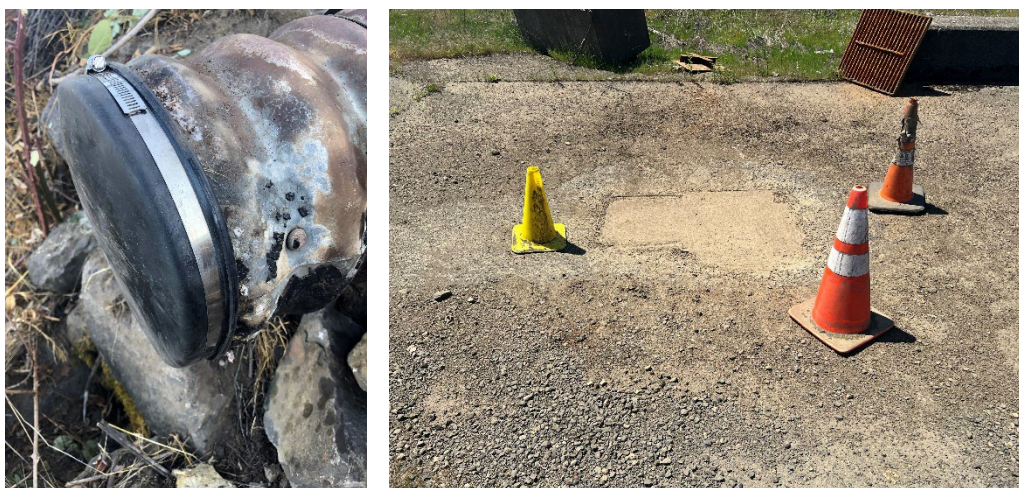
**Figure 8. Basin J Stormwater SCMs (left: capped outfall; right: decommissioned catch basin)**

No discharge was observed from the Basin J outfall during four storm events in 2020. The Port capped the outfall on August 31, 2021 (Geosyntec, 2021). Following the 2021 report the Port conducted additional investigations which identified a single remaining catch basin in Basin J. This catch basin was decommissioned in May 2023. No ponding issues have been observed

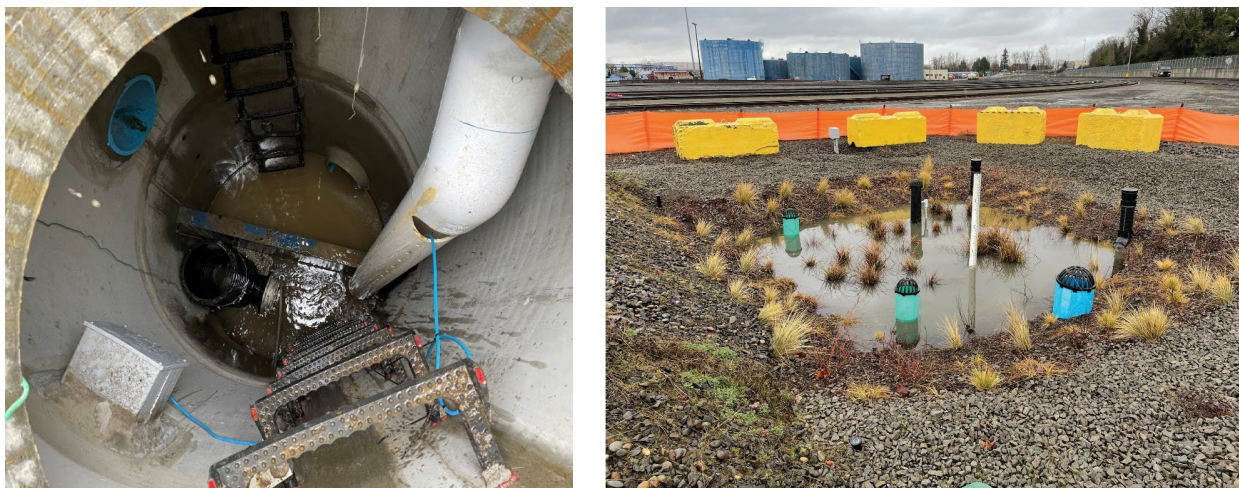
**Figure 9. Basin K1 Stormwater SCMs (left: diversion manhole with pump; right: bioinfiltration basin)**

A permanent stormwater SCM for Basin K1 was constructed in 2021. This SCM consists of a pump station that diverts runoff from Basin K1 up to at least the 1200-Z Tier 2 storm (half of the 2-year storm) to a bioinfiltration basin for treatment and infiltration (Figure 9). The performance of the SCM has been verified and documented since it was constructed, including in the most recent report, the Basin K1 Bioinfiltration Basin Operational Year 2 Comprehensive Report (MFA, 2022), approved by DEQ on 26 February 2024. The report concludes that, based on data collected to date, the bioinfiltration basin is operating as designed. The O&M Plan will continue to be followed, including reporting to DEQ.

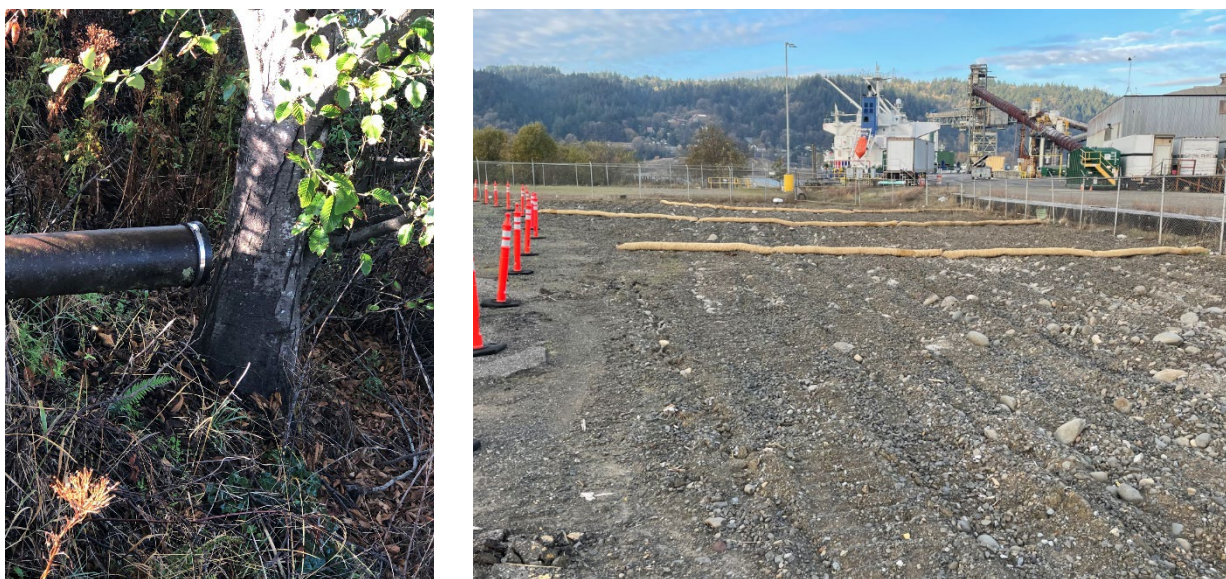
**Figure 10. Basin K2 Stormwater SCMs (left: capped Basin K2 outfall; right: scarified surface and wattles)**

The 2021 Stormwater Evaluation Report (Geosyntec, 2021) documented that there was no discharge observed from the Basin K2 outfall during four storm events in 2020 which ranged from 0.8 inches to 1.12 inches, indicating the outfall is not active. The Port capped the outfall on August 31, 2021 (Geosyntec, 2021). No upstream infrastructure is known to be connected to the Basin K2 outfall.

An additional catch basin which was previously thought to be part of Basin K2 was found to be connected to Basin K1 in late 2021. It was plugged on January 13, 2022. The Port implemented additional SCMs to control ponding observed during larger storm events, including grading and scarifying the ground and installing wattles perpendicular to the slope to promote disperse infiltration. Figure 10 shows photos of the SCMs in Basin K2. No major ponding has been observed in the area since implementation of the SCMs.
