Underground Storage Tank Closure Report
13325 NW Thompson Road
Portland, Oregon 97229
DEQ File #34-24-0611

September 1, 2024

Soil Solutions Environmental Services, Inc.
3540 Southeast 28th Avenue
Portland, Oregon 97202

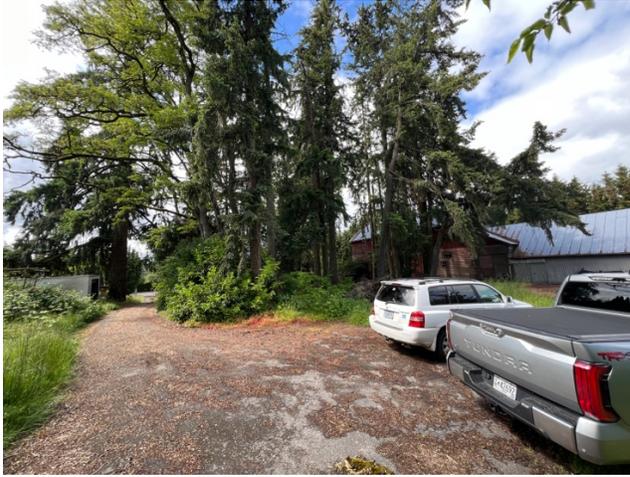
The UST was used as a farm tank, and likely contained gasoline. The UST was located approximately 150-ft north of NW Thompson Road, east of the driveway to 13355 NW Thompson Road. The UST was located in a barn/garage structure, prior to the building's removal. The approximate UST location is shown on Figure 2. Surrounding properties are mostly rural residential and farm properties. A former irrigation well, located approximately 8-ft east of the tank area, was previously decommissioned. A well log for this well abandonment identified as WASH-82046 is included in Appendix D. Drinking water at the site is supplied by the Tualatin Valley Water District.

Photo 1. UST located in barn structure at the adjacent parcel, (13355 NW Thompson Road). View is to the south.

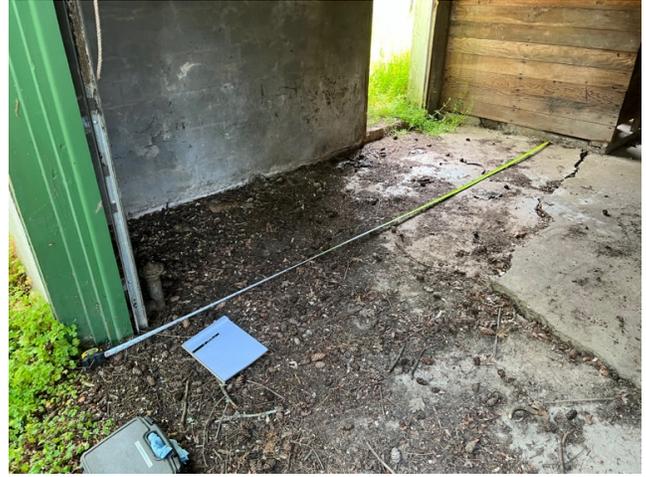
Photo 2. UST location indicated by measuring tape. View is to the northeast.

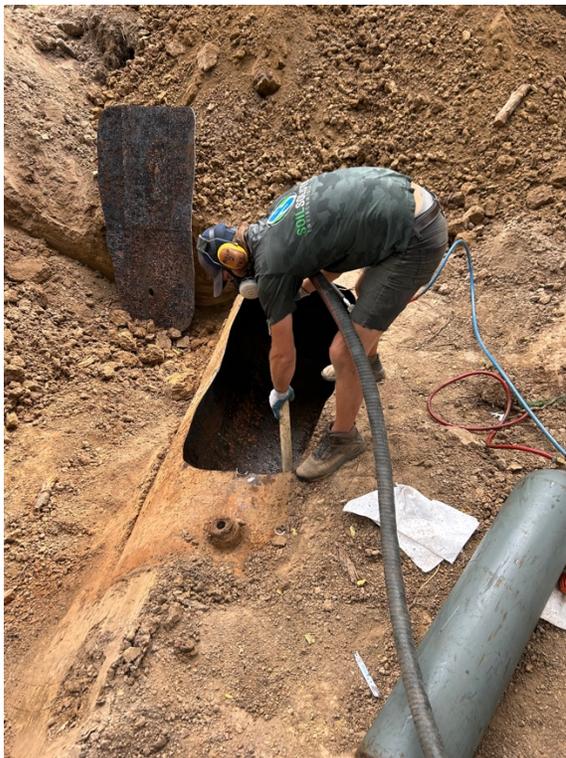
Photo 3. Building was removed, UST was exposed and cut open. View is of the tank area.

On August 21, 2024, SSES exposed, inerted, and cut open the tank. The tank was found to be empty and dry. The interior was thoroughly pressure-washed. The estimated capacity was 575-gallons. The UST appeared corroded with many holes throughout the exterior. The rinse water was consolidated and transported, in bulk, by Oil Re-Refining Company (ORRICO) for proper disposal.

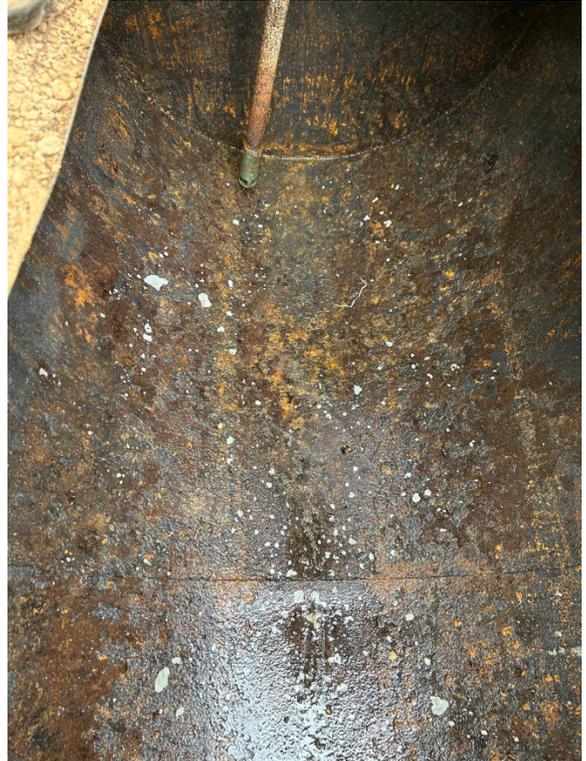
Photo 4. UST contents were removed, and interior was pressure-washed. View is of the tank interior.

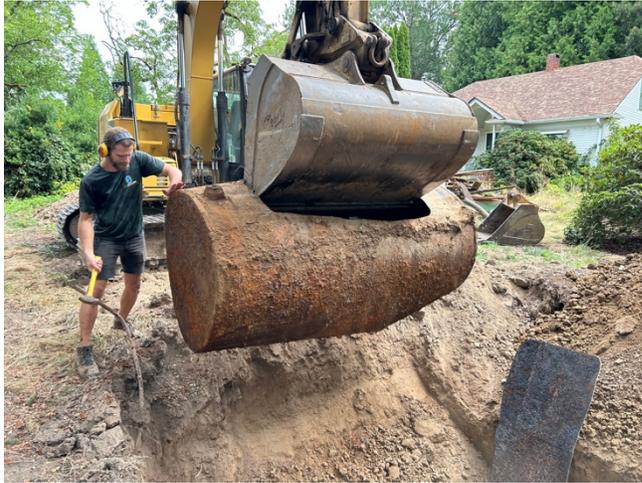
Photo 5. UST was removed from the site. View is to the north.

The entire tank was removed from the ground and transported to SSES for temporary storage. The UST would later be transported, in bulk, to Metro Metals NW.

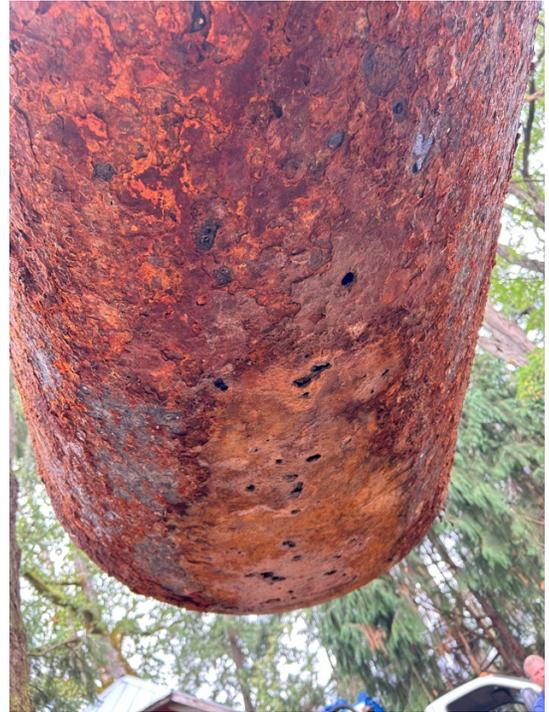
Photo 6. Closeup view of removed UST. Holes were observed throughout the tank.

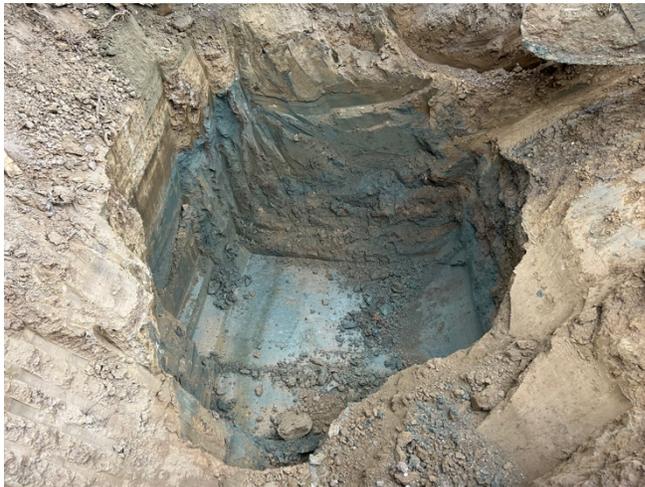
Photo 7. Petroleum-contaminated soil (PCS) was removed from the former tank area. View is to the east.

On August 21, 2024, SSES removed approximately 27.43-tons of petroleum-contaminated soil (PCS) from below the former tank location. Removed PCS was placed directly into a dropbox for disposal at the Waste Management (WM) Hillsboro Landfill. Contaminated soil remained in the excavation.

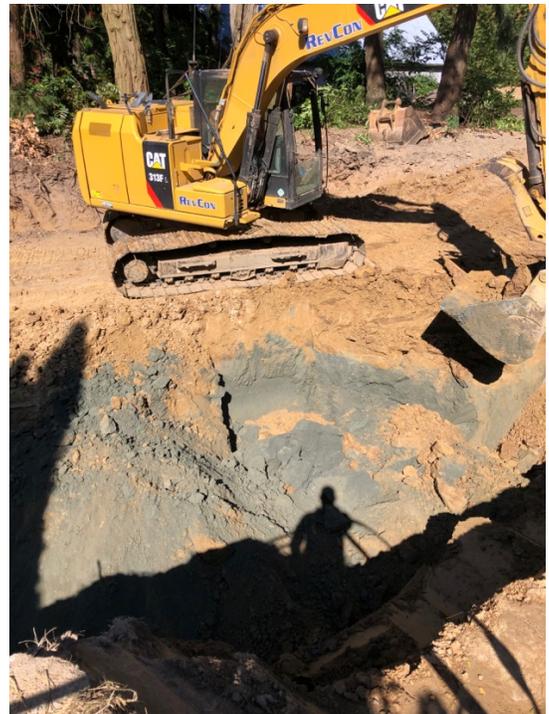
Photo 8. Additional contaminated soil was identified and removed. View is to the northwest.

On August 28, 2024, SSES removed an additional 316.22-tons of PCS west and southwest of the former tank location. SSES collected six soil samples for analysis, designated SG15, SG16, and SG18 through SG21, from the excavation extents. Samples SG15 and SG16, were collected from

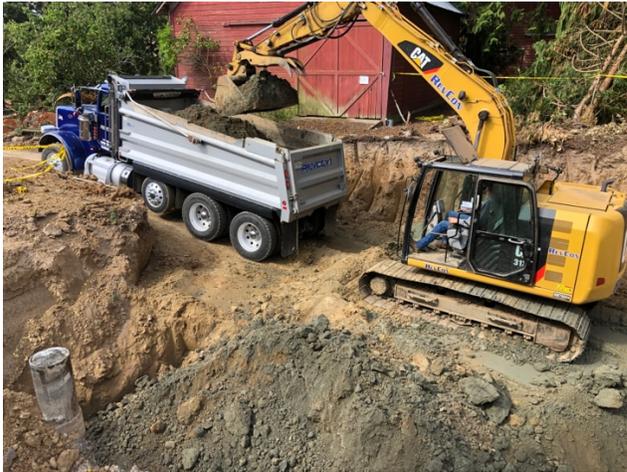
Photo 9. PCS was transported for proper disposal. View is to the southwest.

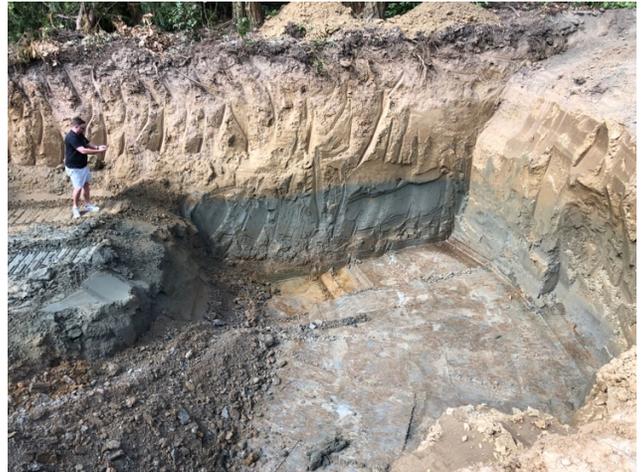
Photo 10. A total of 924.52 tons of PCS was removed and properly disposed.

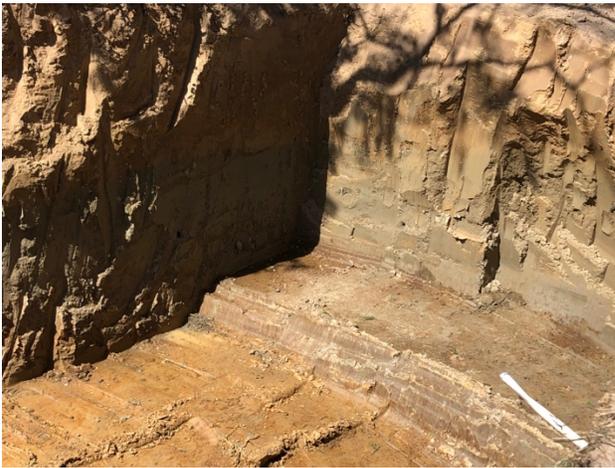
Following removal of PCS, gasoline contaminated soil remained at a maximum concentration of 44 ppm. This was measured in sample SG15, located at 13-ft bgs on the west sidewall of the excavation.

Photo 11. Cleanup confirmation soil samples were collected for analysis. View is of west excavation wall.

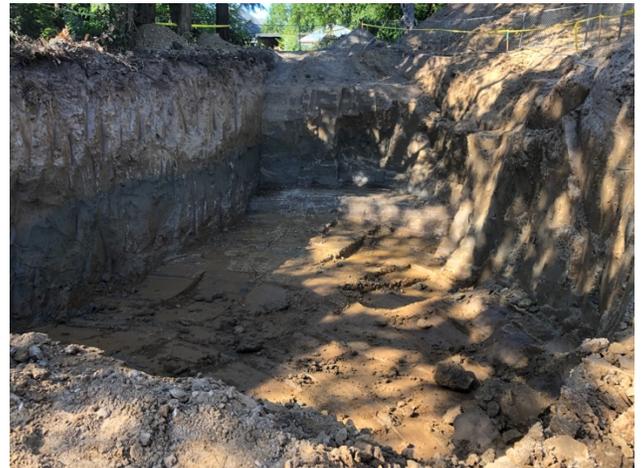
Photo 12. PCS was transported for proper disposal. View is to the north.
