Re: Underground Storage Tank Decommissioning and Remedial Excavation Report  
CVS Pharmacy Store No. 11185  
8145 SE 17<sup>th</sup> Avenue  
Portland, Oregon  
Terracon Project No. 82187157  
LUST ID 26-19-0489

# Underground Storage Tank Decommissioning and Remedial Excavation Report

CVS Pharmacy Store No. 11185  
8145 SE 17th Avenue  
Portland, Oregon  
Terracon Project No. 82187157  
LUST ID 26-19-0489

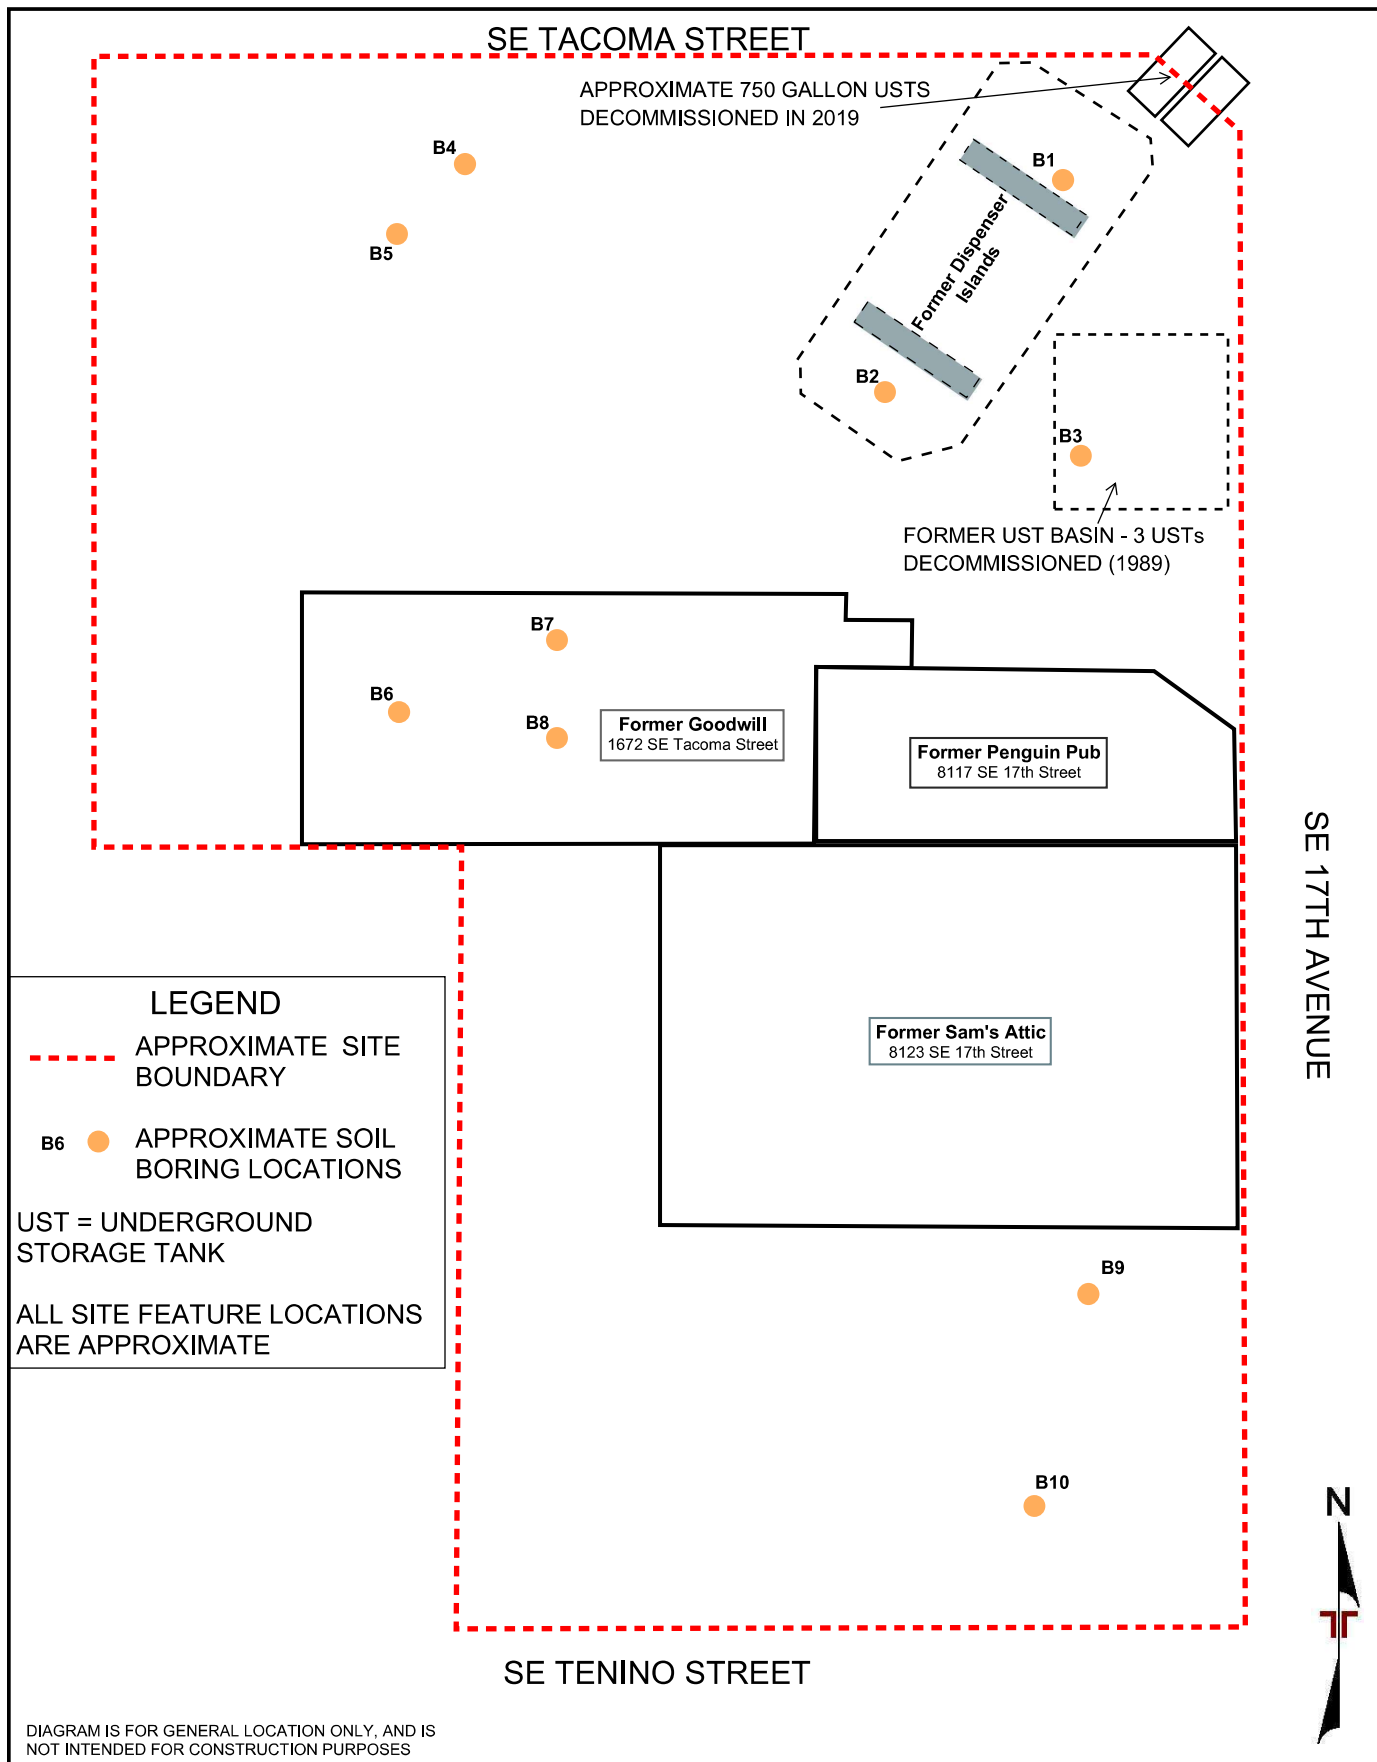
| Project Manager:<br>RJR | Project No.<br>82187157 | <p>700 NE 55th Ave<br/>Portland, OR 97213-3150</p> | <p><b>SITE FEATURE MAPS</b></p> <p><b>CVS Pharmacy Store #11185</b><br/>8145 SE 17th Avenue<br/>Portland, Oregon</p> | Exhibit |

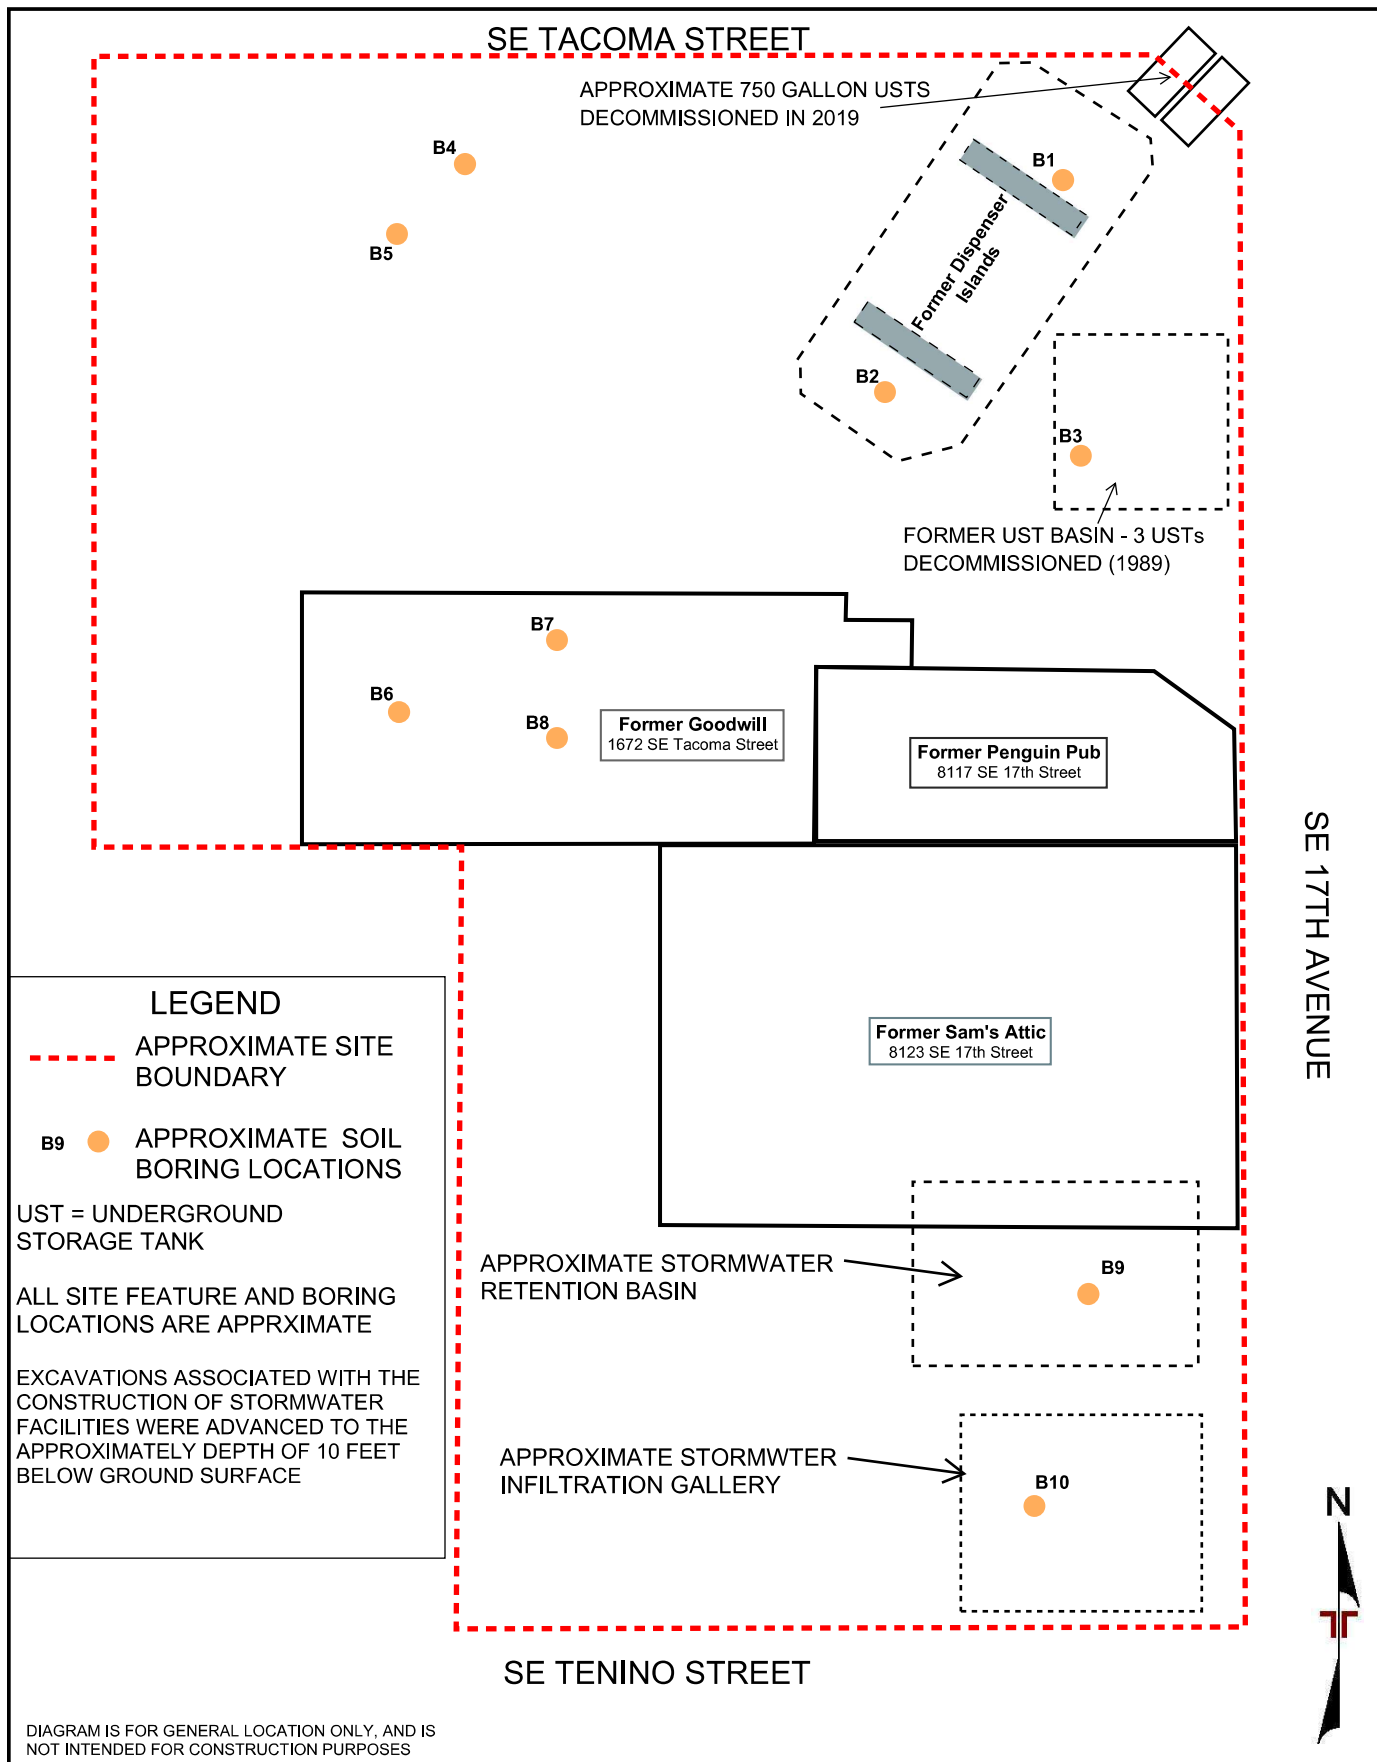
| Drawn by:<br>RJR | Scale:<br>NTS | | <p><b>CVS Pharmacy Store #11185</b><br/>8145 SE 17th Avenue<br/>Portland, Oregon</p> | <p><b>8</b></p> |

| Project Manager:<br>RJR | Project No.<br>82187157 | <p>700 NE 55th Ave<br/>Portland, OR 97213-3150</p> | STORMWATER INFILTRATION GALLERY EXCAVATION AREA | Exhibit |

At the request of the City of Portland, a limited Site investigation (LSI) report was completed in February 2019 to evaluate soil conditions within in the area of a proposed stormwater infiltration gallery (Terracon Project Number 82187157A dated March 20, 2019). Terracon advanced two soil borings in the southern portion of the Site within in the area of the proposed infiltration gallery. Arsenic was detected at a concentration of 3.63 mg/kg, exceeding DEQ RBC for ingestion, dermal contact, and inhalation for occupational receptors, in a shallow soil sample collected from soil boring B-10 at 2.5 feet. During the development of the Site and installation of the infiltration gallery, soils to a depth of approximately 10 feet were excavated and transported off-site for disposal in March 2020. Based on results from additional samples collected from this soil boring (B-10) at depth of 5 to 10 feet and 10 to 15 feet bgs during the LSI in March 2019, in which no detection of arsenic was reported, no confirmation samples were collected following excavation of soils. A Site

plan presented location of the stormwater infiltrations gallery is present in Exhibit 8 in Appendix A. A copy of this report is included in Appendix C.

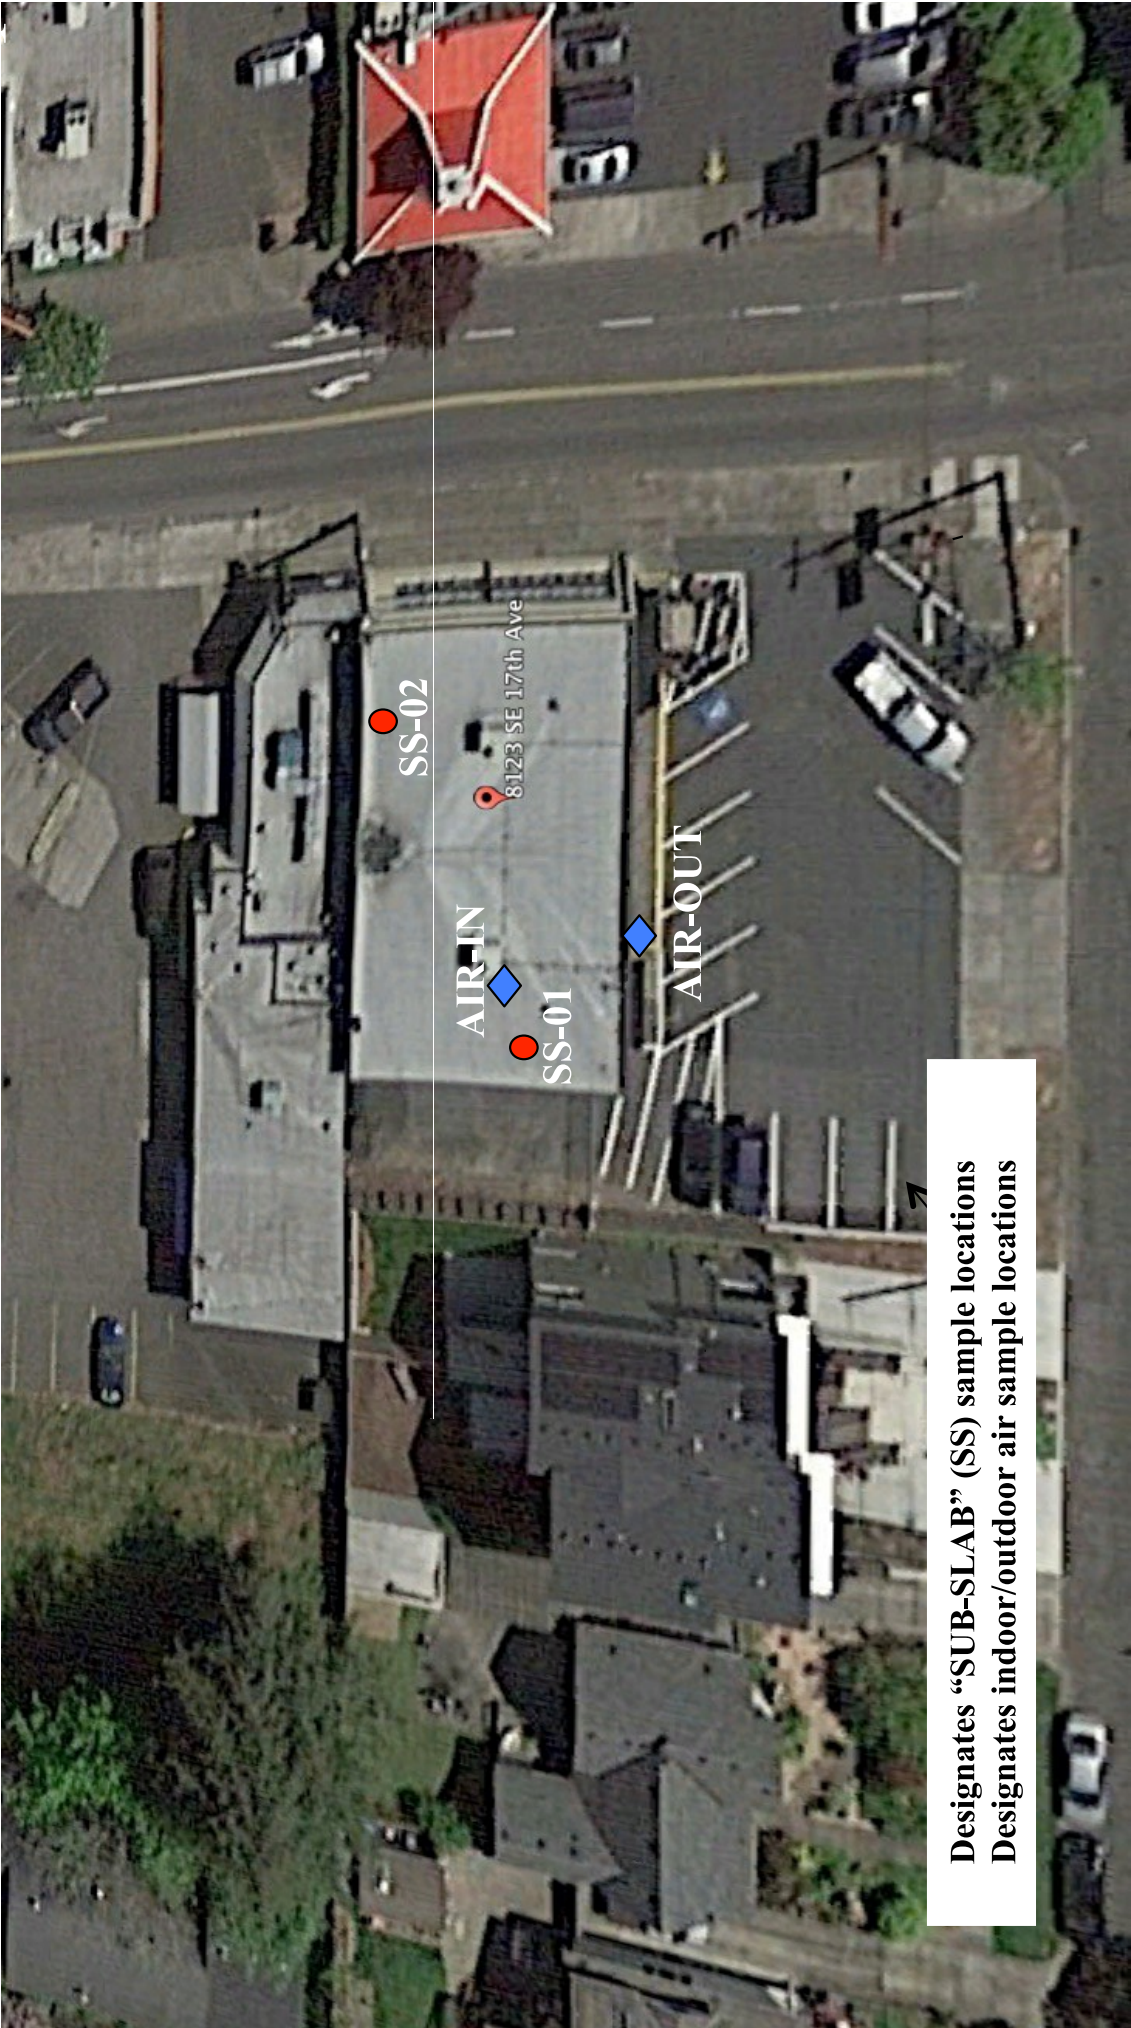
## **Attachment A: Sample Location Map**

Designates “SUB-SLAB” (SS) sample locations  
Designates indoor/outdoor air sample locations

One indoor and one outdoor air sample were collected at the site using 1-liter Tedlar bags over a 3 to 4 hour time period. The air samples were collected concurrent to the collection of the sub-slab samples (described below). The indoor air sample, designated "Air-In", was collected from an open area at the southwestern corner of the Sam's Attic store. The outdoor air sample, designated "Air-Out", was taken outside along the south side of the building in the parking lot area. Sample locations are noted on the Sample Location Map in Attachment A.

RMEC collected two (2) sub-slab soil vapor samples in the building. The sub-slab samples were collected from probes installed through the concrete slab. The sample locations are noted on the Sample Location Map with the designation "SS". At each SS sample location, a one-inch diameter hole was drilled in the concrete floor of the building and a soil vapor probe beneath the building slab. The sample line was capped and sealed in place with a hydrated bentonite slurry.

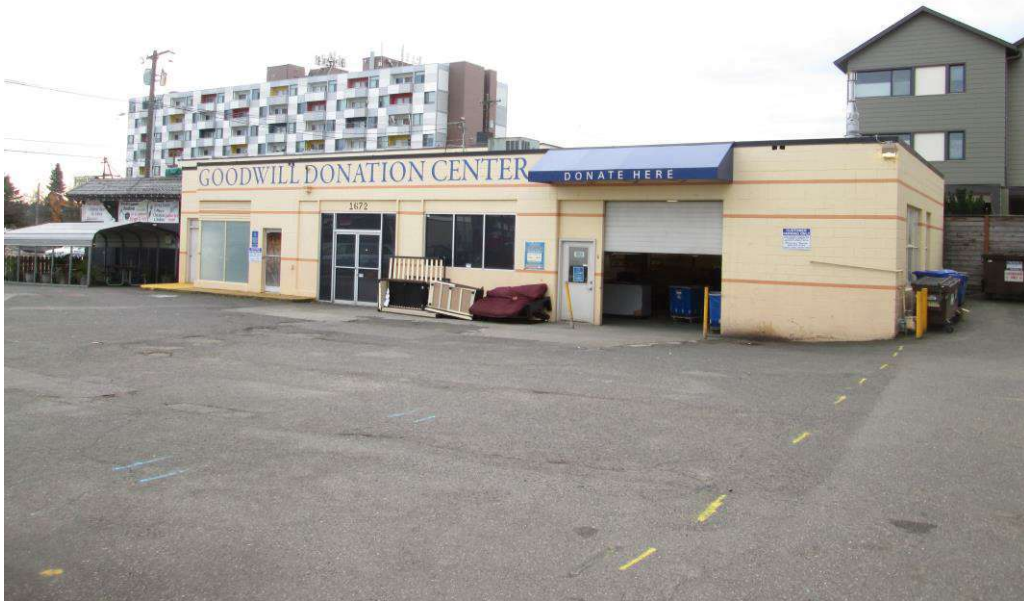
**Photo 1** General view of the existing Goodwill building and former auto service facility at the site.

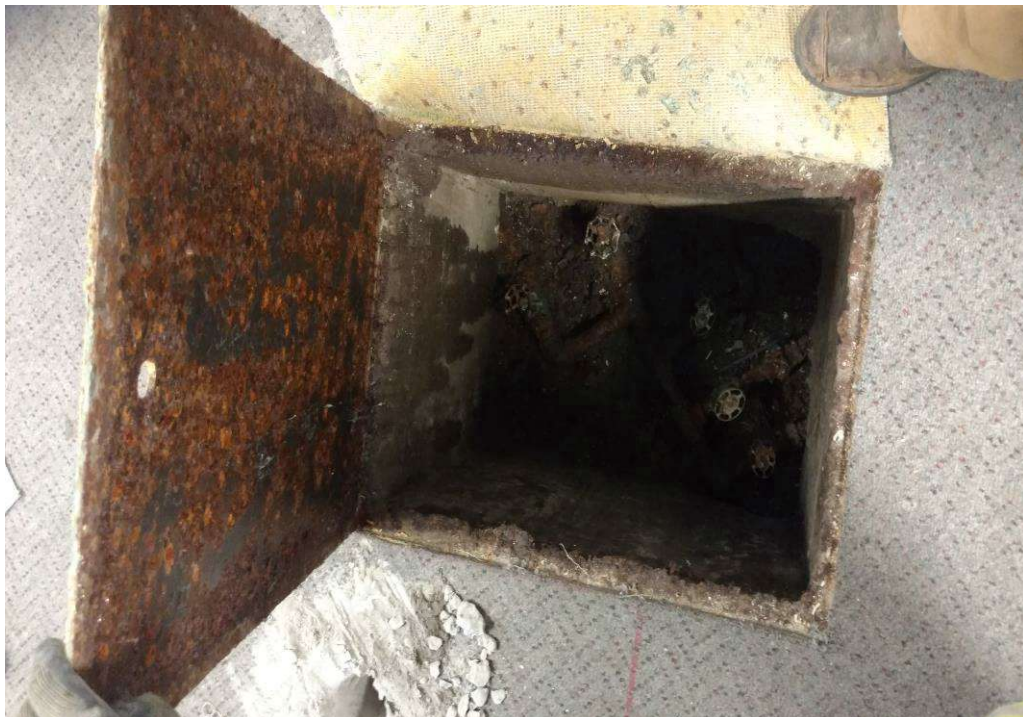
**Photo 2** View of the suspect former waste pit / valve box located inside the Goodwill building.

- Building records indicate the presence or past presence of a potential waste pit in the east bay of the Goodwill Donation Center. This area of the building is covered with carpet and a pit was not observed during the Phase I ESA Site reconnaissance. There is the potential that a pit can be a source of subsurface releases and no prior testing was reported for the pit.
