RE: UST Compliance Inspection

DEQ USTs #8865

Oregon Air National Guard

Full Compliance Inspection - Test

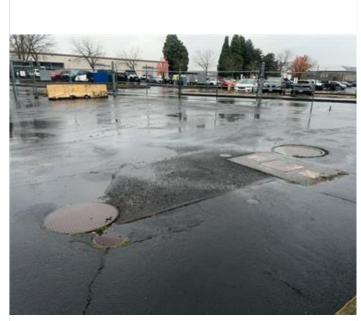
Facility_8865_241113084629_owsto260-1.jpg

- a. SME evaluated both USTs on site on 25 NOV 24 and determined that both have existing overfill alarms that were set at 70% capacity and are functioning
 - 1. UST 260-1 (tank permit no. BGCFH) already had a feature in the existing Veeder Root TLS-250 that senses and audibly alarms for tank overfilling. The alarm was forced to turn on when SME removed the sensor (simulating high level). We have yet to fill the tank up with water to the 70% capacity level to see if the alarm goes off in the presence of SME which will allow them to complete the in-compliance report (note: after this test is completed, the added water will be pumped into the connected oil/water separator IAW our city of Portland sanitary sewer discharge permit).
