RE: Sanitary Sewer Overflow (SSO) – Reporting Form WPCFP Permit #102295, File No. 48780

On March 4, 2025, Lamb Weston notified DEQ of a sanitary sewer overflow event that occurred on March 3, 2025, initiating at 4pm and ending at 6pm under Water Pollution Control Facility Permit (WPCF) 102295. As requested, below is the summary of the events and attached are the SSO Report (Attachment A), incident pictures (Attachment B), and site overview map (Attachment C).

Attachment A  
SSO Reporting Form (Page 1)

Attachment B  
SSO Incident Pictures

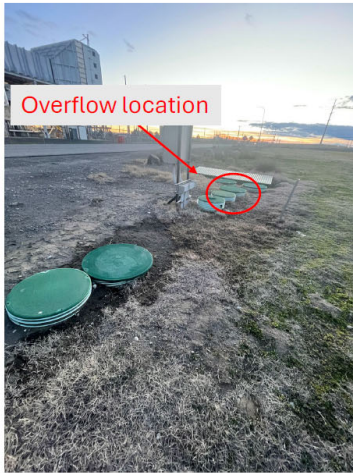
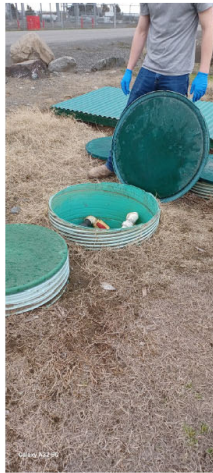
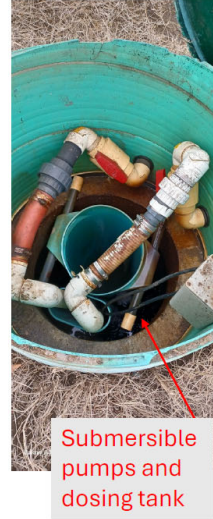
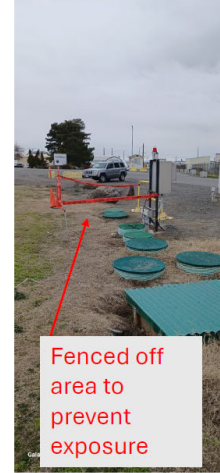
- It was unknown to the Lamb Weston electrical team that the power outage to the shed would cause power loss to the six pumps housed in the 3,000-gallon dosing tank.

- In addition, it was not known that the sub-surface drip irrigation pumps require restarting on the HMI after a power outage.
- This caused an overflow of treated wastewater from the dosing tank lids onto the nearby soil.

Lamb Weston estimates the overflow volume to be around 394 gallons of treated sanitary wastewater.

Baker's Acres Pump Station Tank – Sanitary Sewer Overflow (3/3/25)

Due to the overflow being treated wastewater and near land application infrastructure, as discussed during notification, remediation was limited to fencing off the area to prevent exposure and allowing the area to dry out. Communication was made to the Water Treatment team of the fenced area and caution for working in the area.

Communication with site electricians regarding the incident was discussed and future electrical work impacting near the land application area will be communicated and planned with the Water Treatment department to ensure

adequate measures are in place to minimize the potential for a similar event. Lamb Weston has also communicated to the Third-Party Security Contractor, who is located near the land application area, to monitor the light stack and alarm for potential high levels in the area and to notify appropriate personnel for proper response.
