Department of Environmental Quality

RE: No Further Action Determination
for Smalley Diesel Center II, Sutherlin
LUST # 10-23-0602

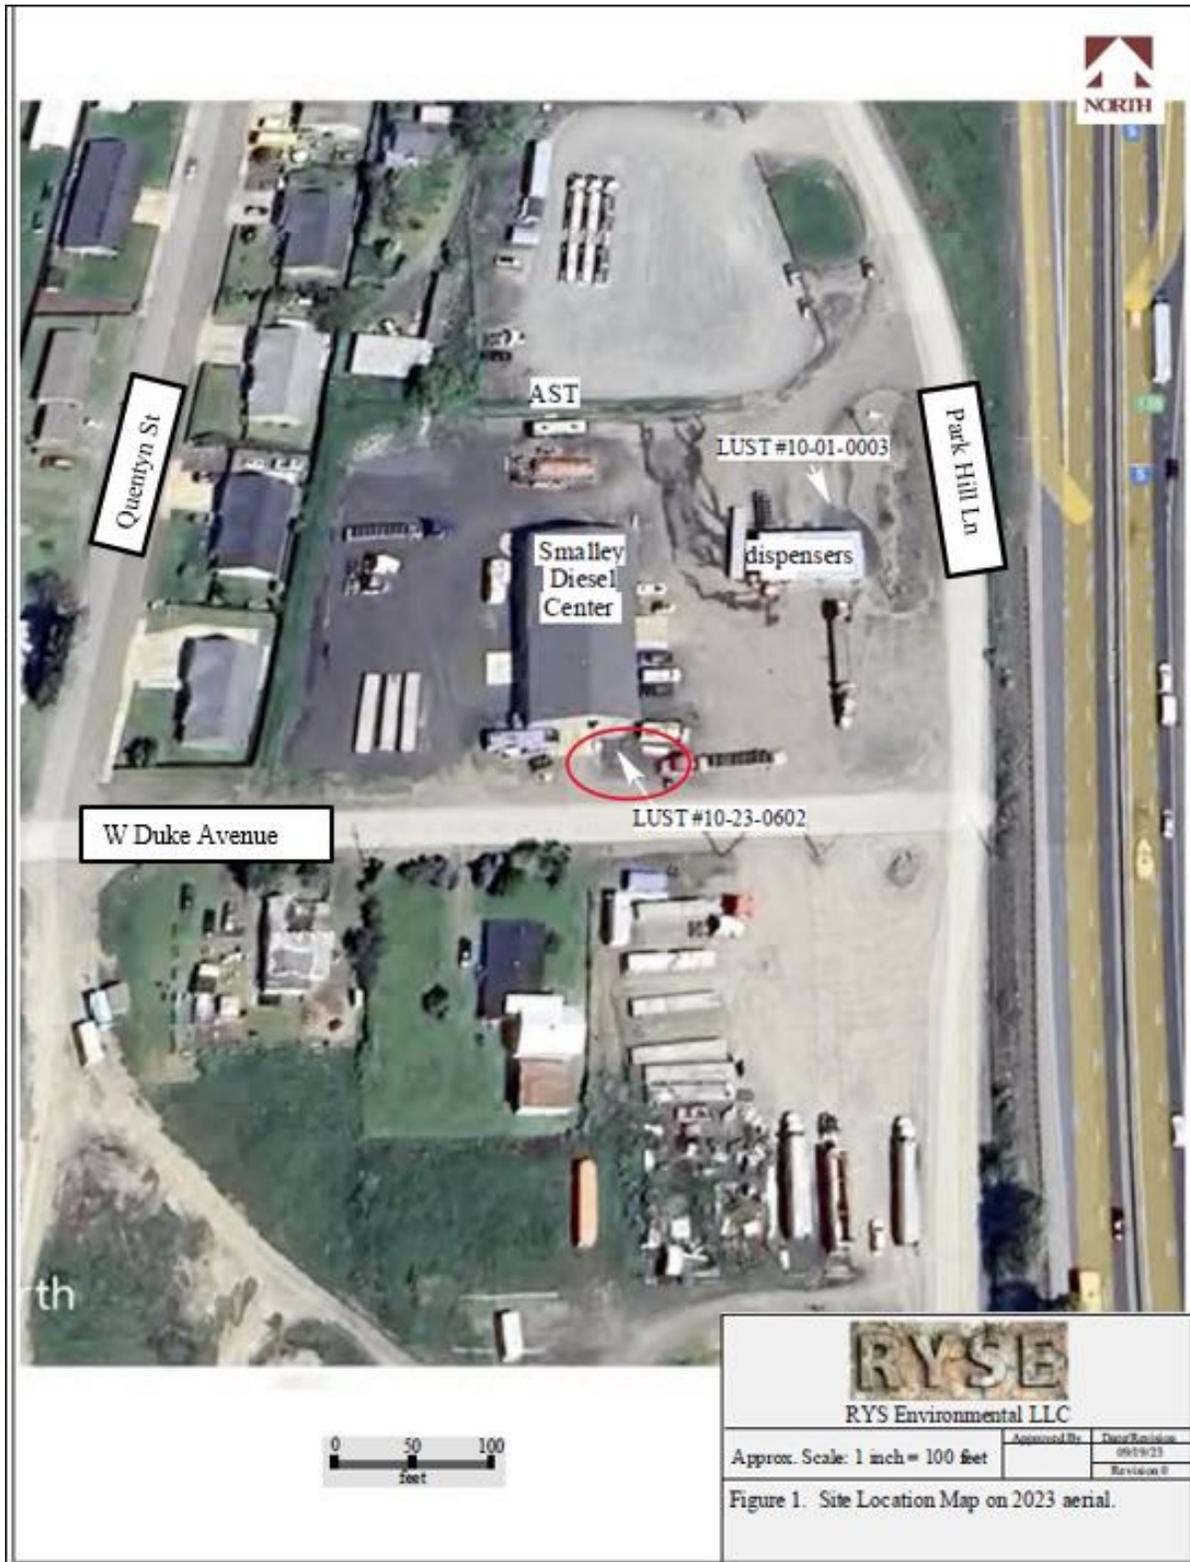
Site map. Red circle indicates where UST tank nest was located (retrieved from RYS Environmental LLC Closure Report, dated September 27, 2023).

- Smalley Diesel Center, Inc. has operated as a diesel repair shop and fuel station since 1980. Prior uses included a vehicle detail shop, infrequent vehicle washing occurred within the main building. Three (3) underground storage tanks (USTs) were located at the southern end of the shop building (Figure 1). Historic use of the USTs is unknown, but it is assumed the tanks contained motor fuel. There was a fuel dispenser island located south of the USTs.
