RE: No Further Action Determination
Silver Falls State Park
LUST #24-93-4076

The Oregon Department of Environmental Quality (DEQ) has completed a review of the available information for the Silver Falls State Park site, including the closure report entitled *UST Decommissioning with Samples*, dated May 4th, 1993, which was submitted to DEQ by On-Line Construction Co. on your behalf. The Silver Falls State Park address is 20024 Silver Falls Hwy Sublimity, Oregon 97385, Marion County, Tax Lot 081E24.

Figure 1: Site Diagram

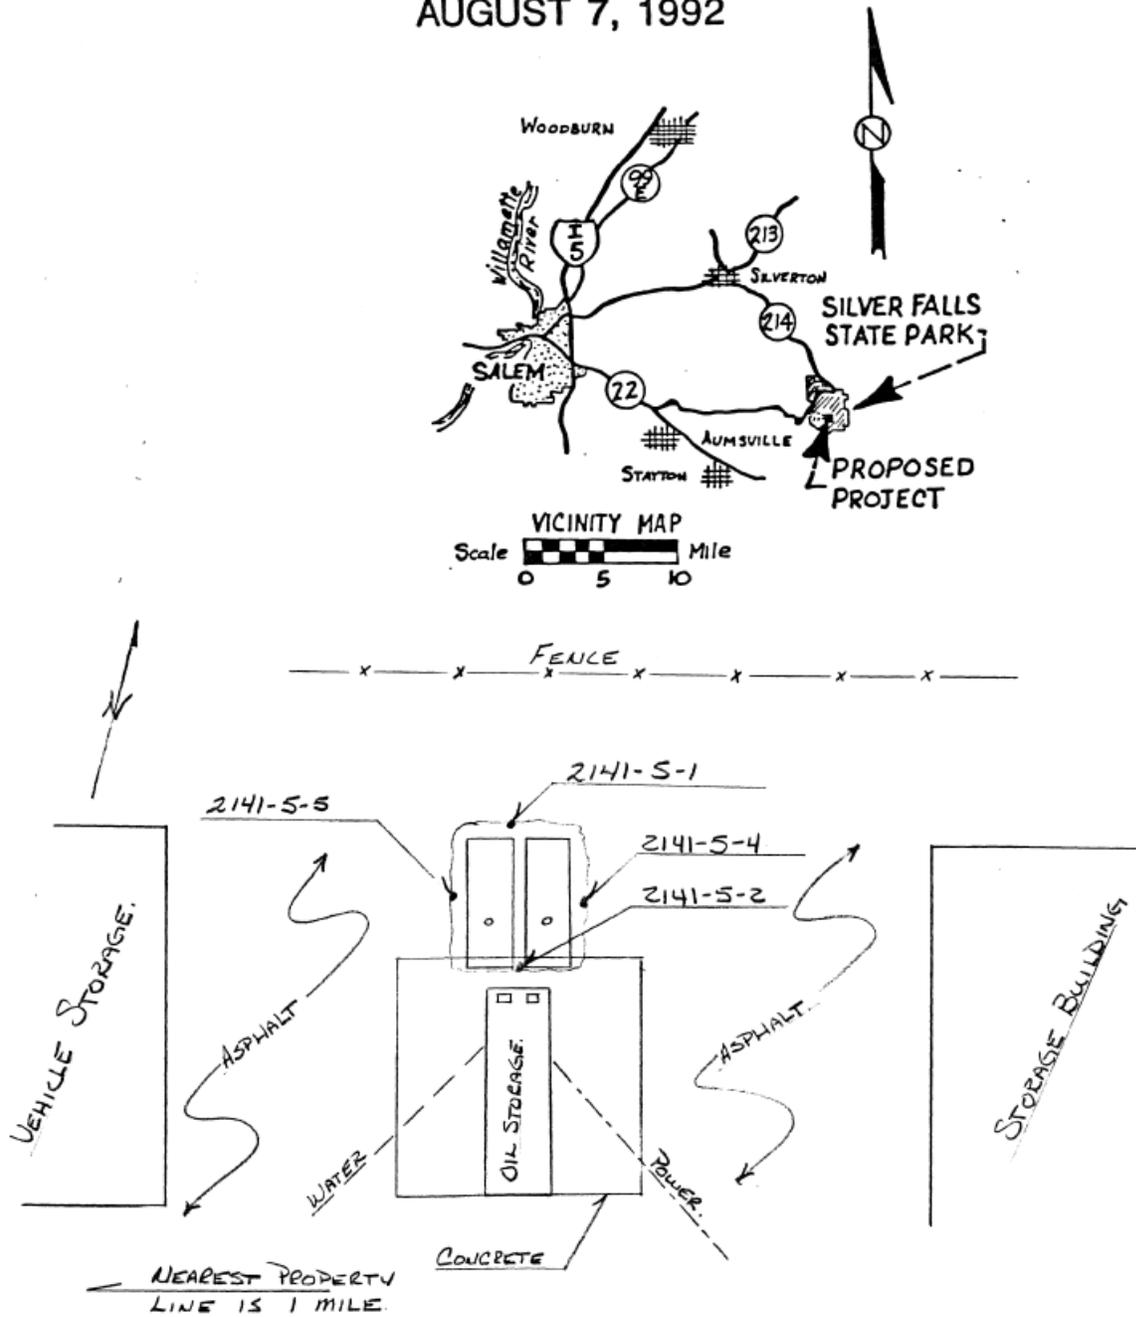
SILVER FALLS STATE PARK

CONSTRUCTION PLAN FOR ABOVE GROUND FUEL TANK
