Date: September 23, 2025

From: Rob Hood, Cleanup Project Manager *RAH*

Subject: Proposed Source Control Decision
Automatic Vending
ECSI #1430

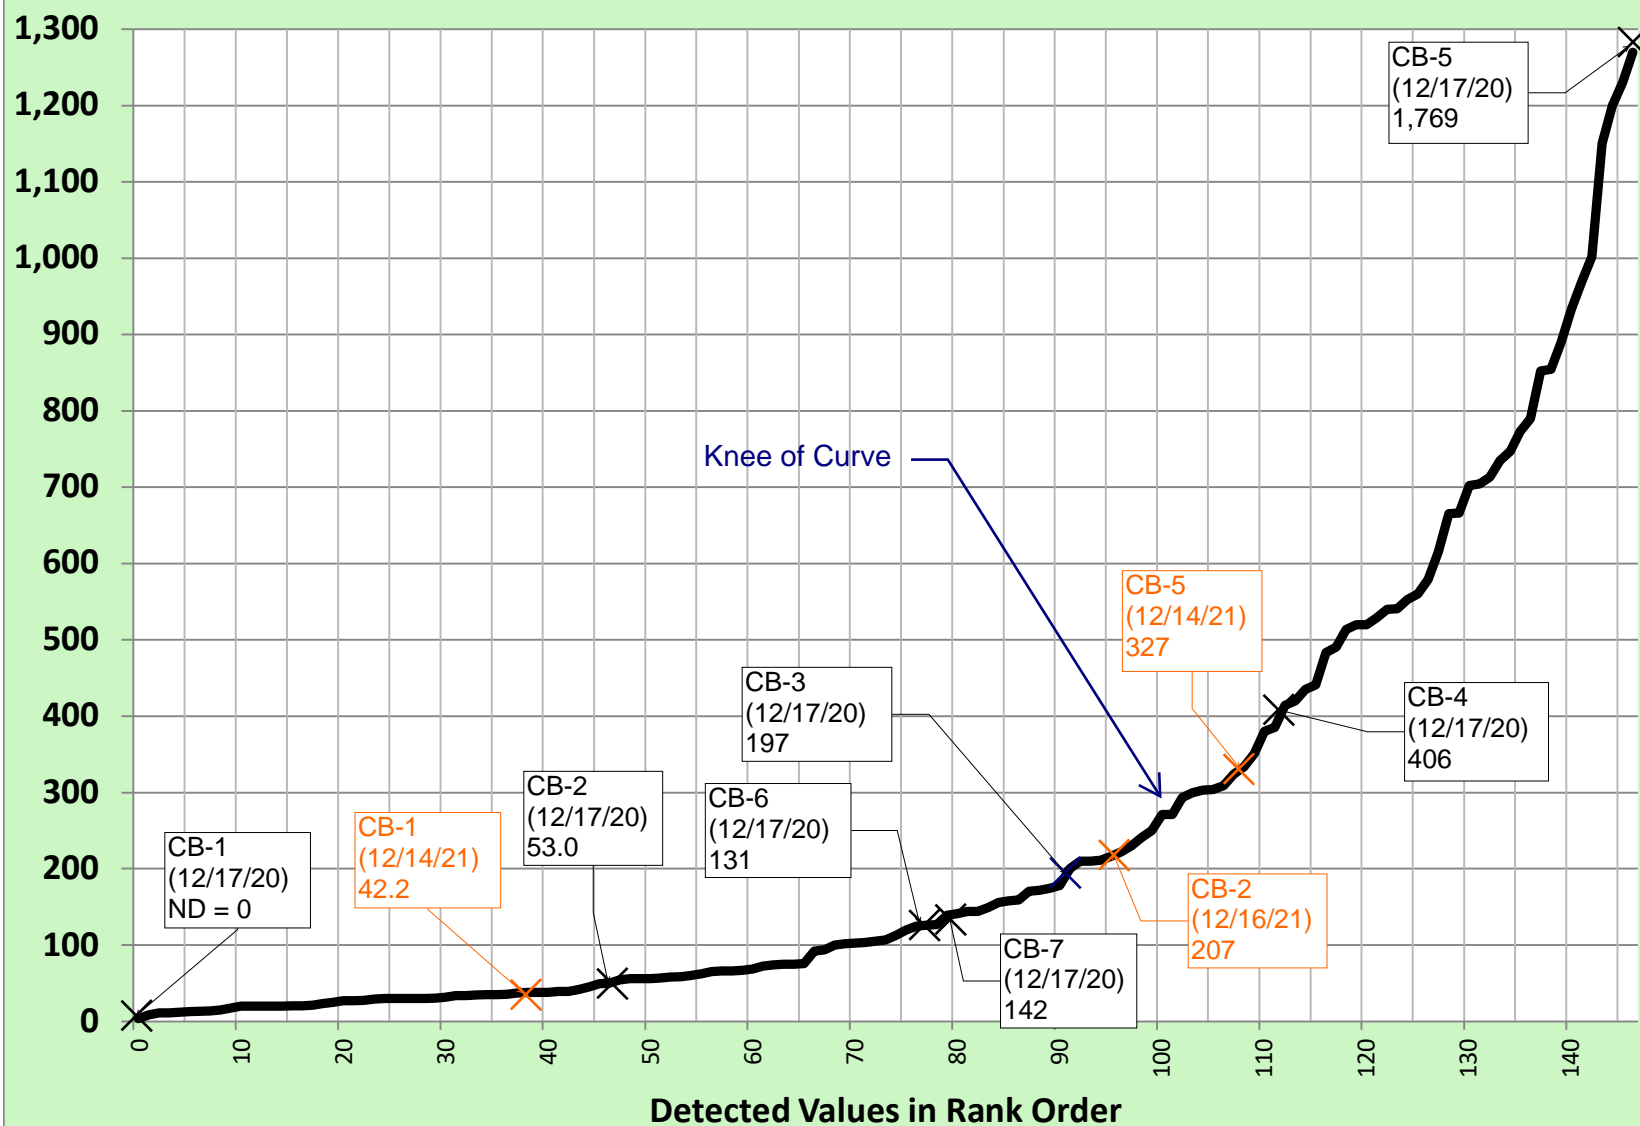
Total PCBs (ug/kg) in Stormwater Solids at Portland Harbor Heavy Industrial Sites

In samples from 2020 PCBs, PAHs, BEHP, dioxins/furans, arsenic, cadmium, mercury, and/or zinc were detected above sediment/riverbank soil PH Cleanup Levels in one or more samples and chromium, mercury, zinc, PCBs and PAHs were detected at concentrates above those typically observed at site industrial sites in Portland Harbor in one or more catch basins. In December 2021, concentrations of PCBs, BEHP, PAHs, arsenic, cadmium, mercury, and zinc, were detected above sediment/riverbank soil PH Cleanup Levels in one or more samples and chromium, mercury, zinc, PCBs and PAHs were detected at concentrates above those typically observed at site industrial sites in Portland Harbor in one or more catch basins.

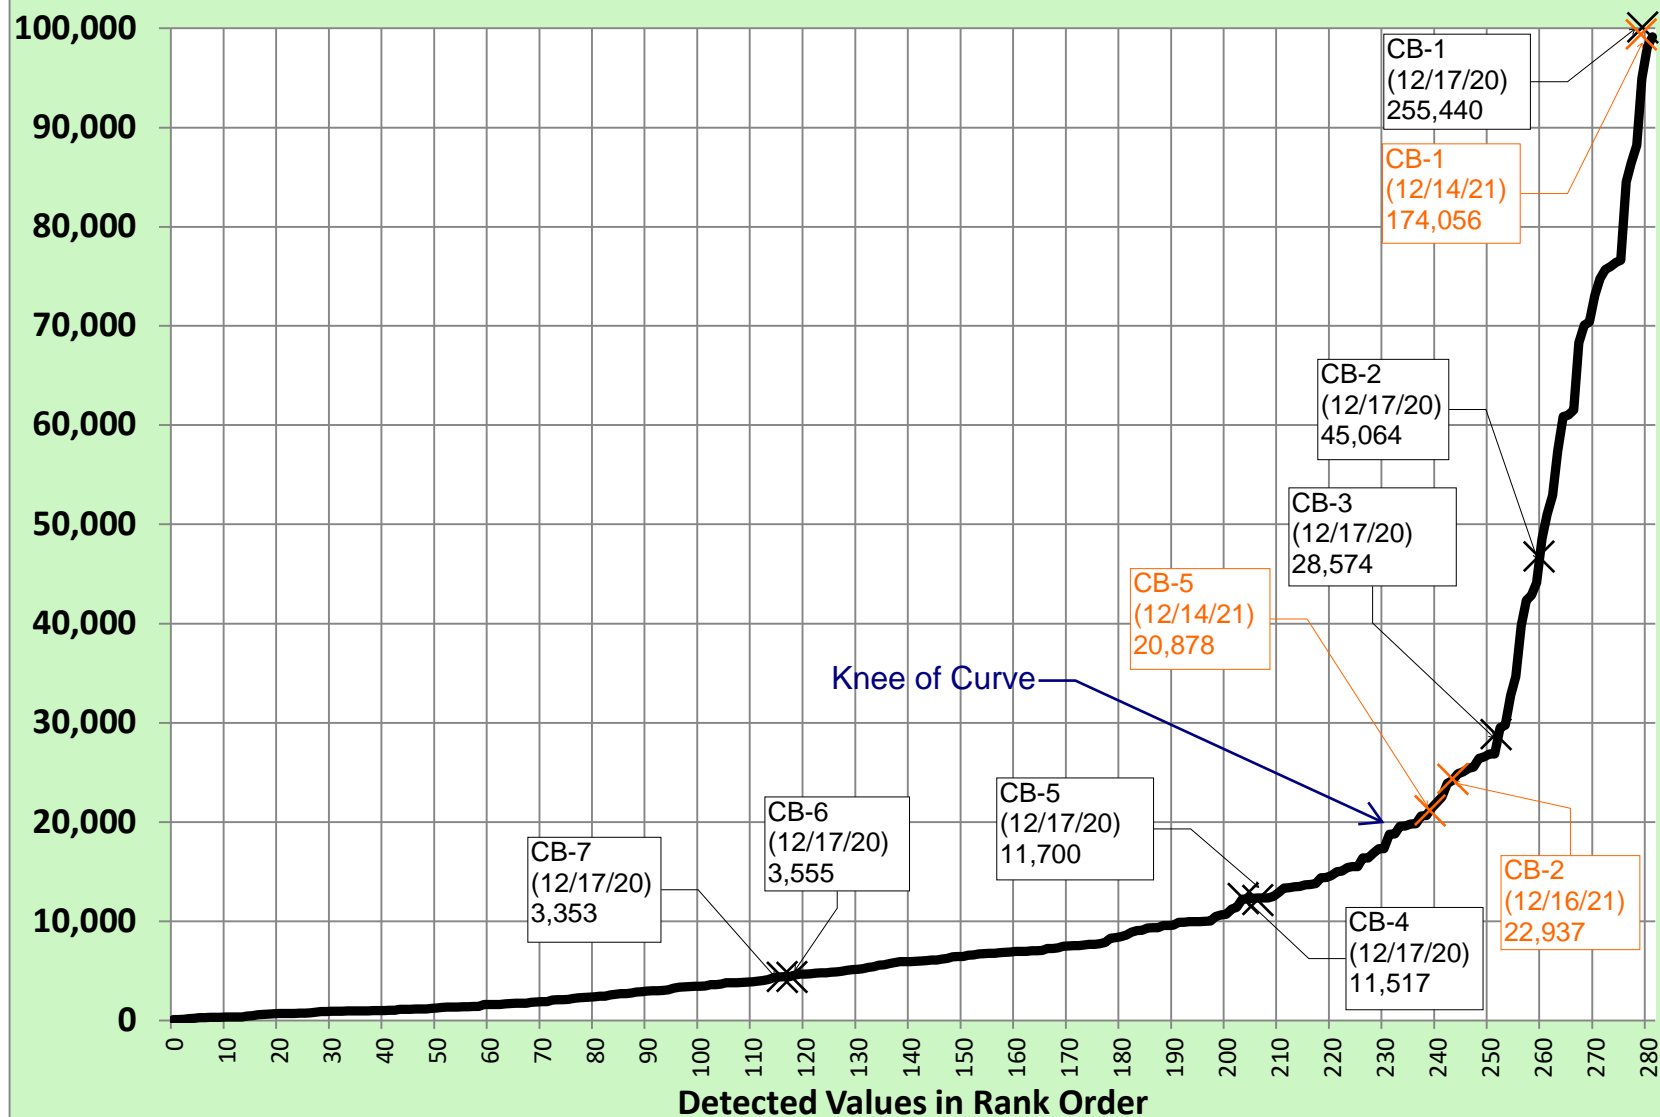
Total PAHs (ug/kg) in Stormwater Solids at Portland Harbor Heavy Industrial Sites

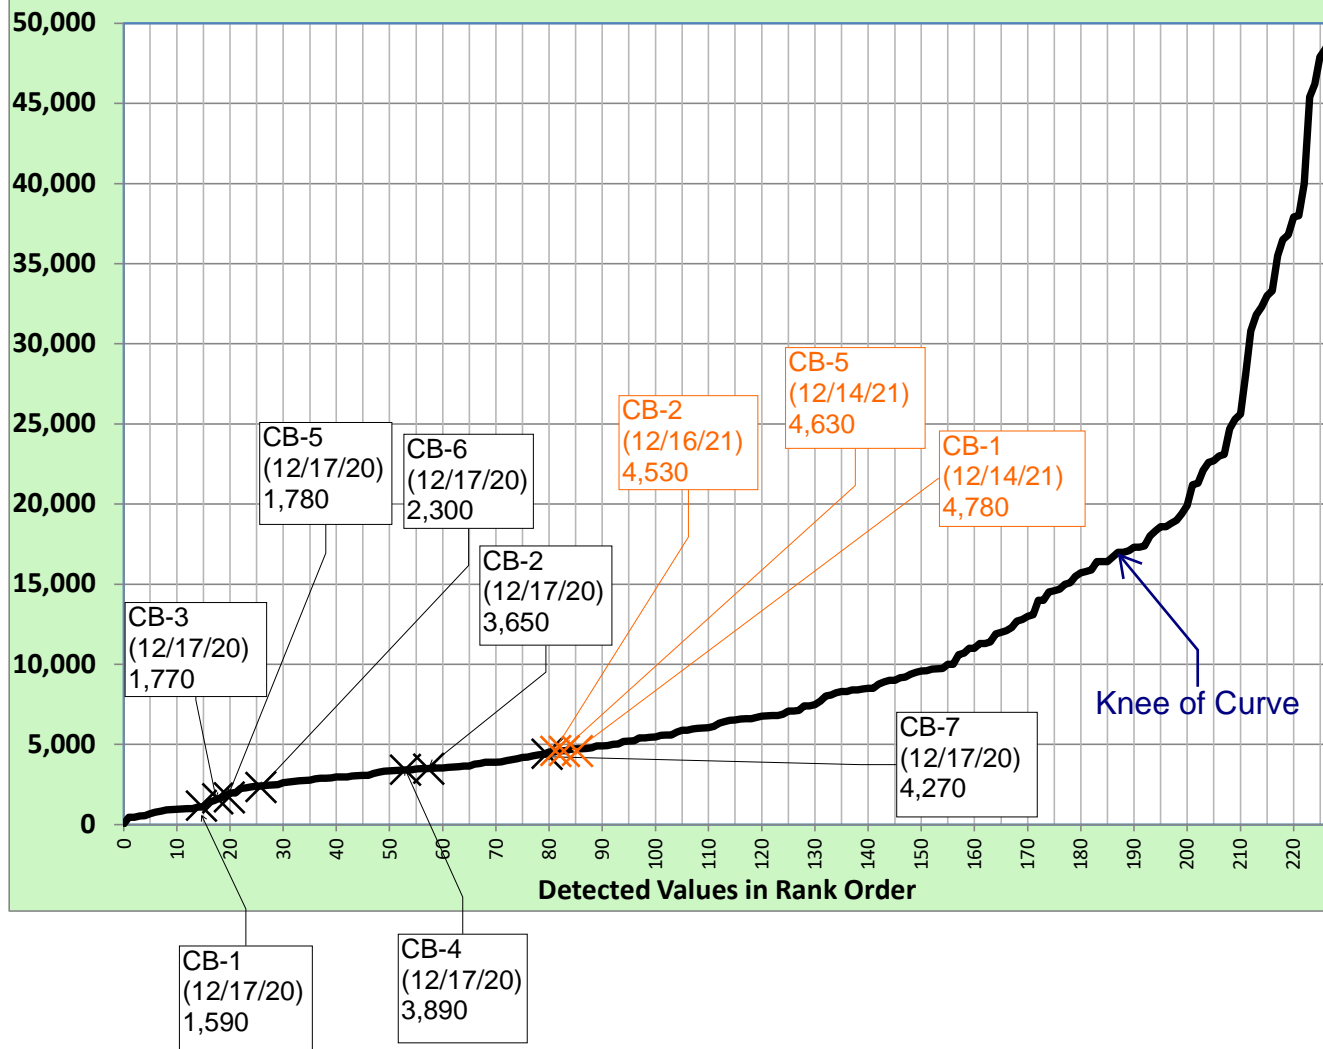
Arsenic (ug/kg) in Stormwater Solids at Portland Harbor Heavy Industrial Sites

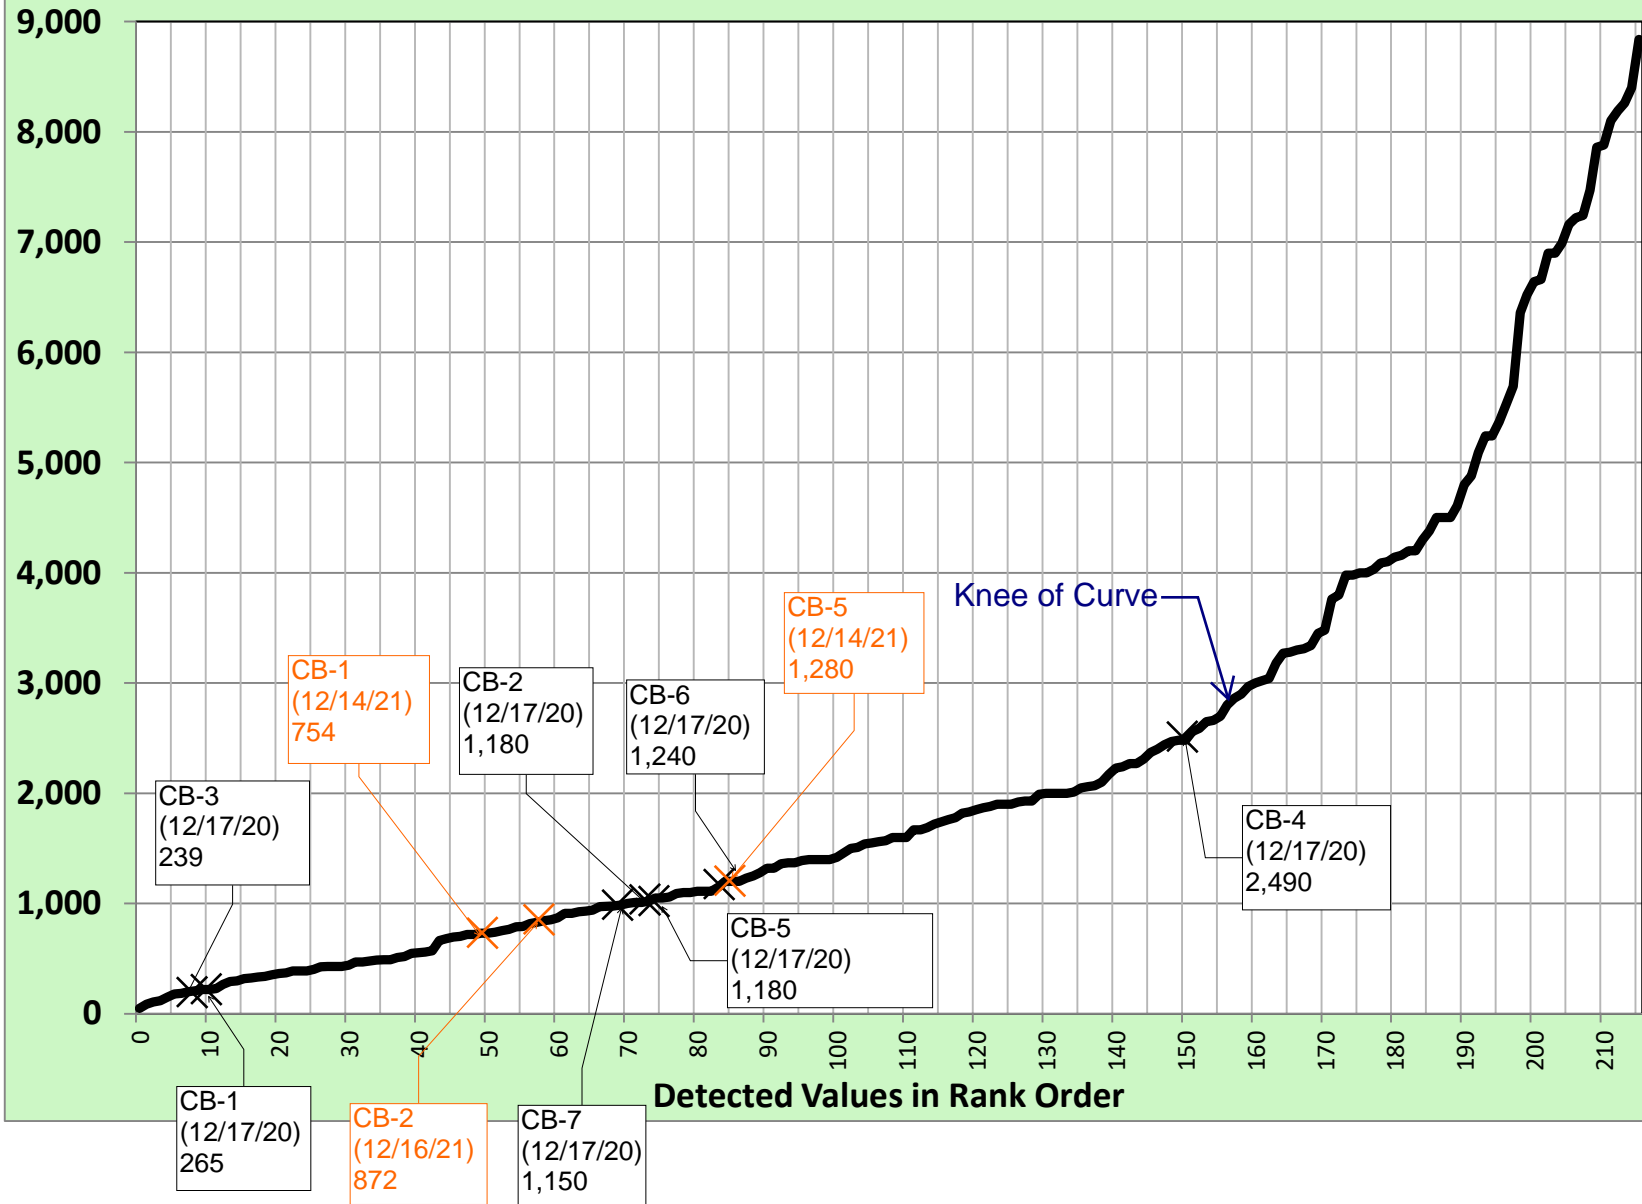
Cadmium (ug/kg) in Stormwater Solids at Portland Harbor Heavy Industrial Sites

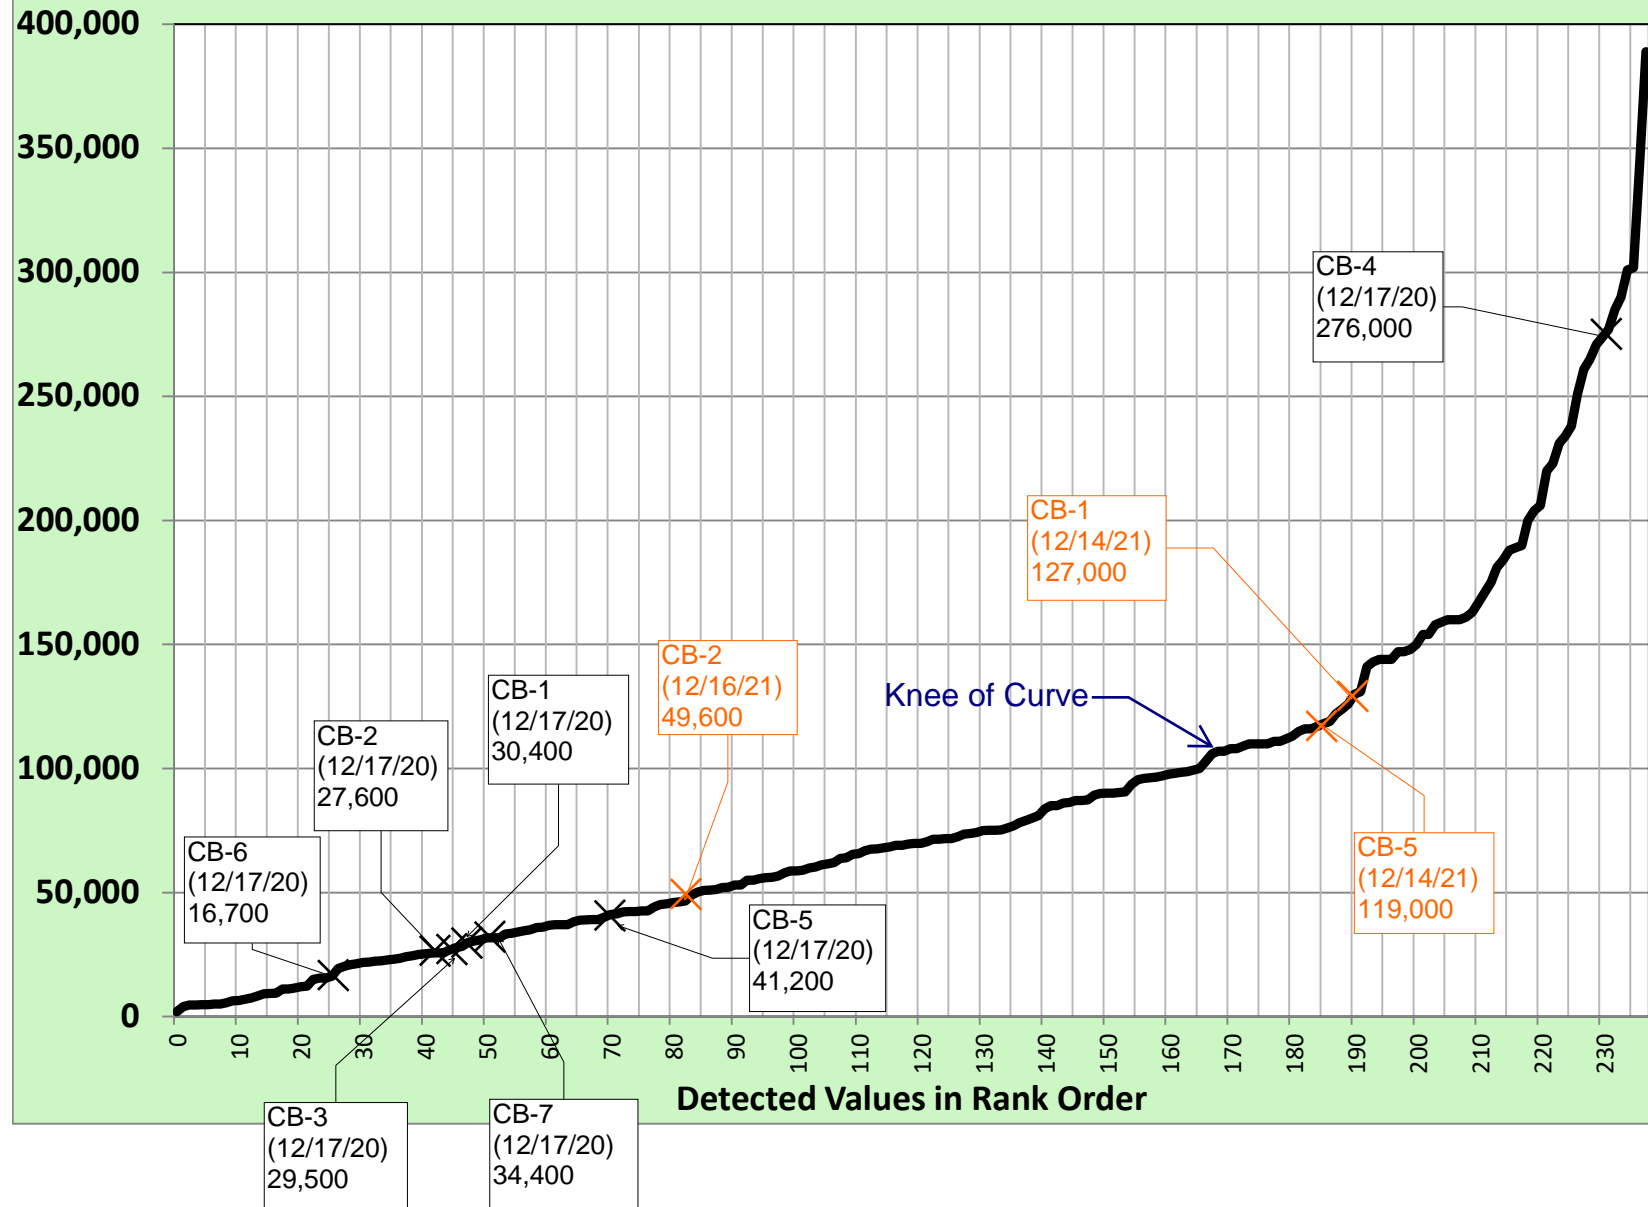
Chromium (ug/kg) in Stormwater Solids at Portland Harbor Heavy Industrial Sites

Chromium, mercury, zinc, PCBs, and PAHs were detected at concentrates above those typically observed at site industrial sites in Portland Harbor in one or more catch basins prior to cleanout, catch basins replacement, site paving and stormwater system upgrades. Sediment accumulation was not observed post stormwater system upgrades. Arsenic, cadmium, zinc, PCBs, benzo(b)fluoranthene, benzo(a)pyrene and total dioxins/furans were detected above their surface water PH Cleanup Level in one or more of the stormwater samples, but concentrations for all COC with surface water PH Cleanup Level exceedance were in the flat portion of the rank order curves in all samples collected prior to, and post stormwater system upgrades.

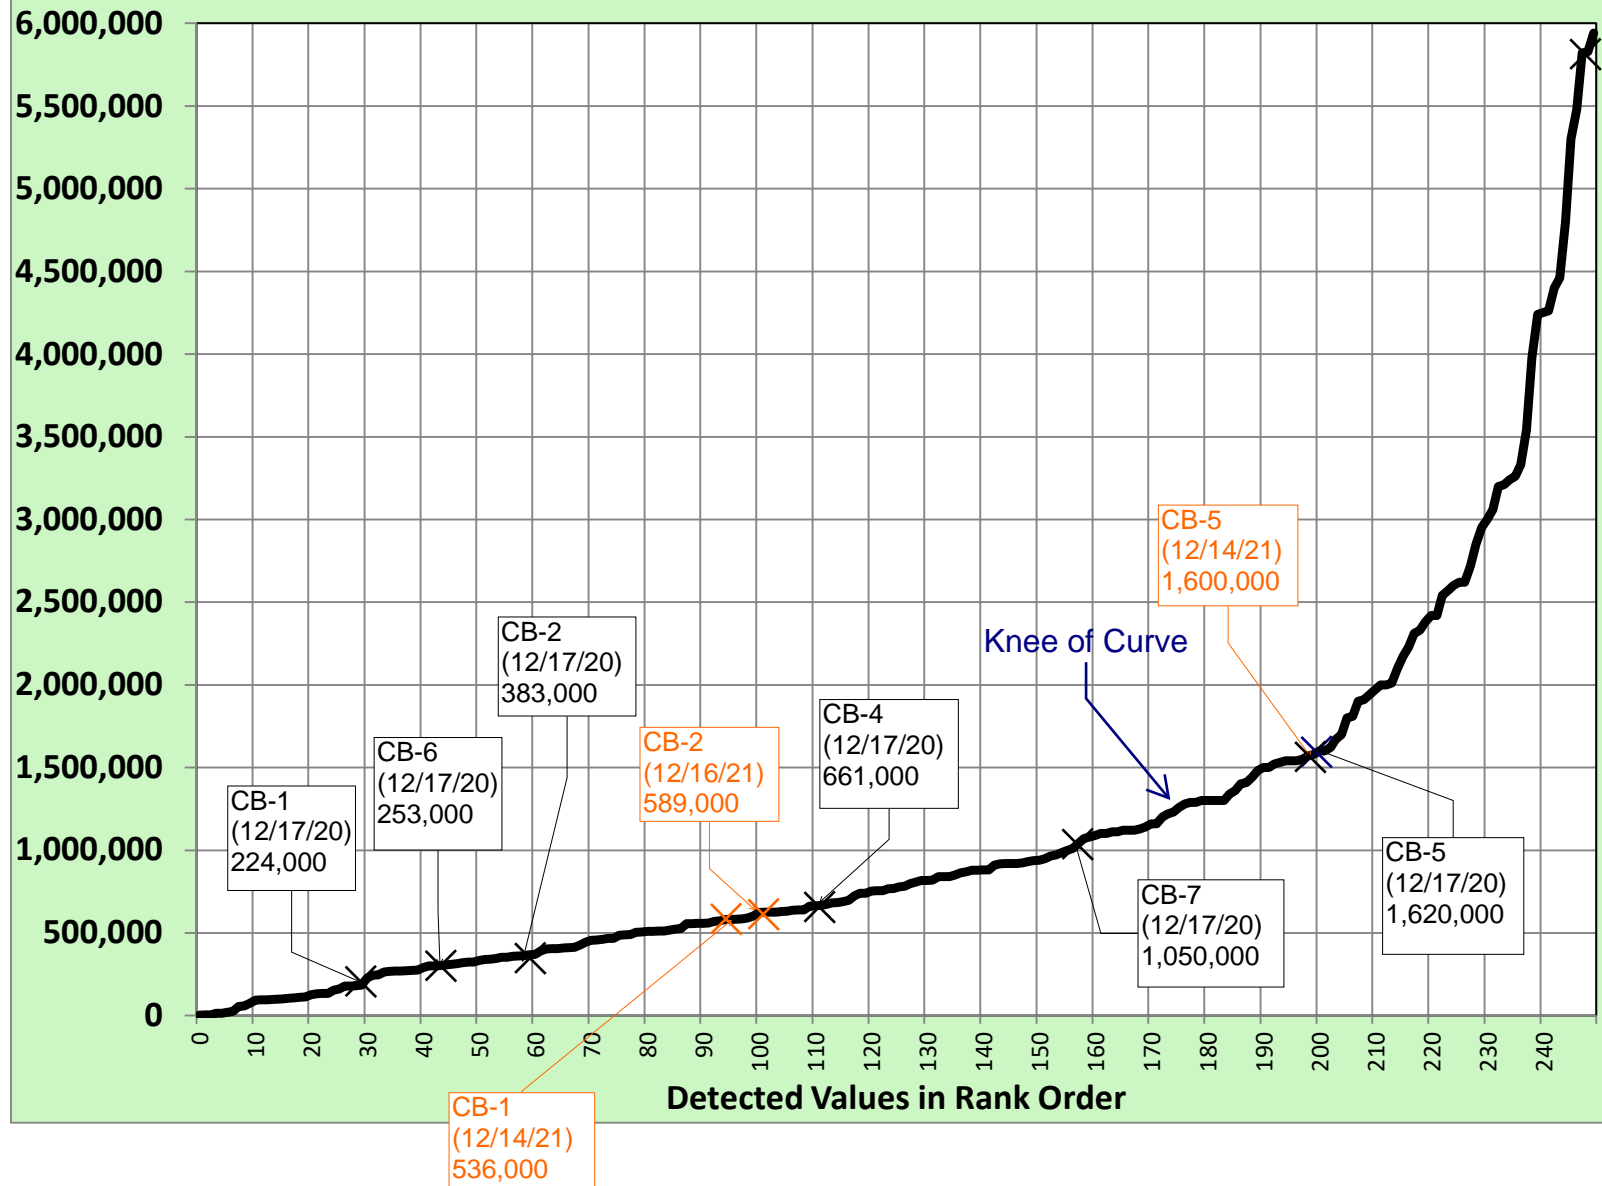
Zinc (ug/kg) in Stormwater Solids at Portland Harbor Heavy Industrial Sites

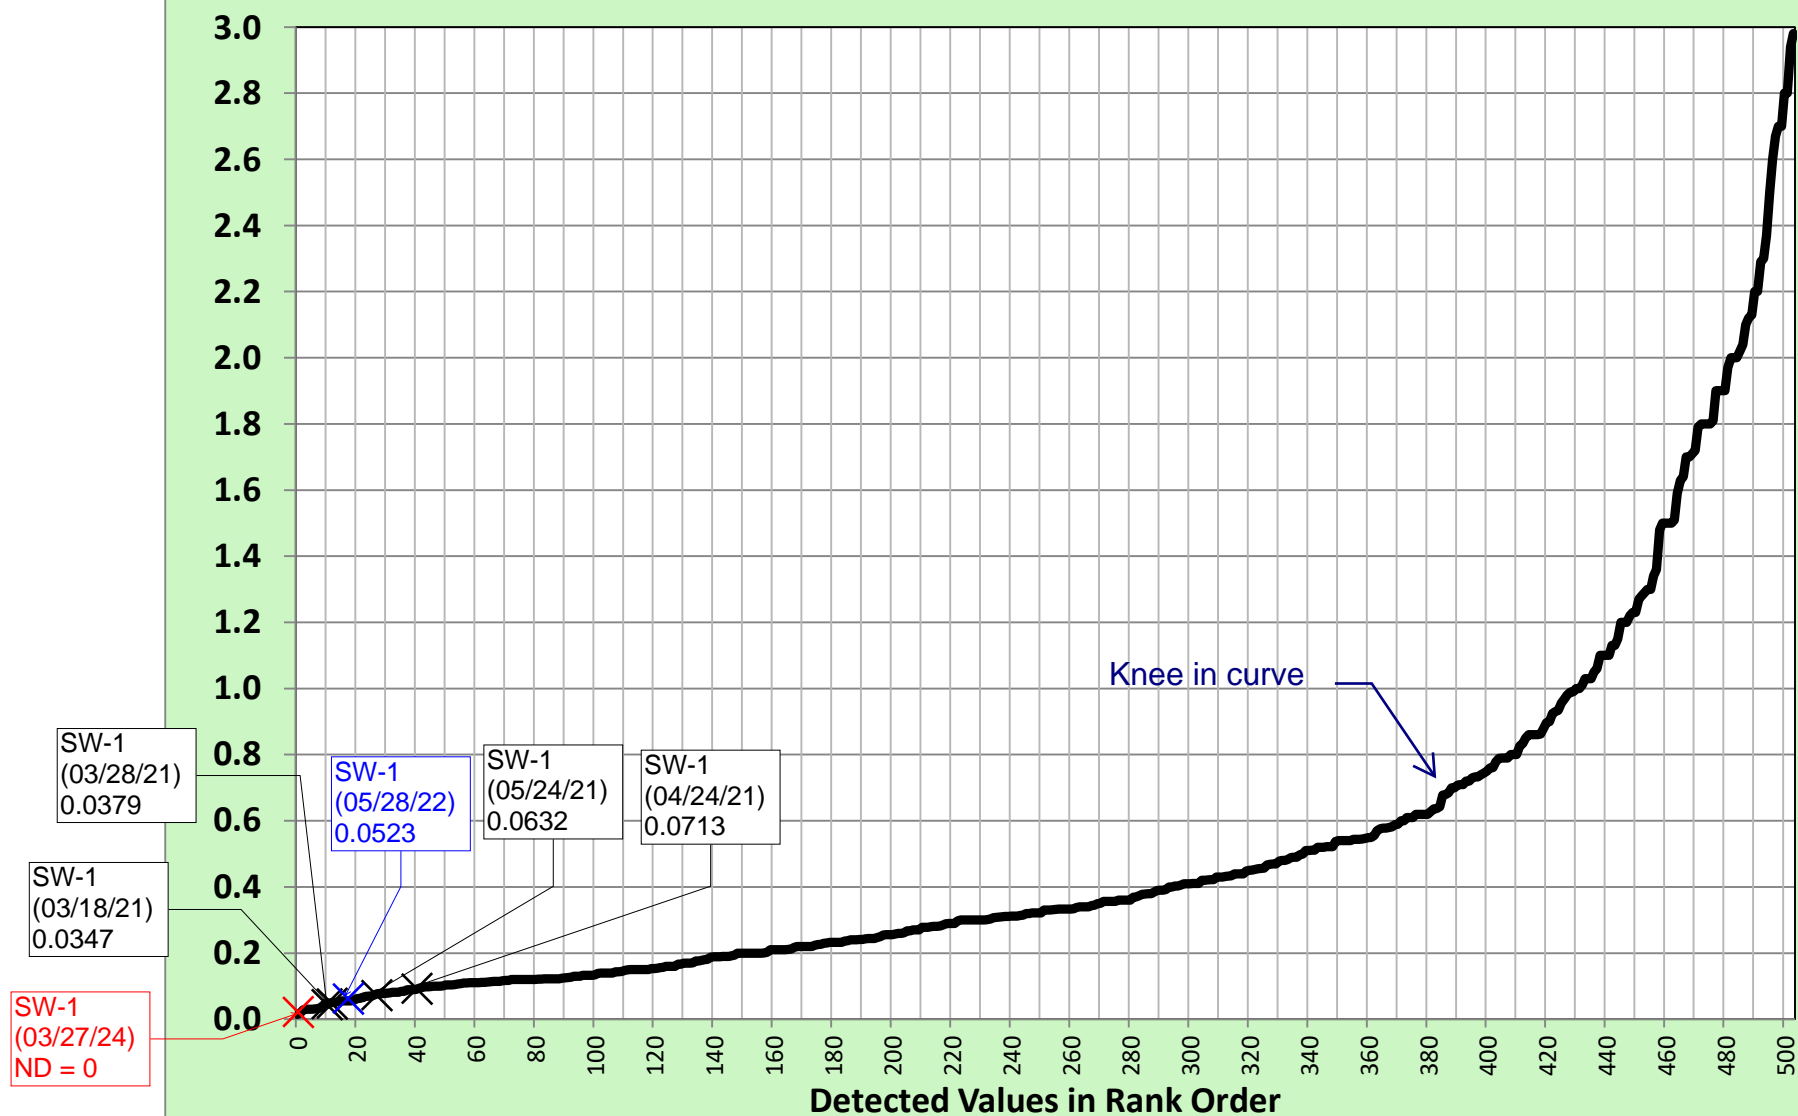
Cadmium (ug/L) in Stormwater at Portland Harbor Heavy Industrial Sites

As shown an initial round of stormwater sampling at the two on-site lateral cleanouts (SW-1 and SW-2) was completed between March 18, 2021, and May 24, 2021. Arsenic, cadmium, zinc, PCBs, benzo(b)fluoranthene, benzo(a)pyrene and total dioxins/furans were detected above their PH Cleanup Level in one or more samples. Detected concentrations for all COCs with PH Cleanup Level exceedance were in the flat portion of the rank order curves. Chloromethane was detected above the JSCS SLV of 2.1 ug/L, at a concentration of 4.04 ug/L in one sample. There is not a rank order curve available for chloromethane.

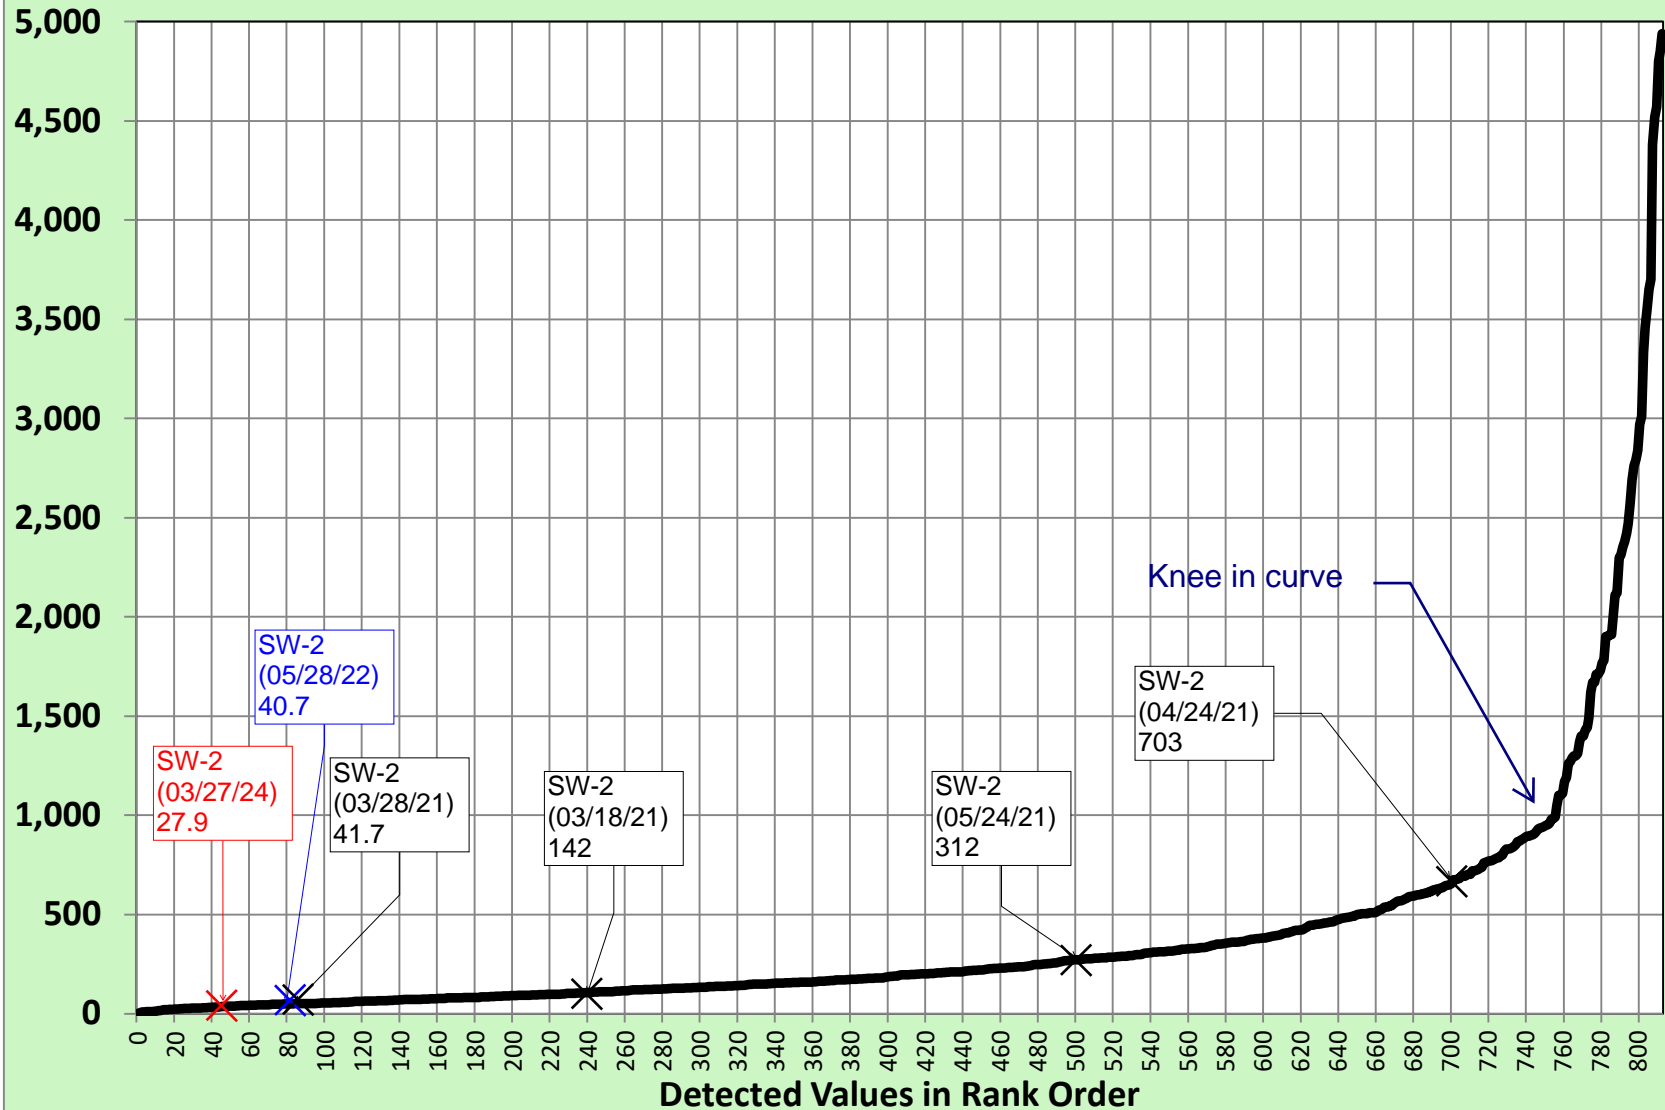
Zinc (ug/L) in Stormwater at Portland Harbor Heavy Industrial Sites

Two additional rounds of stormwater sampling from SW-1 and SW-2 were completed. One in May 2022 following catch basin replacement, and a second in March 2024, following completion of site paving and stormwater system upgrades. Result were consistent with or lower than the 2021 samples and all surface water PH Cleanup Level exceedances plot in the flat portion of the rank order curves.
