Work Plan for Additional Investigation of Stained Soil Area Northwest Pipe Company, Portland Plant (ECSI #138)

This memorandum presents the work plan to further investigate the stained soil area, as requested by DEQ. This work plan summarizes the deeper excavation sample results, presents the proposed work plan approach, and the proposed schedule for completing the investigation.

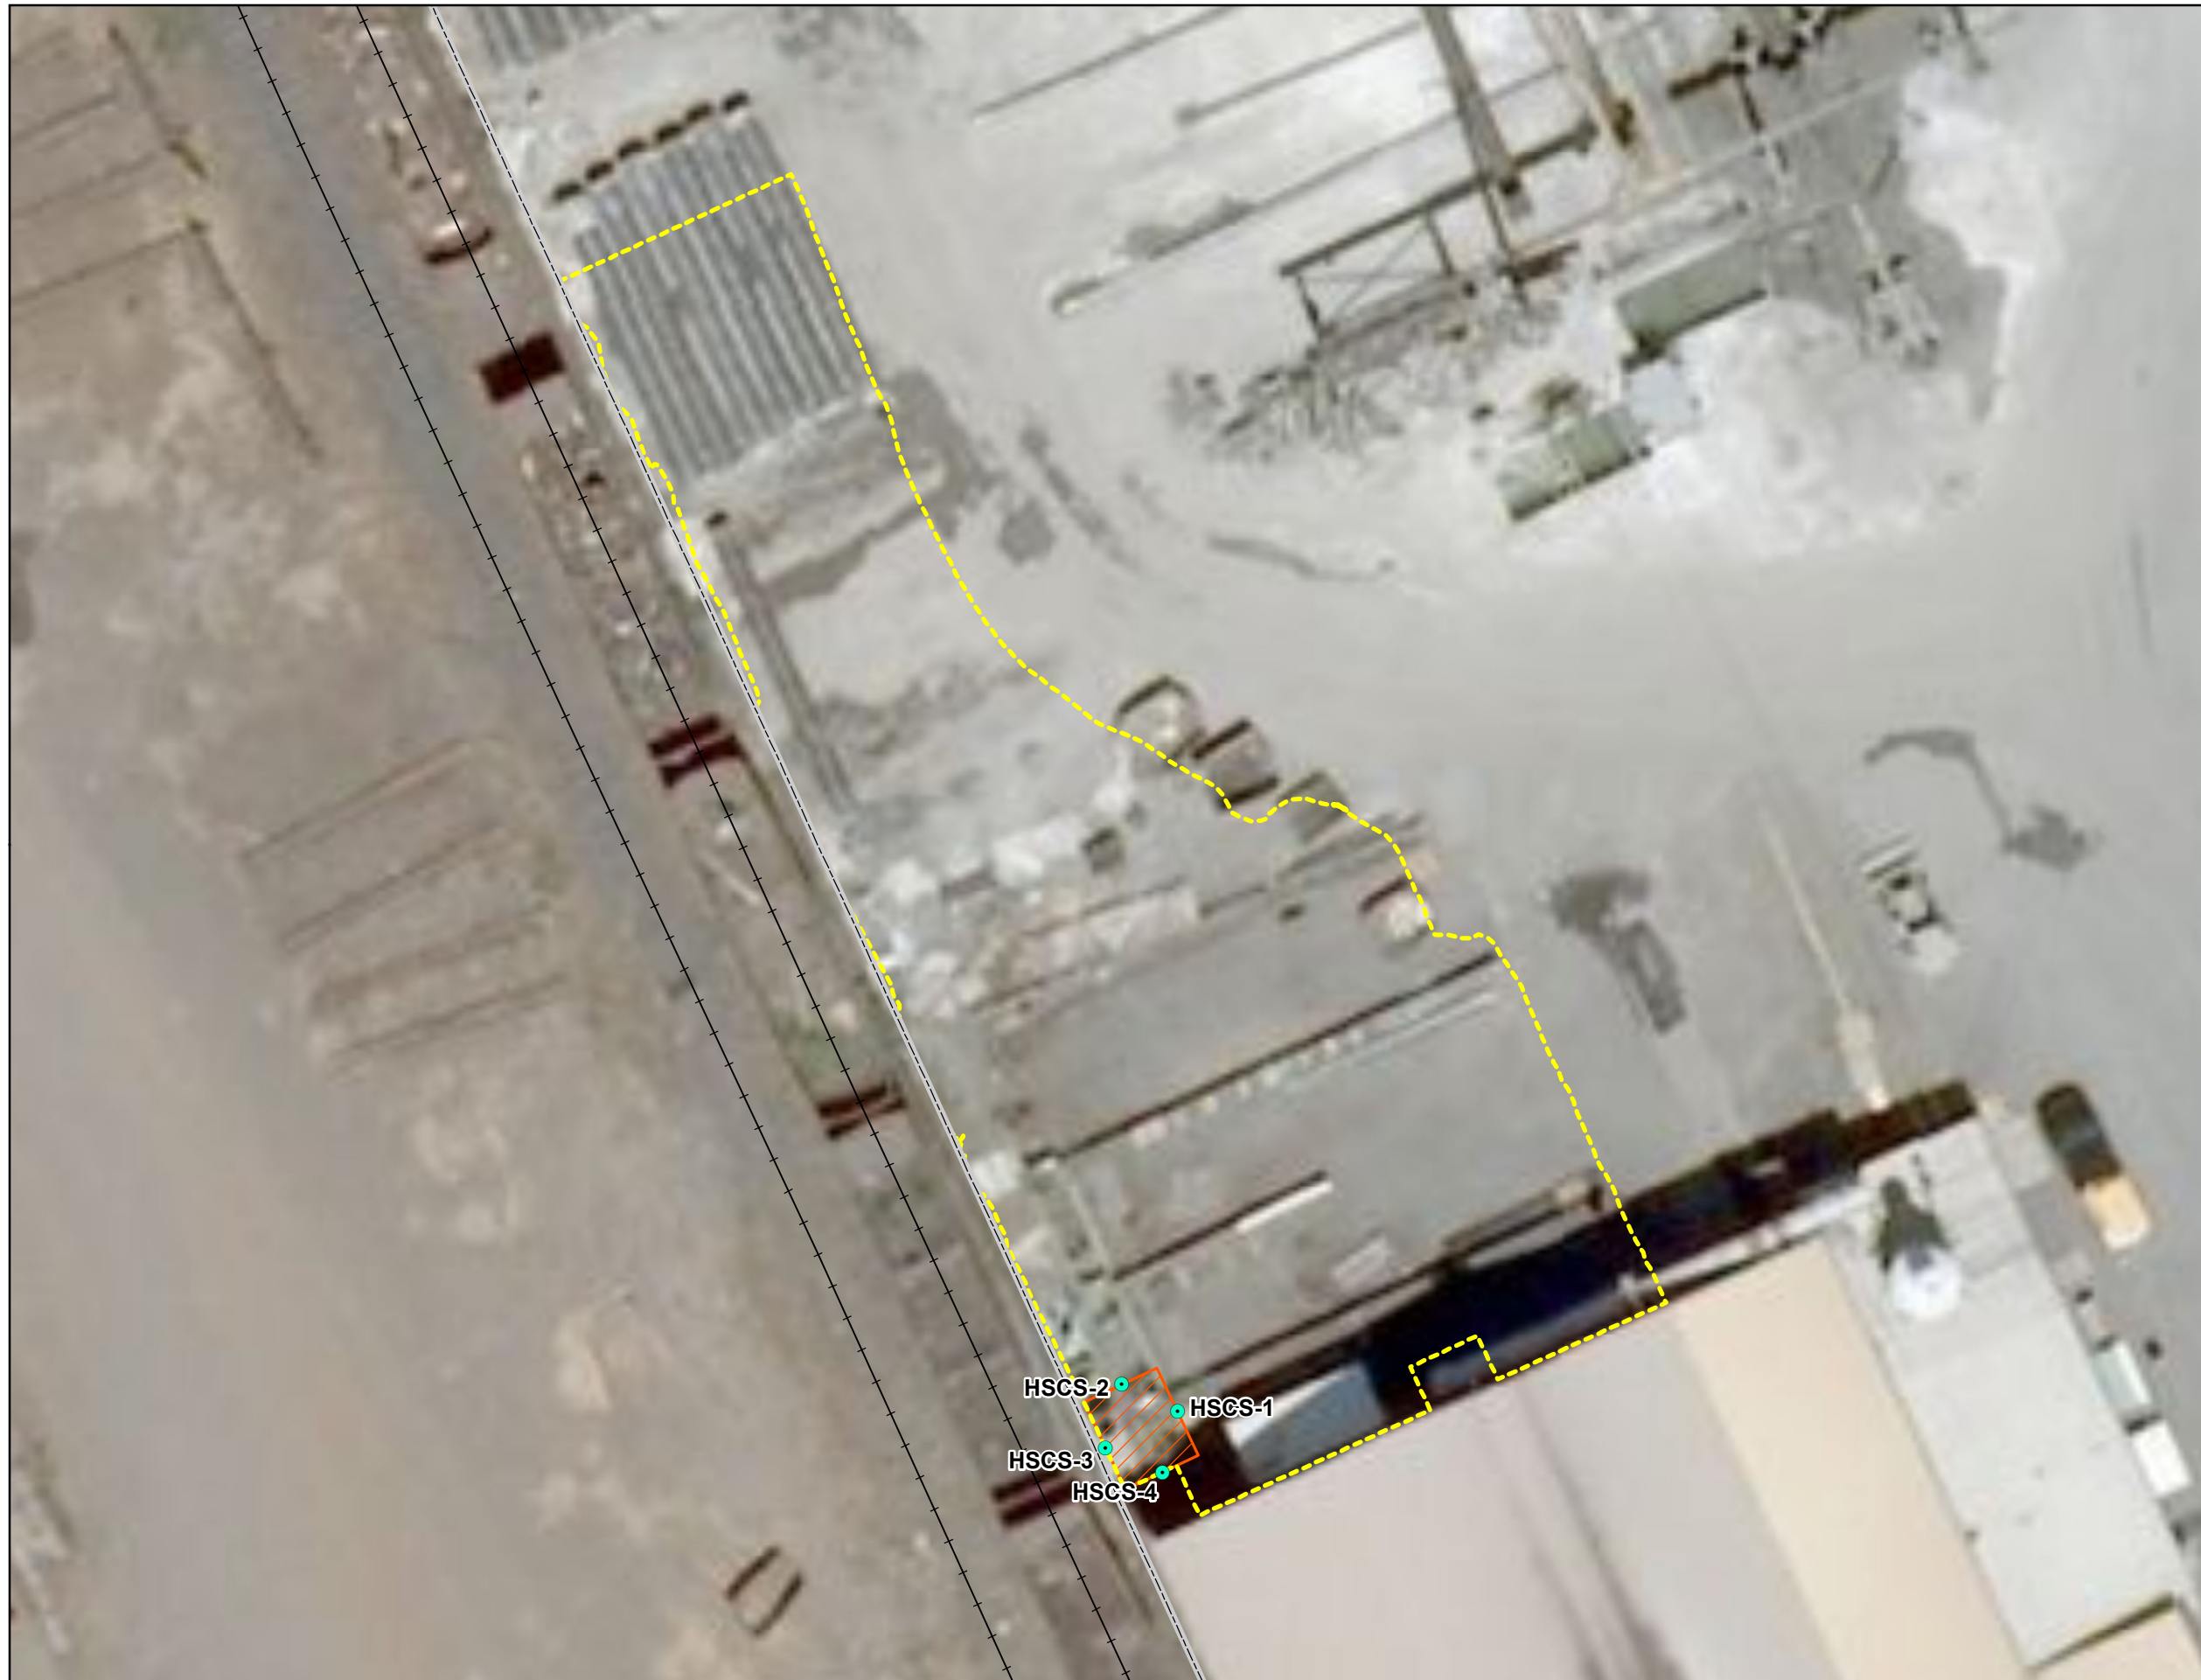
Figure 1
Stained Soil Area
Investigation
Northwest Pipe Company
Portland, Oregon

During the CH2M HILL site visit on September 9, 2011, soil samples were collected from the sidewalls of the deeper excavation. Figure 1 displays the hot spot excavation extent based on hand-held tape measurements, the extent of the deeper excavation area and associated sidewall sample locations.

Soil samples were collected approximately 5.5 feet below the original grade, and 2 feet below the excavated grade at that location. The excavation depth of the hot spot area adjacent to the deeper excavation was approximately 3 feet below the original grade. Samples from the west and south sidewalls were collected from gray-stained soil. Samples from the north and east sidewalls were of native brown soil, as no staining was visible on these sidewalls. The samples were analyzed for PAHs via Environmental Protection Agency (EPA) method SW 8270-SIM and PCBs via EPA method SW 8082. The analytical laboratory report representing the deeper excavation samples is included in Attachment A.
