Bethel-Danebo Closed Landfill Progress Report

For July 2016

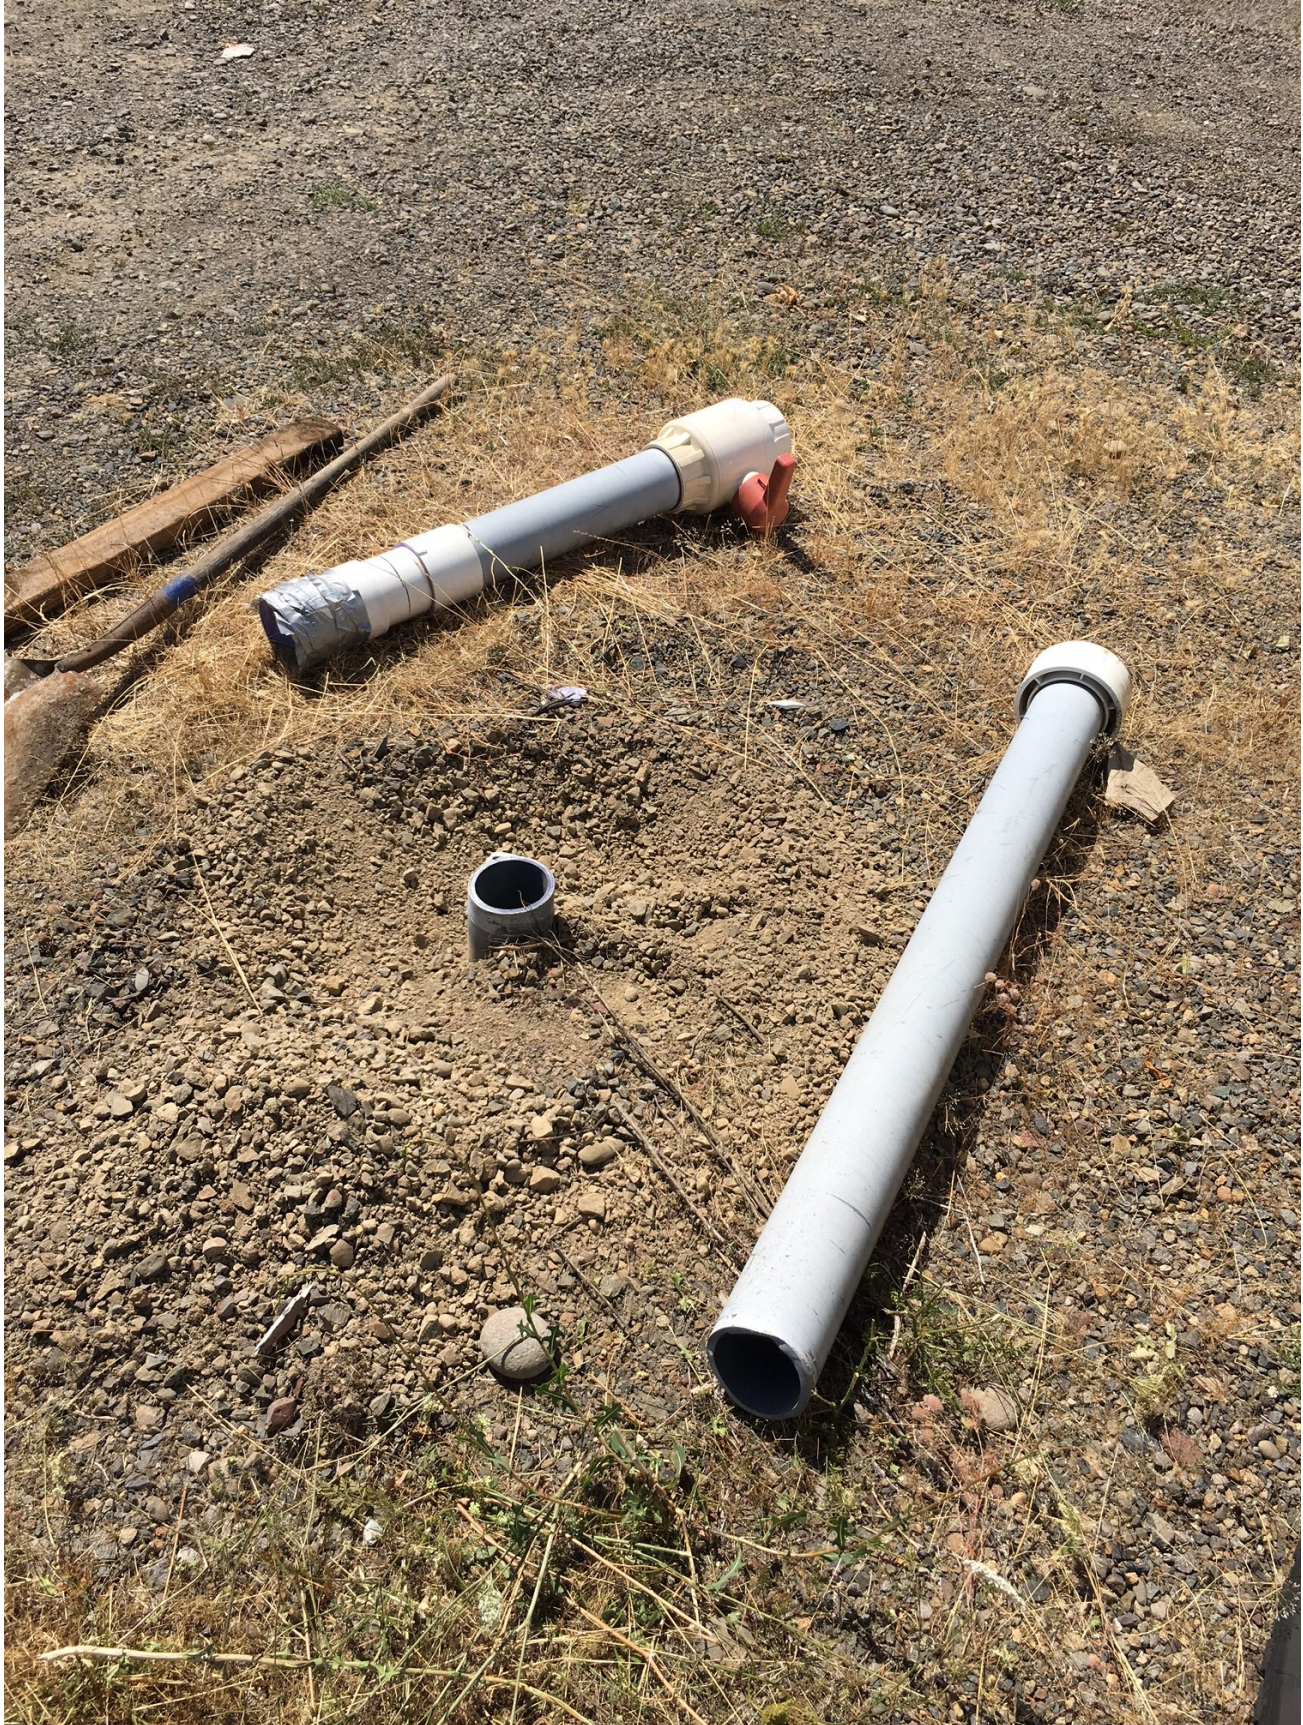
While doing gas sampling this month I noticed the probe in the middle of BCI's storage lot had a lean to it. After further investigation I discovered the riser had been broken off below the ground and someone had placed a 2x4 in the pipe in the ground and slipped the broken off riser pipe over the 2x4. This pipe had been hit in the past and broken off above ground. It was reported to me and I was able to easily fix it. This break went unreported and I suspect had been broken for months. I dug the pipe out and capped it at ground level. I have marked the cap and working with BCI to place a metal plate over it. I suspect this riser break could be the cause of vacuum reduction and the increase in methane percentage at probe08. August's sampling should tell.

- Gas sampling at trench probes and the gas collection system.
- Blower has run continually without issue since June the 25th 2015.
- The blower vacuum is at 7.4. The soils have dried and have some larger cracking.
- Blower exhaust was sampled for methane (BLOWEXAU) a constant 0.3% was observed. I plan to make this a regular sample location.
- Repair of passive exhaust riser on BCI lot. Picture of broken riser attached.

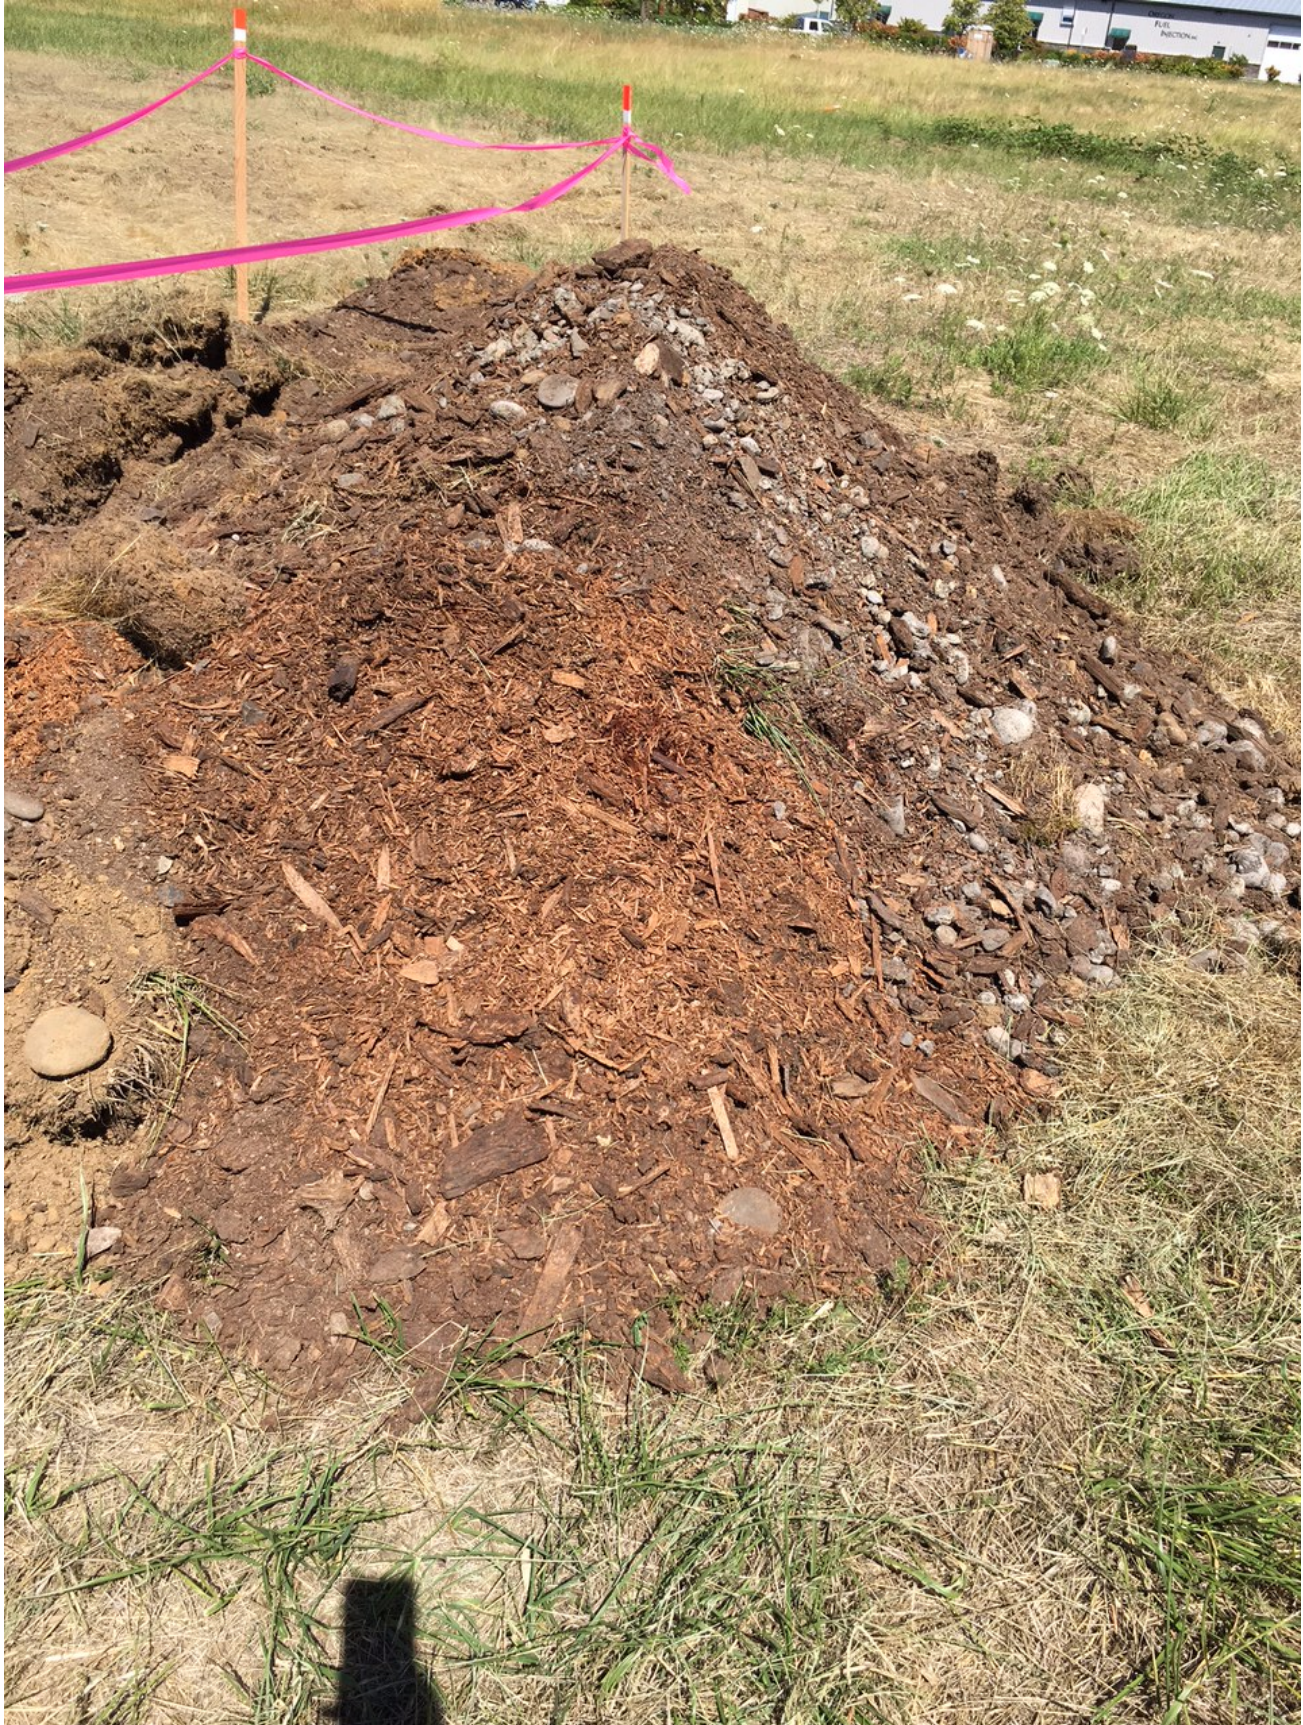
On a random visit past the site I observed several pits that had been dug on lot 26. They appear to have been dug by a back hoe and were anywhere between 4 and 8 feet deep. The lot has had a "for sale" sign on it and I would guess someone was interested in buying. The neighbors tell me it happened on a Sunday and they did not see it being done. The pits were filled the next week and smoothed out with no more activity. One picture attached.
