## Contaminated Media Management Plan

Galvanizers Company  
Portland, Oregon  
ECSI ID#: 1196

**Central Project:** GalvCo-1-01-03

## Risk Evaluation Report

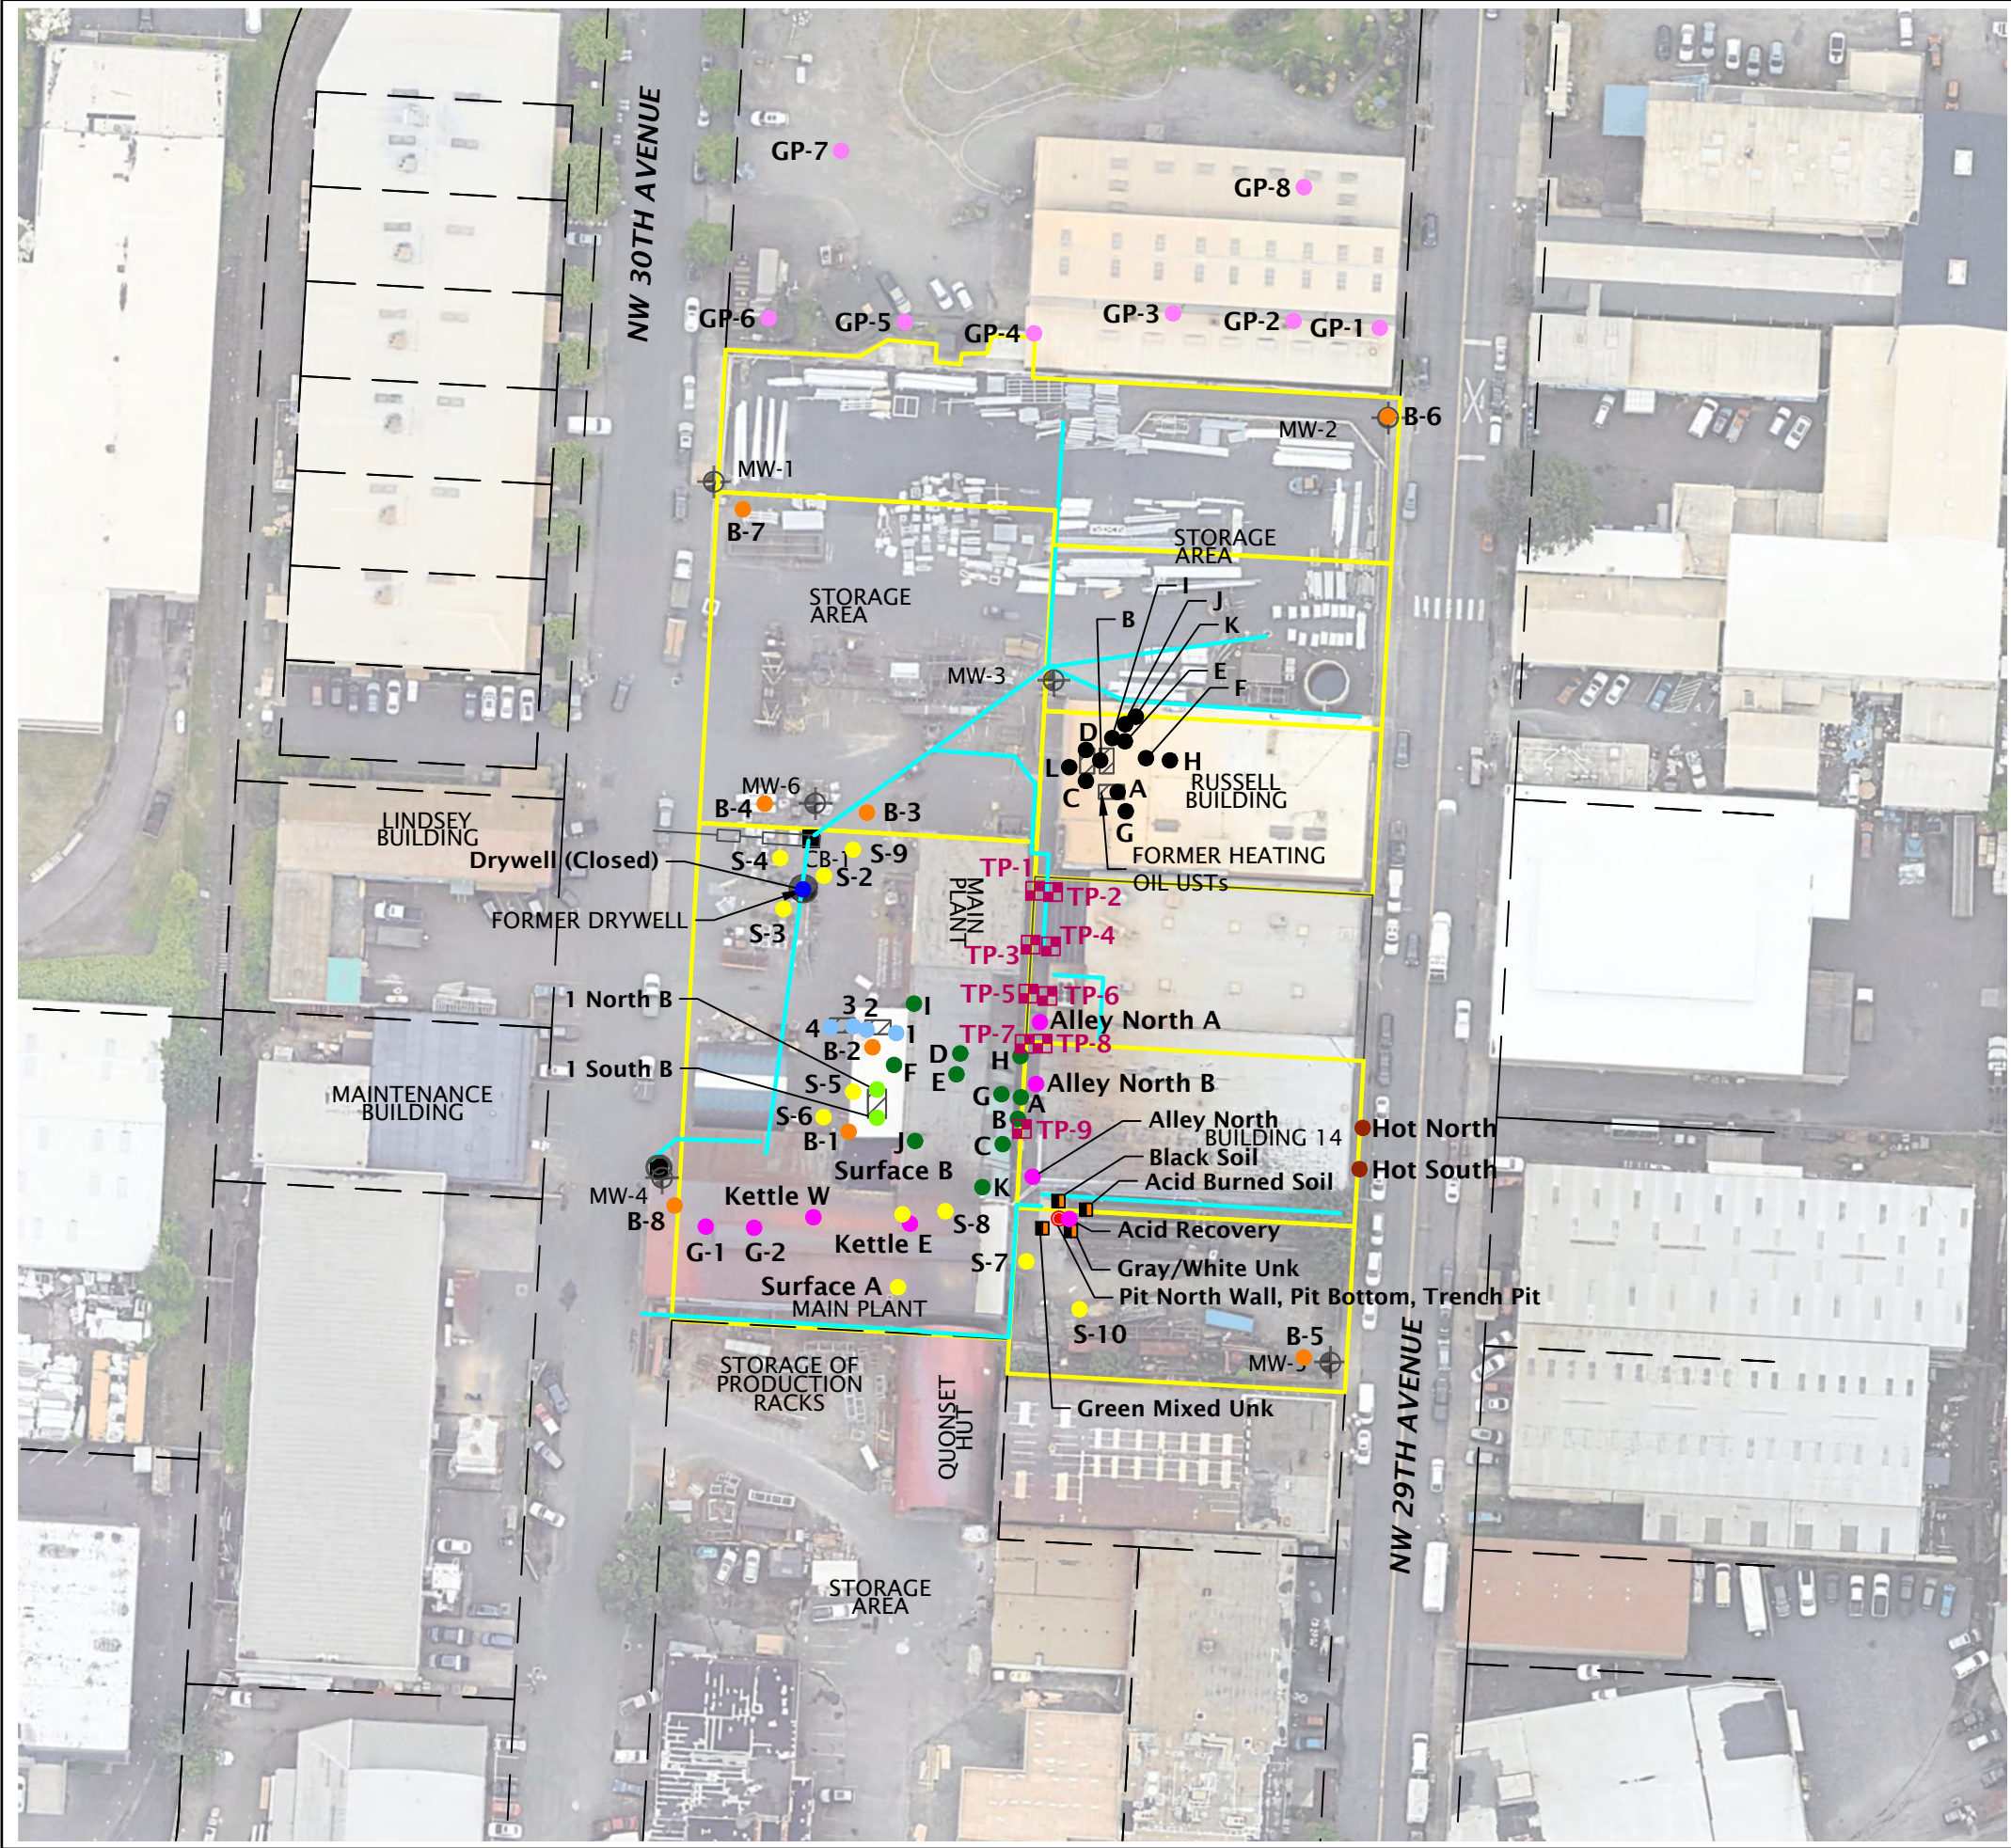
PREVIOUS INVESTIGATION SAMPLE LOCATIONS - ON SITE

- LEGEND:**
- MONITORING WELL
  - ON-SITE CATCH BASIN
  - ON-SITE STORMLINE
  - GALVANIZERS COMPANY PROPERTY
  - TAX LOT BOUNDARY
  - 1992/1993 SAMPLE
  - JULY 1996 SOIL BORING
  - NOVEMBER 1996 SOIL BORING
  - OCTOBER 1998 SOIL BORING
  - OCTOBER 1998 HEATING OIL UST SOIL BORING
  - NOVEMBER 1999 UNKNOWN BACKFILL MATERIAL SAMPLES
  - MAY 1999 SOIL SAMPLE
  - SEPTEMBER 1999 FREEMAN
  - JULY/SEPTEMBER 2000 SOIL BORINGS
  - OCTOBER 2001 TEST PIT
  - AUGUST 2001 CONFIRMATION SAMPLES
  - AREA OF 2001 DRY WELL CLOSURE
  - OCTOBER 2003 SOIL BORING

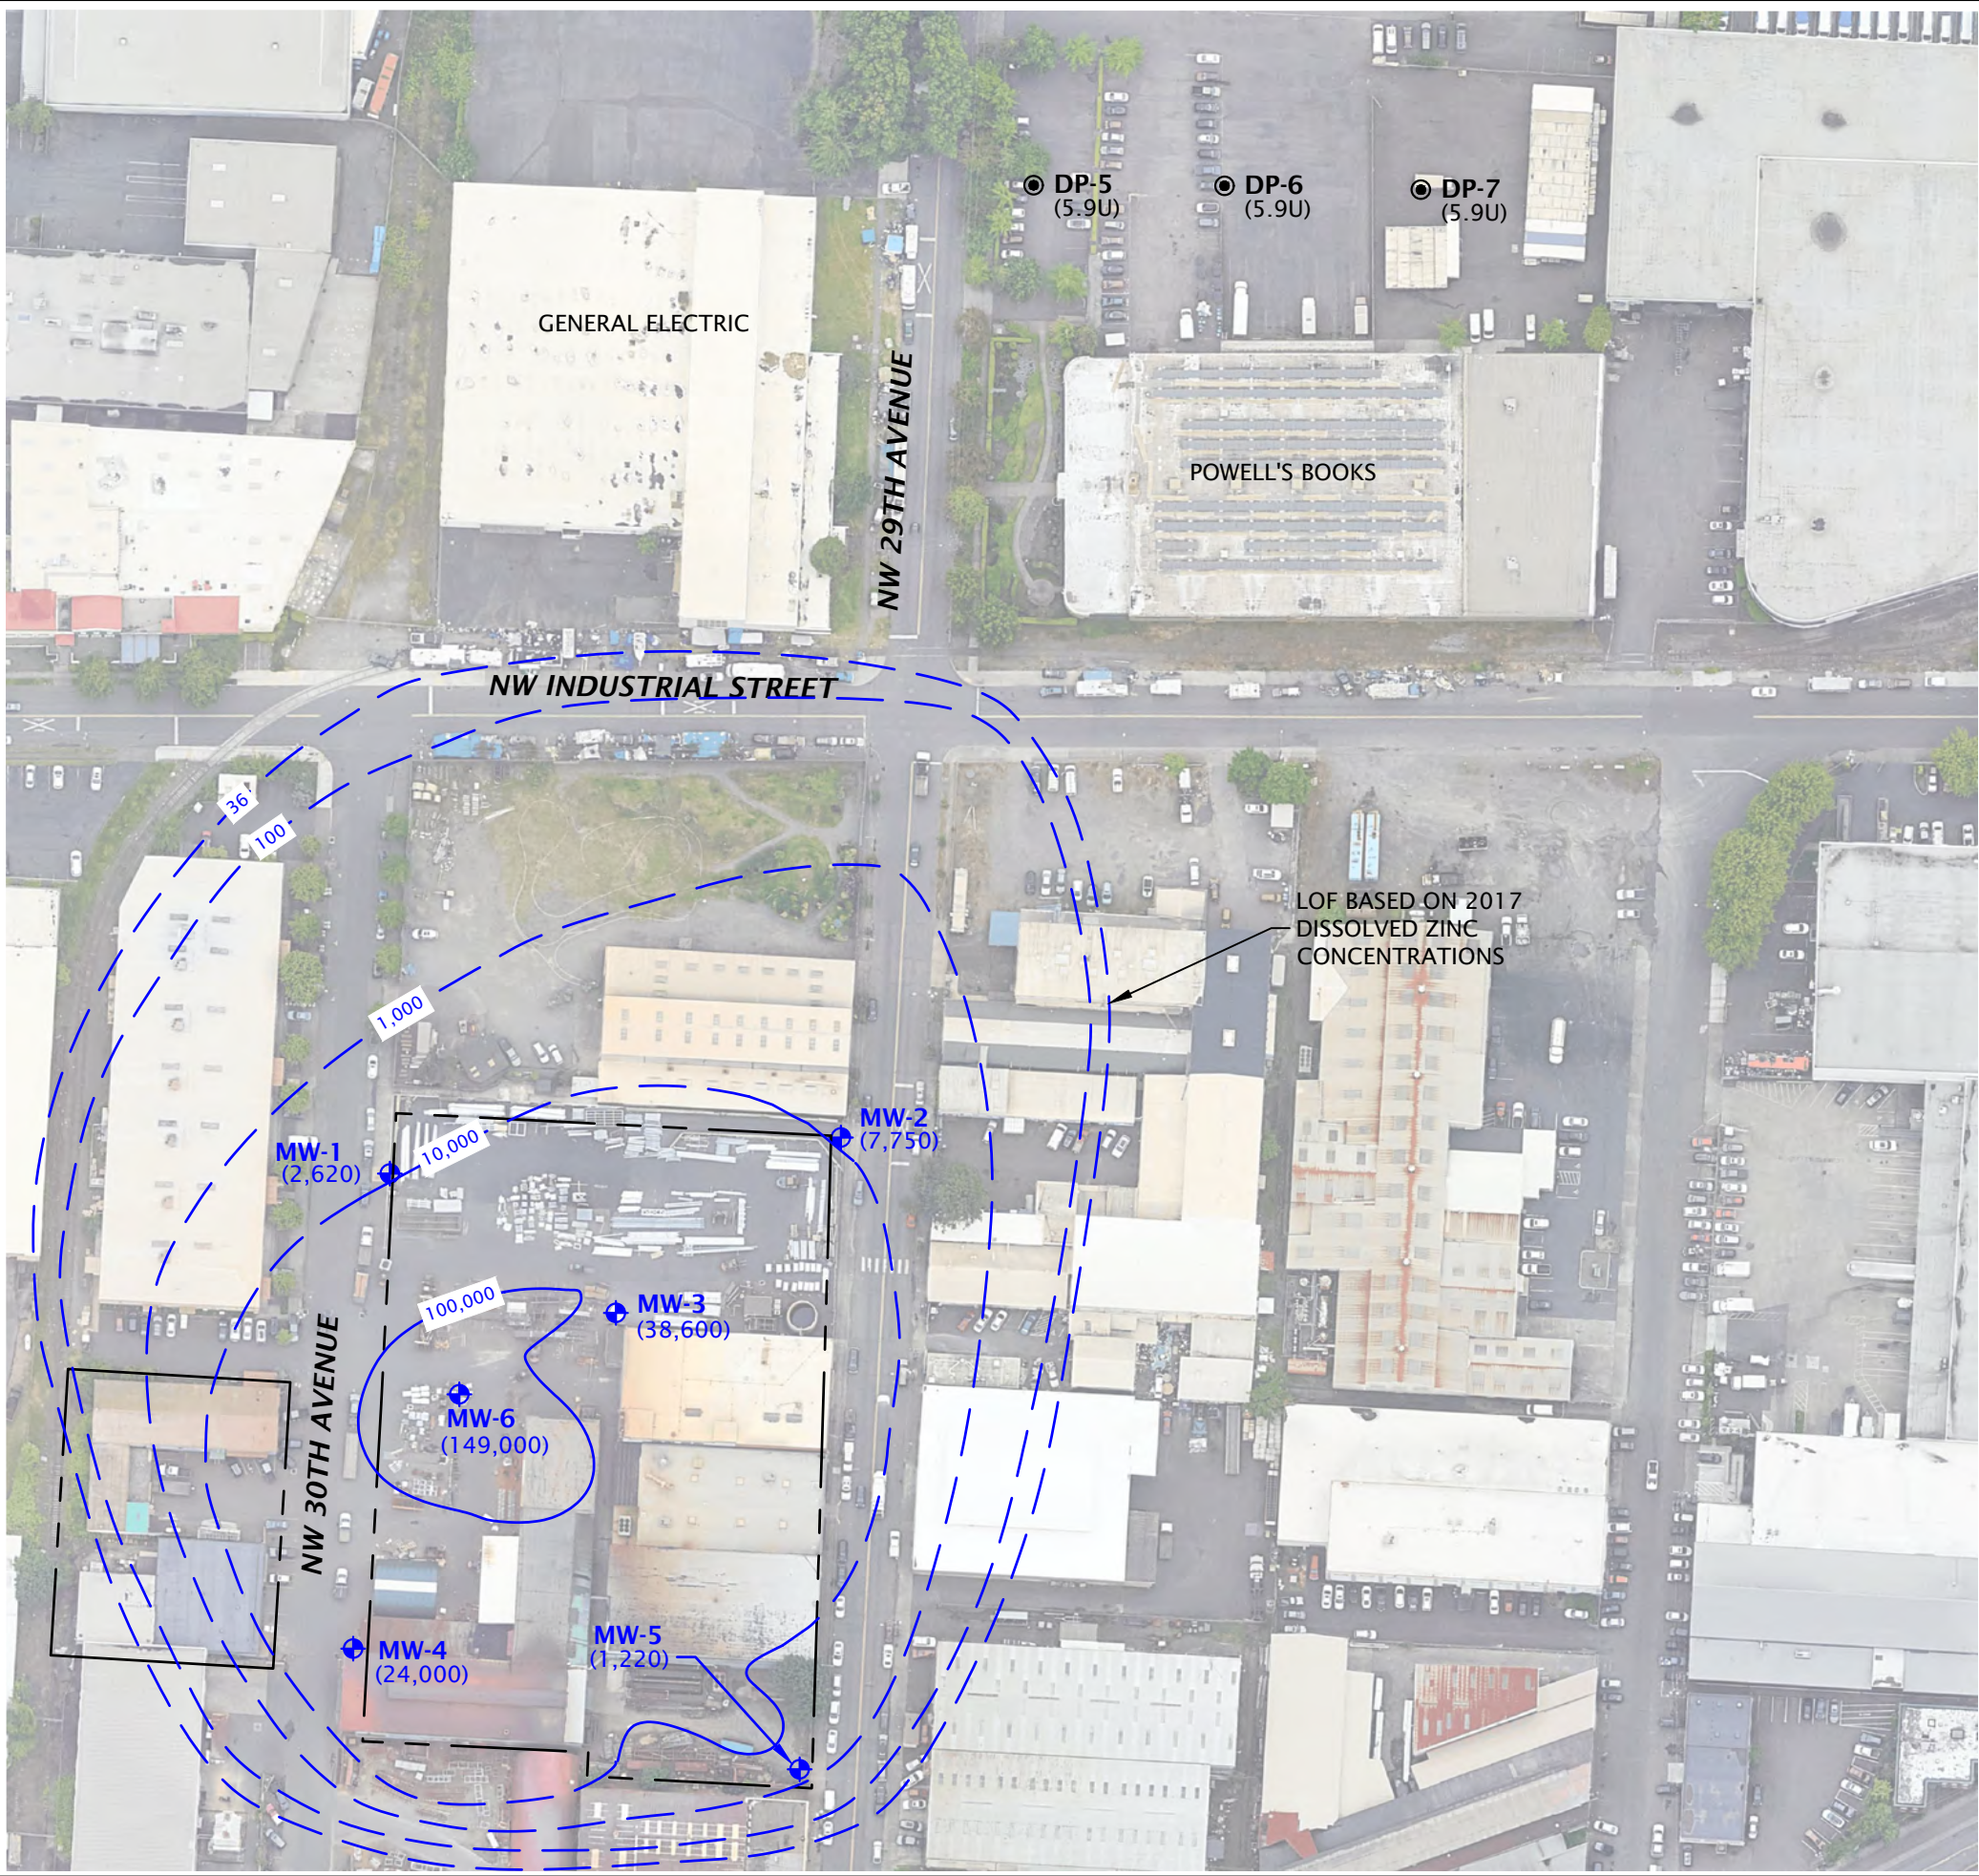
1. ANALYTICAL RESULTS SHOWN ARE FOR GROUNDWATER SAMPLES COLLECTED ON SEPTEMBER 25 AND 26, 2017.

2. CONTOUR INTERVAL: LOGARITHMIC
