Risk Evaluation Report

Galvanizers Company
Portland, Oregon

Central Project: GalvCo-1-01-03

Subject: Risk Evaluation Report
Galvanizers Company
2406 NW 30th Avenue
Portland, Oregon
Central Project No.: GalvCo-1-01

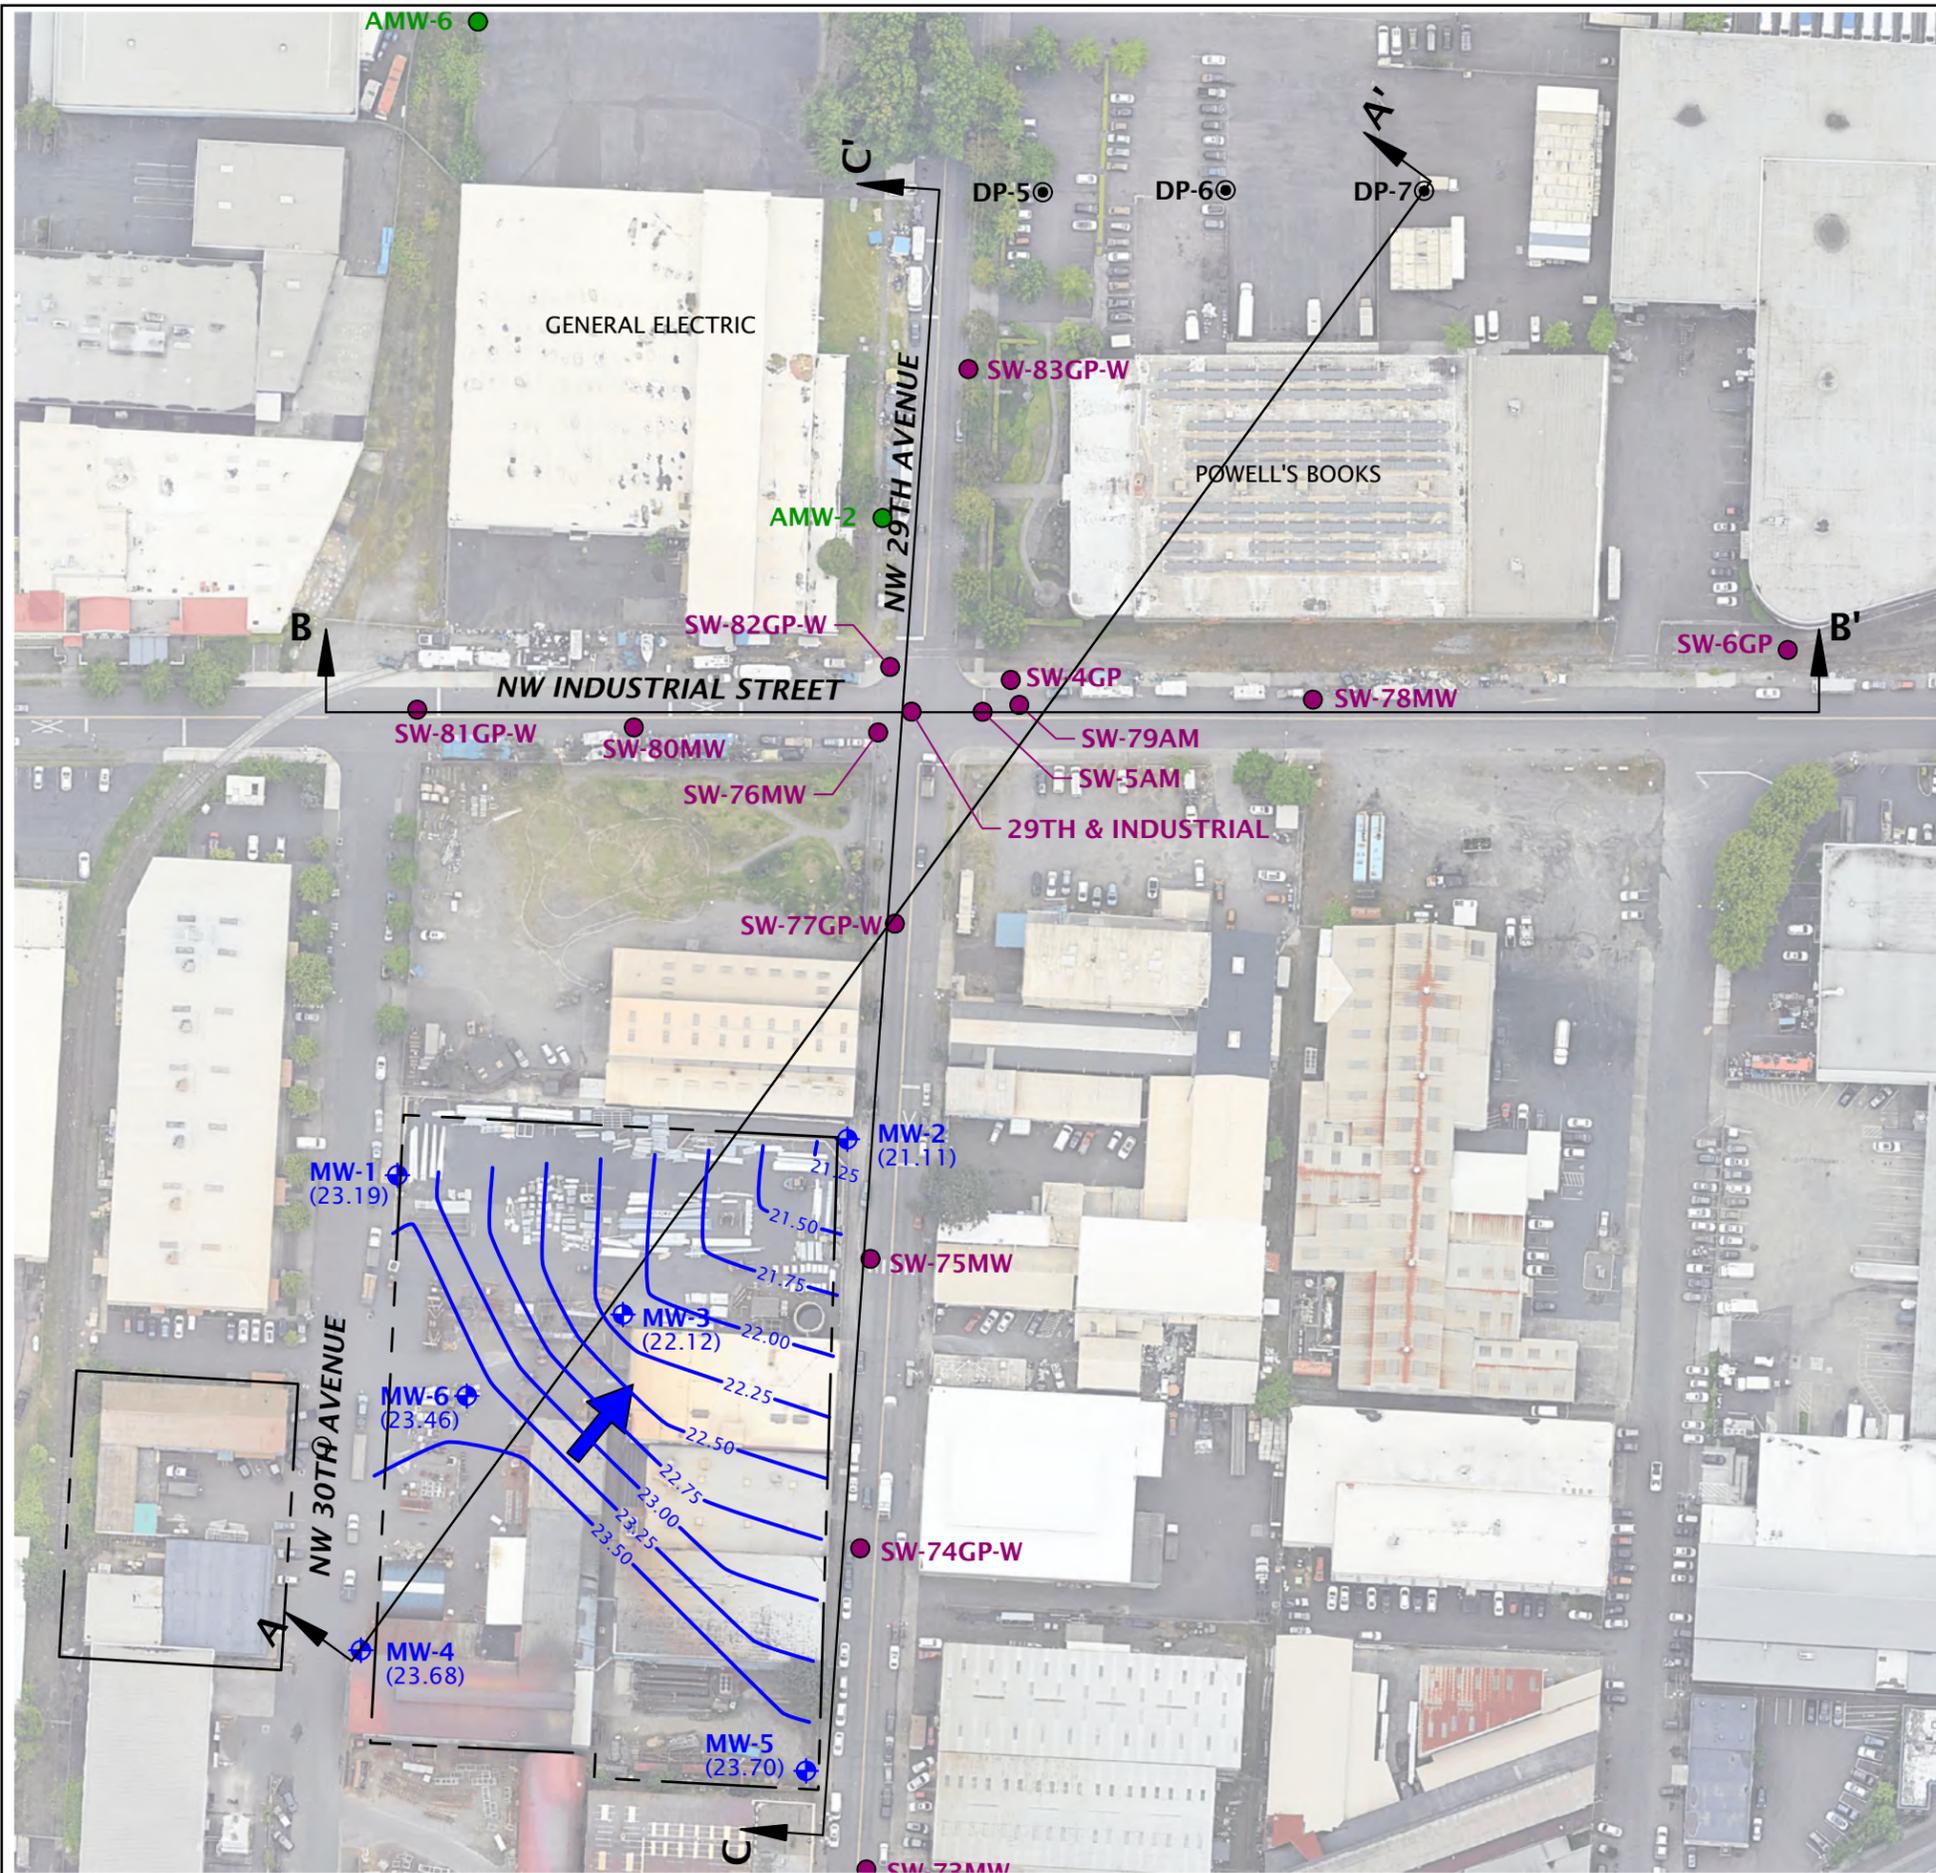
- ◆ MW-1 (23.19) GROUNDWATER MONITORING WELL WITH GROUNDWATER ELEVATION (FEET, COP DATUM)
- SW-5AM 2007, 2008, AND 2009 SHANNON & WILSON SAMPLE LOCATION
- DP-5 DIRECT-PUSH BORING (GEODESIGN 2017)
- AMW-2 2008 MWH SAMPLE LOCATION
- GROUNDWATER CONTOUR (0.25-FOOT INTERVAL)
- ➔ INFERRED GROUNDWATER FLOW DIRECTION
- ↕ CROSS SECTION
- - - SUBJECT PROPERTY BOUNDARY

1. GROUNDWATER ELEVATIONS MEASURED ON SEPTEMBER 26, 2017.
2. GRADIENT = 0.006 FOOT/FOOT.

Based on nearby explorations, subsurface conditions generally consist of sand to a depth of approximately 16 feet below ground surface (bgs) underlain by silt to a depth of approximately 20 feet bgs. Sand with silt underlies the silt to the total depths explored. The sand unit is interpreted as the sluiced fill or dredged fill that was reportedly used to fill Guilds Lake. The silt and sand with silt units are interpreted as the former bottom of Guilds Lake. A potentiometric surface and geologic cross sections showing the subsurface lithology and groundwater elevations are shown on Figures 3 through 6.

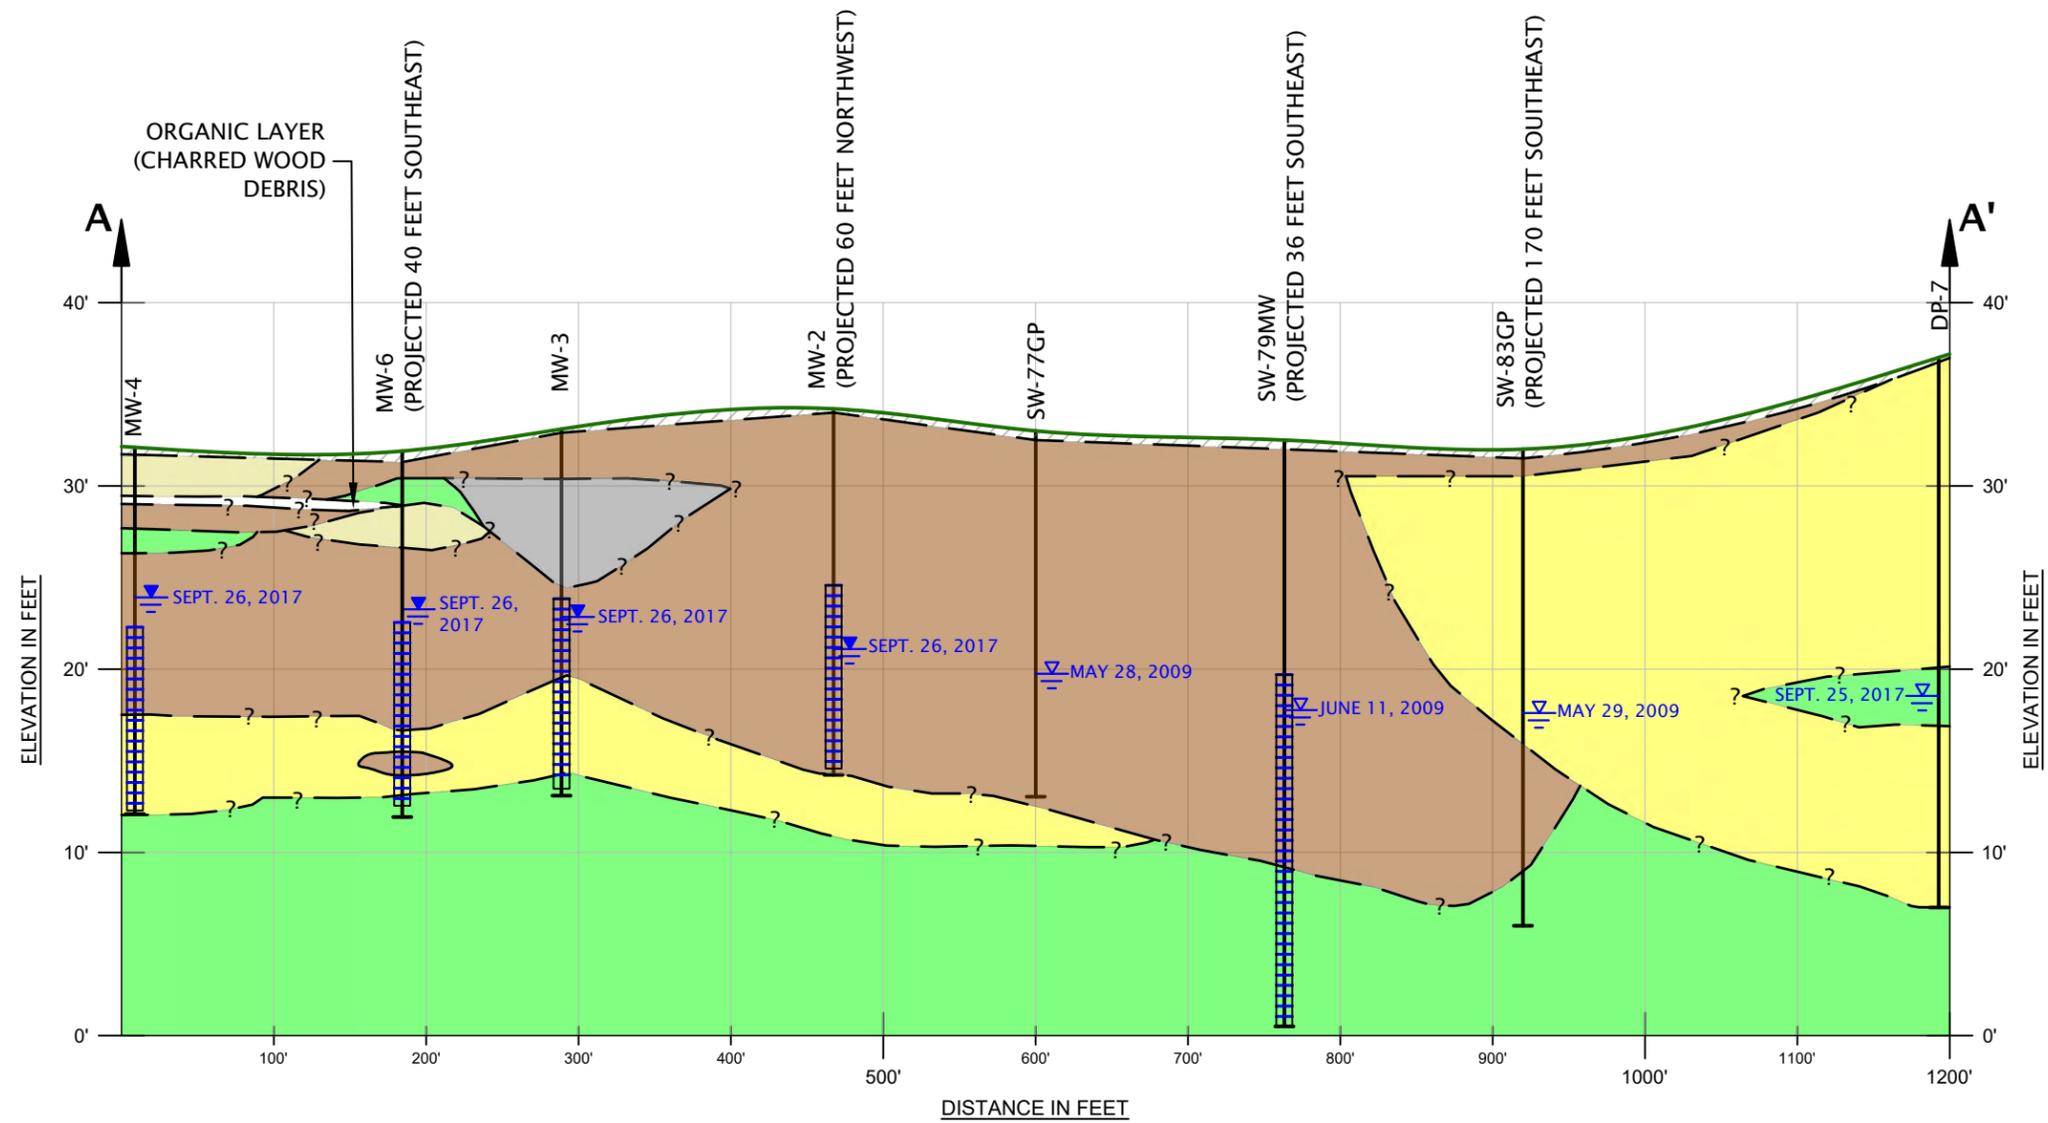
Figure 4

CROSS SECTION A-A'

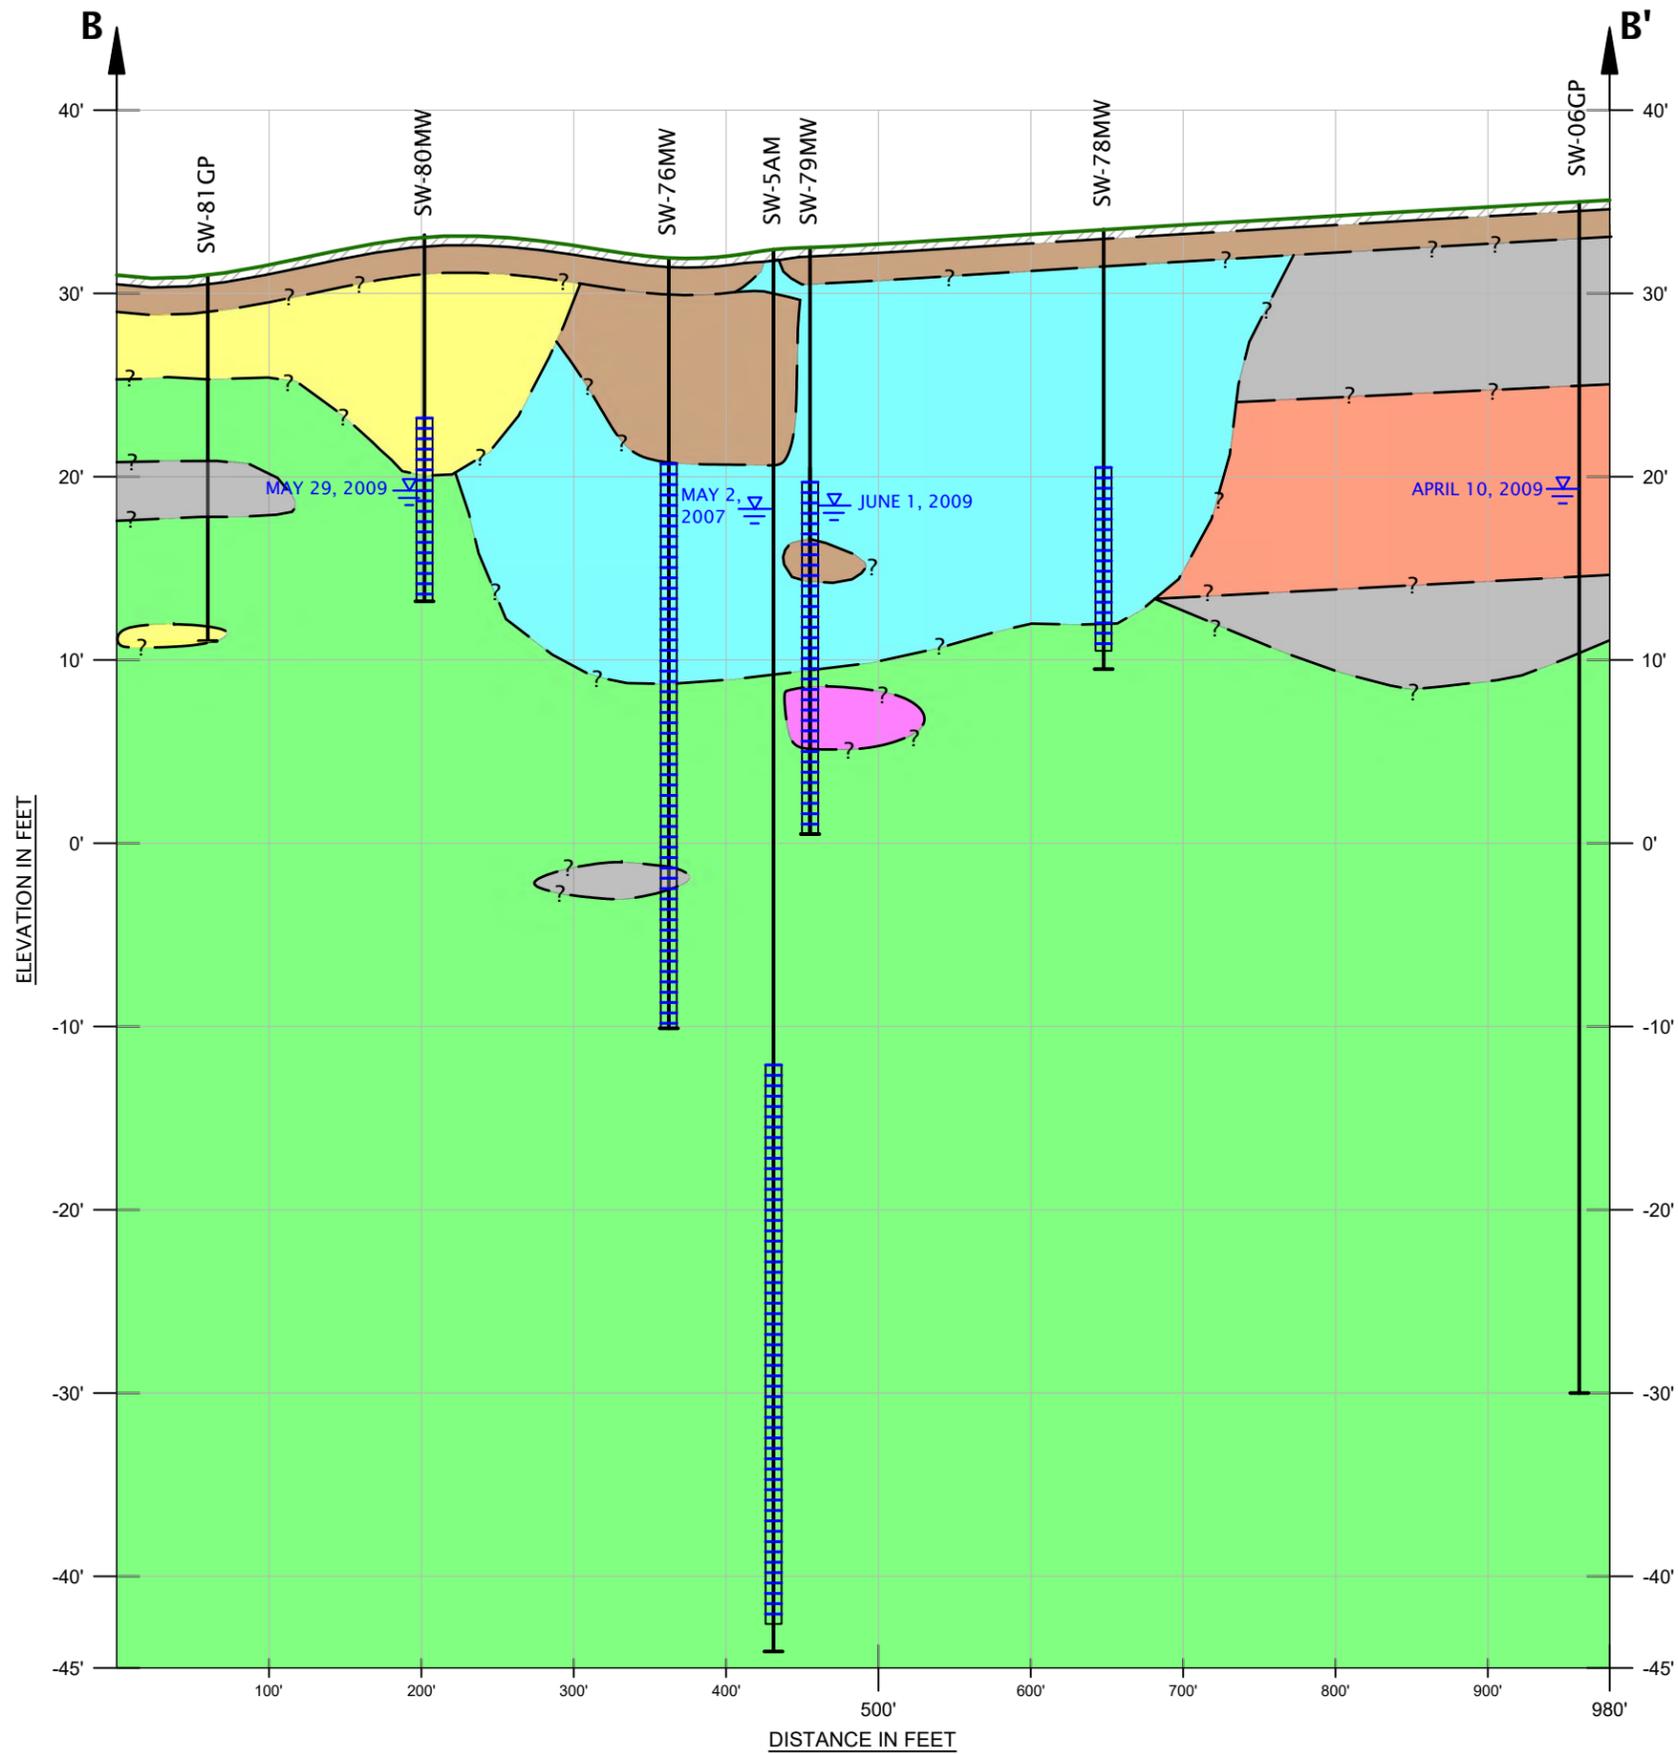
- LEGEND:**
- SURFACE TOPOGRAPHY
 - BORING
 - INTERPRETED CONTACT
 - GROUNDWATER ELEVATION (MEASURED DURING DRILLING)
 - PAVEMENT SECTION
 - GRAVEL WITH SILT AND SAND
 - SAND
 - SILT WITH SAND
 - SILTY SAND
 - GRAVEL WITH SAND
 - SAND WITH SILT
 - SAND WITH SILT AND GRAVEL
 - SCREENED INTERVAL

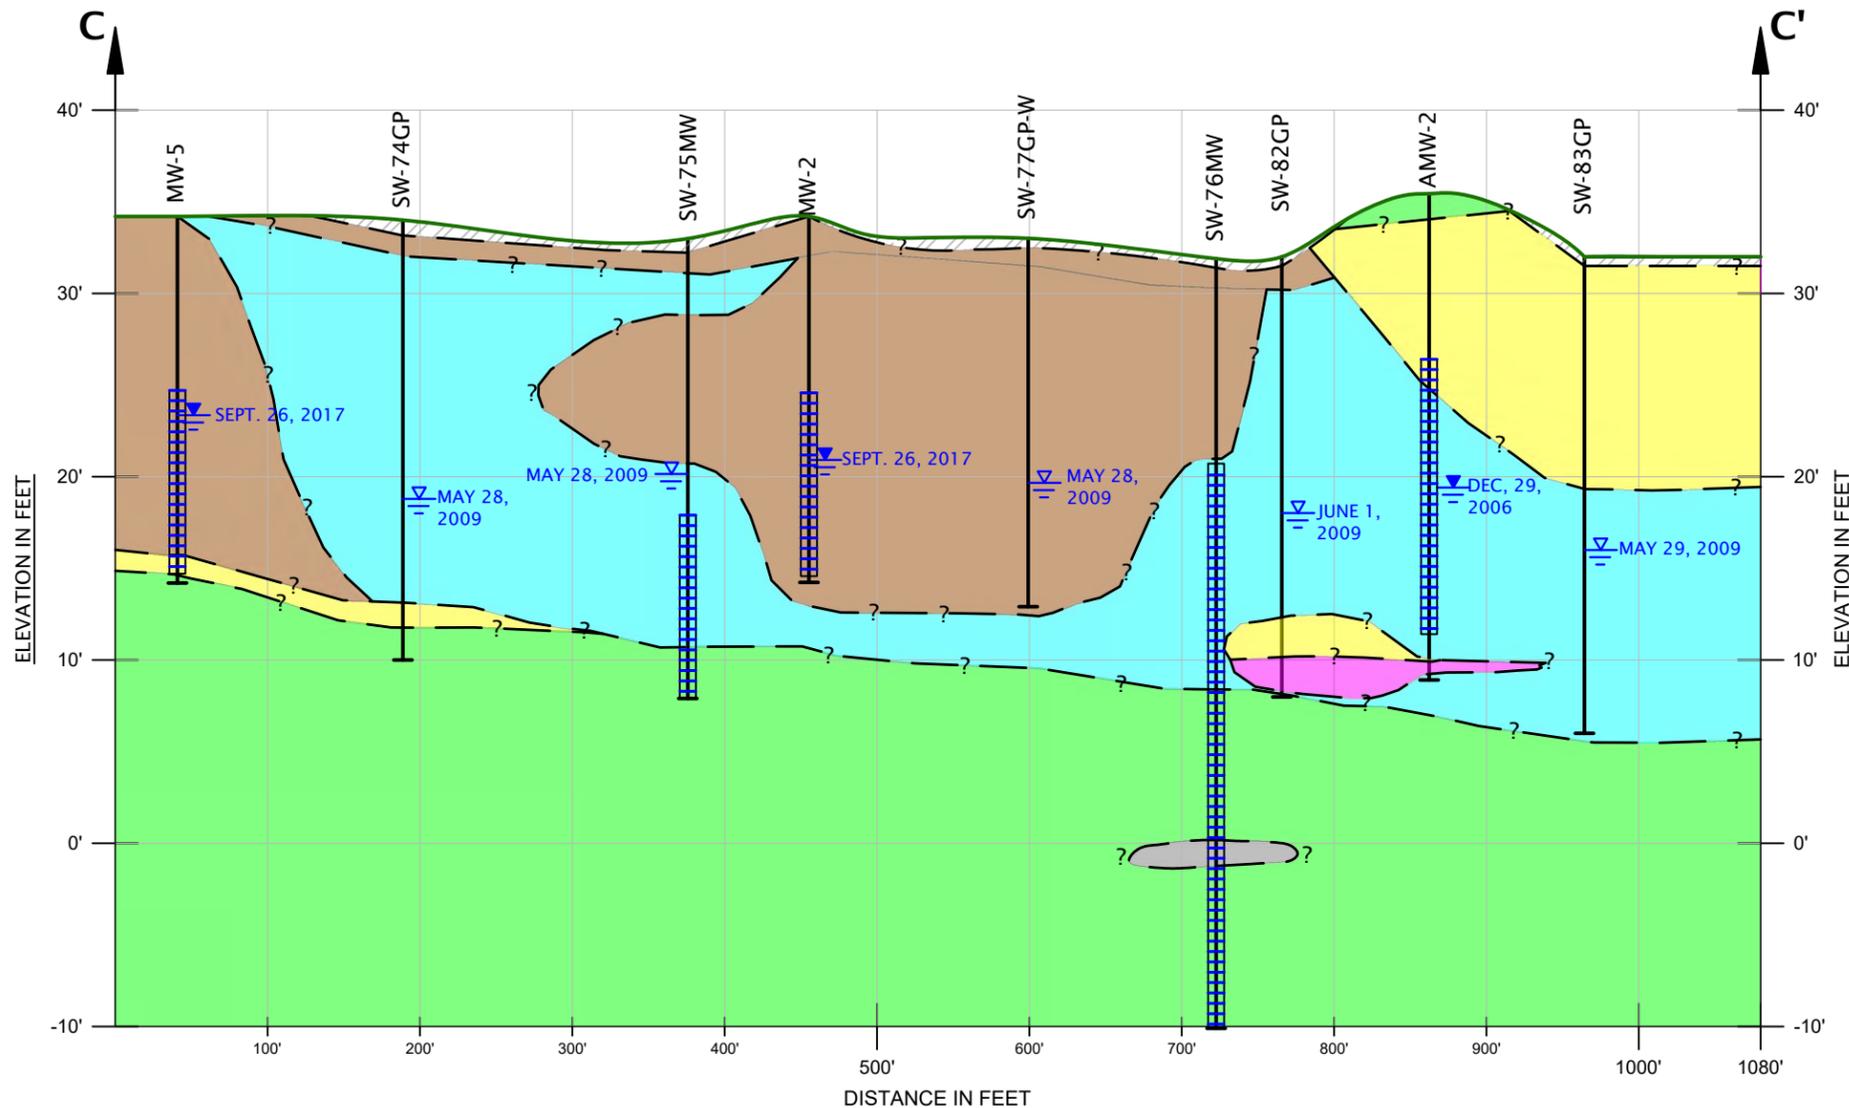
Figure 6

- SURFACE TOPOGRAPHY
- BORING
- INTERPRETED CONTACT
- GROUNDWATER ELEVATION (MEASURED DURING DRILLING)
- STATIC GROUNDWATER ELEVATION
- PAVEMENT SECTION
- GRAVEL WITH SILT AND SAND
- SAND
- SILT WITH SAND
- SILTY SAND
- GRAVEL WITH SAND
- SAND WITH SILT
- SCREENED INTERVAL

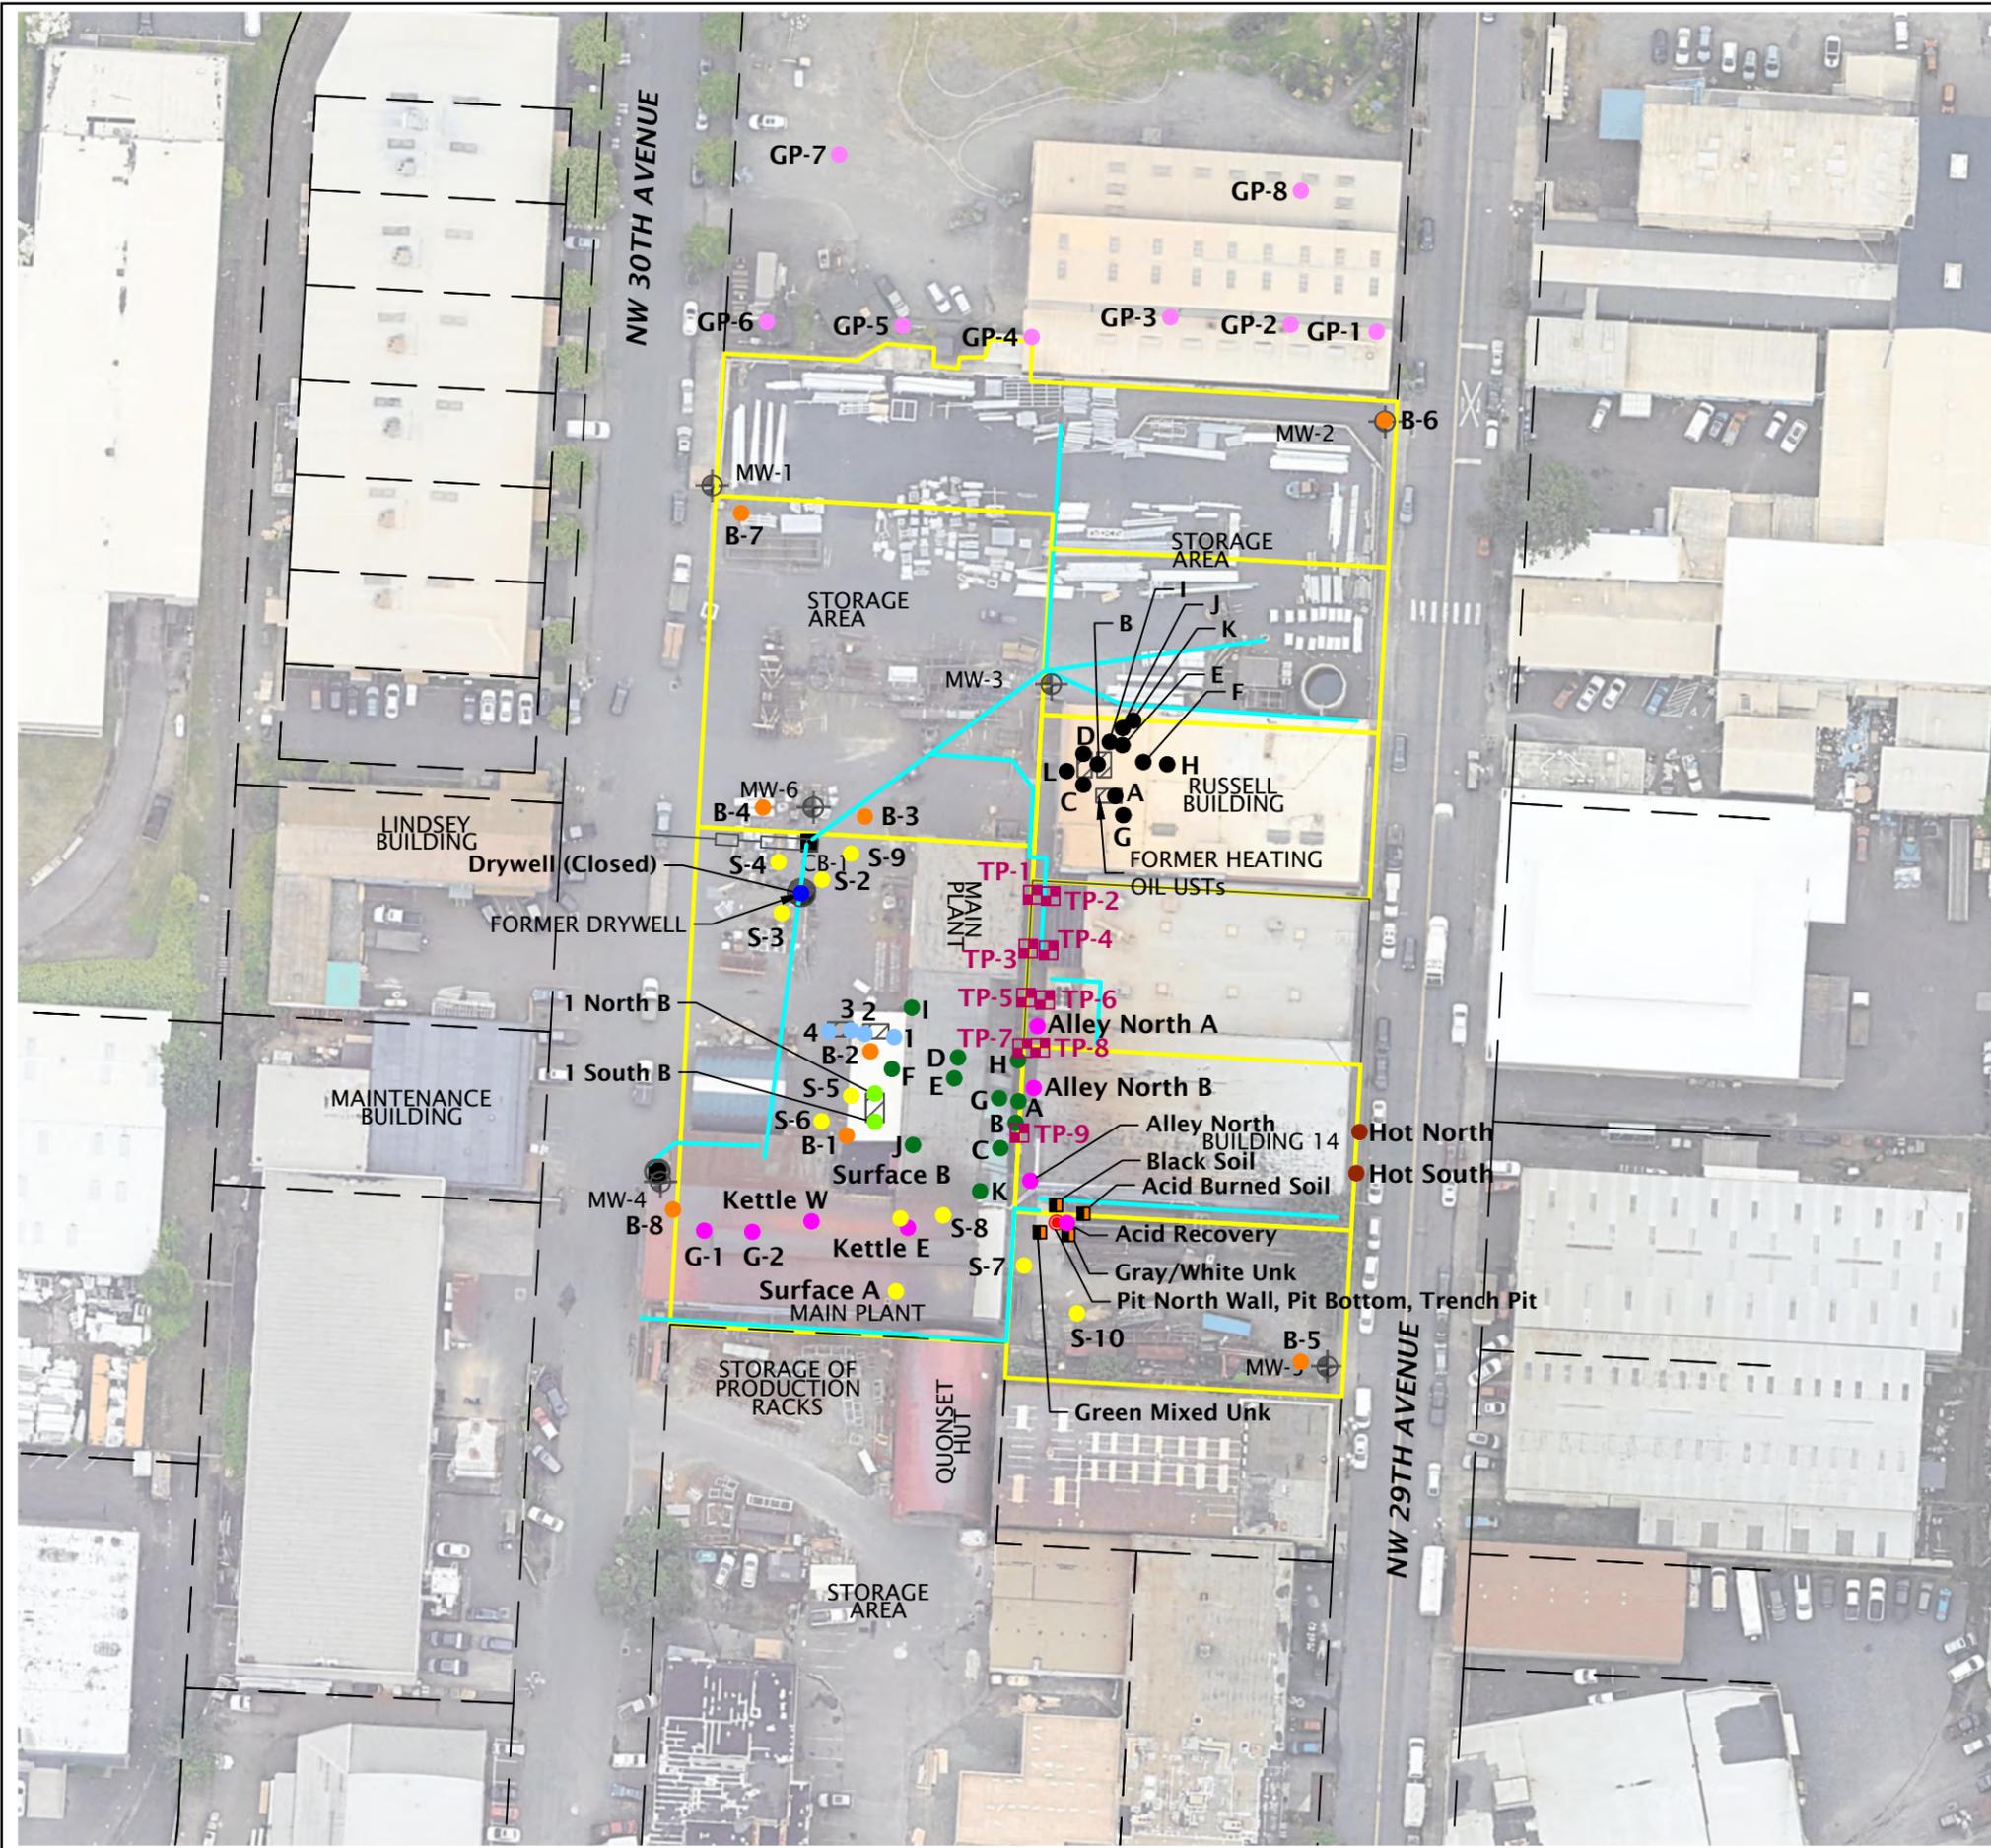
- LEGEND:**
- MONITORING WELL
 - ON-SITE CATCH BASIN
 - ON-SITE STORMLINE
 - GALVANIZERS COMPANY PROPERTY
 - TAX LOT BOUNDARY
 - 1992/1993 SAMPLE
 - JULY 1996 SOIL BORING
 - NOVEMBER 1996 SOIL BORING
 - OCTOBER 1998 SOIL BORING
 - OCTOBER 1998 HEATING OIL UST SOIL BORING
 - NOVEMBER 1999 UNKNOWN BACKFILL MATERIAL SAMPLES
 - MAY 1999 SOIL SAMPLE
 - SEPTEMBER 1999 FREEMAN
 - JULY/SEPTEMBER 2000 SOIL BORINGS
 - OCTOBER 2001 TEST PIT
 - AUGUST 2001 CONFIRMATION SAMPLES
 - AREA OF 2001 DRY WELL CLOSURE
 - OCTOBER 2003 SOIL BORING

As part of on-site investigations and groundwater monitoring, 69 groundwater samples were analyzed for total and/or dissolved metals. One or more of the following metals were detected in the groundwater samples analyzed for total metals: arsenic, barium, cadmium, chromium, copper, iron, lead, manganese, nickel, thallium, and zinc. Additionally, one or more of the following metals were detected in groundwater samples analyzed for dissolved metals: arsenic, barium, cadmium, chromium, copper, lead, manganese, nickel, silver, thallium, and zinc. The greatest detected concentrations were observed in a groundwater sample collected in 1993 from the plant area before facility upgrades. Total iron and total zinc were detected at concentrations of 2,040,000 µg/L and 2,330,000 µg/L, respectively. This sample was collected more than 30 years ago and not representative of current conditions. Total and dissolved metals results are summarized in Table 8. Sample locations are shown on Figure 7.

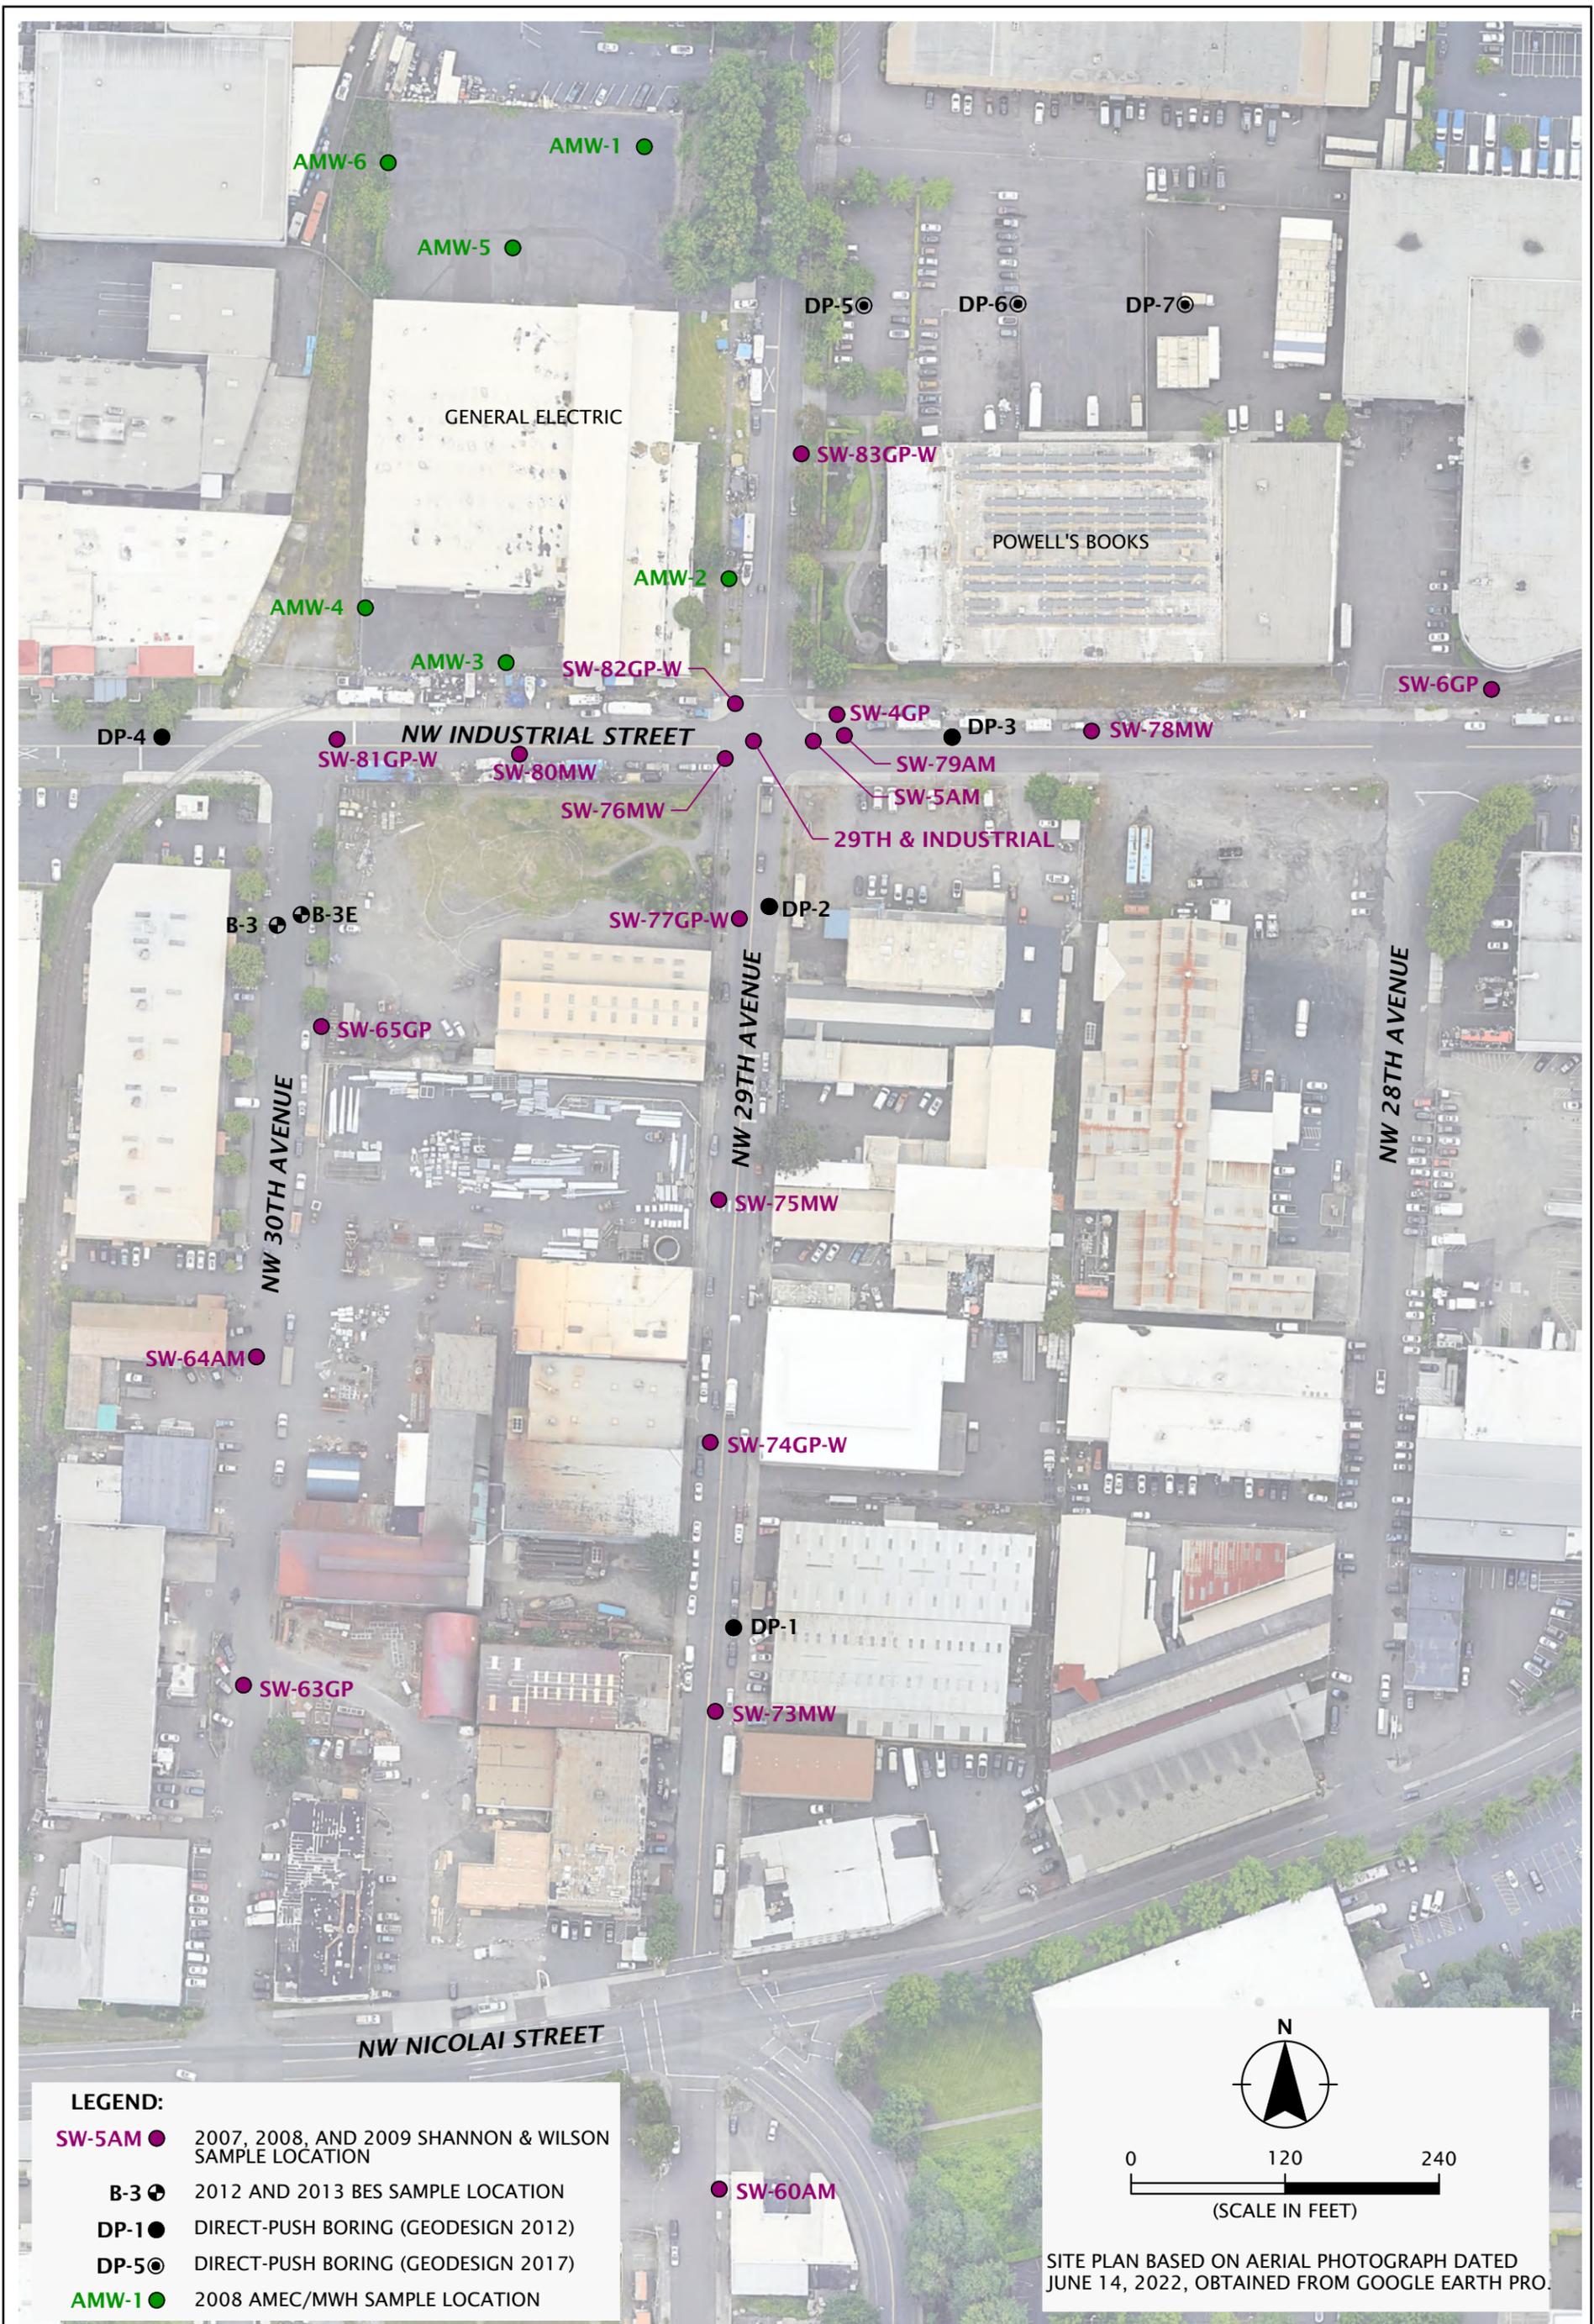
- SW-5AM 2007, 2008, AND 2009 SHANNON & WILSON SAMPLE LOCATION
- B-3 2012 AND 2013 BES SAMPLE LOCATION
- DP-1 DIRECT-PUSH BORING (GEODESIGN 2012)
- DP-5 DIRECT-PUSH BORING (GEODESIGN 2017)
- AMW-1 2008 AMEC/MWH SAMPLE LOCATION

In 2013, BES drilled a boring approximately 25 feet east of boring B3 on NW 30th Avenue (see Figure 8). This investigation was also associated with replacement of the 54-inch-by-54-inch storm line. Three soil samples were collected from the boring at 5-foot intervals between 5 feet bgs and 20 feet bgs. One groundwater sample was collected at a depth of 10 feet bgs (B3E @ 10ft). Soil samples were analyzed for TPH identification and RCRA 8 metals (arsenic, barium, cadmium, chromium, lead, mercury, selenium, and silver). The groundwater sample was analyzed for TPH identification with follow-up analysis for diesel- and/or gasoline-range hydrocarbons, as applicable, and RCRA 8 total and dissolved metals and total and dissolved zinc.³
