Risk Evaluation Report

Galvanizers Company
Portland, Oregon

Central Project: GalvCo-1-01-03

Subject: Risk Evaluation Report
Galvanizers Company
2406 NW 30th Avenue
Portland, Oregon
Central Project No.: GalvCo-1-01

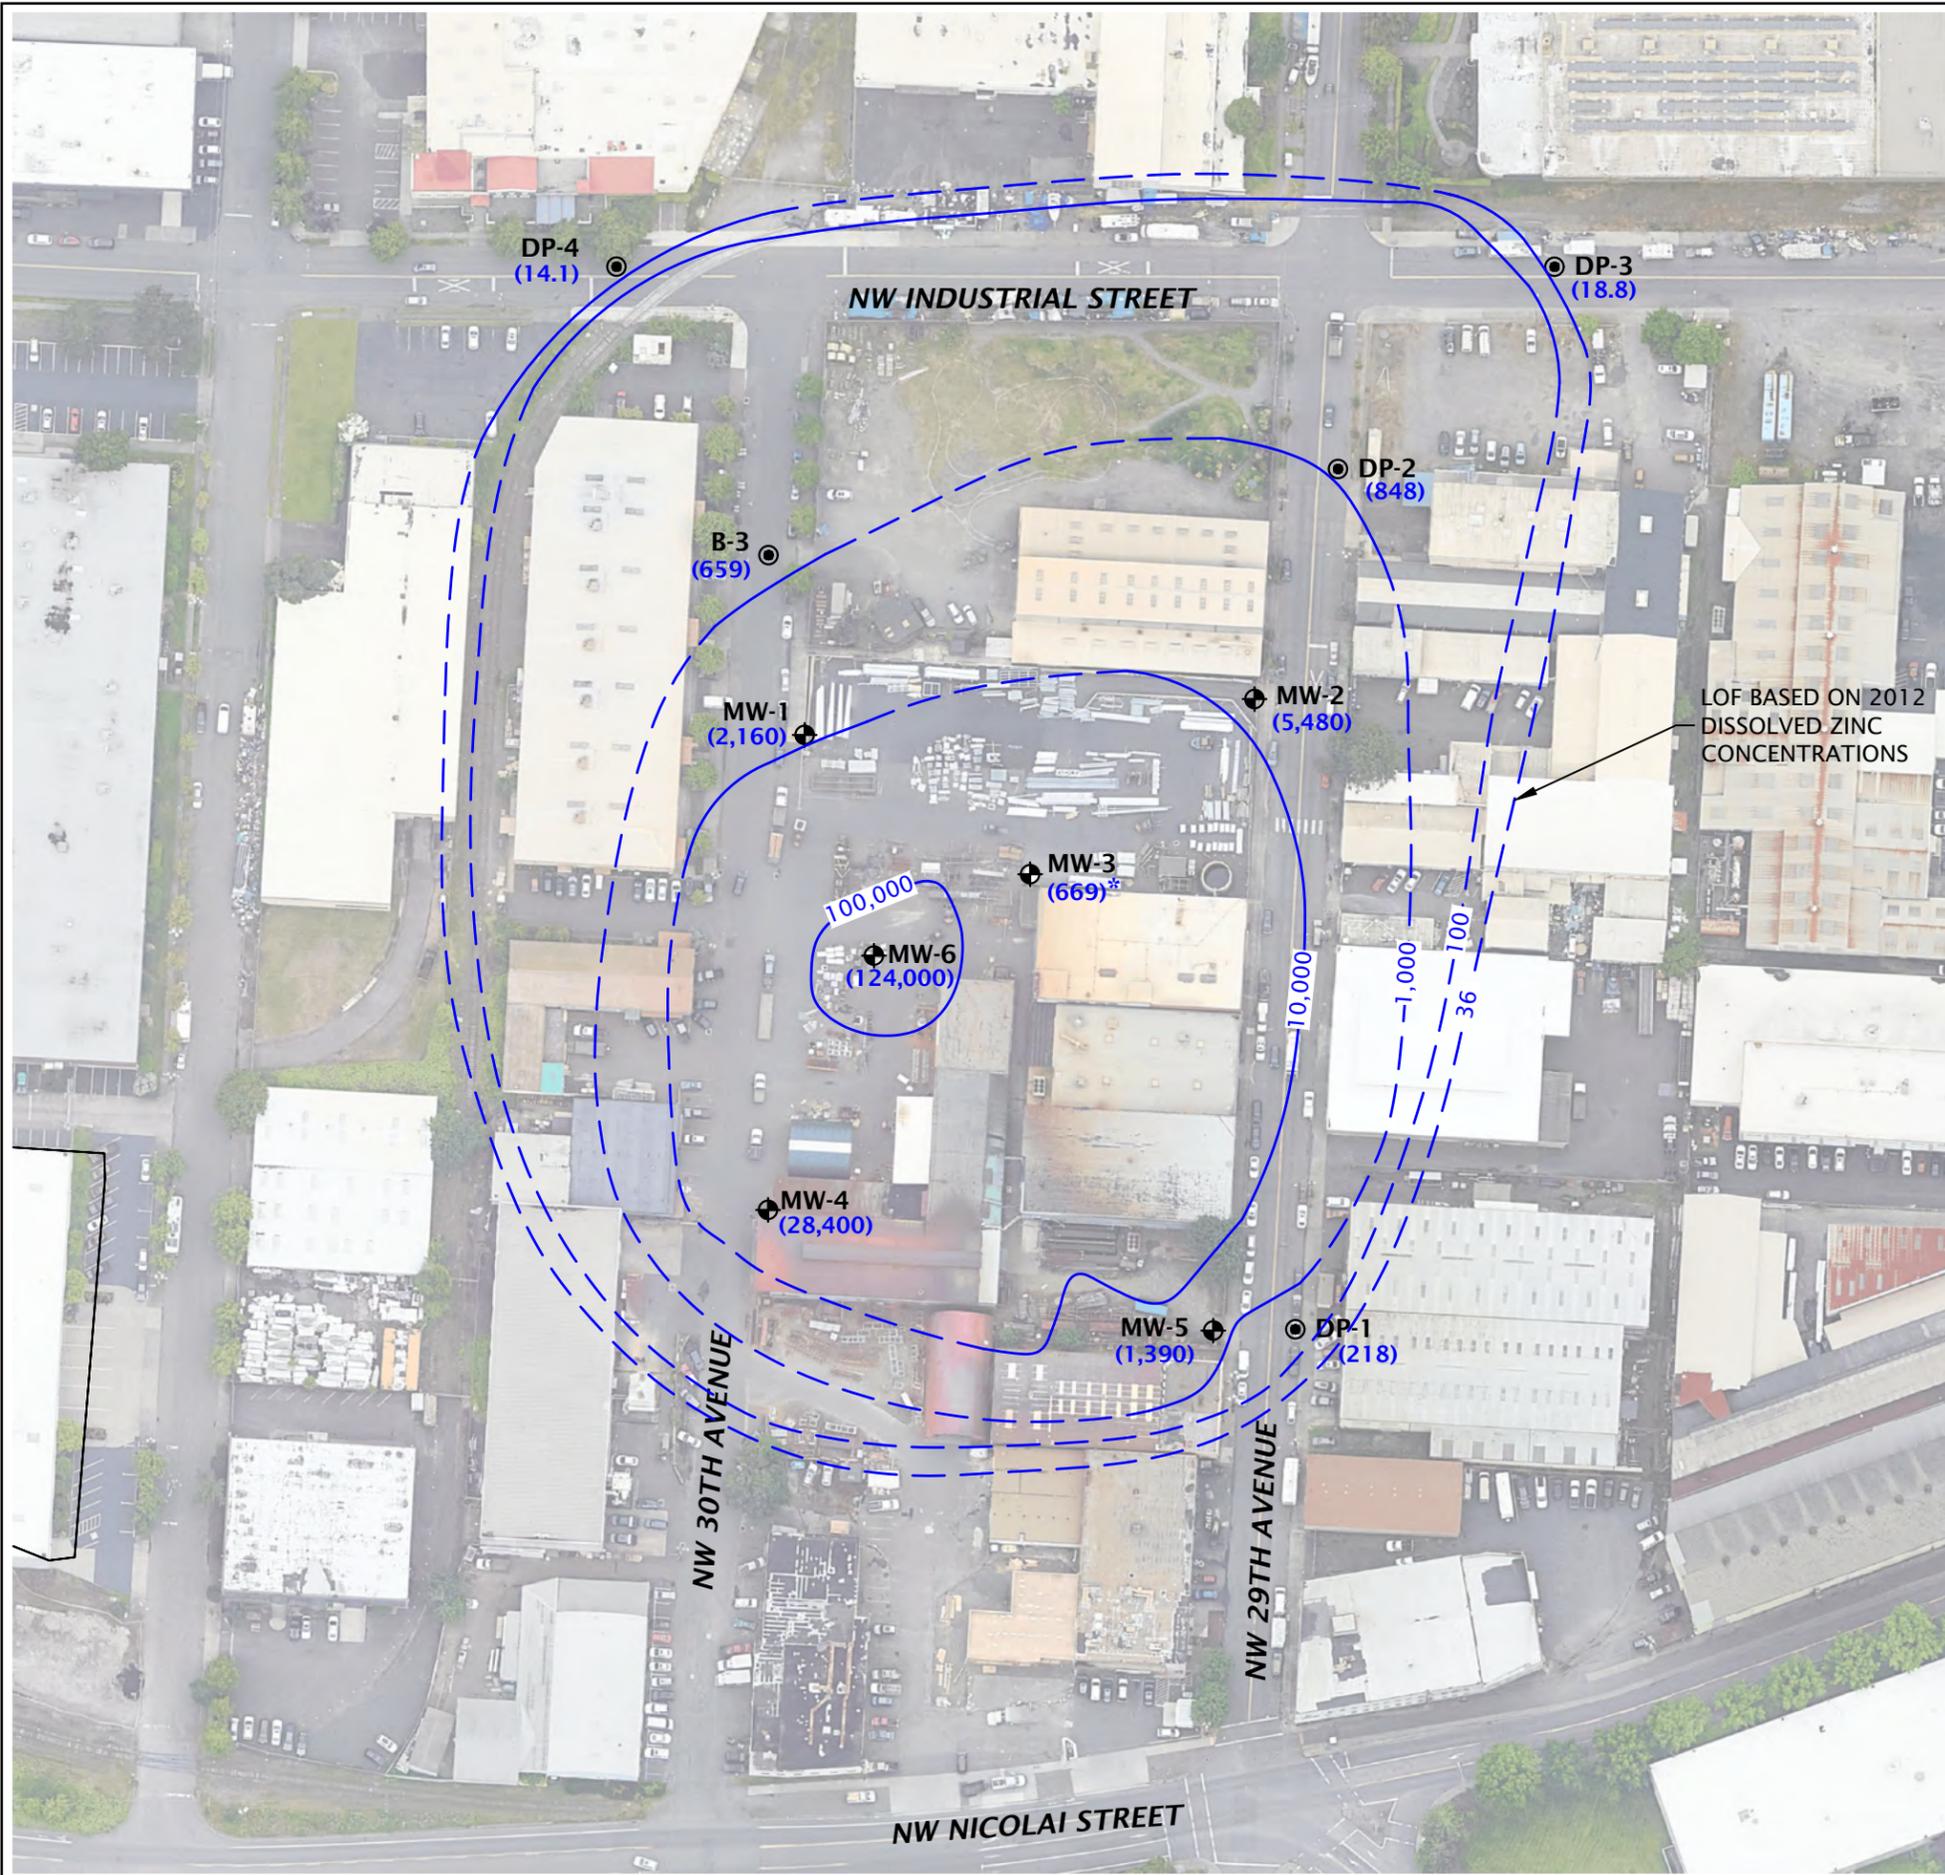
- MW-1** ◆ GROUNDWATER MONITORING WELL
- DP-1** ● DIRECT-PUSH BORING (GEODESIGN, 2012)
- B-3** ● BORING BY BES (2012)
- (669)** DISSOLVED ZINC CONCENTRATION ($\mu\text{g/L}$)
- 10,000** DISSOLVED ZINC ISOCONCENTRATION CONTOUR (INFERRED WHERE DASHED)
- 36** DEQ ECOLOGICAL RBC FOR WATER = $36\mu\text{g/L}$ (INFERRED WHERE DASHED)
- *** DATA POINT CONSIDERED AN OUTLIER AND THEREFORE NOT INCLUDED IN CONTOURS.

1. ANALYTICAL RESULTS SHOWN ARE FOR GROUNDWATER SAMPLES COLLECTED ON OCTOBER 8 AND 9, 2012, BY GEODESIGN AND NOVEMBER 6, 2012, BY COP BES.
2. CONTOUR INTERVAL: LOGARITHMIC

As summarized in Table 8, metals concentrations in groundwater samples were generally low, except for zinc. Greater concentrations of zinc were observed in groundwater samples collected from GP-1-GW and GP-2-GW, northeast of the Subject Property. Zinc concentrations ranged from 3,030 µg/L (GP-6-GW) to 84,000 µg/L (GP-1-GW).

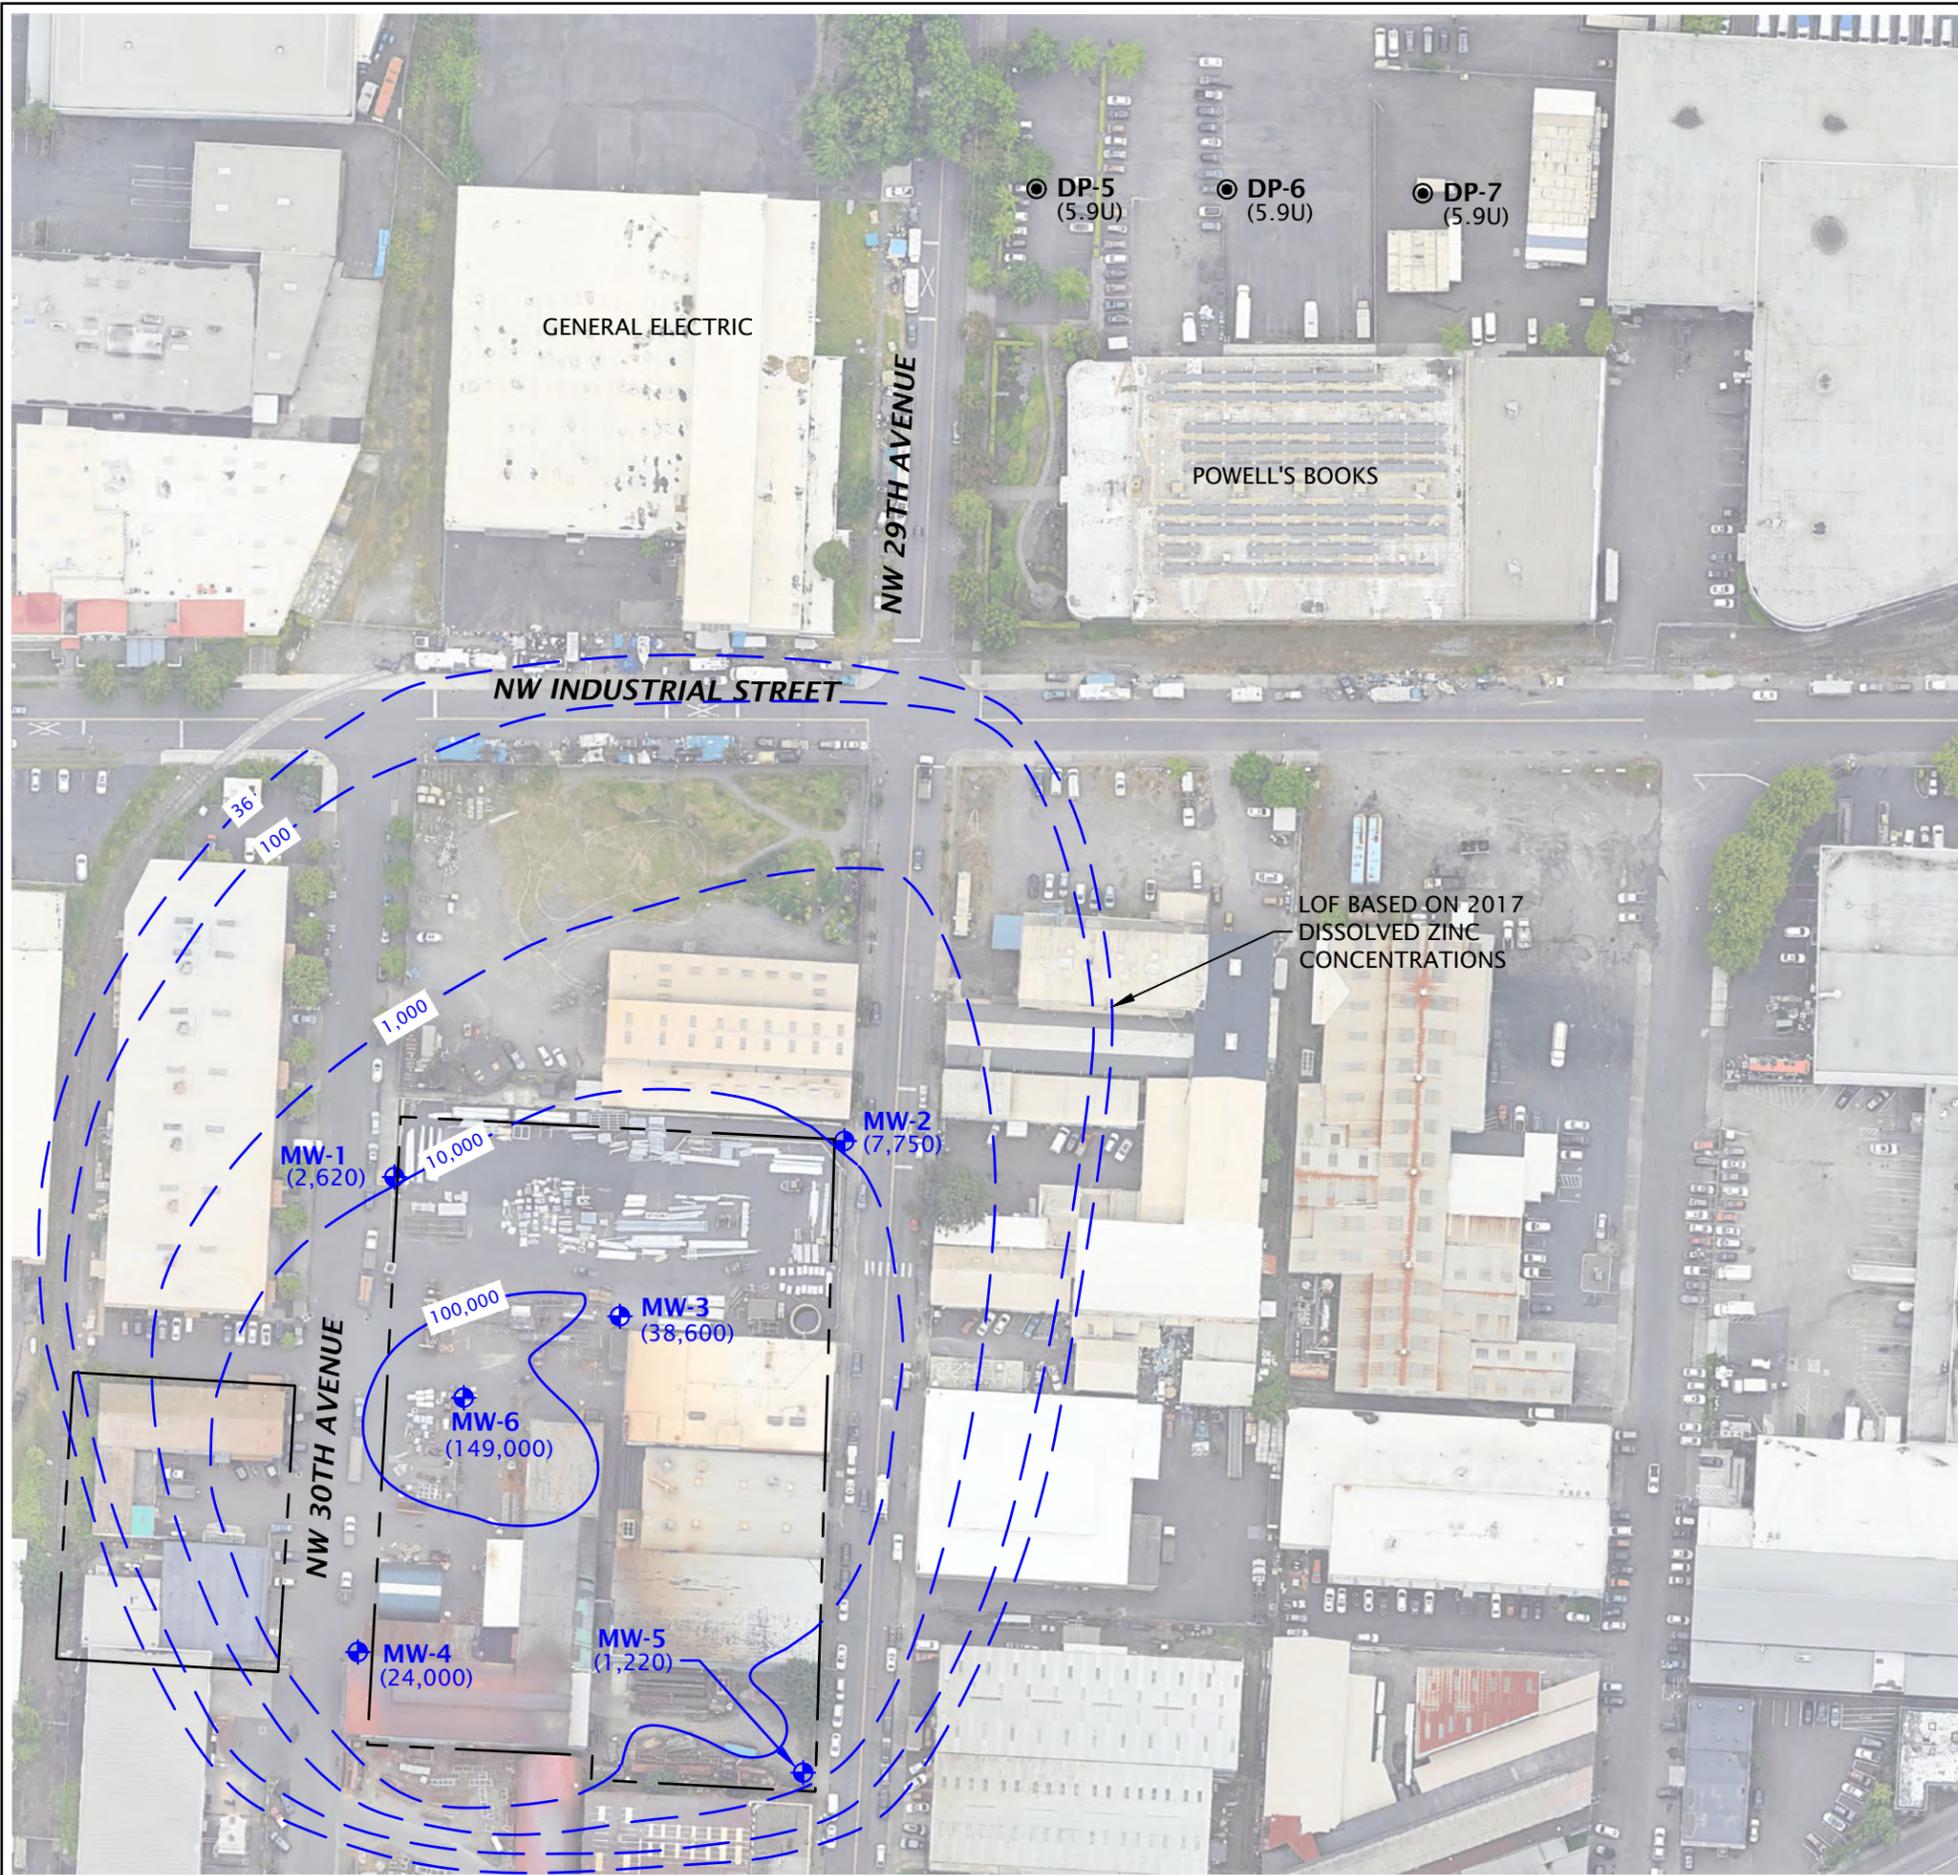
- ◆ MW-1 GROUNDWATER MONITORING WELL
- DP-5 DIRECT-PUSH BORING (GEODESIGN 2017)
- (2,600) DISSOLVED ZINC CONCENTRATION ($\mu\text{g/L}$)
- PROJECT SITE BOUNDARY
- U ANALYTE NOT DETECTED GREATER THAN THE REFERENCED LABORATORY MDL
- ~ 10,000 DISSOLVED ZINC ISOCONCENTRATION CONTOUR (INFERRED WHERE DASHED)
- ~ 36 DEQ ECOLOGICAL RBC FOR WATER = $36\mu\text{g/L}$

1. ANALYTICAL RESULTS SHOWN ARE FOR GROUNDWATER SAMPLES COLLECTED ON SEPTEMBER 25 AND 26, 2017.
2. CONTOUR INTERVAL: LOGARITHMIC

The distribution and transport of zinc in groundwater and soil are dependent on the species of zinc present and the characteristics of the environment. The solubility of zinc is a function of pH. Lower pH values tend to increase the solubility of zinc allowing for greater concentrations of zinc in groundwater. As pH increases closer to neutral (pH=7.0), zinc tends to sorb to soil particles. Groundwater data indicate that on-site groundwater exhibits pH between 3.84 and 6.77. With more acidic conditions on site, elevated zinc concentrations in groundwater are observed. However, zinc concentrations in groundwater significantly decrease as natural buffering conditions neutralize the groundwater, decreasing the solubility of zinc and groundwater. This was demonstrated through fate and transport modeling (GeoDesign, 2017) and off site, downgradient groundwater sampling (GeoDesign, 2018).

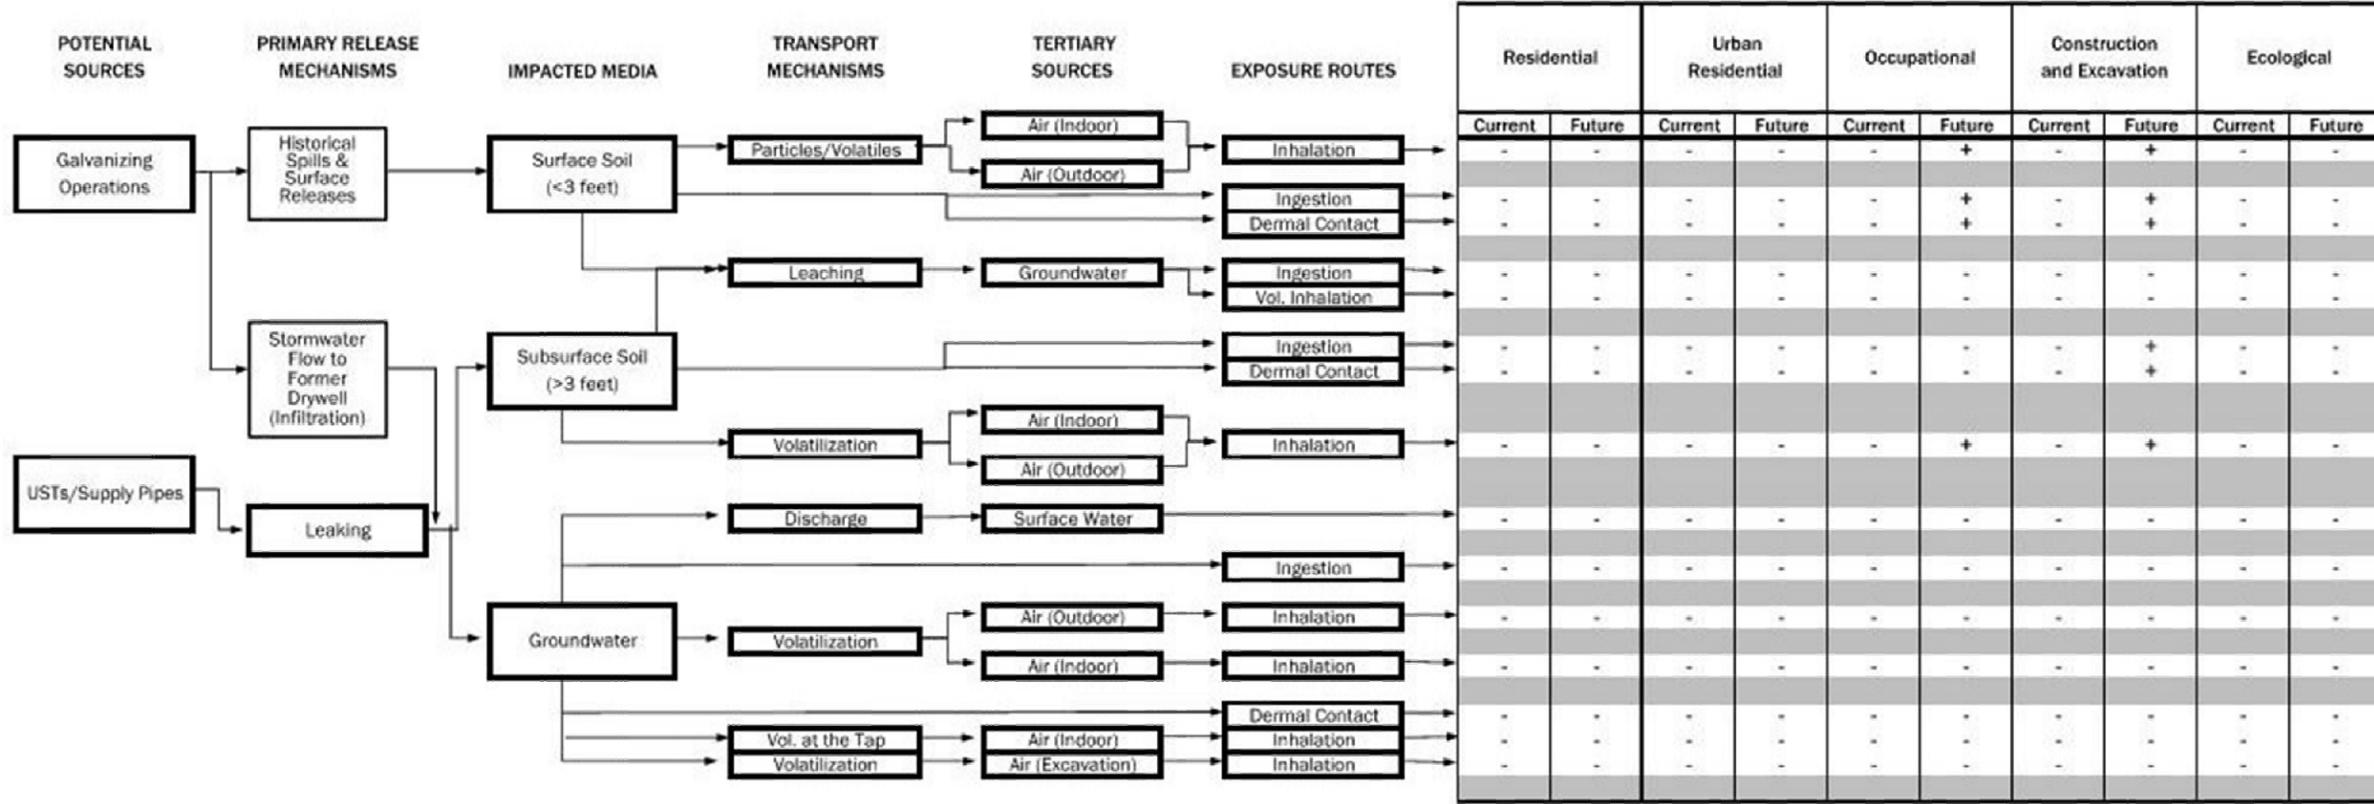
CONCEPTUAL SITE MODEL

Notes:
 + This route is a primary source of exposure.
 - There is no exposure by this route.
