Subject: Letter Report  
Sub-slab Soil Vapor Evaluation  
Former Mall 99 Cleaners  
972 North Pacific Highway  
Woodburn, Oregon  
File No. 24986-001-00

Soil Vapor Sample Locations	
Former Mall 99 Cleaners 976 North Pacific Highway Woodburn, Oregon 97301	
	Figure 1

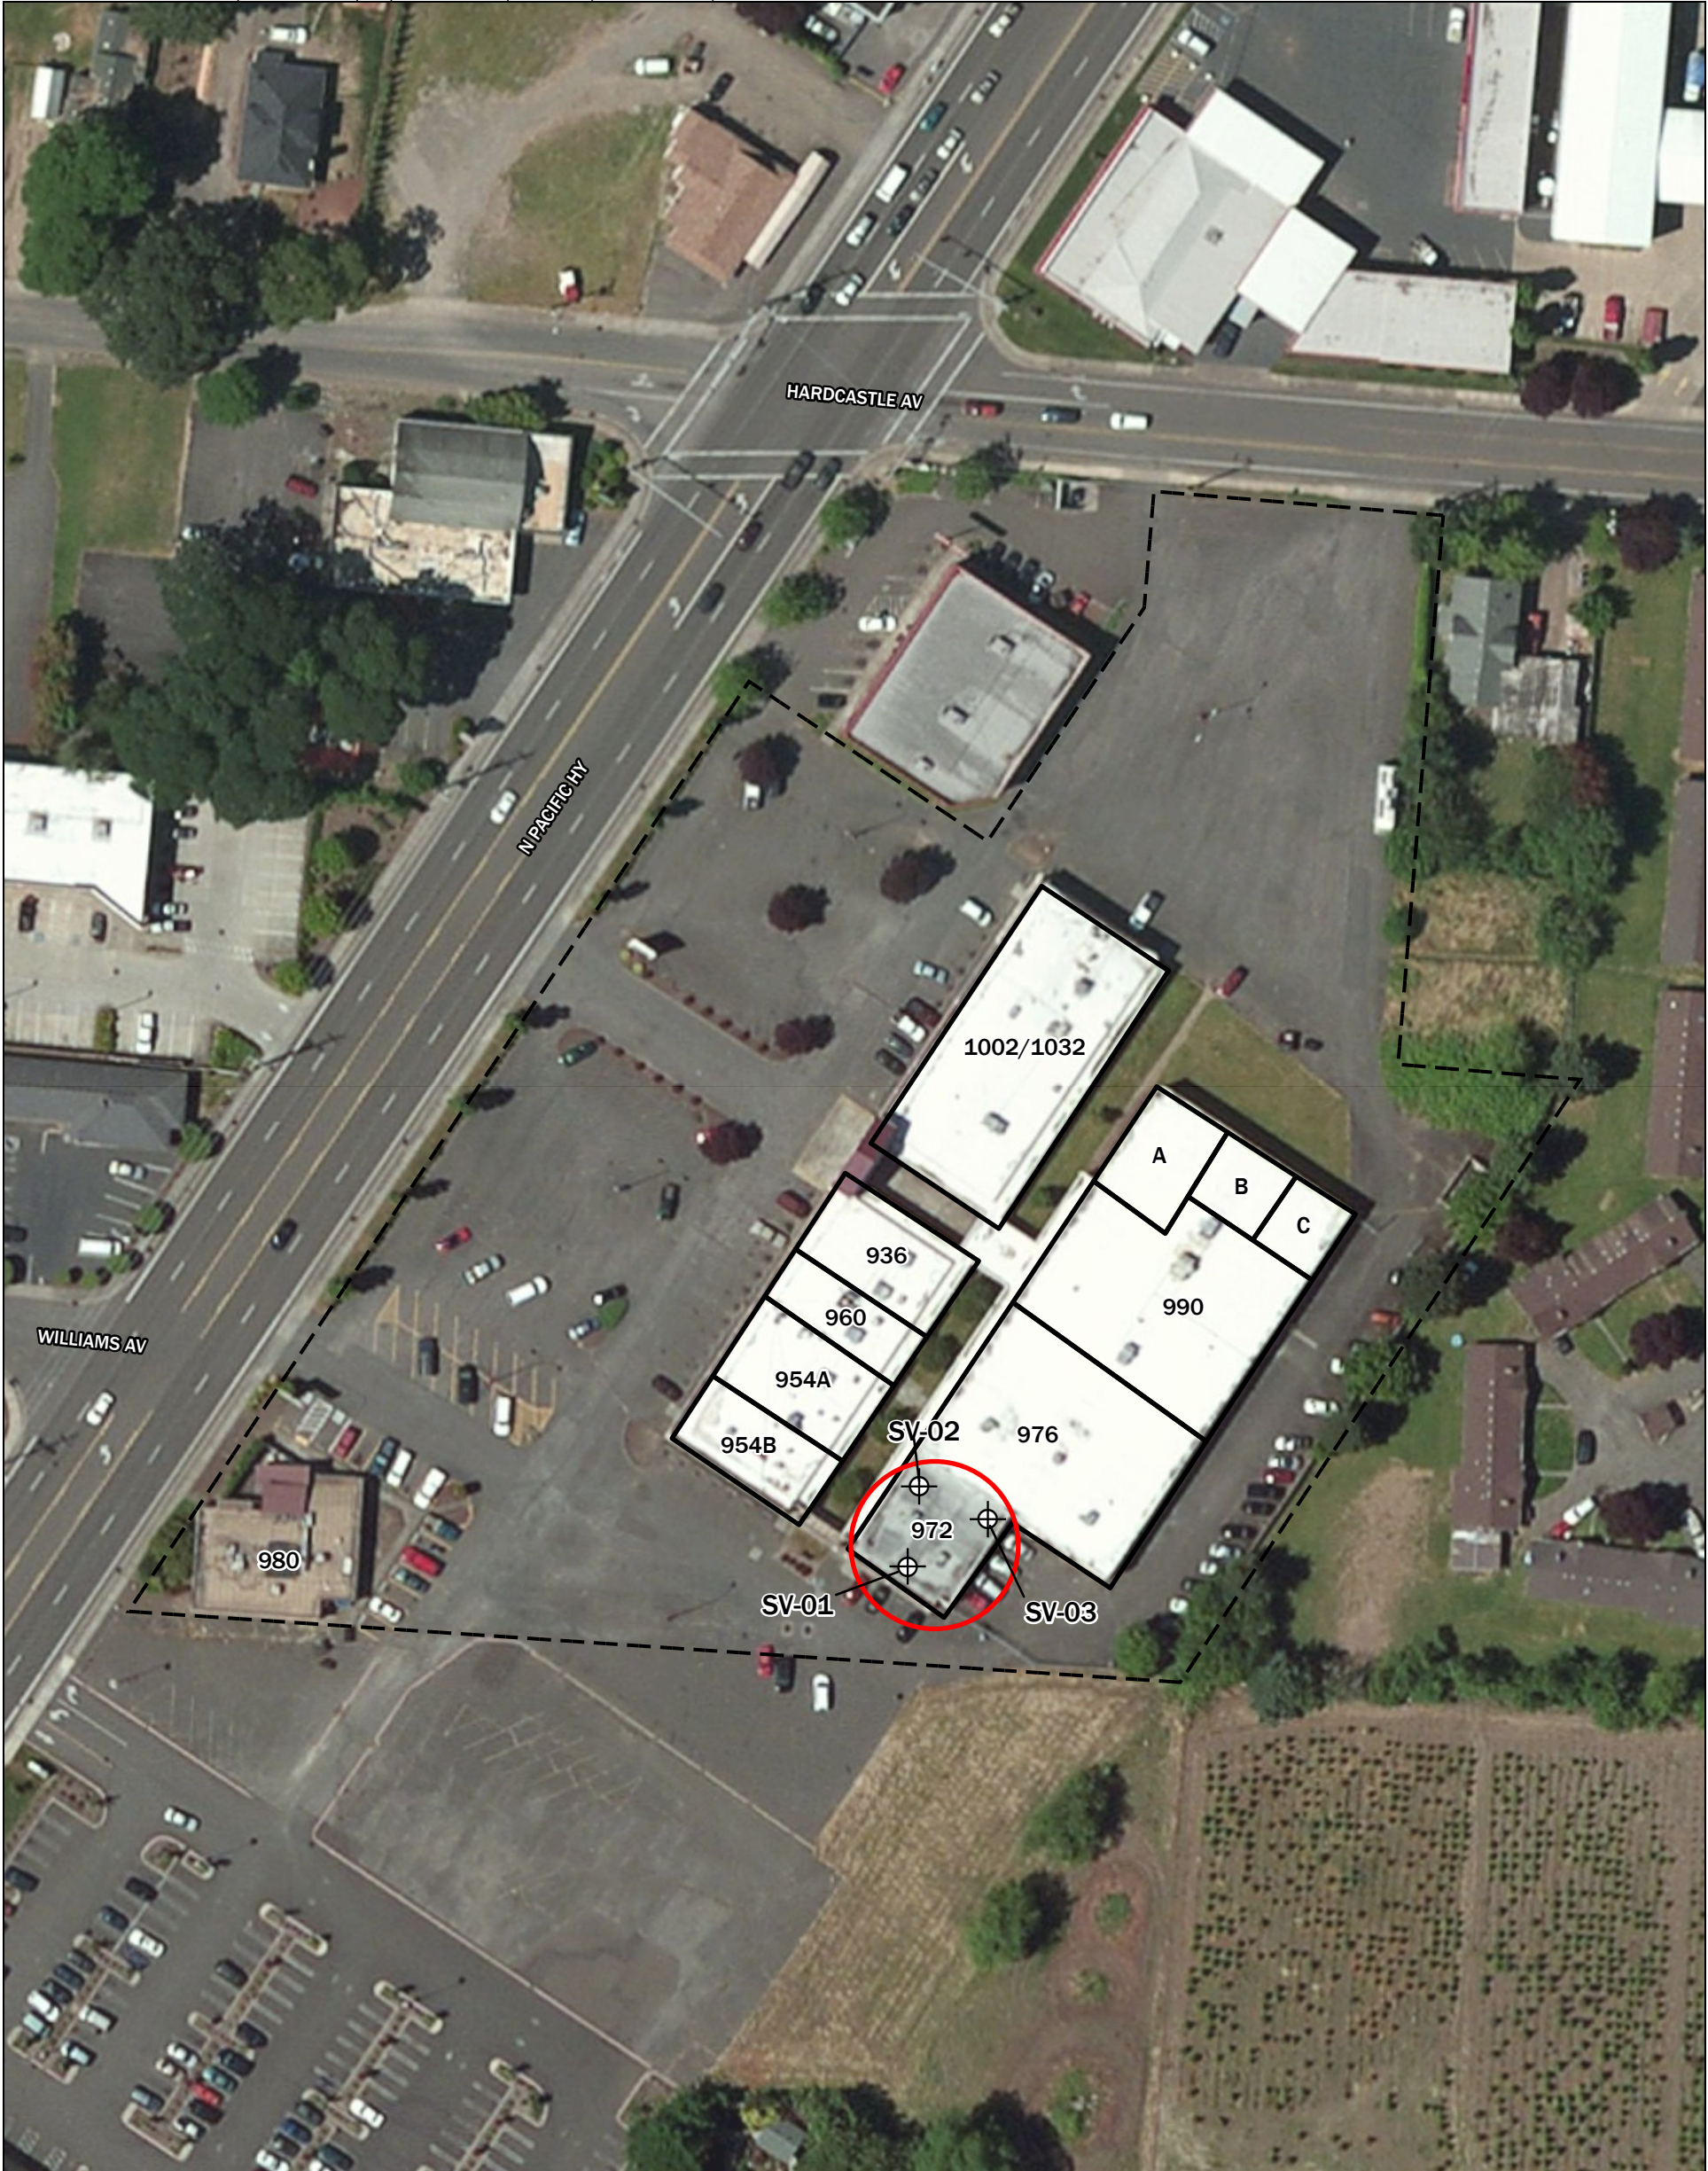
- Coordinated the location of three soil vapor samples within the unit identified as 972 (Figure 1, attached). Sample locations were adjusted in the field based on obstructions, utilities, and to minimize disruption to the facility. Applied Professional Services (APS) performed a private utility locate to clear the sub-slab soil vapor sample locations.

GeoEngineers collected three sub-slab soil-vapor samples (SV-01 through SV-03) on March 5, 2021. The sub-slab sample locations were selected based on the location within the former Mall 99 Cleaners in the 972 North Pacific Highway unit. Sample locations were adjusted where necessary due to physical constraints such as interior walls and partitions and where utility conflicts occurred. Sample SV-01 was collected within the southernmost office, near the entrance on the southern side of the building, SV-02 was collected near the center of the western office cubicles, and SV-03 was collected in the electrical/storage room located near the northeast corner of the unit. Approximate sample locations are shown in Figure 1.

- PCE was detected in all three soil vapor samples (SV-01 through SV-03) at concentrations ranging from 48.7 micrograms per cubic meter ( $\mu\text{g}/\text{m}^3$ ) in SV-03 to 7,670  $\mu\text{g}/\text{m}^3$  in SV-01. The detected concentrations were less than the DEQ RBC for the Occupational Exposure Scenario (47,000  $\mu\text{g}/\text{m}^3$ ).

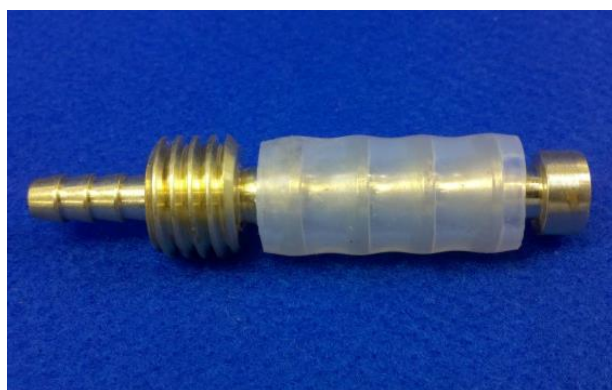
Figure 1. Assembled VAPOR PIN®

- Assembled VAPOR PIN® [VAPOR PIN® and silicone sleeve(Figure 1)]; Because of sharp edges, gloves are recommended for sleeve installation;
- Hammer drill;
- 5/8-inch (16mm) diameter hammer bit (hole must be 5/8-inch (16mm) diameter to ensure seal. It is recommended that you use the drill guide). (Hilti™ TE-YX 5/8" x 22" (400 mm) #00206514 or equivalent);
- 1½-inch (38mm) diameter hammer bit (Hilti™ TE-YX 1½" x 23" #00293032 or equivalent) for flush mount applications;
- ¾-inch (19mm) diameter bottle brush;
- Wet/Dry vacuum with HEPA filter (optional);
- VAPOR PIN® installation/extraction tool;
- Dead blow hammer;
- VAPOR PIN® flush mount cover, if desired;
- VAPOR PIN® drilling guide, if desired;

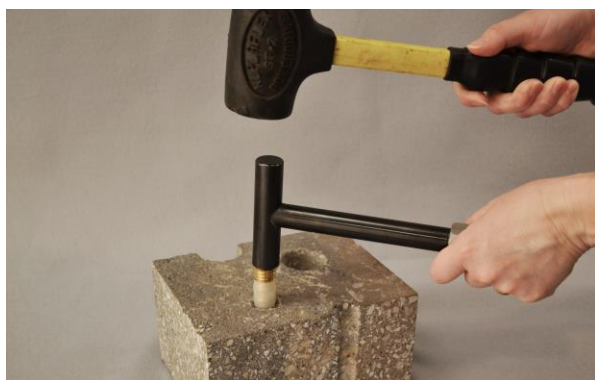
Figure 2. Installing the VAPOR PIN®

- 5) Remove the drill bit, brush the hole with the bottle brush, and remove the loose cuttings with the vacuum.
- 6) Place the lower end of VAPOR PIN® assembly into the drilled hole. Place the small hole located in the handle of the installation/extraction tool over the vapor pin to protect the barb fitting, and tap the vapor pin into place using a dead blow hammer (Figure 2). Make sure the installation/extraction tool is aligned parallel to the vapor pin to avoid damaging the barb fitting.

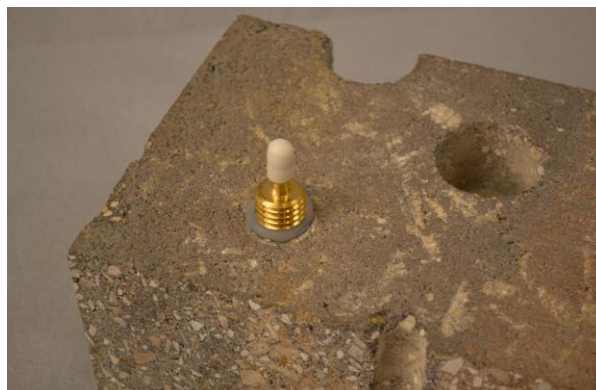
Figure 3. Installed VAPOR PIN®

During installation, the silicone sleeve will form a slight bulge between the slab and the VAPOR PIN® shoulder. Place the protective cap on VAPOR PIN® to prevent vapor loss prior to sampling (Figure 3).

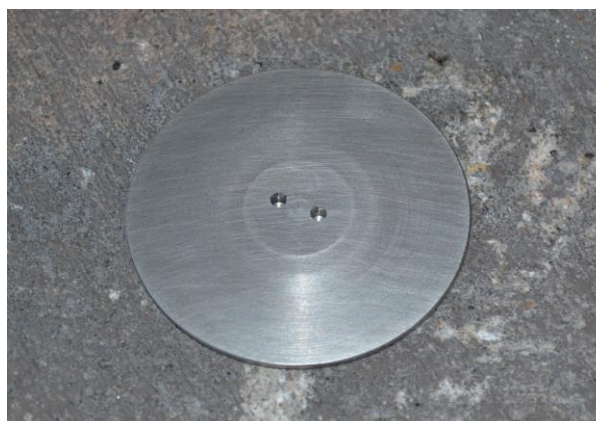
Figure 4. Secure Cover Installed

- 7) For flush mount installations, cover the vapor pin with a flush mount cover, using either the plastic cover or the optional stainless-steel Secure Cover (Figure 4).

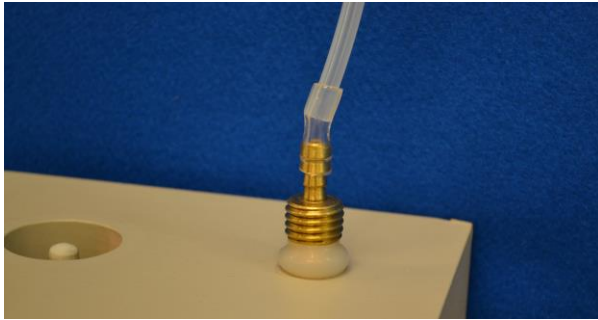
Figure 5. VAPOR PIN® sample connection

Nylaflow tubing (Figure 5). Put the Nylaflow tubing as close to the VAPOR PIN® as possible to minimize contact between soil gas and Tygon™ tubing.

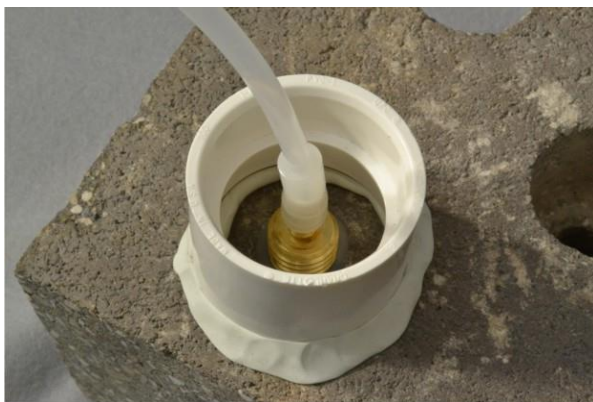
Figure 6. Water dam used for leak detection

10) Conduct leak tests in accordance with applicable guidance. If the method of leak testing is not specified, an alternative can be the use of a water dam and vacuum pump, as described in SOP Leak Testing the VAPOR PIN® via Mechanical Means (Figure 6). For flush-mount installations, distilled water can be poured directly into the 1 1/2 inch (38mm) hole.

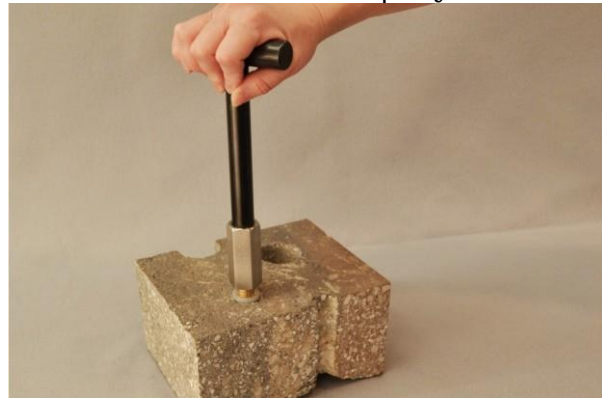
Figure 7. Removing the VAPOR PIN®

1) Remove the protective cap, and thread the installation/extraction tool onto the barrel of the VAPOR PIN® (Figure 7). Turn the tool clockwise continuously, don't stop turning, the VAPOR PIN® will feed into the bottom of the installation/extraction tool and will extract from the hole like a wine cork, DO NOT PULL.
