# CONTAMINATED MEDIA MANAGEMENT PLAN-REVISED

## **FORMER ESCO MAIN PLANT #1, #2 2141 NW 25TH AVENUE PORTLAND, MULTNOMAH COUNTY, OREGON**

**Point Source Solutions Project No: ESCI #6285  
January 22, 2026**

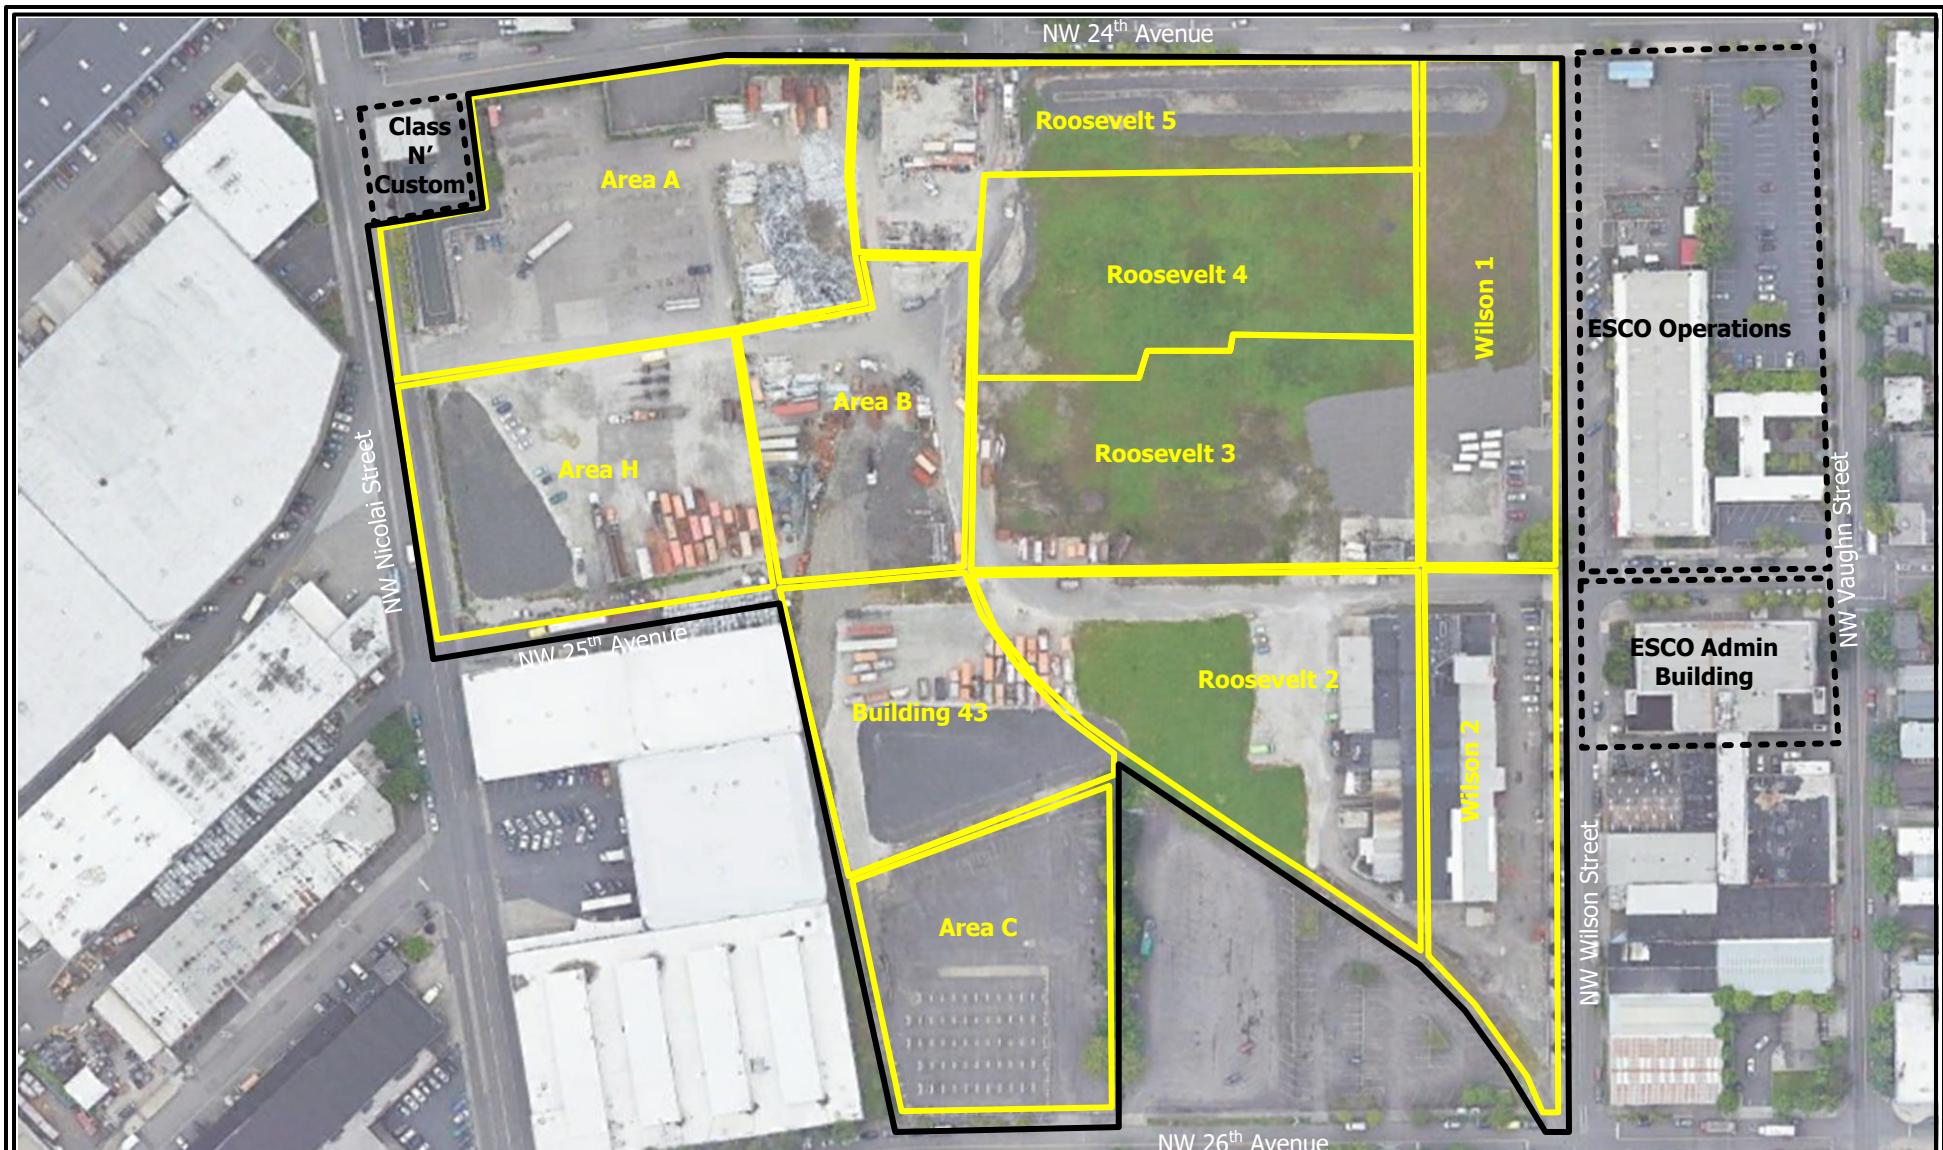
**FIGURE 3: SITE PLAN**

ESCO Main Plant #1/#2 BESA Area Designations

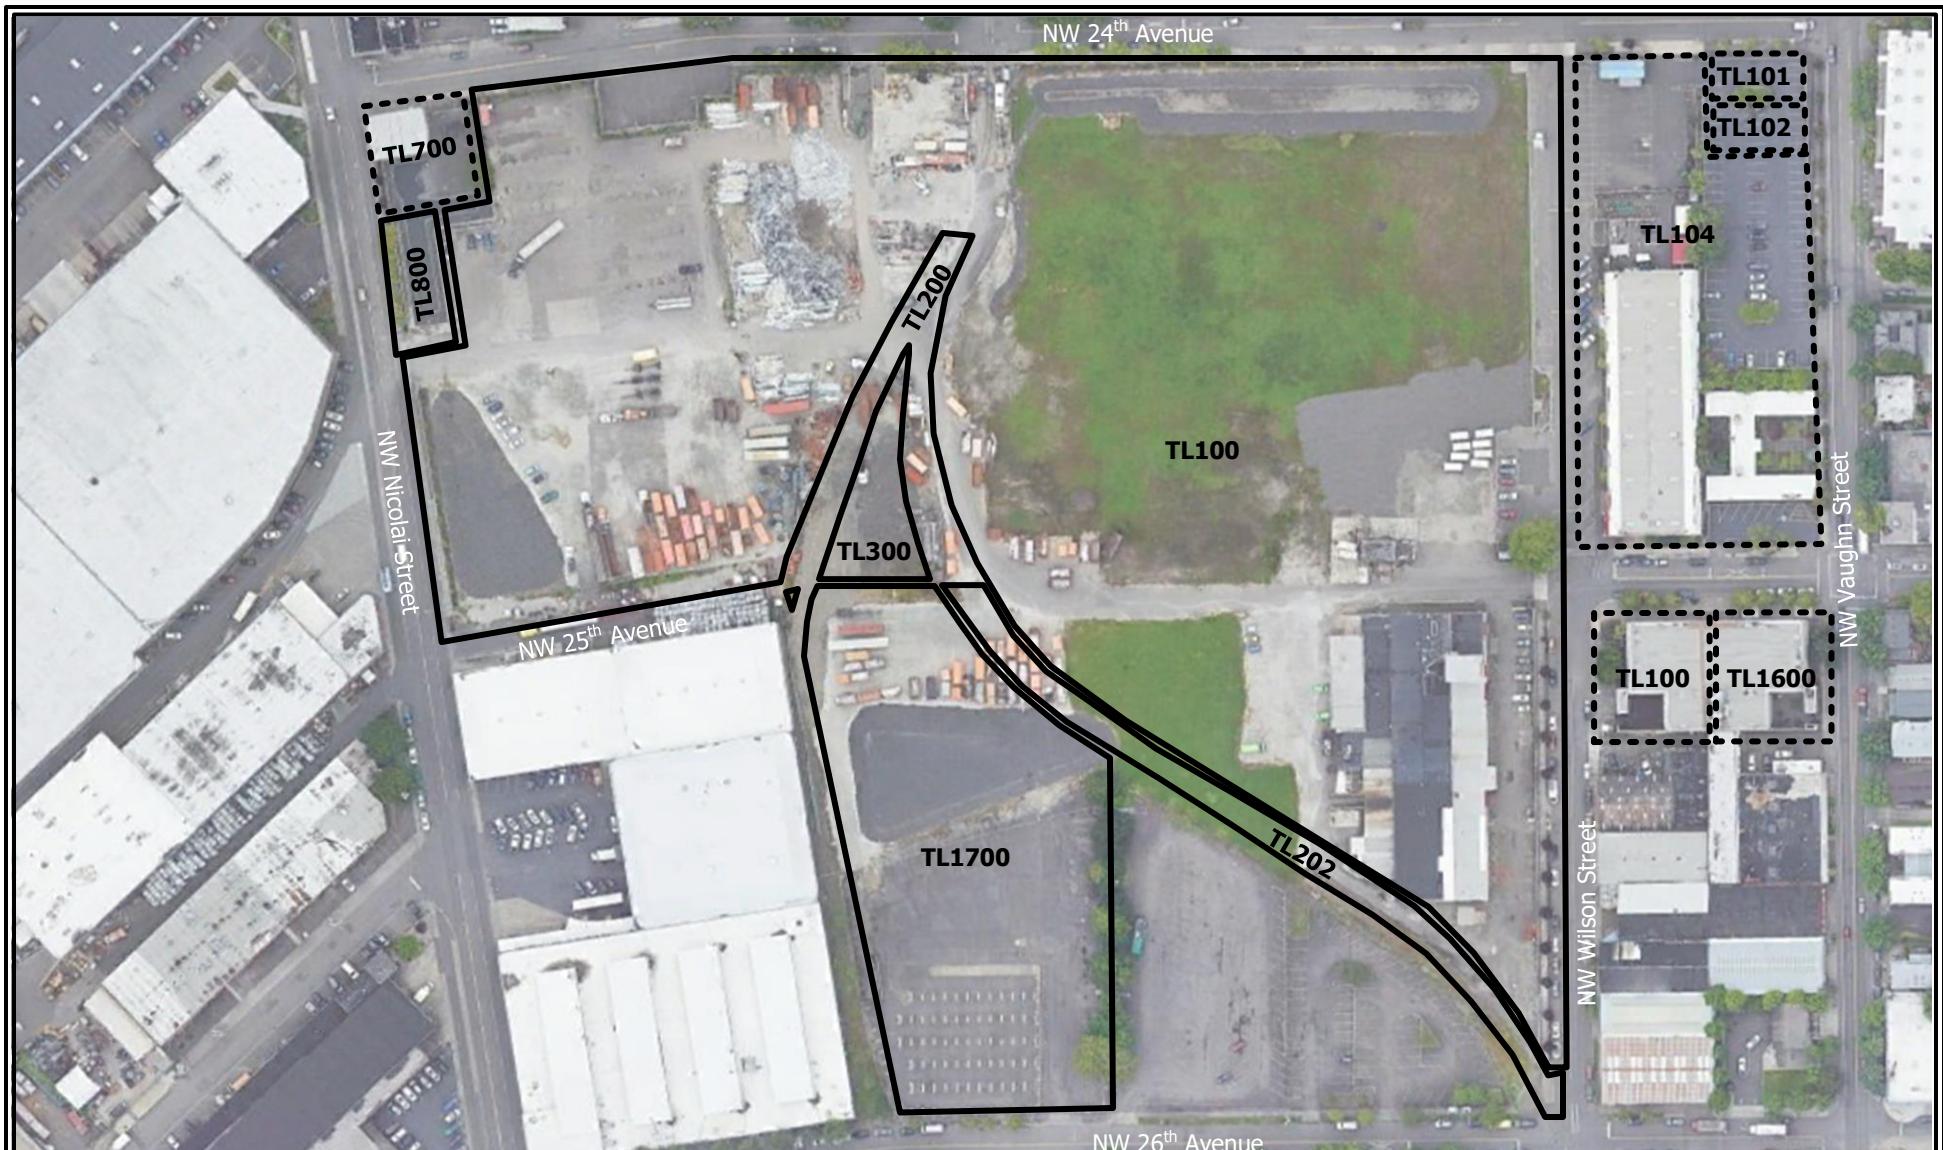
**FIGURE 4: TAX LOTS**

Background Imagery from Google Earth 2022  
(Tax Lots Sourced from Portland Maps)

The Site is identified in **Figure 1** (Site Location Map), **Figure 2** (Topographic Map), **Figure 3** (Site Plan), **Figure 4** (Tax Lots), and **Figure 5** (Former UST Location Diagram), attached to this report.

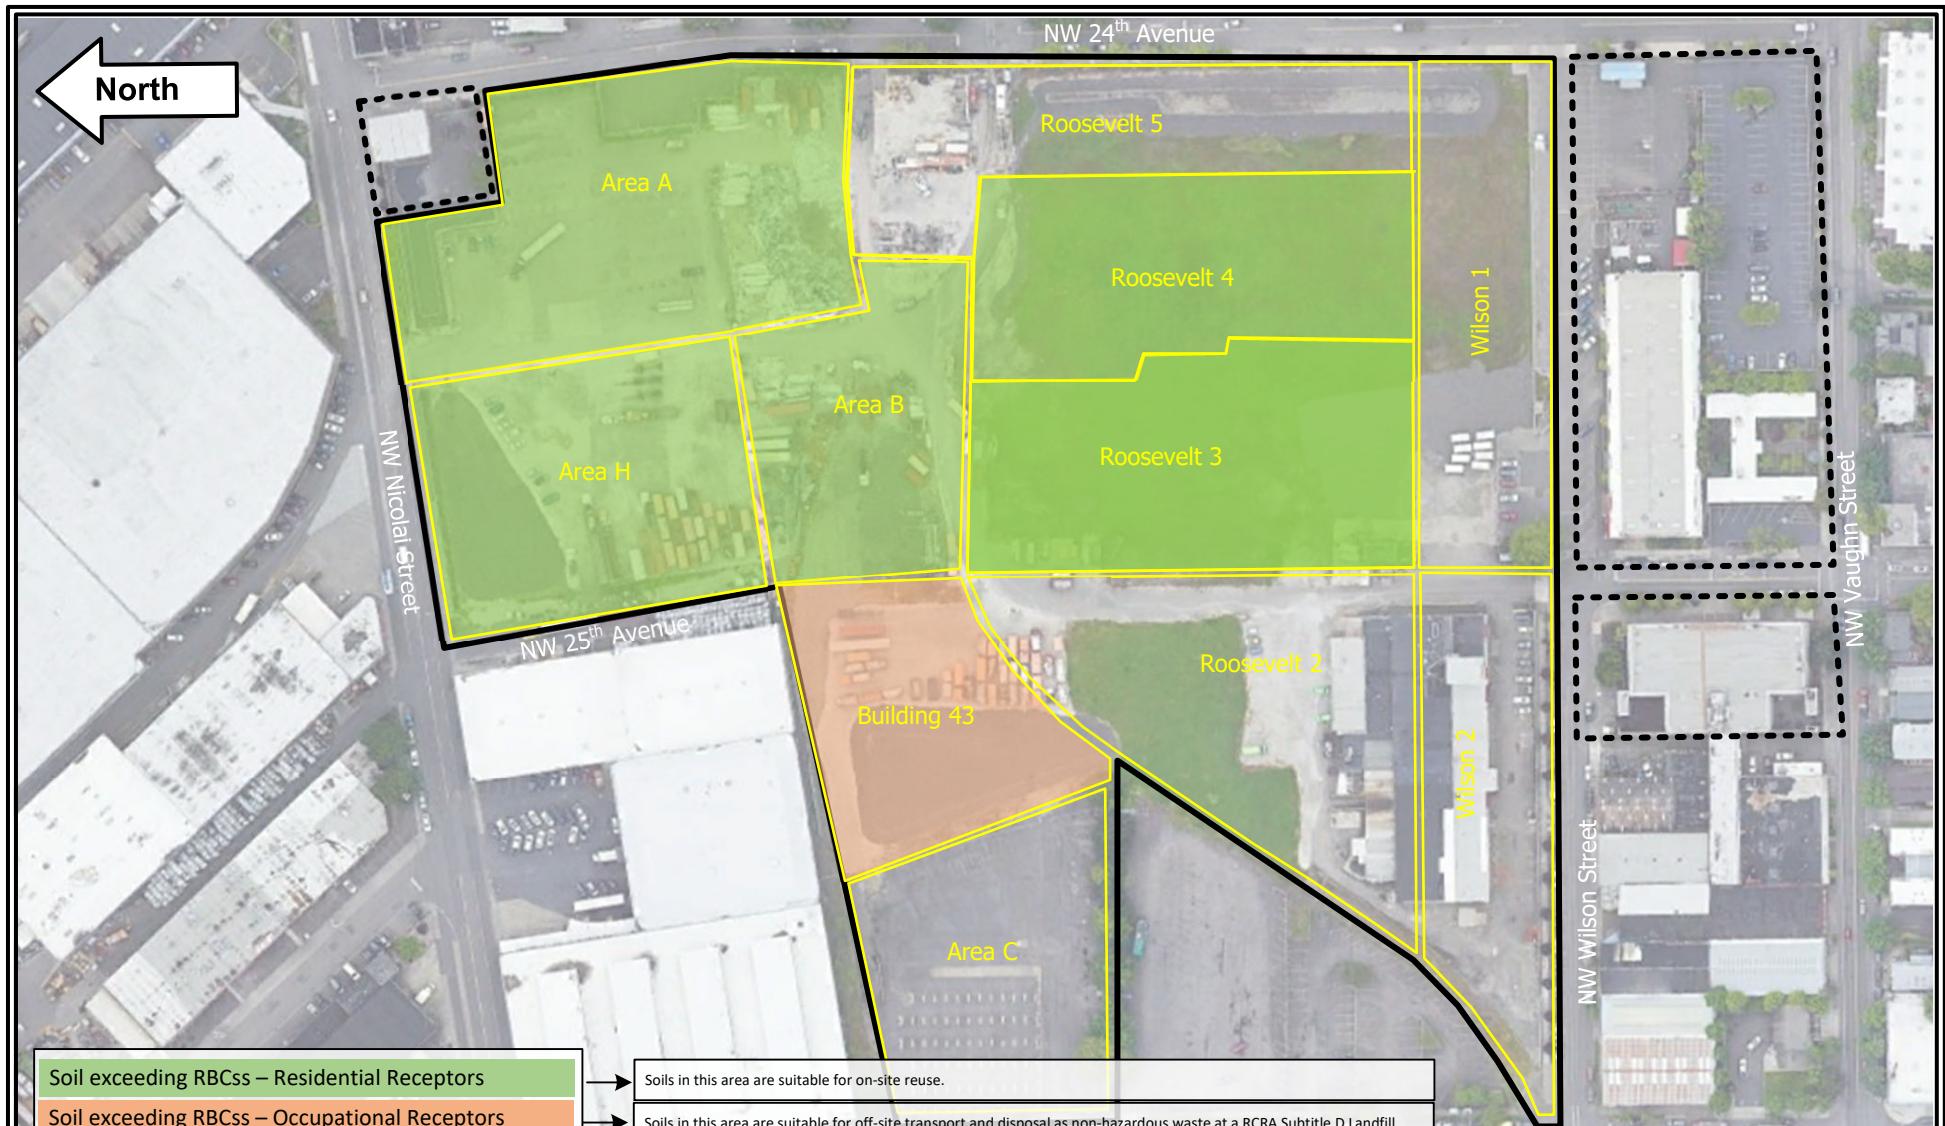
## FIGURE 6A: ESTIMATED RESIDUAL SOIL CONTAMINATION - PAHs

Residual Soil Contamination Presented is from the 0.5'-2.5' bgs Subsurface Interval

Note: Contaminants represented in the figure did not exceed the construction or excavation worker RBCs in any of the subareas; shading based on a combination of ISM data and discrete sampling data collected from each subarea

Based on our knowledge of the environmental condition of the Site, soil generated during earthwork at the Site can be re-used on site without additional testing requirements, assuming (1) it is geotechnically suitable, (2) does not exceed its ODEQ CFSL and/or Soil Ingestion, Inhalation, and Dermal Contact RBC<sub>ss</sub> for Residential Receptors and (3) is ultimately capped with either a structure, pavement, or an approved geotextile. Refer to **Figures 6, 7, & 8** for the extent of estimated residual soil contamination on the Site.

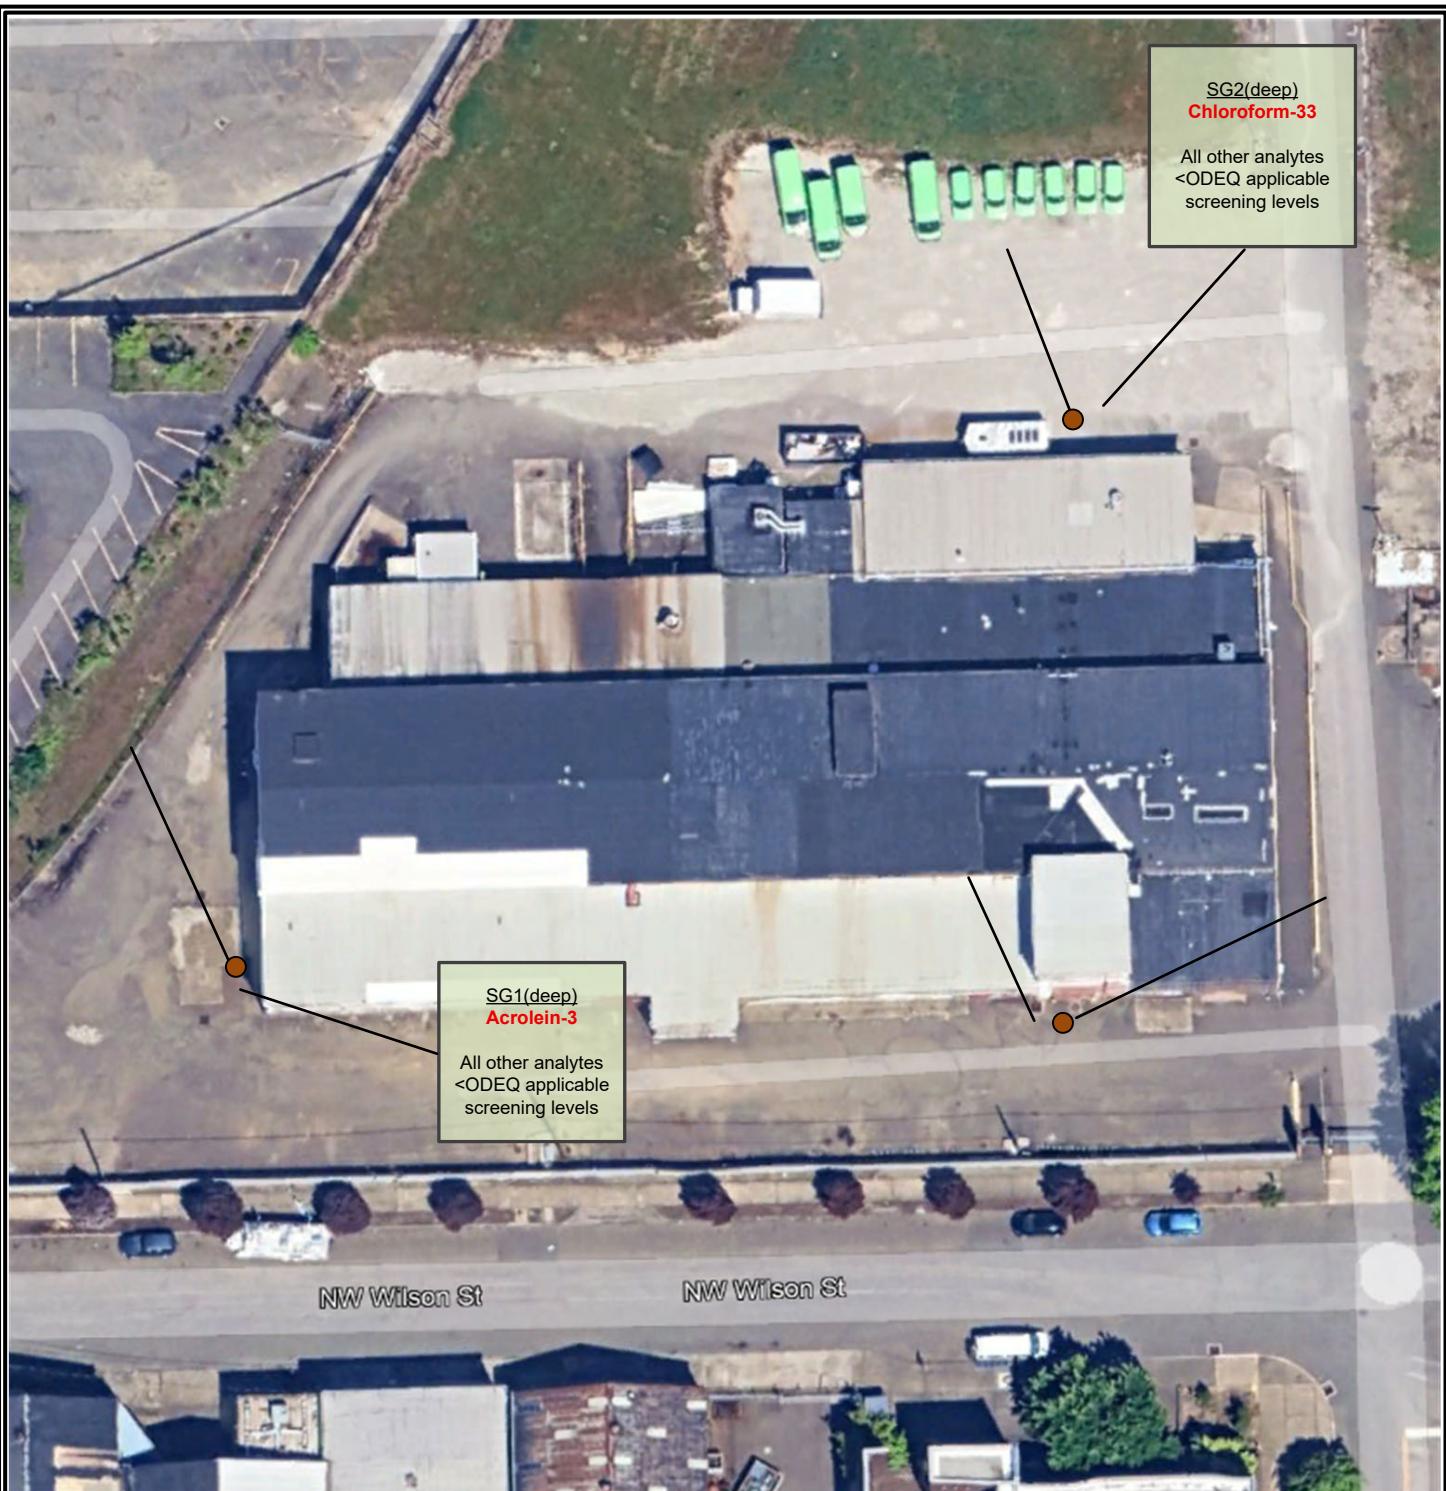
**FIGURE 9a: BUILDING 4 SAMPLE LOCATION DIAGRAM (>RBCsv for commercial receptors; September 2025)**

- Vapor Sample results in ug/m<sup>3</sup>
- RED = Detected above RBCsv for commercial receptors
- Only constituents that exceeded applicable screening levels are presented.

- Shallow Soil Vapor Sample Location
- Deep Soil Vapor Sample Location

**With the exception of the area immediately surrounding Building 4, soil vapor has not been evaluated on the Site. The evaluation of soil vapor immediately surrounding Building 4 indicates occurrences of volatile organic compounds which may require mitigation should redevelopment occur.**

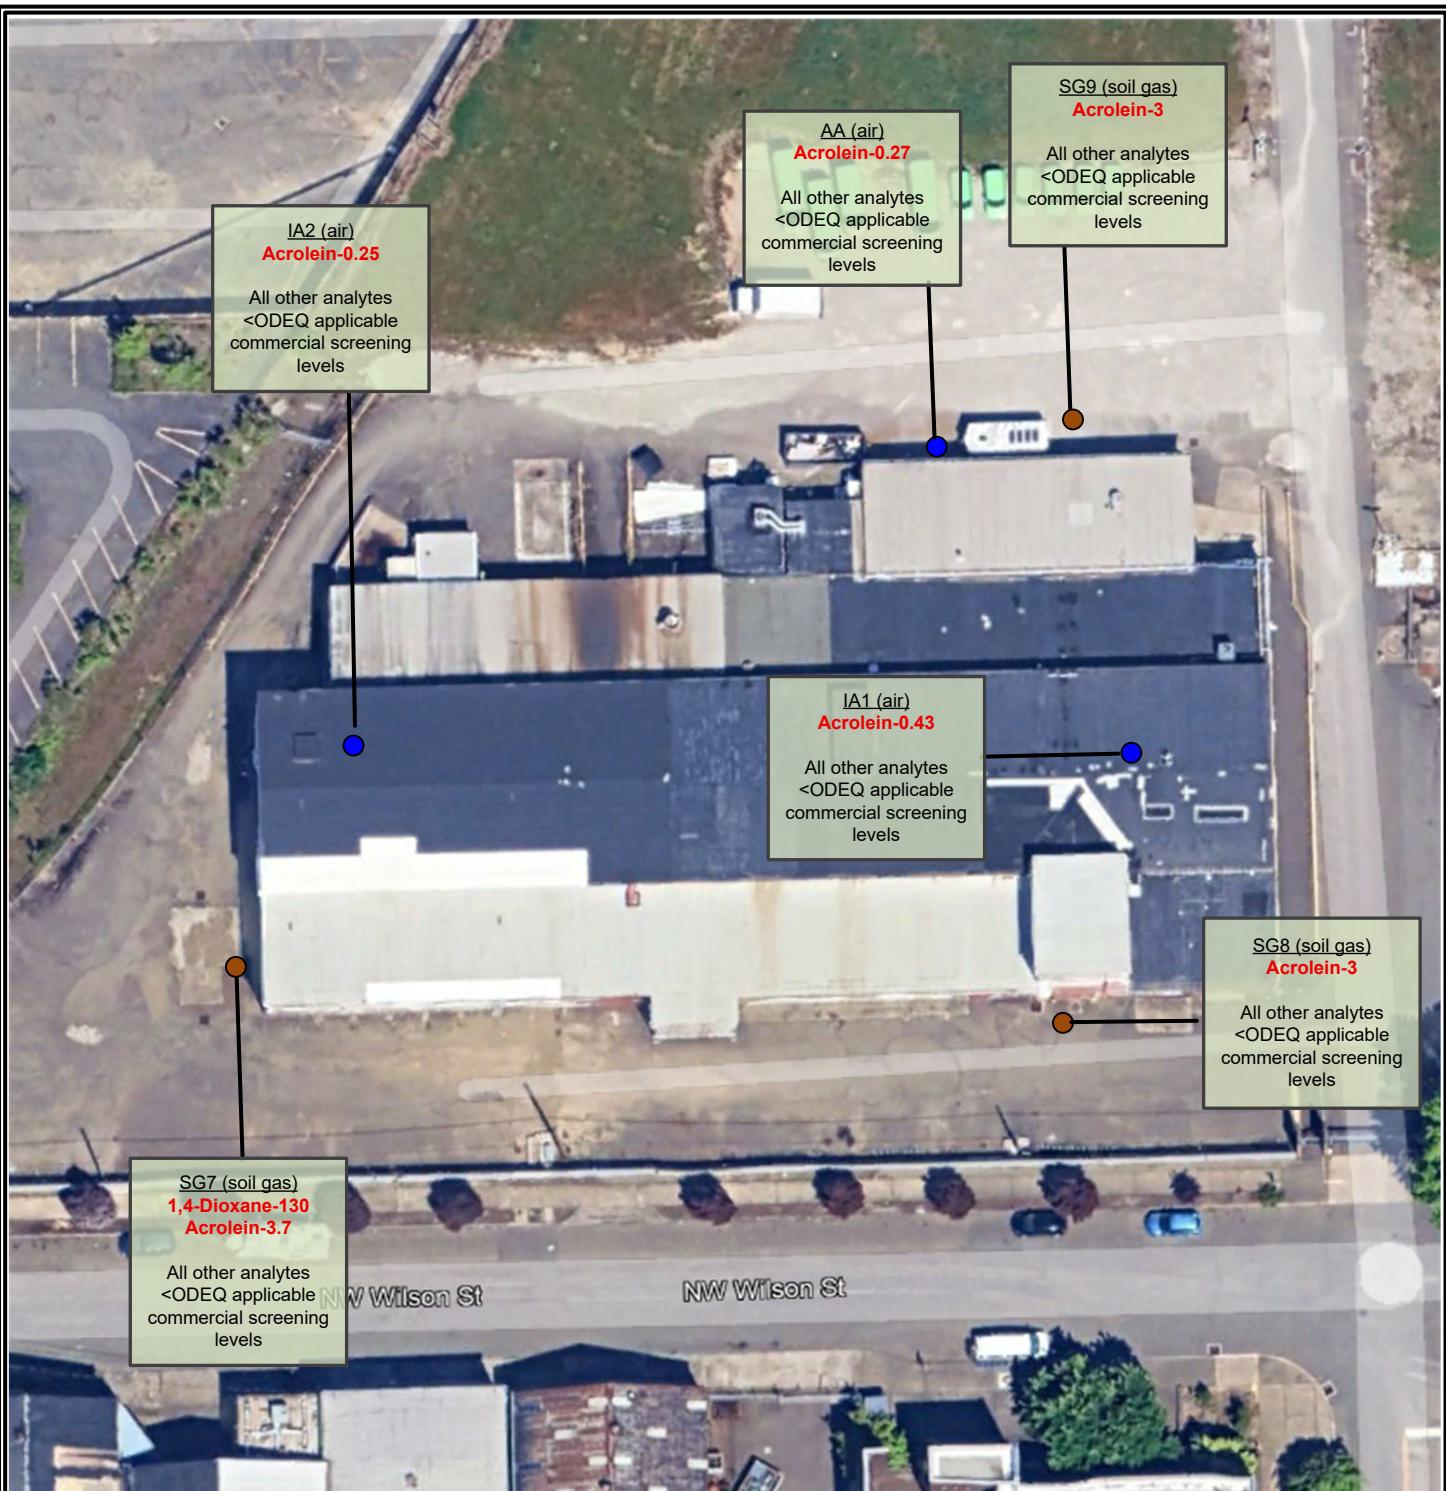
**FIGURE 9b: BUILDING 4 SAMPLE LOCATION DIAGRAM (>RBCsv/RBCair for commercial receptors; November 2025)**

● Soil Gas Sample Location

● Indoor/Outdoor (Ambient) Sample Location

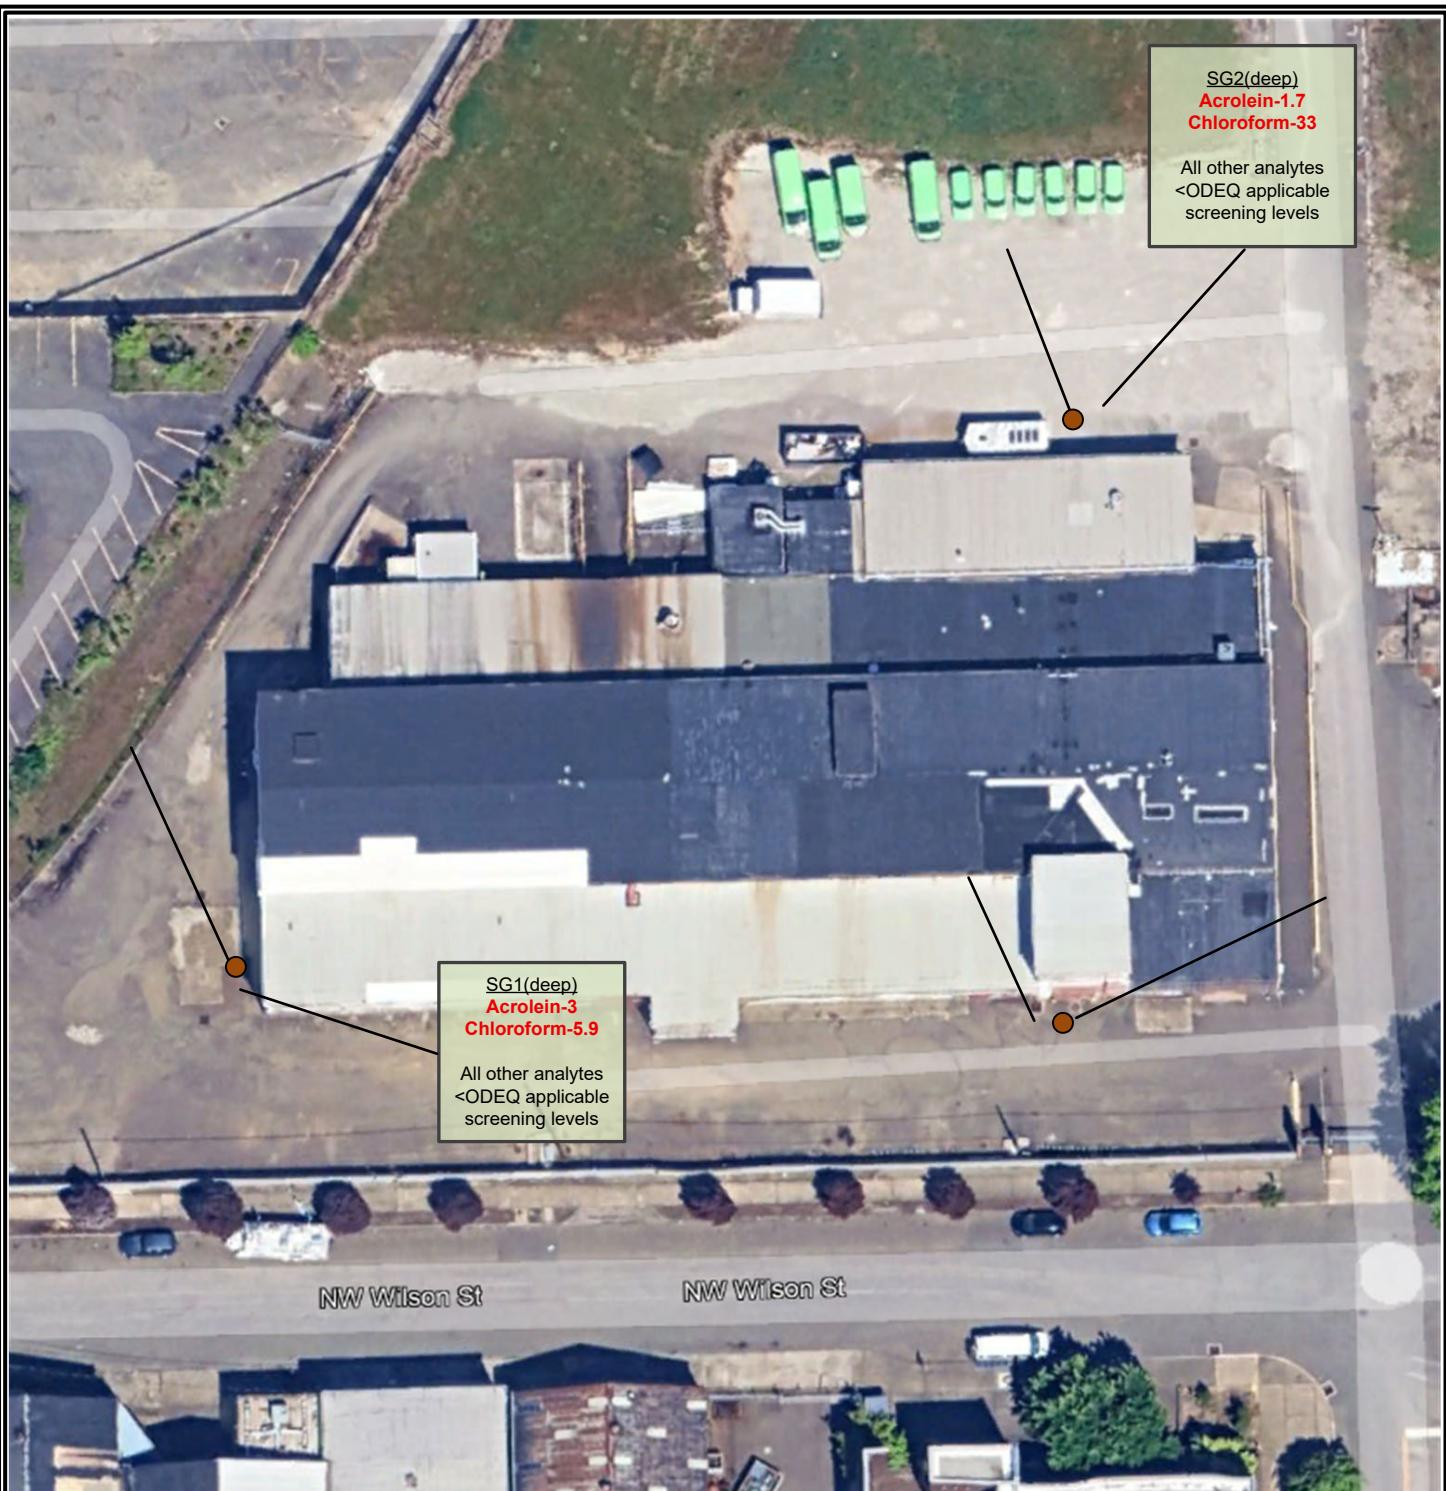
**FIGURE 10a: BUILDING 4 SAMPLE LOCATION DIAGRAM (>RBCsv for residential receptors; September 2025)**

- Vapor Sample results in ug/m<sup>3</sup>
- RED = Detected above RBCsv for residential receptors
- Only constituents that exceeded applicable screening levels are presented.

- Shallow Soil Vapor Sample Location
- Deep Soil Vapor Sample Location
