RE: UST Compliance Inspection
DEQ UST #1395
Global AF DBA (LBBC)
1519 Adams Ave.
La Grande, OR 97850

ent of Environmental Quality - Underground Storage
 Technical Compliance Rating - UST Inspection Report

Field Citation
For UST Violations

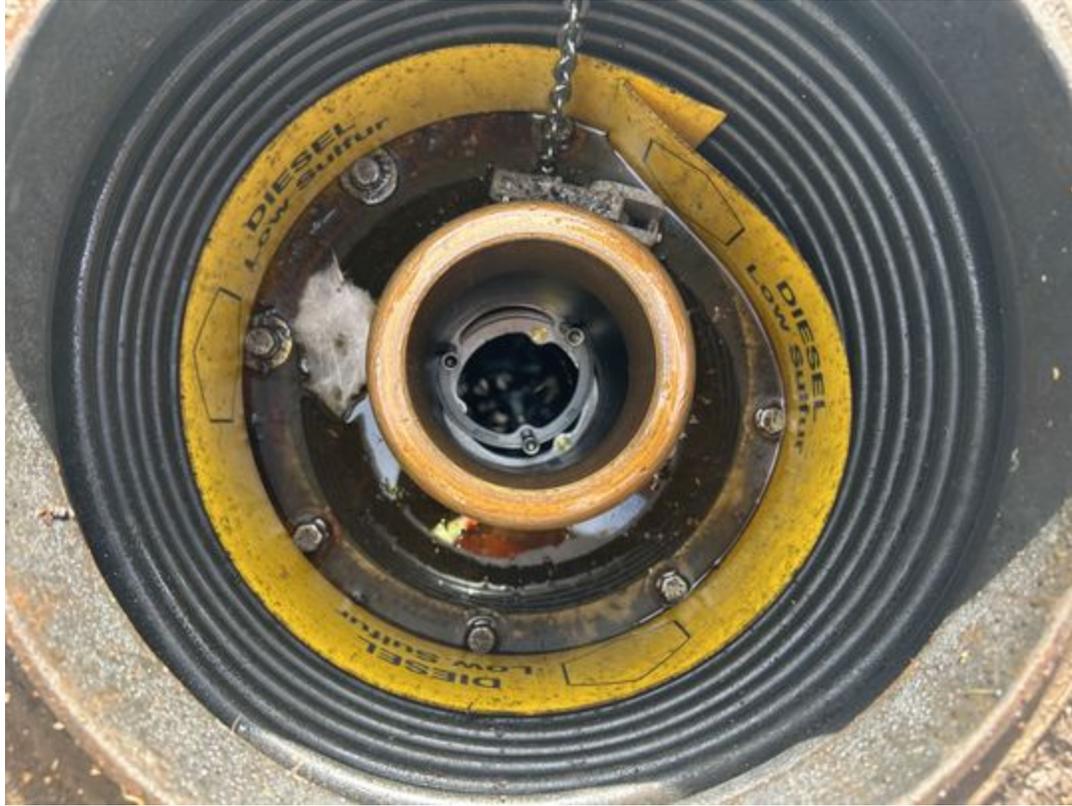
photos-20251111-215745die.jpg

die: Adapter not set right, was cut needs to repair -
 Pul - drop tube? what's up with drop tube?

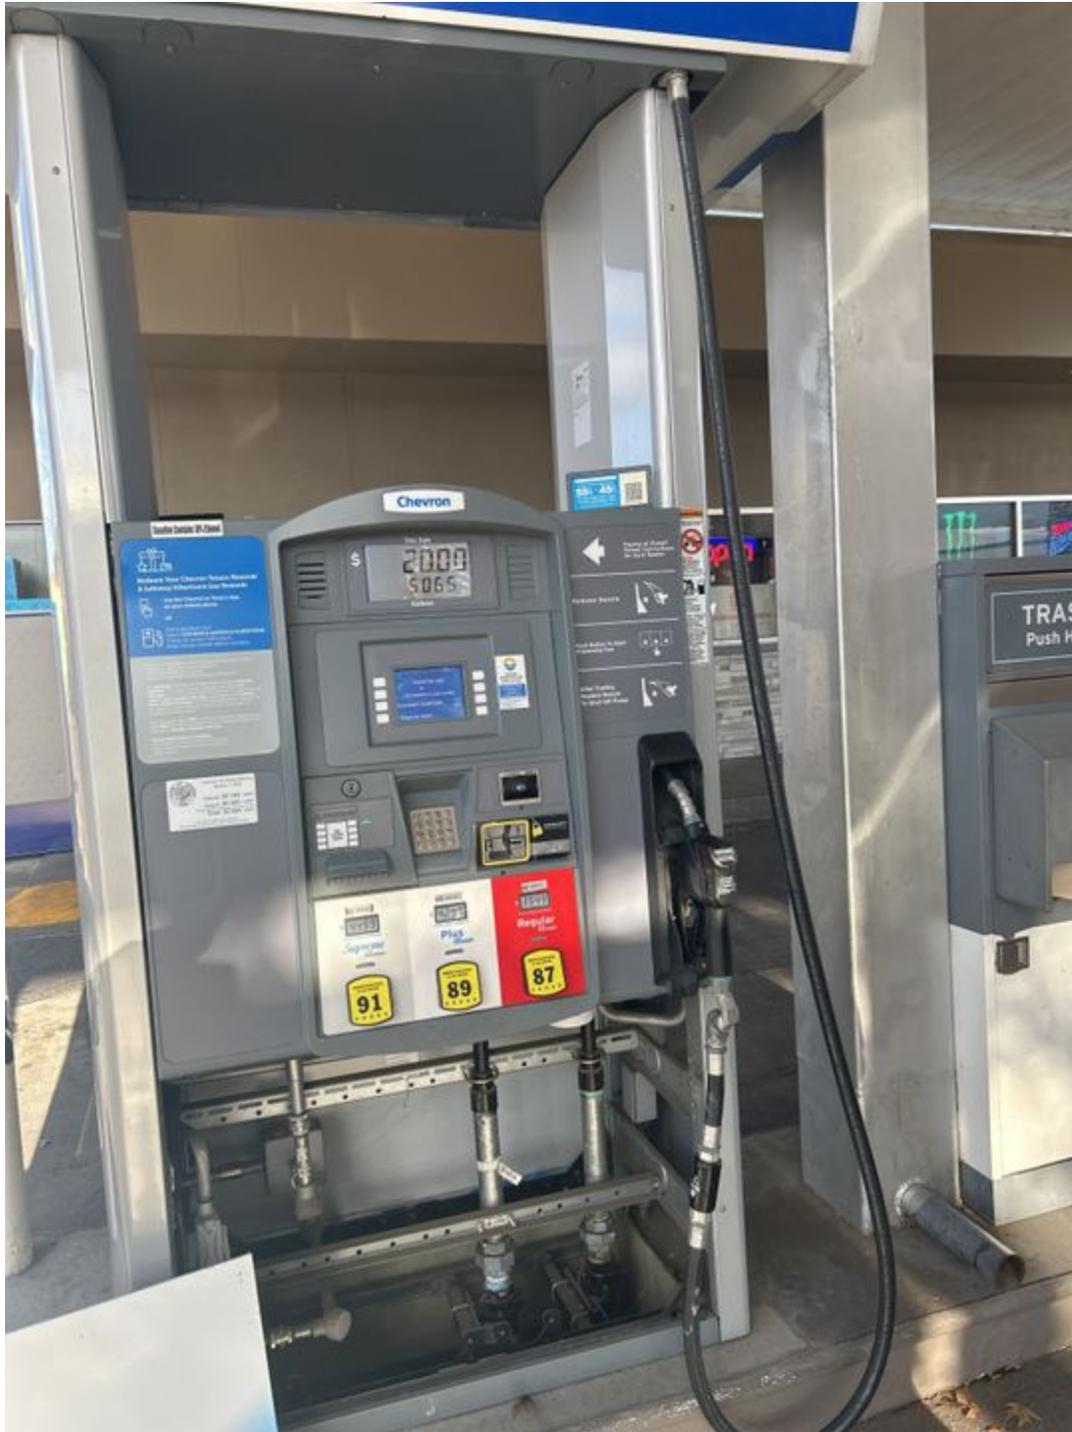
photos-20251111-222331-34changebreakaway.jpg

3/4, 1/2 block away →
