**RISK EVALUATION REPORT**

Galvanizers Company  
2406 NW 30<sup>th</sup> Avenue  
Portland, Oregon  
DEQ ECSI No. 1196

For  
Galvanizers Company and the Oregon Department of Environmental Quality  
November 22, 2023

Project: Galvanizer-1-02-03

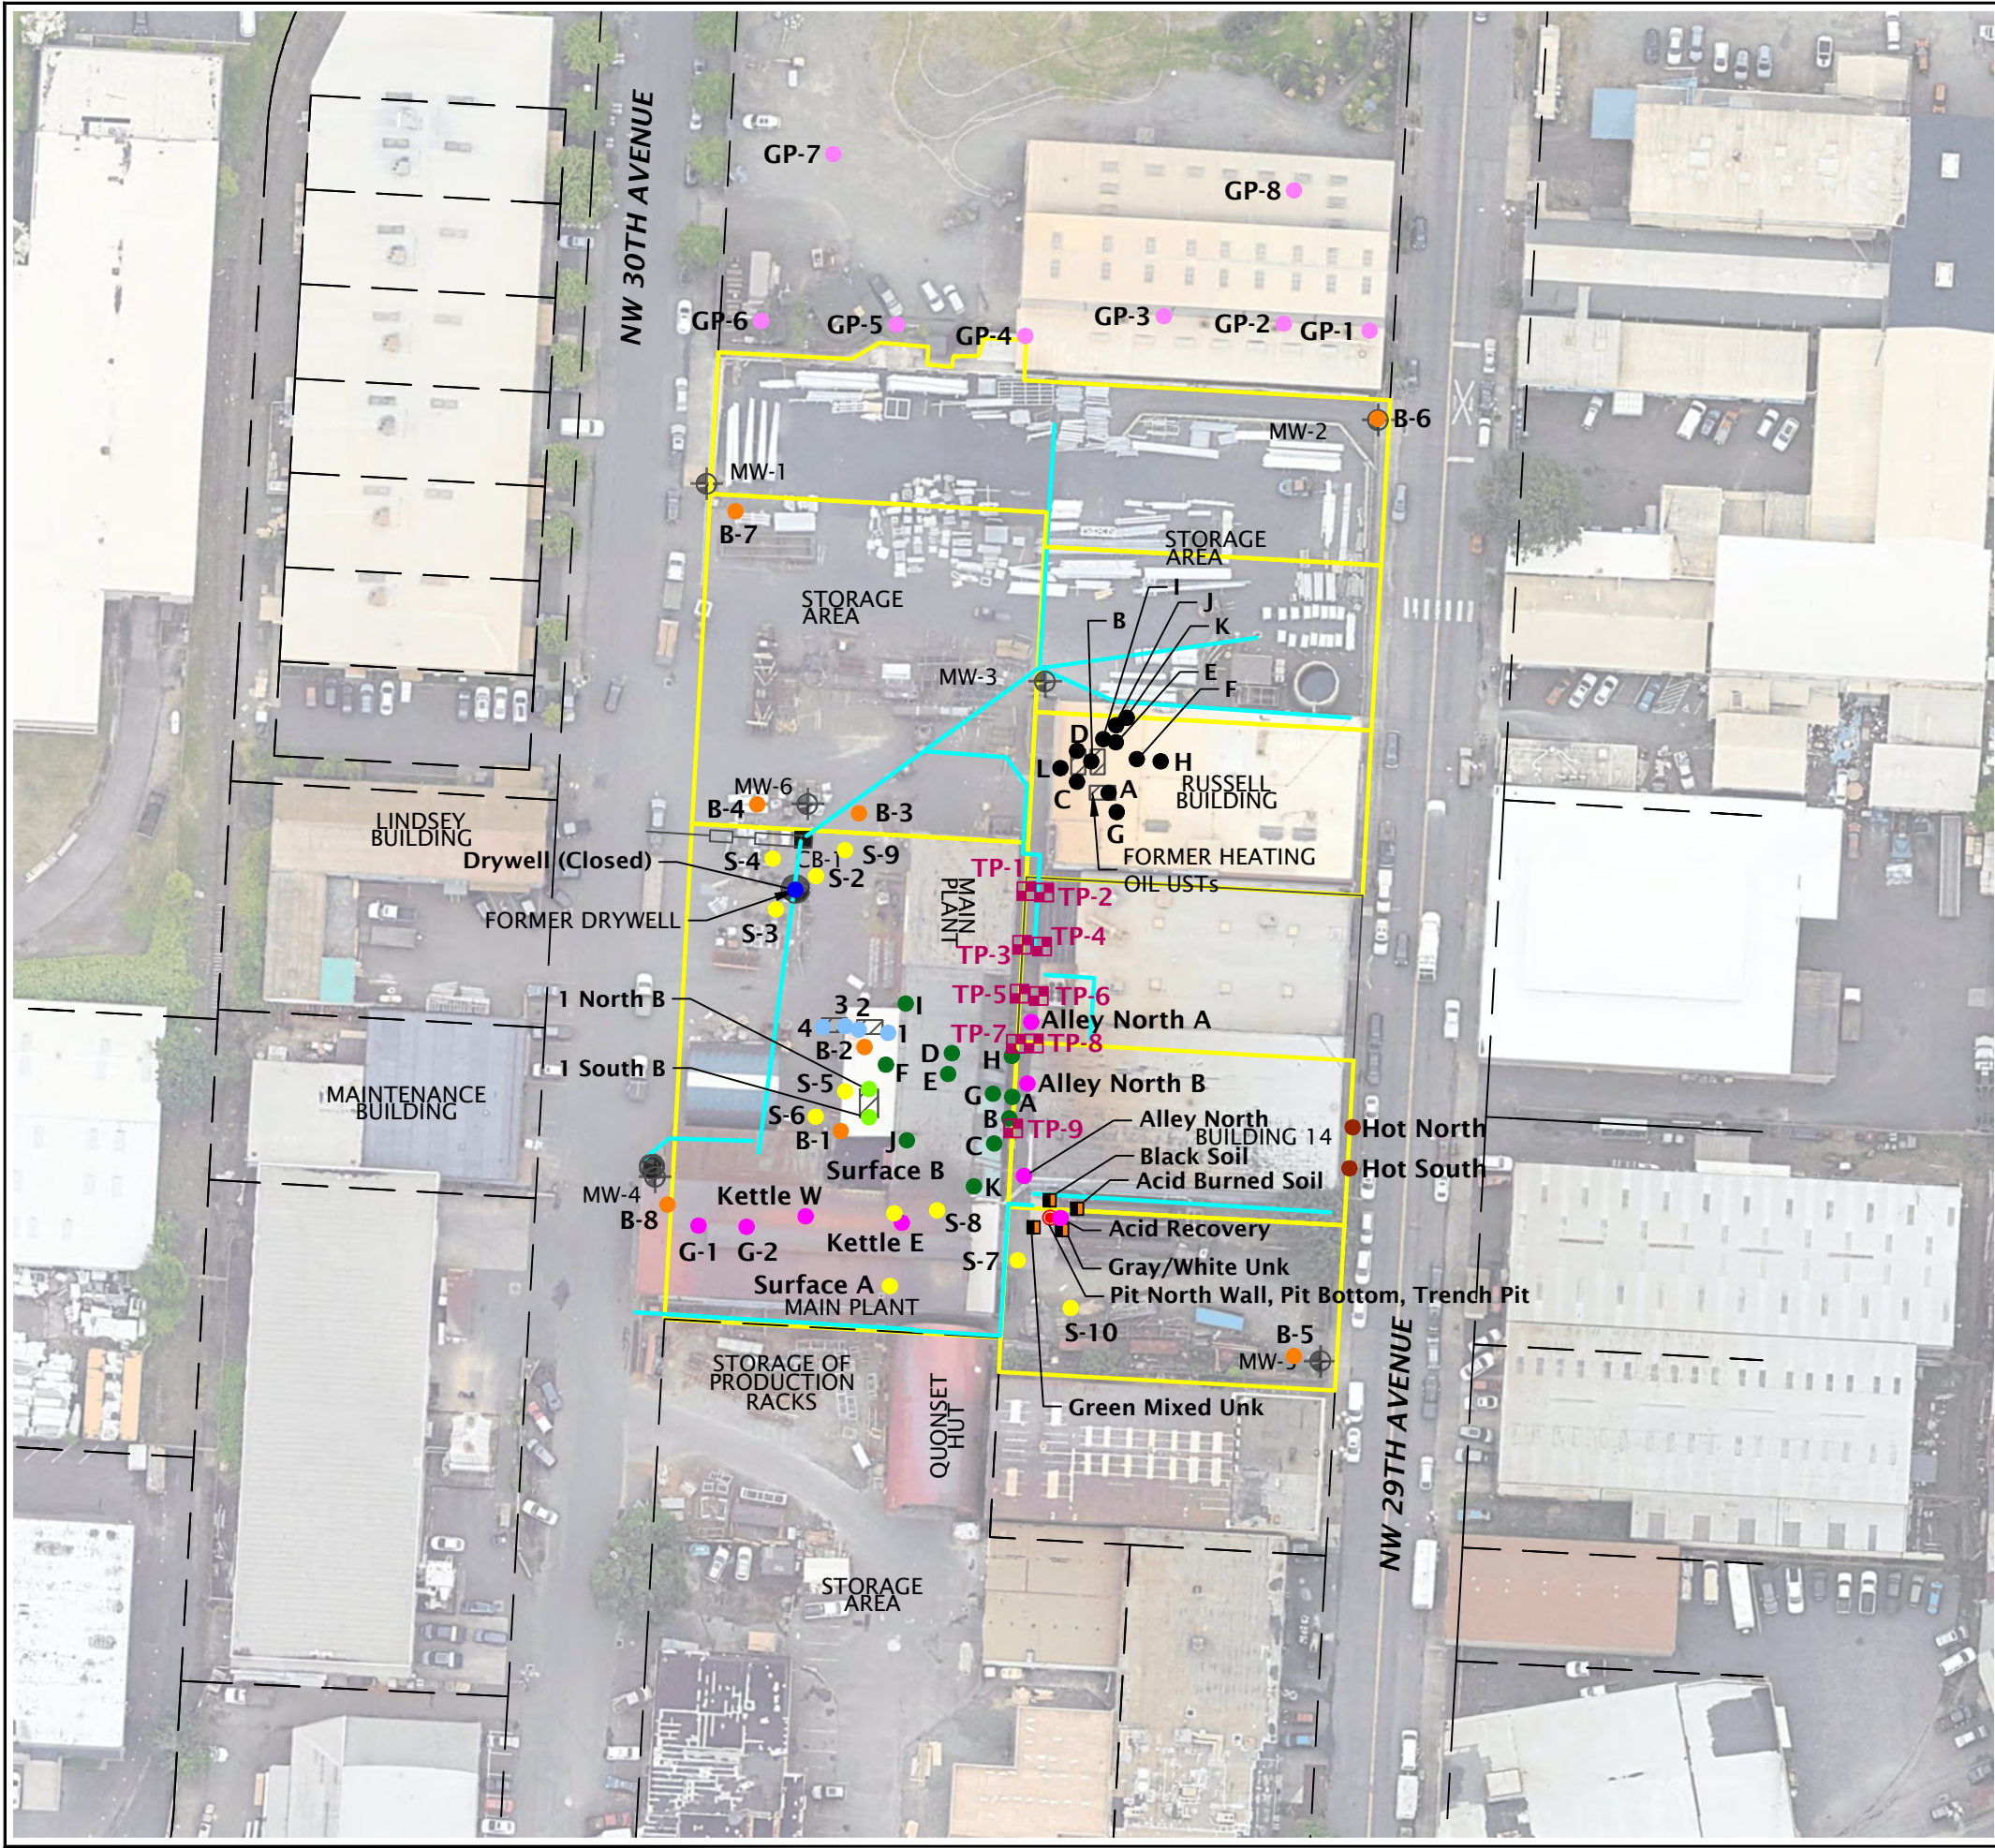
- MONITORING WELL
- ON-SITE CATCH BASIN
- ON-SITE STORMLINE
- GALVANIZERS COMPANY PROPERTY
- TAX LOT BOUNDARY
- 1992/1993 SAMPLE
- JULY 1996 SOIL BORING
- NOVEMBER 1996 SOIL BORING
- OCTOBER 1998 SOIL BORING
- OCTOBER 1998 HEATING OIL UST SOIL BORING
- NOVEMBER 1999 UNKNOWN BACKFILL MATERIAL SAMPLES
- MAY 1999 SOIL SAMPLE
- SEPTEMBER 1999 FREEMAN
- JULY/SEPTEMBER 2000 SOIL BORINGS
- OCTOBER 2001 TEST PIT
- AUGUST 2001 CONFIRMATION SAMPLES
- AREA OF 2001 DRY WELL CLOSURE
- OCTOBER 2003 SOIL BORING

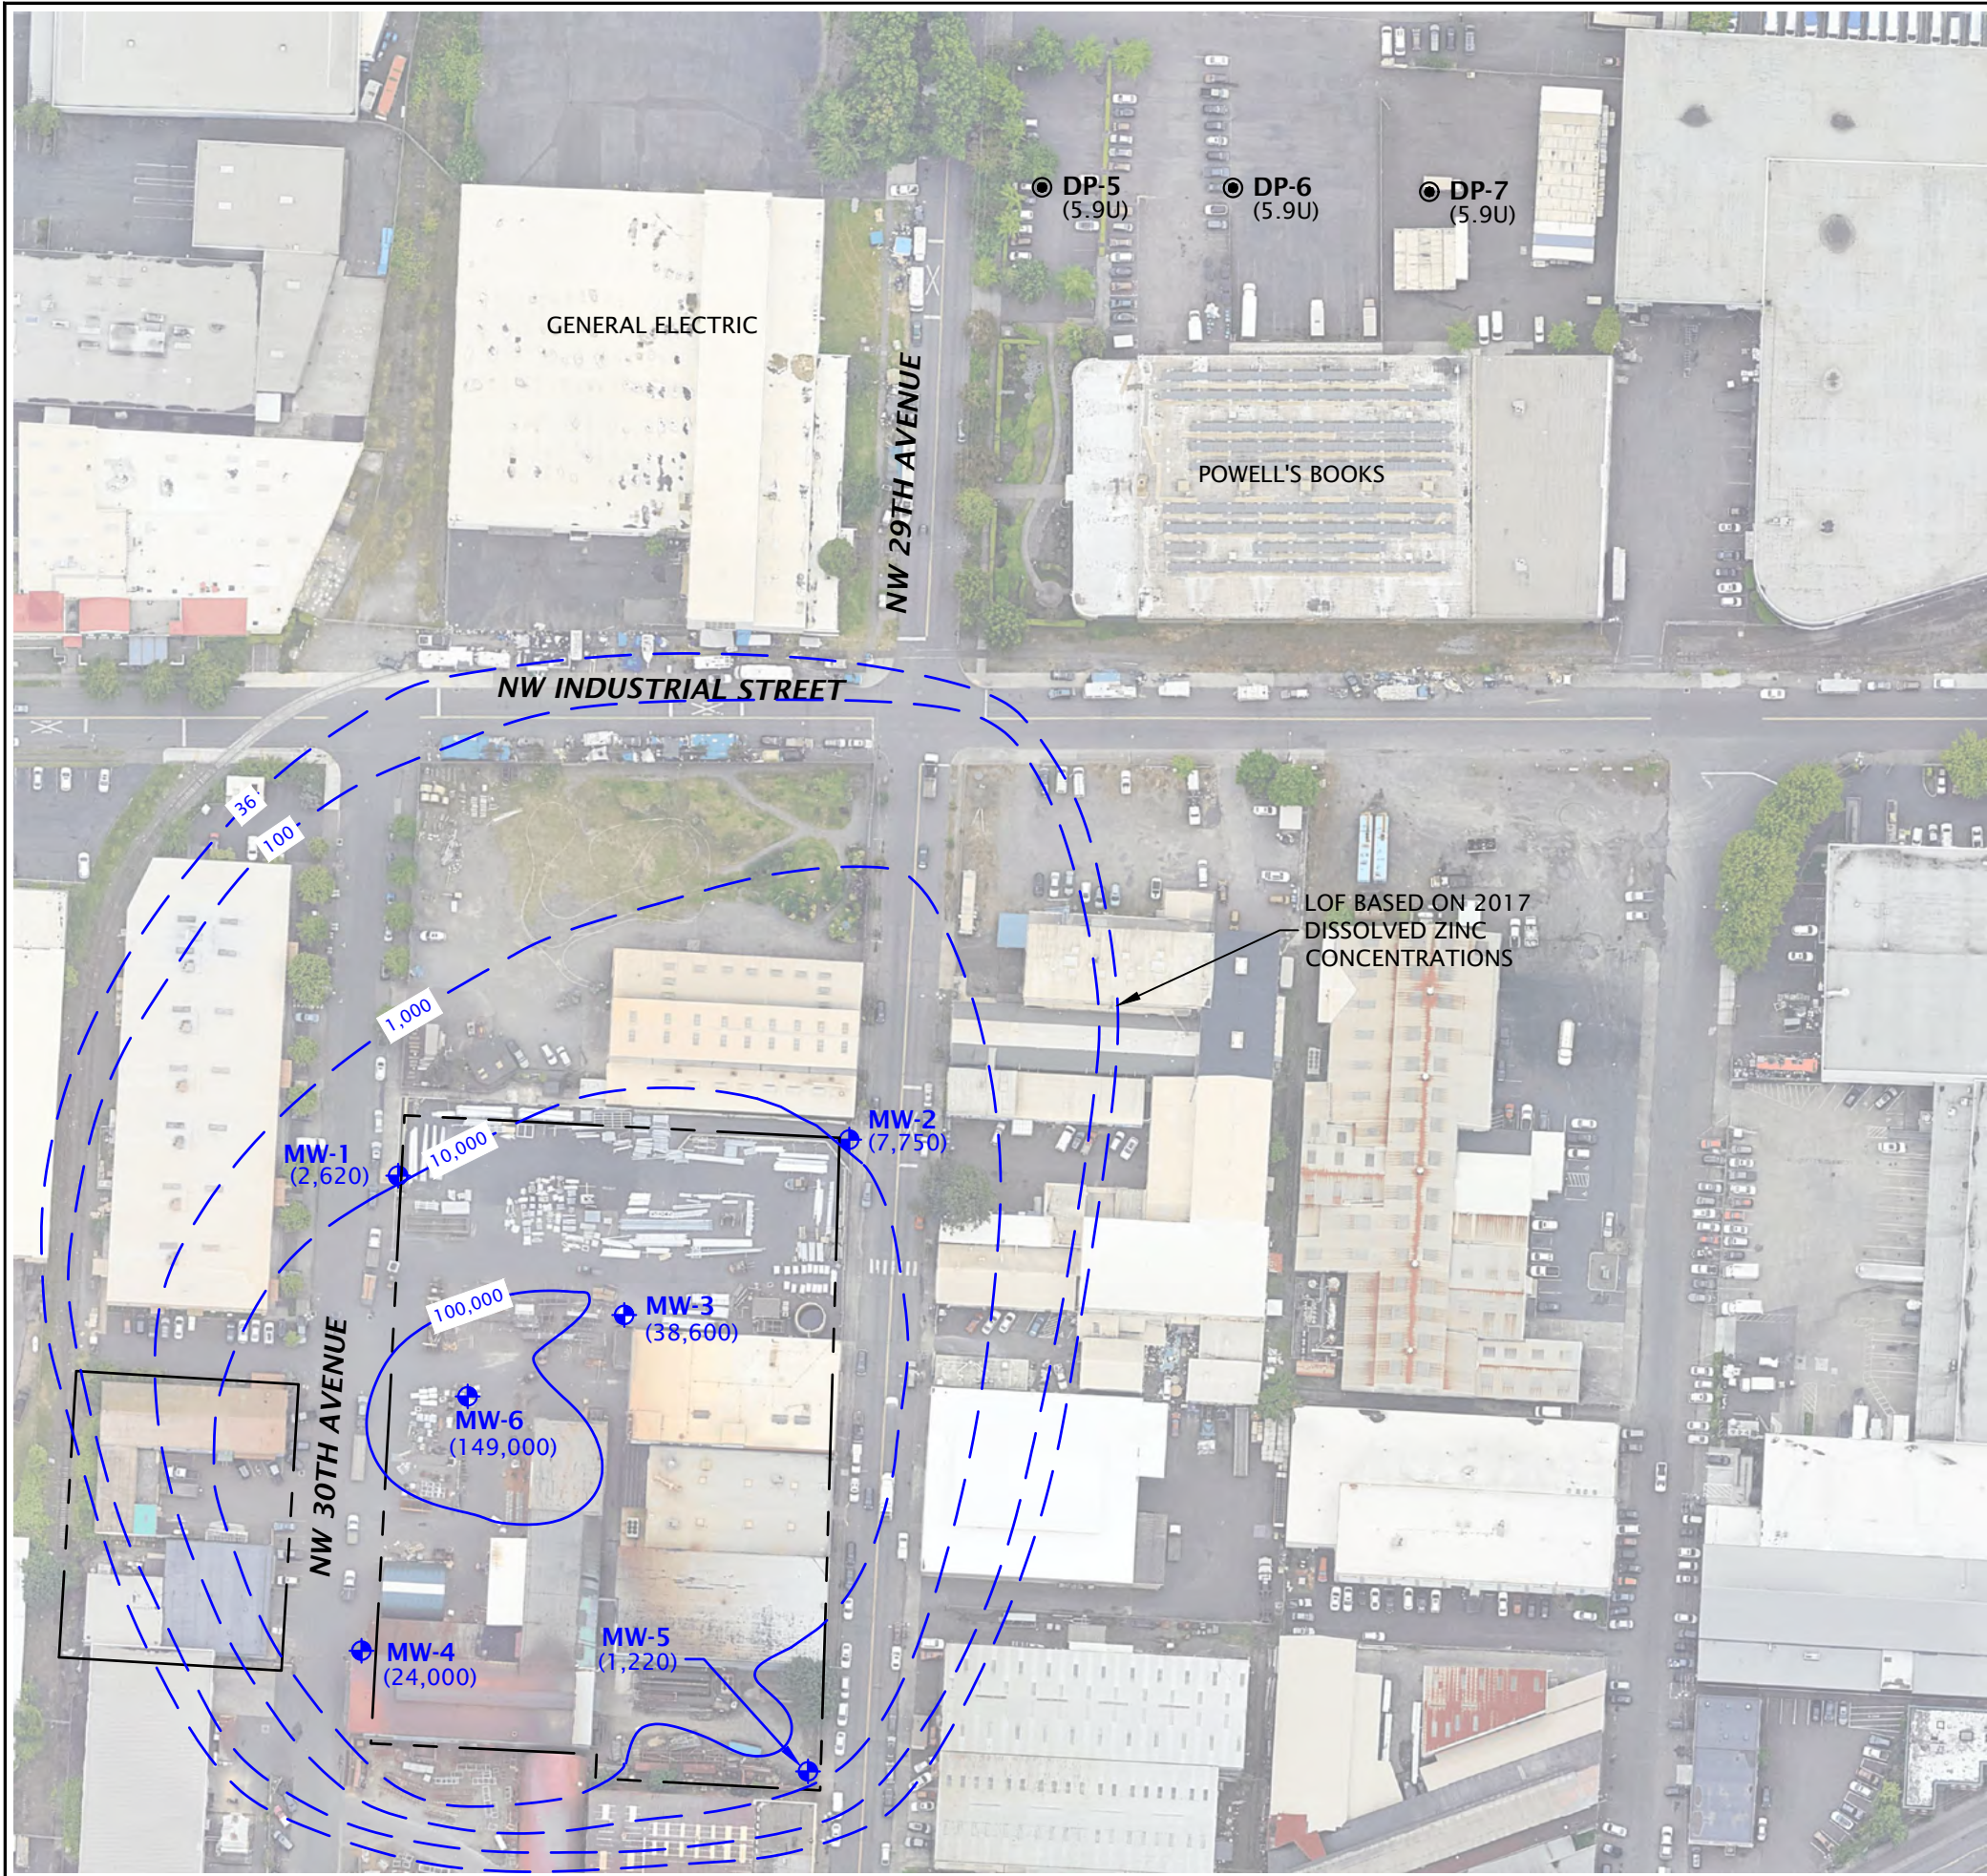
- MW-1 GROUNDWATER MONITORING WELL
- DP-5 DIRECT-PUSH BORING (GEODESIGN 2017)
- (2,600) DISSOLVED ZINC CONCENTRATION ( $\mu\text{g/L}$ )
- PROJECT SITE BOUNDARY
- U ANALYTE NOT DETECTED GREATER THAN THE REFERENCED LABORATORY MDL
- 10,000 DISSOLVED ZINC ISOCONCENTRATION CONTOUR (INFERRED WHERE DASHED)
- 36 DEQ ECOLOGICAL RBC FOR WATER =  $36\mu\text{g/L}$

- ANALYTICAL RESULTS SHOWN ARE FOR GROUNDWATER SAMPLES COLLECTED ON SEPTEMBER 25 AND 26, 2017.
- CONTOUR INTERVAL: LOGARITHMIC

The distribution and transport of zinc in groundwater and soil are dependent on the species of zinc present and the characteristics of the environment. The solubility of zinc is a function of pH. Lower pH values tend to increase the solubility of zinc allowing for greater concentrations of zinc in groundwater. As pH increases closer to neutral (7.0), zinc tends to sorb to soil particles. Groundwater data indicate that on-site groundwater exhibits pH between 3.84 and 6.77. With more acidic conditions on site, elevated zinc concentrations in groundwater are observed. However, zinc concentrations in groundwater significantly decrease as natural buffering conditions neutralize the groundwater, decreasing the solubility of zinc and groundwater. This was demonstrated through fate and transport modeling (GeoDesign, 2017) and off site, downgradient groundwater sampling (GeoDesign, 2018).
