**FIFTH FIVE-YEAR REVIEW REPORT FOR
MCCORMICK & BAXTER CREOSOTING COMPANY SUPERFUND SITE
MULTMOMAH COUNTY, OREGON**

**Oregon Department of Environmental Quality
Northwest Region
Portland, Oregon**

**U.S. Environmental Protection Agency
Region 10
Seattle, Washington**

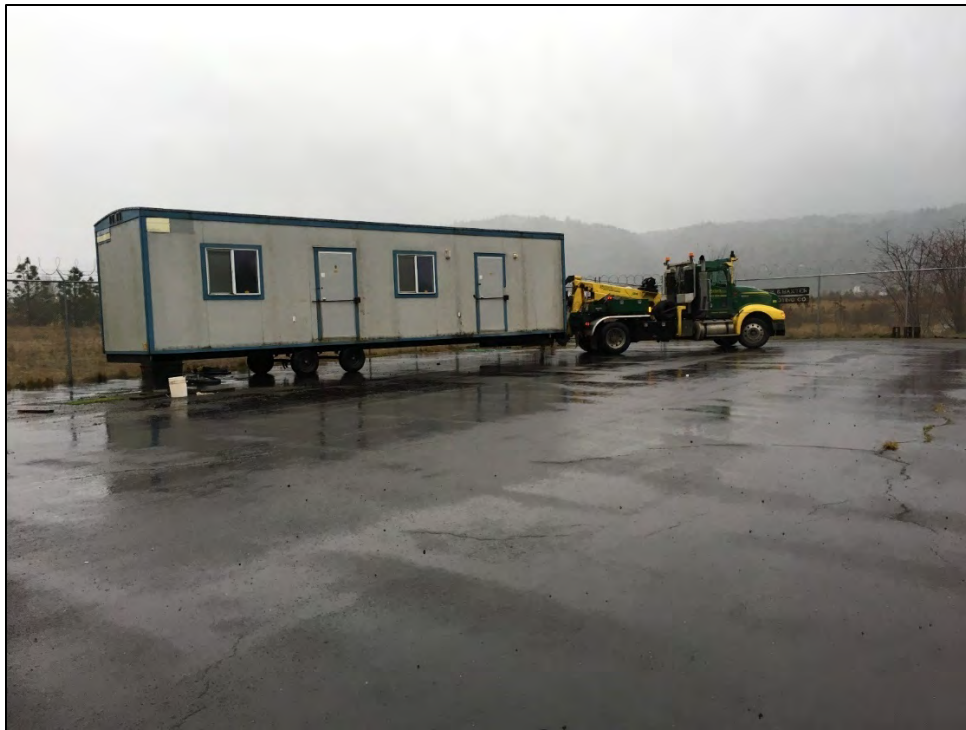
Photograph 3: Removal of the jobsite trailer from the paved storage area, February 2017.

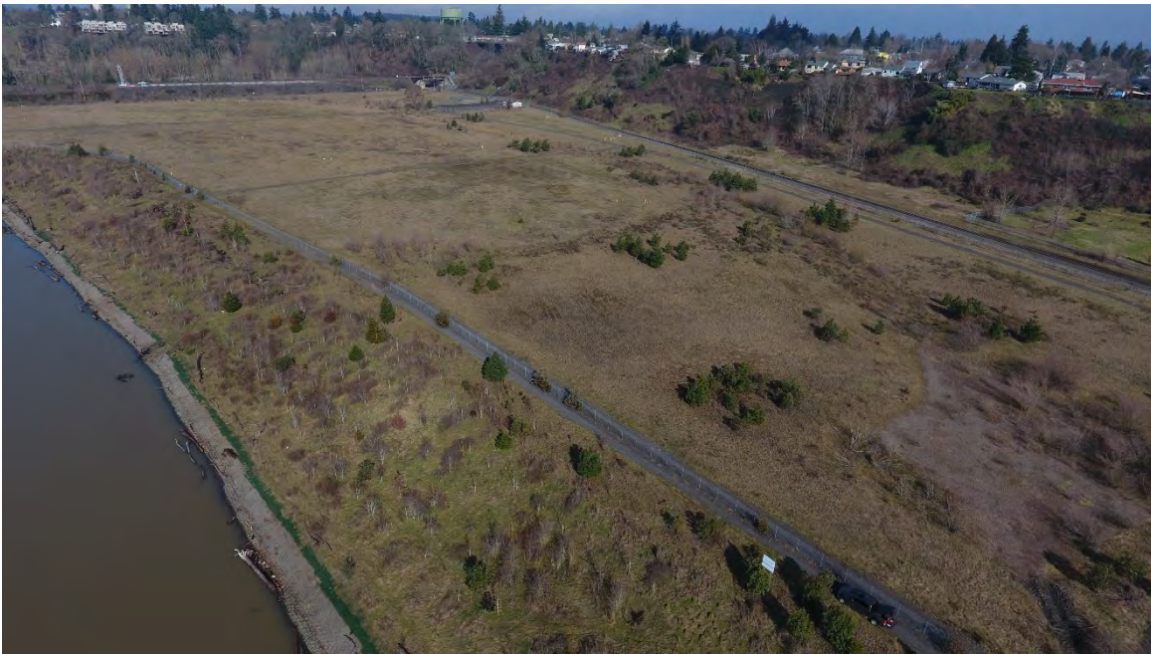
Photograph 4: Aerial view of the site from UAS survey, February 2017.

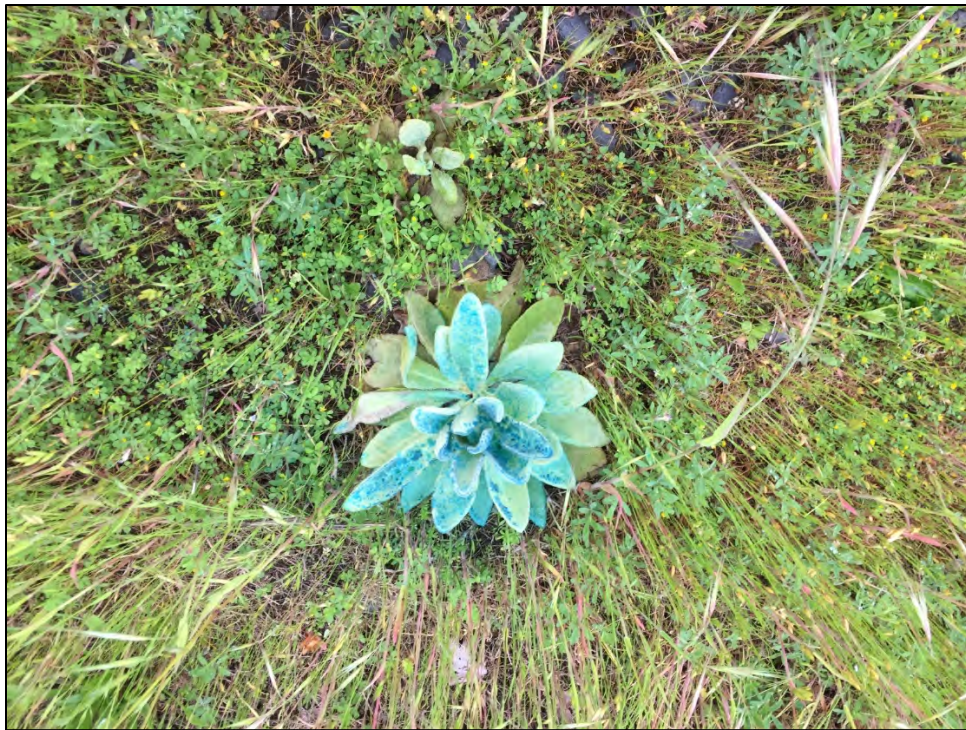
Photograph 5: Invasive weed after being sprayed with blue dyed herbicide, May 2017.

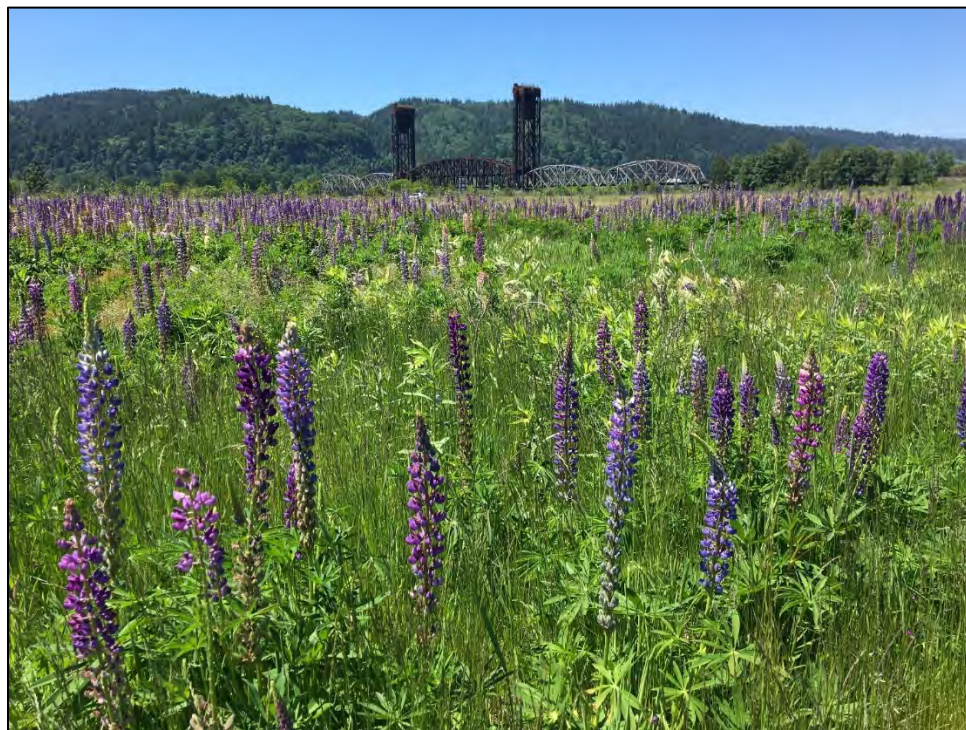
Photograph 6: Vegetation coverage (lupines in foreground) of the impermeable soil cap, May 2017.

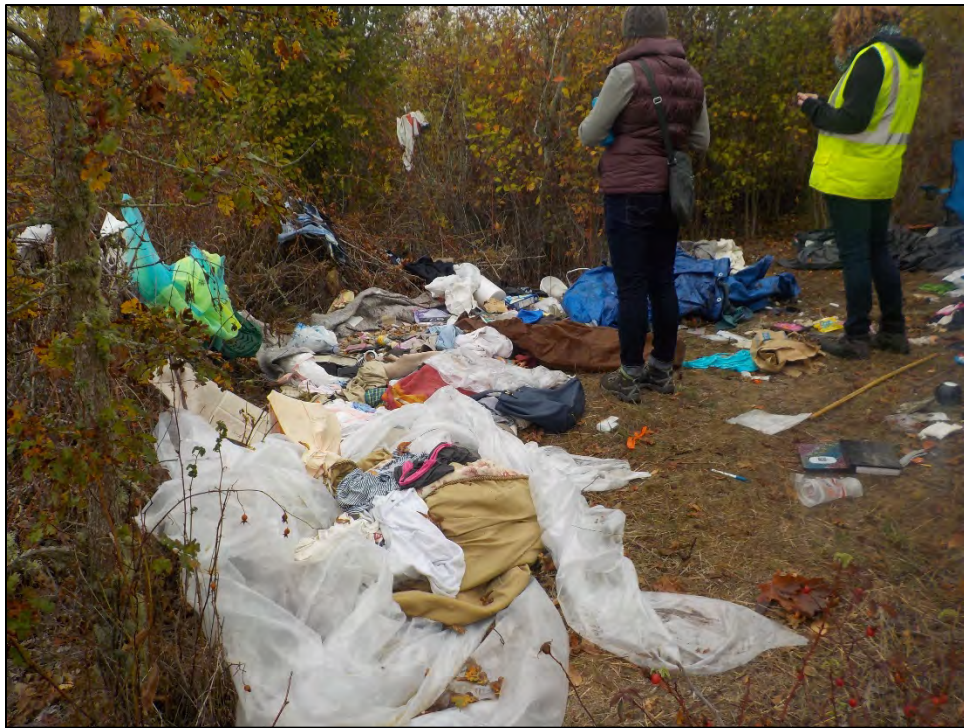
Photograph 12: Trash dumpsite in the riparian area, October 2018.

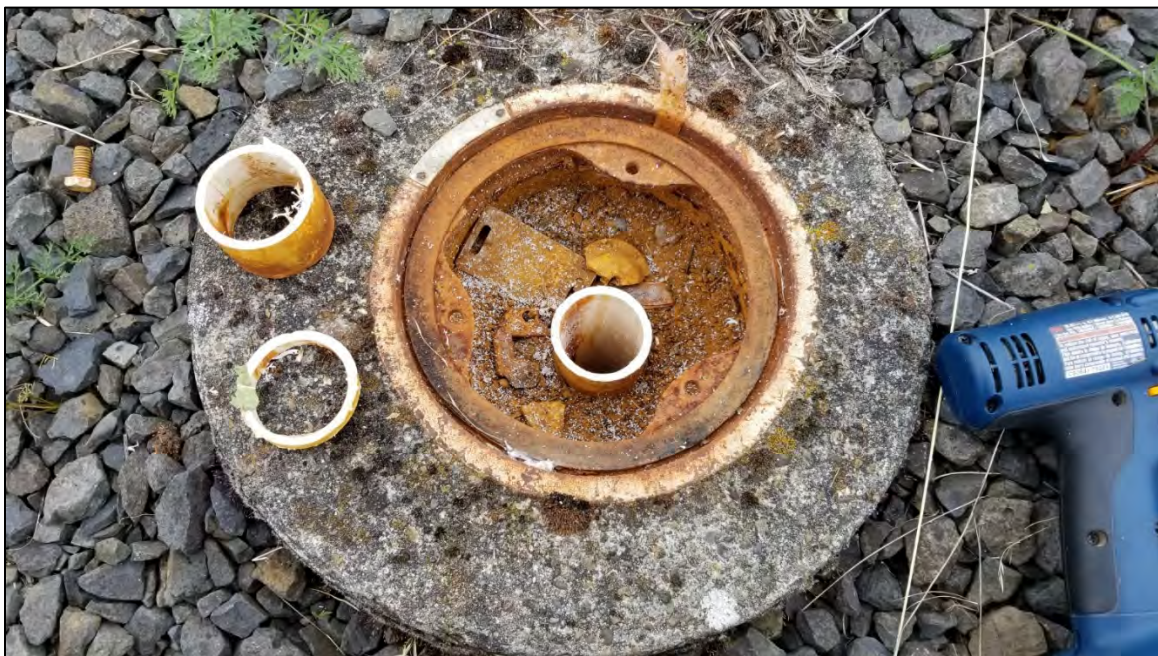
Photograph 13: Trimming MW-59s well casing to maintain well box lid functionality due to subsided well box, August 2019.

The MW-59s well casing protrudes too high for the monument lid to be installed (Photo 6). It was agreed between DEQ and Hart Crowser that the well casing should be cut down 3-inches. A survey will be completed before and after cutting the well casing.

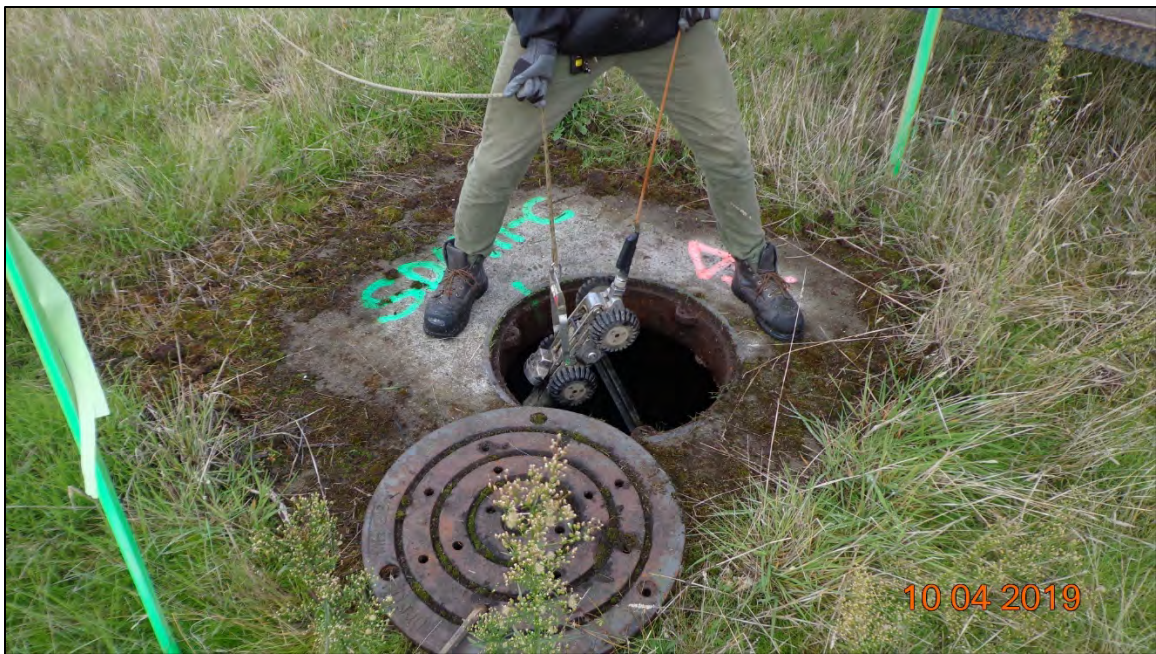
Photograph 14: Storm sewer video inspection using a remote crawler during subsidence monitoring evaluation, October 2019.

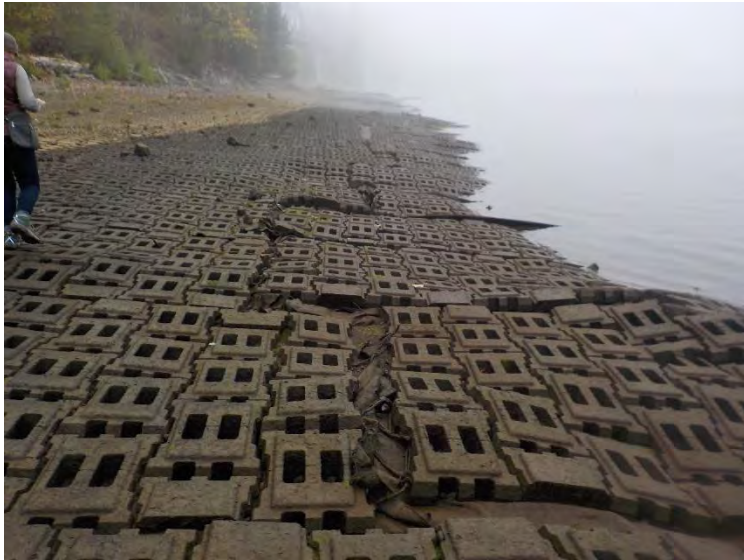
Photo 1 –View of separation gaps in the ACB along the Willamette Cove Shoreline.

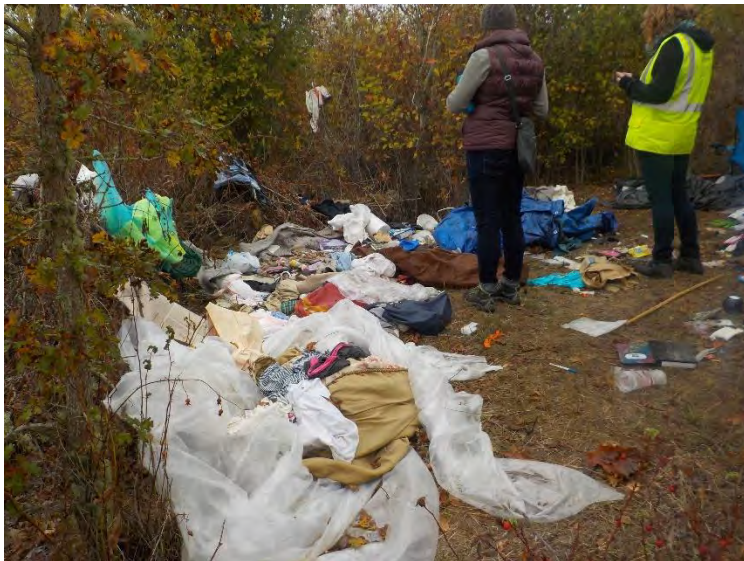
Photo 2 –View of debris left from dump site in the riparian area.

Site Activities / Miscellaneous Field Activities			
<ul style="list-style-type: none"> ■ DEQ is coordinating with Metro to cleanup the dumpsites in the riparian area along the Willamette River shoreline before the end of February 2019. ■ DEQ is in discussions with the City of Portland's contractor to use the site as a staging area for construction equipment. 			
Deliverables			
<ul style="list-style-type: none"> ■ A Budget and Assumption Proposal was submitted on February 5, 2019 to continue Groundwater Operational and Maintenance activities. It is currently being reviewed. 			
Budget Status: Currently at/or below the anticipated budget.			
Meeting Status:			
Date / Time		TBD – April/May 2019	
Location		McCormick & Baxter Facility

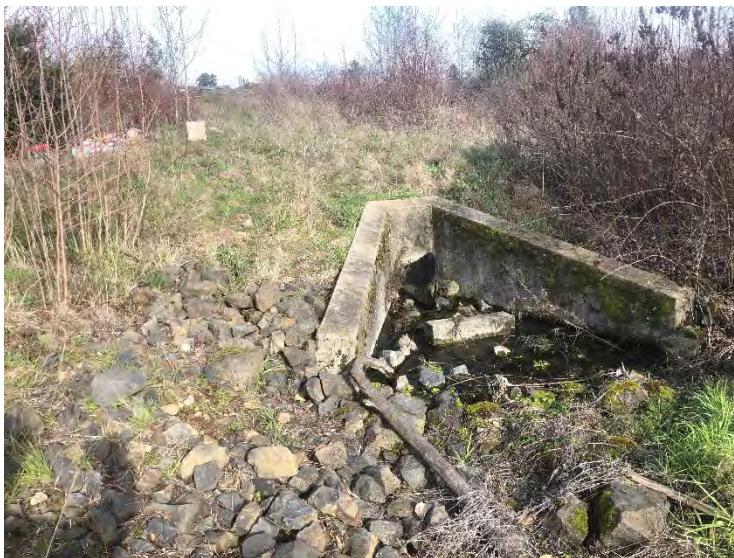
Photo 2 –View of stormwater discharge outfall at approximately 5 gallons per minute.

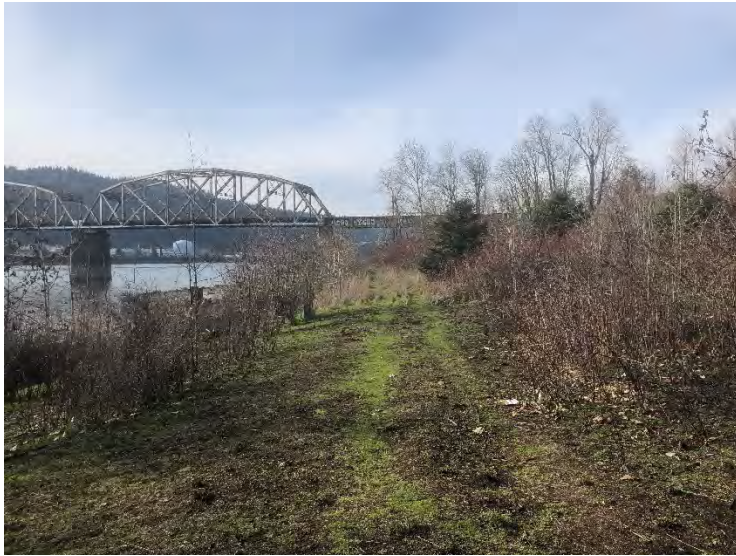
Photo 3 –View of returning vegetation in the riparian area after the fire in August 2018.

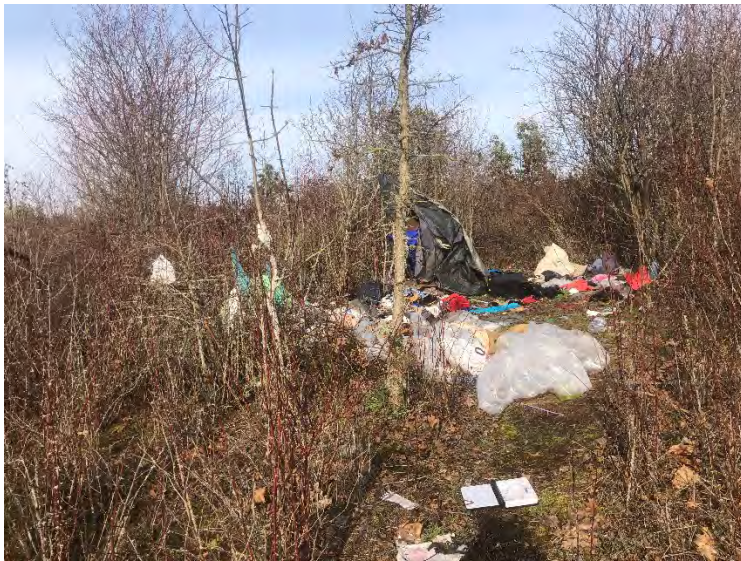
Photo 4 –View of debris from dump site in the riparian area.

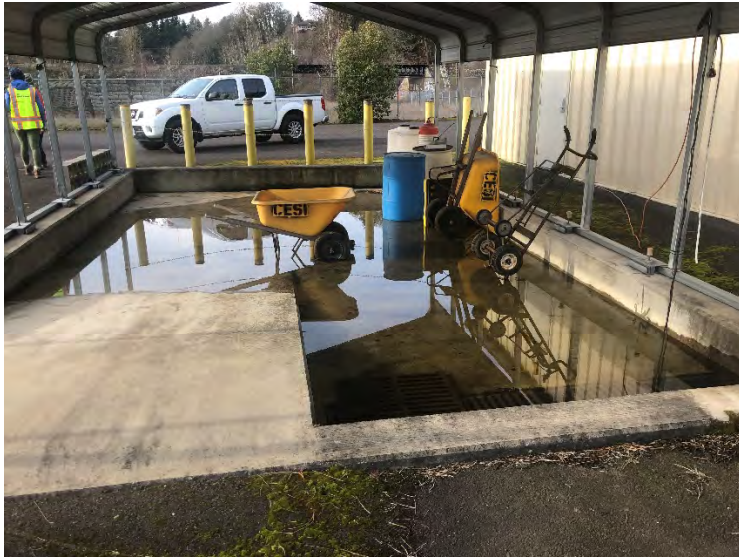
Photo 5 –View of the ponding at the site outdoor storage area. Pump was reset.

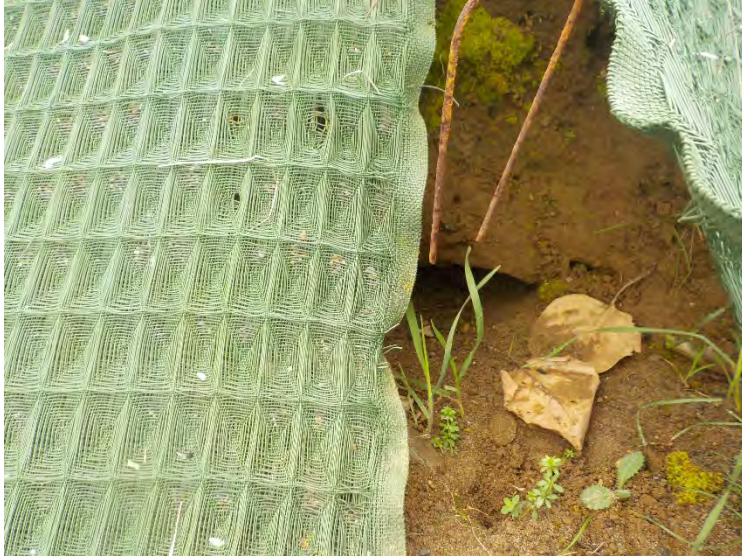
Photo 1 –View of the erosion under the TRM along the riparian area.

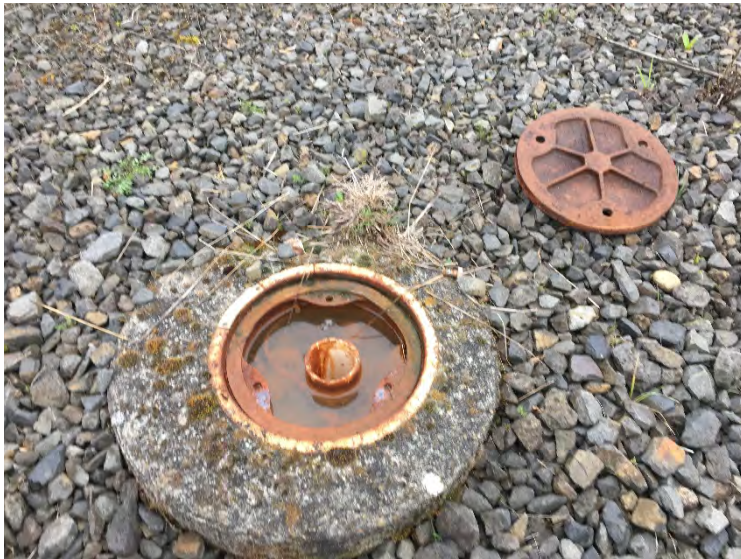
Photo 6 –View of the inner casing protruding past the monument in MW-59s.

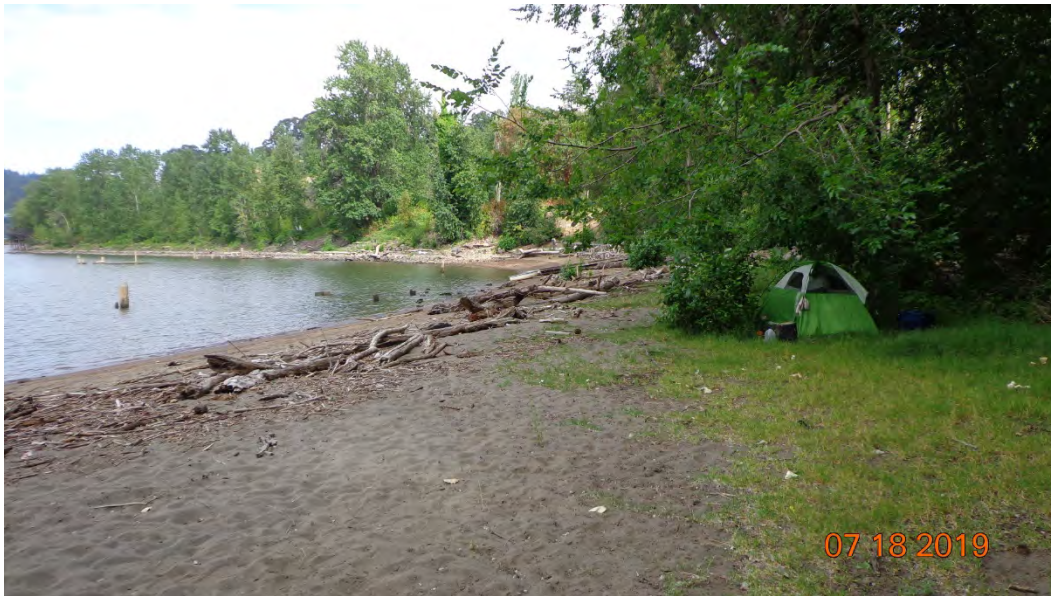
Photo 1 –View of
encampment along Willamette
Cove shoreline

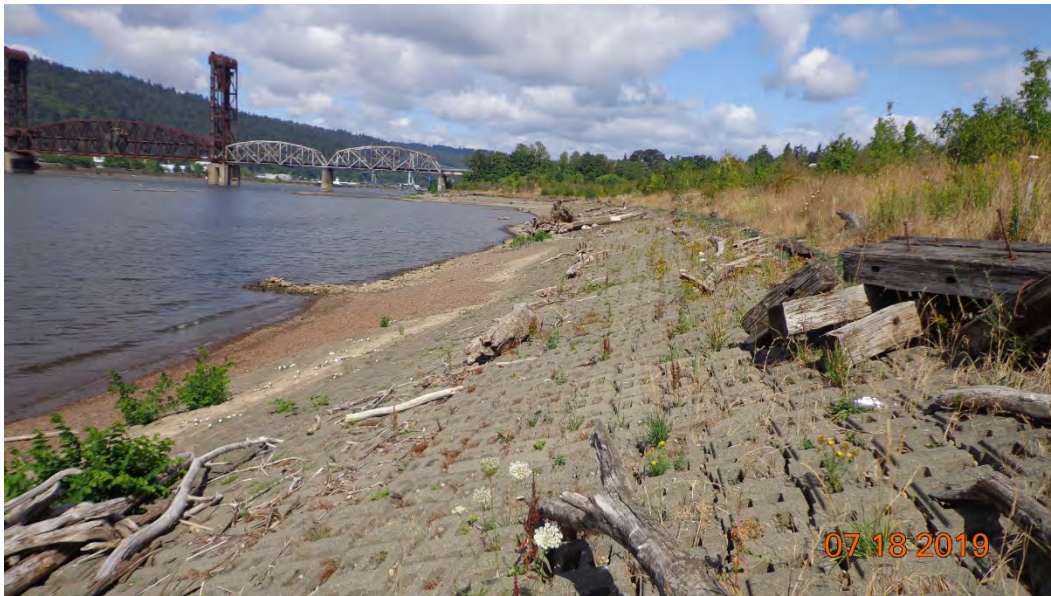
Photo 3 –View of riparian area shoreline with gravel and ACB coverage.

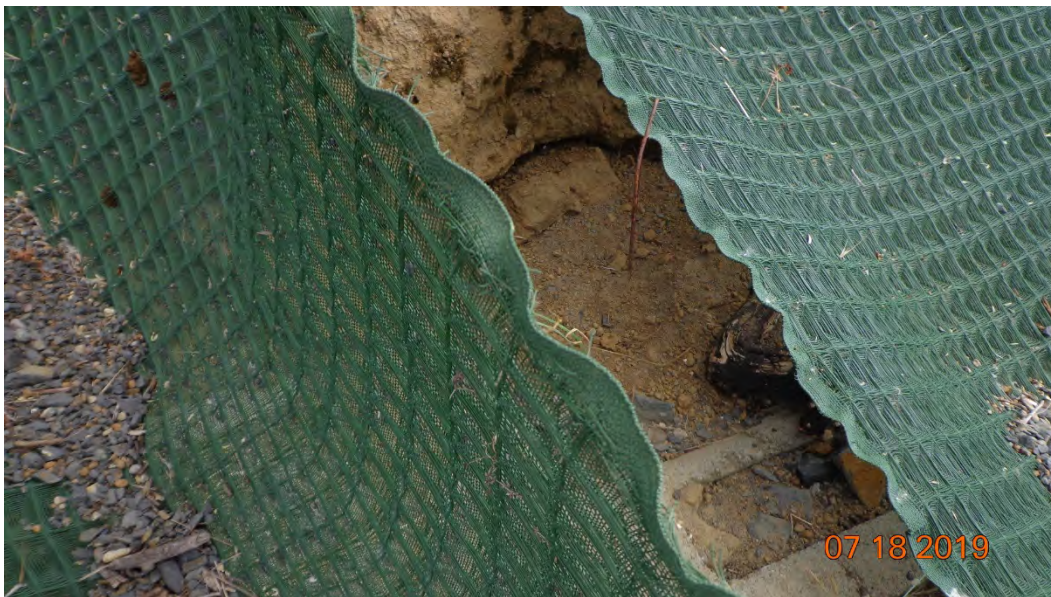
Photo 4 –View of small erosional pocket between seam of TRM.

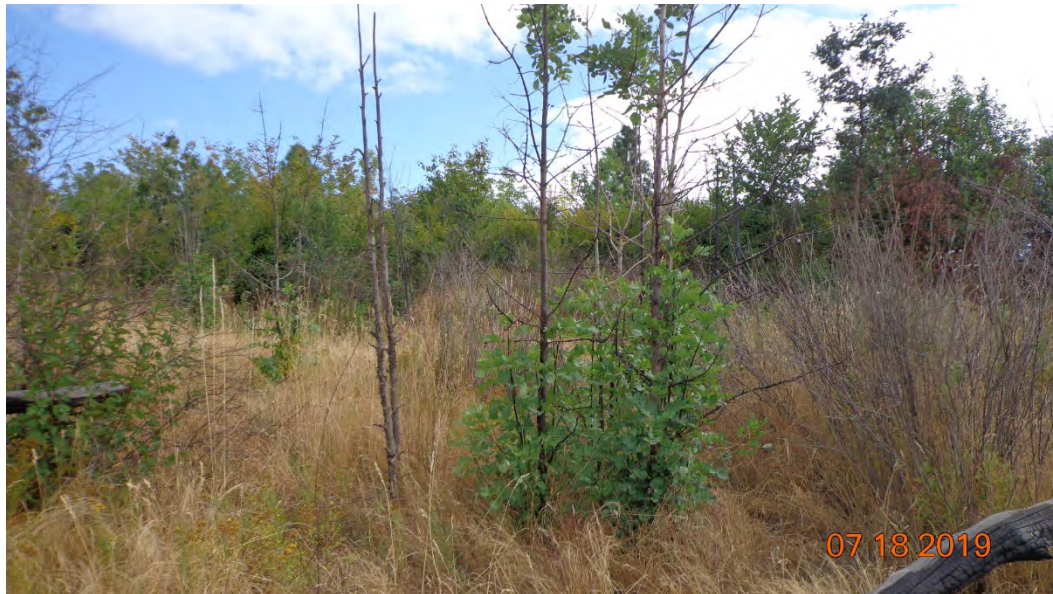
Photo 5 –View of new foliage
on tree trunks charred by the
August 2018 brush fire.

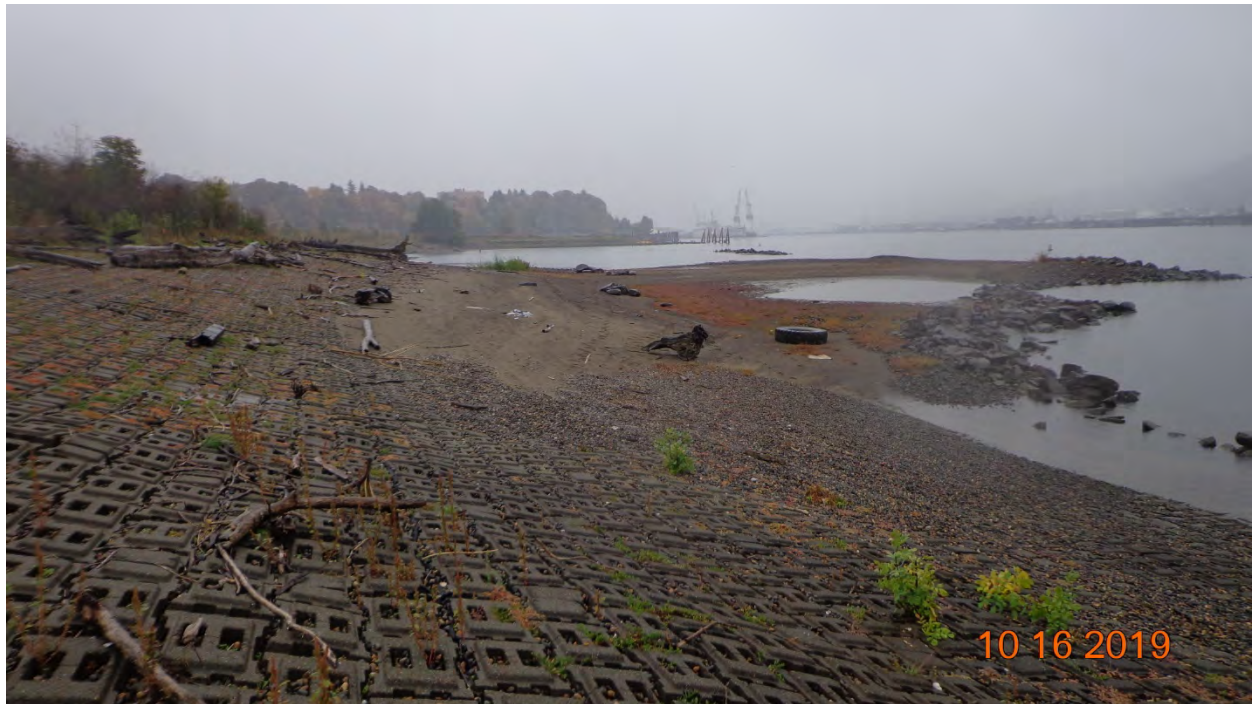
Photo 3: View of tidal mud flats at low tide during and the large, discarded tire that is present.

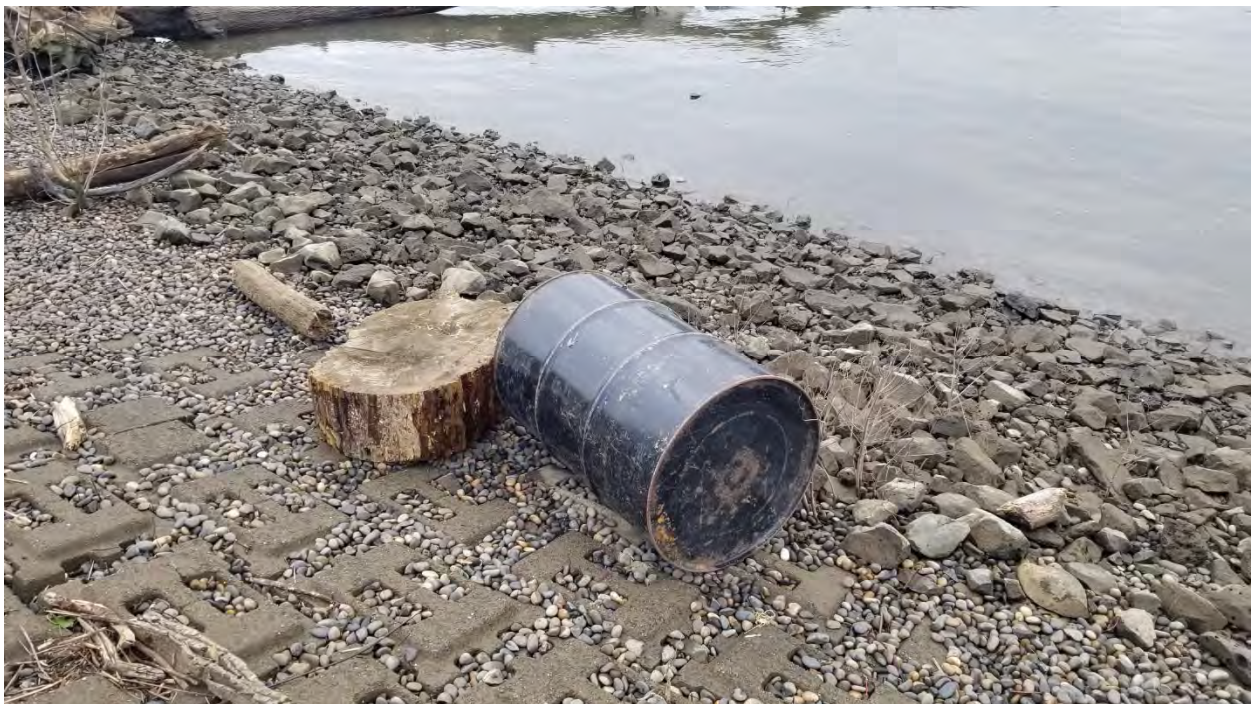
Photograph 4: Debris (empty 55-gallon drum) present along the riparian area shoreline.

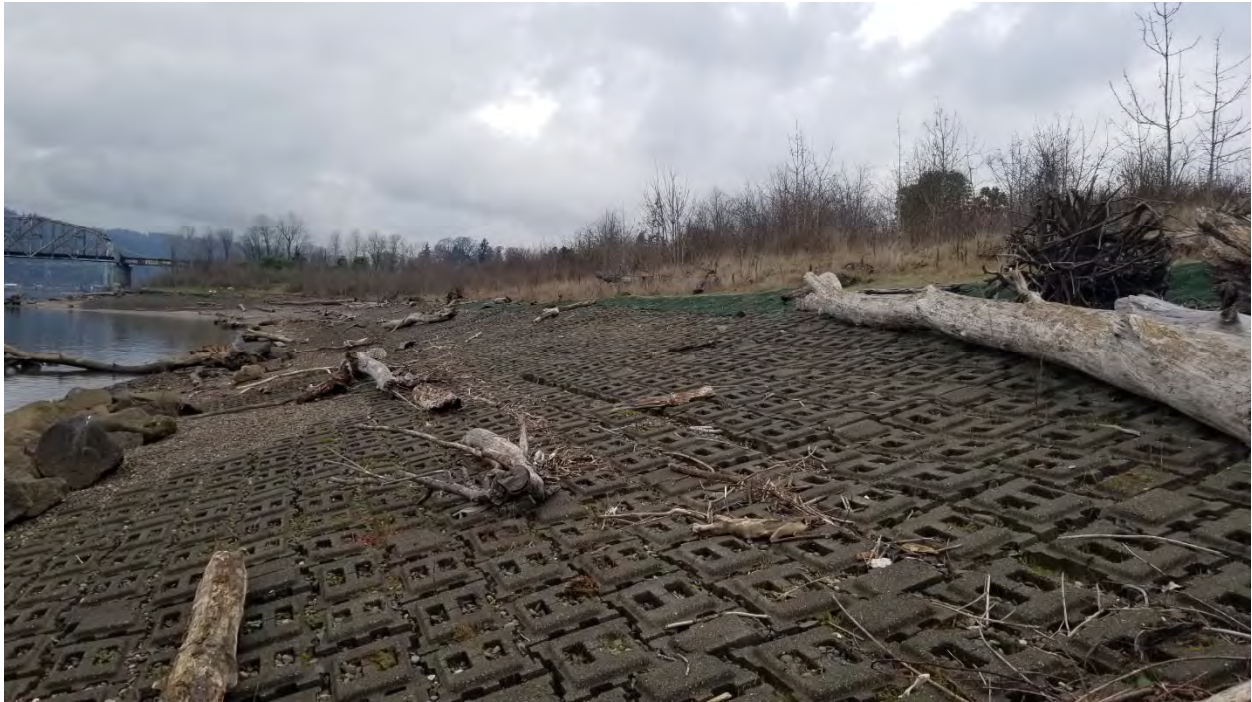
Photograph 5: Driftwood present on the shoreline of the Riparian Area.

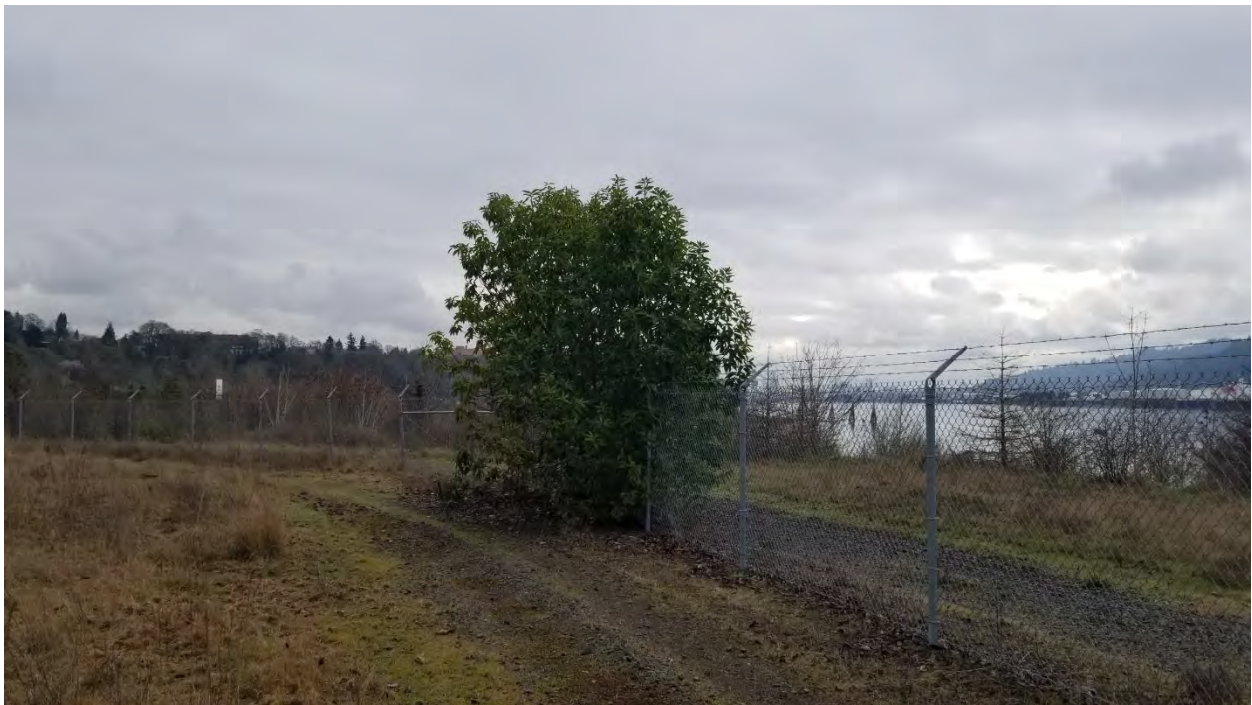
Photograph 8: Volunteer madrone tree growing along fence-line that needs to be removed.

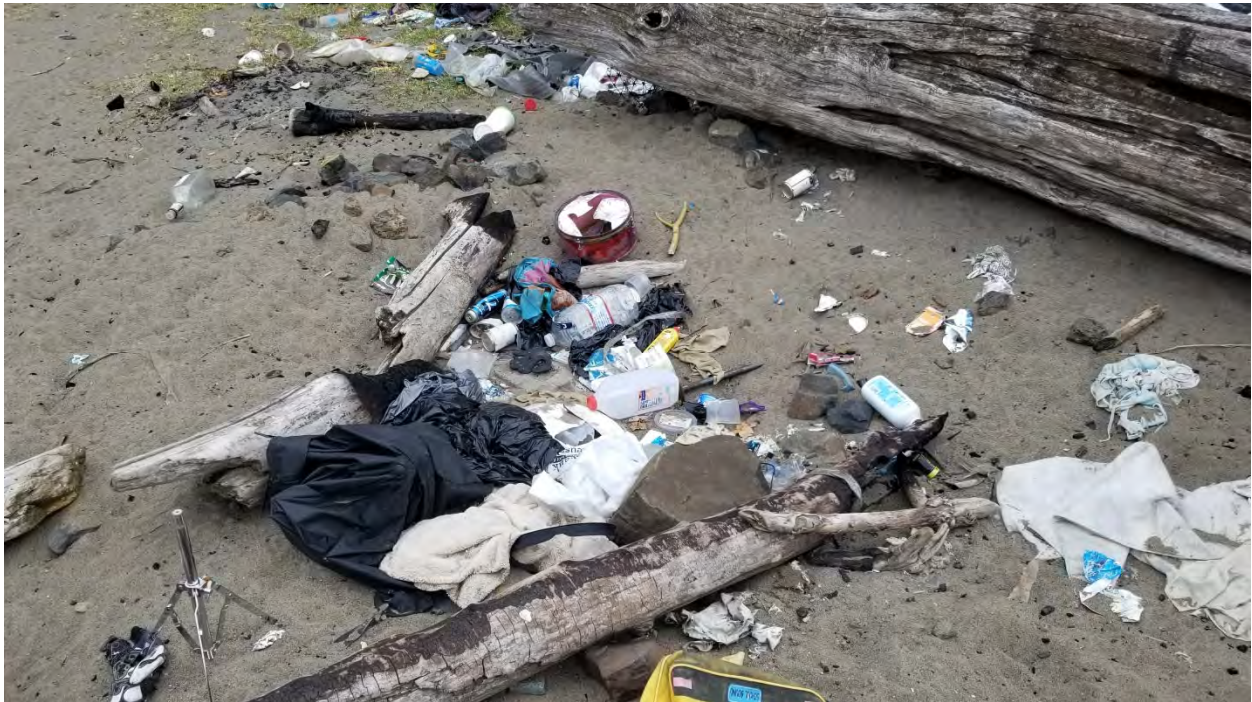
Photograph 2: Trash on Willamette River riverbank at base of access road down do shoreline.

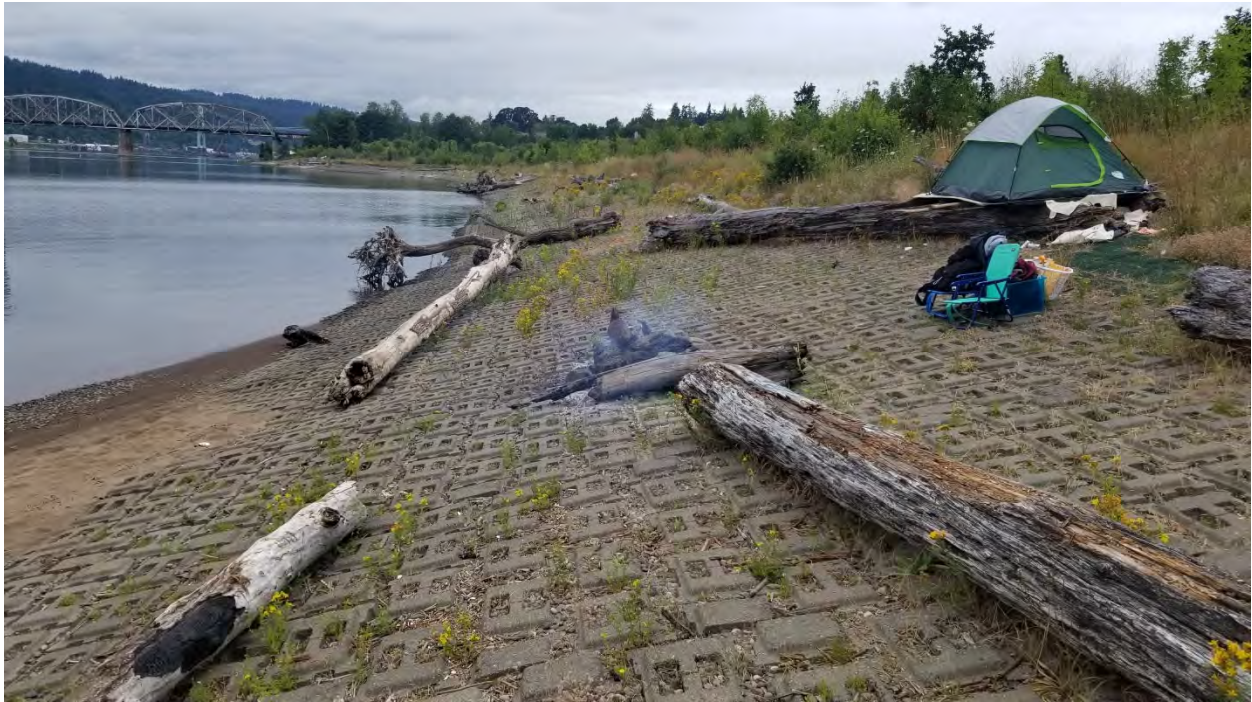
Photograph 3: Pedestrian camping on shoreline on southern end of the site.

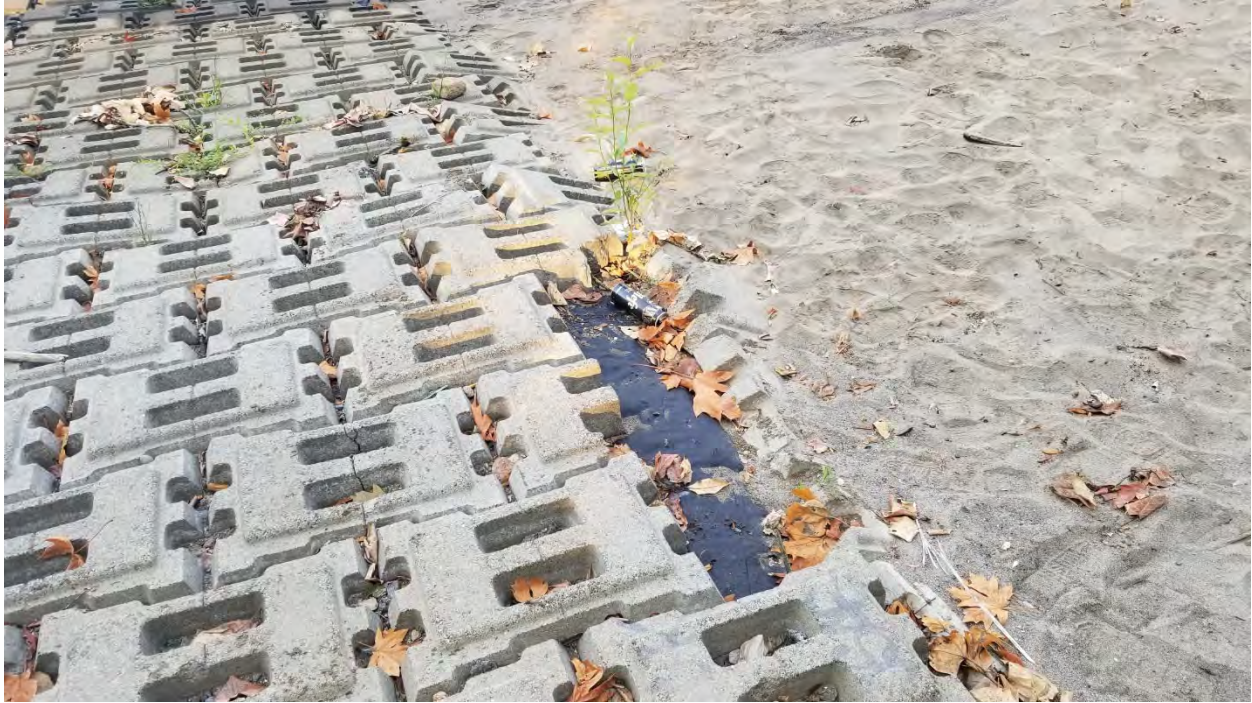
Photograph 1: Buckling and sagging of the ACB border on the eastern edge of the Willamette Cove ACB.

The eastern most edge of the ACB armoring was observed to be buckling/sagging during the last inspection. Repairs were made to place more material under individual blocks and then they were concreted in place. The repair is functioning and will be monitored over the next few inspections to verify that the repair is holding.

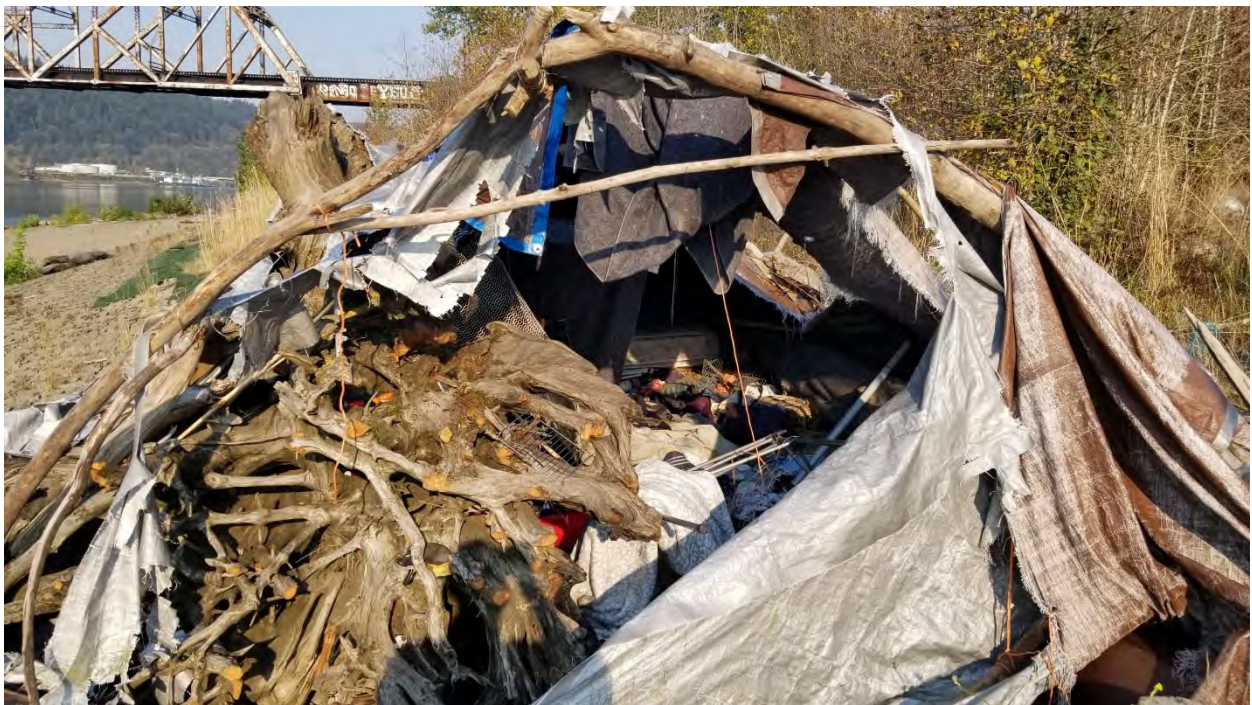
Photograph 2: Abandoned transient camp along shoreline of Willamette River.

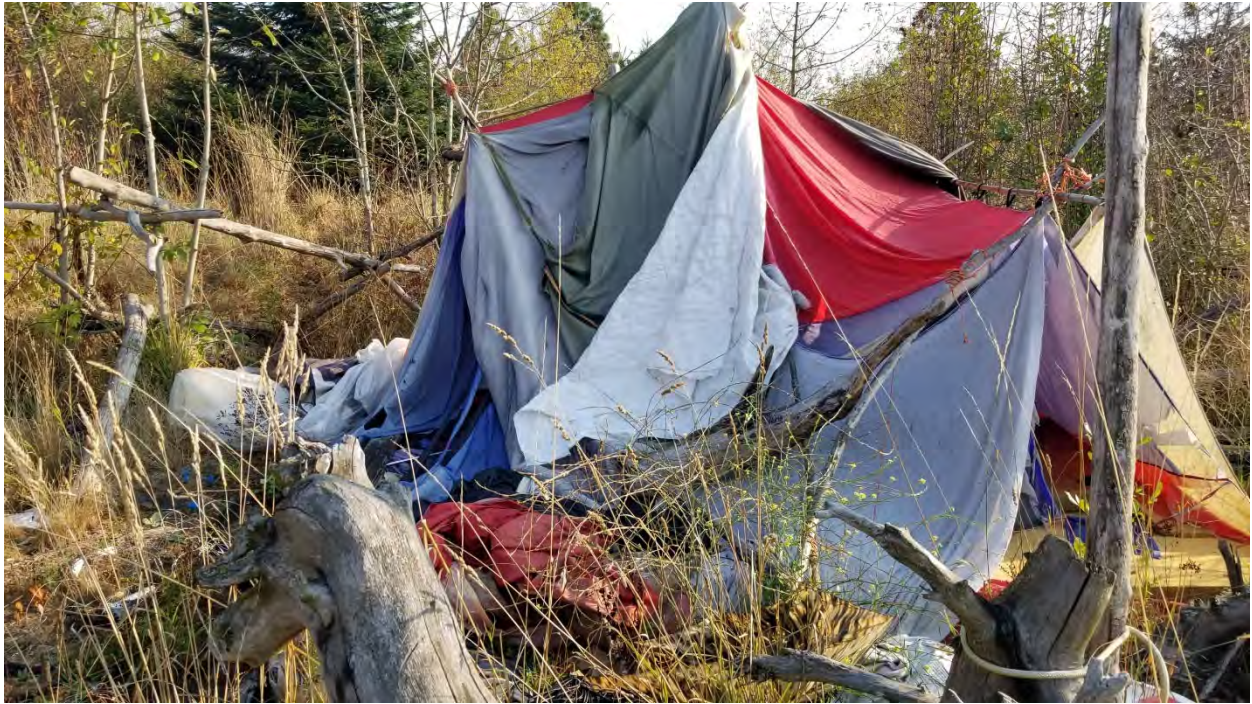
Photograph 3: Abandoned transient camp along shoreline of Willamette River.

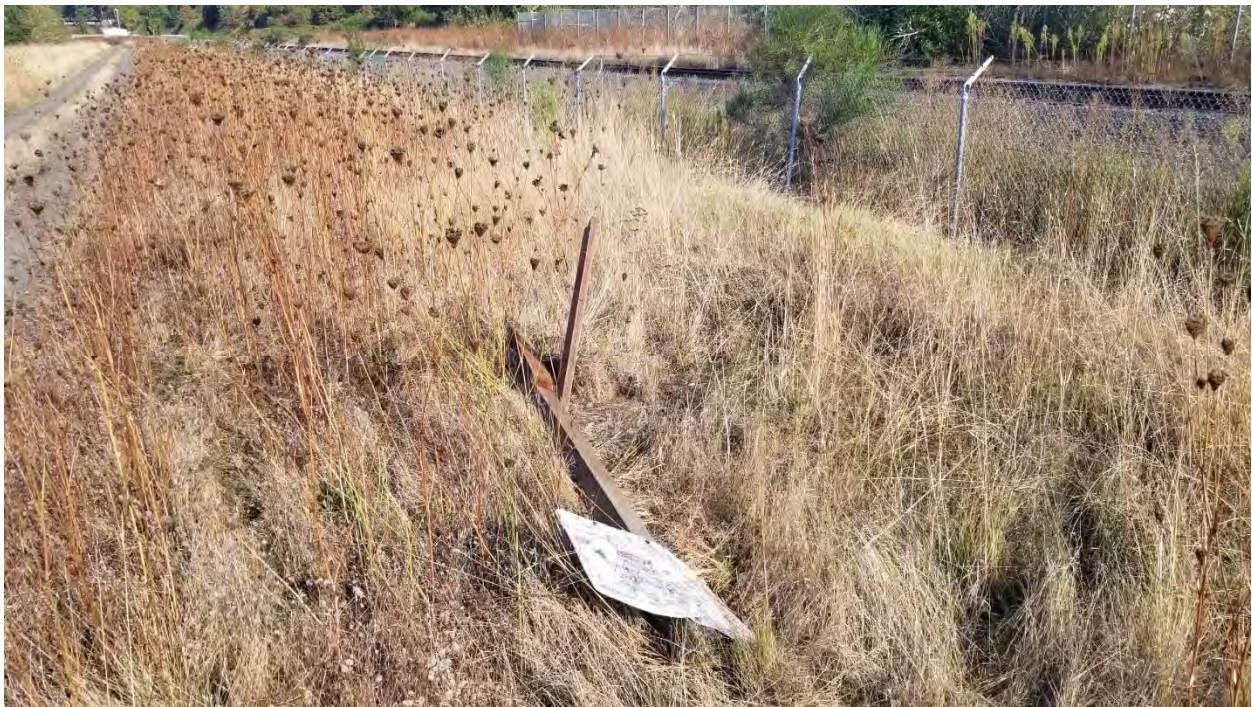
Photograph 6: Downed warning sign between gravel road and perimeter fence along railroad tracks.

The down sign-posts identified during the previous site inspection were replaced during maintenance activities performed on 12/9/20. The signs on the posts were very weathered, no longer legible, and unable to be reused. Hart Crowser is in the process of having replacement signs made and will attach them once completed.

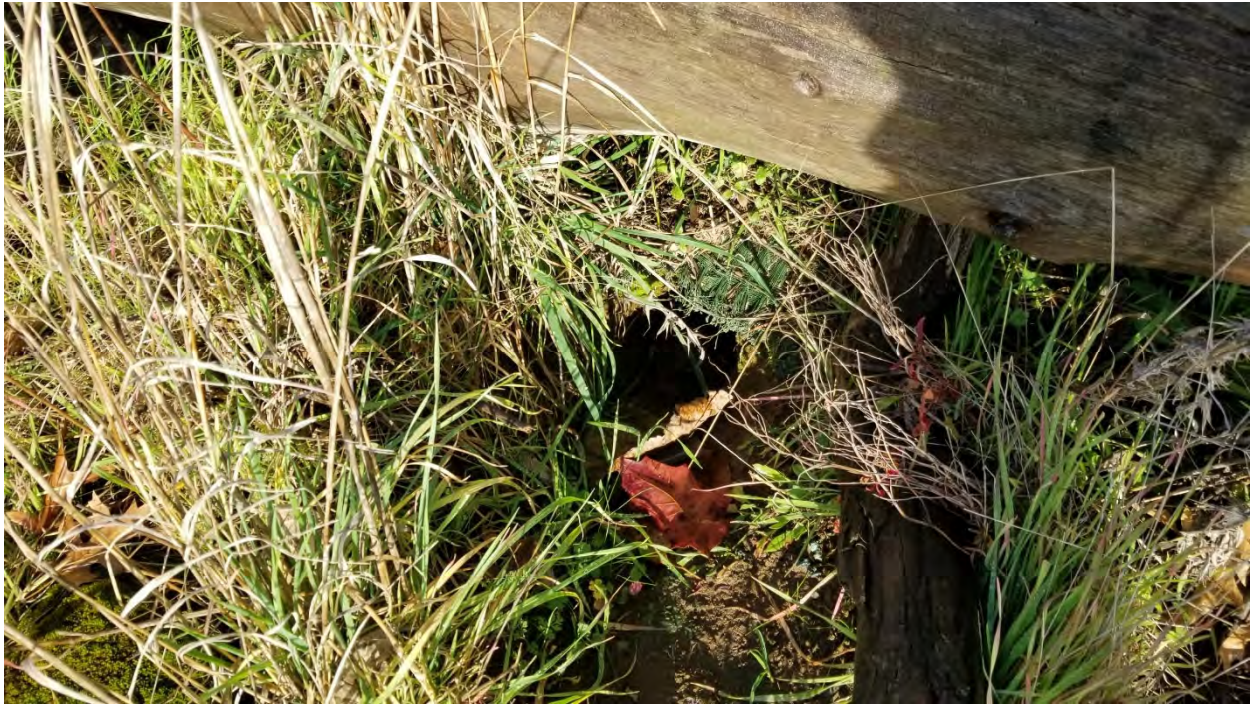
The abandoned transient encampment that has been present since the first quarter inspection remains at the top of the ACB along the Willamette River shoreline. Metro is unable to provide cleanup assistance so Hart Crowser is including trash and debris removal costs for inclusion in the BAP being prepared and will begin preparing an RFB for those services. Small items of trash or debris were also observed along the shoreline.

Photograph 3: Abandoned transient camp along shoreline of Willamette River.

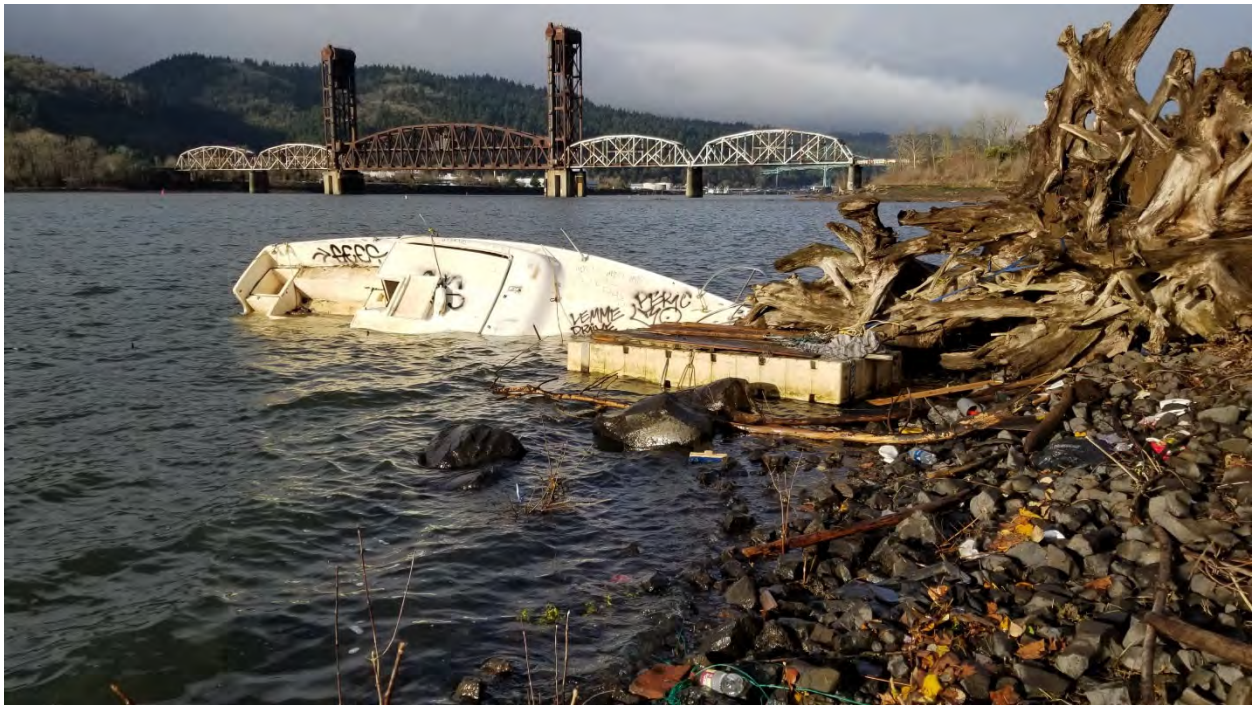
Photograph 4: Abandoned boat on the shoreline of the Willamette River.
