**FIFTH FIVE-YEAR REVIEW REPORT FOR
MCCORMICK & BAXTER CREOSOTING COMPANY SUPERFUND SITE
MULTMOMAH COUNTY, OREGON**

**Oregon Department of Environmental Quality
Northwest Region
Portland, Oregon**

**U.S. Environmental Protection Agency
Region 10
Seattle, Washington**

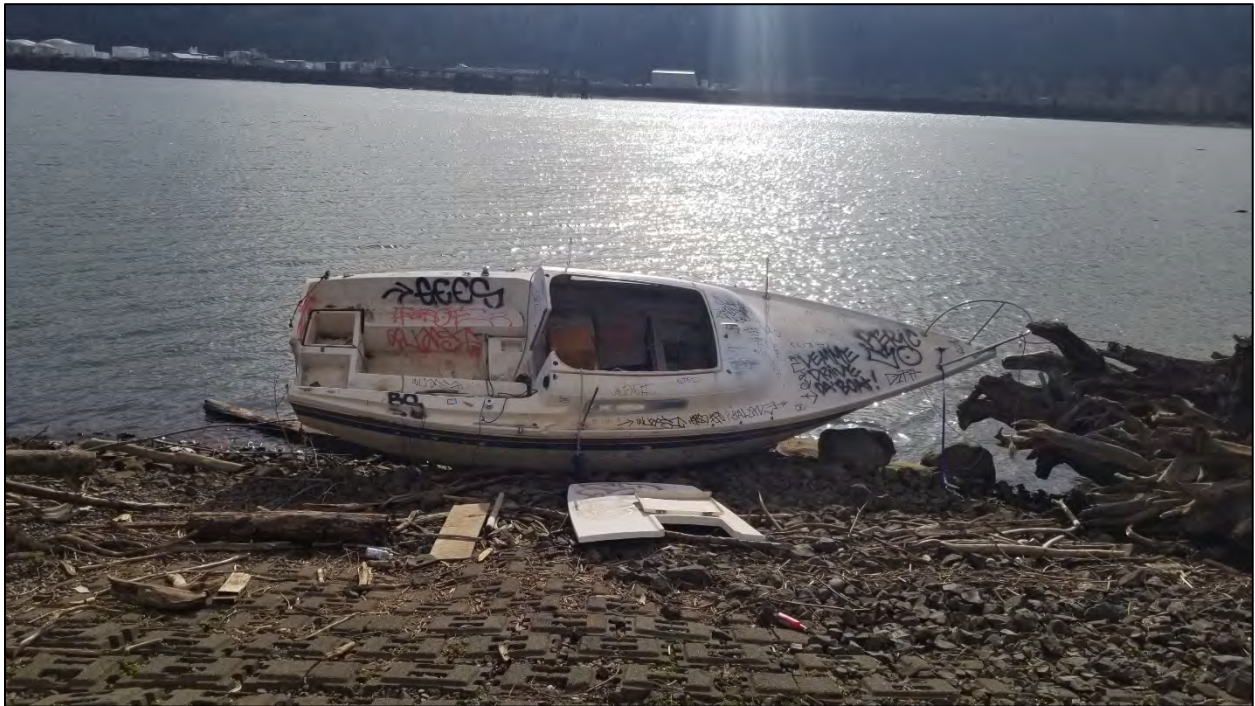
Photograph 4: Abandoned vessel on the shoreline of the Willamette River is still present. View facing west.

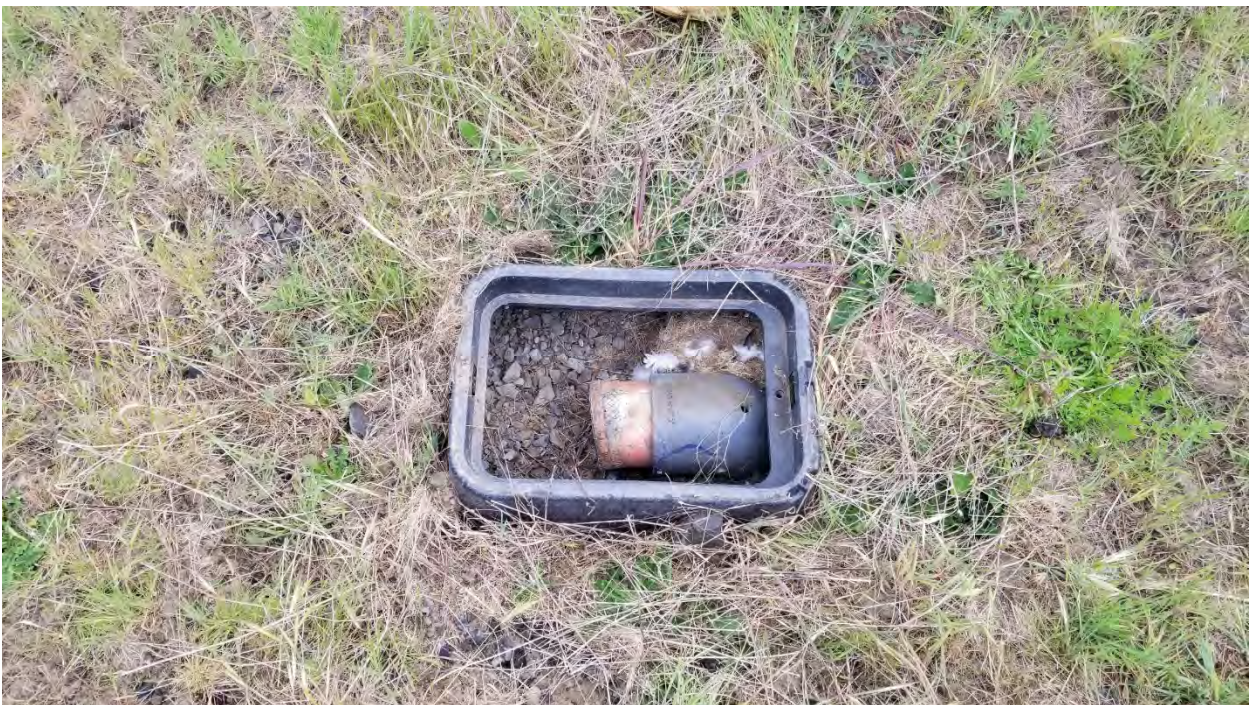
Photograph 6: Rodent nesting inside the gas vent vault box at GV-3.
