### MARINA ADVISORY COMMITTEE

February 26, 2024 at 2pm

HDR was retained by the City of Warrenton to perform an evaluation of the Warrenton Marina to assess general condition of the docks, identify any recommended repairs and/or replacement of the docks, and provide guidance on prioritization of upgrades and maintenance.

# **Underwater Condition Assessment of Warrenton Marina**

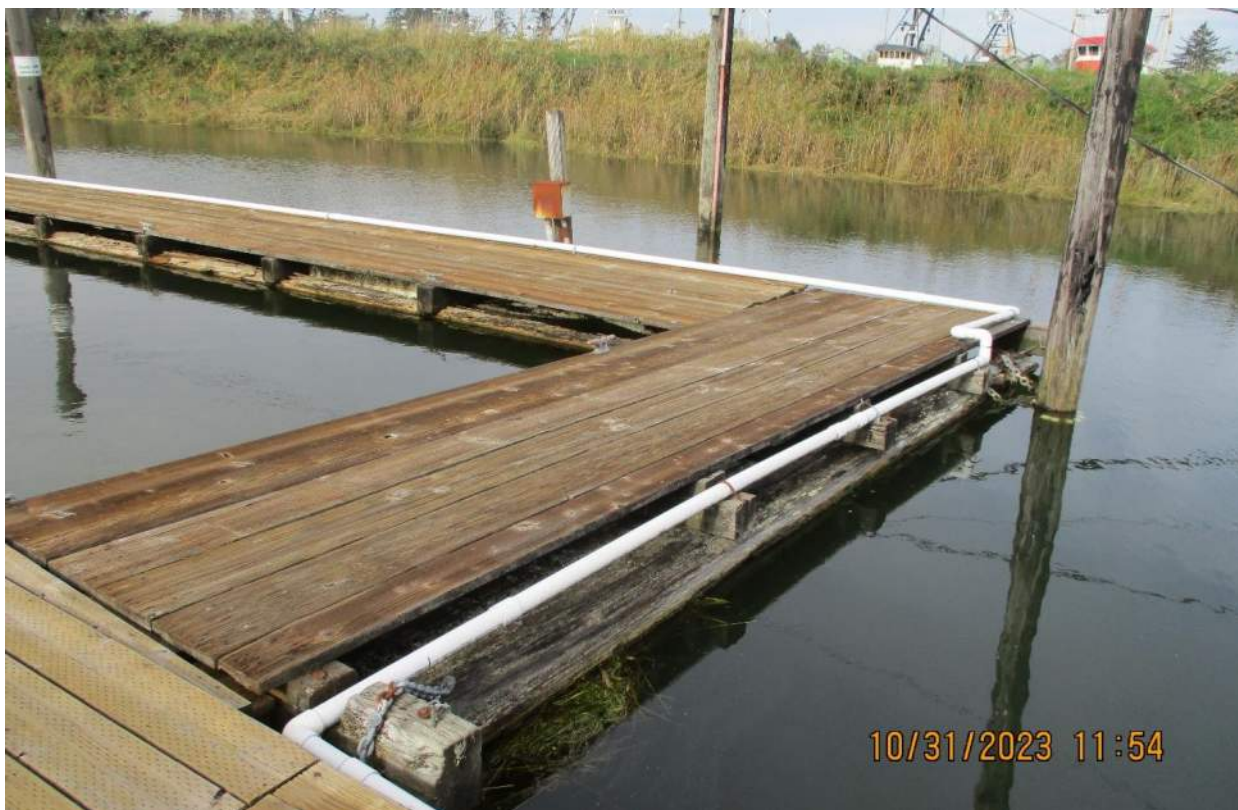
Throughout the facility, there are locations where the dock is not level under its own self weight (see Photos 7 and 8). Areas where this was particularly pronounced are noted in Figure 1. It should be noted that the entire facility exhibits a general lack of buoyancy and the deficiencies noted in Figure 1 are those areas that were particularly noticeable as having even less buoyancy than typical.

**Photo 8:**  
Corner where Dock M and N meet. Note the sag in the corner due to lack of float log buoyancy.

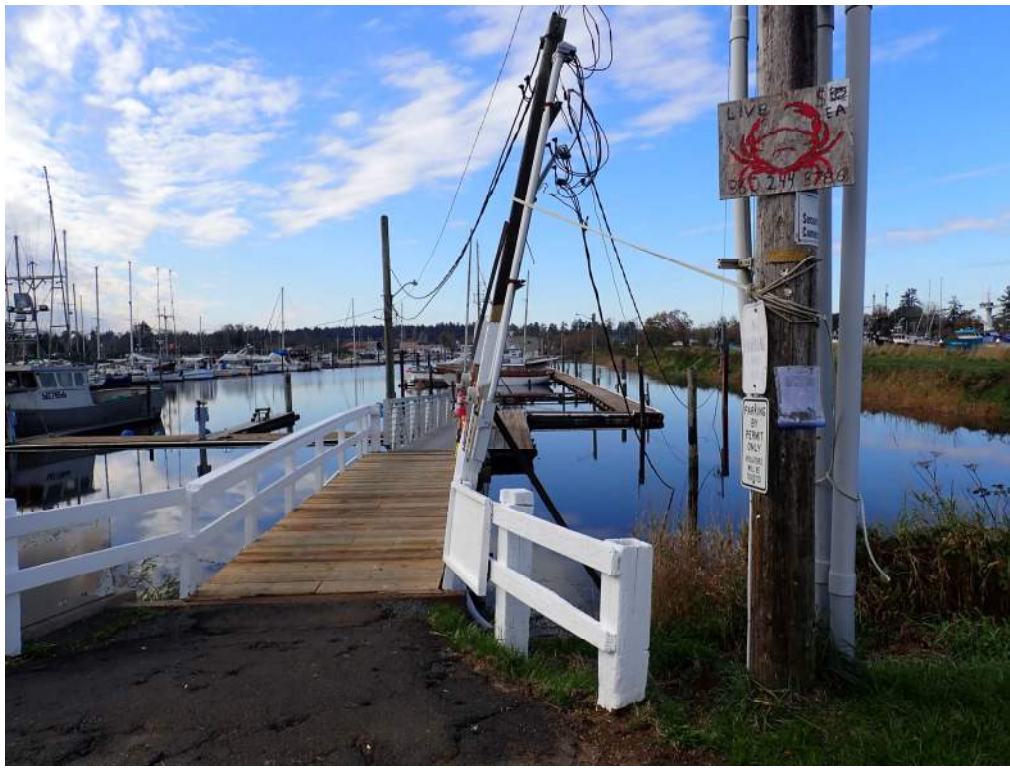
There was a partially submerged utility line near the northeast entrance of the marina due to a utility pole that was unstable and leaning on the entrance dock (see Photo 17).

Photograph 17– Unstable Utility Line Post at Northeast Marina Entrance Looking West

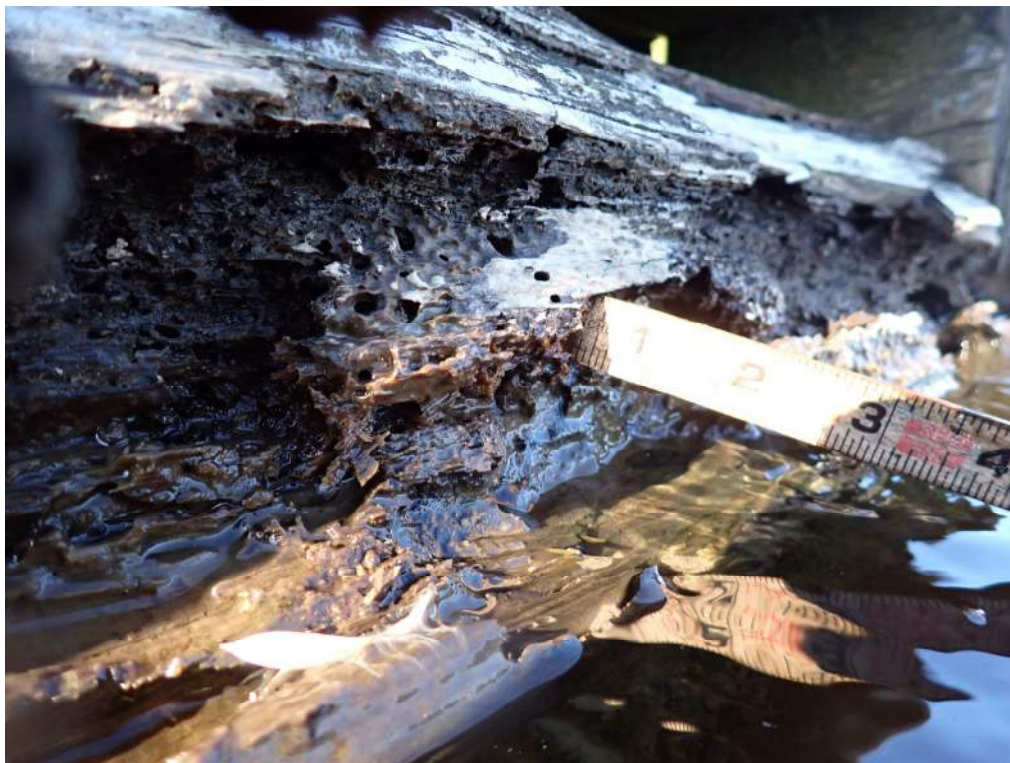
Photograph 18– Typical Evidence of Marine Borers in Timber Floats

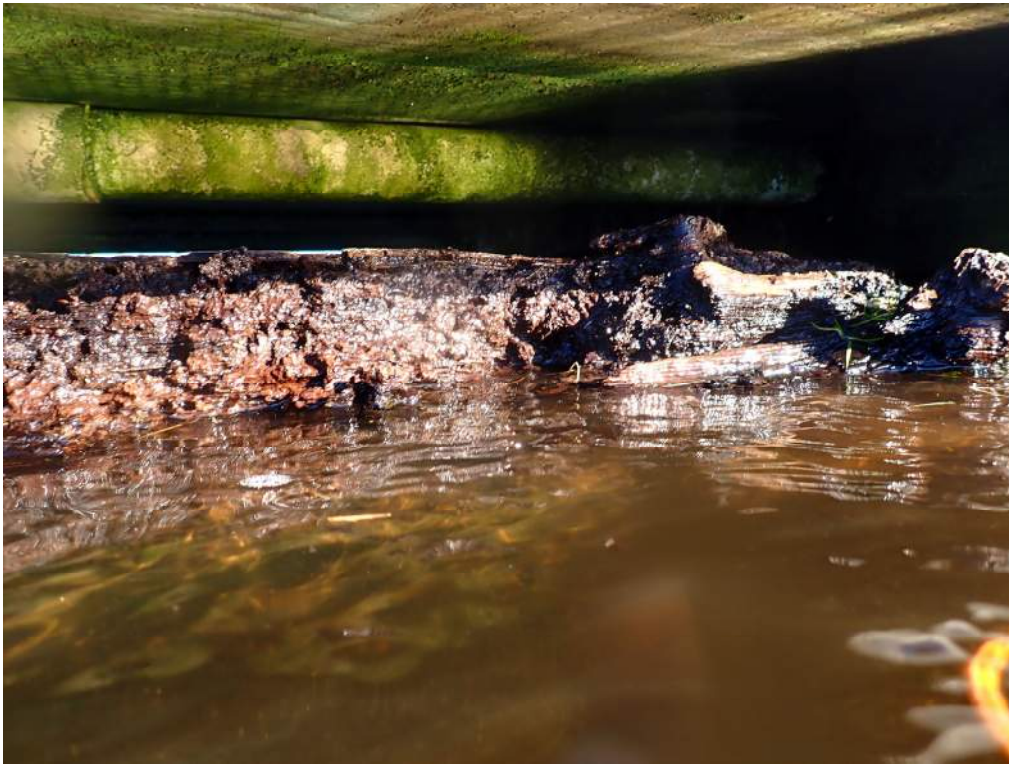
Overall, the timber floats were in **serious** condition, exhibiting minor to severe damage. Approximately 70% of the timber floats exhibited minor to major damage consisting of up to 50% loss of cross-sectional area, with the remaining 30% exhibiting severe damage consisting of greater than 50% loss of cross sectional area (See Photos 19 and 20). The timber floats also exhibited evidence of marine borer activity (see Photo 18). In many instances, the connections between the timber floats and the transverse timber members were loose or missing due to the deterioration of the timber and/or the steel connection hardware (see photo 29). In some cases the loose connections, combined with loss of section and bearing capacity of some timber floats, resulted in the rotation of several sections of dock making them unstable to walk on (see Photo 31). There was a chain connecting the two floating logs adjacent to Slip 36 which exhibited flaking rust and significant section loss (see Photo 30). Refer to Figures I-02 through I-09 in Appendix B for extents and locations of timber float defects.

Photograph 19– Typical Area of Severe Section Loss in Timber Floats

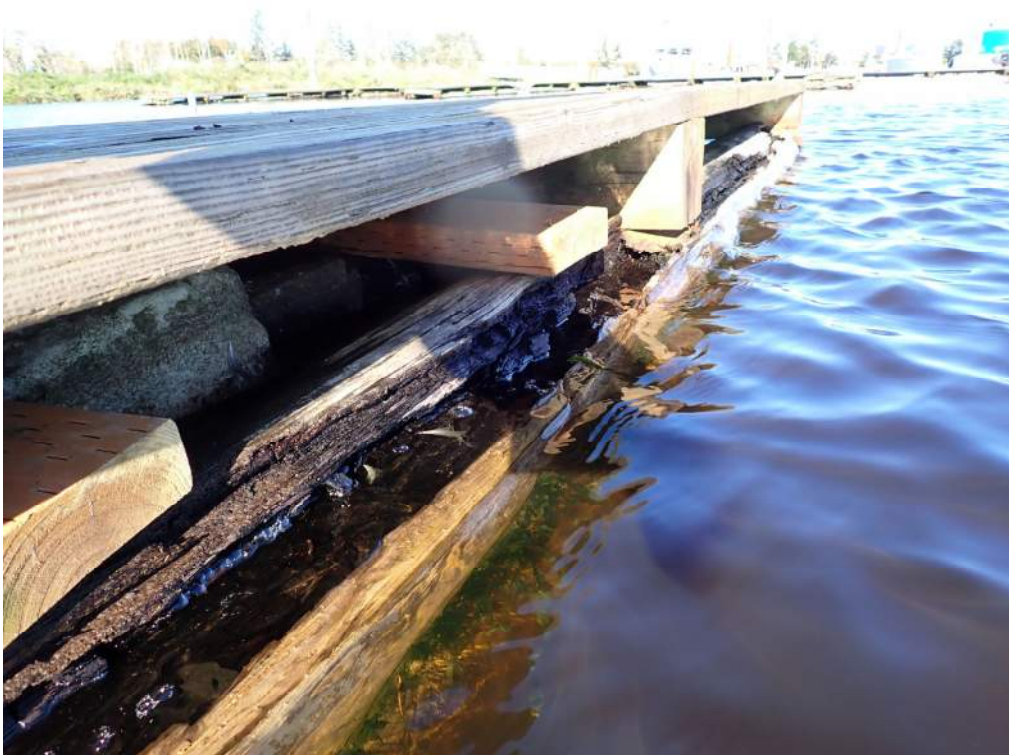
Photograph 20– Typical Area of Severe Section Loss in Timber Floats

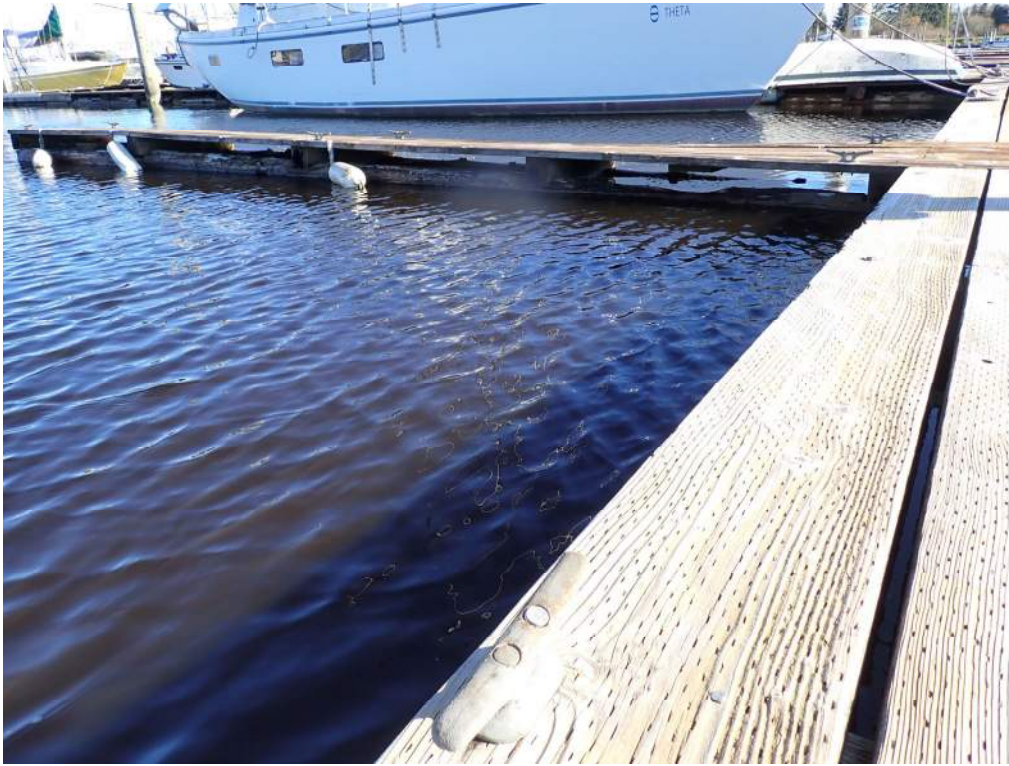
Photograph 31– Typical Rotated Finger Pier (Dock C, between Slips 65 and 66)
