## ST HELENS FIBERBOARD FACILITY UPLAND REMEDY

### First Quarter 2022 Progress Report

# UPLAND CAP INSPECTION FORM

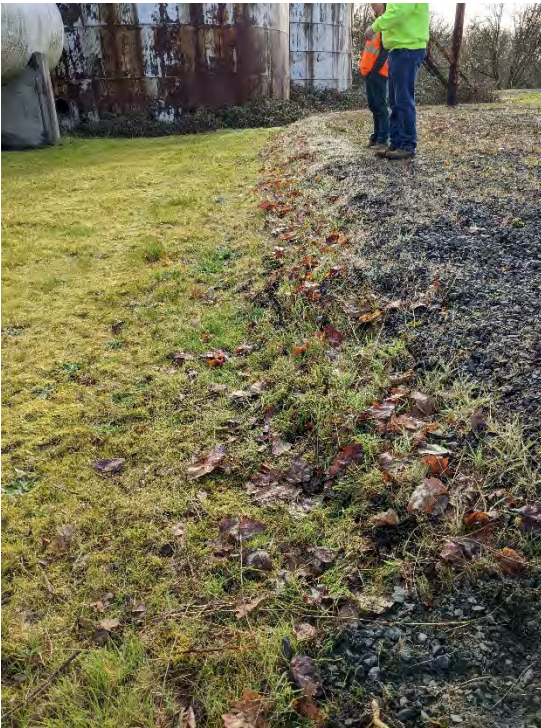
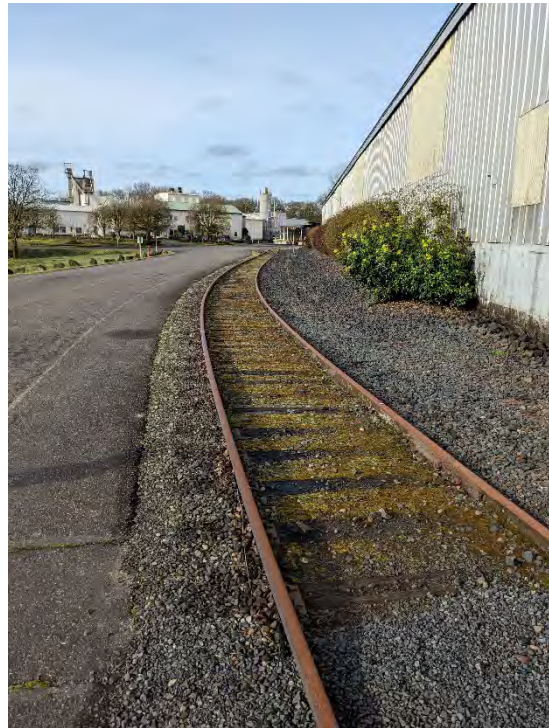
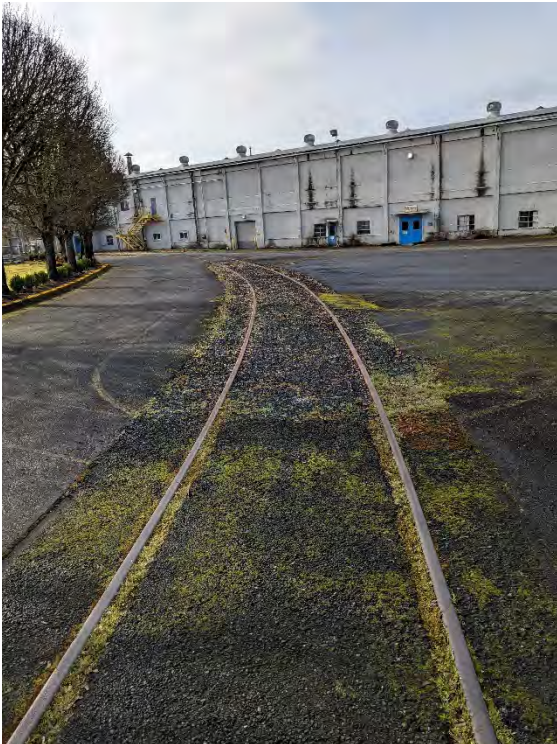
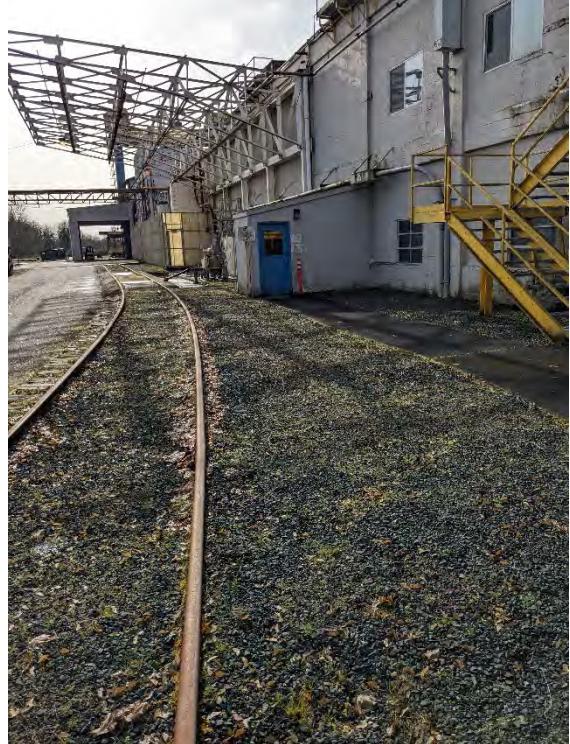
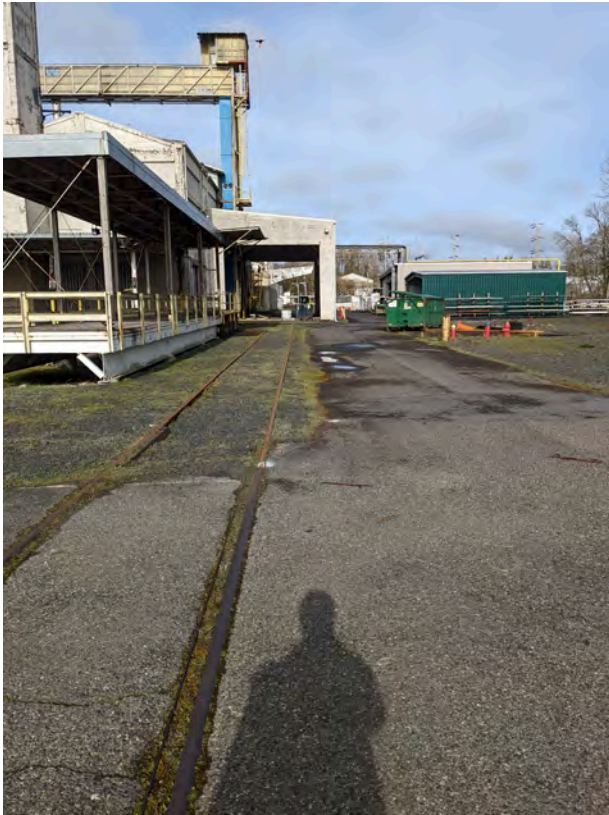
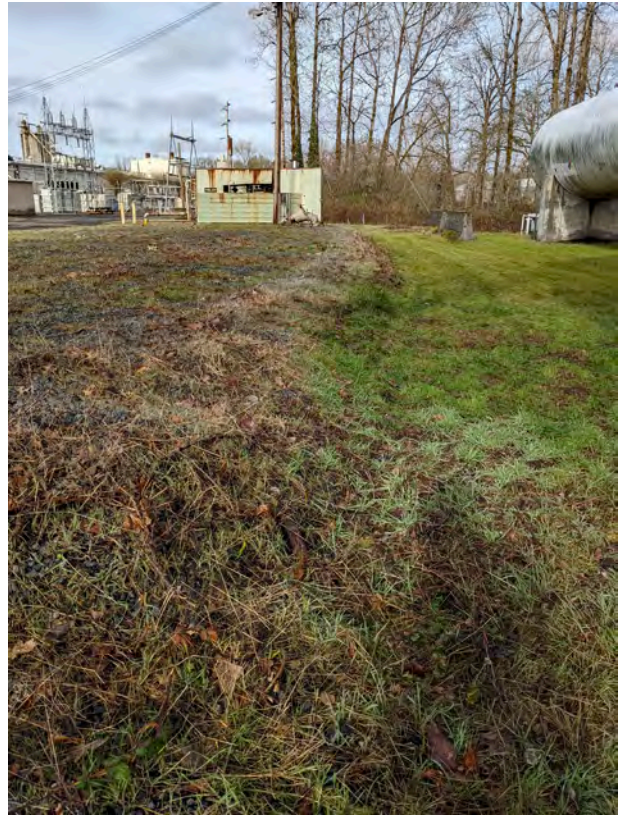
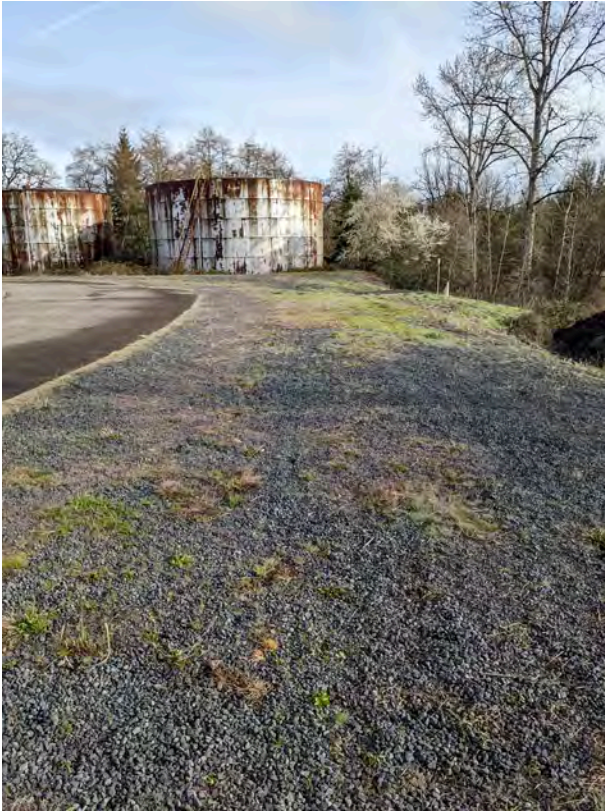
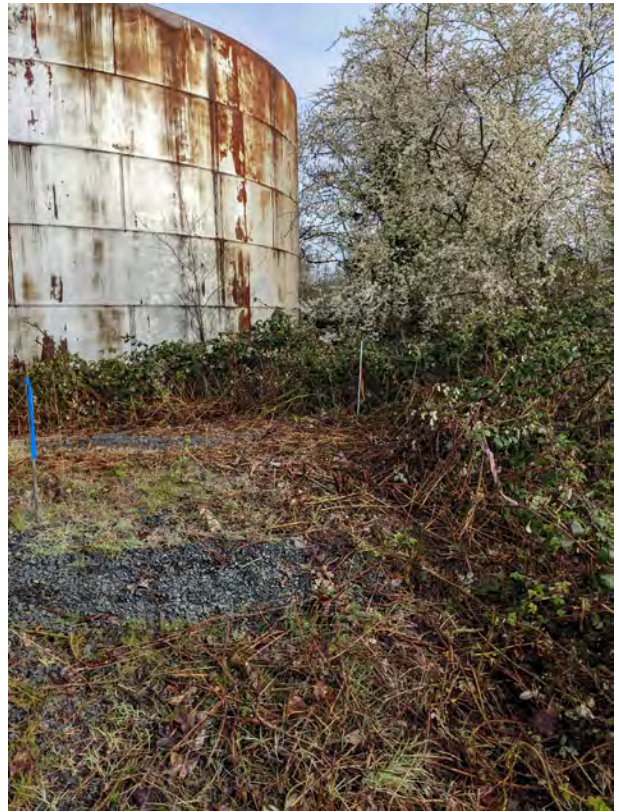
Condition: The gravel cap is in good condition throughout area #1. Some invasive weeds are encroaching on the gravel cap near the sand test pile. Moss present on asphalt.

AWI cleared vegetation from the cap, reestablished the cap boundary, and knocked back blackberry. More vegetation management needed near sand test pile.

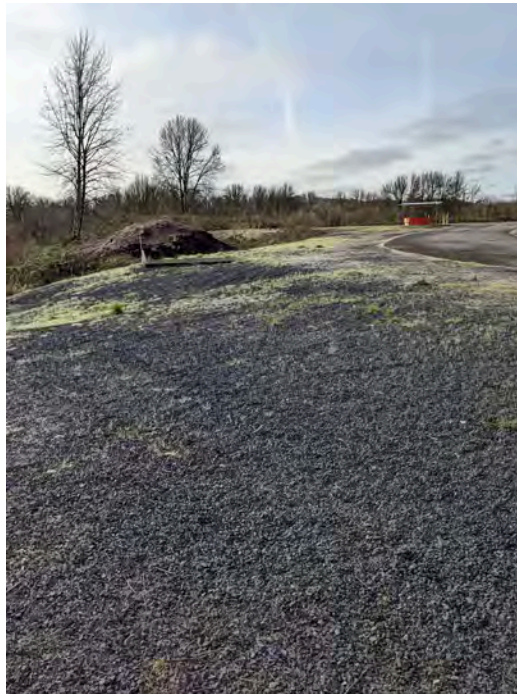
Vegetation management may be needed in this area to prevent encroachment on the cap.

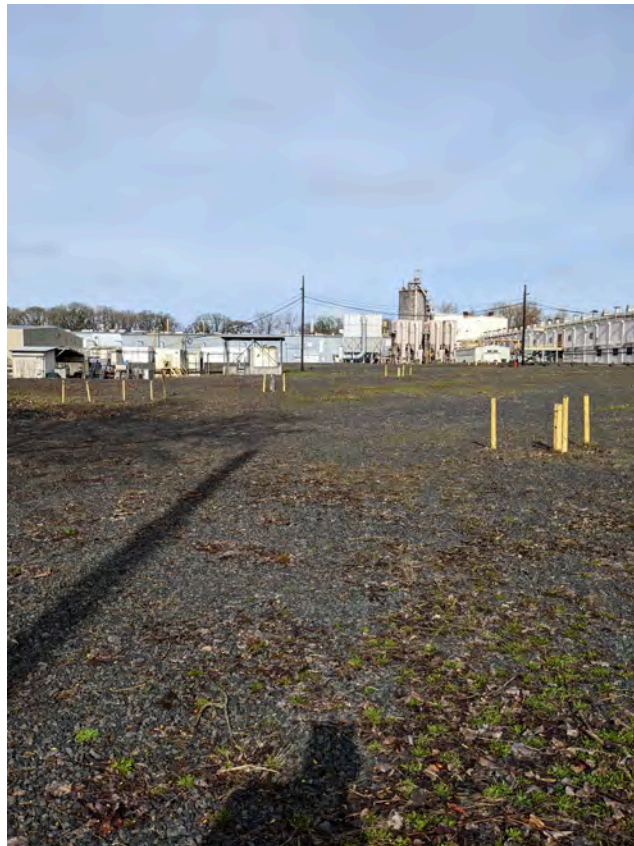
Condition: Native and invasive grasses present in upper portions of cap.

AWI cleared larger deep rooting vegetation.
