Seismic Vulnerability Assessment Phase 1

Phillips 66 Terminal Portland, Oregon

for Phillips 66 Pipeline LLC

May 30, 2024

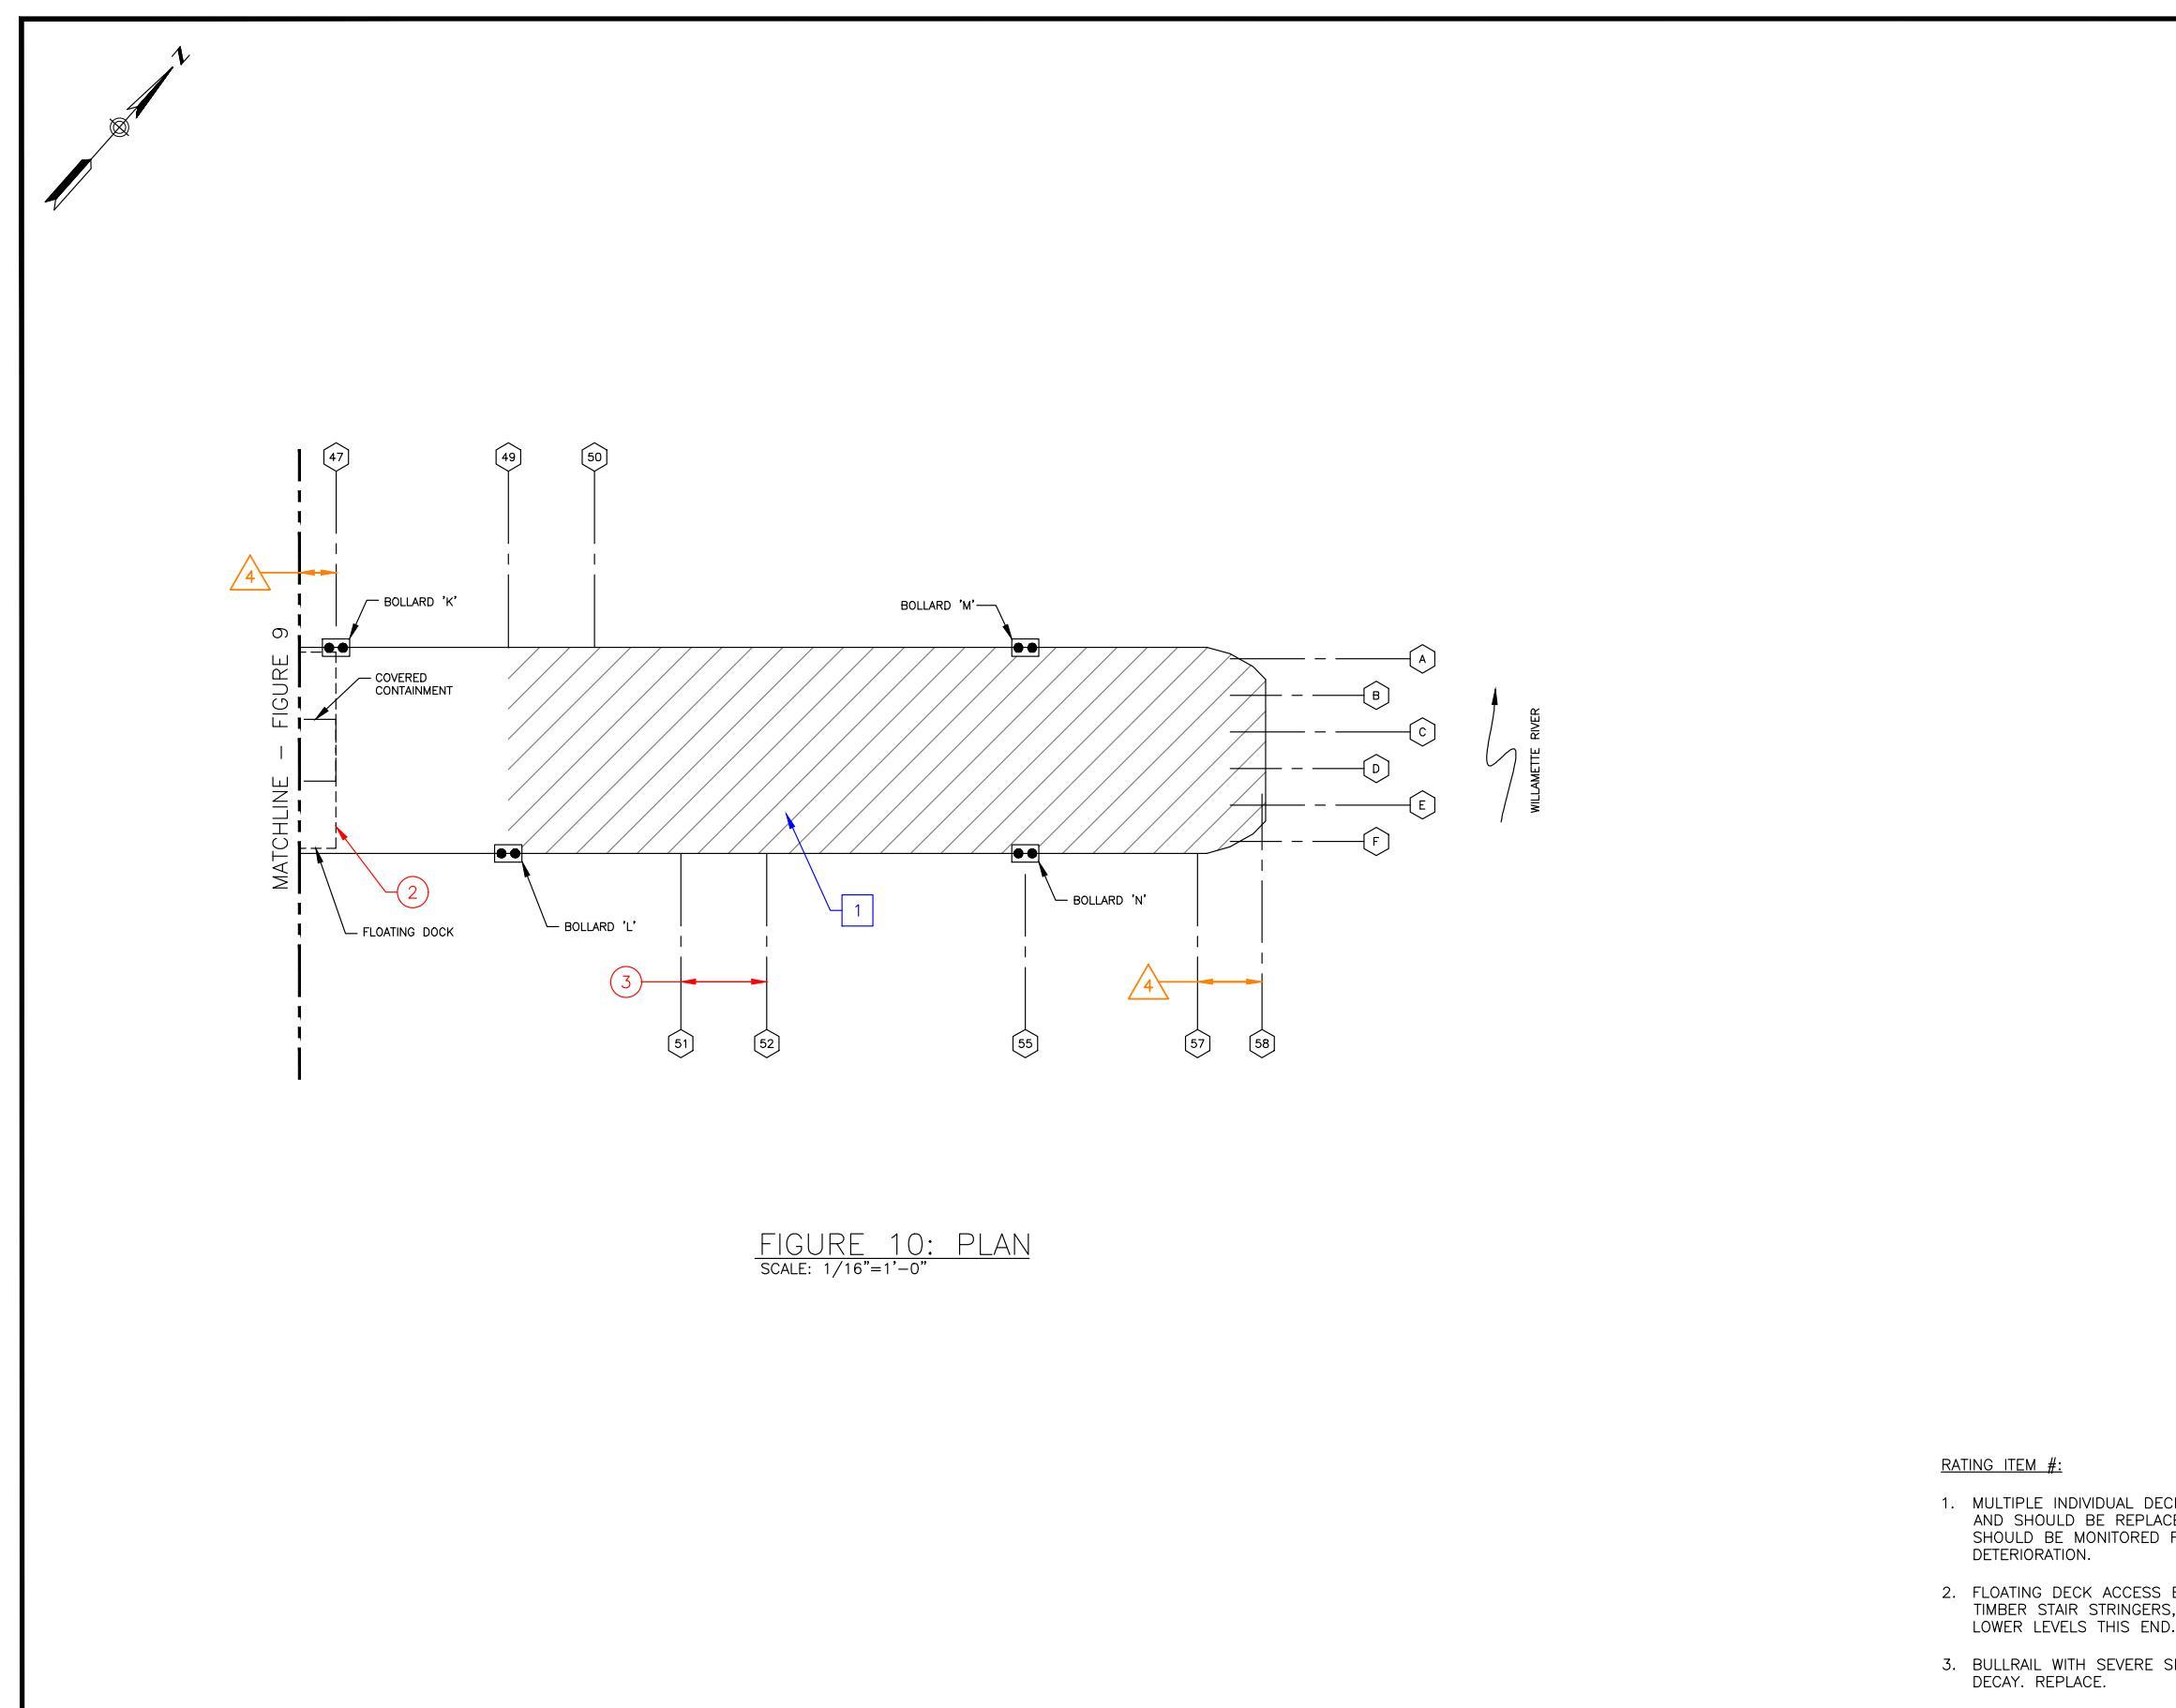
FIGURE 9: PLAN scale: 1/16"=1'-0"

- RATING ITEM #:
- MULTIPLE INDIVIDUAL DECK BOARDS SH SIGNIFICANT ROT AND LOSS OF SECTIO INFESTATION, SWELLING. THE AREA SH SURVEYED FOR BOARD REPLACEMENT. REMAINDER SHOULD BE MONITORED FO DETERIORATION.
- FLOATING DECK ACCESS BELOW DECK: TIMBER STAIR STRINGERS, HANDRAILS, LOWER LEVELS THIS END.
- REPLACE INDIVIDUAL DECK BOARDS ON SUBSTRUCTURE PLATFORM NEAR ACCES GATE.
- 4. BULLRAIL EXHIBITS SPLITTING DAMAGE.
- BULLRAIL EXHIBITS CROSS GRAIN TENS TORSIONAL SPLITTING. REPLACE.

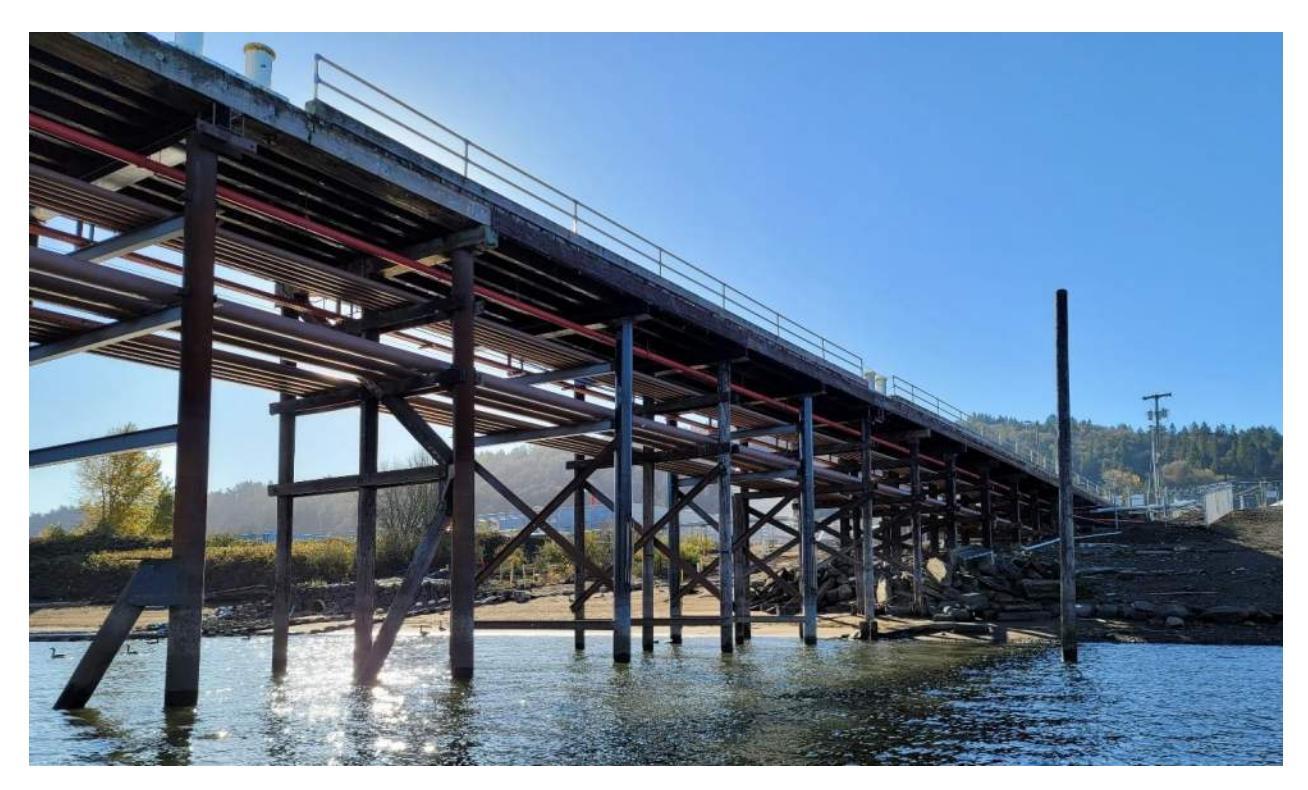
Picture 3. Pier approach from the downstream side. Note the combination of steel piles and bracing with the original timber elements.

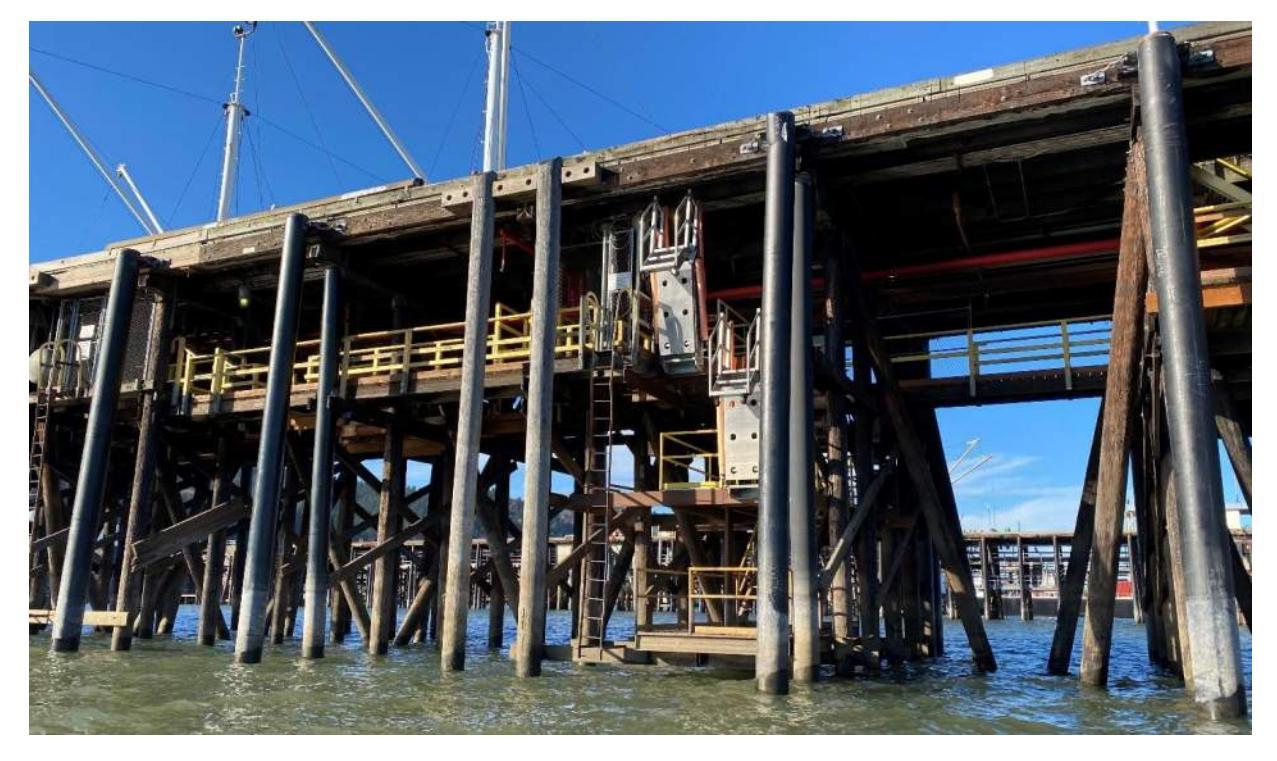
Picture 8. Upstream berth. Note the substructure walkways, multi-level platforms, ladder, and retractable gangways.

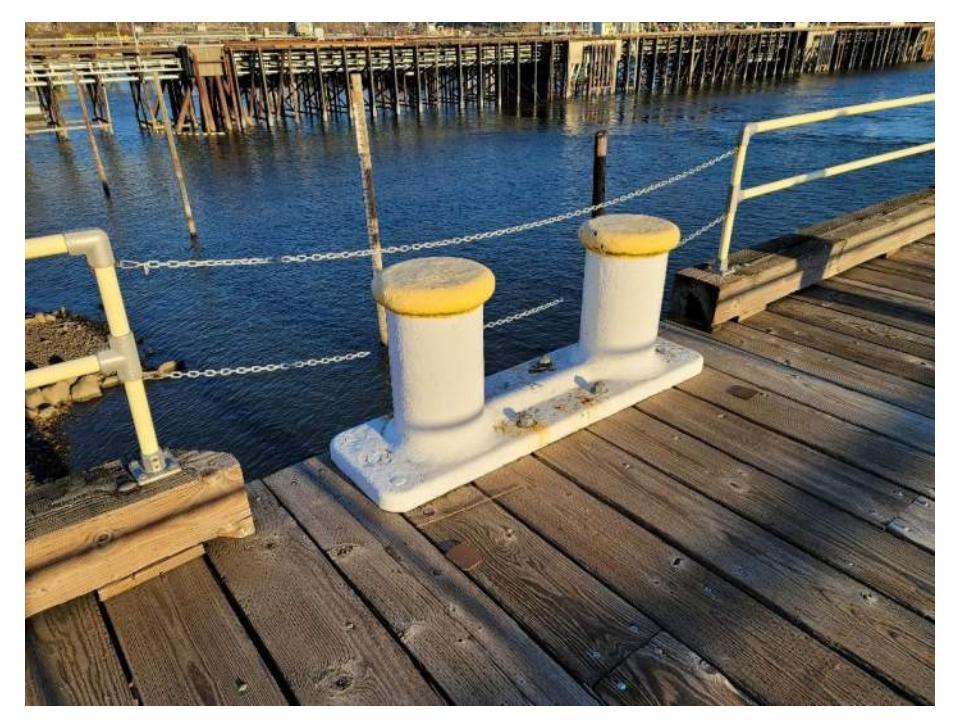
Picture 18. Bollard 'A', deck, handrails along approach. It does not appear to see regular use.

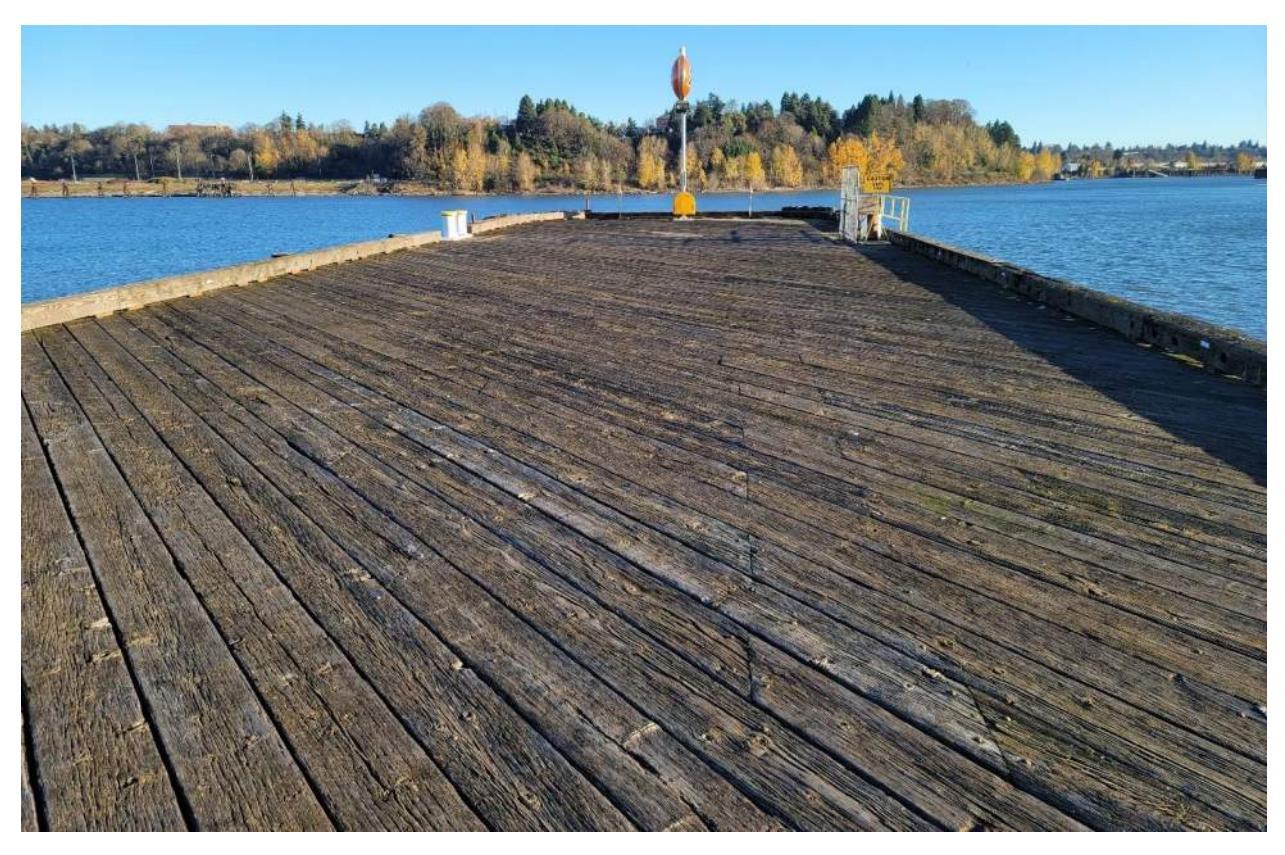
Picture 21. Decking riverside of the service area.

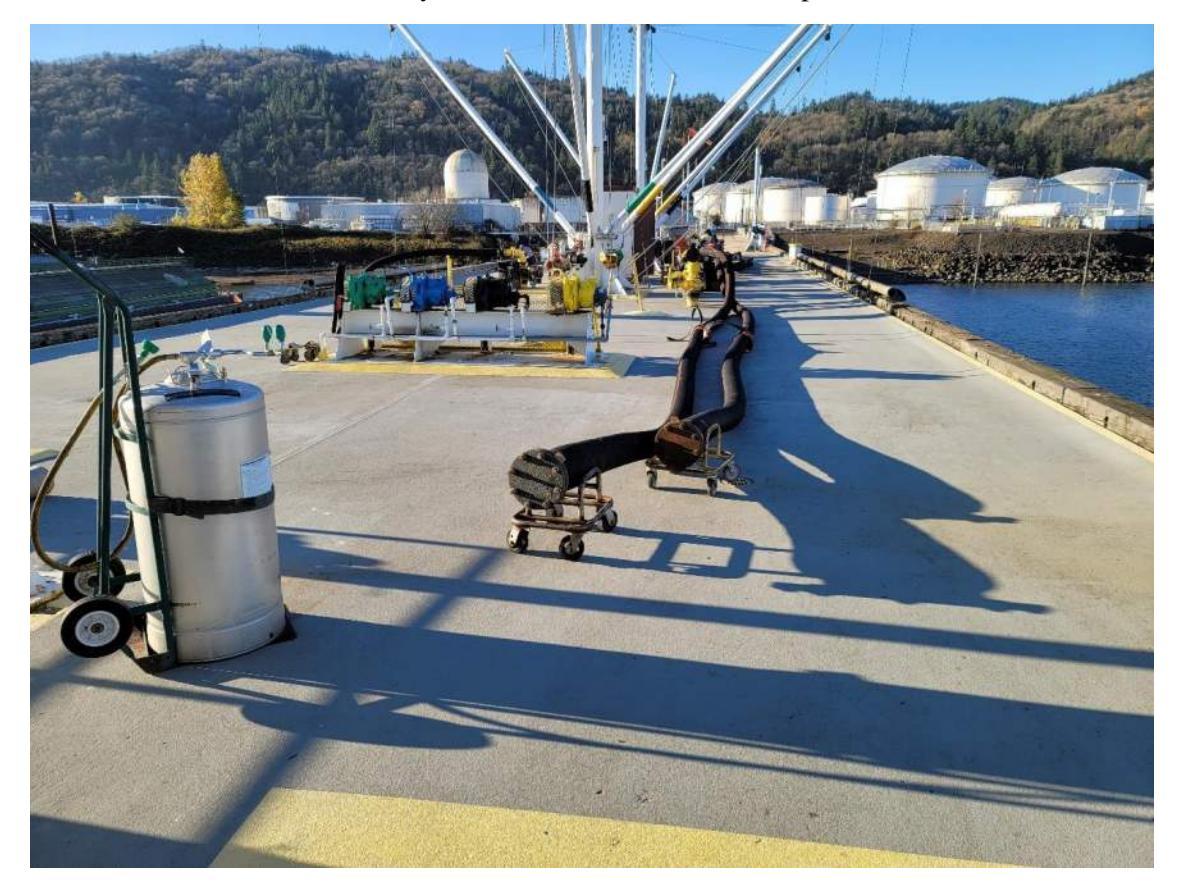
Picture 24. Service area. Note good condition of concrete surface.

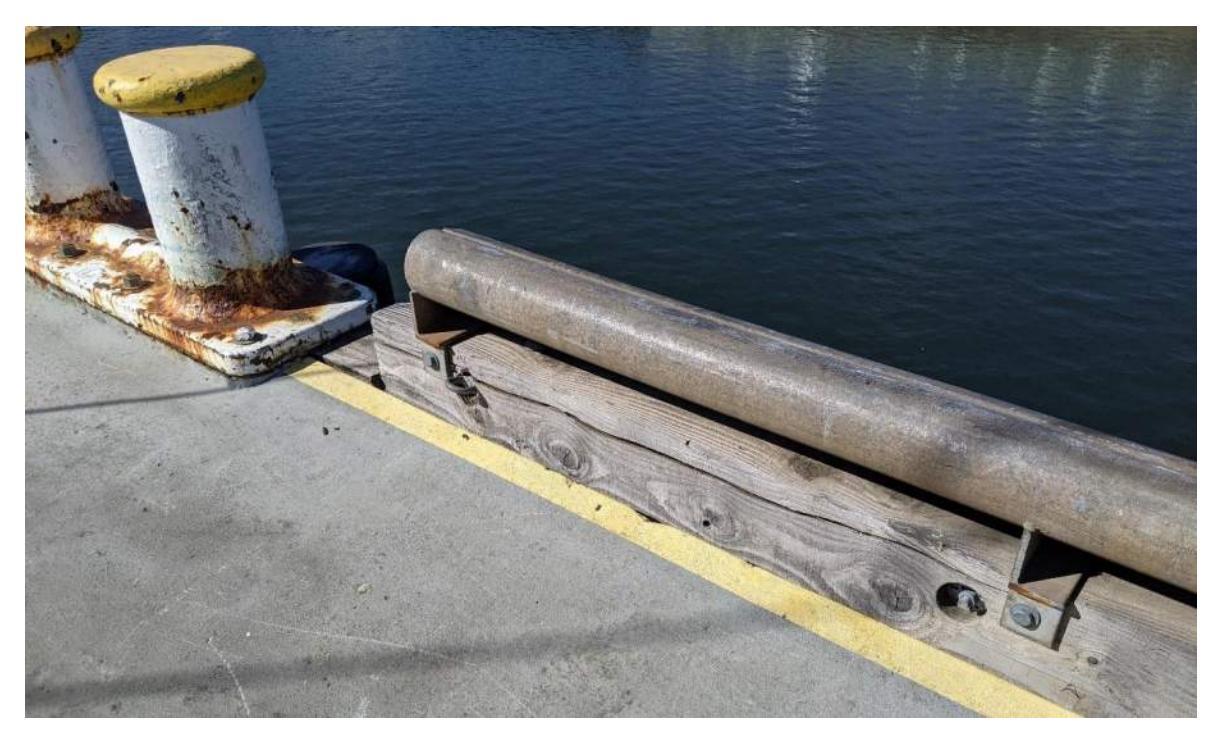
Picture 25. Split in bullrail, downstream berth.

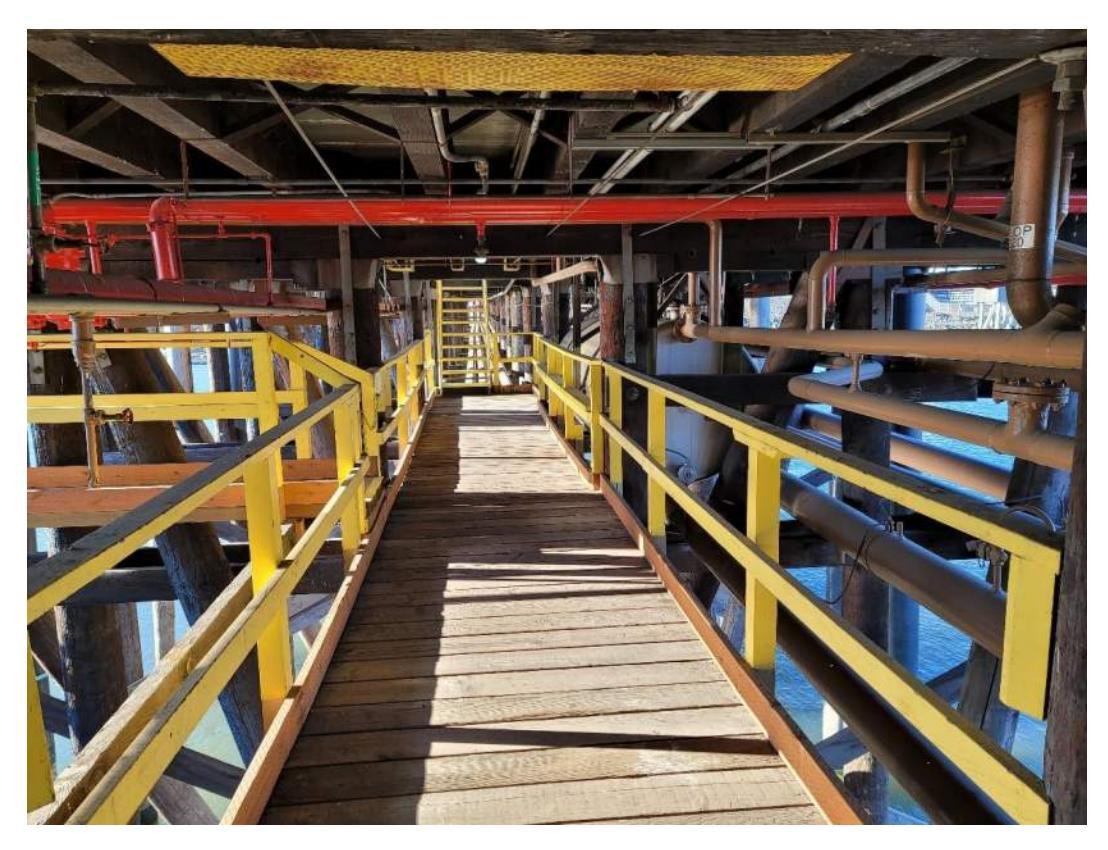
Picture 29. Substructure walkways, typical. Decking, handrails, paint in good shape.

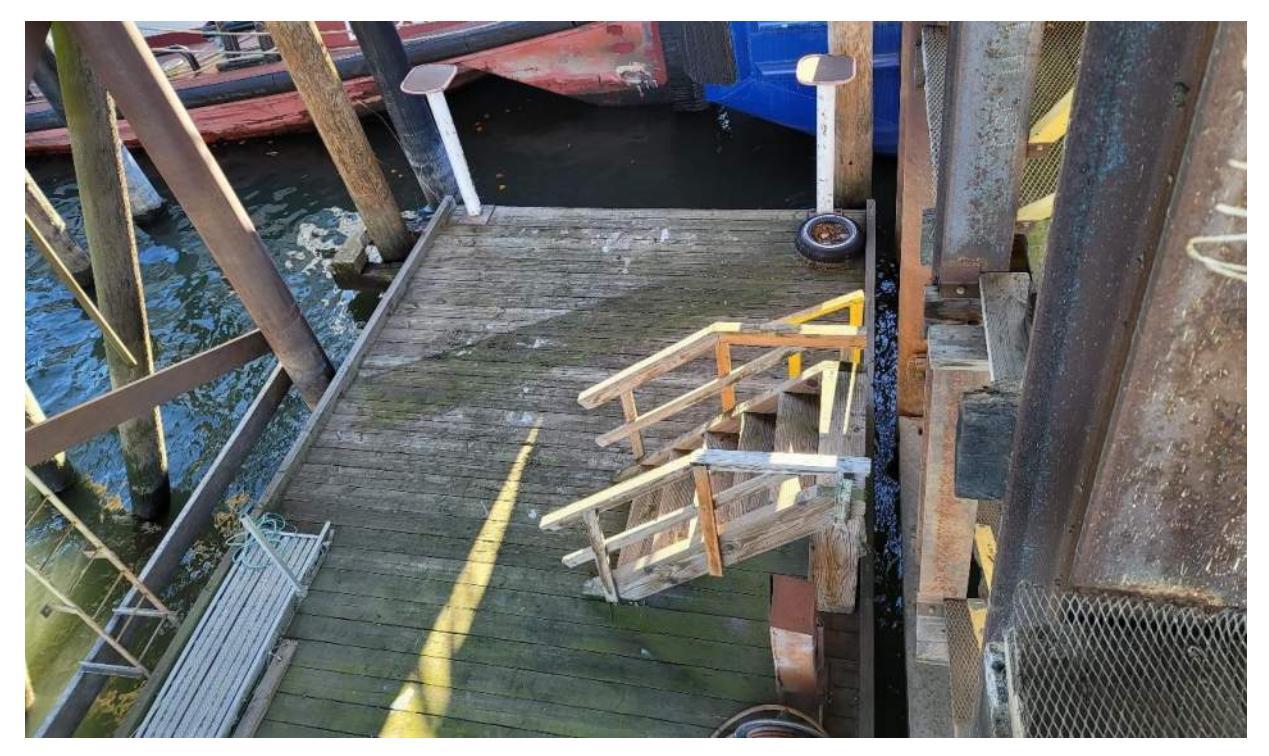
Picture 30. Floating deck, note stairs, timber guide (upper left). The deck is listing from left-to-right in the photo. The steel ladder to the left access the limited access walkway area.

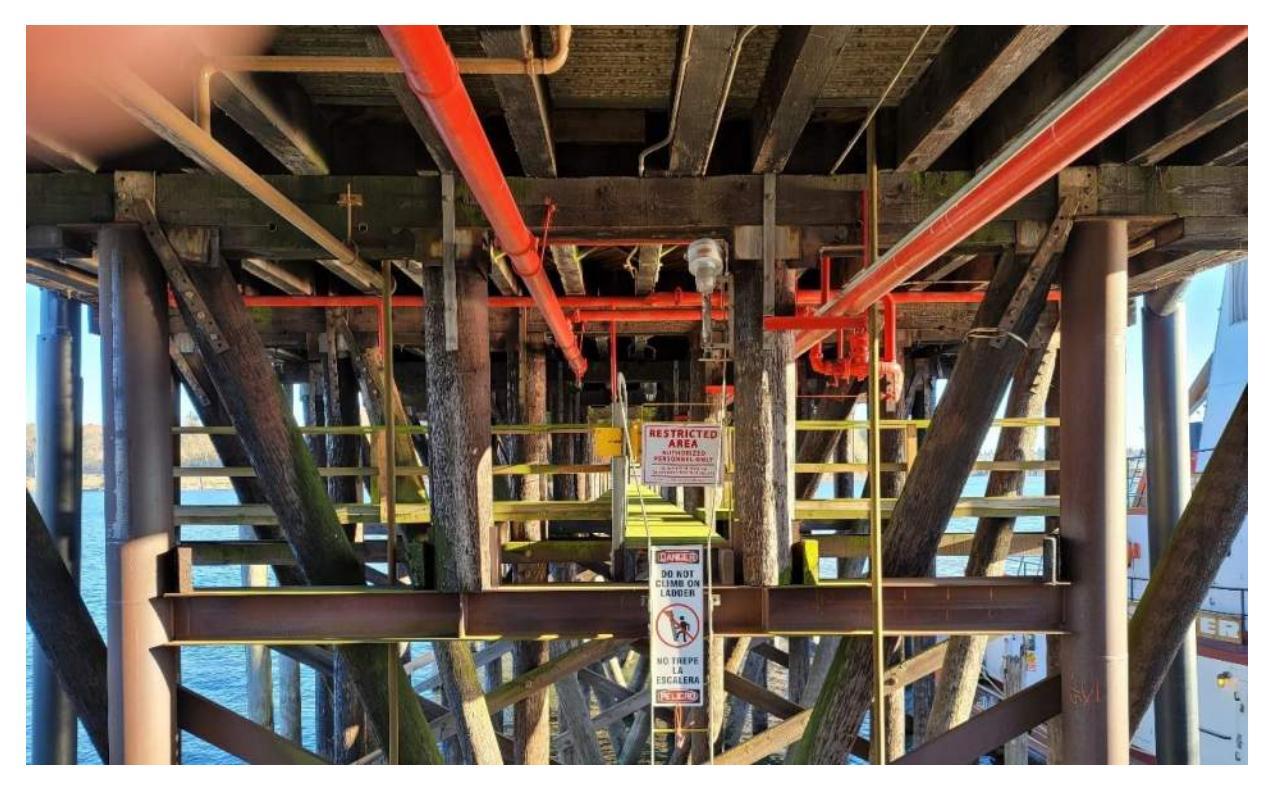
The pier structure is in FAIR condition overall. Some significant sections of decking are in poor condition and should be addressed in the near-term. One pile cap at Grid 47 is showing signs of overstress (see Appendix B, Picture 31). A few bullrails should be replaced in the near-term. All

Picture 31. Grid 47, looking east. Note significant sag (evidence of overstressing) in the pile cap and lack of mid-span support where the piles were removed below. Limited access walkway area is visible in the background.

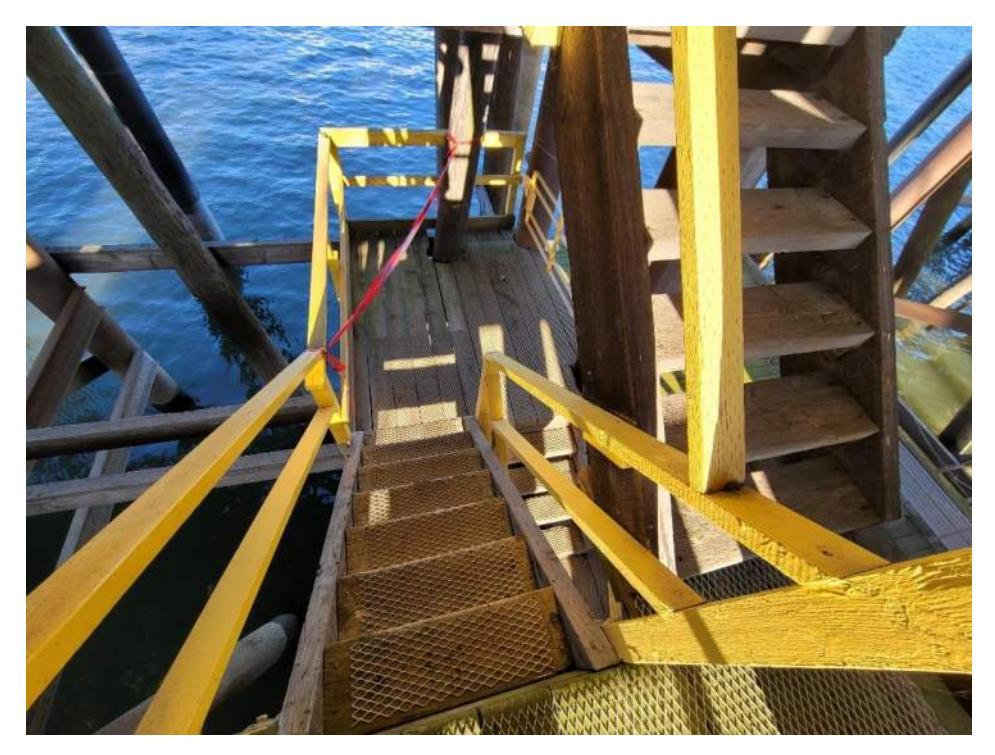
Picture 32. Stairs/platforms to the floating deck, Grid 46. The lower two levels were flagged for safety concerns.

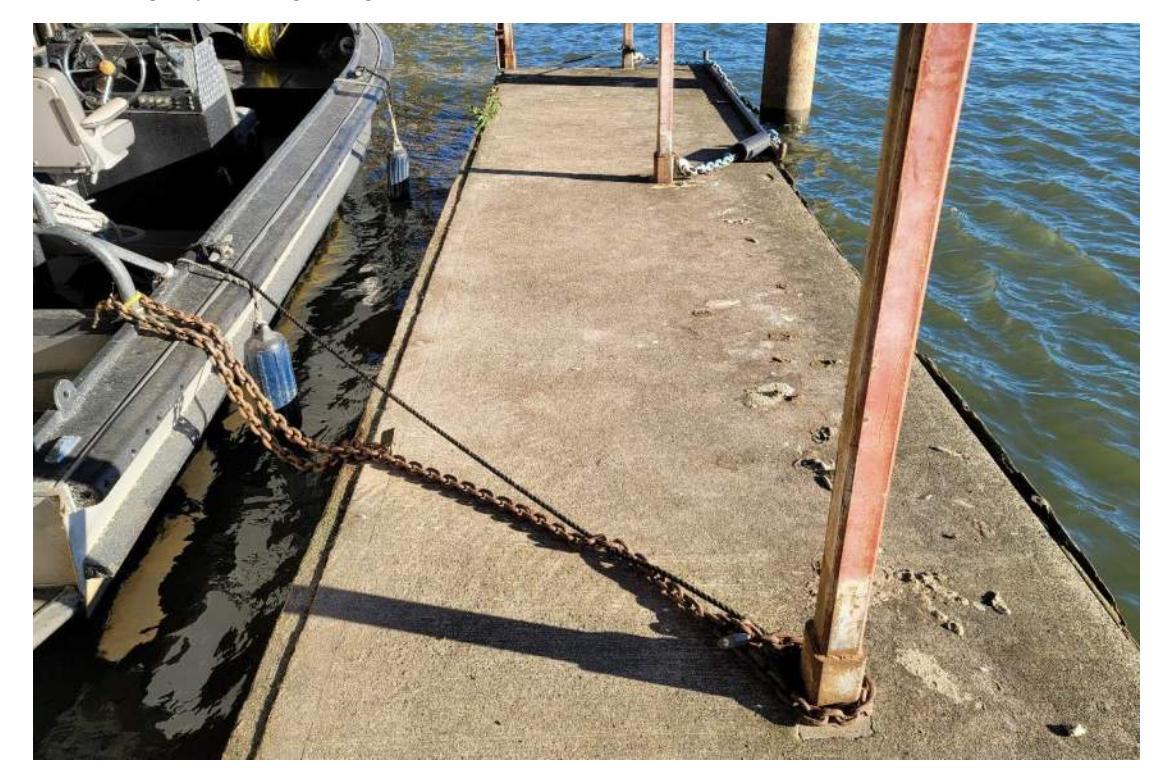
Picture 41. Boathouse structure. Note good condition of concrete, roof columns.

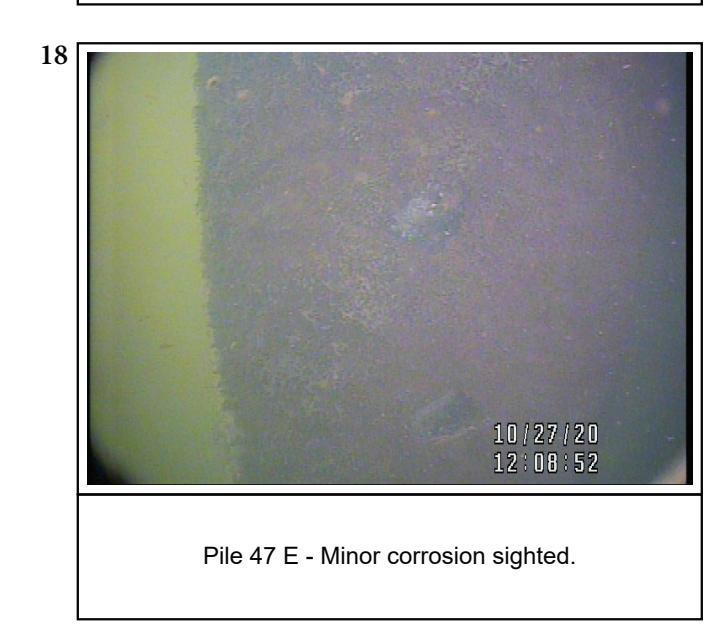
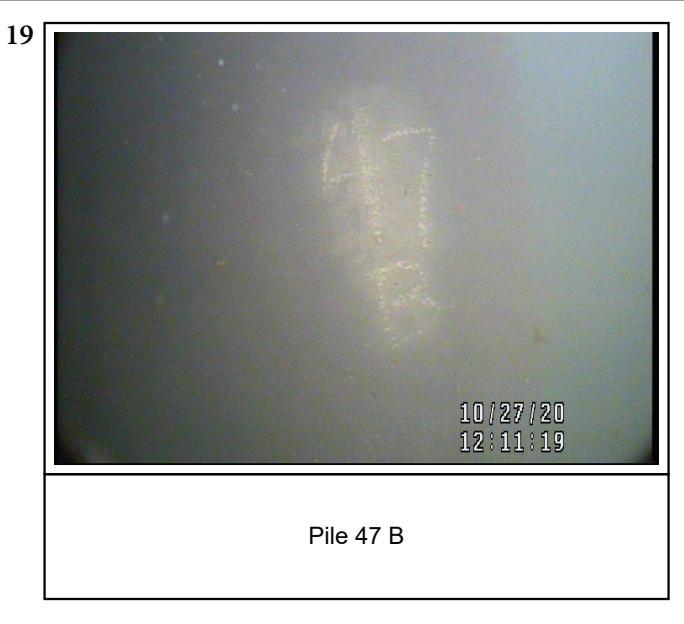
Pile 47 B - Minor corrosion sighted.
