ALPHA TECHNICAL GROUP INC.

**Pacterm- Portland Terminal
Seismic Vulnerability Assessment (SVA)
Phase 1**

Rev Date: May 30, 2024

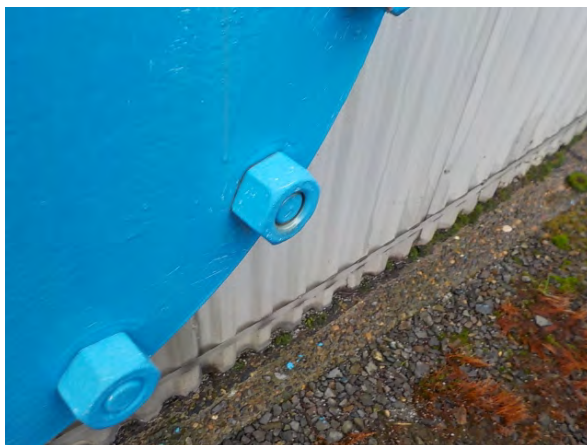
Short Bolts

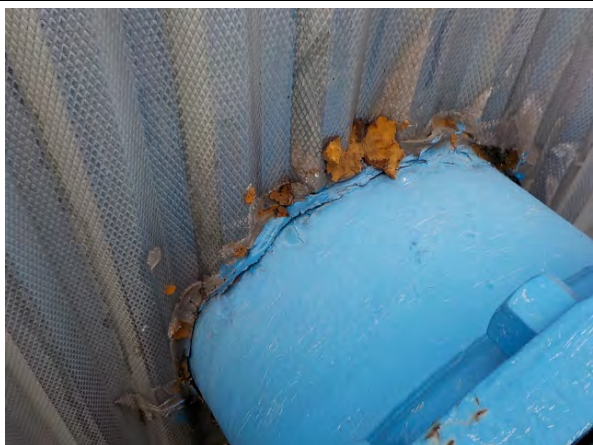
It would appear that the caulking which protects the insulation from the incursion of rain water was found to aged and cracking.

Insulation seal

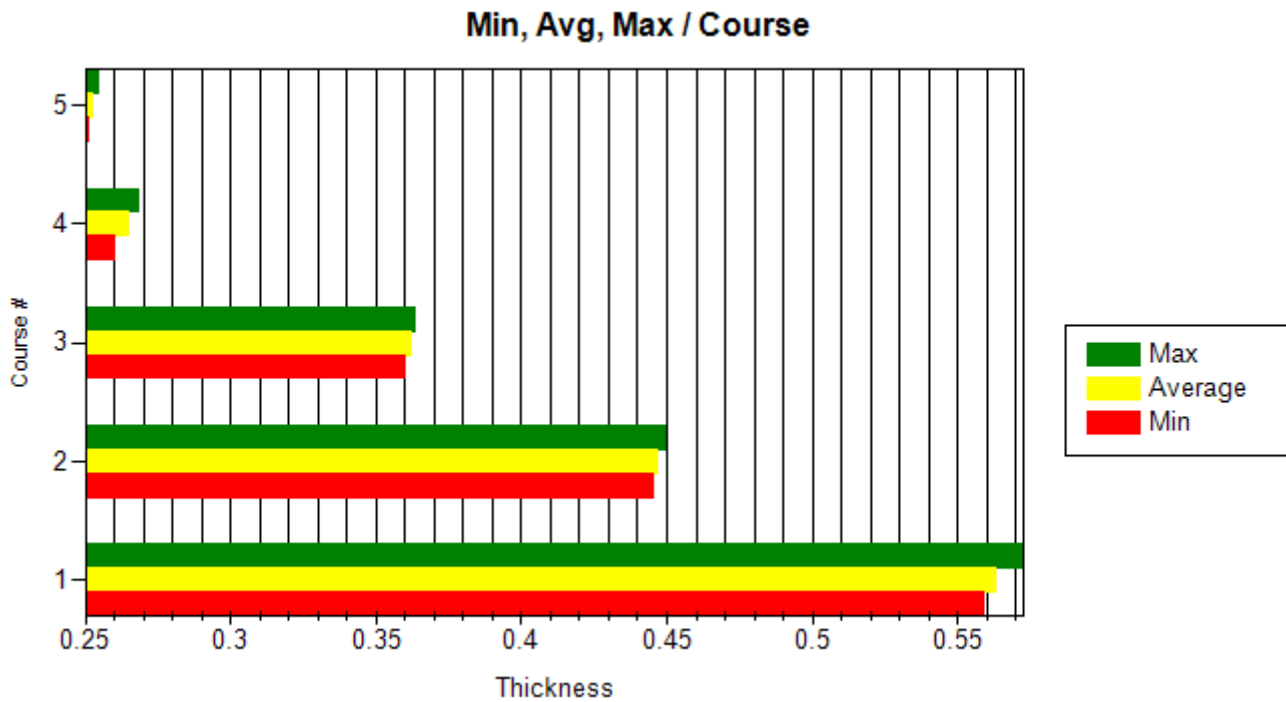
Calculations based on shell UT readings found the shell to be suitable for continued service. The course with the lowest projected remaining life span is the 3rd course with a recorded low of 0.360" compared the original nominal thickness of 0.375". The 3rd course a computed corrosion rate of 0.00037 inches per year with a projected life expectancy of 303.20 years.

Course #	Min	Avg	Max
5	0.251	0.252	0.254
4	0.260	0.265	0.268
3	0.360	0.362	0.363
2	0.445	0.447	0.449
1	0.559	0.563	0.573
<i>Global</i>	0.251	0.378	0.573

The following chart depicts the average thickness reading (in) on the shell plates versus the course number.

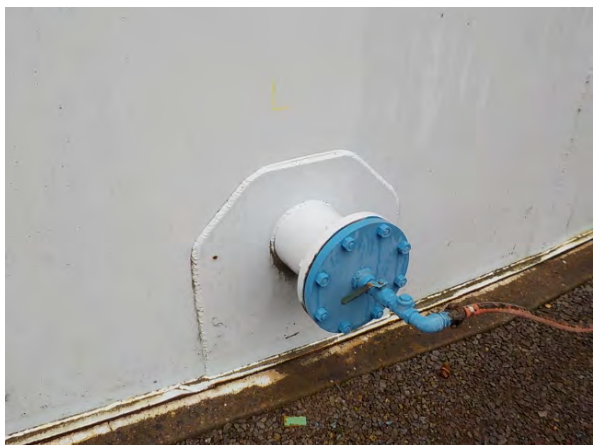
All nozzles, including manways, were square with no evidence of distortion. Nozzle L was found to have numerous bolts with short thread protrusion on nozzle flange bolts. Per API a minimum of two (2) threads should extend beyond the outer face of the nut.

INSPECTION RECOMMENDATIONS	
Recommendation ID	REC - 1
Component	Nozzles and appurtenances
Recommendation Headline	Short thread protrusion on nozzle flange bolts.
Recommendation Description	<p>Findings: Nozzle L was found to have numerous bolts with short thread protrusion on nozzle flange bolts. Per API A minimum of two (2) threads should extend beyond the outer face of the nut.</p> <p>Recommendations: It is recommended that, one at a time the all-thread be replaced with a long enough piece so that proper thread protrusion can be achieved.</p> <p>Post Actions:</p>
Recommendation Priority	Mandatory
Author Name	Byron Johnson API 653 Certification No. 33622 <i>Byron D. Johnson</i>
Status	This mandatory repair has been addressed as of 1/22/2021 and is acceptable.

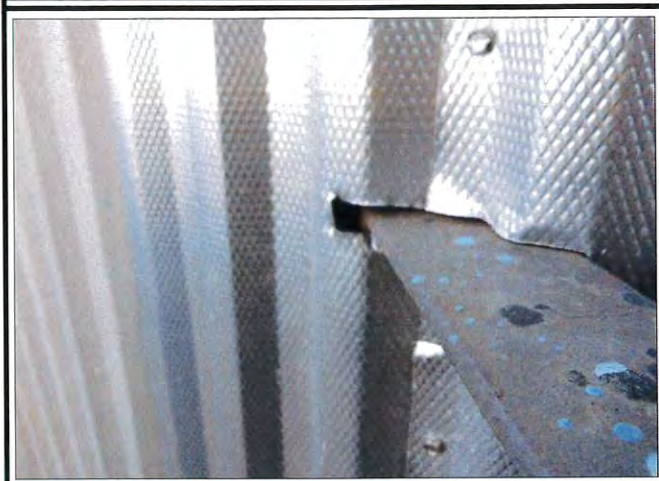
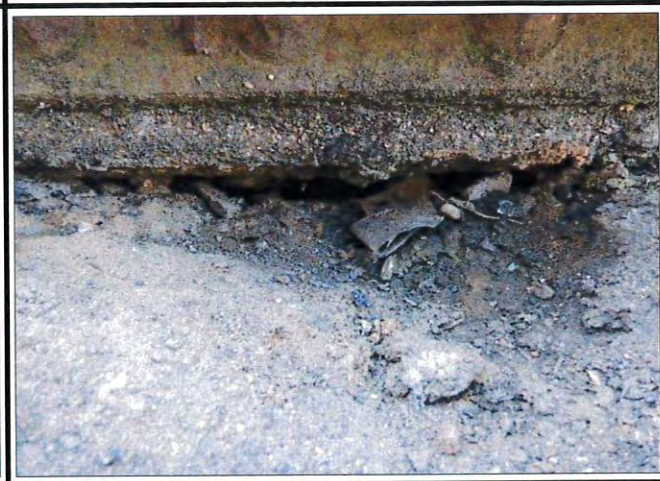
Asphalt Ring Grading	Roof Insulation Hole (Typical)

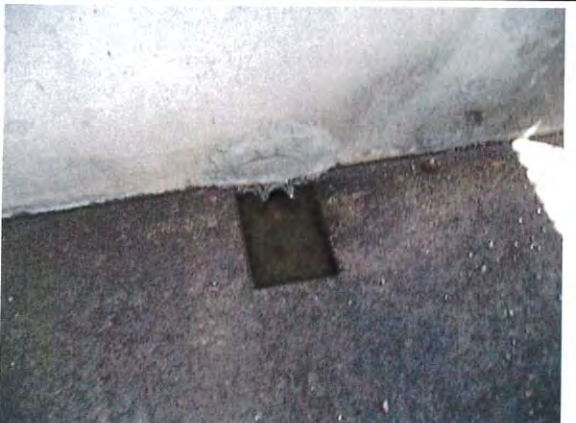
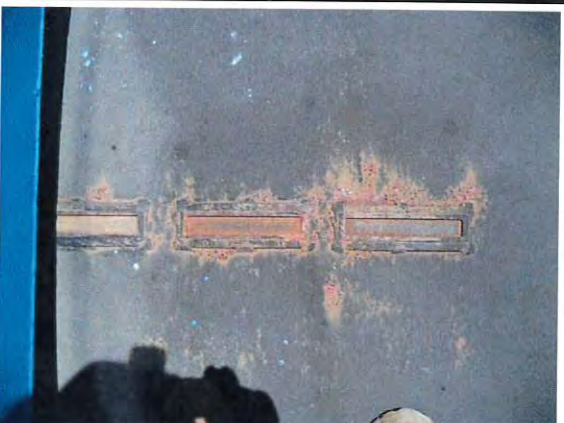
INSPECTION RECOMMENDATIONS	
Recommendation ID	REC - 2
Component	Shells
Recommendation Headline	Coating
Recommendation Description	<p>Findings: Some minor coating failure in the form of paint blistering with rust pitting was noted on the shell.</p> <p>Recommendations It is recommended that the shell coating be repaired as needed.</p>
Recommendation Priority	Optional
Status	
Author Name	Alec Arpino API 653 Certification No. 77549

West Head	Coating Failure 1

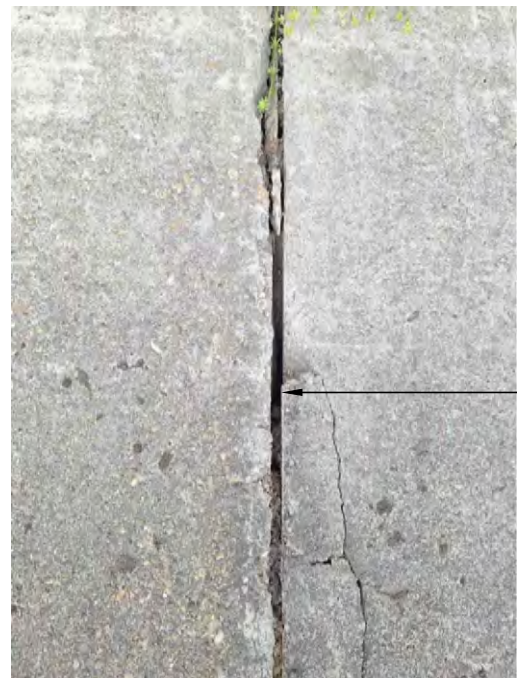
PHOTO #1 - OLD TANK FARM

VERTICAL CONTROL JOINTS IN CONCRETE DIKE WALL

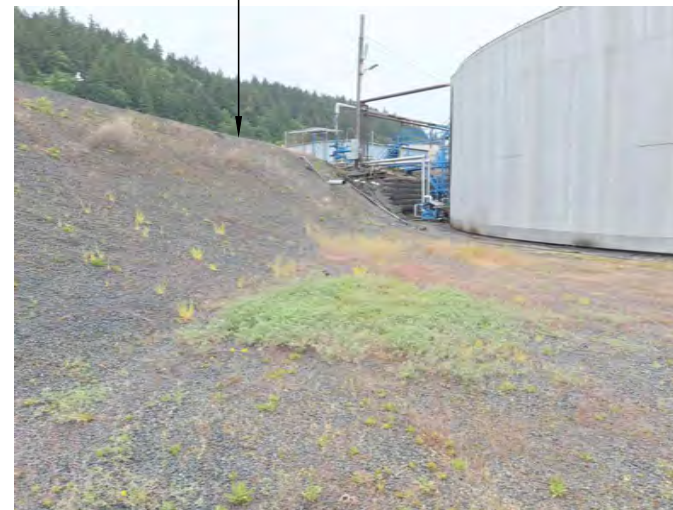
PHOTO #3 - OLD TANK FARM

EARTH BERM, TYPICAL

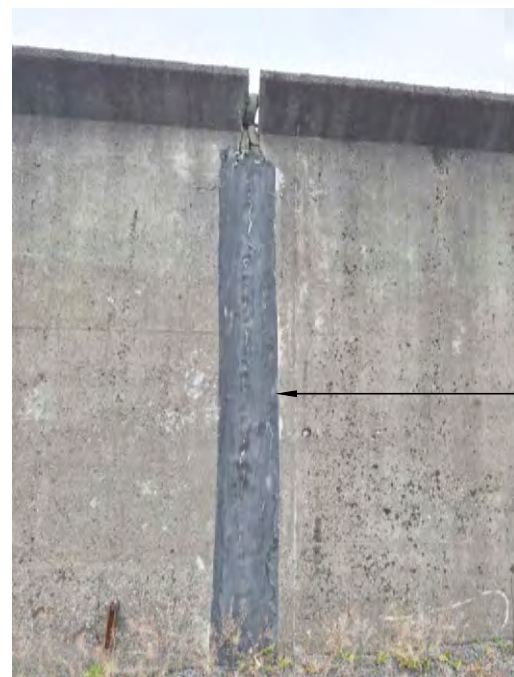
PHOTO #5 - OLD TANK FARM

SEALED JOINT

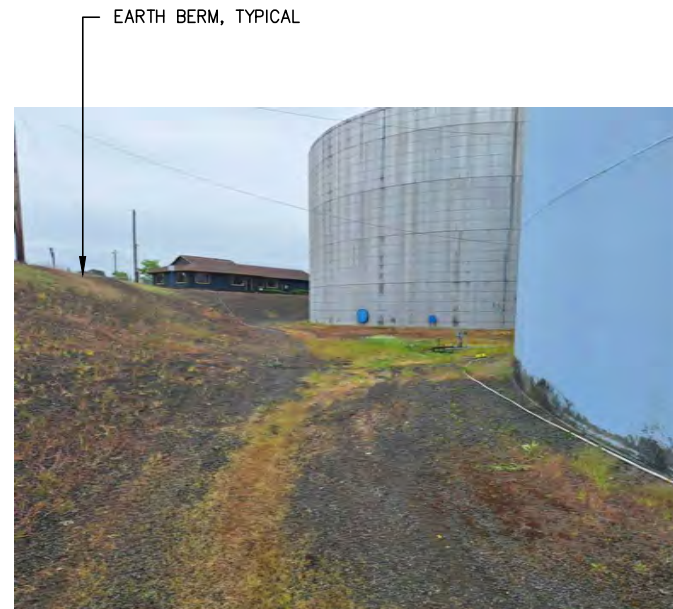
PHOTO #6 - NEW TANK FARM

EARTH BERM, TYPICAL
