Seismic Vulnerability Assessment  
Phase 1

Phillips 66 Terminal  
Portland, Oregon

File No. 20545-035-02  
May 30, 2024

# WILLAMETTE RIVER TERMINAL: MARINE FACILITY STRUCTURAL CONDITION ASSESSMENT

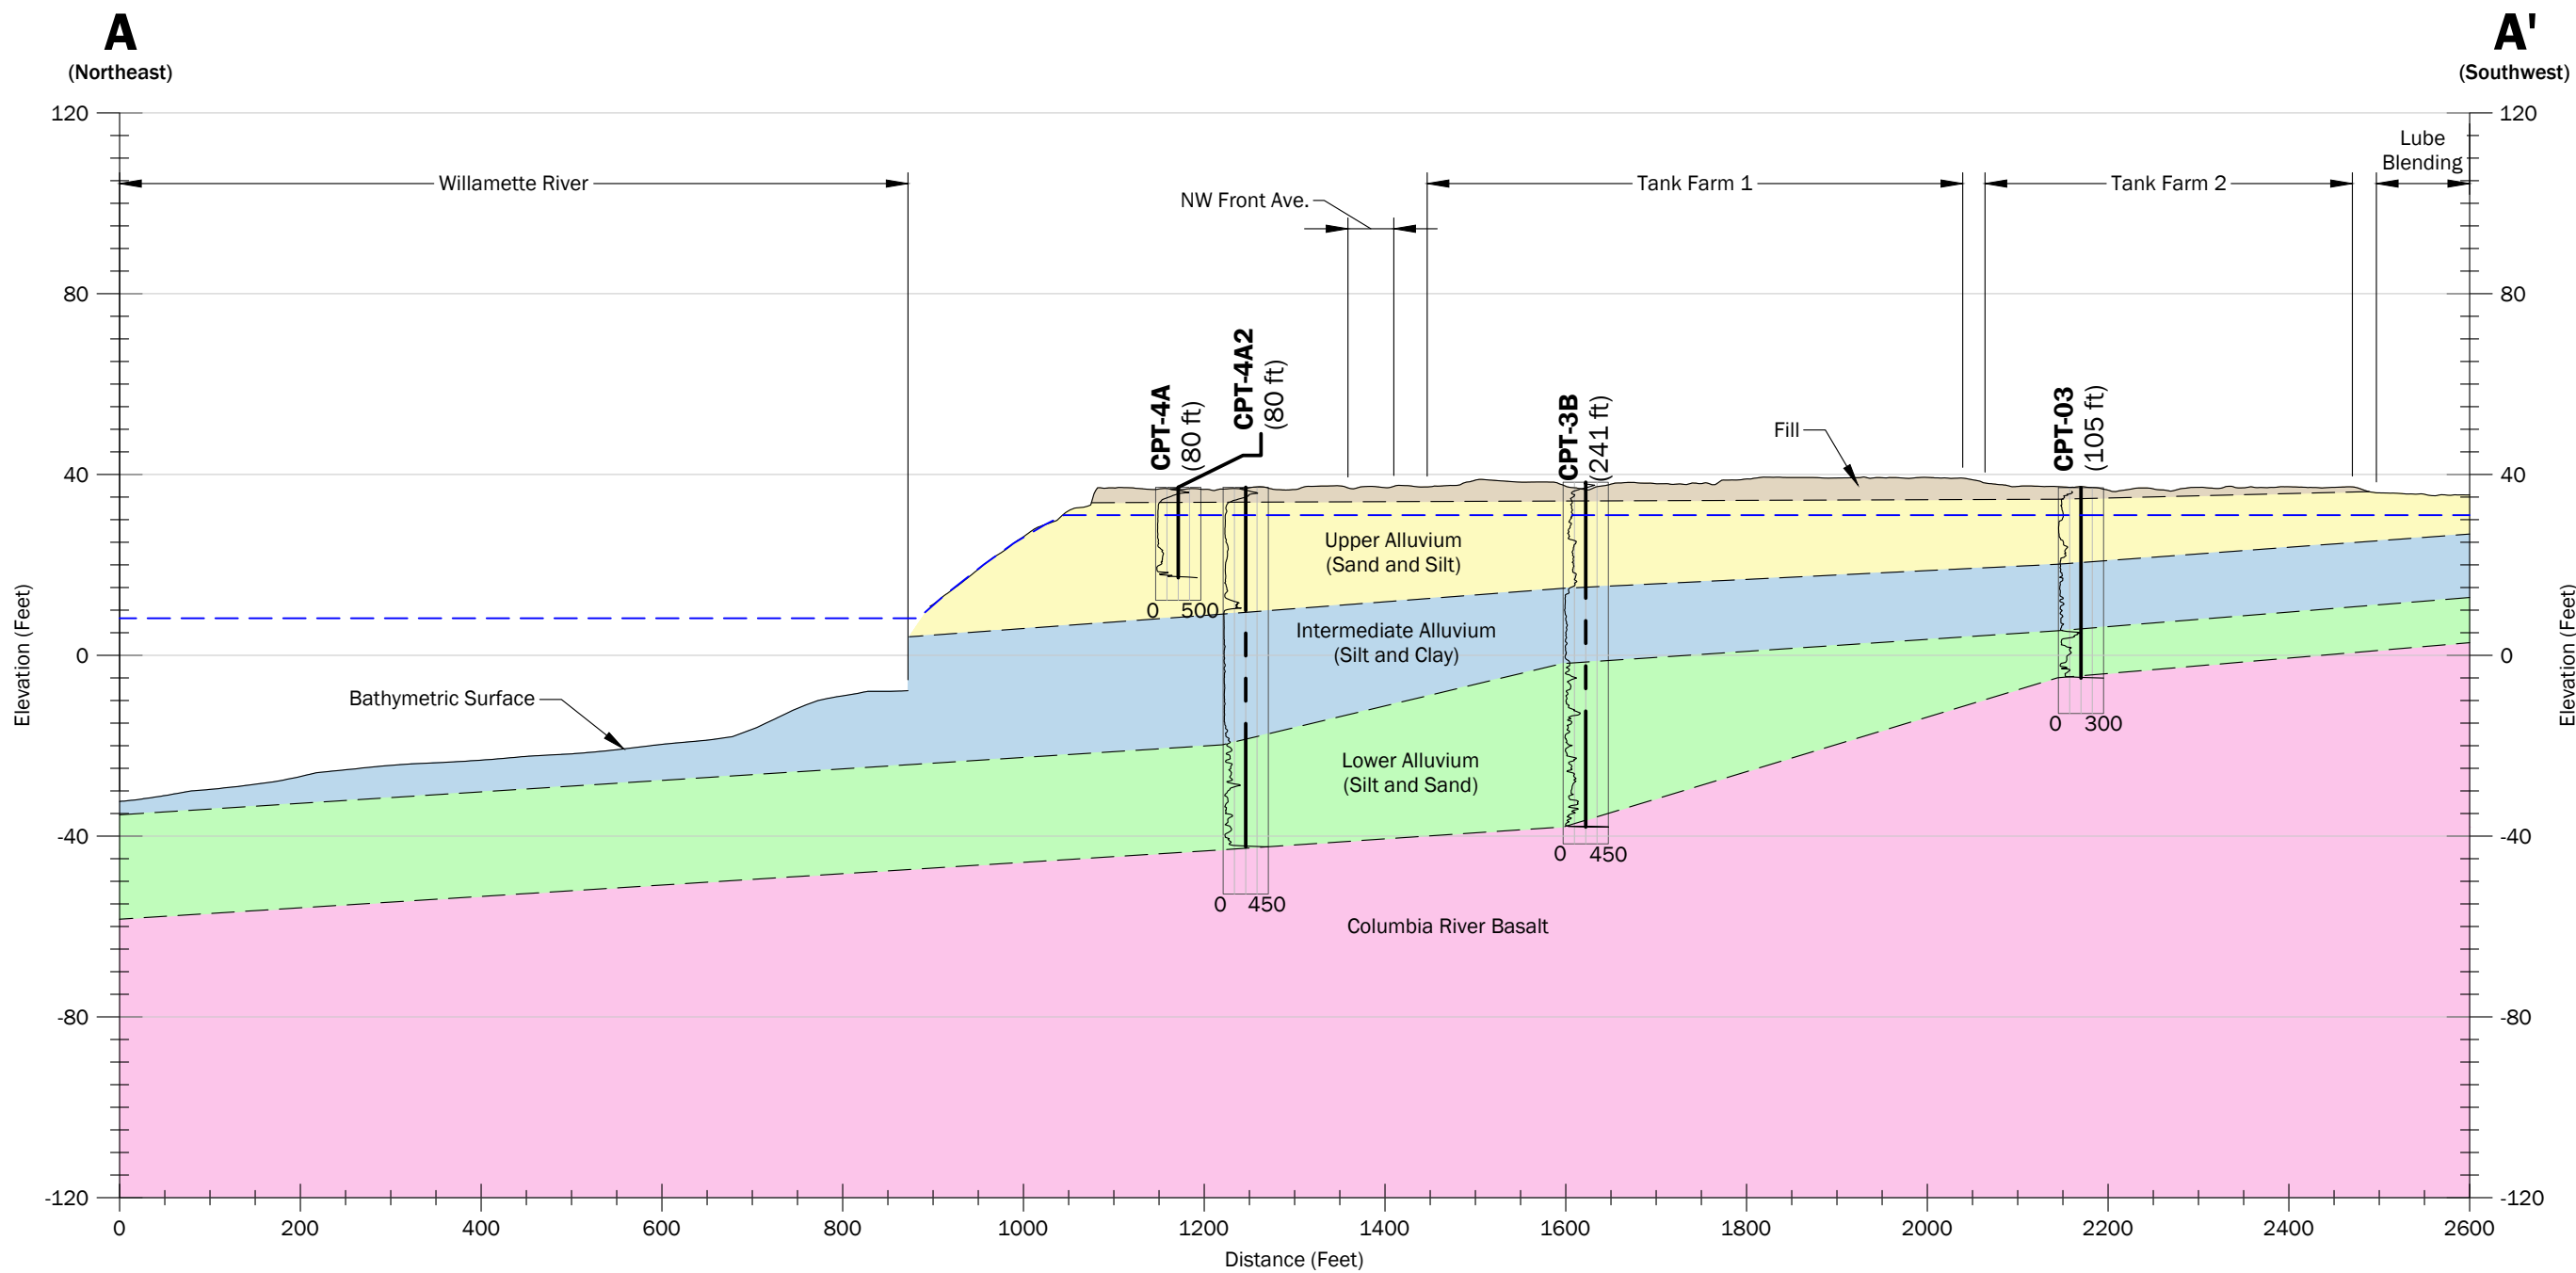
<b>Cross Section A-A'</b>	
Phillips 66 Portland Terminal Facility Improvement, Portland, Oregon	
	<b>Figure 4</b>

The general site conditions including surface, subsurface and groundwater conditions were summarized in Section 2. One representative cross section was developed across the terminal as shown in Figure 4 for use in the geotechnical assessment. The location of the cross section is shown in Figure 3. Our interpretation of the subsurface conditions are also depicted in Figure 4. Considering the water level in the Willamette River, a design groundwater table was assumed at 9 feet bgs.

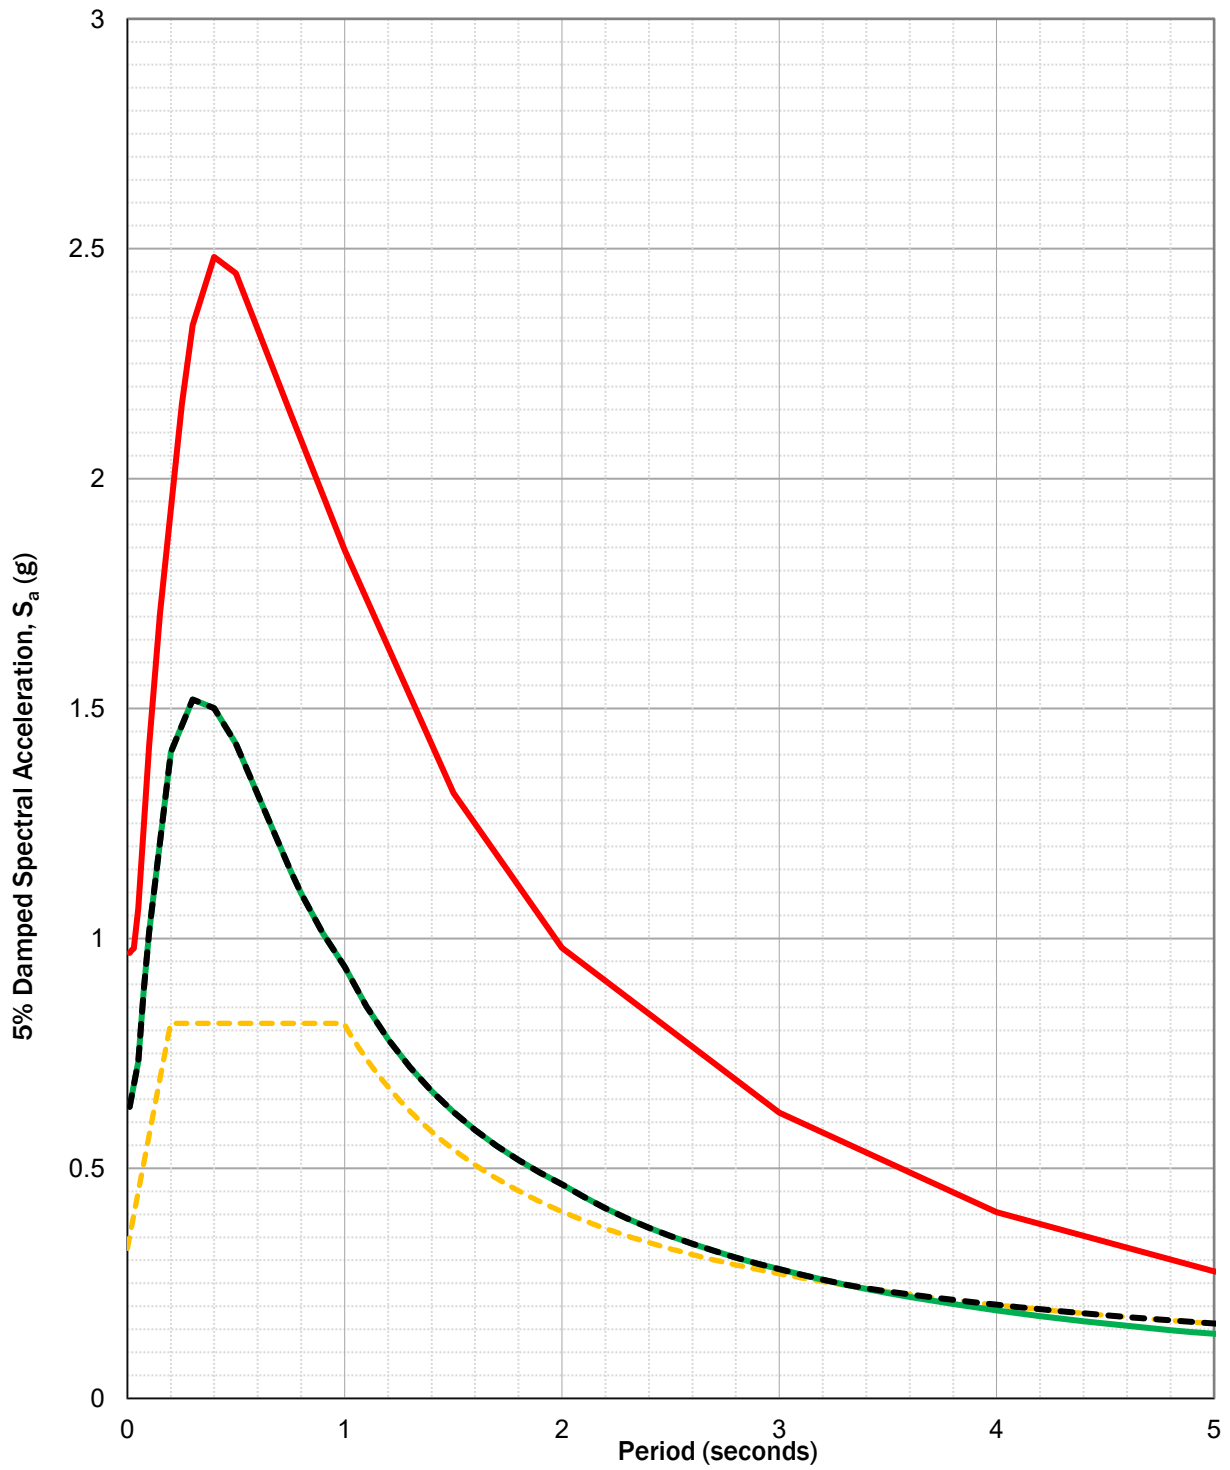
<b>Recommended Site-Specific MCE<sub>R</sub> Response Spectrum</b>	
Phillips 66 Terminal Portland, Oregon	
	<b>Figure 5</b>

A site-specific ground motion analysis was completed to develop the site-specific risk-targeted maximum-considered earthquake (MCRR) horizontal response spectrum. Table 1 and Figure 5 present our recommended site-specific MCER response spectrum. Please refer to Appendix A, Section A.4, for additional details regarding the development of the recommended site-specific MCER response spectrum.

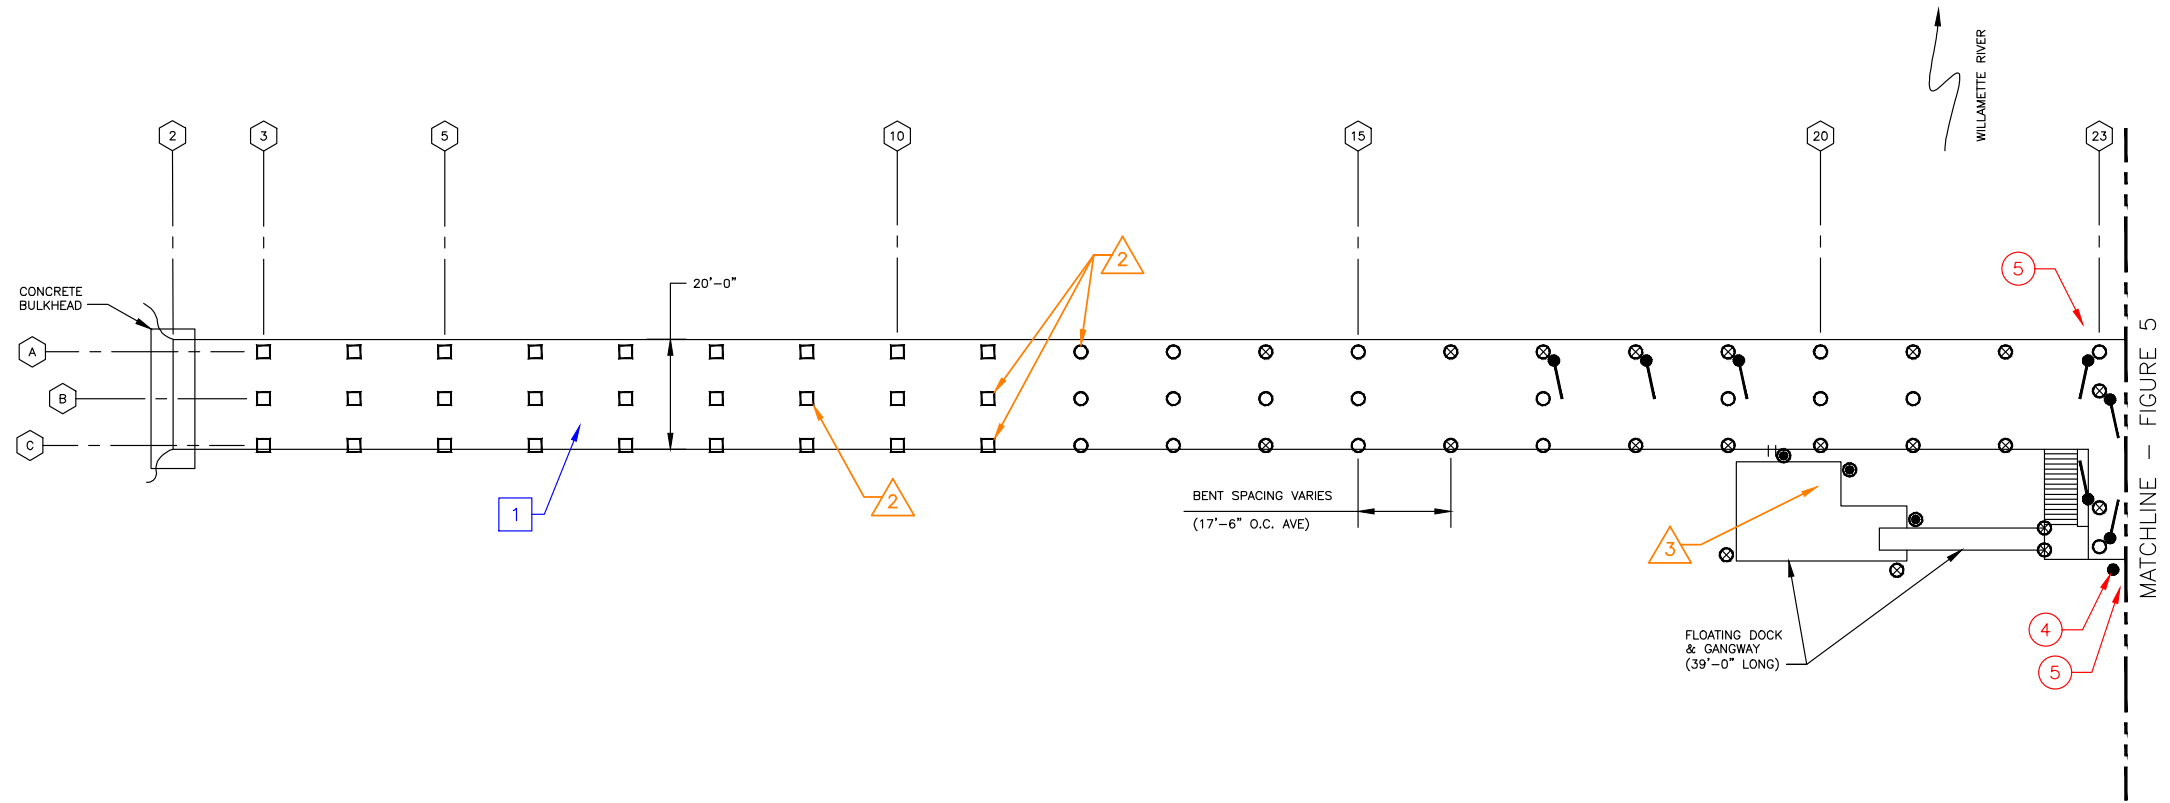
FIGURE 4: PLAN  
SCALE: 1/16"=1'-0"

1. STRINGER (INNERMOST OF THE TWO EDGE STRINGERS) TO BE REPLACED.
2. FOUR TIMBER PILES WITH 1" SIGNIFICANT LONGITUDINAL SPLITS; MONITOR FOR DETERIORATING CONDITION.
3. REPAIR CONNECTIONS BETWEEN INDIVIDUAL CONCRETE SECTIONS OF GANGWAY LANDING TO PREVENT INDEPENDENT MOTION AND FURTHER LISTING.
4. REMOVE DEAD-HEAD PILE FROM DOCK, FROM WATER LINE IF PRESENT.
5. REPLACE MISSING FENDER PILE(S).

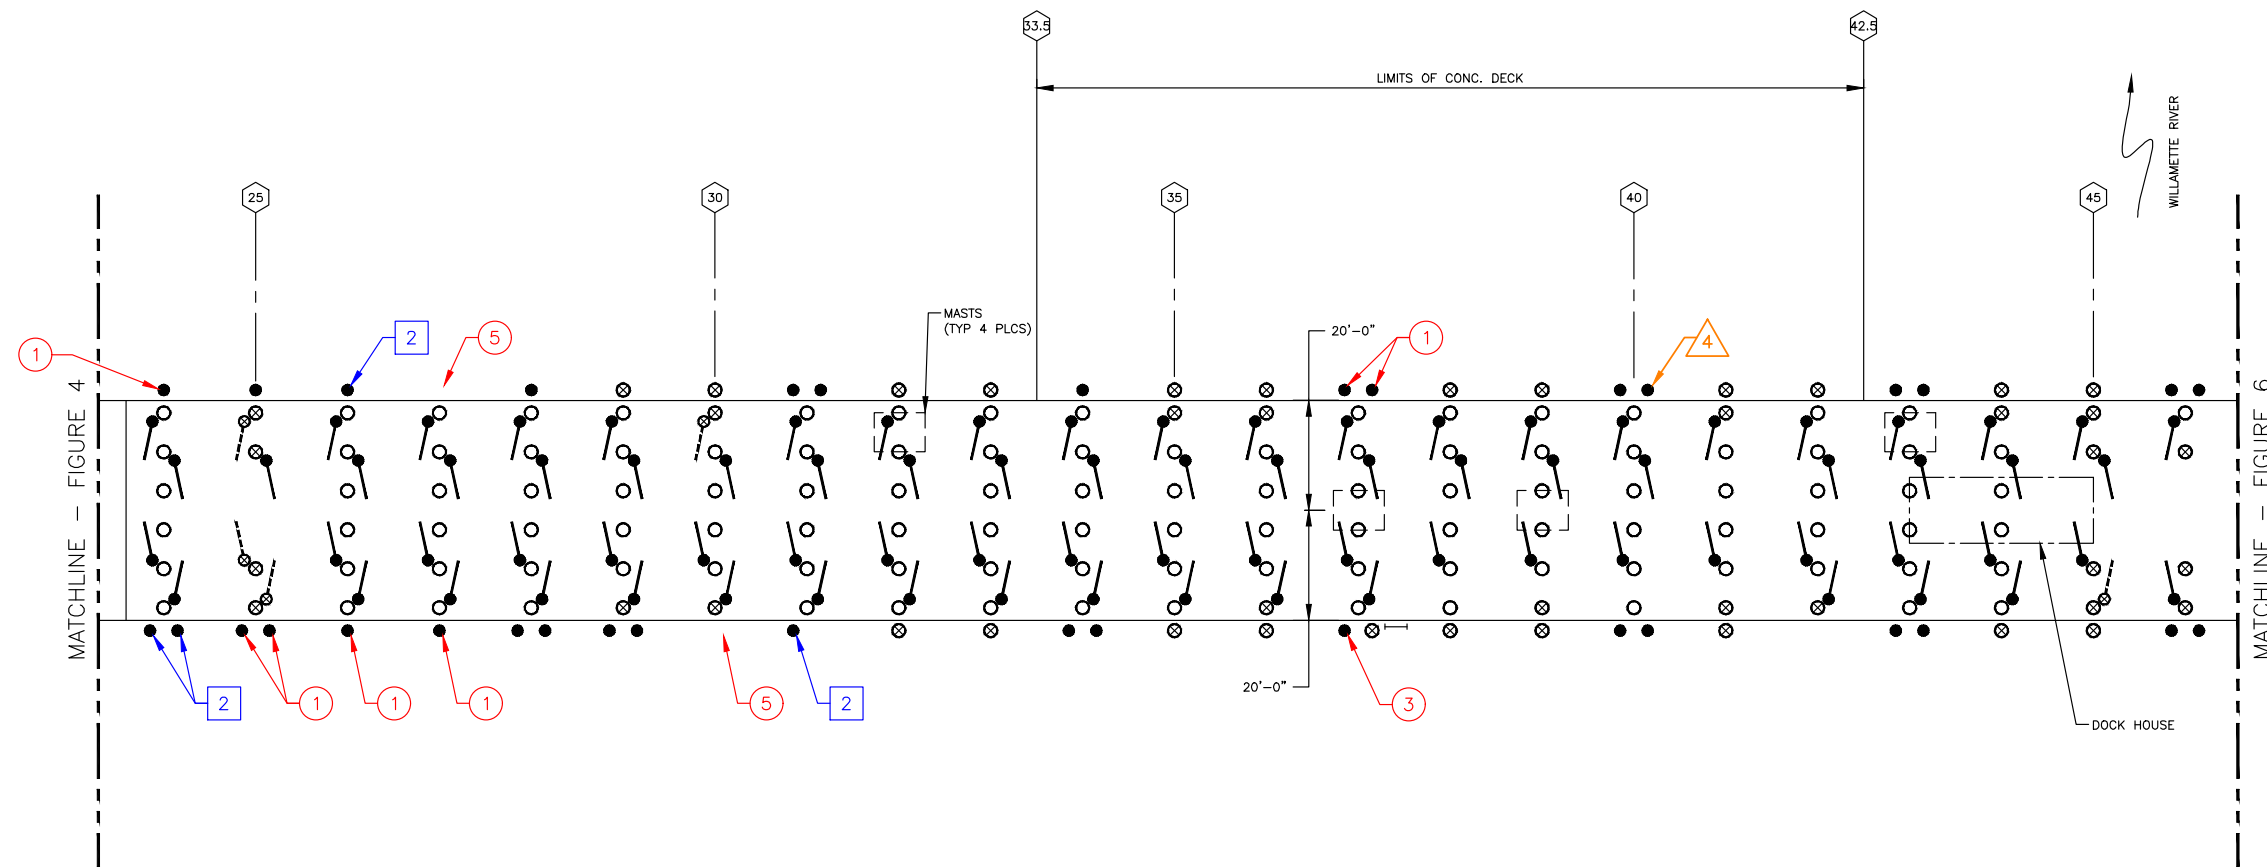
FIGURE 5: PLAN  
SCALE: 1/16"=1'-0"

1. REMOVE BROKEN FENDER PILE(S) AND REPLACE PILE(S).
2. MONITOR FOR FURTHER DETERIORATION OR CONSIDER REPLACEMENT.
3. REMOVE BROKEN FENDER PILE.
4. REPLACE FENDER PILE.
5. REPLACE MISSING FENDER PILE(S).

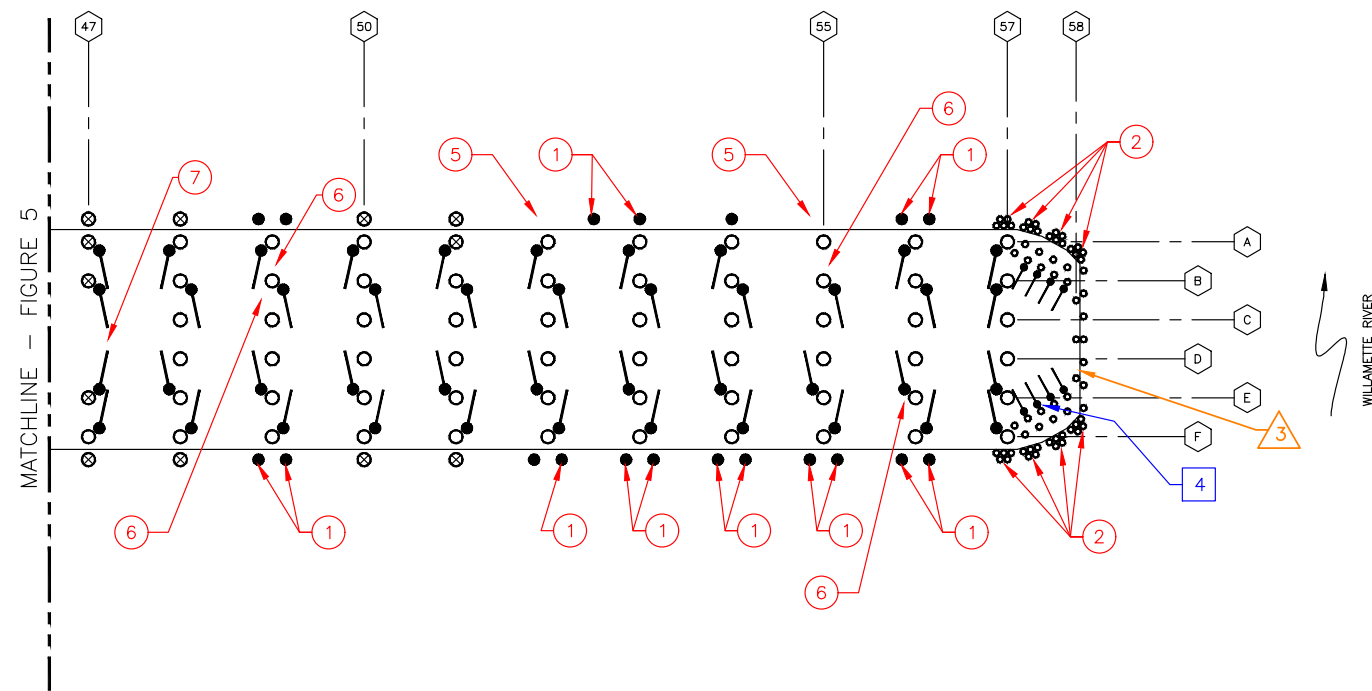
FIGURE 6: PLAN  
SCALE: 1/16"=1'-0"

1. REMOVE BROKEN FENDER PILE(S) AND REPLACE PILE(S).
2. REMOVE BROKEN CLUSTER PILES AND REPLACE WITH NEW FENDERS, FENDER PILES, OR OTHER PIER HEAD PROTECTION SYSTEM.
3. REPLACE PILE CAP GRID 58.
4. 57E-58E SMALL DIAMETER PILES: CONSIDER AMENDING WITH NEW PIER HEAD PROTECTION SYSTEM.
5. REPLACE MISSING FENDER PILE(S).
6. BROKEN LATERAL BRACING MEMBERS.
7. REPLACE PILE CAP AT GRID 47. MAY BE NECESSARY TO ADD (1) PLUMB PILE FOR ADDITIONAL SUPPORT.

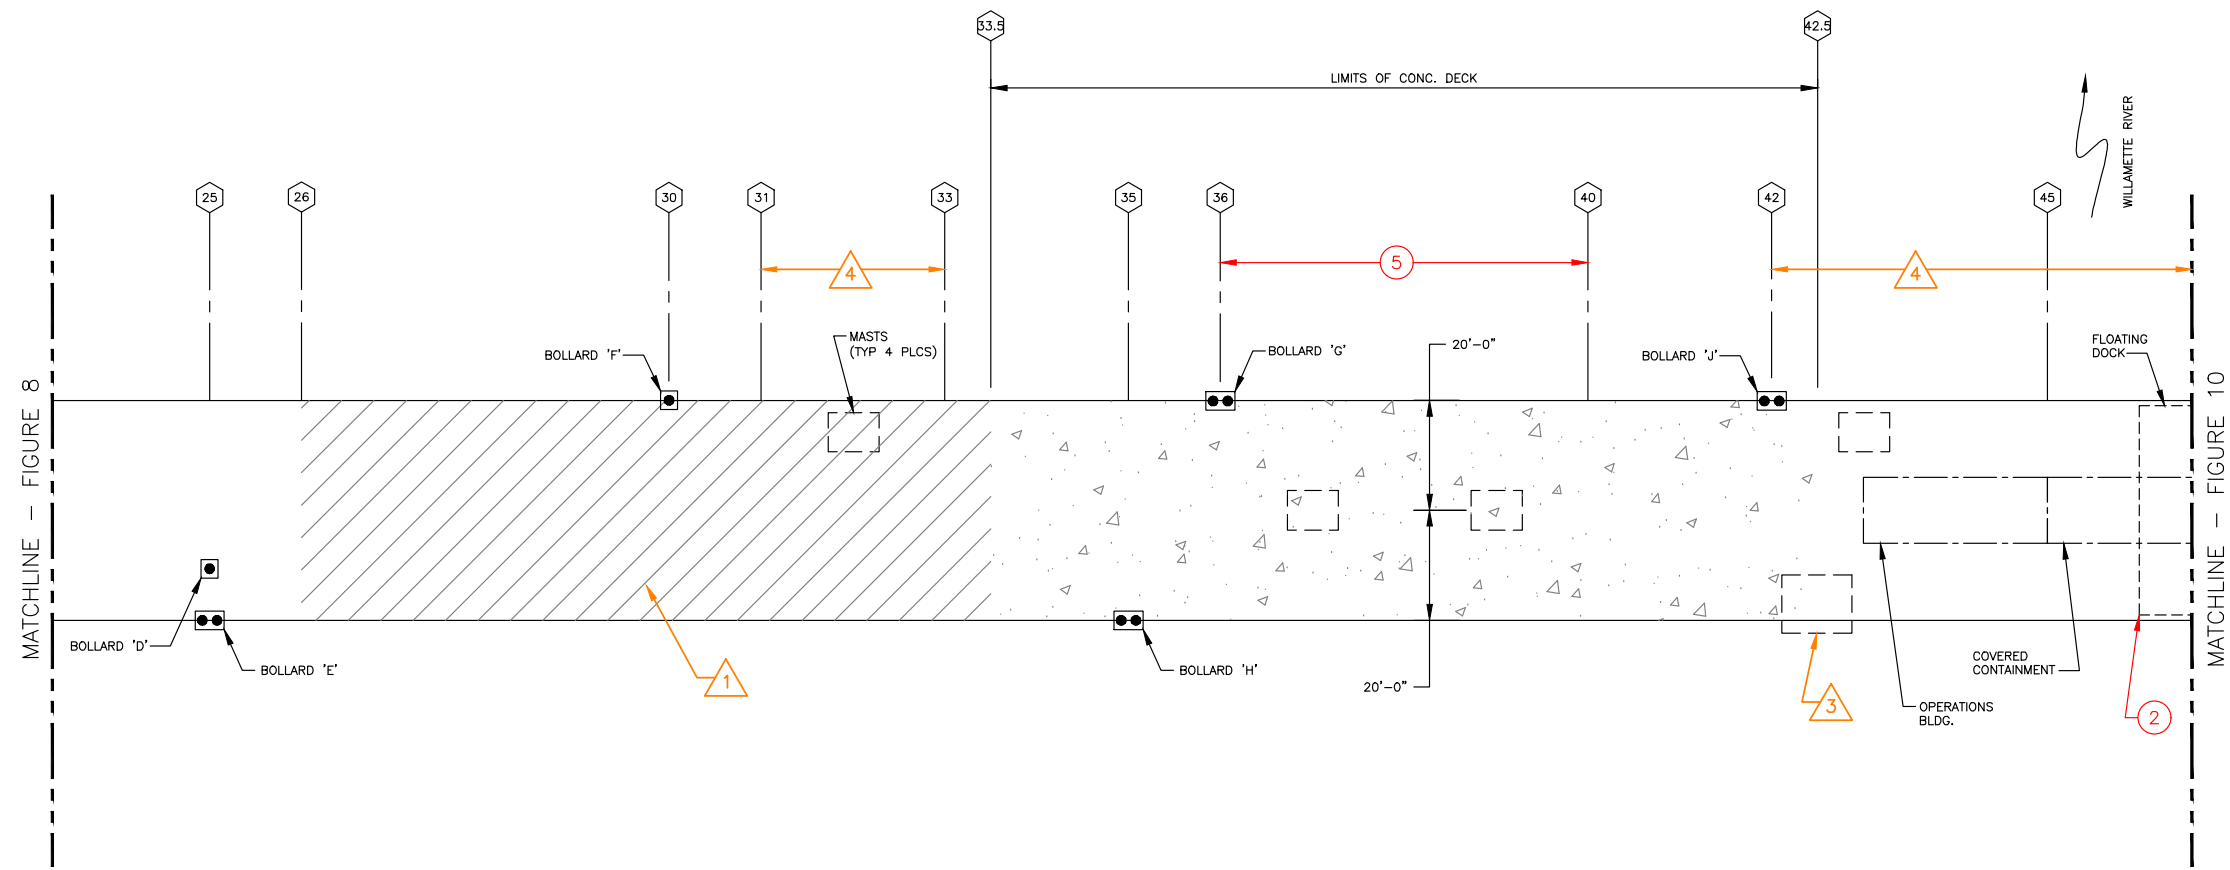
FIGURE 9: PLAN  
SCALE: 1/16"=1'-0"

1. MULTIPLE INDIVIDUAL DECK BOARDS SHOW SIGNIFICANT ROT AND LOSS OF SECTION, MOLD INFESTATION, SWELLING. THE AREA SHOULD BE SURVEYED FOR BOARD REPLACEMENT. THE REMAINDER SHOULD BE MONITORED FOR FUTURE DETERIORATION.
2. FLOATING DECK ACCESS BELOW DECK: REPLACE TIMBER STAIR STRINGERS, HANDRAILS, LADDER ON LOWER LEVELS THIS END.
3. REPLACE INDIVIDUAL DECK BOARDS ON SUBSTRUCTURE PLATFORM NEAR ACCESS SWING GATE.
4. BULLRAIL EXHIBITS SPLITTING DAMAGE. REPLACE.
5. BULLRAIL EXHIBITS CROSS GRAIN TENSION OR TORSIONAL SPLITTING. REPLACE.

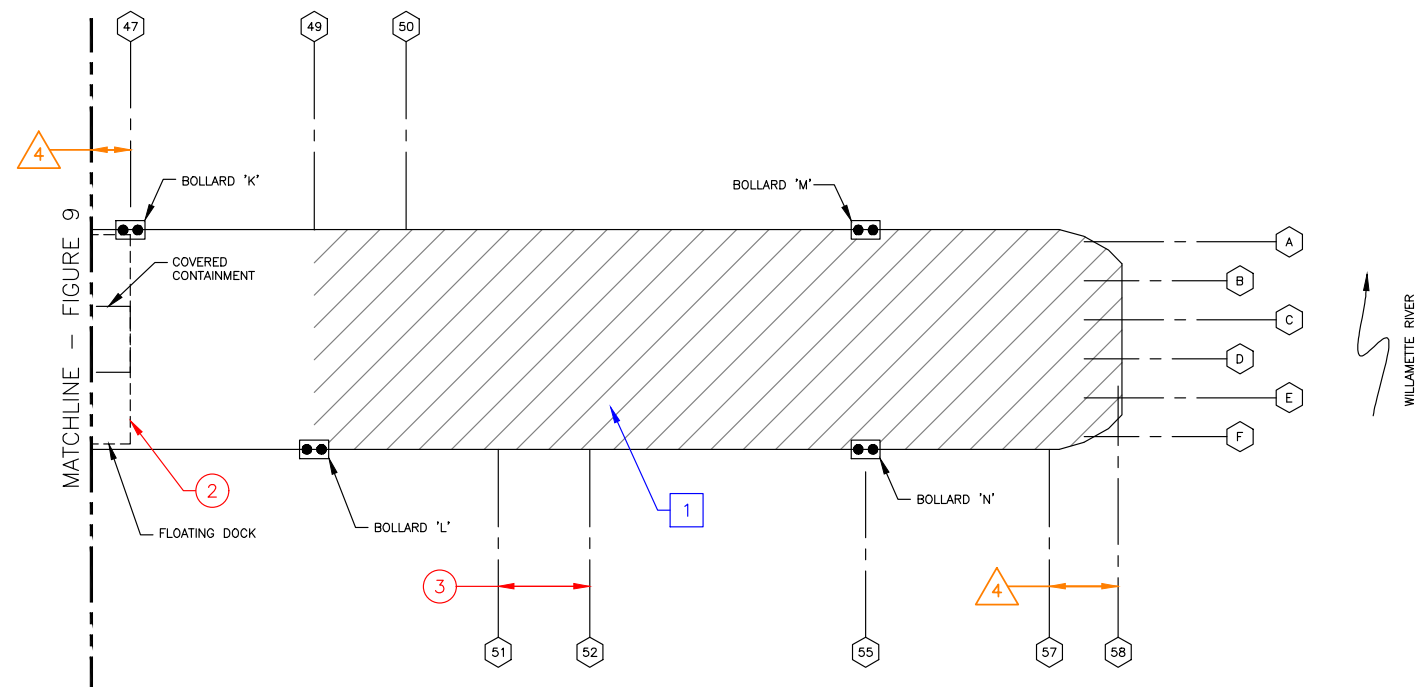
FIGURE 10: PLAN  
SCALE: 1/16"=1'-0"

1. MULTIPLE INDIVIDUAL DECK BOARDS IN DISREPAIR AND SHOULD BE REPLACED. THE REMAINDER SHOULD BE MONITORED FOR FUTURE DETERIORATION.
2. FLOATING DECK ACCESS BELOW DECK: REPLACE TIMBER STAIR STRINGERS, HANDRAILS, LADDER ON LOWER LEVELS THIS END.
3. BULLRAIL WITH SEVERE SPLITTING DAMAGE AND DECAY. REPLACE.
4. BULLRAIL SHOWS SPLITTING DAMAGE. REPLACE.

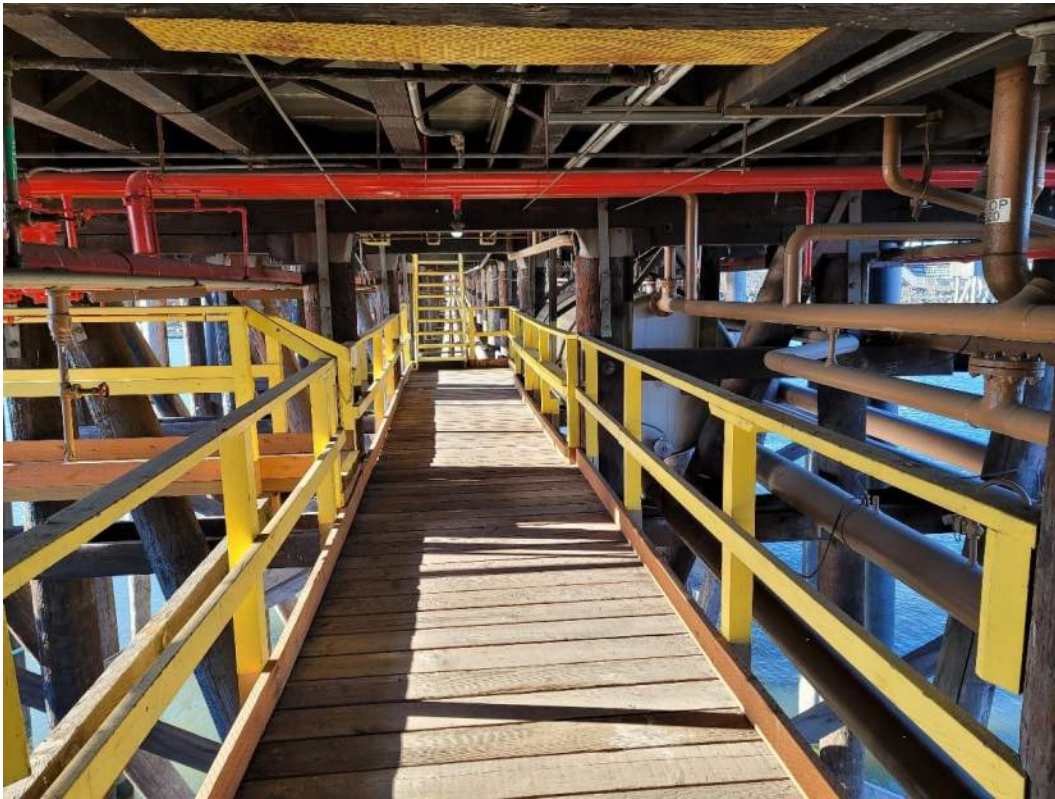
Picture 29. Substructure walkways, typical. Decking, handrails, paint in good shape.

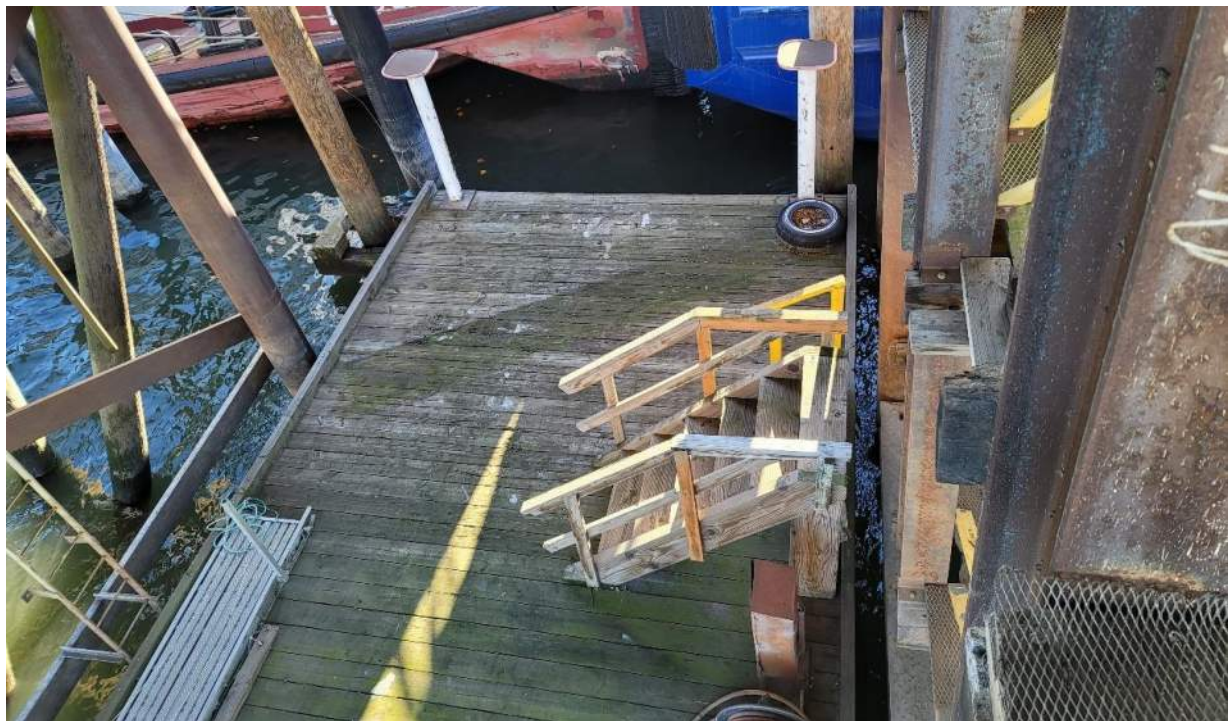
Picture 30. Floating deck, note stairs, timber guide (upper left). The deck is listing from left-to-right in the photo. The steel ladder to the left access the limited access walkway area.

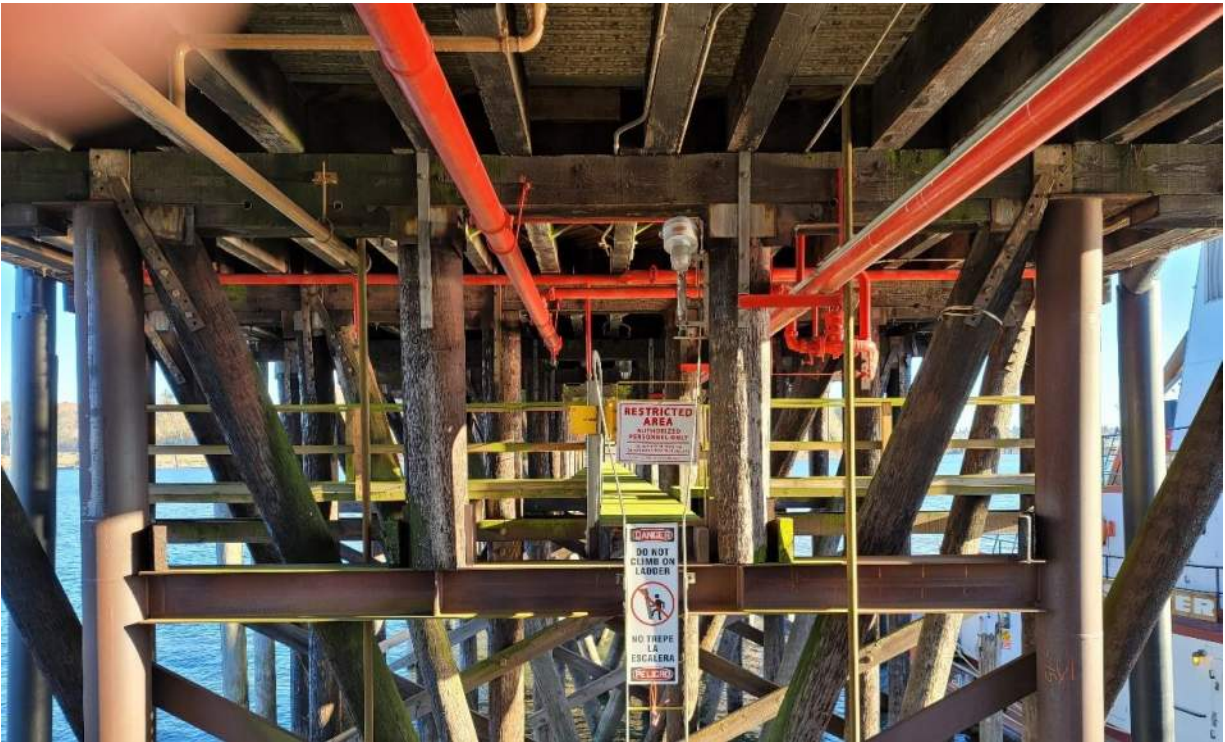
The pier structure is in FAIR condition overall. Some significant sections of decking are in poor condition and should be addressed in the near-term. One pile cap at Grid 47 is showing signs of overstress (see Appendix B, Picture 31). A few bullrails should be replaced in the near-term. All

Picture 31. Grid 47, looking east. Note significant sag (evidence of overstressing) in the pile cap and lack of mid-span support where the piles were removed below. Limited access walkway area is visible in the background.

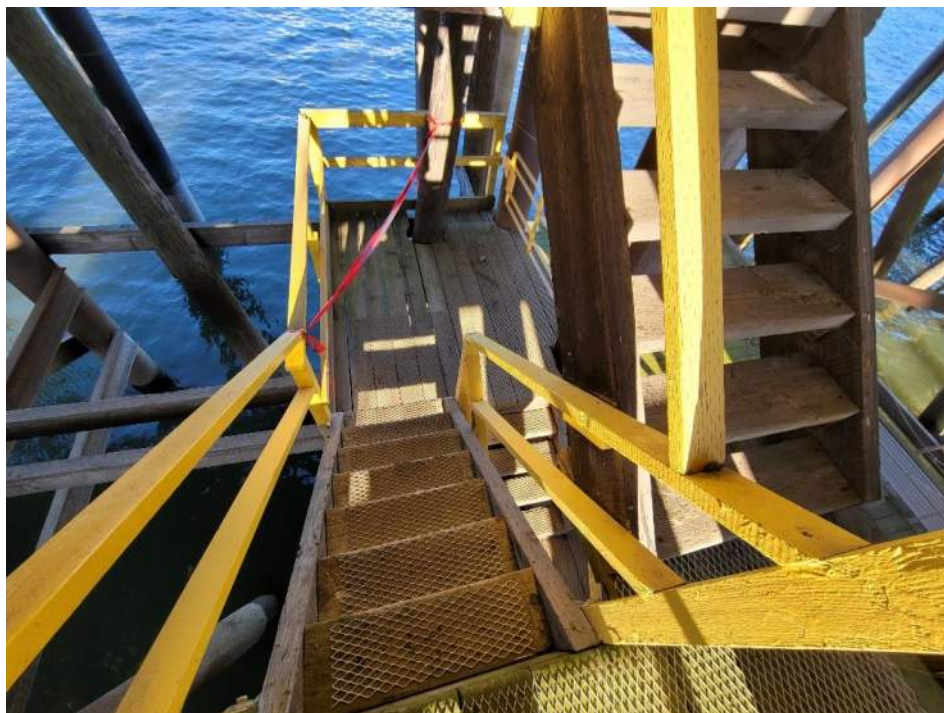
Picture 32. Stairs/platforms to the floating deck, Grid 46. The lower two levels were flagged for safety concerns.

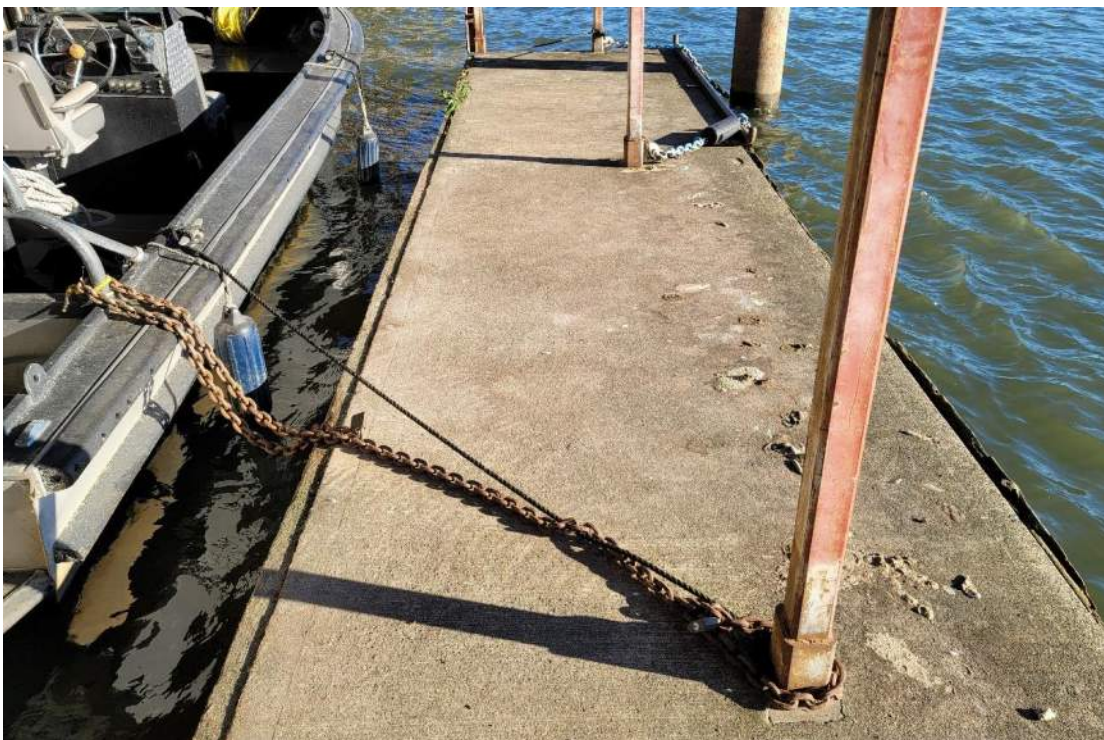
Picture 41. Boathouse structure. Note good condition of concrete, roof columns.

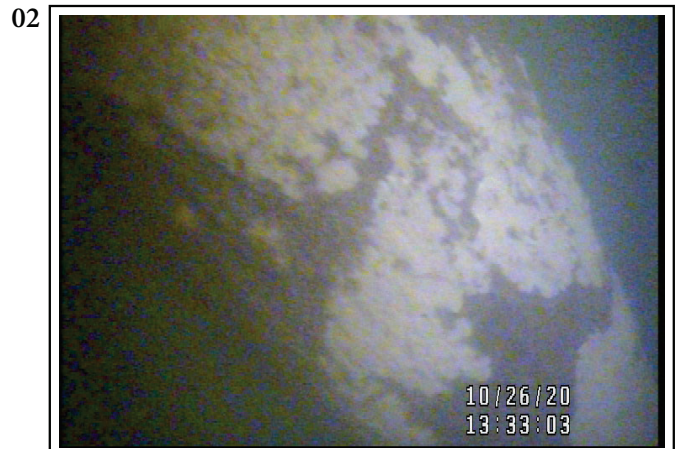
Typical Timber Pile Condition.

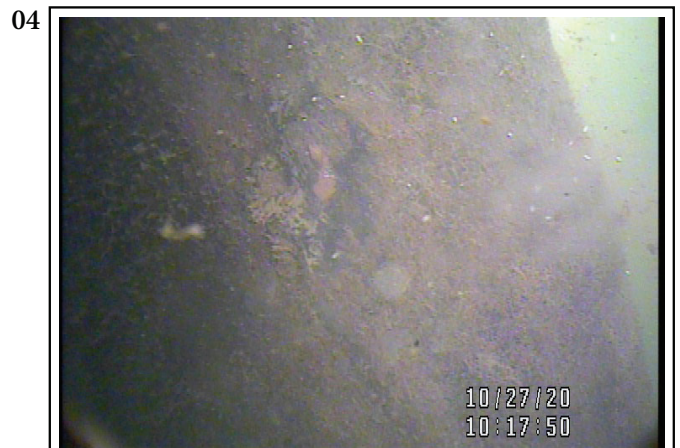
Pile 51 C - Minor soft spot, approx. baseball size.

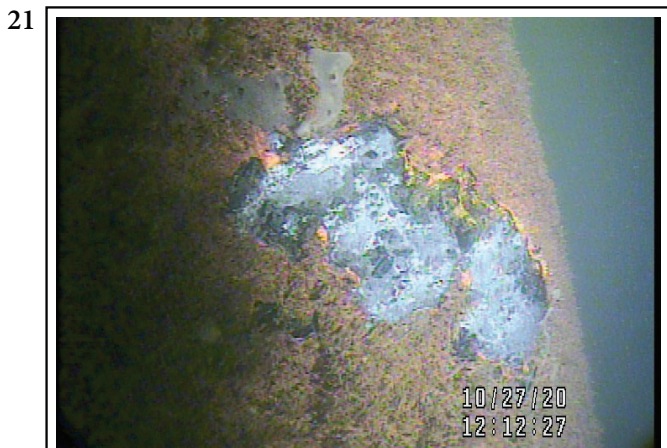
Pile 47 B - Minor corrosion sighted.

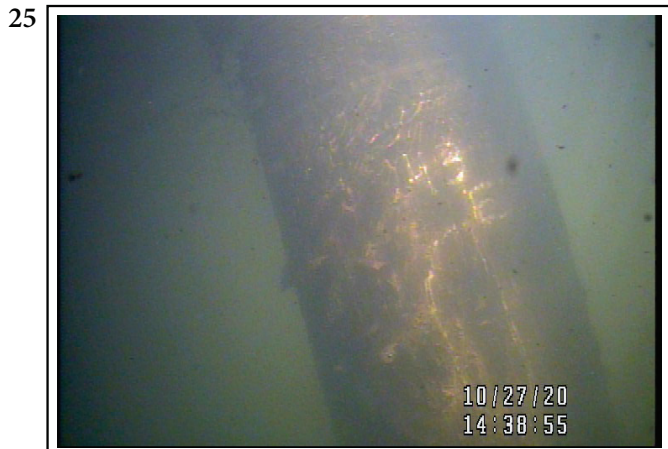
Pile 43 E - Timber compromise observed.
