Re: Annual Site Activity Summary Report—2020

Zidell Waterfront Property, 3121 SW Moody Avenue, Portland, OR

2020 Annual Site Inspection Summary

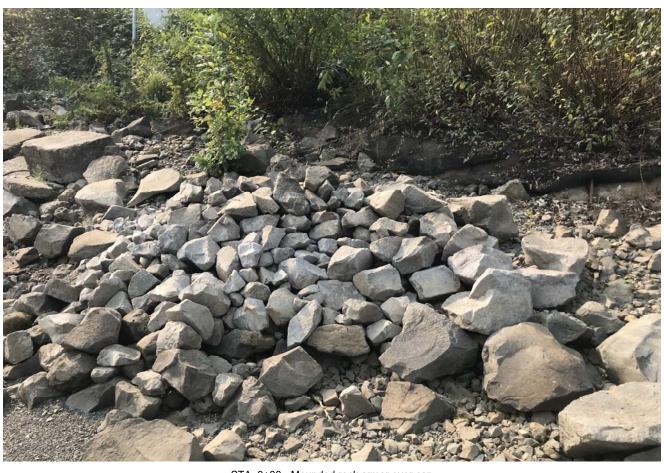
No significant erosion was observed on the bank. Some bank armor near STA: 0+20 is mounded up over the lower bank; it appears that this is caused by human activity. There are some minor vegetation

STA: 0+00 - Mounded rock armor over cap

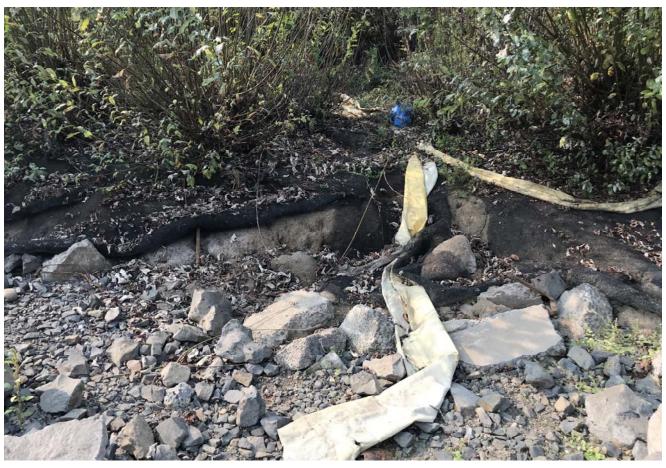
STA 0+20 - Exposed TRM and visible soil, negligible change from 2019 inspection

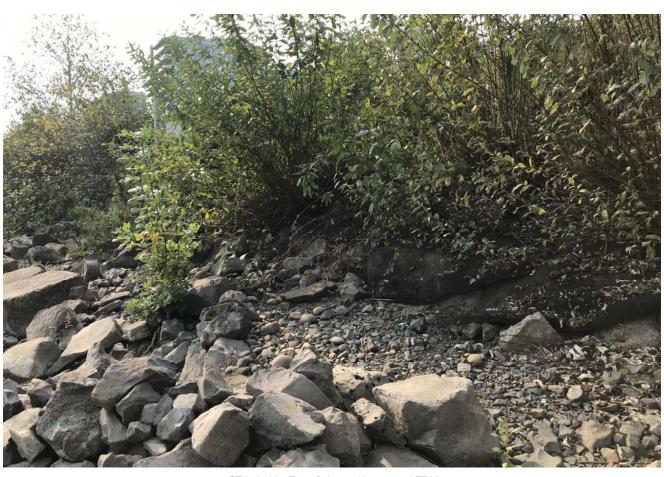
STA: 0+20 - Toe of slope with exposed TRM

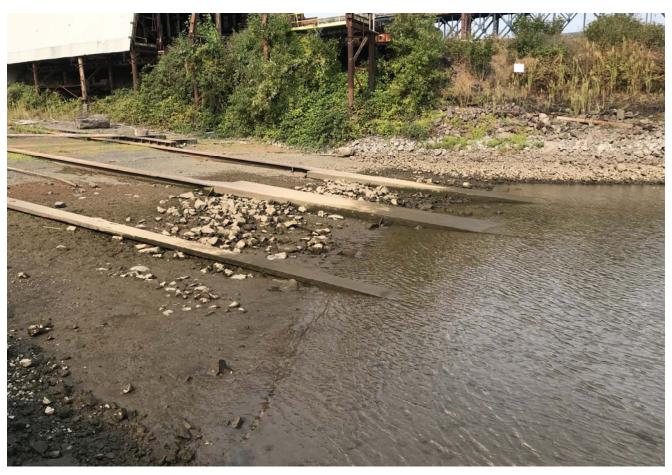
The sediment cap is in generally good condition; sediment buildup was observed in the slipway.

Slipway rails and sedimentation

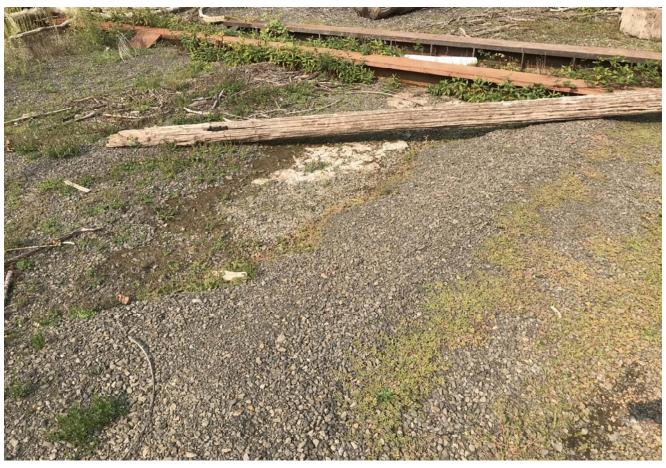
Debris and gravel shoaling in slipway

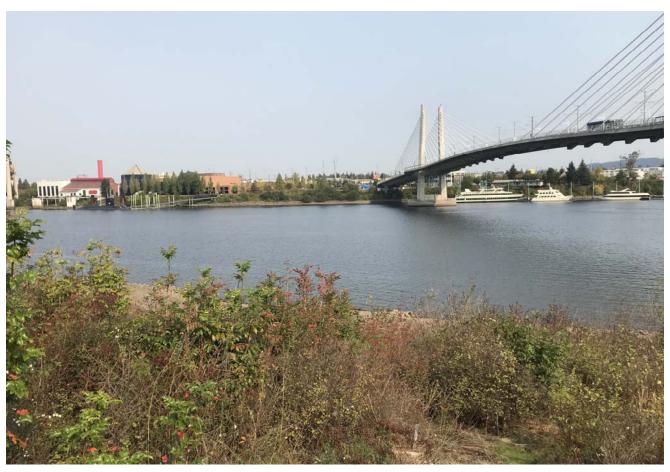
STA: 19+50 - Top of bank looking east

The bank appears to be in good shape above elevation of 10 feet up to STA: 19+50. Lower bank erosion has been noted from STA: 19+50 to 26+00 at various locations (approximately 60 percent of the bank line) from elevation 11 feet to 18 feet, as shown in the photo log. 2018 repair areas appear to be stable, with vegetation well-established. Habitat gravel on the repair areas appears to have remained on top of the rock armor.

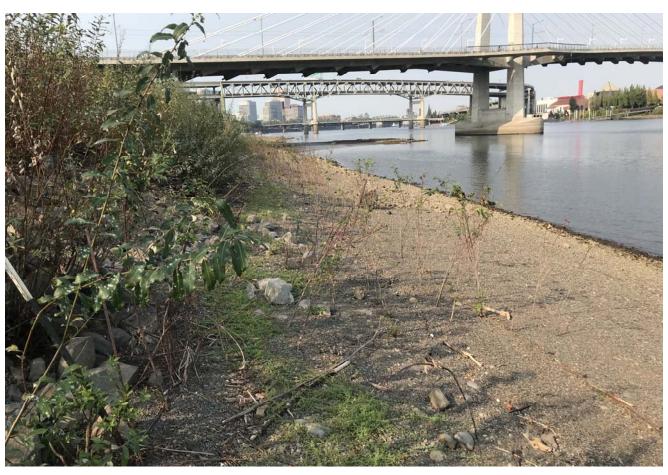
No new bank erosion was observed above the top of the rock armor. Rock armor, including 2018 repair areas, appears to be in good shape, with little movement or change compared to the 2019 site inspection.

STA: 13+75 - 2018 Bank repair area

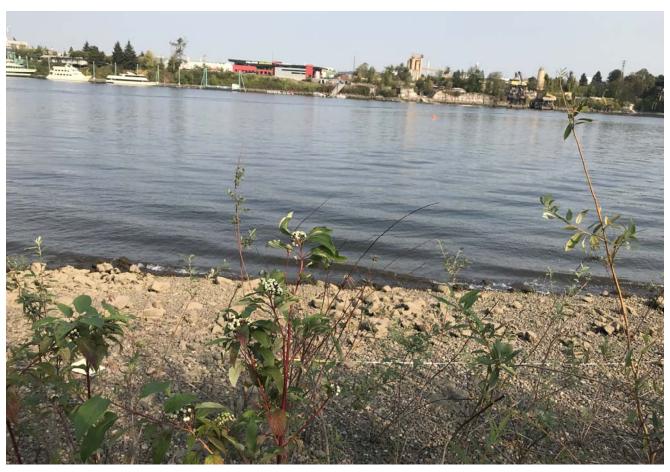
STA: 14+00 - Live stake plantings from 2018 bank repair

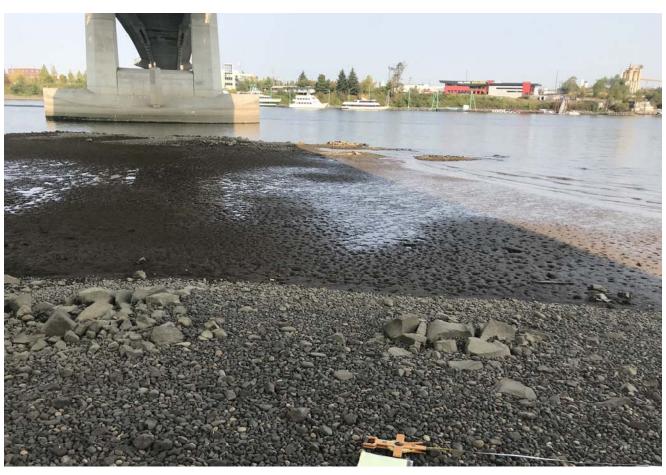
Vegetation coverage is dense above elevation of 10 feet in most areas. Vegetation on the bank area below the Tilikum Crossing bridge envelope is compromised by shading and/or lack of water; localized spots of minor erosion are visible where water drips from the overhead structure. 2018 repair areas are revegetating vigorously through the newly placed rock armor, and live stakes installed on lower portions of the bank have become established.

Bank area below Tilikum Crossing envelope, looking west

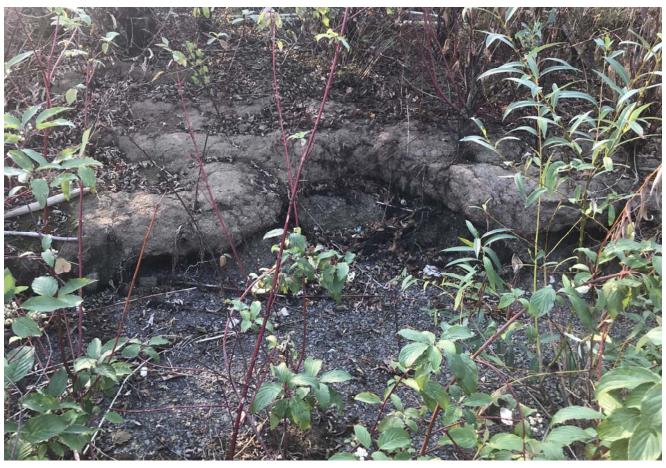
STA: 24+00 - Lower bank erosion elevation 11'-18'

- Bank repair below elevation 18 feet is recommended in areas of continued erosion north
 of the Tilikum Crossing. The 2018 bank repair continues to be effective, and each
 inspection conducted since then has found successive increases in vegetative
 establishment.
- Monitor erosion areas above the rock armor beneath the Ross Island Bridge. The bank appears stable; however, additional erosion would be detrimental to cap stability.
- Continue to monitor vegetation on the lower bank areas of the Downstream Reach. Irrigation of the bank vegetation, primarily newer plantings, should continue during dry periods in summer and fall.
- Monitor the small, exposed RCM area in the slipway. If gravel displacement continues, raking or placement of additional gravel may be required.

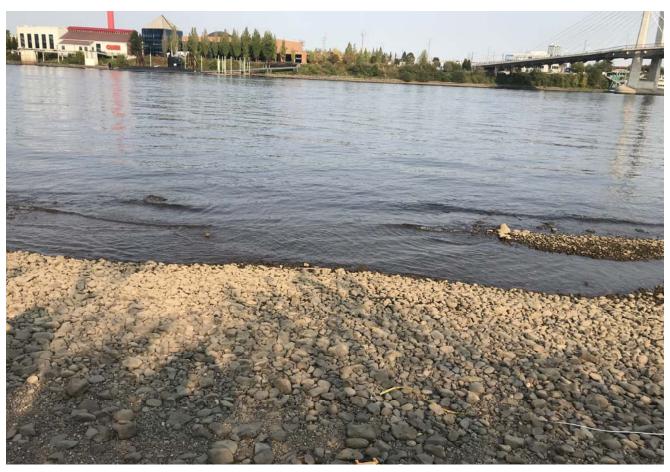
STA: 25+50 - Toe of slope looking east

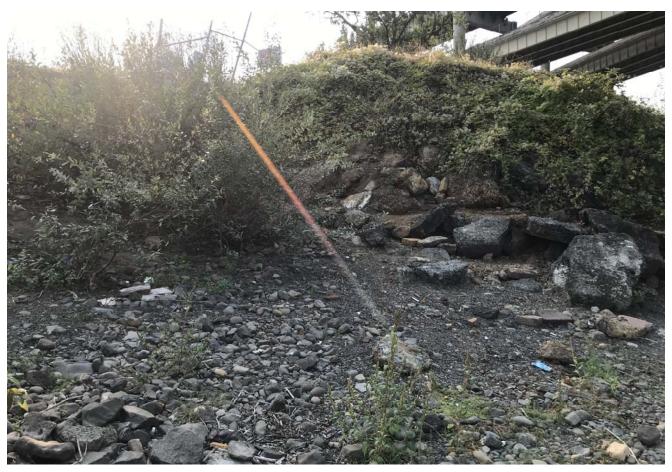
STA: 25+75 - Lower bank erosion below elevation 16'

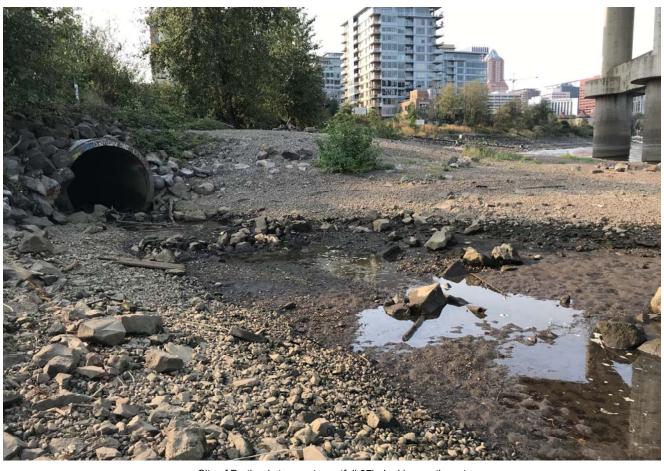
STA: 26+50 - Cap area looking west

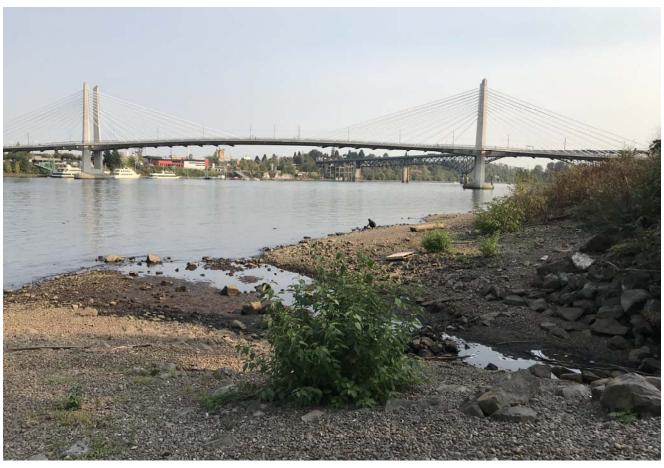
- Minimal discharge from City of Portland outfall 07b (near the Marquam Bridge) was observed. Discharge appeared to be murky, with bubbles, sediment, and discoloration.
- Debris (trash, clothing, etc.) from vagrant activity was observed at various locations on the bank; however, as a result of increased monitoring and security measures, the site is cleaner than during the 2019 inspection.

City of Portland outfall 07b flow path, looking southeast

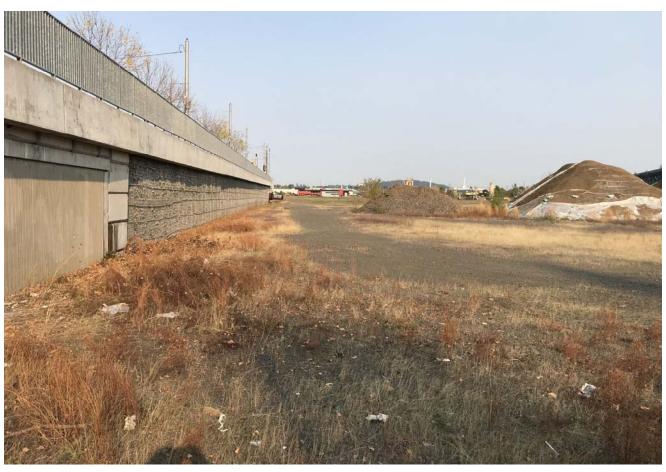
Gravel material stockpiles on upland cap

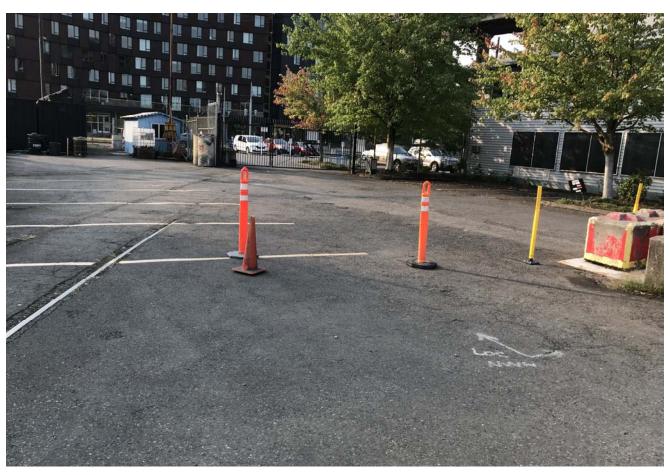
Operational area - Main access gate looking northwest

The gravel cap appears in good condition. No changes to the asphalt cap were observed. Equipment and materials were removed from the operational areas following closing of barge building operations. The barge building interior is secured and was not accessible during the inspection.
