Re: Annual Site Activity Summary Report—2018
Zidell Waterfront Property, 3121 SW Moody Avenue, Portland, OR
ECSI No. 689

2018 ANNUAL INSPECTION SUMMARY

RE: 2018 Annual Site Inspection Summary

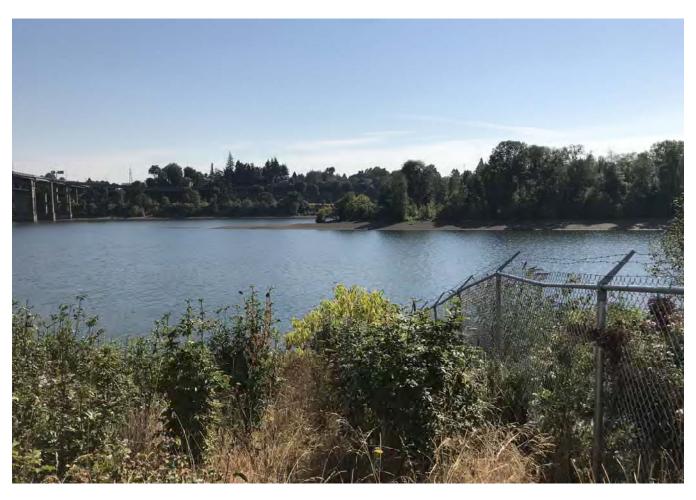
STA: 0+00 - Top of bank looking east.

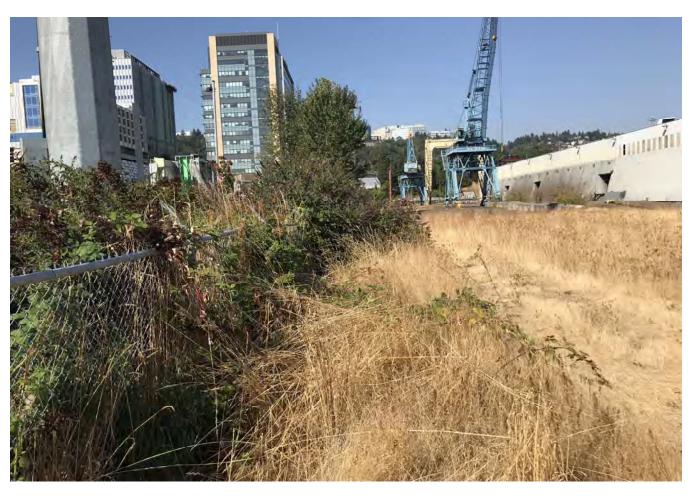
STA: 0+00 - Top of bank looking west.

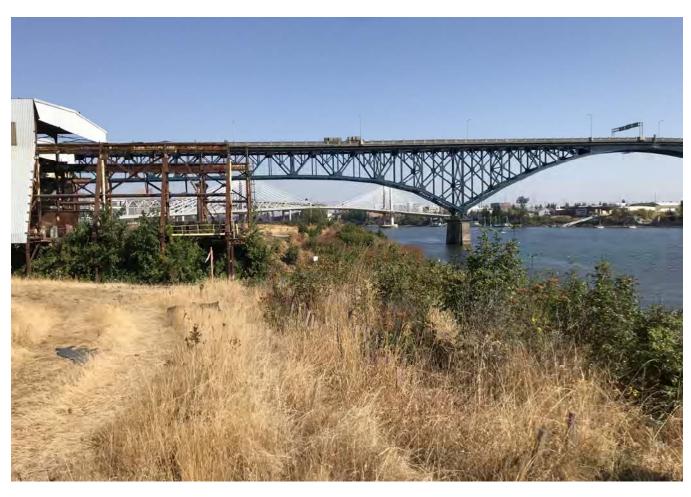
STA: 0+00 - Top of bank looking downstream.

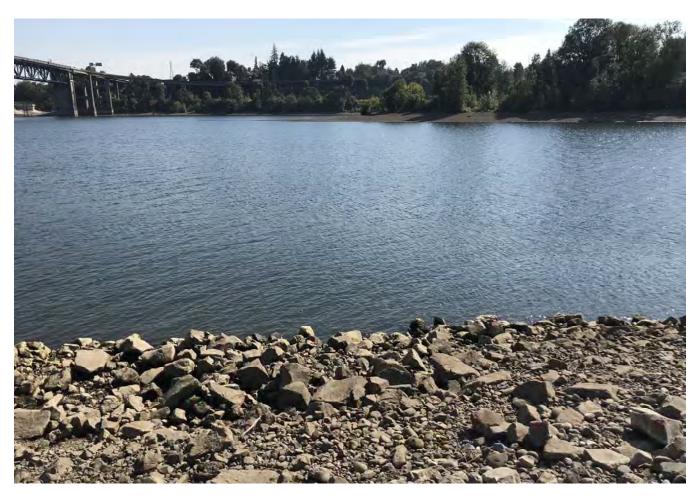
STA: 0+00 - Top of rock armor looking east.

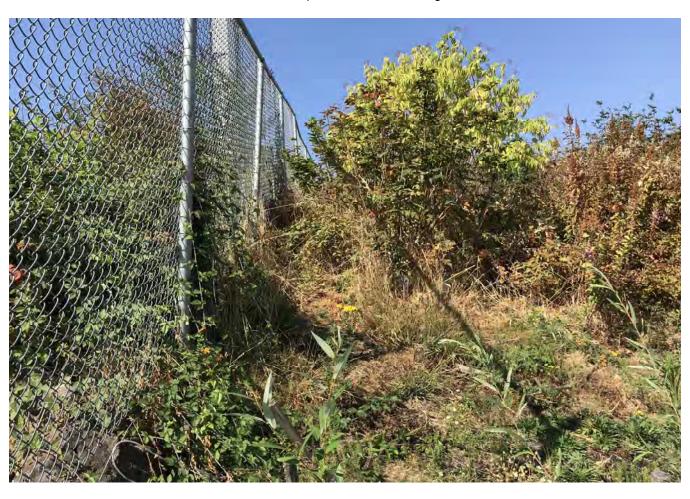
STA: 0+00 - Top of rock armor looking west.

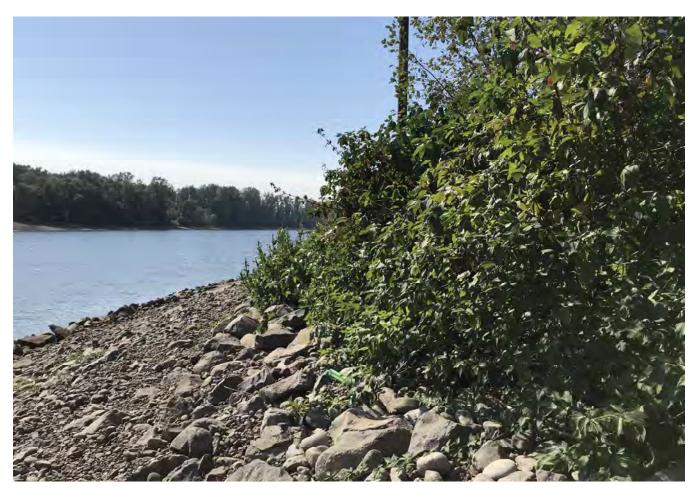
STA: 0+00 - Top of rock armor looking upstream.

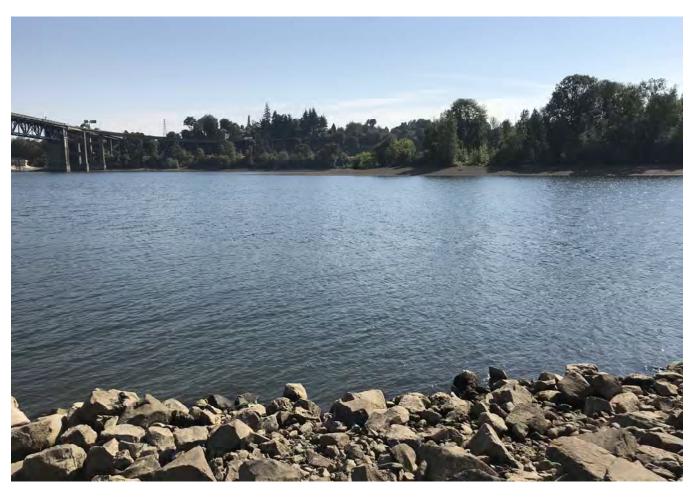
STA: 0+00 - Edge of water looking east.

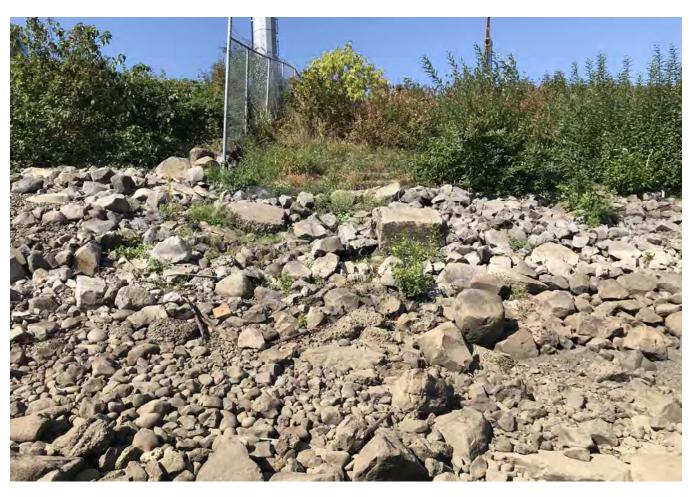
STA: 0+00 - Edge of water looking west.

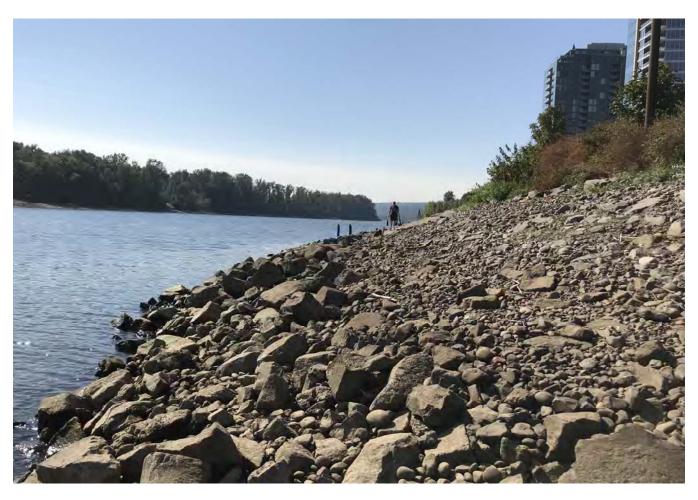
STA: 0+00 - Edge of water looking upstream.

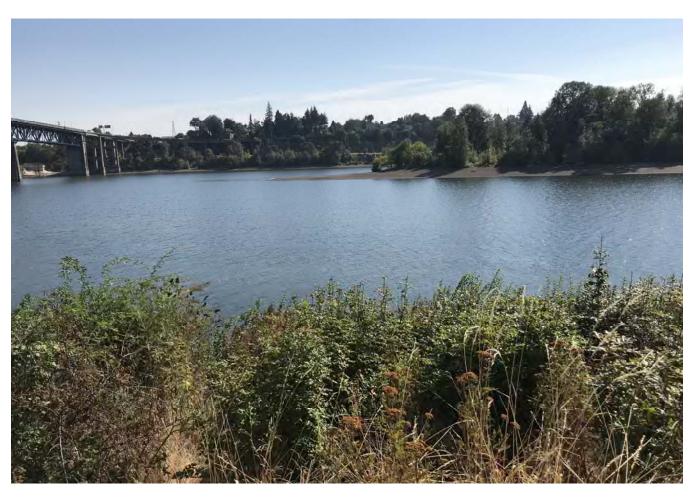
STA: 0+25 - Top of bank looking east.

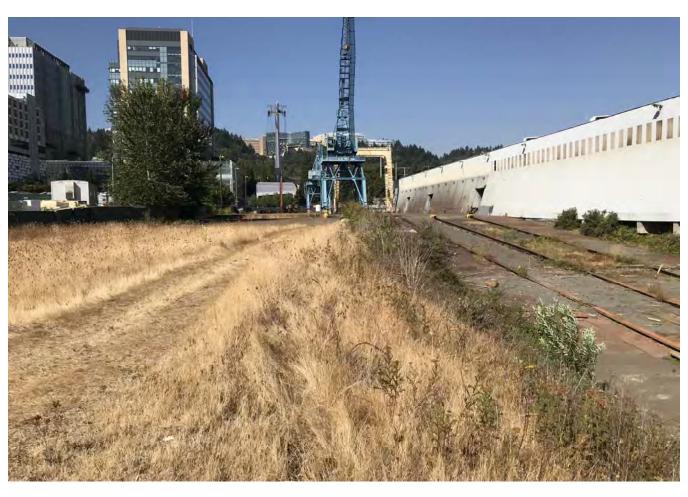
STA: 0+25 - Top of bank looking west.

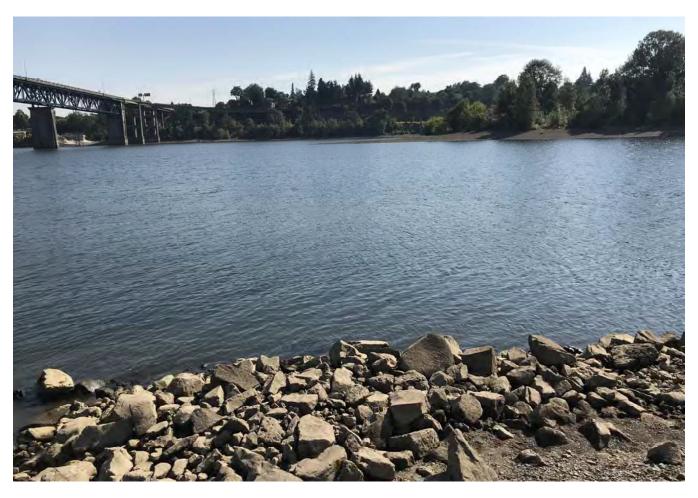
STA: 0+25 - Top of rock armor looking east.

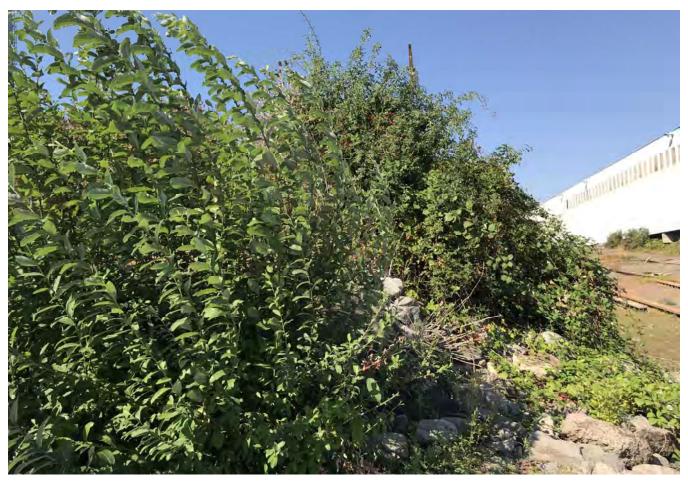
STA: 0+25 - Top of rock armor looking west.

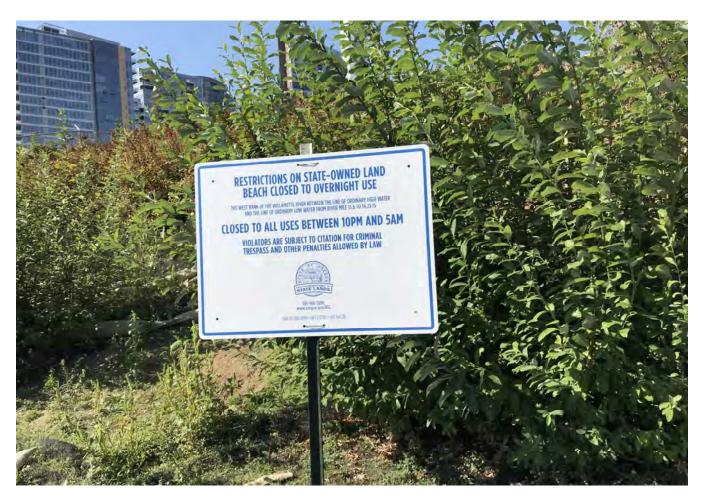
STA: 0+25 - Restriction sign posted at top of rock armor.

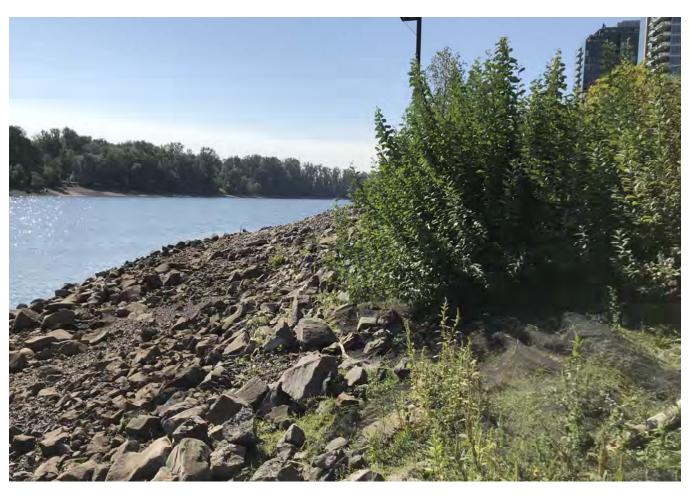
STA: 0+25 - Top of rock armor looking upstream.

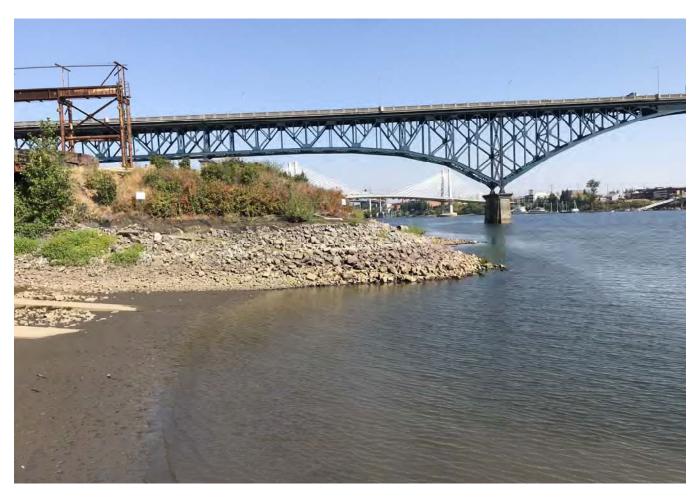
STA: 0+25 - Top of rock armor looking downstream.

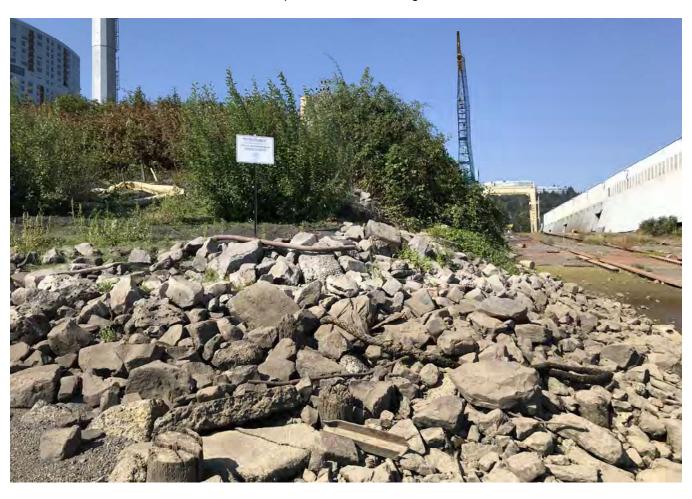
STA: 0+25 - Edge of water looking west.

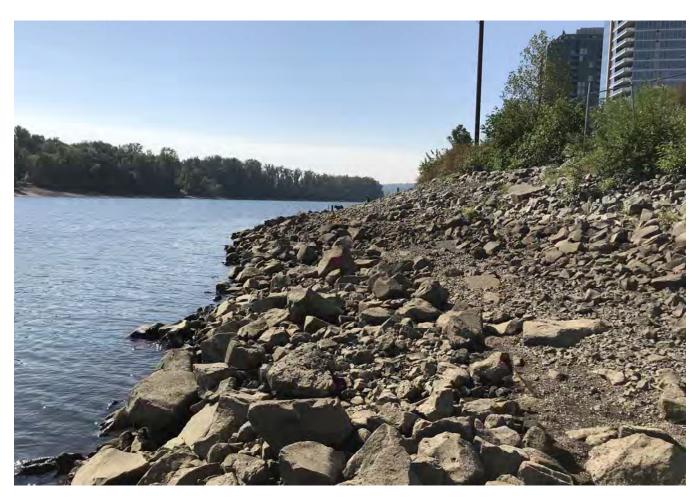
STA: 0+25 - Edge of water looking upstream.

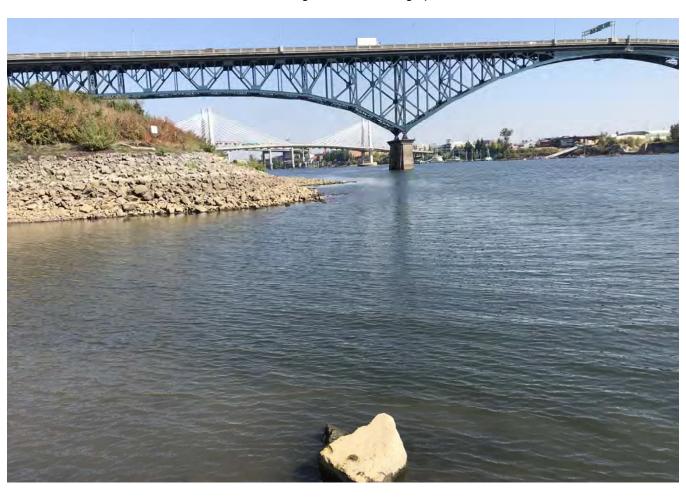
STA: 0+25 - Edge of water looking downstream.

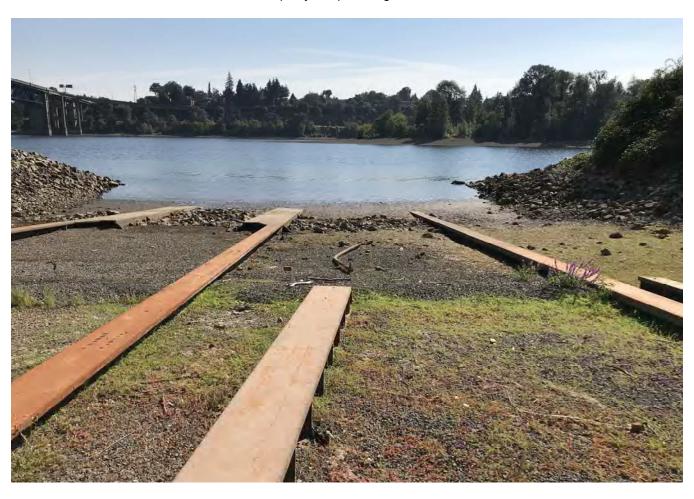
Slipway ramp looking east.

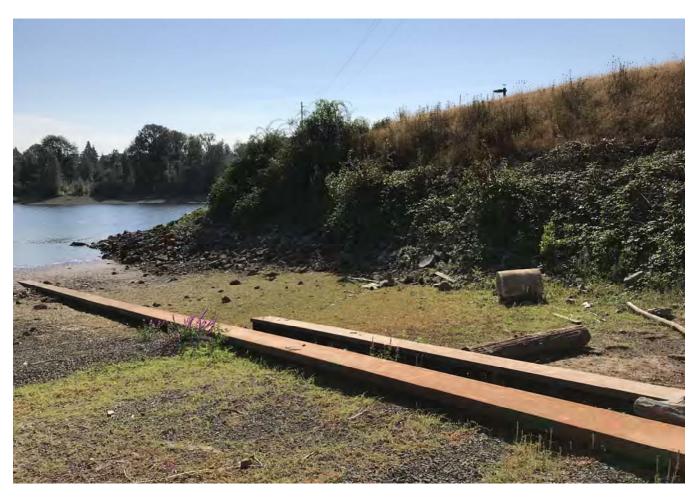
Slipway ramp looking southeast.

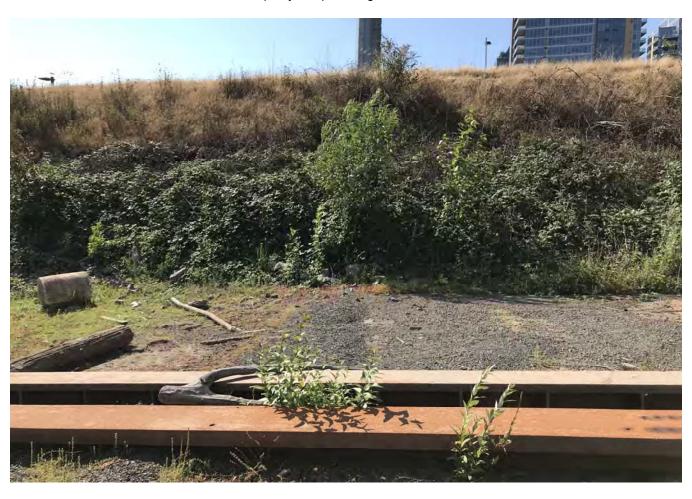
Slipway ramp looking south.

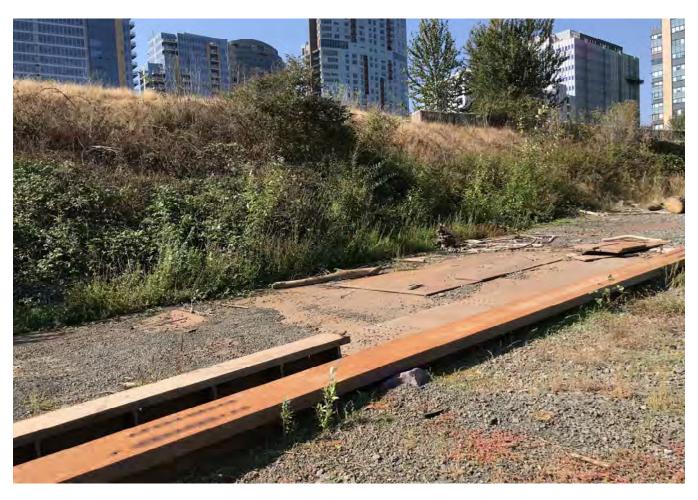
Slipway ramp looking southwest.

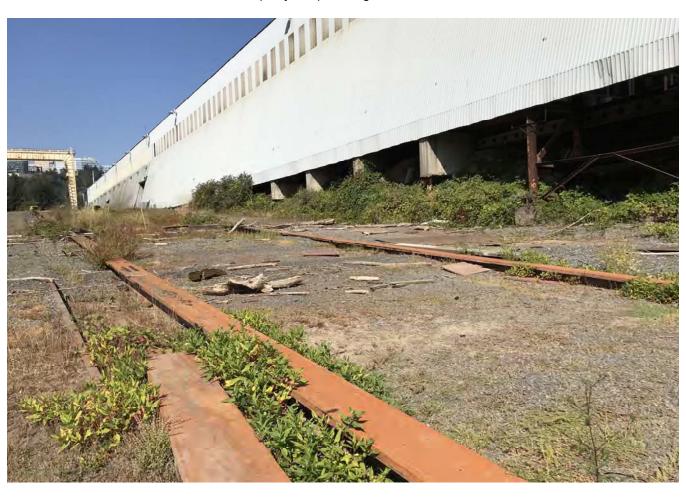
Slipway ramp looking northwest.

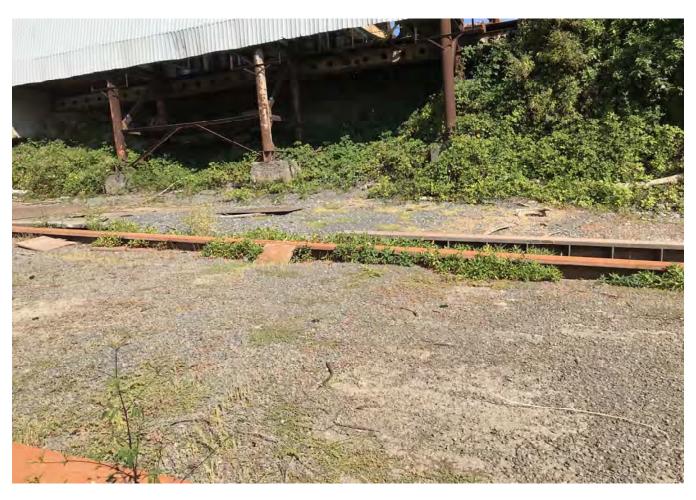
Barge building and slipway ramp looking north.

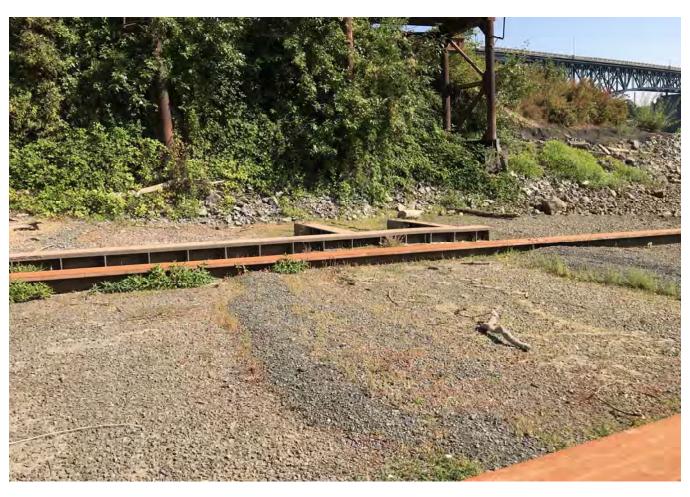
Slipway rails and barge building structure looking northeast.

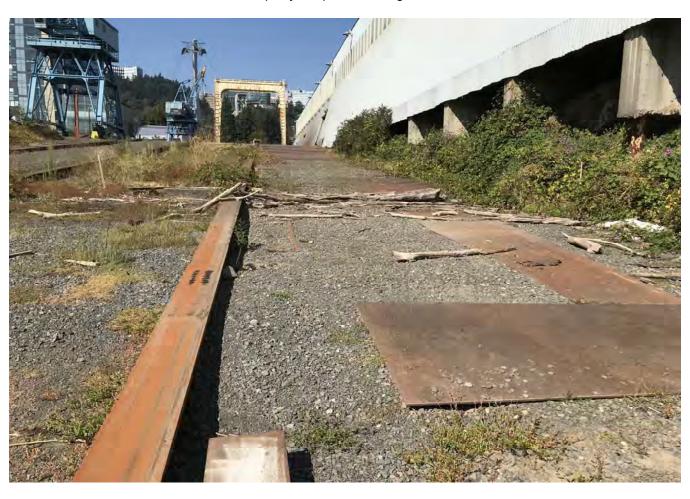
Sediment cap is in generally good condition; sediment build up was observed in the slipway.

Debris and gravel in slipway ramp looking west.

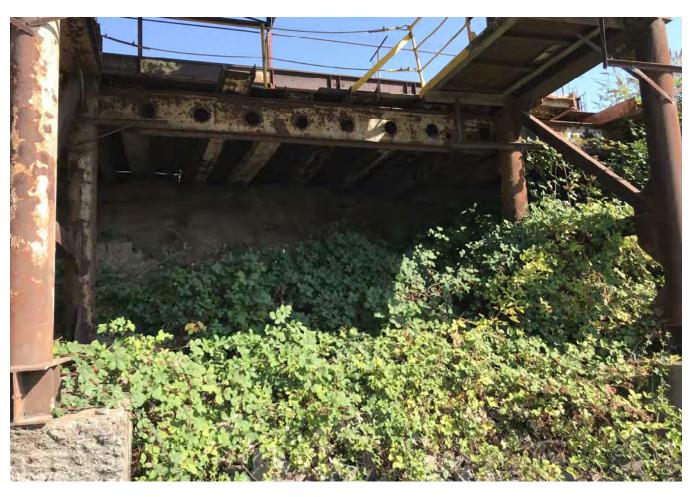
Underside of barge building structure looking north from slipway.

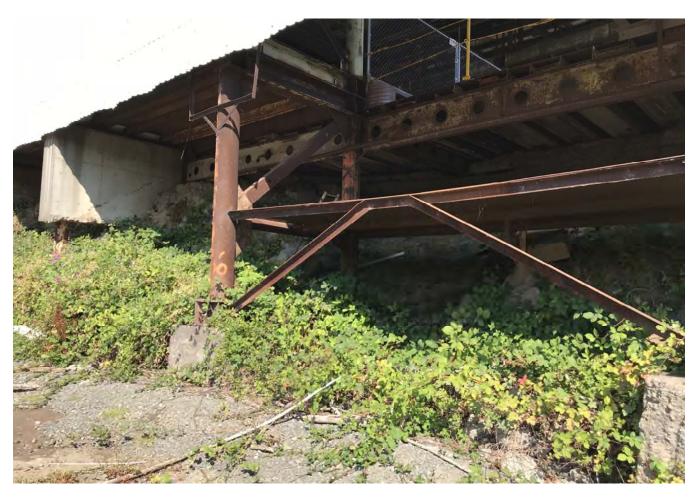
Underside of barge building structure looking northwest from slipway.

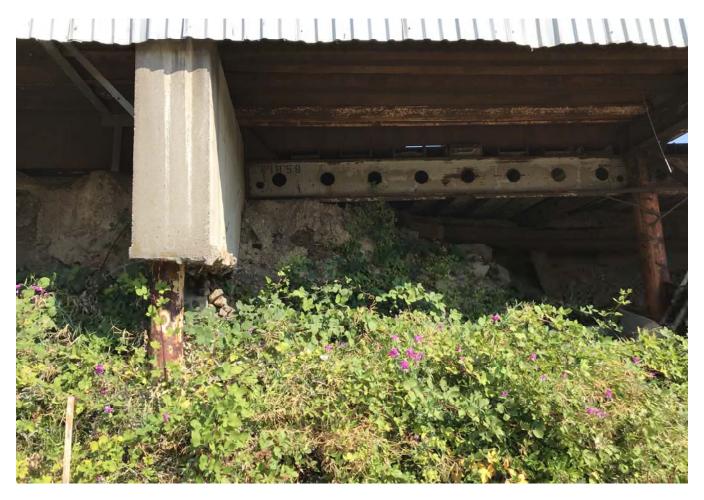
Underside of barge building structure looking north from slipway.

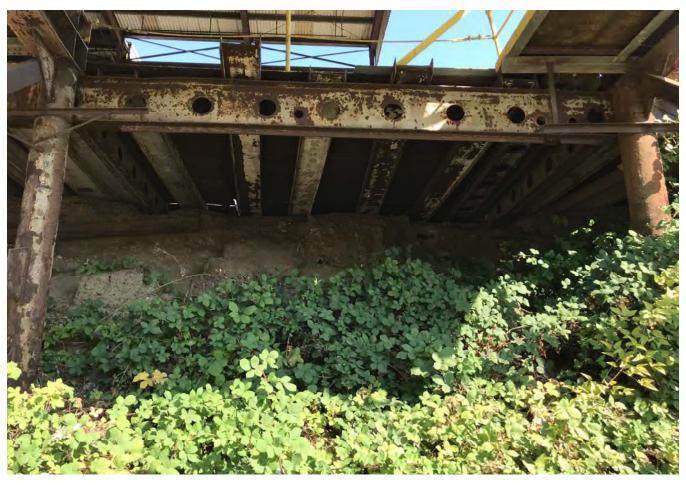
Underside of barge building structure looking north from slipway.

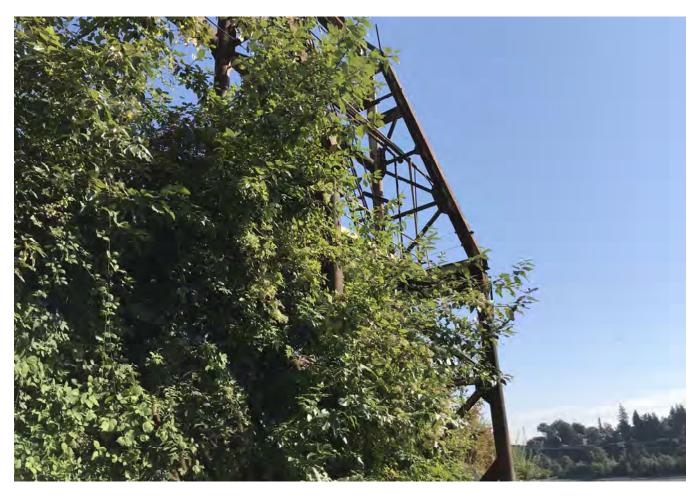
Vegetation growing beneath east end of barge building structure.

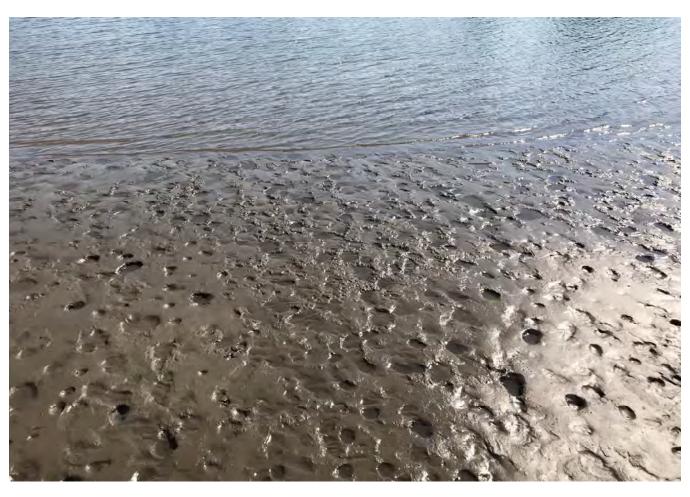
Sediment buildup in the slipway ramp looking east.

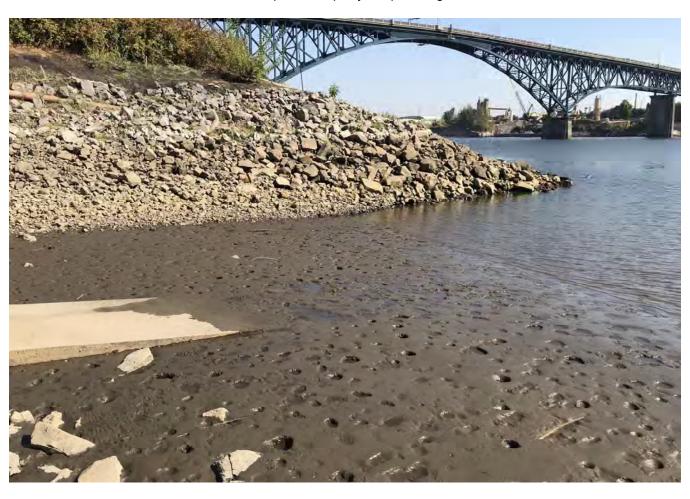
Sediment buildup in the slipway ramp looking northeast.

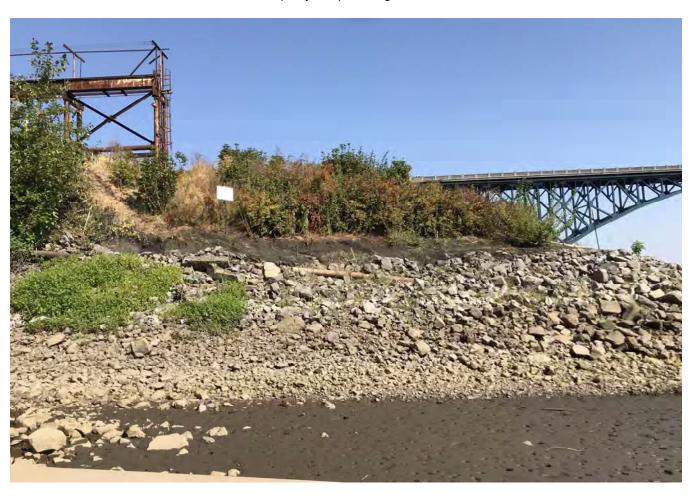
Bank vegetation above elevation of 15 feet is very dense. A few more spots were noted immediately above the top of the rock armor but no visible erosion. Overall, vegetative coverage is good. The north slipway reach (STA: 2+50 to 3+00) has some vegetation loss between elevations of 15 to 18 feet.

North slope of slipway ramp looking north.

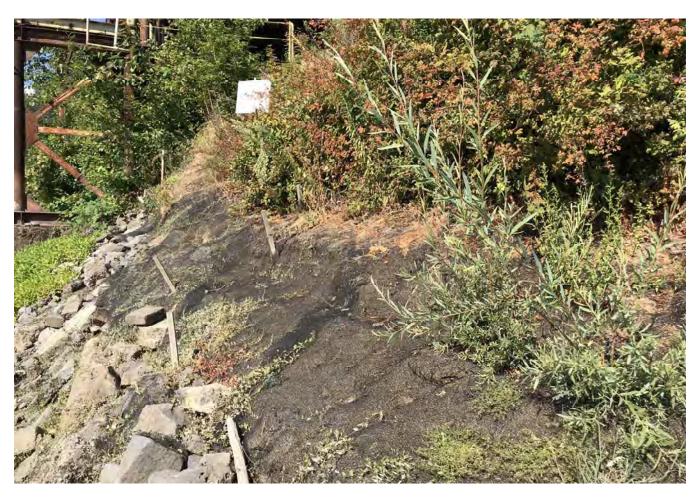
North slope of slipway ramp at top of rock armor looking west.

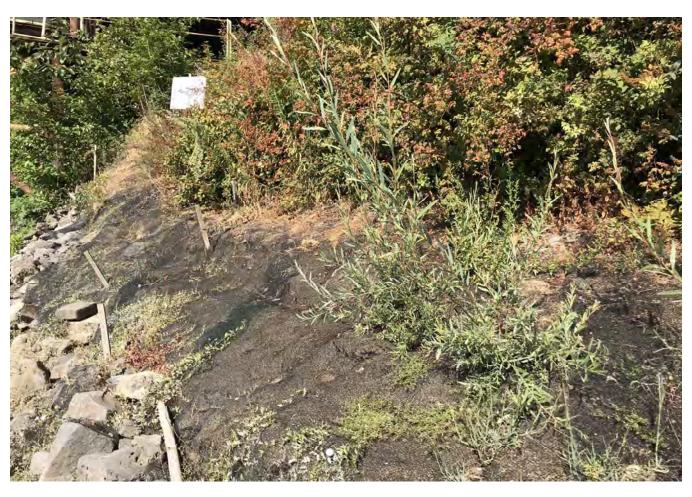
North slope of slipway ramp at top of rock armor looking west.

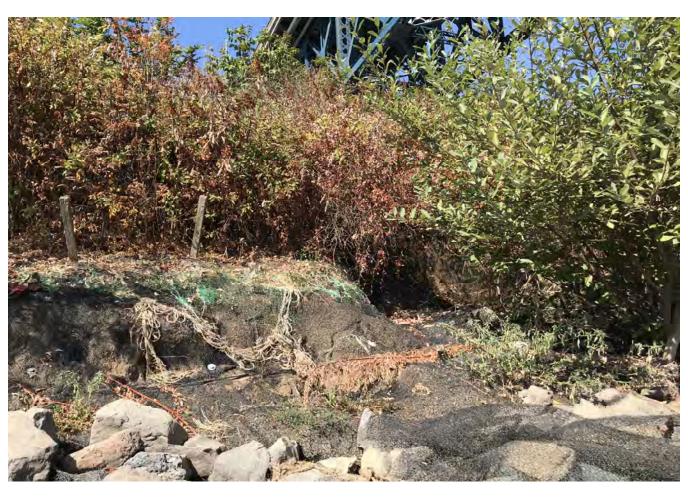
STA: 6+00 - Bank erosion above rock armor.

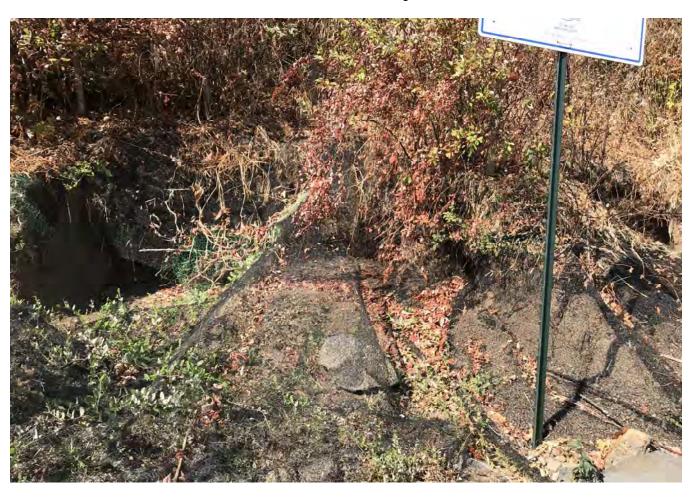
Spots of erosion were observed between elevations of 15 and 18 feet at STA: 6+25 and 6+75, coinciding with the north and south edges of the Ross Island Bridge. Bank armor appears stable.

STA: 6+25 - Bank erosion above top of rock armor.

- 1. Bank repair is planned for the erosion areas noted in the North Bridge and Downstream Reaches. This work should be completed during low water to ensure access and better work conditions. We anticipate that this will address all significant areas with observed erosion.
- 2. Continue to monitor vegetation on the lower bank areas of the Downstream Reach. Continued irrigation of the bank vegetation, primarily newer plantings, should continue during dry periods in summer and fall.
- 3. Reinspect vegetation in the lower elevations of the Slipway and Bridge Reaches

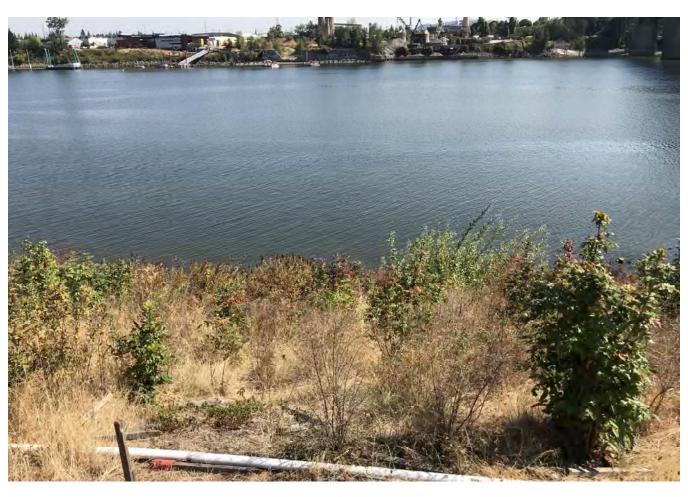
Bank erosion was observed between the top of the rock armor and elevation above 18 feet. Some demarcation fabric is visible along the top of the rock armor enhancement area. Some rock armor from the armor enhancement area appears to have moved from the bank to approximately 25 feet over the sediment cap.

STA: 7+50 - Bank erosion over top of rock armor.

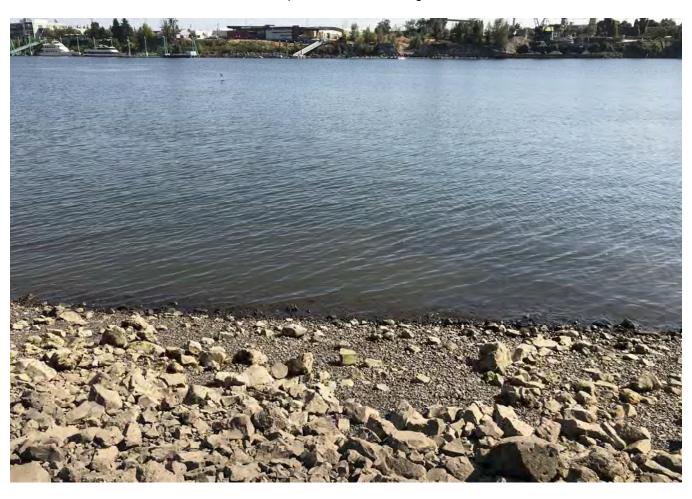
STA: 11+00 - Bottom of rock armor looking east.

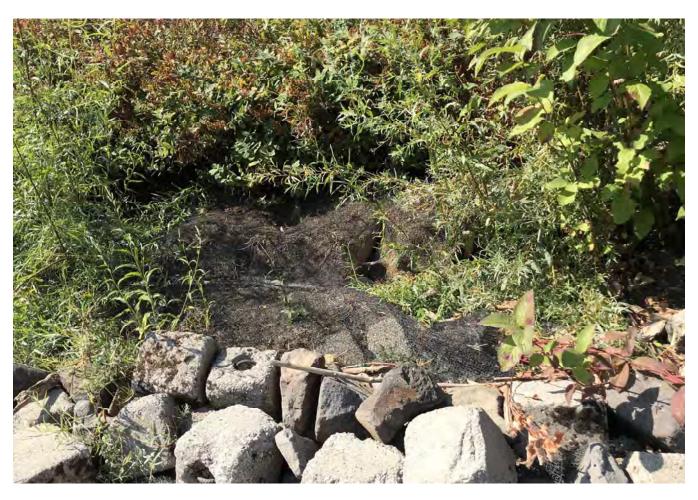
STA: 11+00 - Bottom of rock armor looking west.

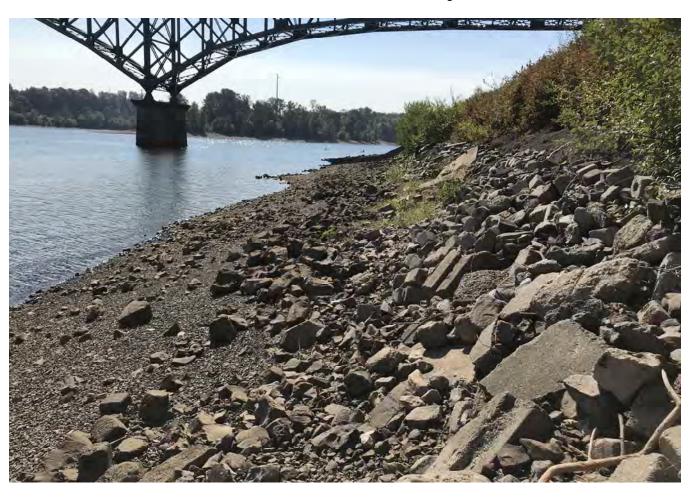
STA: 11+00 - Bottom of rock armor looking upstream.

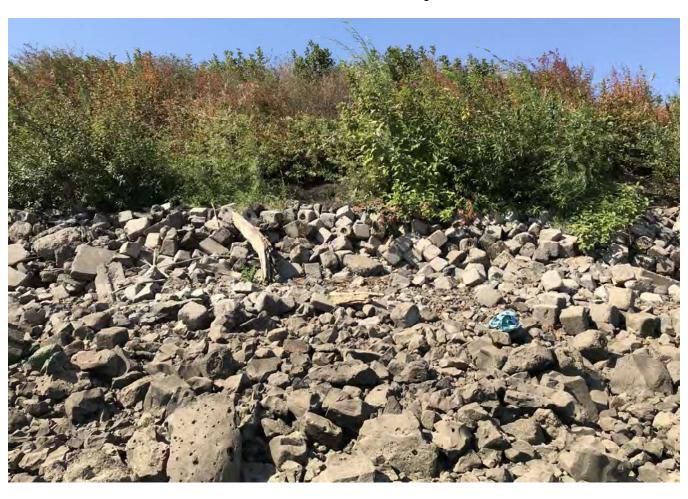
STA: 11+00 - Edge of water looking west.

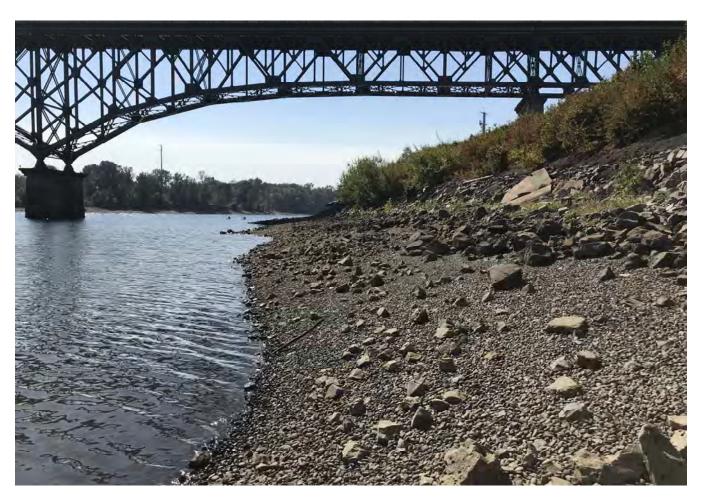
STA: 11+00 - Edge of water looking upstream.

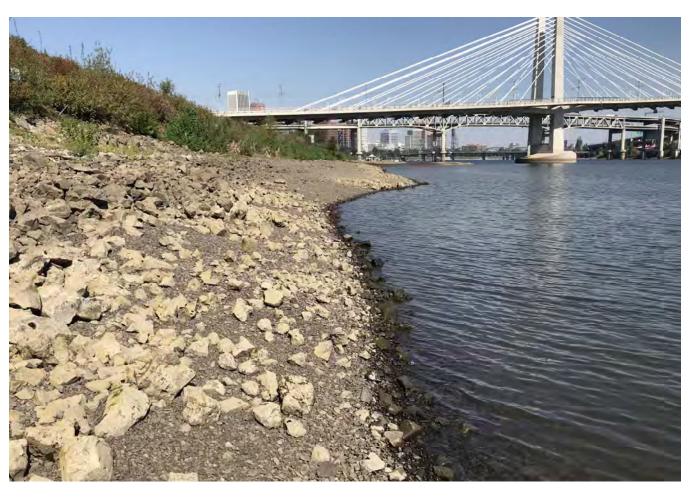
STA: 11+00 - Edge of water looking downstream.

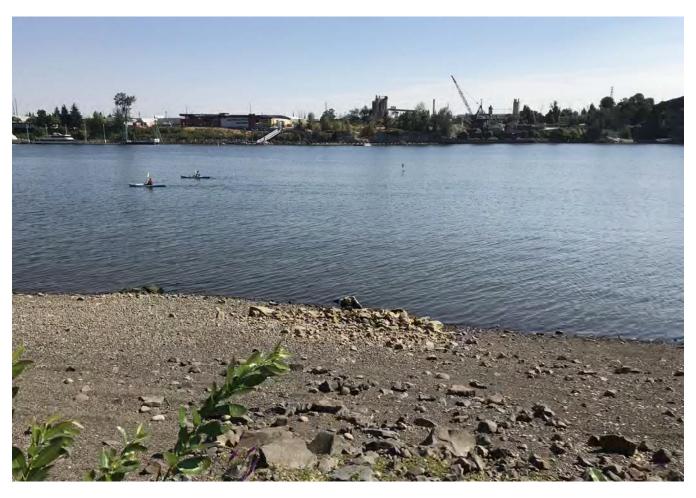
STA: 11+50 - Toe of slope looking east.

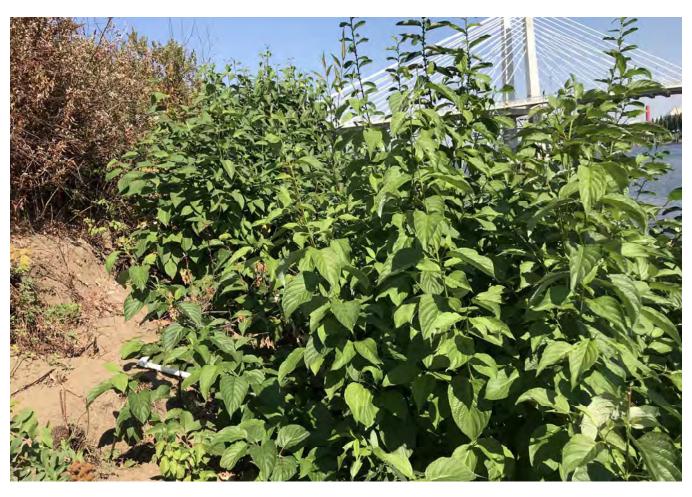
STA: 11+50 - Vegetation on lower bank looking north.

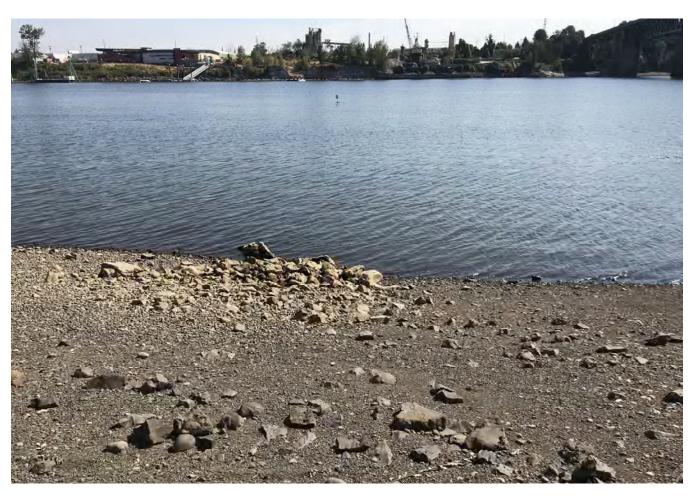
STA: 11+50 - Toe of slope looking east.

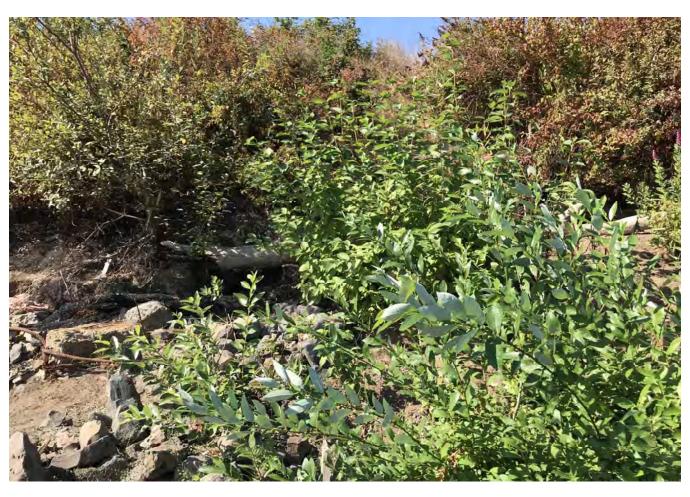
STA: 11+50 - Toe of slope looking west.

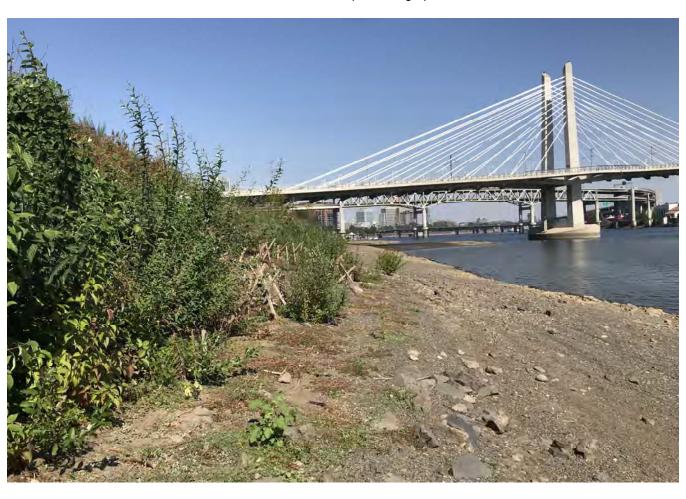
STA: 11+50 - Toe of slope looking downstream.

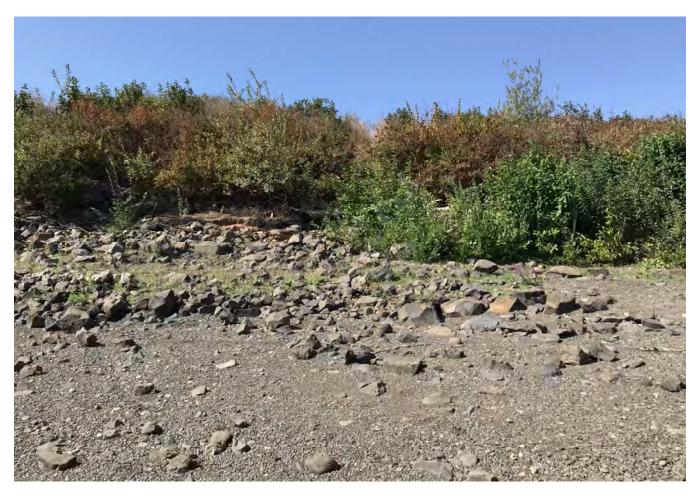
STA: 11+50 - Edge of water looking west.

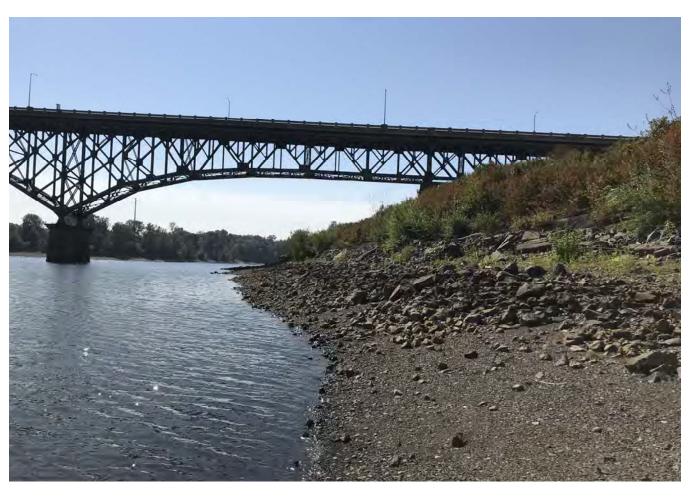
STA: 11+50 - Edge of water looking upstream.

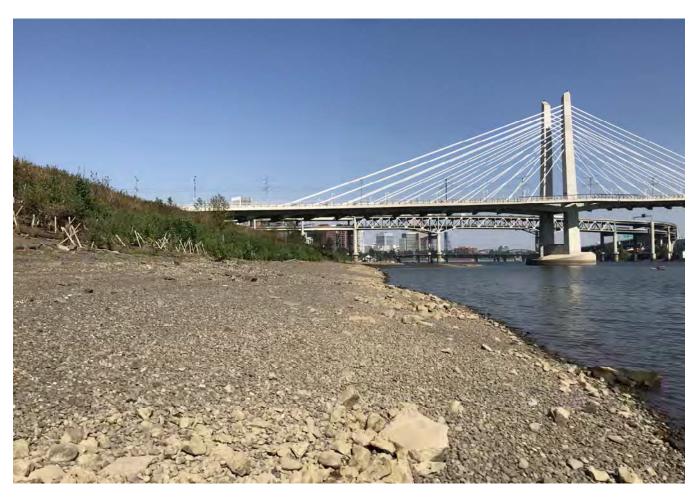
STA: 11+50 - Edge of water looking downstream.

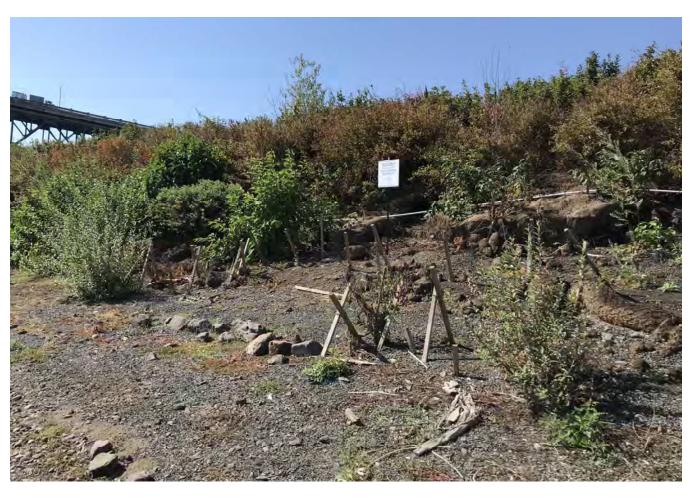
STA: 12+50 - Bank erosion and access restriction sign looking southwest.

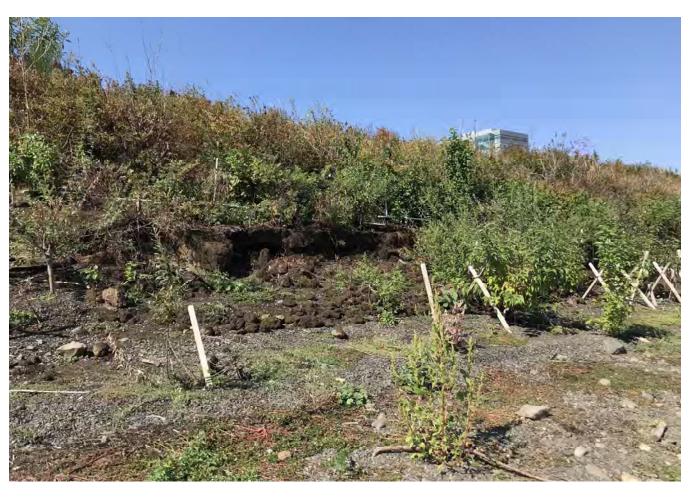
STA: 12+75 - Bank erosion on lower bank looking northwest.

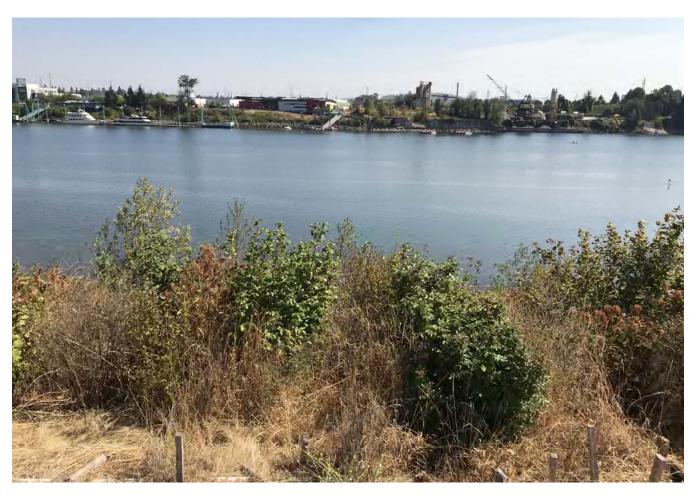
STA: 13+00 - Top of bank looking east.

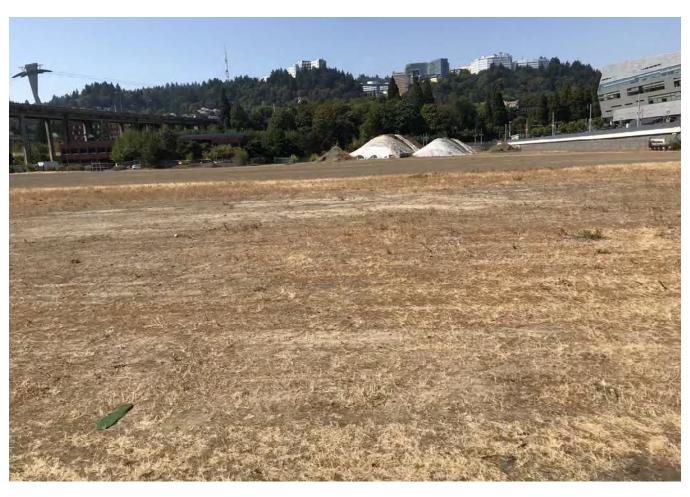
STA: 13+00 - Top of bank looking west.

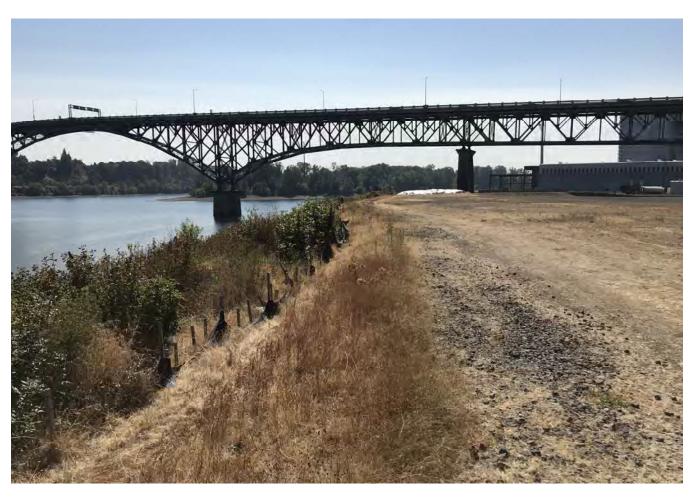
STA: 13+00 - Top of bank looking upstream.

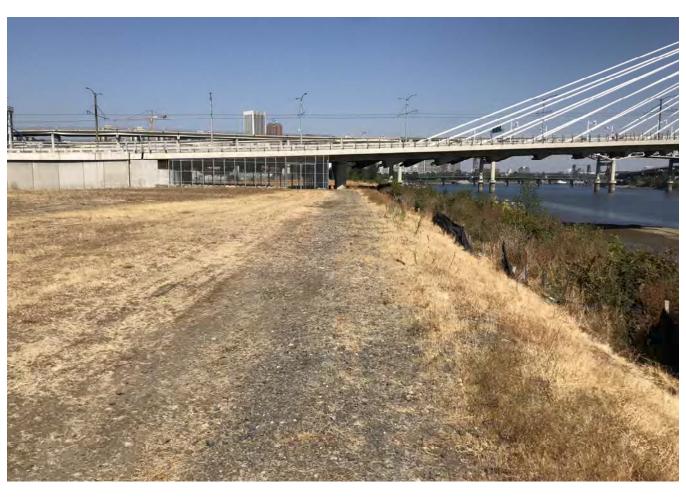
STA: 13+00 - Top of bank looking downstream.

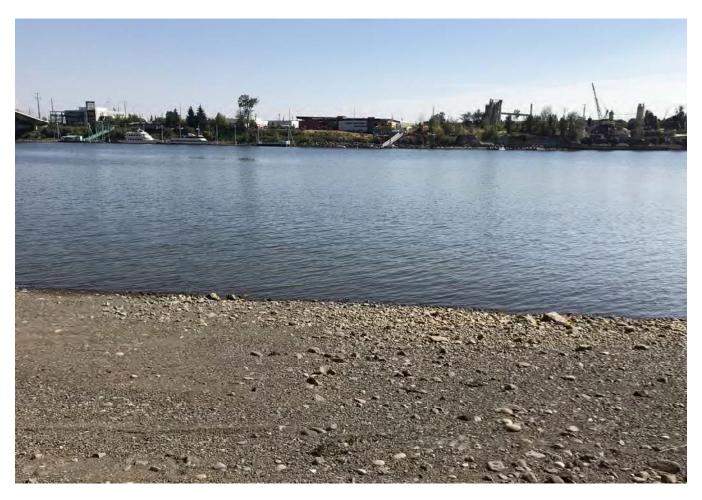
STA: 13+00 - Toe of slope looking east.

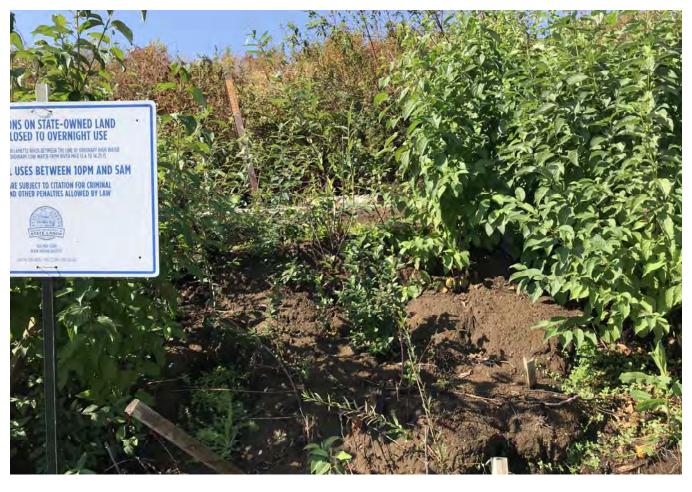
STA: 13+00 - Toe of slope looking west.

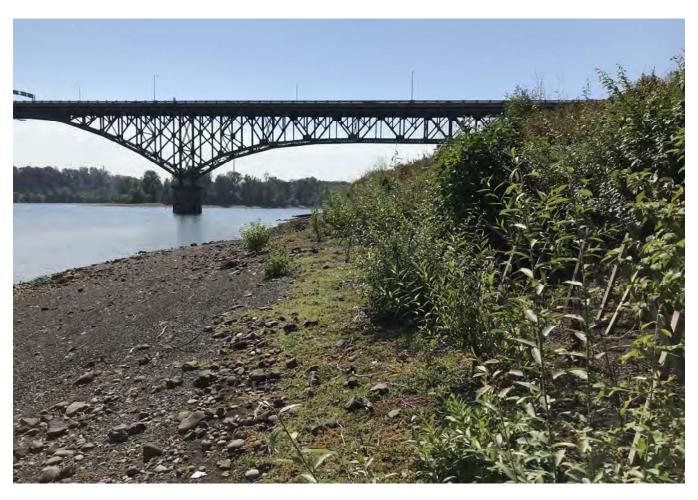
STA: 13+00 - Toe of slope looking upstream.
