Re: Annual Site Activity Summary Report—2018
Zidell Waterfront Property, 3121 SW Moody Avenue, Portland, OR
ECSI No. 689

2018 ANNUAL INSPECTION SUMMARY

RE: 2018 Annual Site Inspection Summary

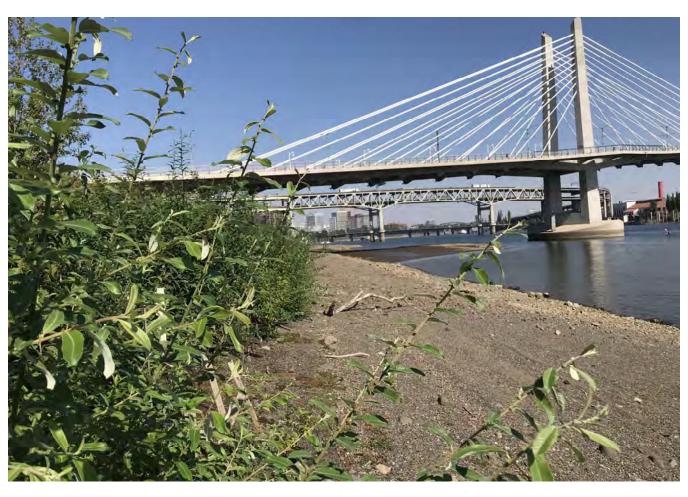
STA: 13+00 - Toe of slope looking downstream.

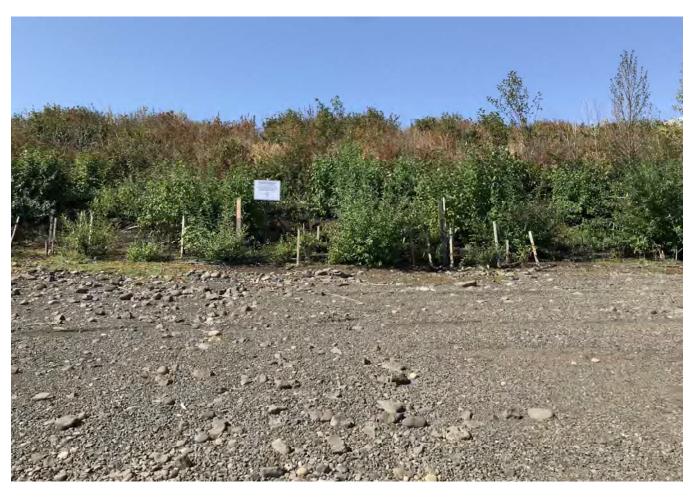
STA: 13+00 - Edge of water looking west.

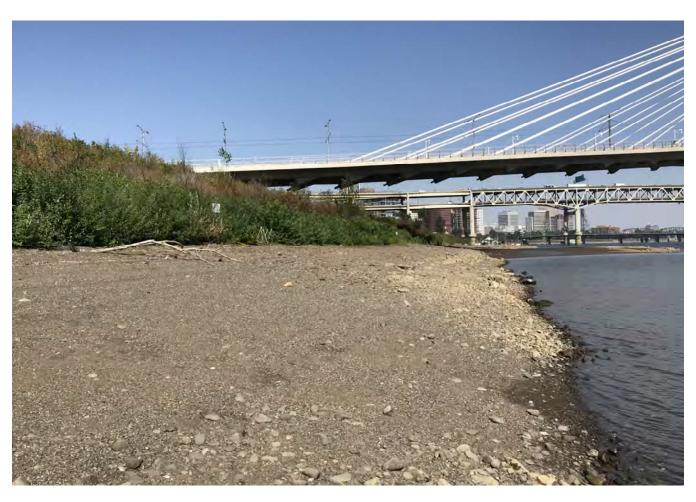
STA: 13+00 - Edge of water looking downstream.

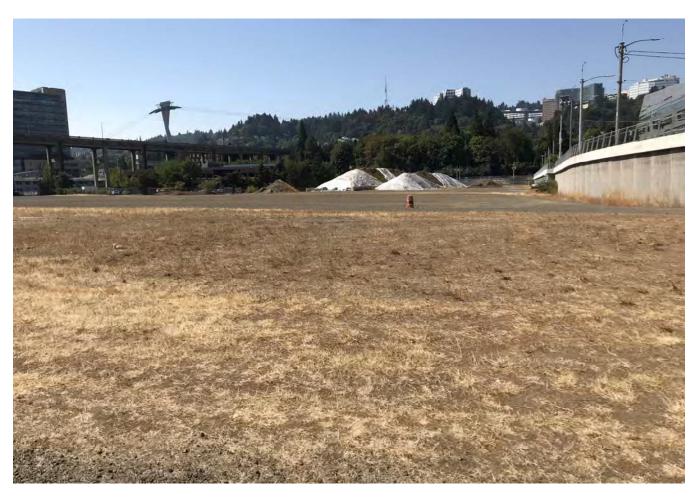
STA: 15+00 - Top of bank looking west.

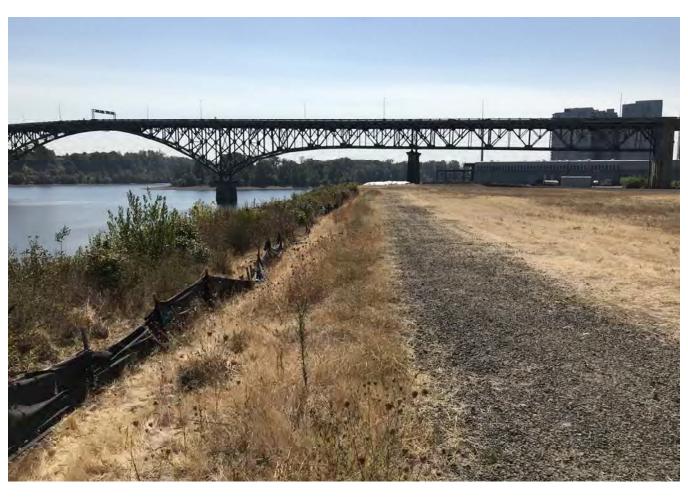
STA: 15+00 - Top of bank looking upstream.

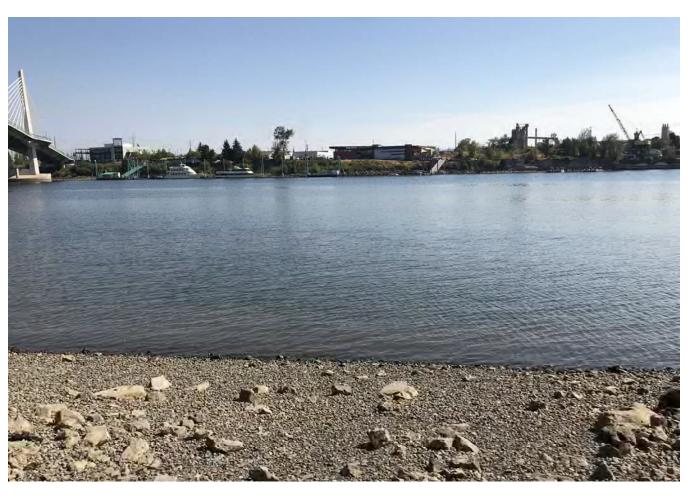
STA: 15+00 - Toe of slope looking east.

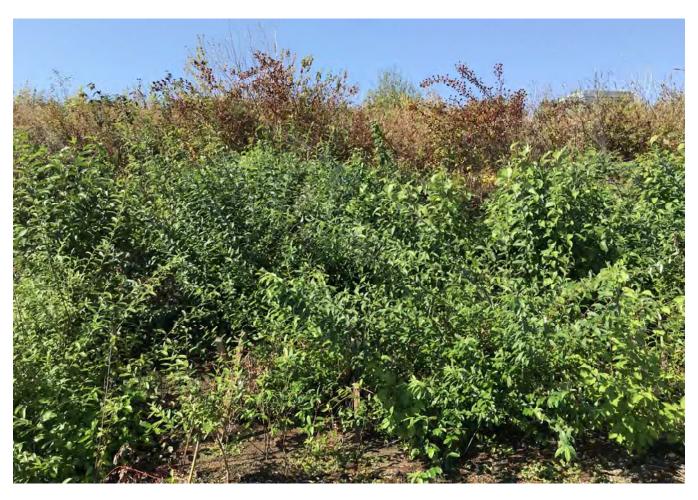
STA: 15+00 - Toe of slope looking west.

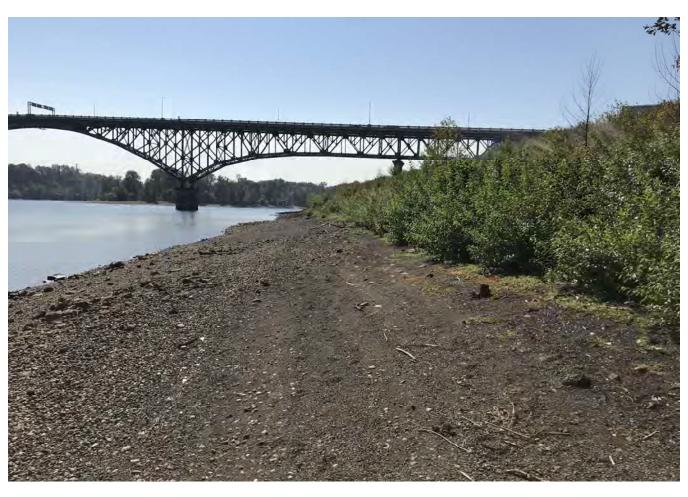
STA: 15+00 - Toe of slope looking upstream.

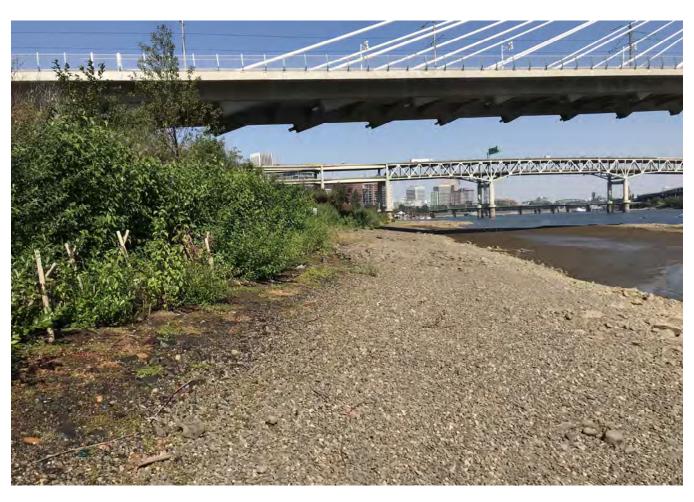
STA: 15+00 - Toe of slope looking downstream.

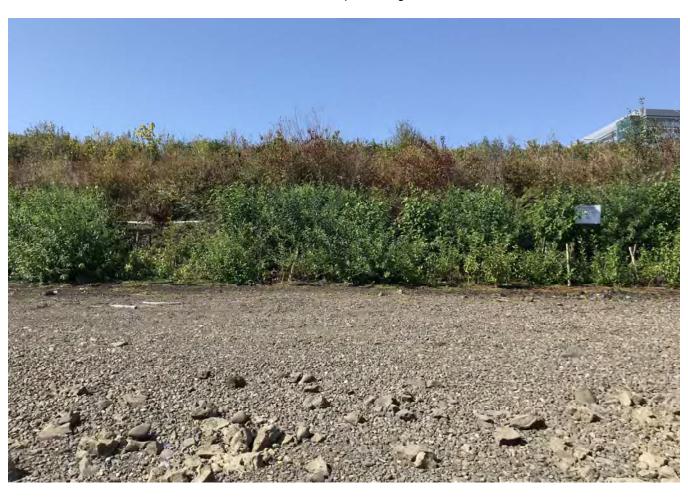
STA: 15+00 - Edge of water looking west.

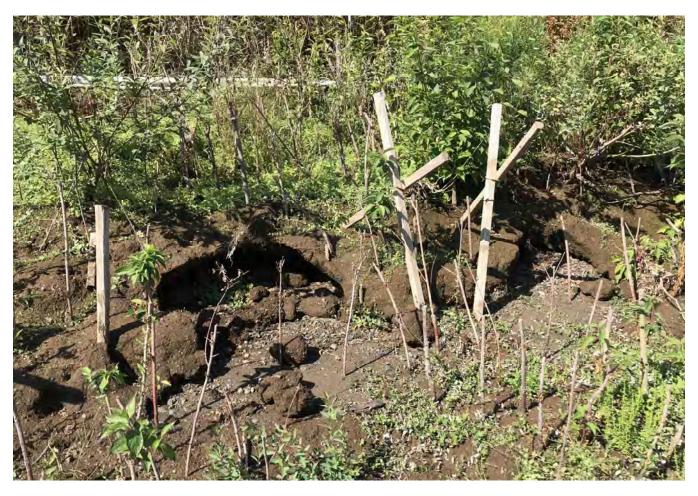
STA: 18+50 - Erosion and vegetation loss on lower bank.

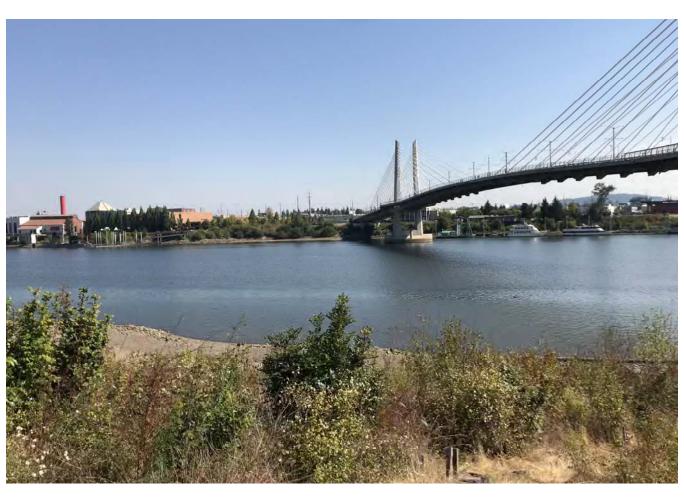
STA: 18+50 - Undercut erosion on lower bank.

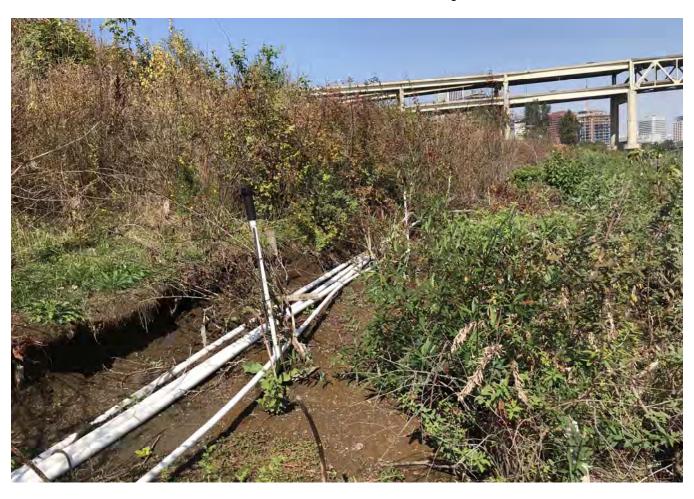
STA: 20+50 - Erosion on lower bank around irrigation lines.

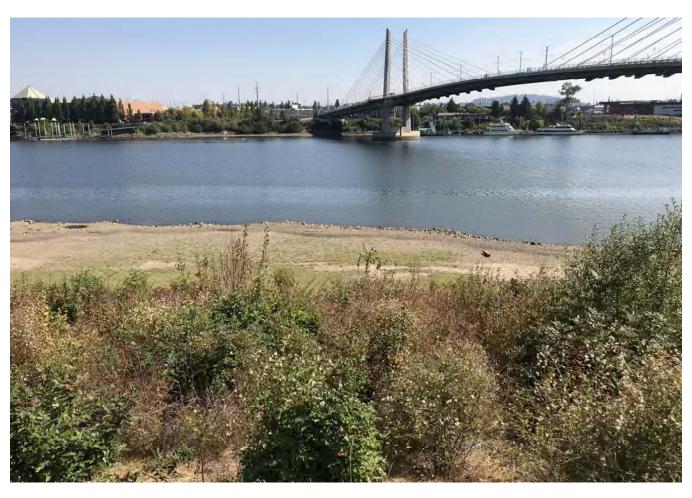
STA: 20+50 - Erosion on lower bank around irrigation lines.

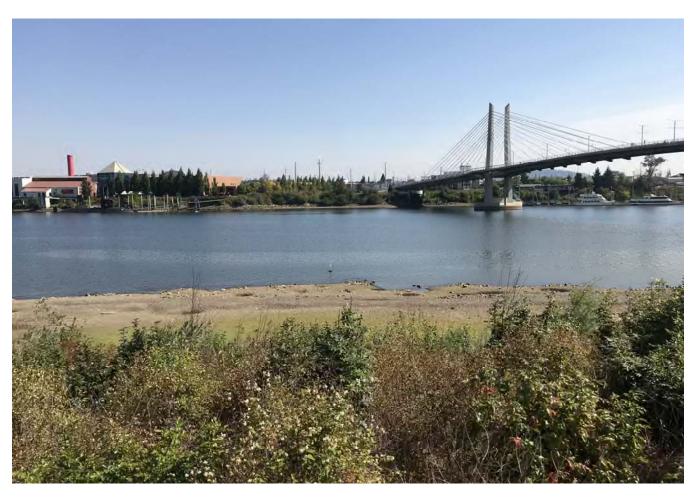
STA: 23+00 - Plant cage growth.

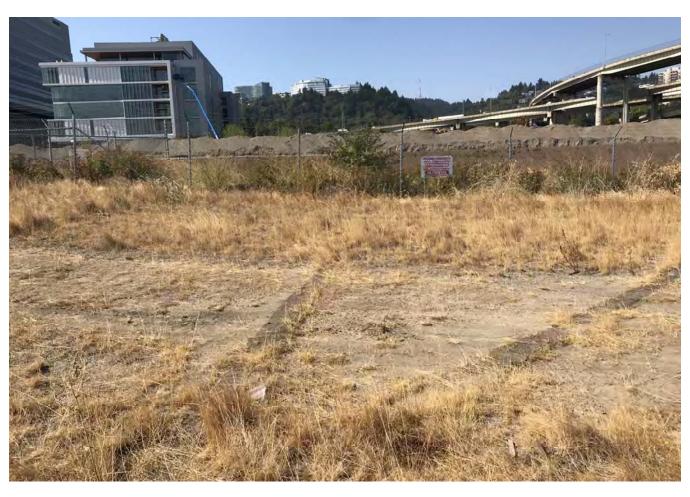
STA: 23+50 - Top of bank looking east.

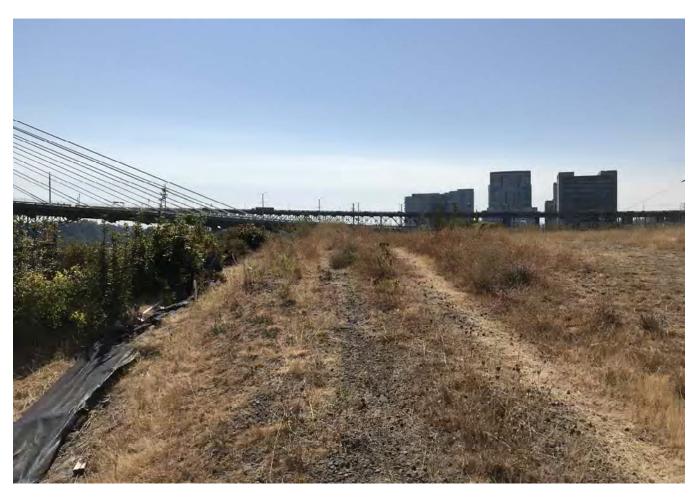
STA: 23+50 - Top of bank looking west.

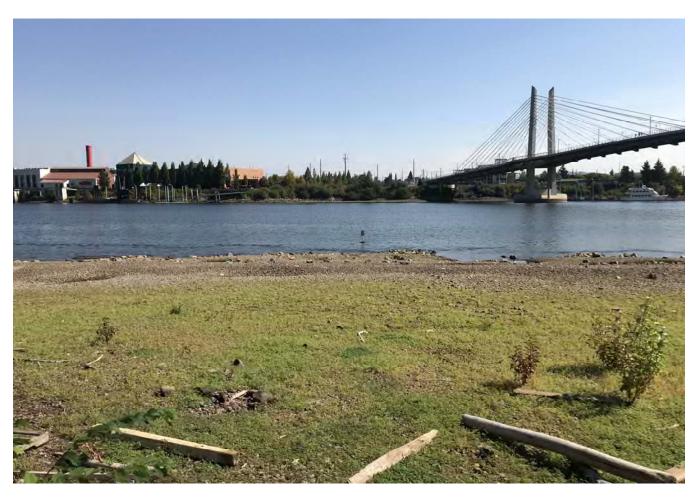
STA: 23+50 - Top of bank looking downstream.

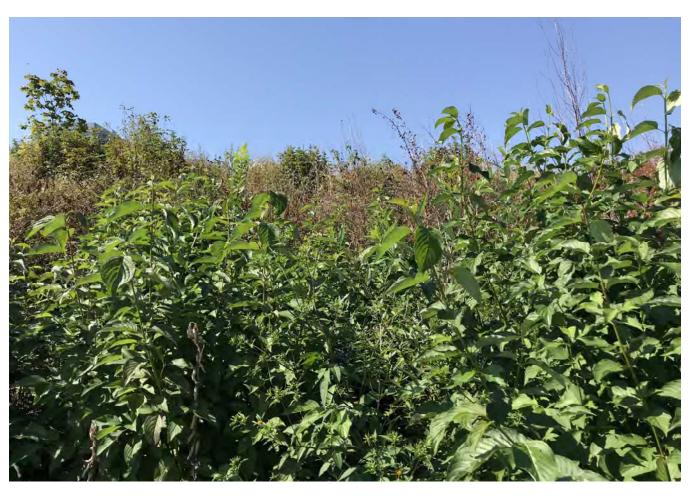
STA: 23+50 - Toe of slope looking east.

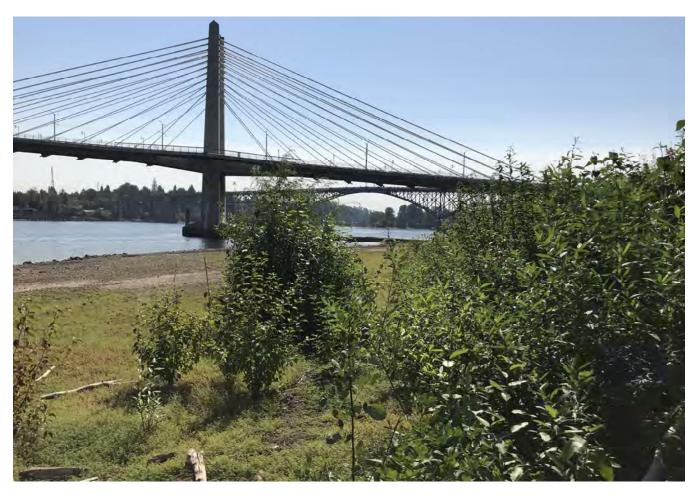
STA: 23+50 - Toe of slope looking west.

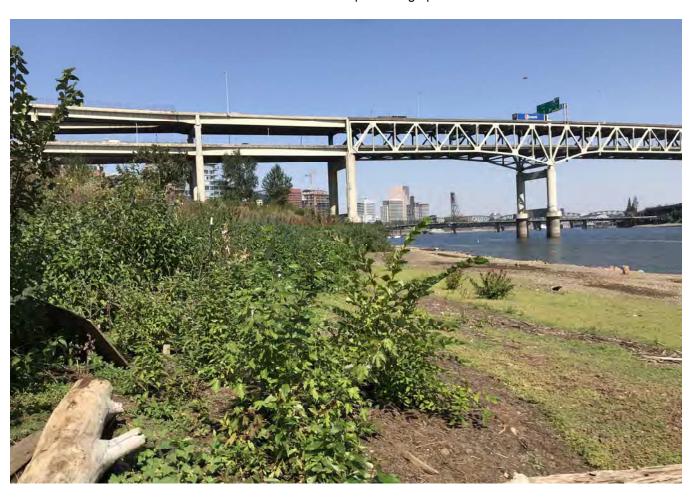
STA: 23+50 - Toe of slope looking upstream.

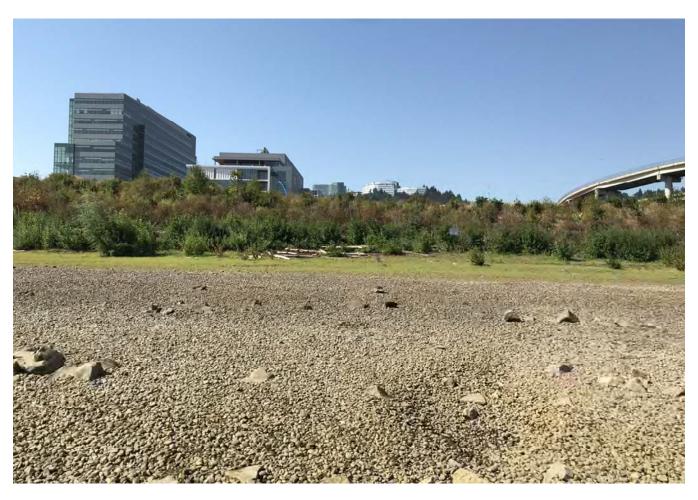
STA: 23+50 - Toe of slope looking downstream.

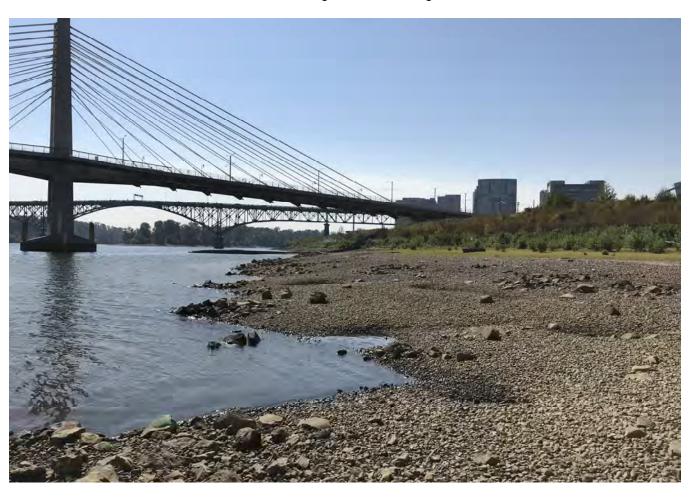
STA: 23+50 - Edge of water looking west.

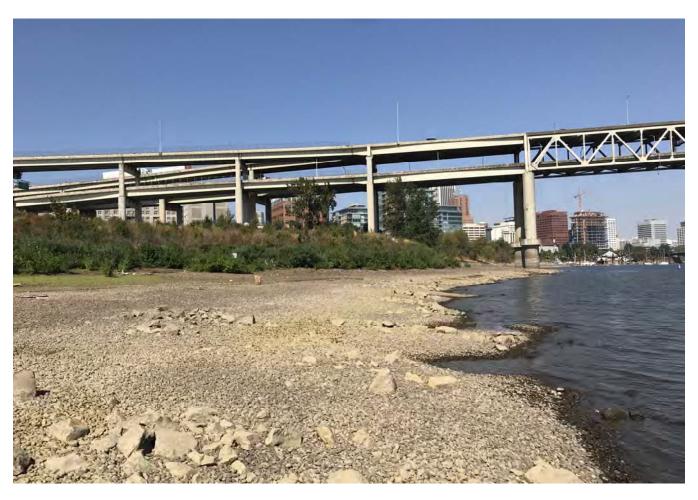
STA: 23+50 - Edge of water looking upstream.

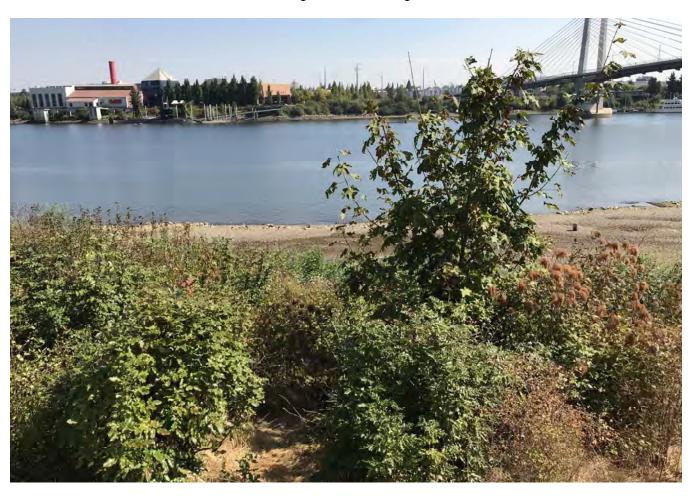
STA: 23+50 - Edge of water looking downstream.

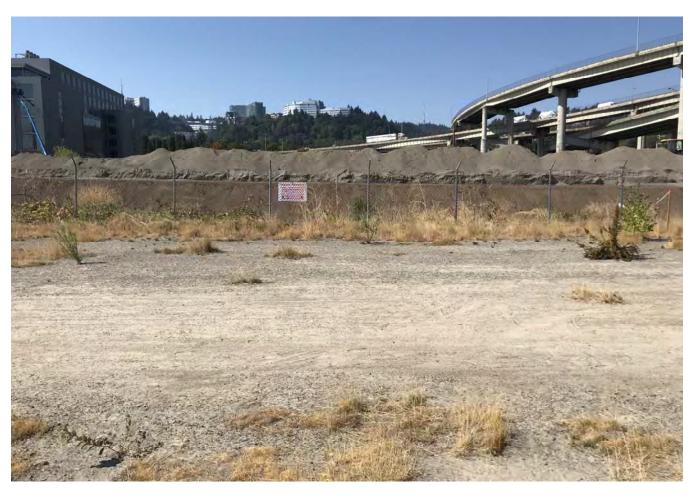
STA: 25+50 - Top of bank looking east.

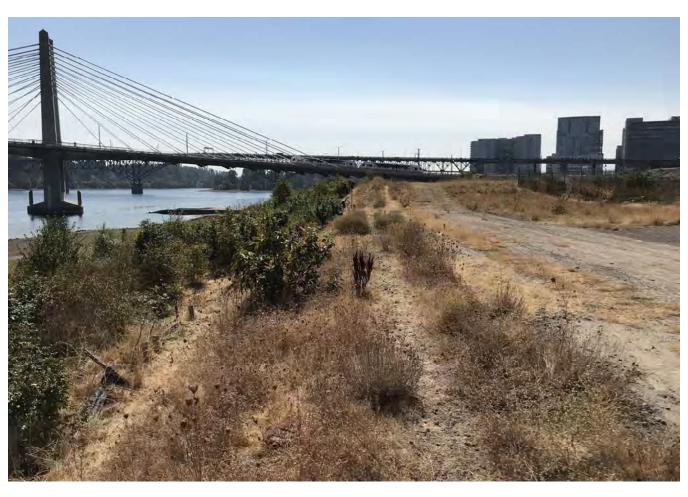
STA: 25+50 - Top of bank looking west.

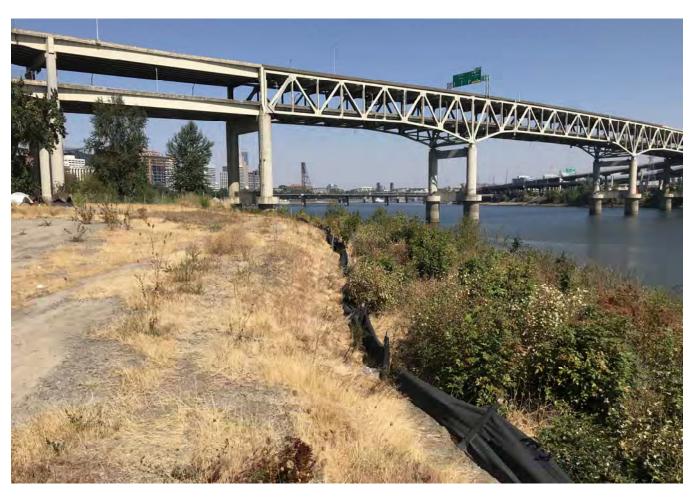
STA: 25+50 - Top of bank looking upstream.

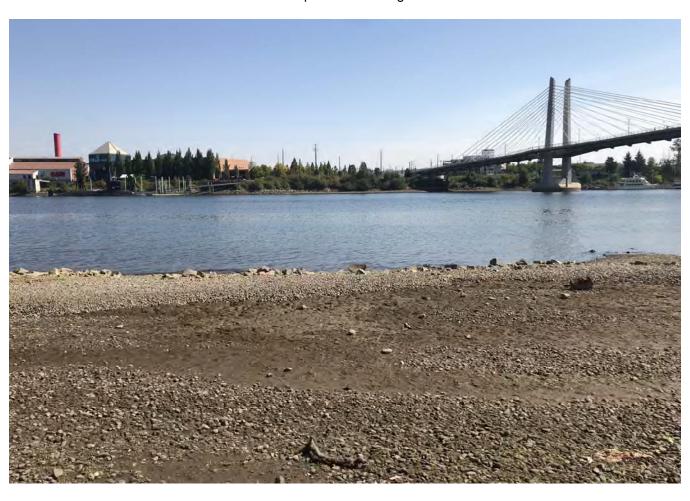
STA: 25+50 - Top of bank looking downstream.

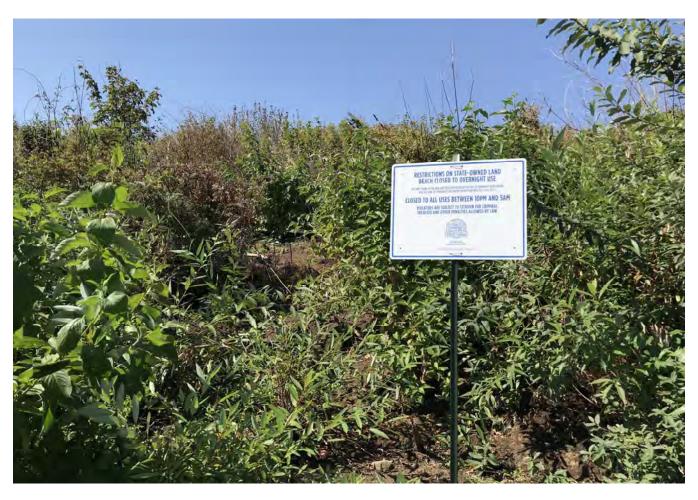
STA: 25+50 - Toe of slope looking east.

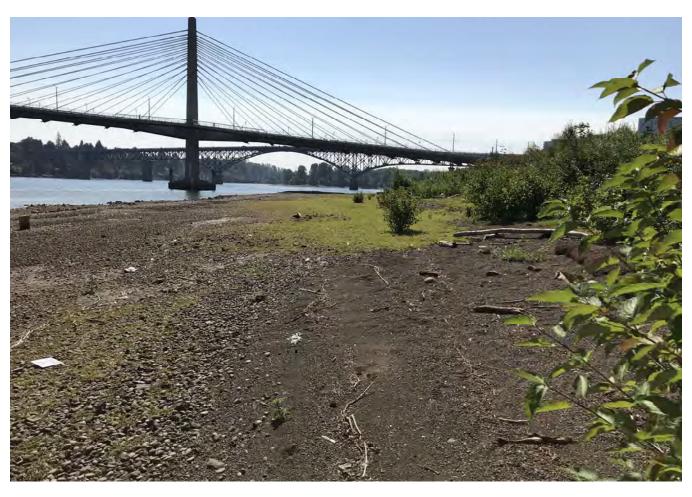
STA: 25+50 - Toe of slope looking west.

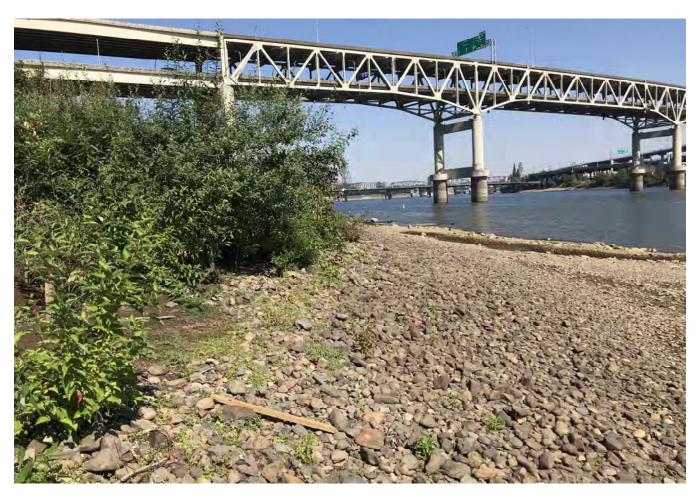
STA: 25+50 - Toe of slope looking upstream.

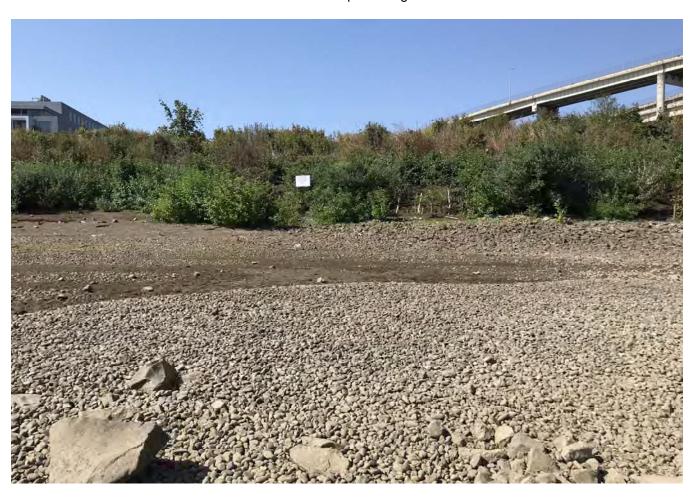
STA: 25+50 - Toe of slope looking downstream.

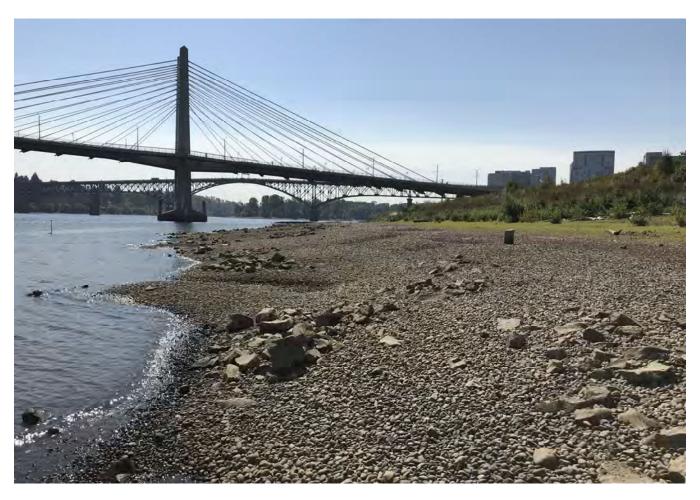
STA: 25+50 - Edge of water looking west.

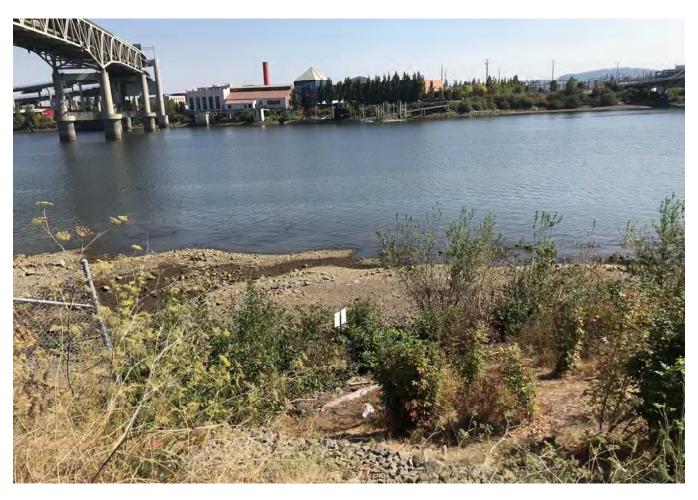
STA: 25+50 - Edge of water looking downstream.

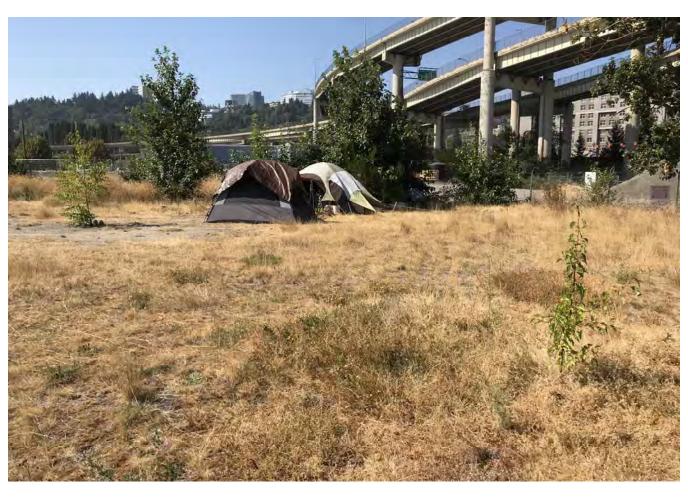
STA: 26+50 - Top of bank looking east.

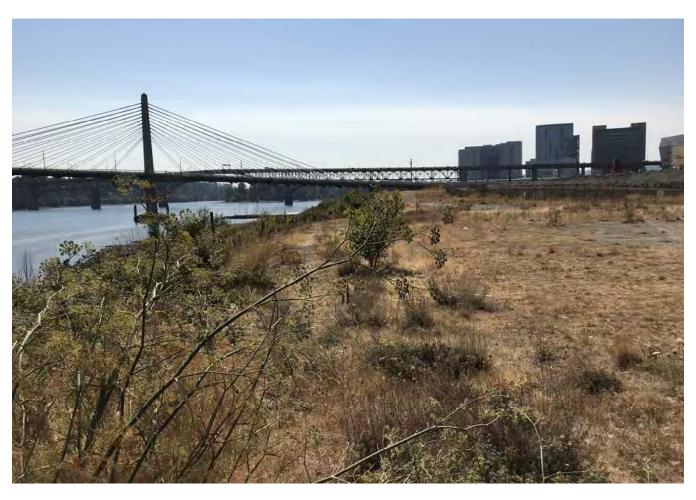
STA: 26+50 - Top of bank looking west.

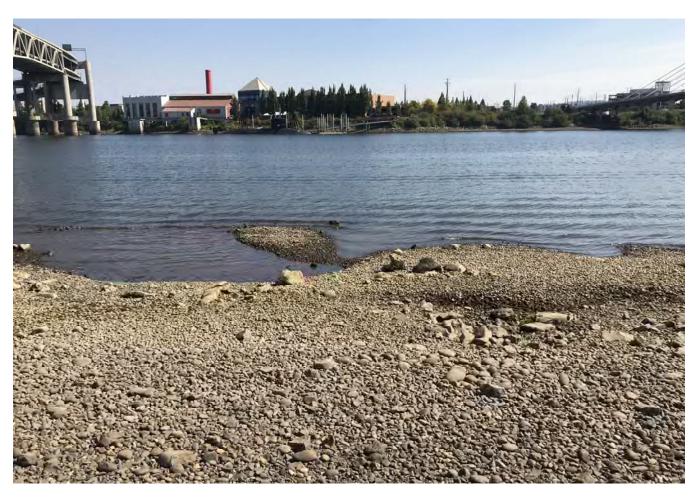
STA: 26+50 - Top of bank looking downstream.

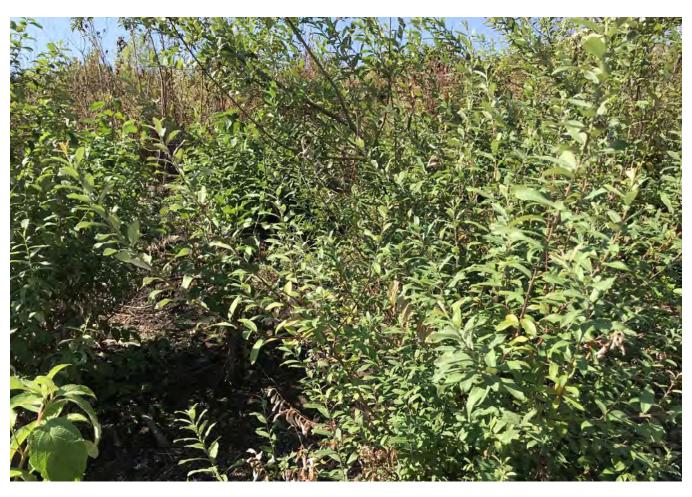
STA: 26+50 - Toe of slope looking east.

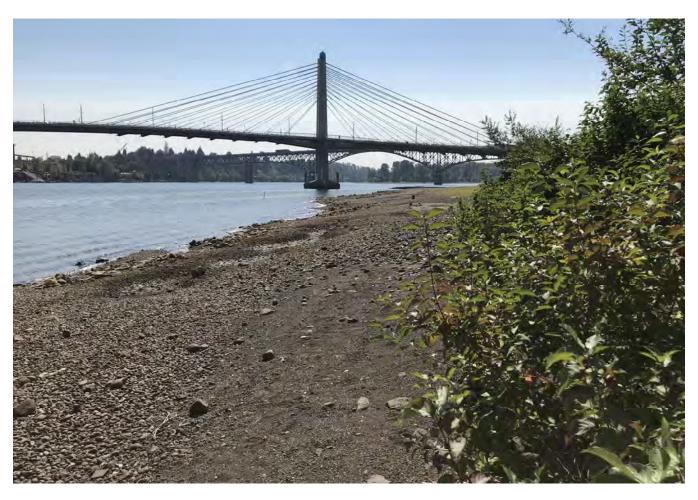
STA: 26+50 - Toe of slope looking west.

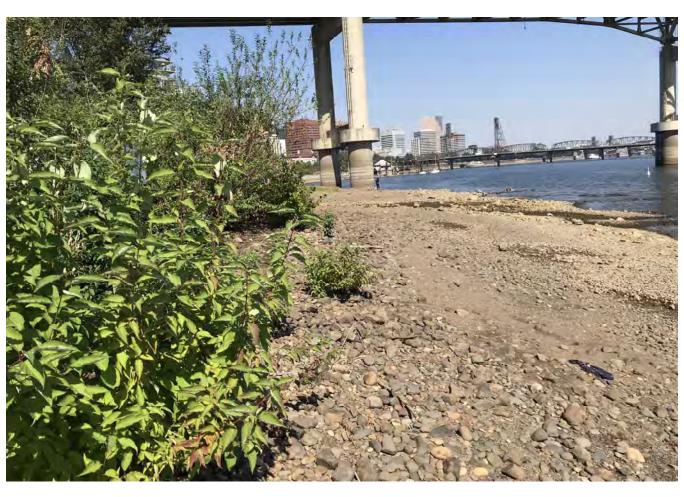
STA: 26+50 - Toe of slope looking upstream.

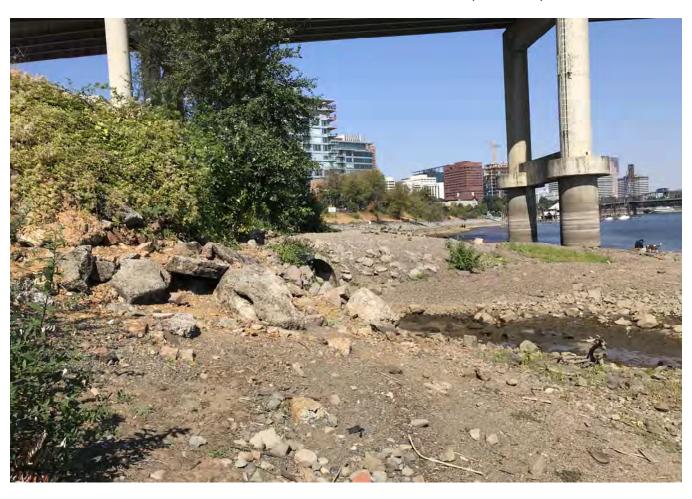
STA: 26+50 - Minor bank erosion on lower bank; with topsoil still in place.

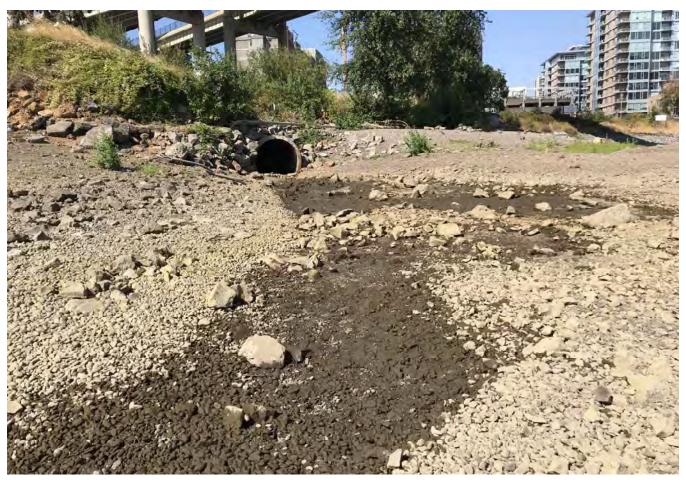
Cap area downstream of City outfall 07B.

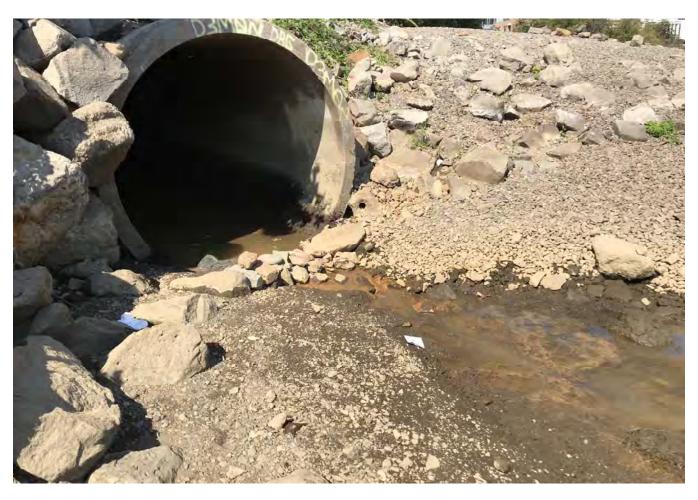
City outfall 07B.

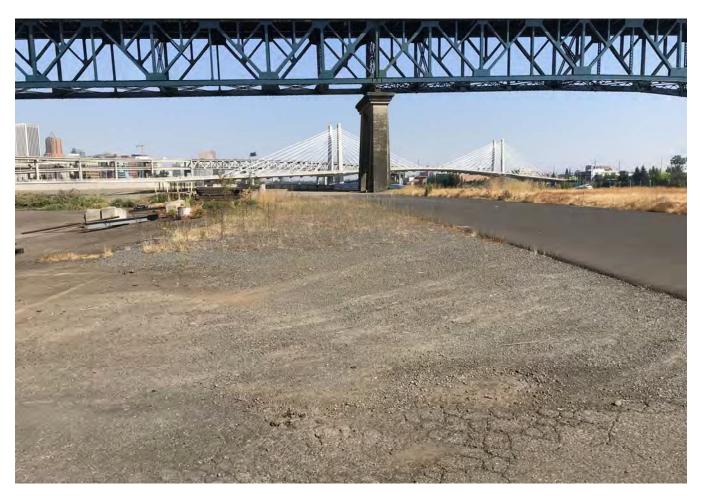
The sediment cap condition appears consistent with previous inspection with no notable changes. Significant sedimentation was observed over the shallow portions of the cap beneath the Tilikum Crossing.

Area under Tililkum Crossing Bridge.

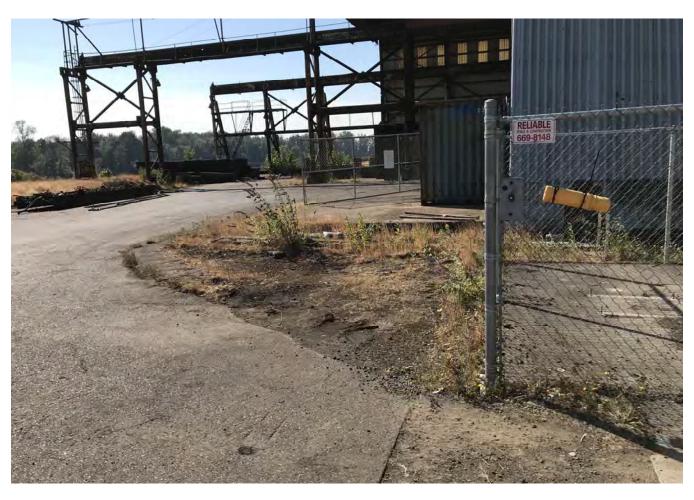
Operational area north of barge building looking west.

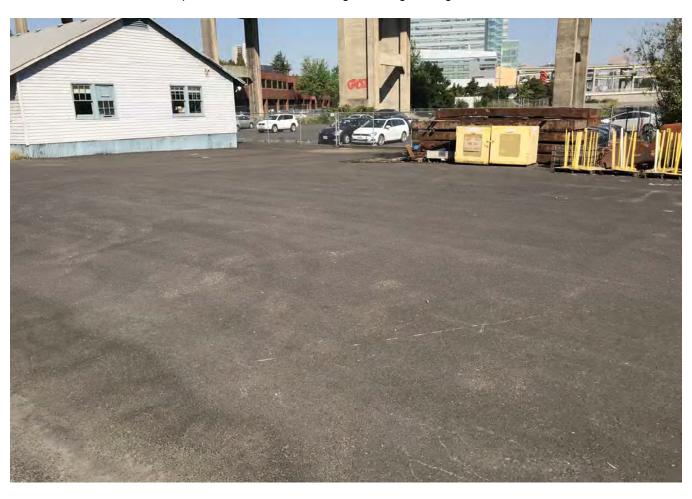
Operational area north of barge building looking southeast.

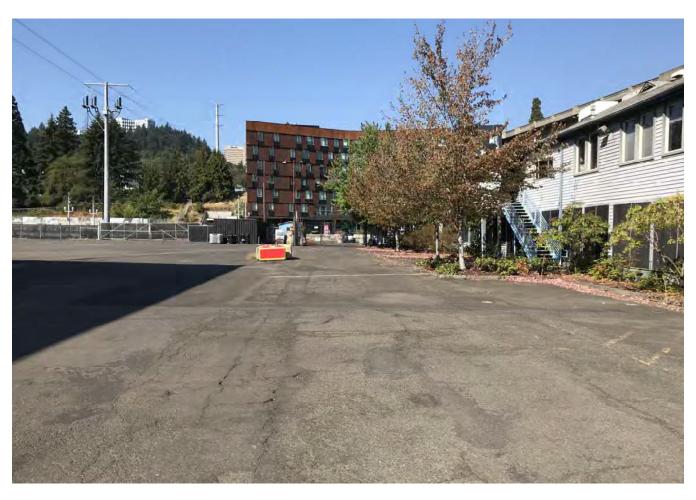
Operational area near office looking northwest.

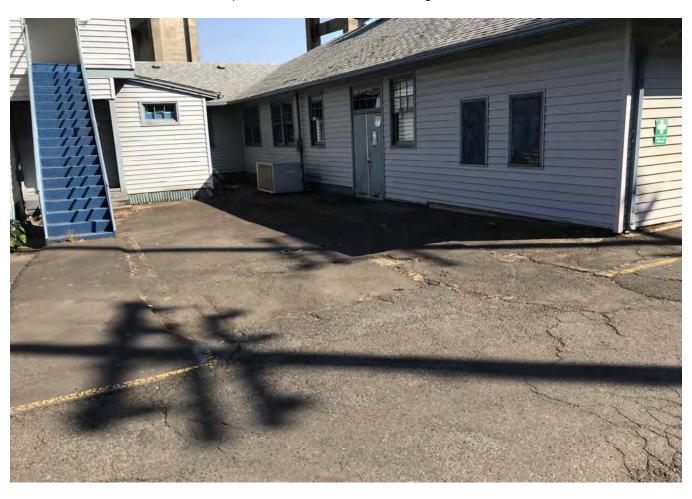
Operational area near office looking west.

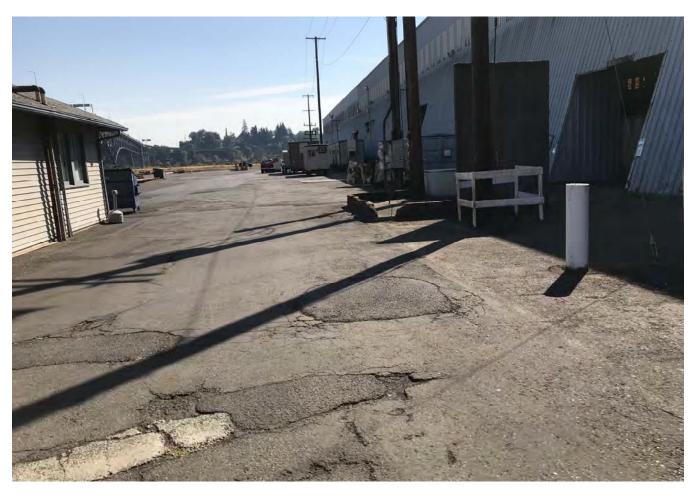
Office building, southeast corner looking north.

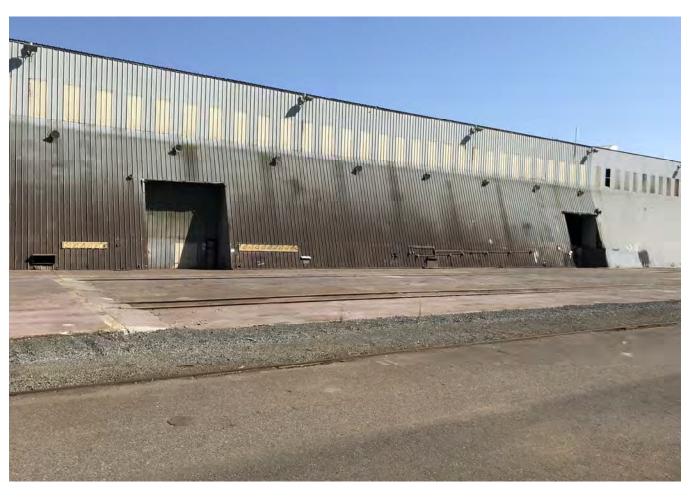
Operational area southwest of barge building looking east (photo directly above and below).

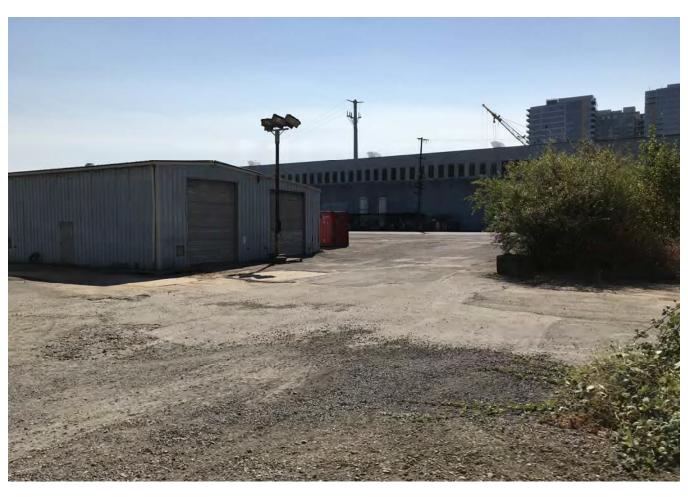
Paved operational area and boat building looking southeast.

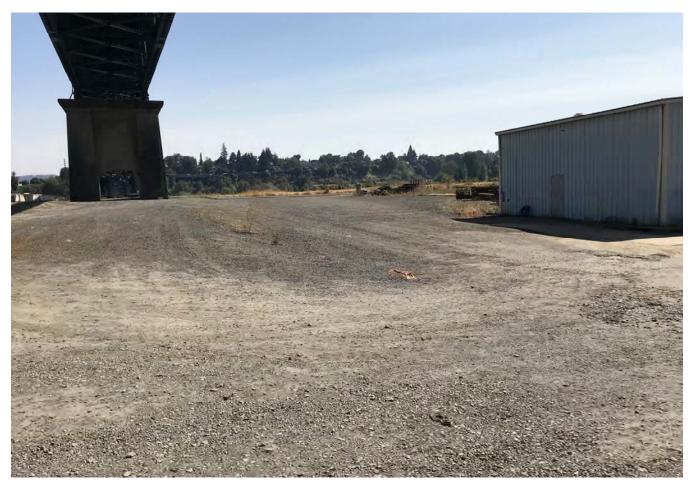
Operational area and boat building looking east.

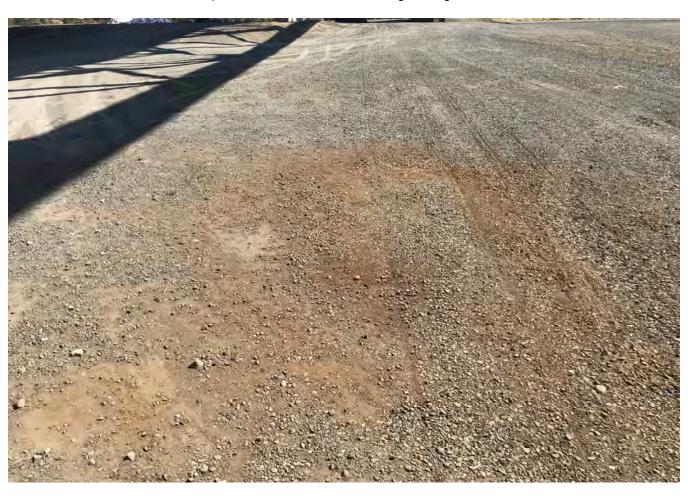
Gravel cap beneath Ross Island Bridge.

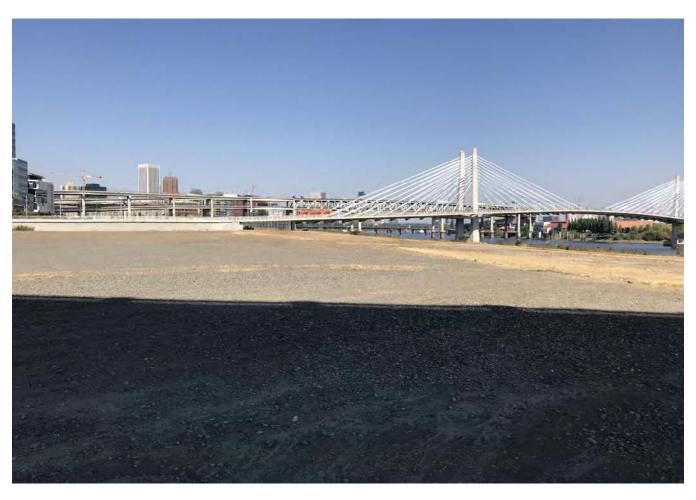
Upland cap, Southeast corner of site looking north.

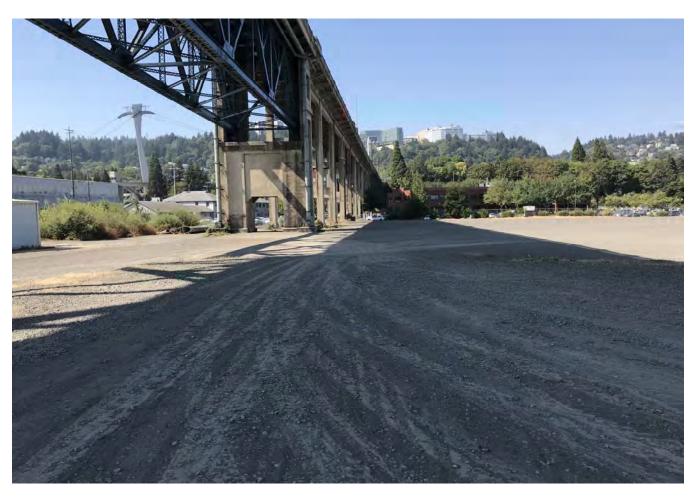
Upland cap, Southeast corner looking west.

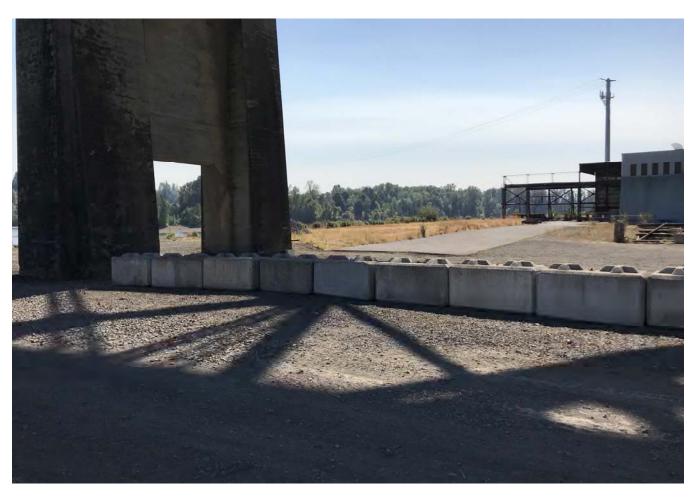
Upland cap, Southeast corner looking southeast.
