Re: Annual Site Activity Summary Report—2023

Zidell Waterfront Property, 3121 SW Moody Avenue, Portland, OR

2023 ANNUAL SITE INSPECTION SUMMARY

2023 Annual Site Inspection Summary

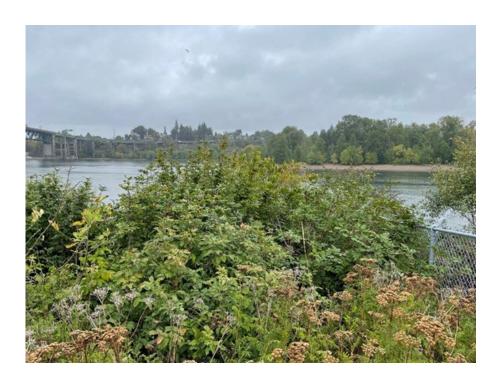
Photo No. 2.

STA 0+00: Top of bank looking west.

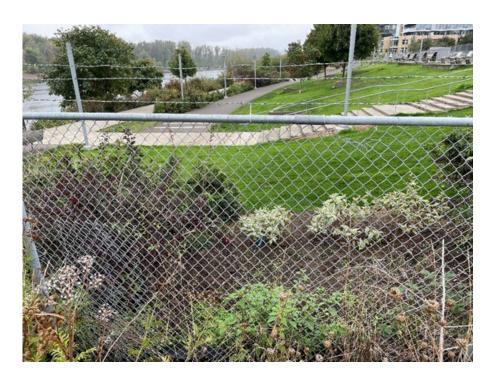
Photo No. 4.

STA 0+00: Top of bank looking north.

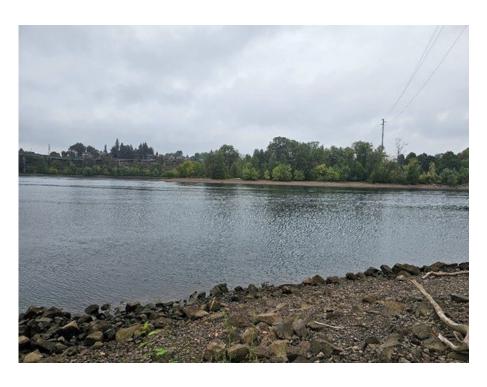
Photo No. 6.

STA 0+00: Top of rock armor looking west.

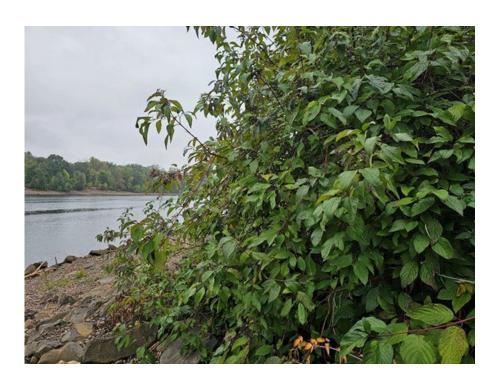
Photo No. 8.

STA 0+00: Top of rock armor looking north.

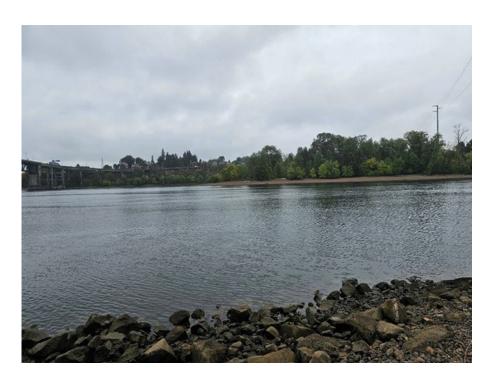
Photo No. 10.

STA 0+00: Toe of bank looking west.

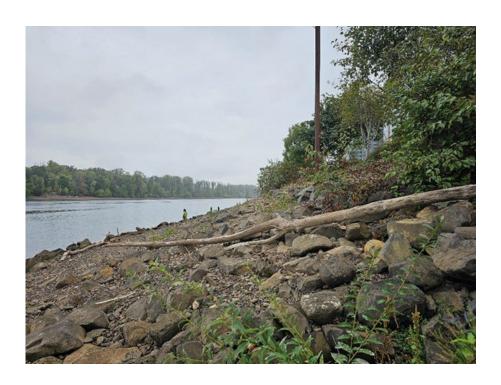
Photo No. 12.

STA 0+00: Toe of bank looking north.

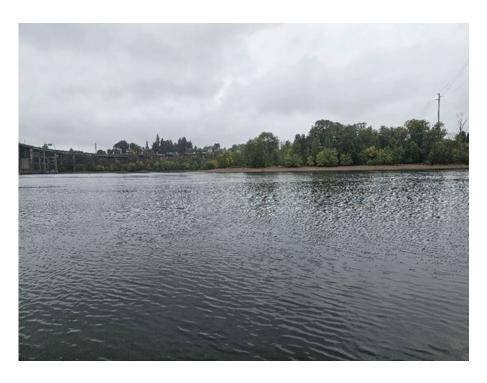
Photo No. 14.

STA 0+00: Edge of water looking west.

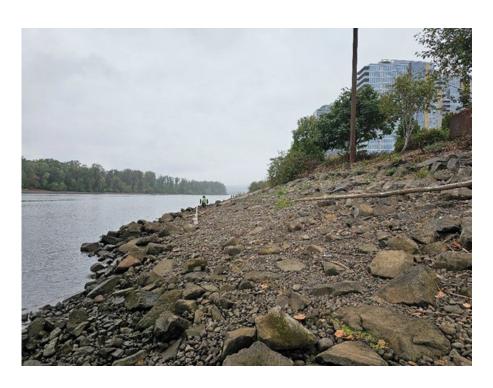
Photo No. 16.

STA 0+00: Edge of water looking north.

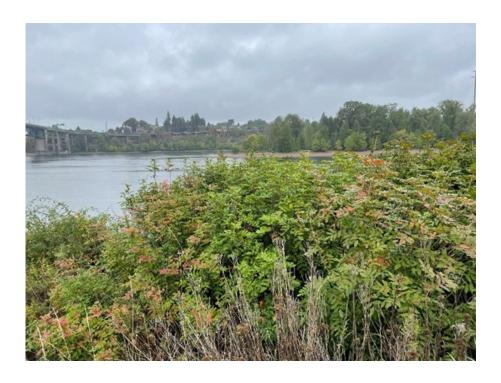
Photo No. 18.

STA 0+25: Top of bank looking west.

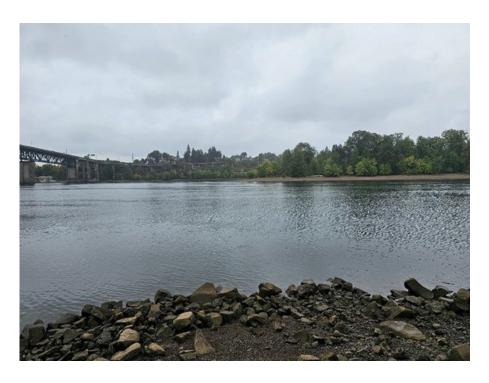
Photo No. 22.

STA 0+25: Top of rock armor looking west.

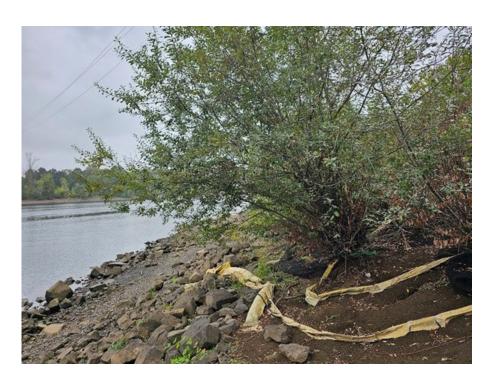
Photo No. 24.

STA 0+25: Top of rock armor looking north.

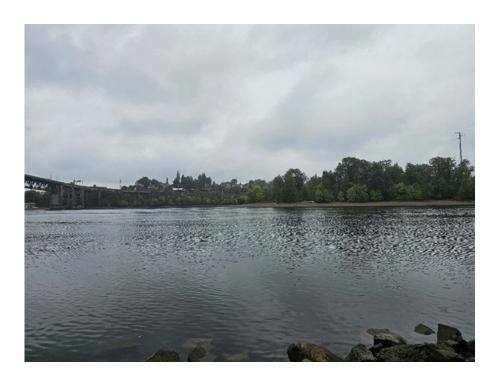
Photo No. 26.

STA 0+25: Toe of bank looking west.

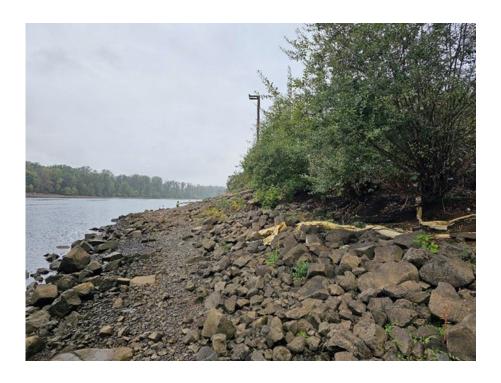
Photo No. 28.

STA 0+25: Toe of bank looking north.

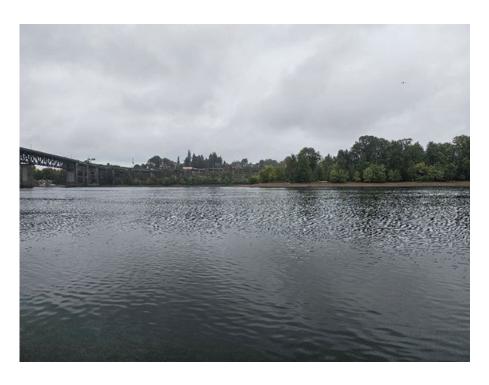
Photo No. 30.

STA 0+25: Edge of water looking west.

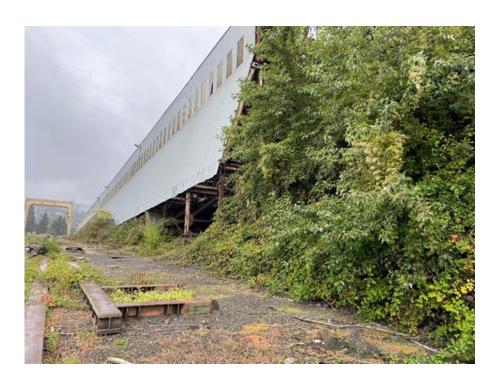
Photo No. 34.

The sediment cap is in generally good condition. Sediment buildup was observed in the slipway.

Slipway: Looking north at east end of structure.

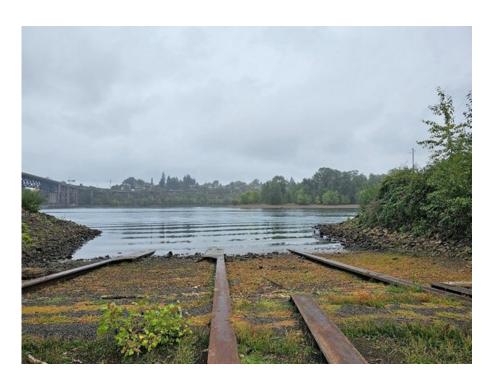
Photo No. 36.

Middle of slipway looking west.

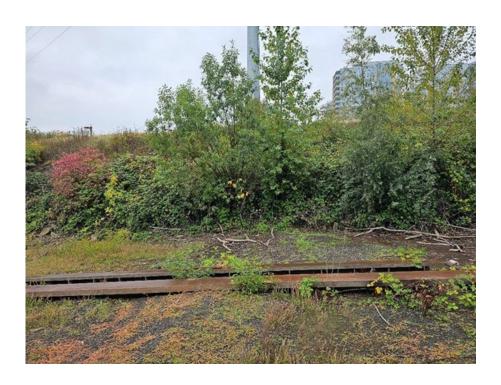
Photo No. 38.

Middle of slipway looking north.

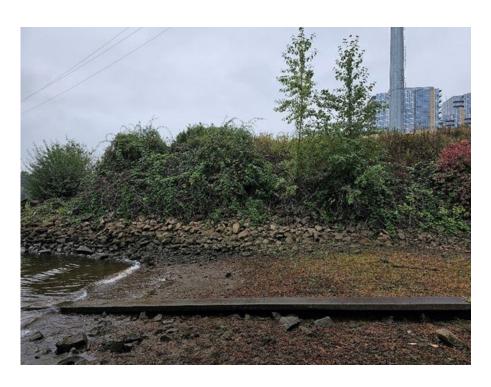
Photo No. 42.

Slipway: Edge of water looking north.

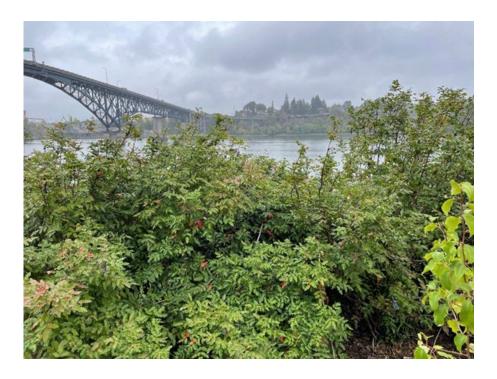
Photo No. 44.

STA 3+00: Top of bank looking west.

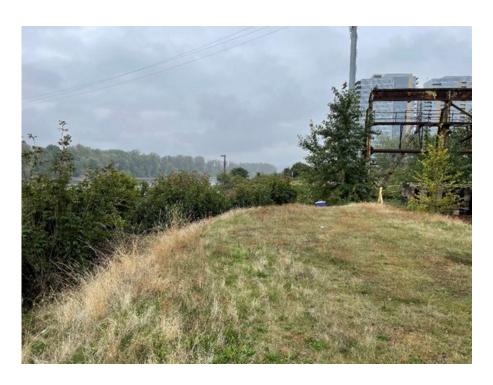
Photo No. 46. Description STA 3+00: Top of bank looking north.

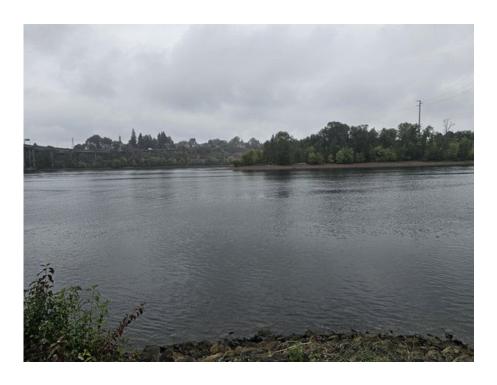
Photo No. 48. STA 3+00: Top of rock armor looking west.

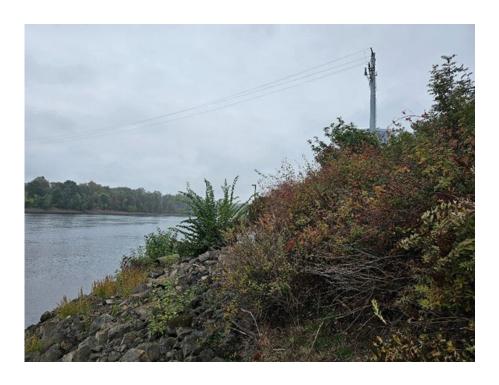
Photo No. 50.

STA 3+00: Top of rock armor looking north.

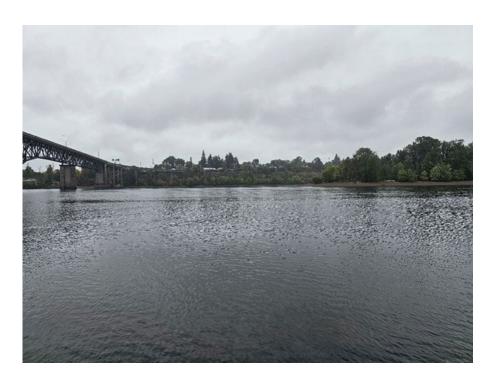
Photo No. 52.

STA 3+00: Toe of bank looking west.

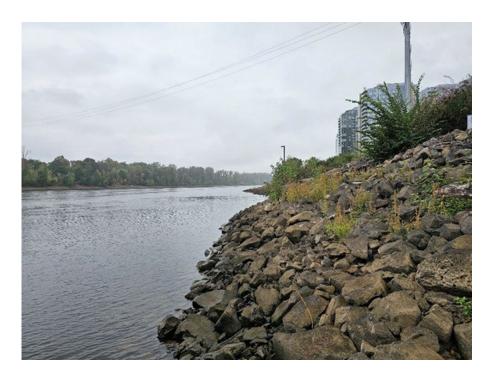
Photo No. 54.

STA 3+00: Toe of bank looking north.

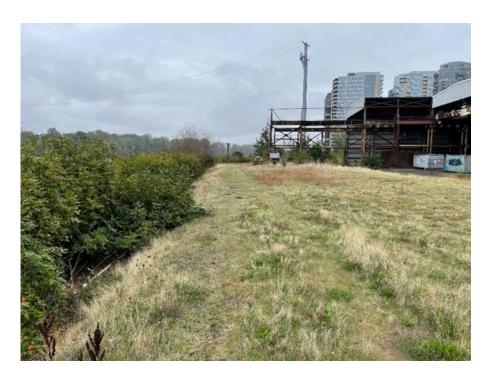
Photo No. 58.

STA 5+00: Top of bank looking north.

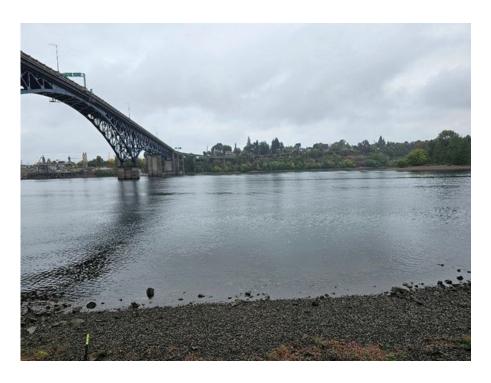
Photo No. 60.

STA 5+00: Top of rock armor looking west.

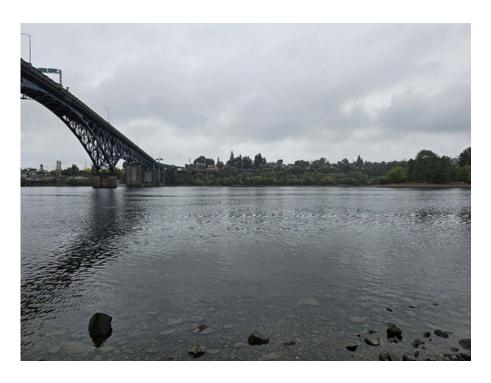
Photo No. 64.

STA 5+00: Toe of bank looking west.

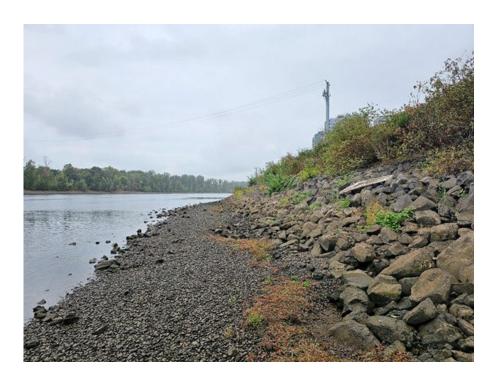
Photo No. 66.

Sediment cap is generally in good condition. Minor pockets of sediment deposition were observed at the toe of the bank where the rock armor intersects gravel and cobble armor around STA 5+00. There was no notable erosion along the south/middle bridge reach.

STA 5+00: Toe of bank looking north.

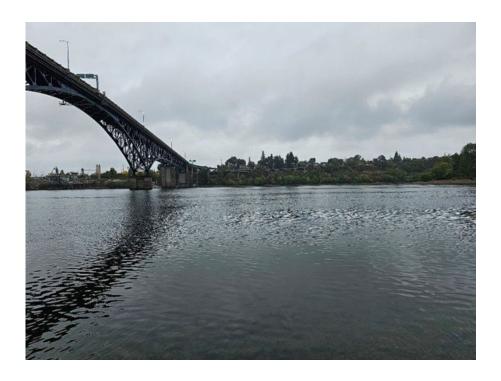
Photo No. 68.

STA 5+00: Edge of water looking west.

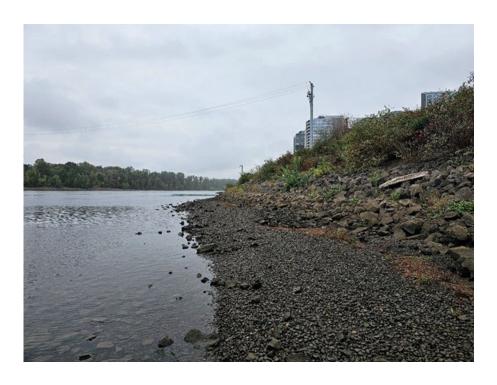
Photo No. 70.

STA 5+00: Edge of water looking north.

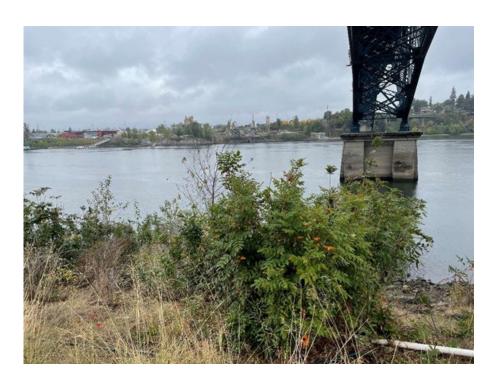
Photo No. 72.

STA 7+00: Top of bank looking west.

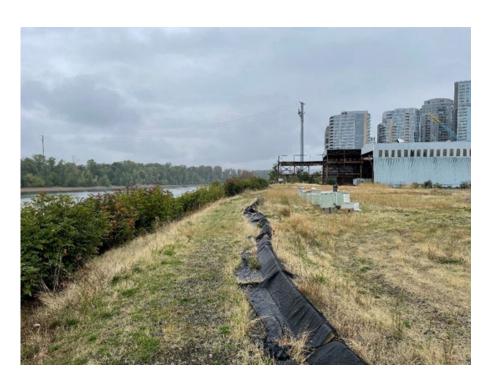
Photo No. 74.

STA 7+00: Top of bank looking north.

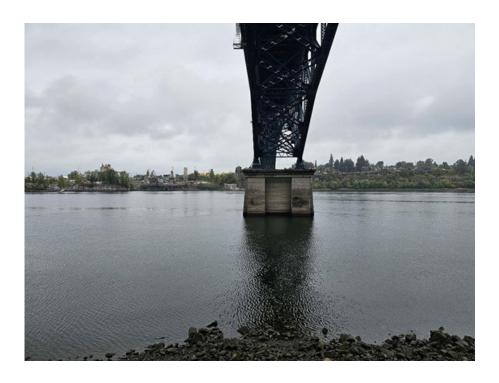
Photo No. 76.

STA 7+00: Top of rock armor looking west.

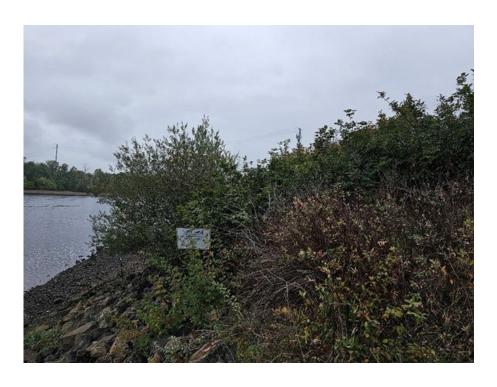
Photo No. 78.

STA 7+00: Top of rock armor looking north.

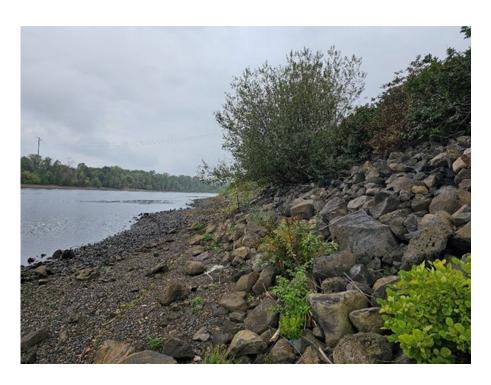
Photo No. 82.

STA 7+00: Top of bank looking north.

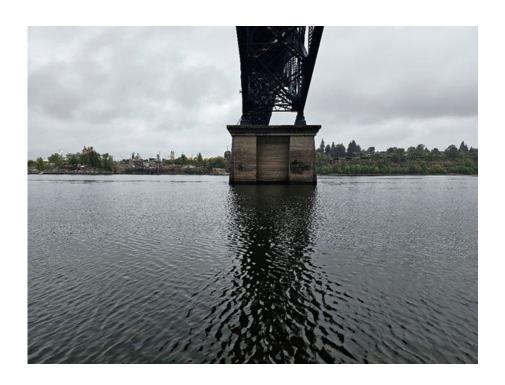
Photo No. 84.

STA 7+00: Edge of water looking west.

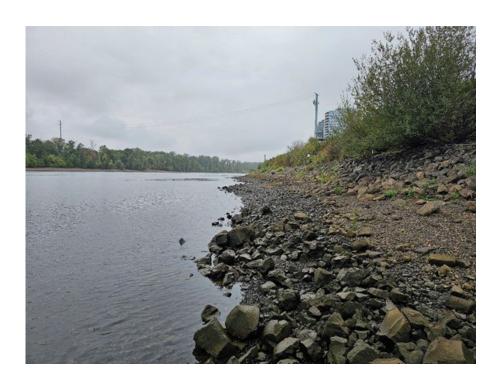
Photo No. 86.

STA 7+00: Edge of water looking north.

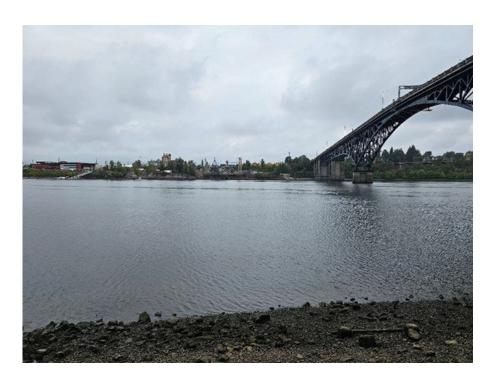
Photo No. 92.

STA 9+00: Top of rock armor looking west.

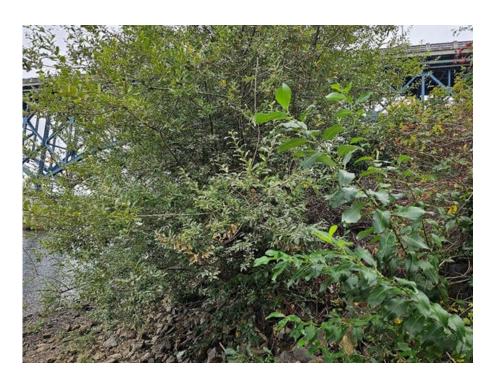
Photo No. 94.

STA 9+00: Top of rock armor looking north.

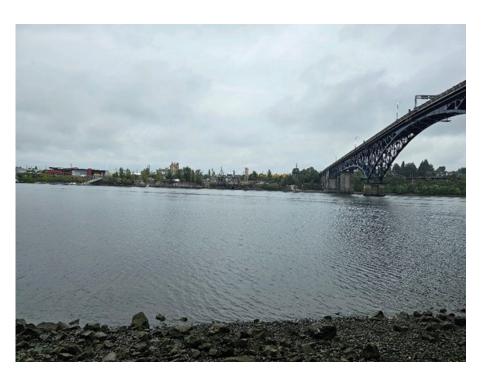
Photo No. 96.

STA 9+00: Toe of bank looking west.

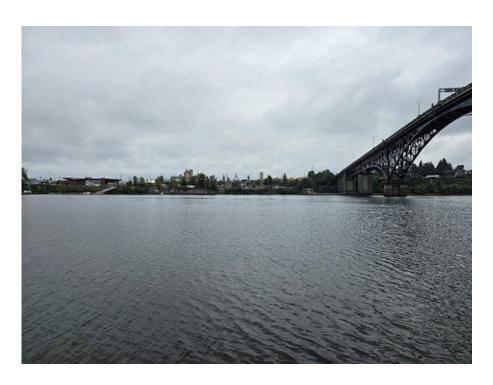
Photo No. 100.

STA 9+00: Edge of water looking west.

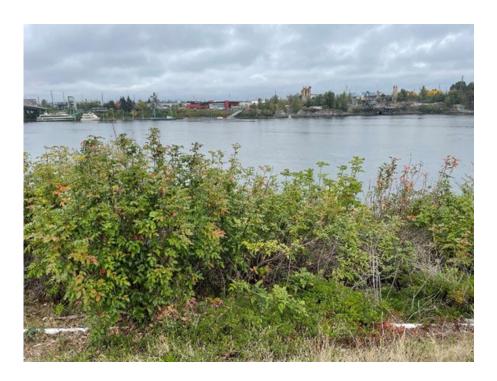
Photo No. 104.

STA 11+00: Top of bank looking west.

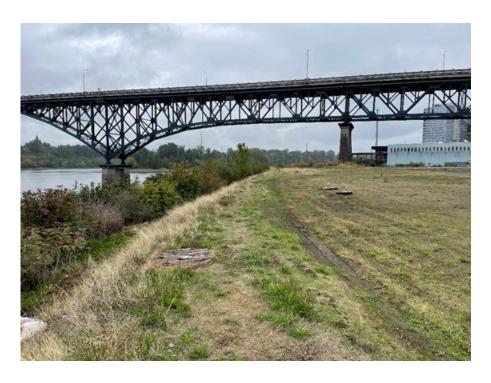
Photo No. 106.

STA 11+00: Top of bank looking north.

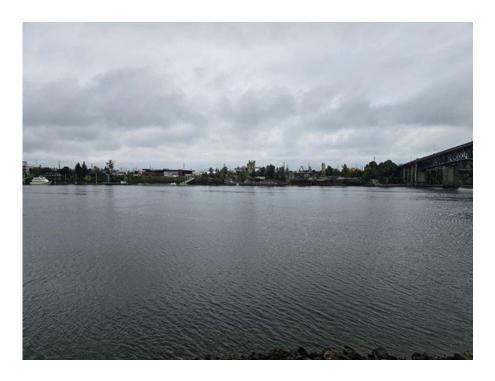
Photo No. 108.

STA 11+00: Top of rock armor looking west.

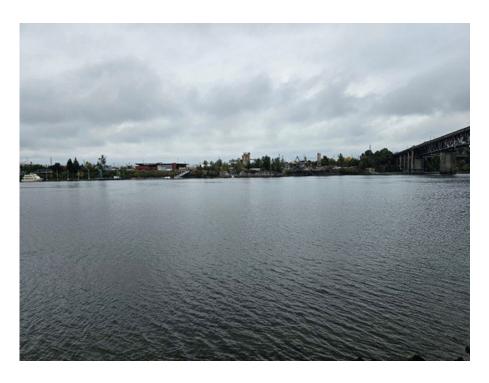
Photo No. 112.

STA 11+00: Toe of bank looking west.

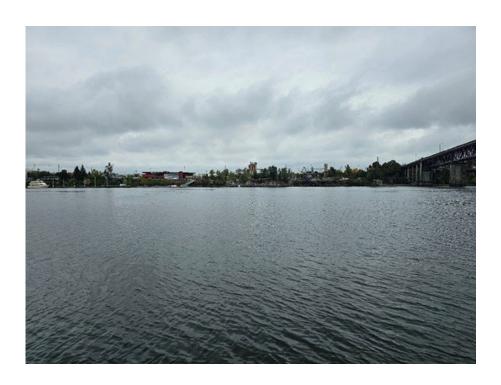
Photo No. 116.

STA 11+00: Edge of water looking west.

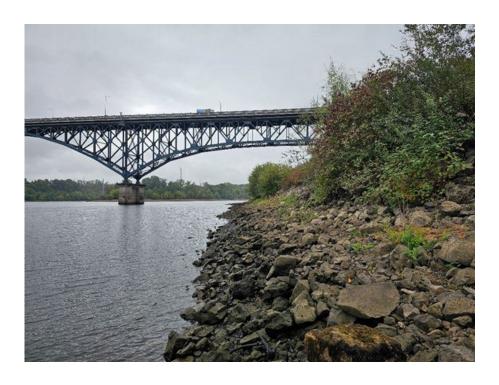
Photo No. 118.

STA 11+00: Edge of water looking north.

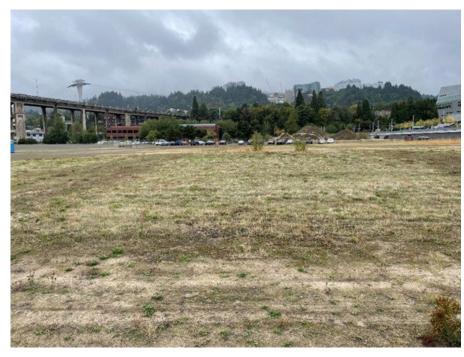
STA 13+00: Top of bank looking west.

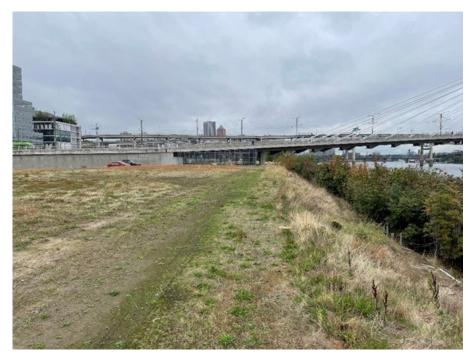
Photo No. 122.

STA 13+00: Top of bank looking north.

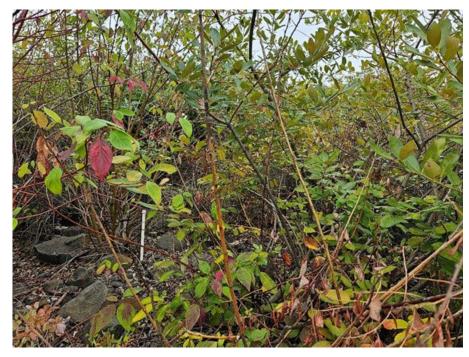
Photo No. 124.

STA 13+00: Top of rock armor looking west.

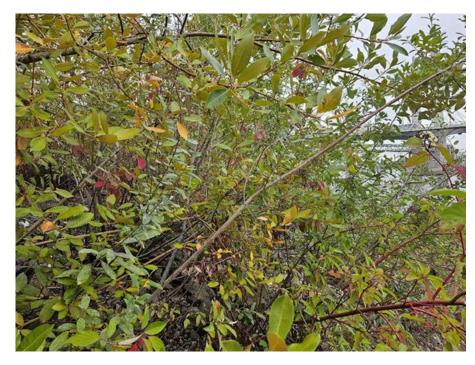
Photo No. 126.

STA 13+00: Top of rock armor looking north.

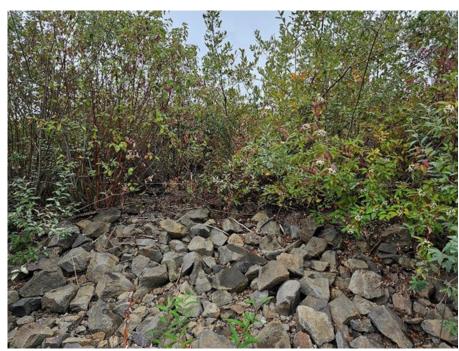
Photo No. 128.

STA 13+00: Toe of bank looking west.

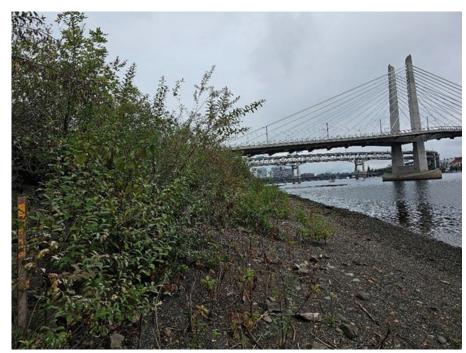
Photo No. 130.

STA 13+00: Toe of bank looking north.

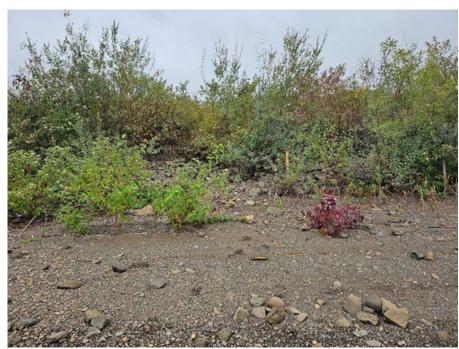
Photo No. 132.

STA 13+00: Edge of water looking west.

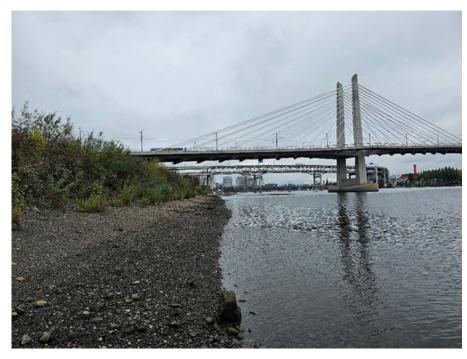
Photo No. 134.

STA 13+00: Edge of water looking north.

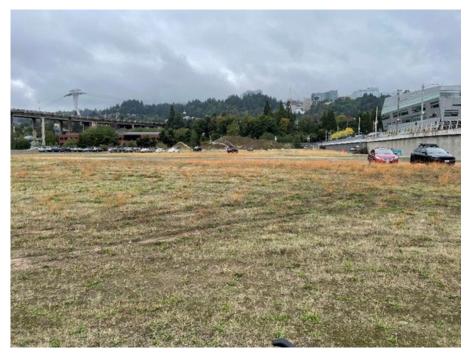
STA 15+00: Top of bank looking west.

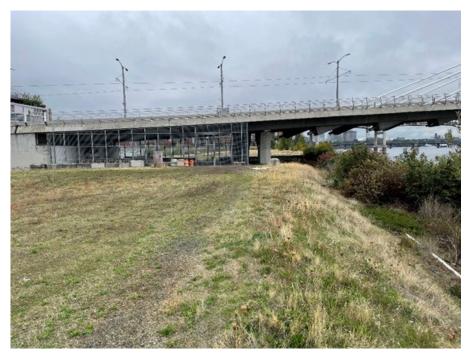
Photo No. 138.

STA 15+00: Top of bank looking north.

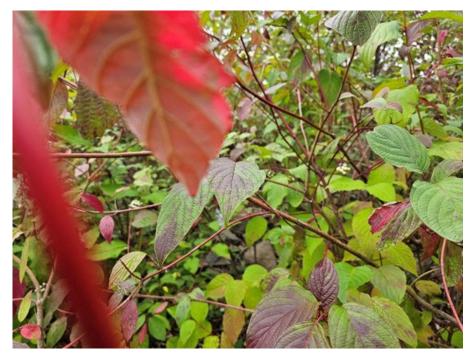
Photo No. 140.

STA 15+00: Toe of bank looking west.

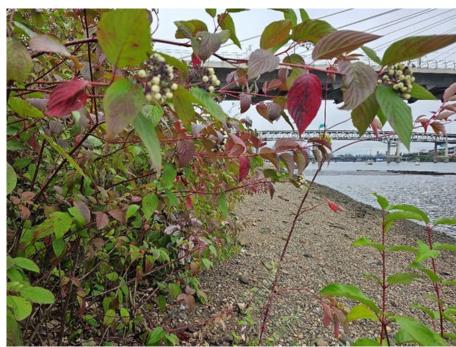
Photo No. 142.

STA 15+00: Toe of bank looking north.

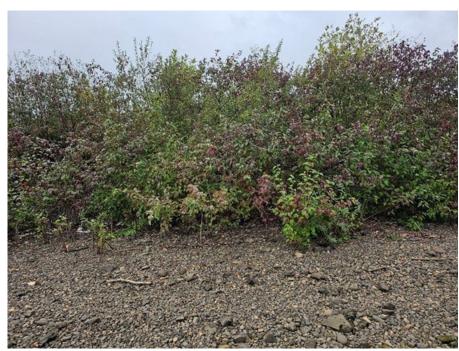
Photo No. 144.

STA 15+00: Edge of water looking west.

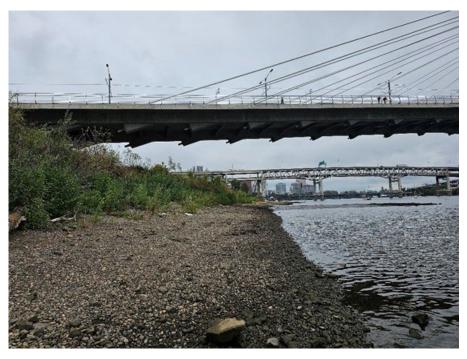
Photo No. 146.

STA 15+00: Edge of water looking north.

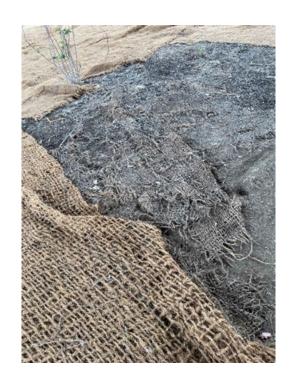
STA 17+00: Burnt erosion control mat beneath the Tilikum Crossing bridge deck. Soil is stable.

• Repair and replace burned coir matting as needed.

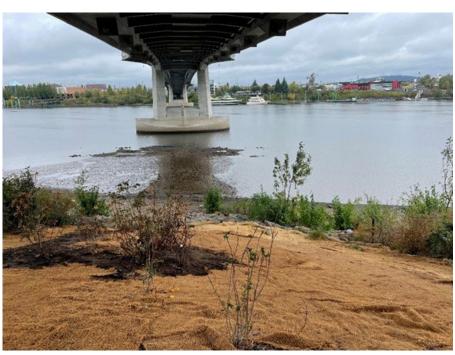
Photo No. 148.

STA 17+00: Top of bank looking east.

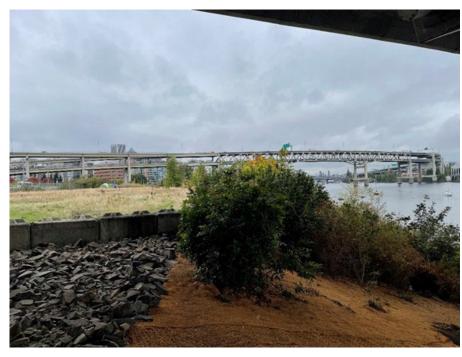
STA 17+00: Top of bank looking north.

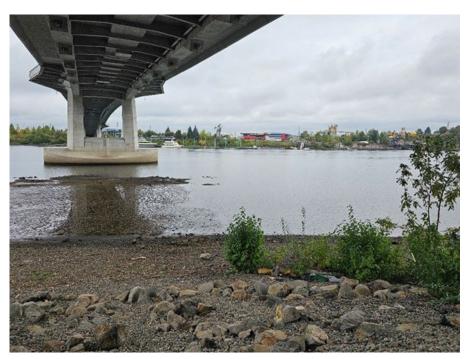
STA 17+00: Top of rock armor looking east.

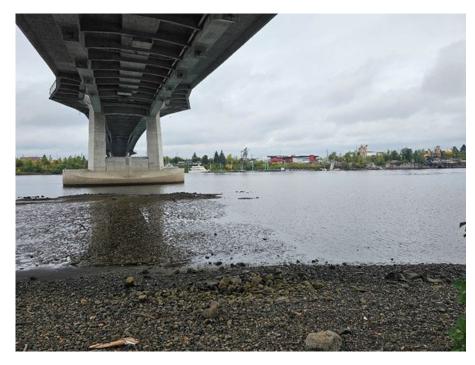
Photo No. 154.

STA 17+00: Toe of bank looking east.

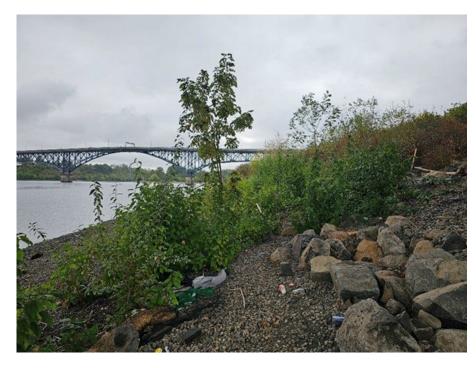
Photo No. 156.

STA 17+00: Toe of bank looking south.

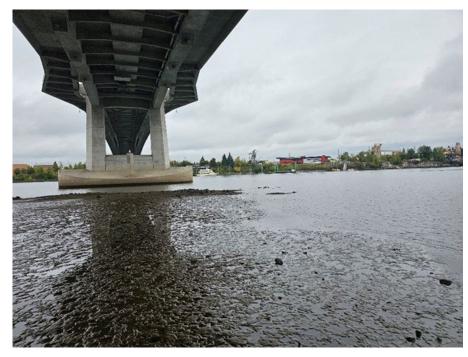
Photo No. 158.

STA 17+00: Edge of water looking east.

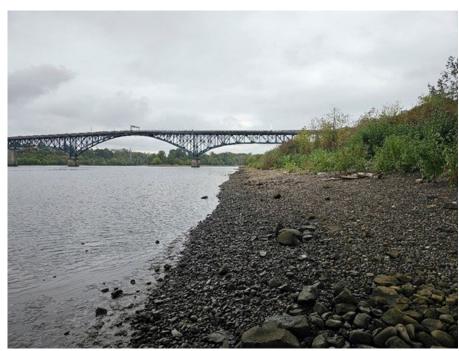
Photo No. 160.

STA 17+00: Edge of water looking south.

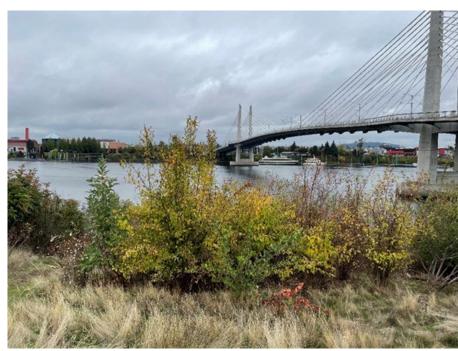
Photo No. 163.

STA 19+50: Top of bank looking west.

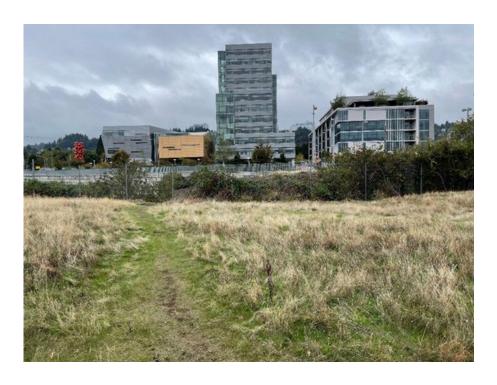
Photo No. 164.

STA 19+50: Top of bank looking south.

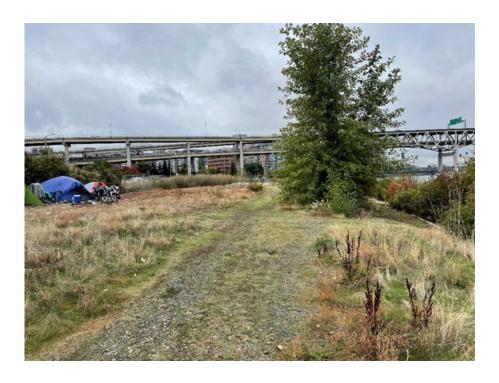
Photo No. 166.

STA 19+50: Top of rock armor looking east.

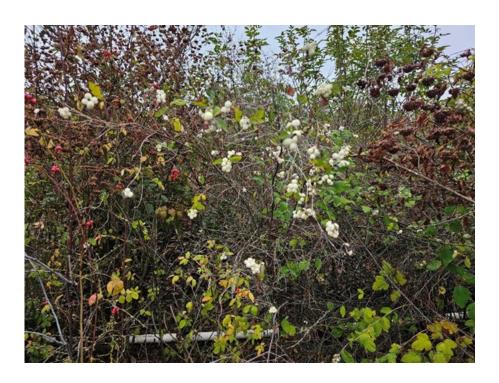
Photo No. 168.

STA 19+50: Top of rock armor looking south.

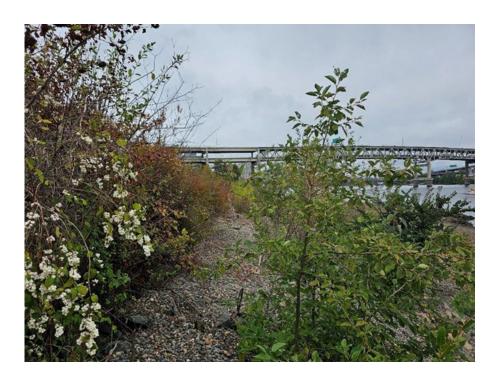
Photo No. 170.

STA 19+50: Toe of bank looking east.

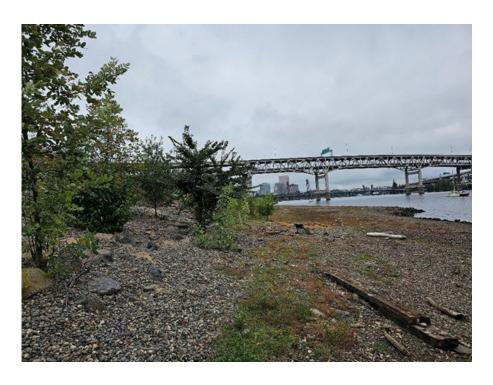
Photo No. 174.

STA 19+50: Edge of water looking east.

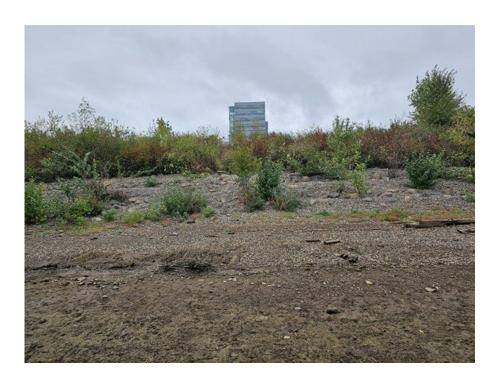
Photo No. 176.

STA 19+50: Edge of water looking south.

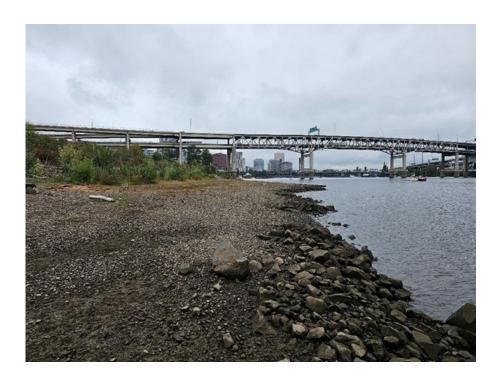
Photo No. 178.

STA 21+50: Top of bank looking east.

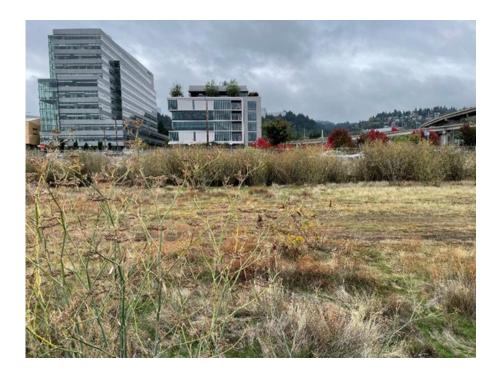
Photo No. 180.

STA 21+50: Top of bank looking south.

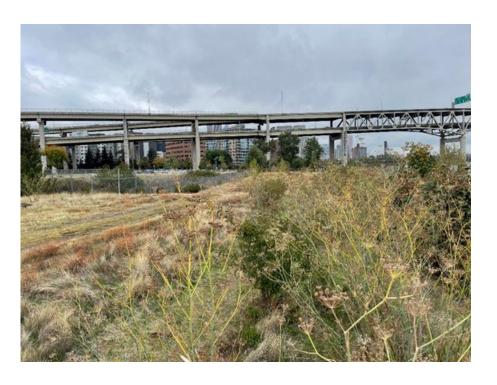
Photo No. 182.

STA 21+50: Top of rock armor looking east.

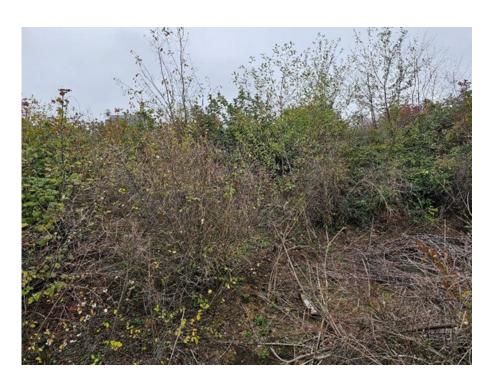
Photo No. 184.

STA 21+50: Top of rock armor looking south.

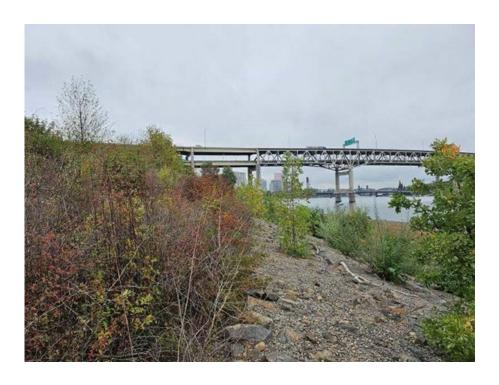
Photo No. 186.

STA 21+50: Toe of bank looking east.

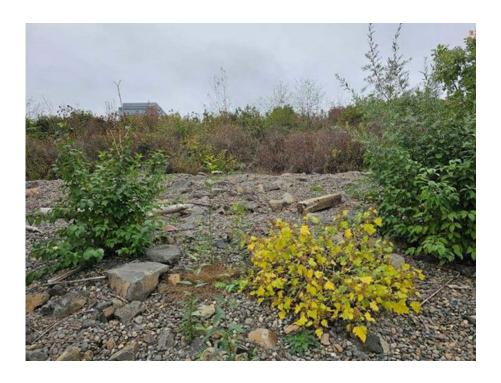
Photo No. 188.

STA 21+50: Toe of bank looking south.

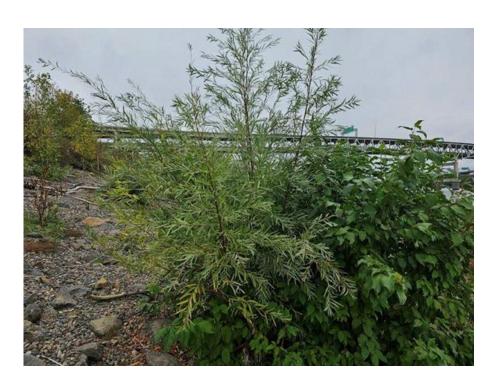
Photo No. 190.

STA 21+50: Edge of water looking east.

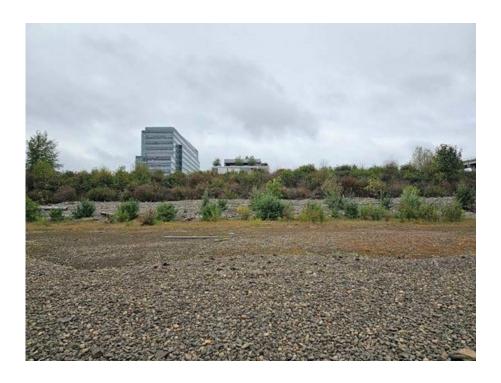
Photo No. 192.

STA 21+50: Edge of water looking south.

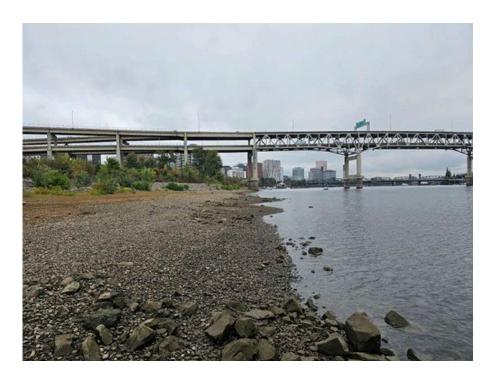
Photo No. 194.

STA 23+50: Top of bank looking east.

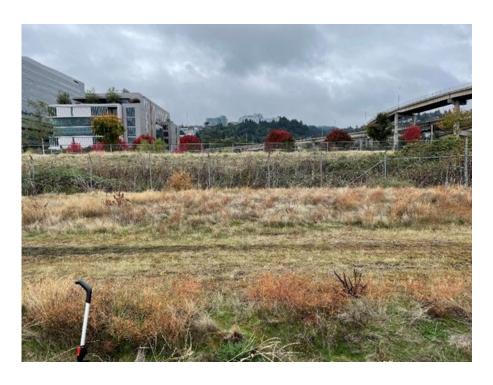
Photo No. 196.

STA 23+50: Top of bank looking south.

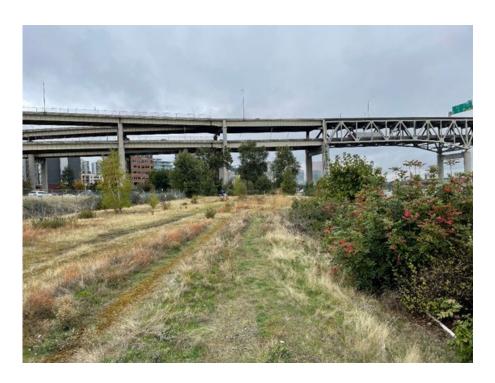
Photo No. 198.

Top of rock armor looking east.

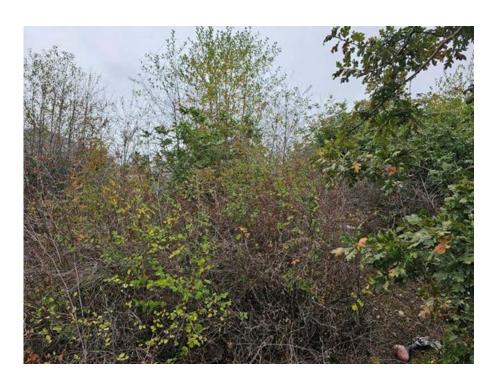
Photo No. 200.

STA 23+50: Top of rock armor looking south.

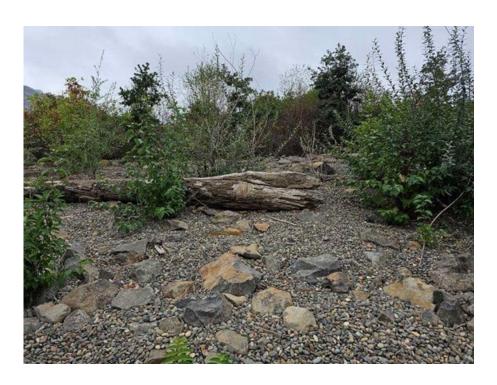
Photo No. 204.

STA 23+50: Toe of bank looking south.

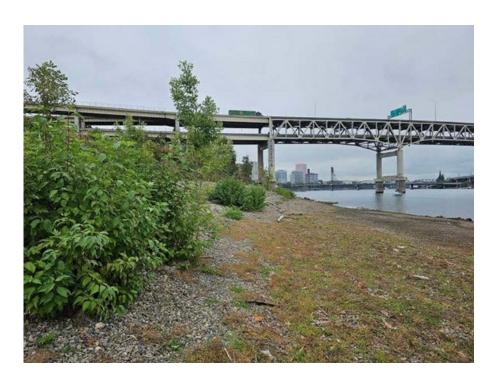
Photo No. 206.

STA 23+50: Edge of water looking east.

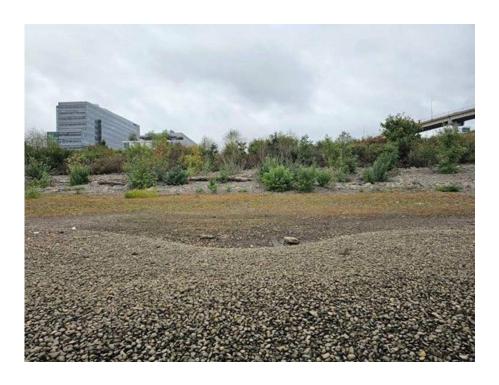
Photo No. 208.

STA 23+50: Edge of water looking south.

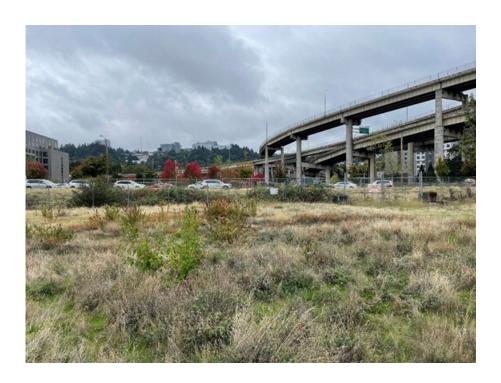
Photo No. 212.

STA 25+50: Top of bank looking south.

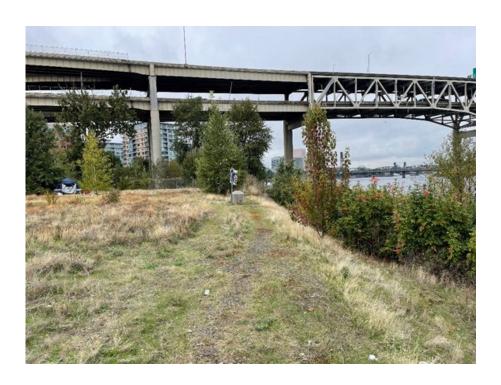
Photo No. 214.

STA 25+50: Top of rock armor looking east.

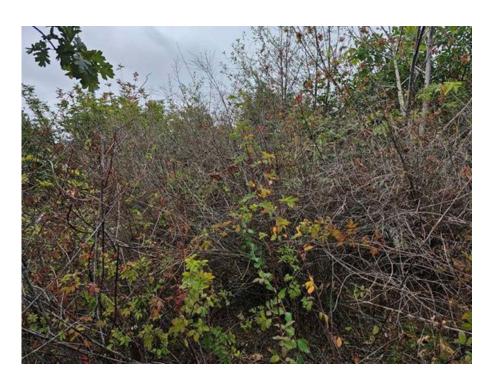
Photo No. 216.

STA 25+50: Top of rock armor looking south.

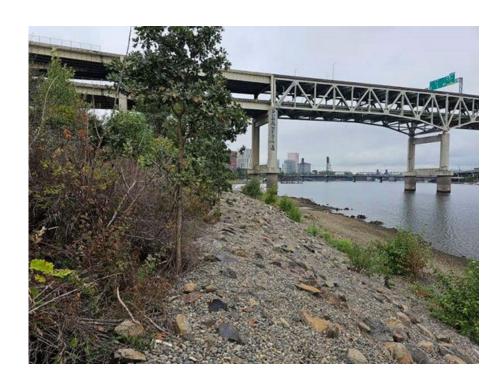
Photo No. 218.

STA 25+50: Toe of bank looking east.

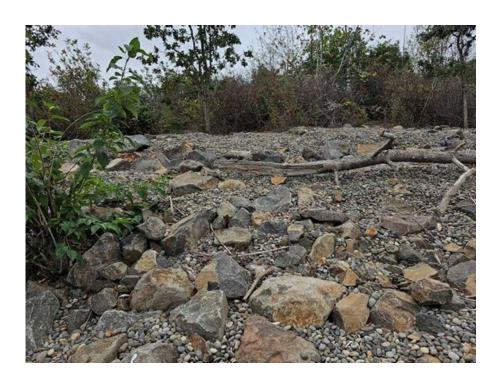
Photo No. 220.

STA 25+50: Toe of bank looking south.

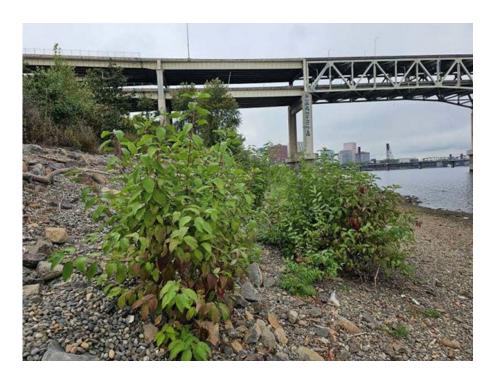
Photo No. 222.

STA 25+50: Edge of water looking east.

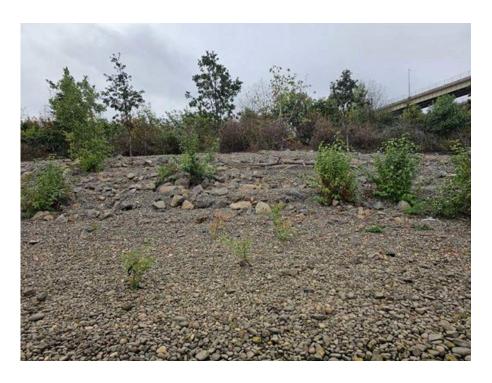
Photo No. 224.

STA 25+50: Edge of water looking south.

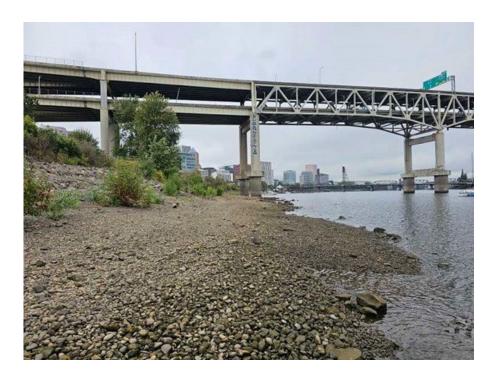
Photo No. 226.

Northern edge of the upland cap, located just south of the Tilikum

Crossing, looking east.

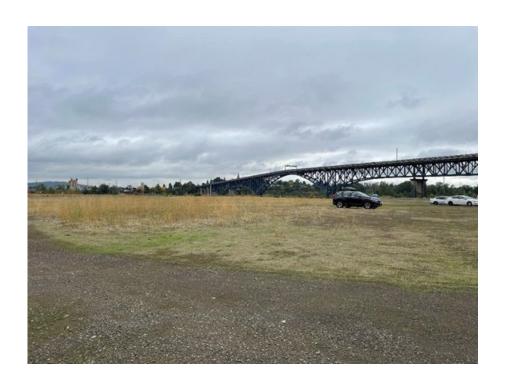
Photo No. 228.

Northern edge of the upland cap, located just south of the Tilikum Crossing, looking south.

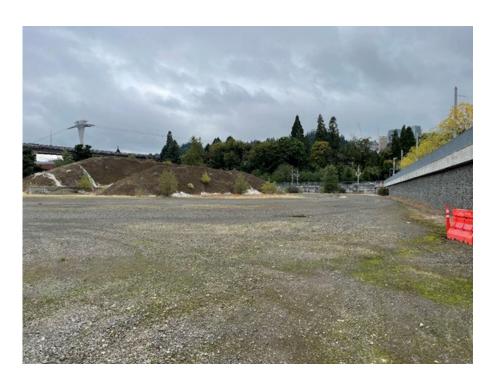
Photo No. 230.

Northwest corner of the upland cap, located just south of the Tilikum Crossing, looking east.

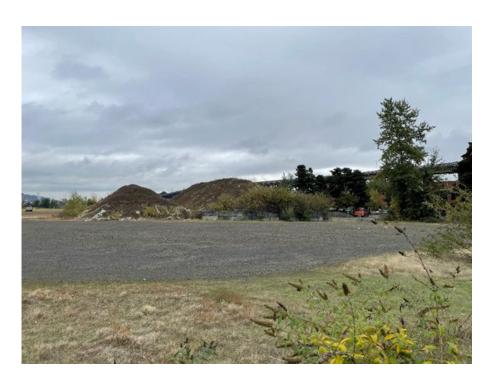
Northern edge of the upland cap, located just south of the Tilikum Crossing, looking east.

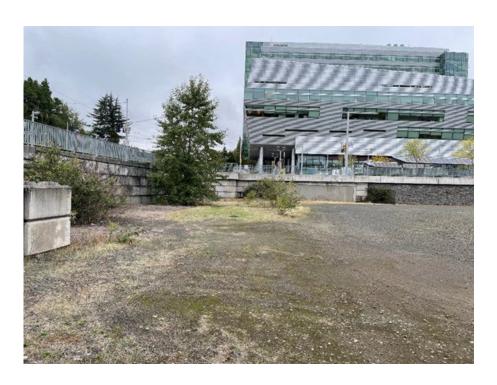
Photo No. 234.

Western edge of the upland cap, looking northeast.

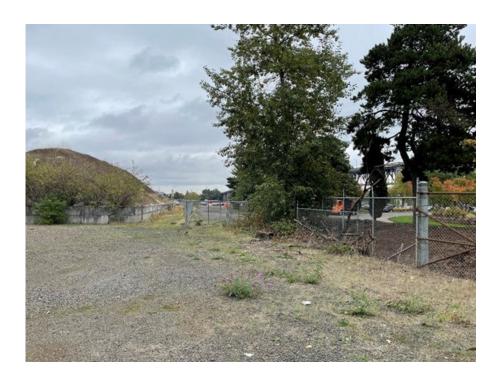
Photo No. 236.

Northern edge of the upland cap, located just south of the Tilikum Crossing, looking east.

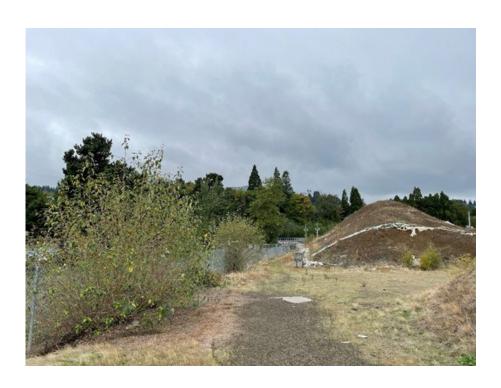
Northwest entrance of the upland cap, looking north.

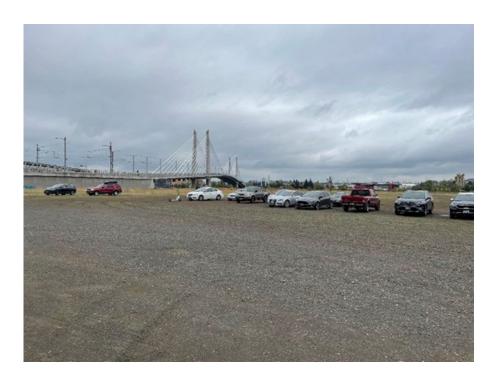
Northwest entrance of the upland cap, looking east.

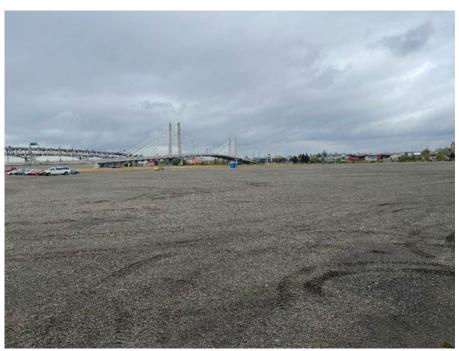
Photo No. 243.

Western edge of the upland cap, located beneath the Sellwood Bridge, looking northwest.

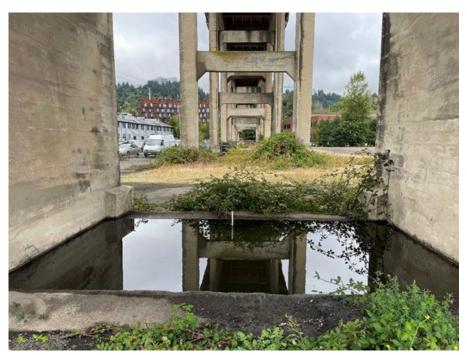
Photo No. 245.

Standing water beneath the Sellwood Bridge, looking west.

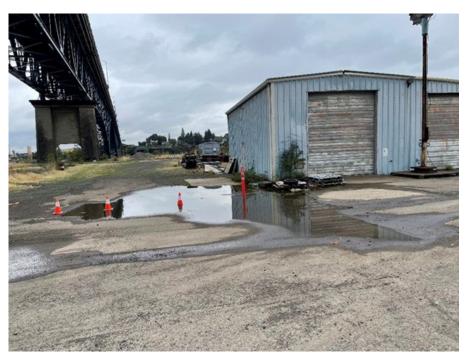
Photo No. 247.

The upland gravel cap north of the Ross Island Bridge appears in good condition. No changes to the asphalt cap were observed to the south of the Ross Island Bridge. A possible leak from the city water works main on the Ross Island Bridge has created a constant puddle located below the south side of the bridge. Equipment and materials were removed from the operational areas following closure of barge building operations. The building's interior is secured and was not accessible during the inspection.

Puddle from suspected water works pipe leak at Ross Island Bridge, looking east.

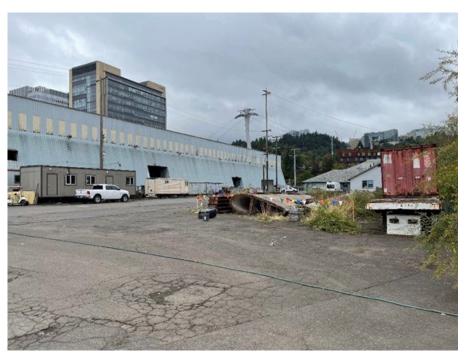
Photo No. 249.

The southern section of the upland cap, looking southwest.

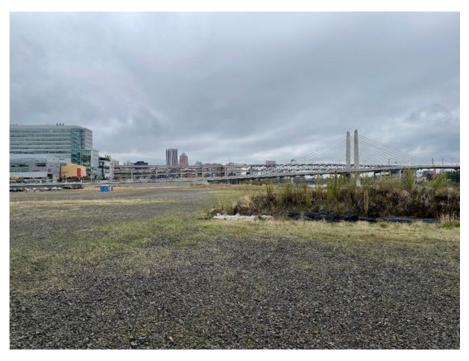
Photo No. 251.

A view from the southern section of the upland cap, looking north.

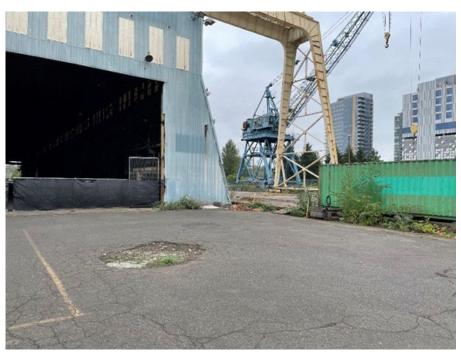
Southwest corner of the upland cap, looking northeast.
